NASA TN D-6845

APOLLO EXPERIENCE REPORT -
LUNAR MODULE INSTRUMENTATION SUBSYSTEM

by David E. O'Brien III and Jared R. Woodfill IV

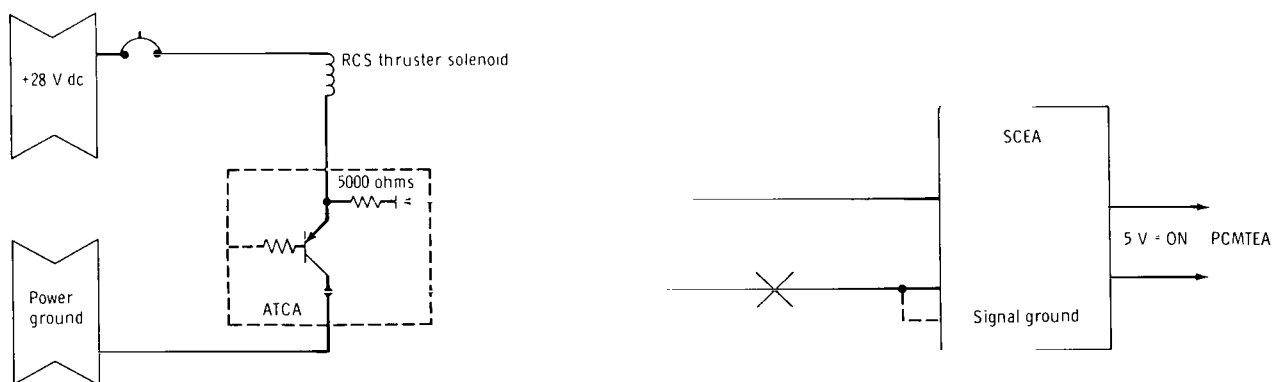
Figure 13. - Discrete buffer, showing the lead to power ground rerouted to signal ground.

Some difficulties arose during the vehicle/instrumentation-subsystem integration. One of the most difficult problems involved the discrete buffer that monitors the reaction control subsystem (RCS) thruster commands in the attitude and translation control assembly (ATCA) (fig. 13). The discrete buffer is designed to monitor either mechanical or solid-state switch closures. The buffer gives a 5-volt ON signal when the resistance across mechanical contacts drops below 120 000 ohms or when the voltage across a solid-state switch drops below 4 volts with a corresponding drop in resistance. The firing command is given in the ATCA by grounding the low side of a solenoid through a transistor switch. The inputs of the discrete buffers are connected across the transistor so that, when the system is activated, the buffer input senses 28 volts until a firing command is given; then, voltage drops to zero and the buffers produce a 5-volt ON output signal. The problem arose when the solenoid circuit breaker was open and no voltage was present across the transistor and buffer inputs. The high emitter-to-collector resistance normally prevents the buffer from giving the ON signal. However, during these periods of no voltage on the transistor, the buffer would occasionally output the 5-volt ON signal. This problem was attributed to noise on the power ground to which one side of the buffer was connected. This connection was moved to signal ground, and the other input remained on the high side (emitter) of the transistor.

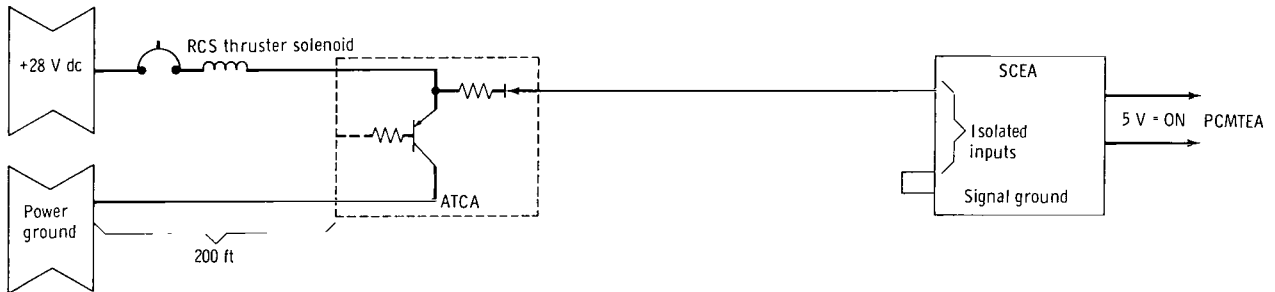
Figure 14. - Discrete buffer, showing how the 200-foot ground lead produced a +6-V dc potential between SCEA and signal ground.

After this change, RCS tests were performed at the White Sands Test Facility (WSTF), and a new problem appeared in the form of short-firing indications. The buffer would give the ON command and then go OFF after a few seconds while the ATCA was still firing the thrusters. The cause of this problem was traced to the setup at the WSTF. The ATCA and the SCEA were located in the blockhouse, and command wires were routed to the pad where the thruster and the electrical power were located. Therefore, the ground wire leading from the collector of the transistors was approximately 200 feet in length (fig. 14). When the firing command was given, the voltage at the transistor dropped to zero, but rose to 6 volts as the current through the solenoid increased. This 6-volt rise was caused by the IR (current \times resistance) drop across the 200-foot ground lead. If the buffer had been connected in the original configuration, with its low side on the collector instead of on signal ground, this short-firing indication would not have occurred. Only a small (0.5 volt) drop across the transistor rather than the 6-volt drop between the transistor and the battery ground would have reached the buffer. No modification was made to the WSTF test setup after the problem had been identified.

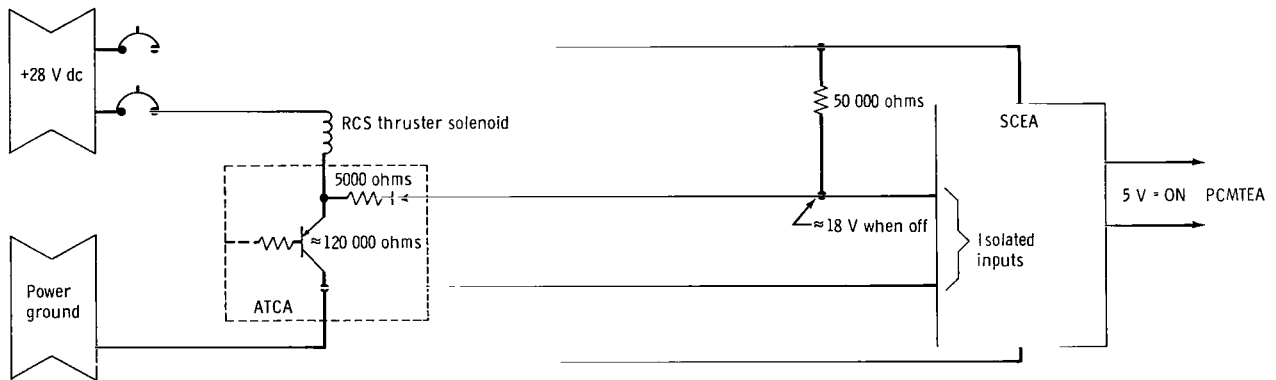
Figure 15. - Discrete buffer, showing how a 50 000-ohm resistor between SCEA power and ATCA transistor produced approximately 18 V dc when transistor was off.

Meanwhile, the first problem (spurious jet firing) still was occurring occasionally. Further investigation revealed that some of the ATCA transistors had a low emitter-to-collector resistance of approximately 120 000 to 130 000 ohms. This low resistance, with noise on the power ground, was sufficient to trigger the buffer into the ON state sporadically. With the new information, the low side of the buffer input was returned to the collector side of the transistor, and a 50 000-ohm resistor was placed between the SCEA circuit breaker and the emitter side of the ATCA transistor (fig. 15). This resistor formed a voltage divider whenever the SCEA was energized and maintained approximately 18 volts across the buffer input until the transistor switched on and the voltage dropped to approximately 0.5 volt. The current through the resistor and transistor was negligible with the transistor on or off. This arrangement proved to be a satisfactory fix for the interface incompatibility.

The first problem occurred again when the open-contact resistance of a relay decreased with usage until it reached the 120 000-ohm level and triggered the buffer on. This condition was eliminated in a similar manner.

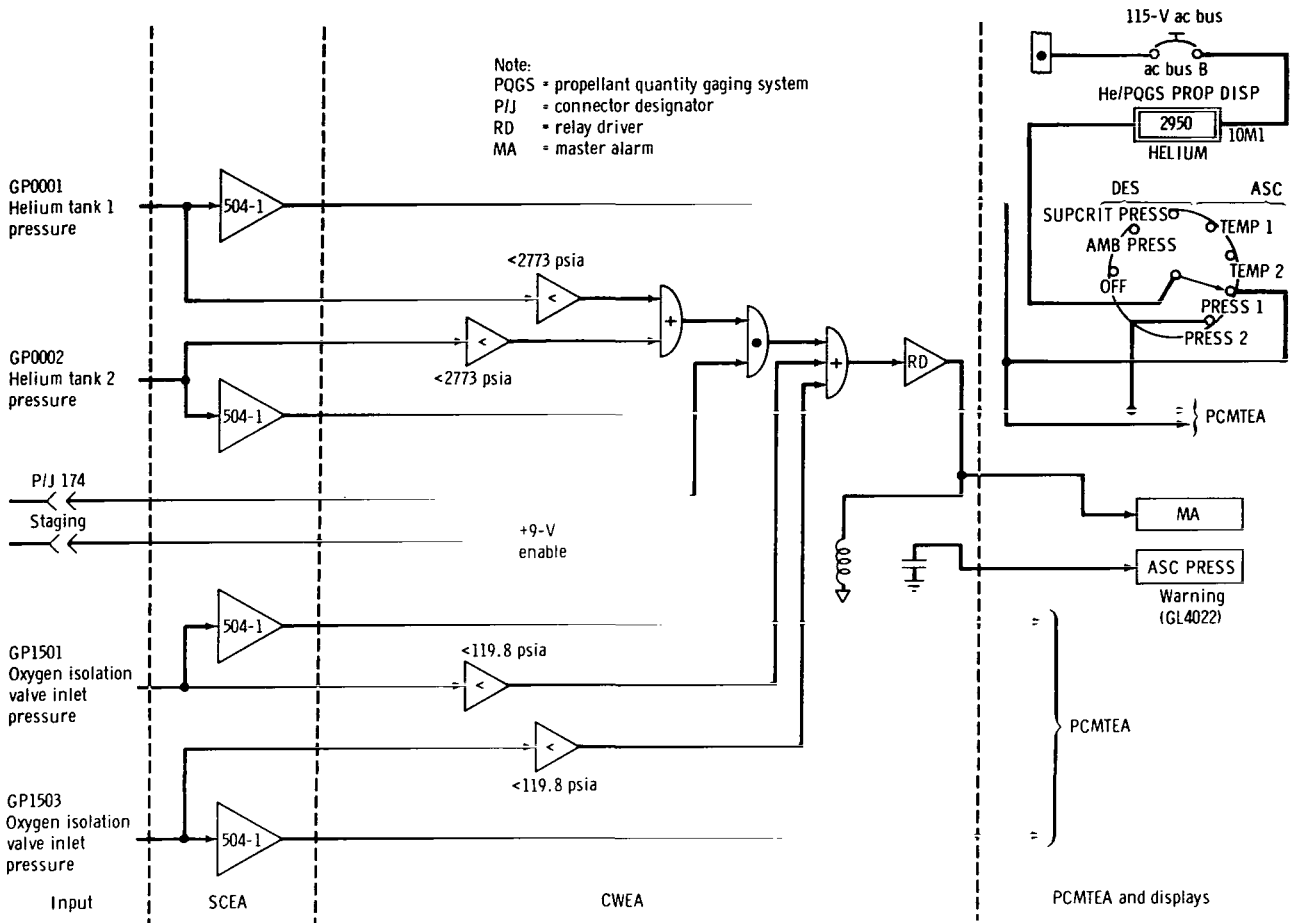
Figure 18. - Ascent pressure failure-detection circuit.

The ascent pressure failure-detection circuit (fig. 18) consists of four separate parameters in OR-gate configuration. An out-of-tolerance condition existing at any one

of the four input parameters activates the warning light. Once the light is activated, subsequent failures at the other inputs cannot be detected. Because an out-of-tolerance condition is expected as a result of low isolation-valve inlet pressure (GP1501 and GP1503), an ascent helium leak (GP0001 or GP0002) cannot be detected by the CWEA. Helium tank pressures are available to the crew by means of onboard digital display and to the MSFN by means of telemetry.

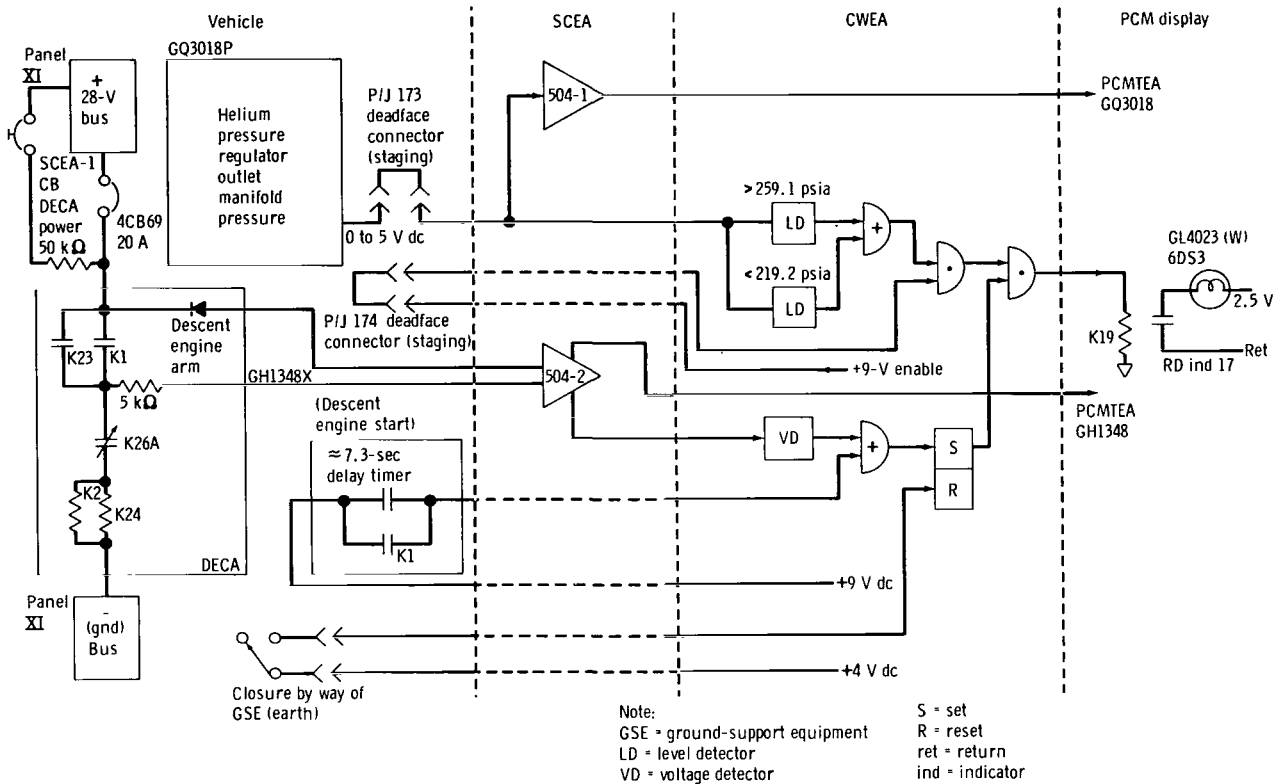
Figure 19. - Helium pressure regulator manifold failure-detection circuit.

Venting of descent helium will cause a descent helium regulator warning indication and a master alarm.

Discussion. - The fuel vent (GQ3500X) and the oxidizer vent (GQ4000X) are used to vent the descent helium shortly after lunar landing. The helium regulator outlet pressure (GQ3018P) will fall below the CWEA trip level of 219.2 psia and activate warning light GL4023 (fig. 19) and the master alarm.

Corrective action. - The master alarm should be reset. The warning light will be extinguished automatically at staging. However, it can be extinguished before staging by cycling the CWEA circuit breaker following removal of descent engine arm.

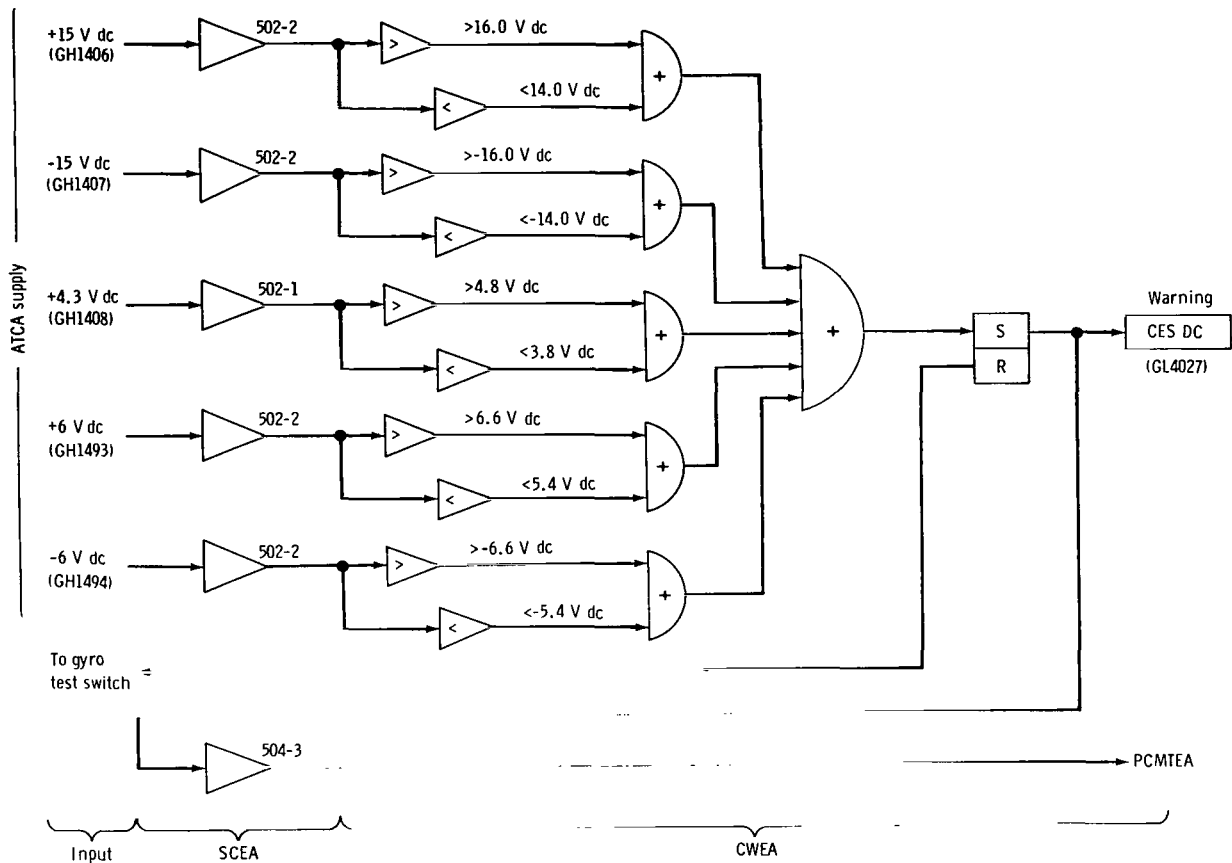
Figure 20. - Control electronics section dc power-supply failure-detection circuit.

During LM missions, the CWEA is turned on prior to activation of the CES power supplies. As a result, the level detectors in the CWEA sense zero voltages at their respective inputs and produce logic ones at their outputs. The flip-flop is set, the annunciator lights are turned on, and the master alarm is activated. The annunciator lights can be extinguished by resetting the flip-flop by means of the rate gyro assembly gyro test switch. This action, however, does not remove the logic one at the input to the flip-flop.

When the CES power supplies are subsequently turned on by means of the ATCA circuit breaker, two possibilities exist.

2. One or more of the power supplies fails to come within limits. In this case, the logic one remains at the input to the flip-flop, and the failure-detection circuits are unable to detect the failure.

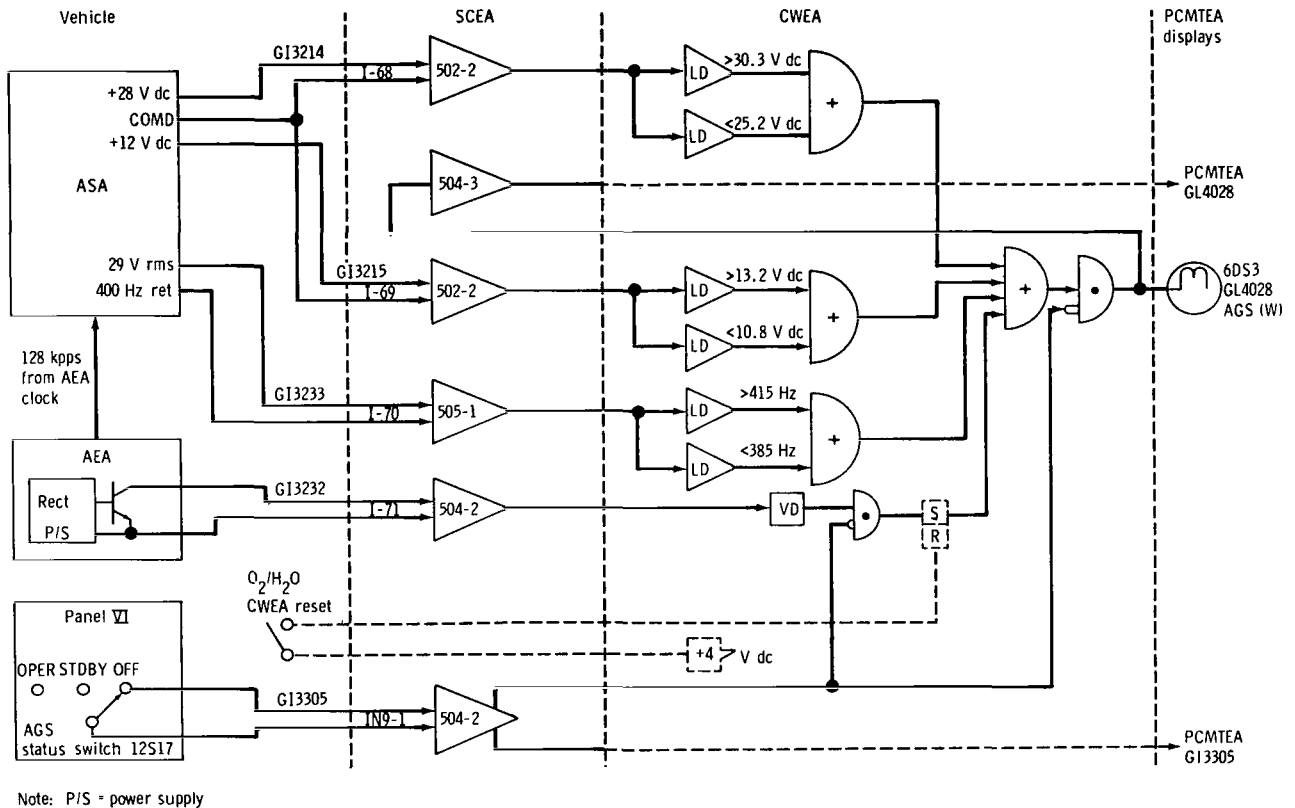
Figure 22. - Abort guidance section power-supply failure-detection circuit.

Discussion. - The CWEA abort guidance circuit (fig. 22) monitors four separate AGS parameters. Three of these are power-supply parameters located in the abort sensor assembly (ASA). The fourth parameter being monitored is the abort electronics assembly (AEA) test mode fail (TMF). All four parameters are OR-gated and fed to a dual-input AND-gate, which is inhibited when the AGS status switch is in the off position.

Abort guidance section power up: A master alarm occurs when the AGS status switch is moved from the off position to the standby position. In this case, the CWEA inhibit is removed and the ASA power supplies are turned on. The AGS warning light will stay on until the AEA circuit breaker is closed and all ASA power supplies reach a stabilized, in-limits condition, removing the failed indication from the CWEA input. The 400-hertz ASA power supply is derived from a 128-kpps clock pulse provided by the AEA; therefore, the AEA circuit breaker must be closed to extinguish the AGS warning light in the standby position.

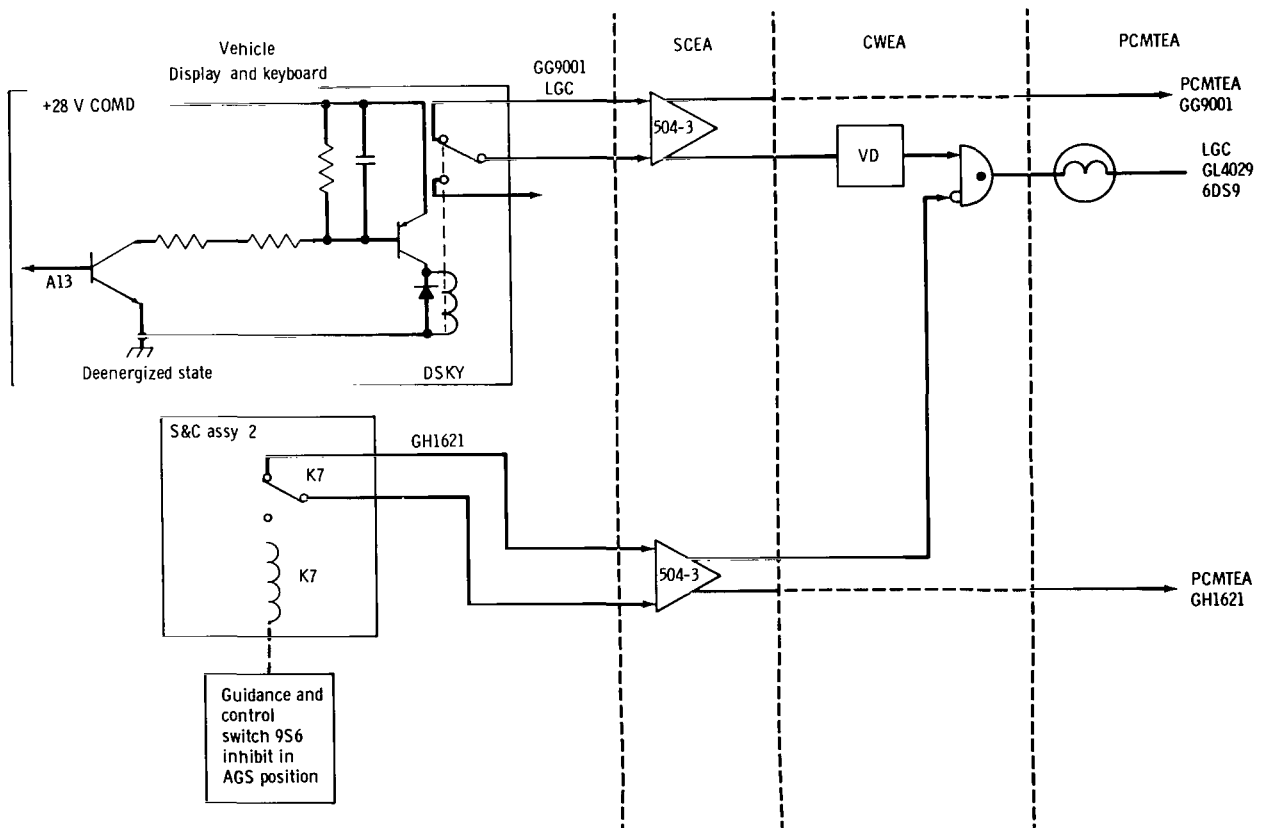
Figure 23. - Lunar module guidance computer failure-detection circuit.

A false master alarm may be generated with activation of the LM guidance computer (LGC)/display and keyboard (DSKY) circuit breaker subsequent to turn-on of the CWEA circuit breaker (fig. 23).

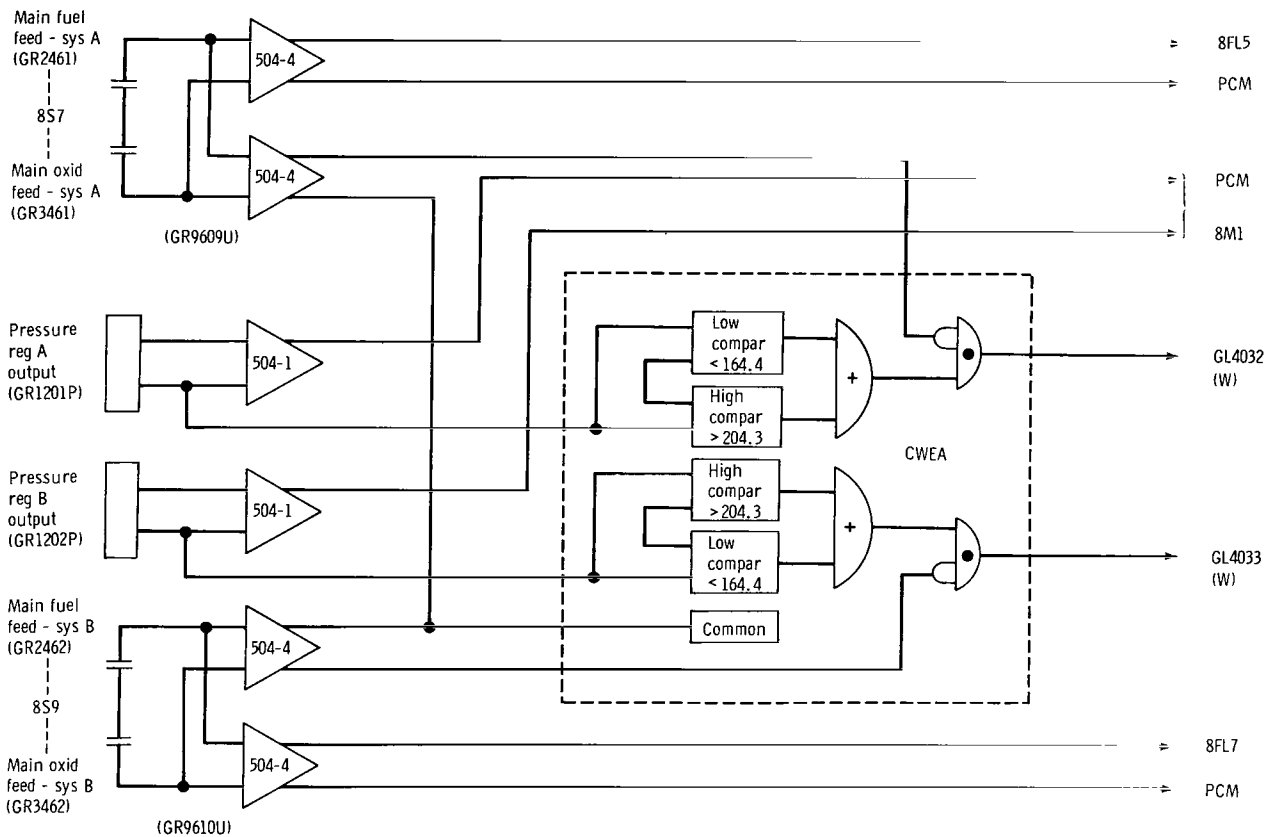
Figure 25. - Reaction control subsystem helium pressure regulator failure-detection circuit.

The RCS helium regulator warning lights come on prior to pressurization (fig. 25).

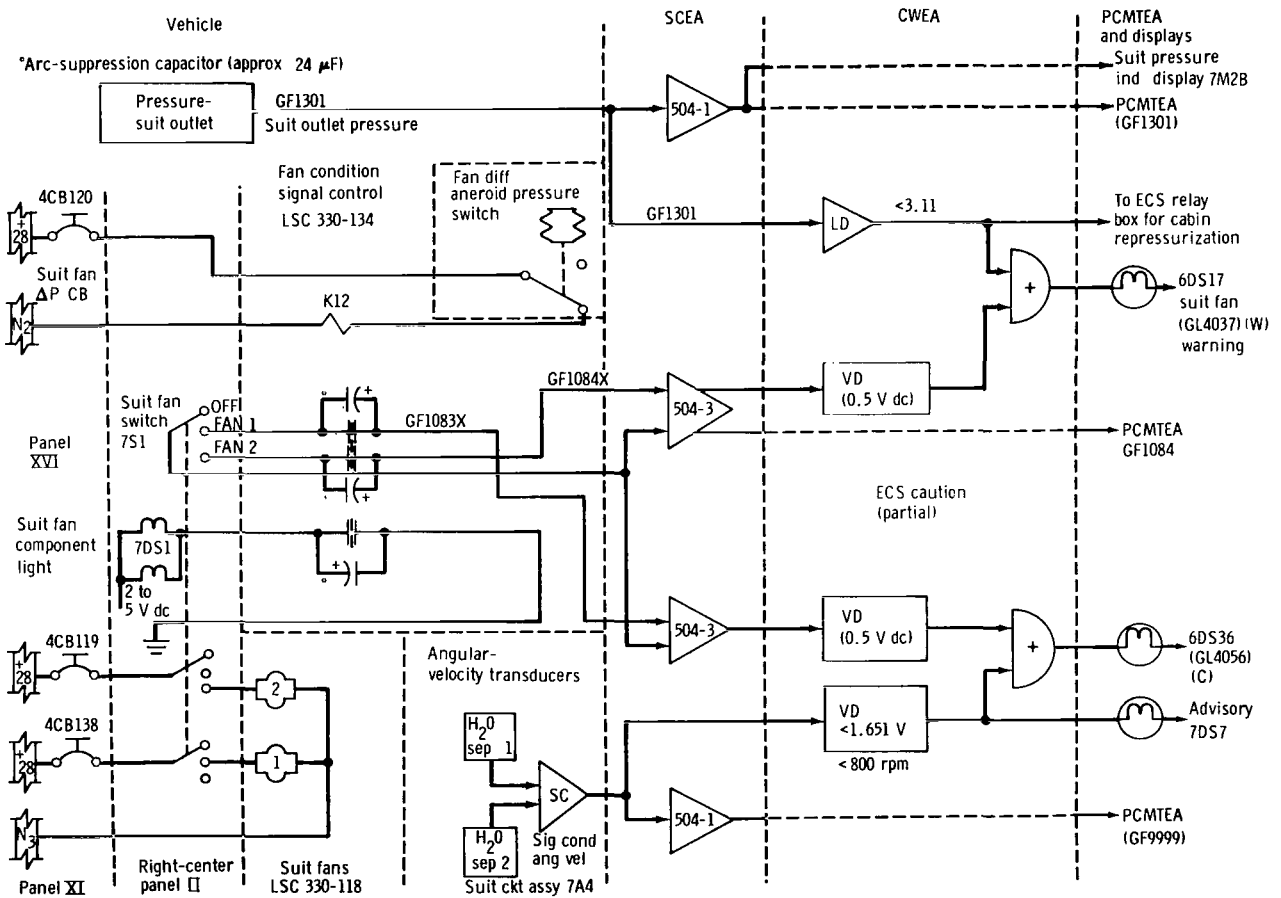
Figure 26. - Environmental control subsystem suit outlet pressure failure-detection circuit.

Switching from suit fan 1 to suit fan 2 (under a condition of low differential pressure with fan condition signal-control relay K12 energized) may cause two successive suit/fan warnings (fig. 26).

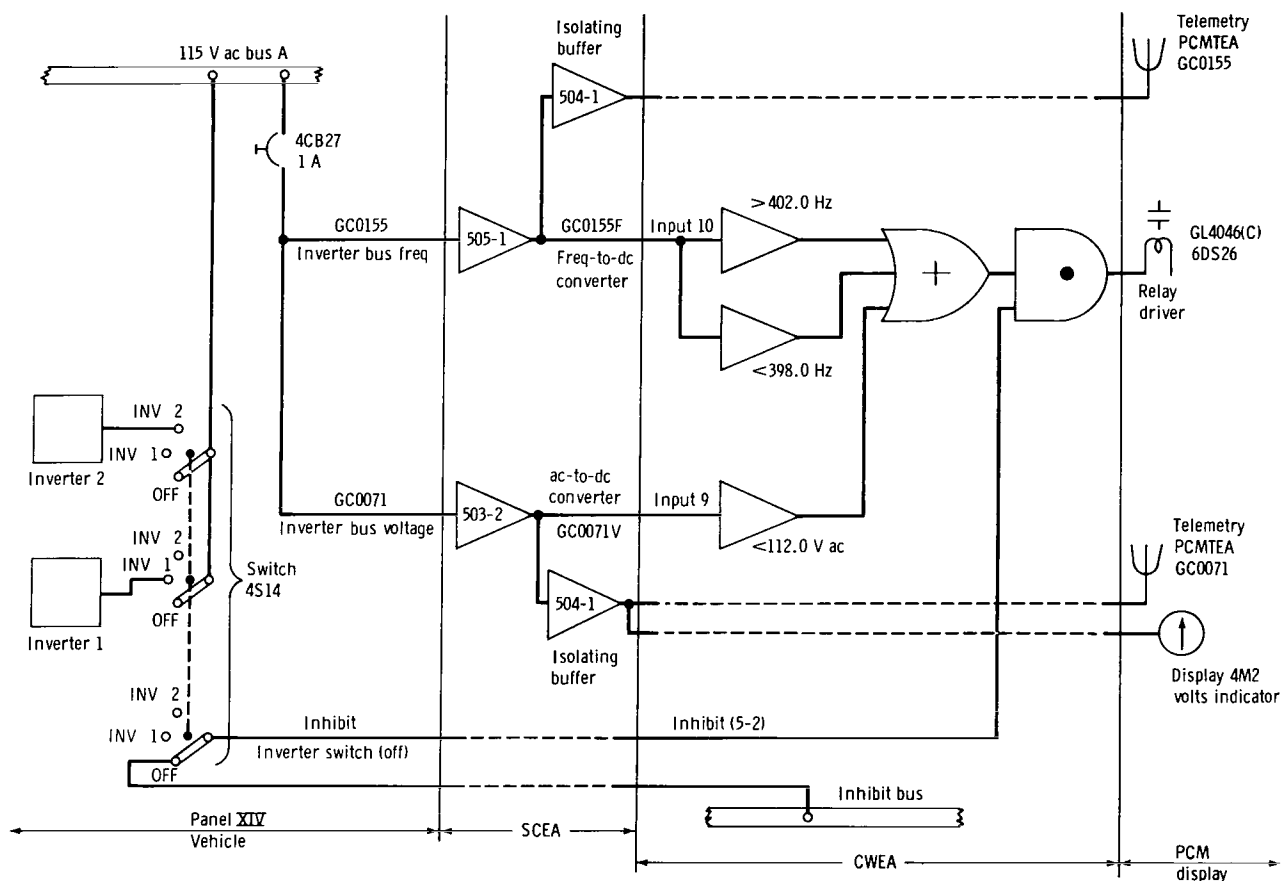
Figure 27. - Electrical power subsystem inverter voltage and frequency failure-detection circuit.

An inverter caution occurs when selecting either inverter from the off position (fig. 27).

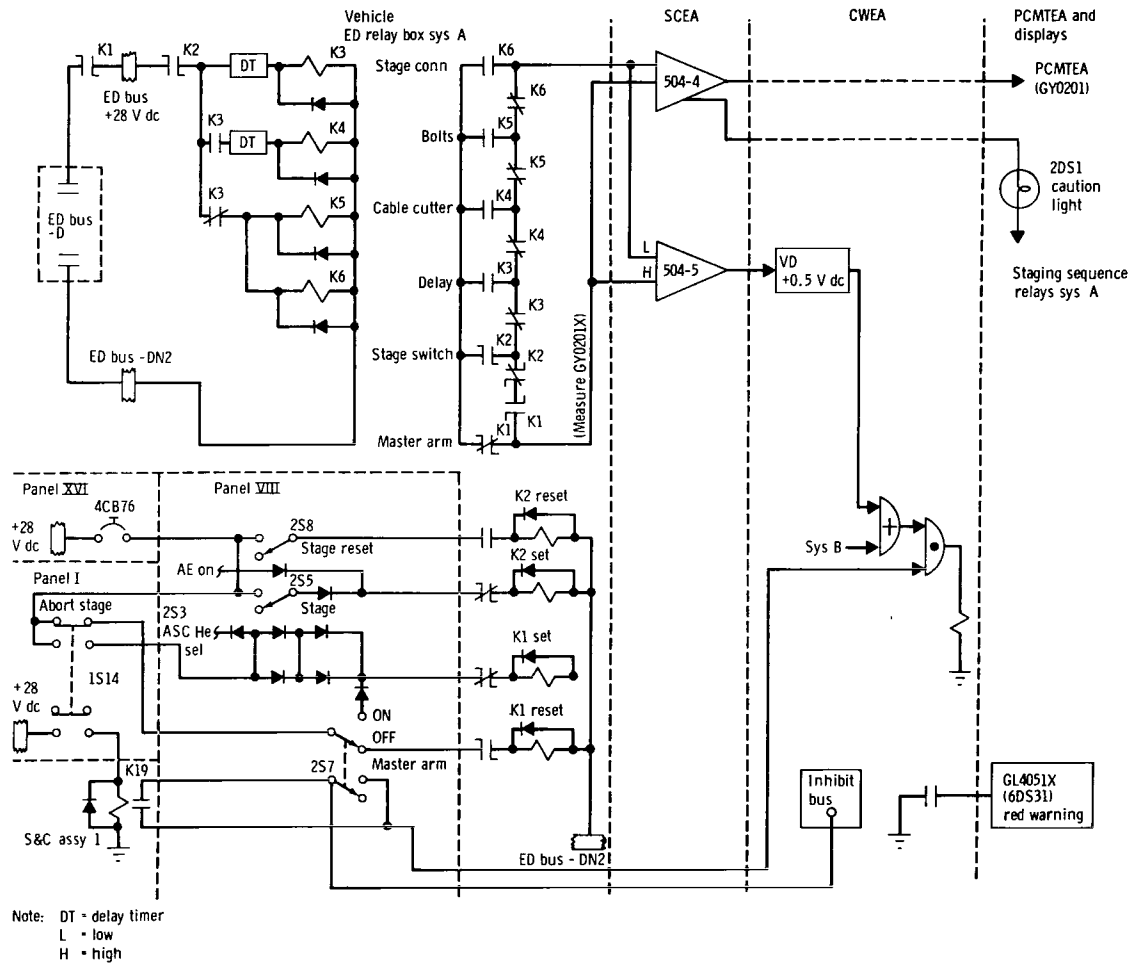
Figure 30. - Explosive devices subsystem stage sequence failure-detection circuit.

Discussion. - When the abort stage switch (fig. 30) is depressed, ED relay K1 is set and the ED bus is armed. This action completes the contact closure path in the relay "daisy chain" (relays K1 to K6) and provides an input to the CWEA. The master alarm does not operate, however, because S&C relay K19 also is energized by the abort stage switch and inhibits the CWEA. A third set of contacts on the abort stage switch signals the CES to issue a stage command. This stage command from the CES sets relay K2, which initiates staging by sequentially energizing relays K3 to K6.

Resetting the abort stage switch after staging removes the inhibit voltage from the CWEA by deenergizing relay K19. Relay K1 is reset, removing the +28 volts from the ED bus and deenergizing relays K3 to K6. Relay K2 has no automatic-reset capability and, therefore, completes the closed-contact path to the SCEA input, activating the master alarm.

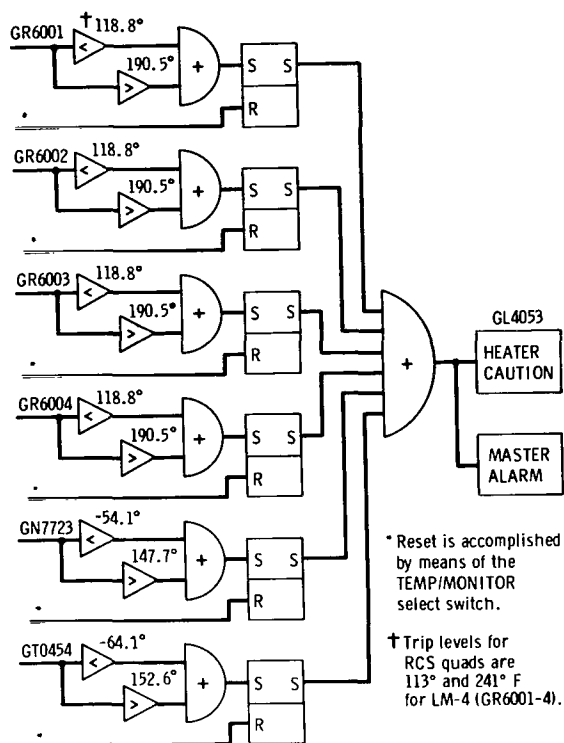
Figure 31. - Heater caution circuit.

Characteristic 1 is caused by the lack of a staging enable to the CWEA logic (fig. 31). When vehicle staging is performed, the wiring to the LR temperature sensor is severed by the cable cutter. This operation places an open circuit at the input to the SCEA, which is analogous to an out-of-temperature condition at the high end; and the CWEA initiates a master alarm.

other undesirable characteristics of this circuit were identified. During touchdown on a lunar landing mission, heat from the descent engine plume will be reflected back to the LR antenna from the lunar surface. This heat will cause the LR antenna temperature to go beyond the upper limits and initiate a master alarm during a period of high activity. After landing, the LR electronics and antenna heater circuit breakers are opened to conserve battery power. Following an undetermined period of cold soak on the lunar surface, the antenna temperature would gradually decrease to an in-limits condition, remove the failure indication to the CWEA, and enable it for future failures. The antenna temperature would continue to decrease until it eventually reached the out-of-limits condition on the low end and would initiate a second master alarm.

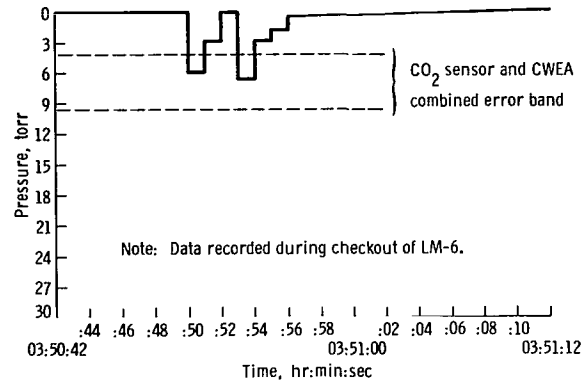
Figure 32. - Typical plot of carbon dioxide pressure variation during ground checkout.

A master alarm may occur during vehicle ground checkout when the carbon dioxide (CO₂) sensor circuit breaker is closed (fig. 32). This possibility results from a transient voltage produced by the CO₂ sensor when power is applied. The magnitude of this transient voltage varies with CO₂ sensors and may not be sufficient to trip the ECS caution light and produce a master alarm. A master alarm resulting from this characteristic has been experienced only during checkout of one vehicle (LM-4).

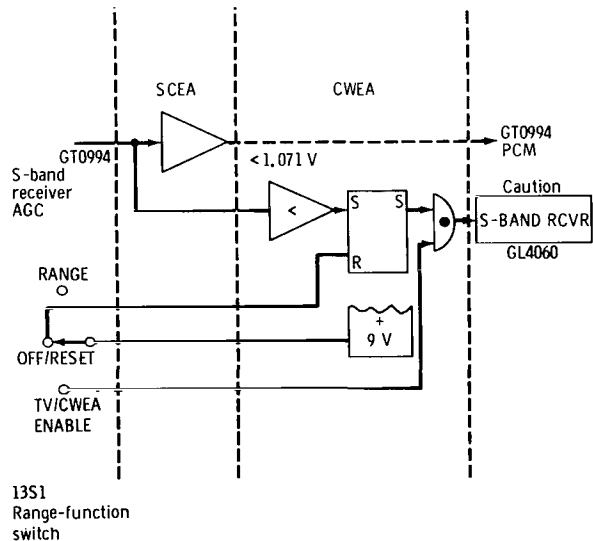
Figure 33. - S-band receiver AGC failure-detection circuit.

At the completion of the S-band ranging function, the S-band range-function switch (13S1) is placed in the off/reset position (fig. 33). This action will reset the S-band caution circuit. However, any subsequent decrease of the S-band automatic gain control (AGC) voltage (as a result of signal fading) below the CWEA reference level, while the switch remains in the off/reset position, will register a failure in the CWEA memory. Subsequent enabling of the S-band caution indicator would cause a master alarm.

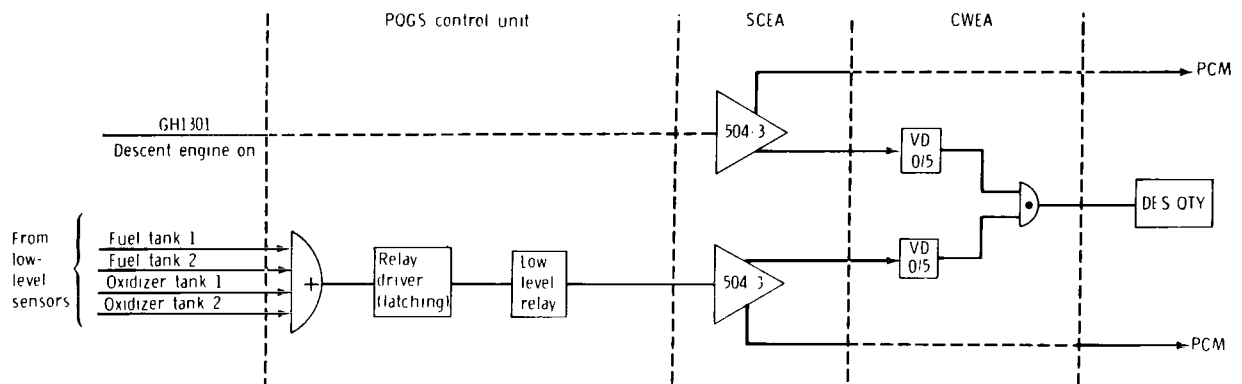
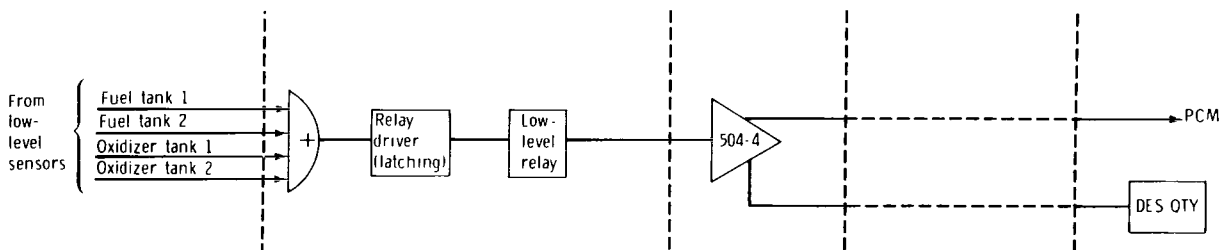
Figure 34. - Descent propellant low-level quantity circuit.

Discussion. - The GL4024 warning indication (fig. 34) was designed to alert the crew to a propellant quantity remaining equal to 2 minutes at 25 percent thrust. There is a high probability that the propellant level will reach this point prior to touchdown on a normal lunar landing.
