MSC-05161

APOLLO 15 MISSION REPORT

MANNED SPACECRAFT CENTER
HOUSTON, TEXAS
DECEMBER 1971

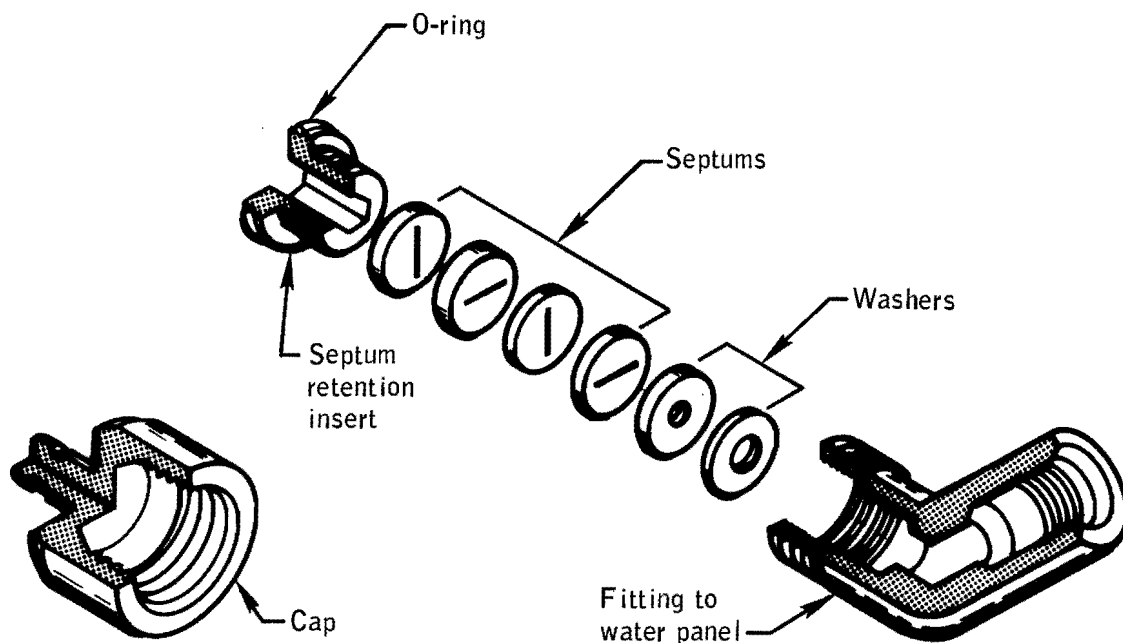
Figure 14-2.- Water panel chlorine injection port.

Postflight inspection and dimensional checks of the injection port assembly showed that all components were within established tolerances.

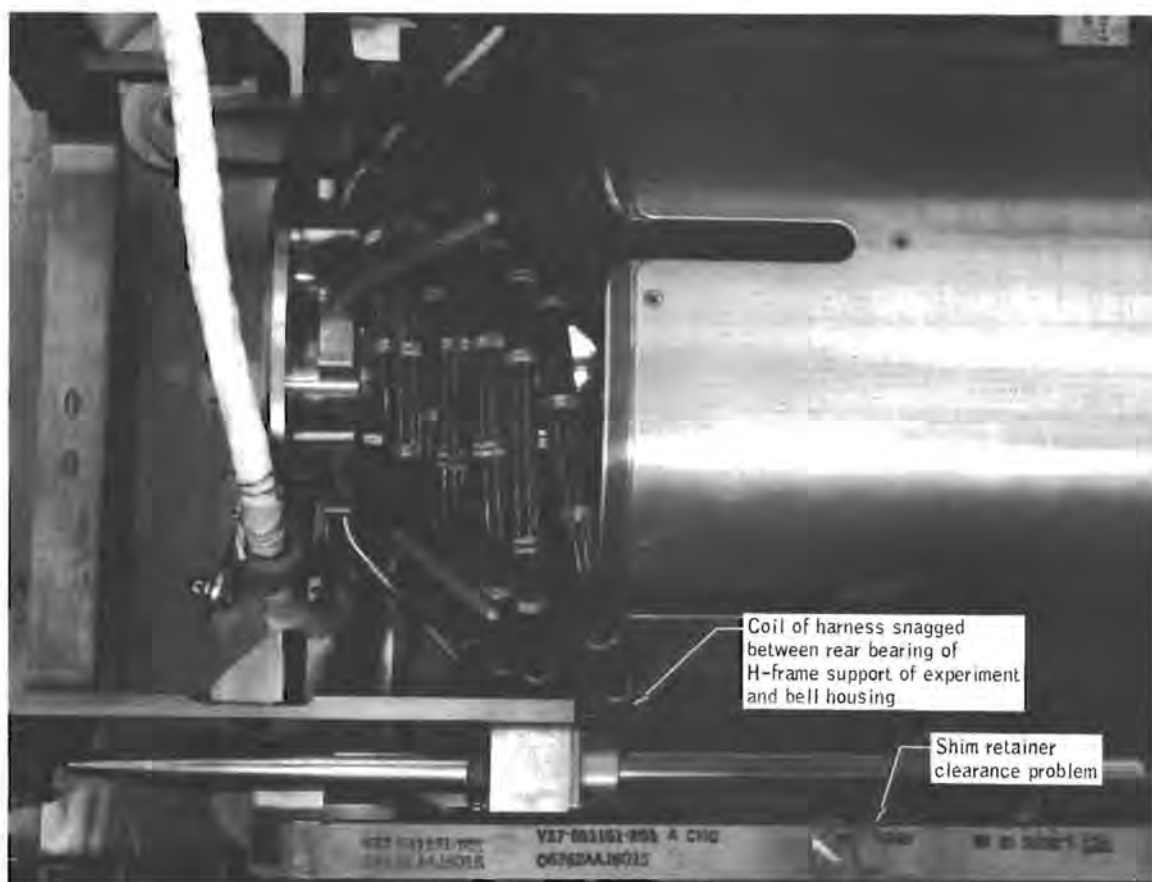
Figure 14-7.- Bottom view of mass spectrometer deployment mechanism (experiment removed).

An inflight test of the Apollo 15 boom indicated that the problem was a function of temperature. Testing and examination of the Apollo 16 spacecraft showed that the failure was possibly caused by pinching of the cable harness during the last several inches of boom retraction. The cable could have been pinched between the bell housing and rear H-frame bearing (figure 14-7), or a cable harness loop was jammed by a boom alignment finger against the bell housing (fig. 14-8).

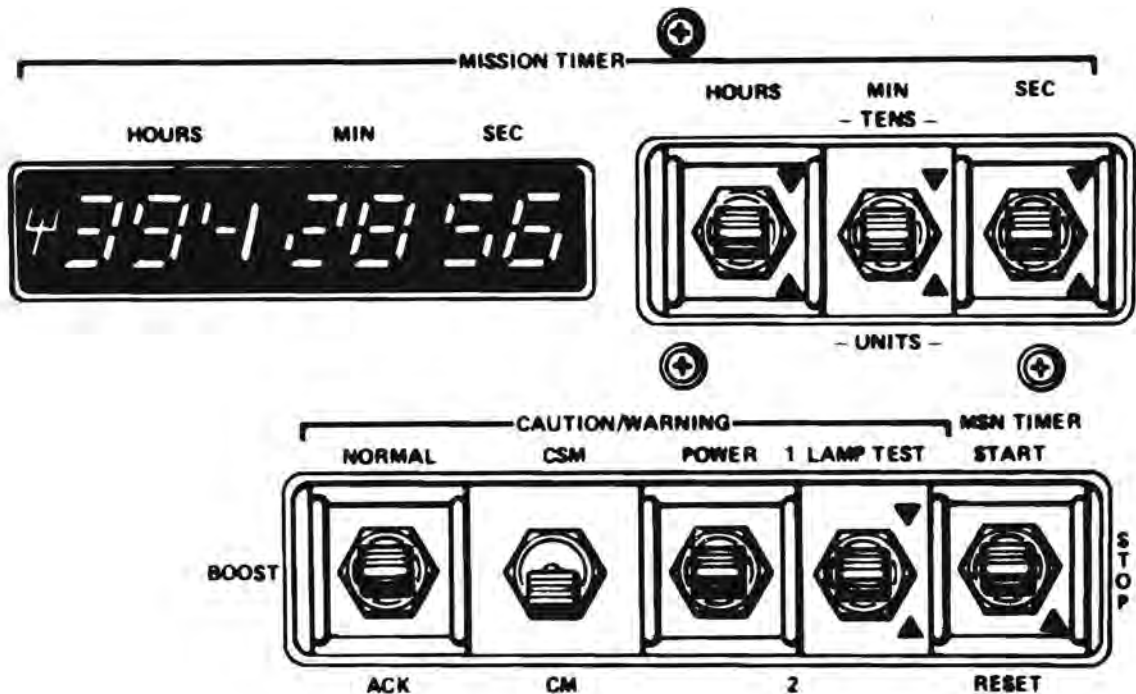
Figure 14-10.- Mission timer.

The panel 2 mission timer stopped at 124:47:37. Several attempts to start the clock by cycling the start/stop/reset switch from the stop to the start position failed (fig. 14-10). The timer was reset to 124:59:00 using the hours, minutes, and seconds switches, and the timer again failed to start when the switch was cycled. The switch was then placed in the

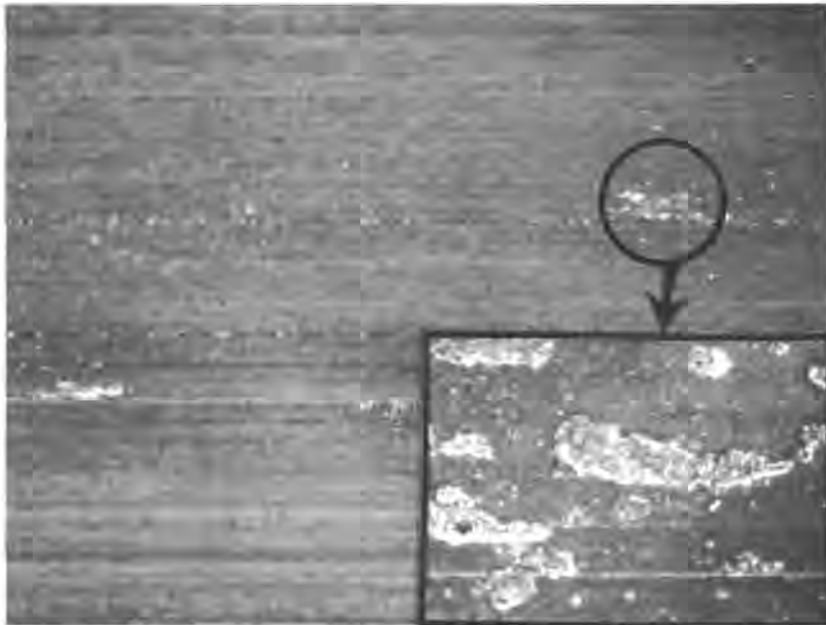
Figure 14-14.- Recording tape photographed under 50 power and 400 power magnification showing silver oxide deposits.

A 10-foot leader coated with a silver oxide compound is spliced to the beginning and end of the magnetic tape roll to activate the end-of-reel sensors on the tape transport. There has been a history of this material flaking off and affecting tape performance. Tape screening procedures were implemented by the manufacturer in 1968 to eliminate this problem. No further problems were encountered until Apollo 15. The recording method for Apollo 14 and previous missions was considerably different than that for the Apollo 15 mission. Bit packing densities for the Apollo 15 mission tape approach 9000 bits per inch while those for the previous missions were only 800 bits per inch. Abnormalities in the tape would have considerably more effect with the higher packing density. The utilization of the Apollo 15 mission recorder is also considerably higher, allowing more time for deposits to build up.

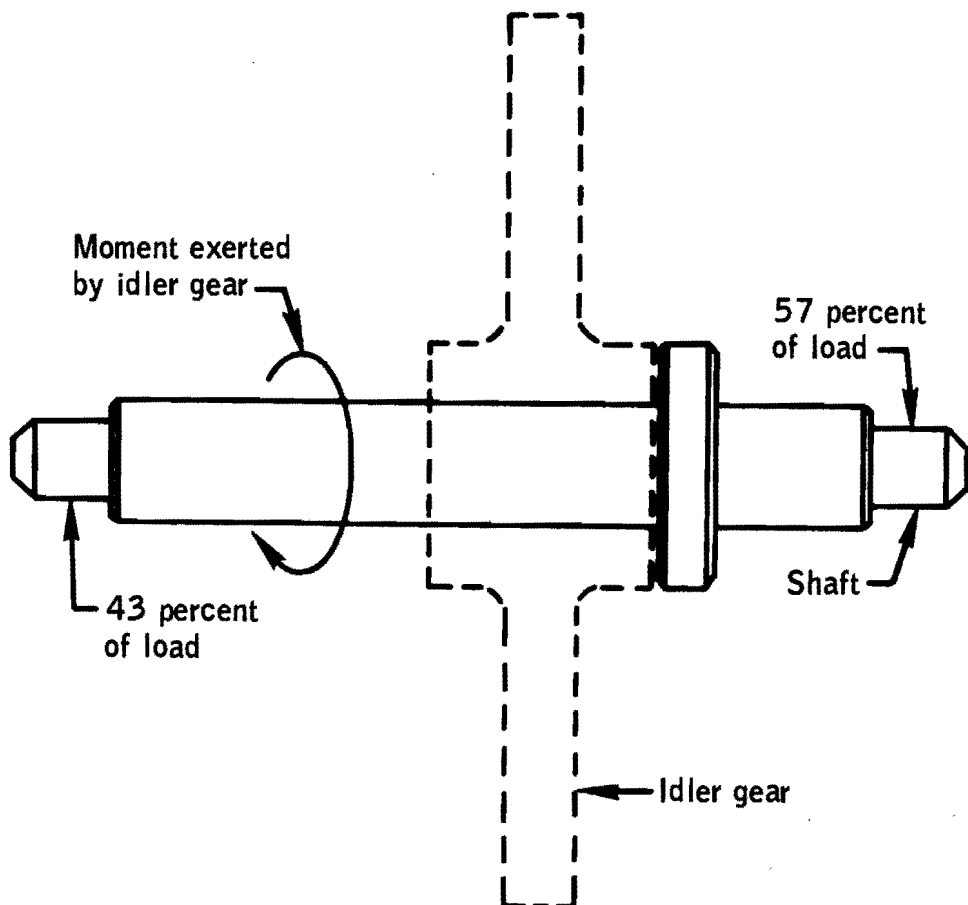
Figure 14-16.- Forces on idler gear shaft in countdown mode.

Inspection of the unit showed that the magnesium bearing points had been elongated as shown in figure 14-17. Torque from the stepping motor applied to the idler gear not only resulted in rotation of the shaft but also caused the shaft to tilt (fig. 14-17). The wearing eventually allowed the shaft to tilt sufficiently to cause the gear to rub against the

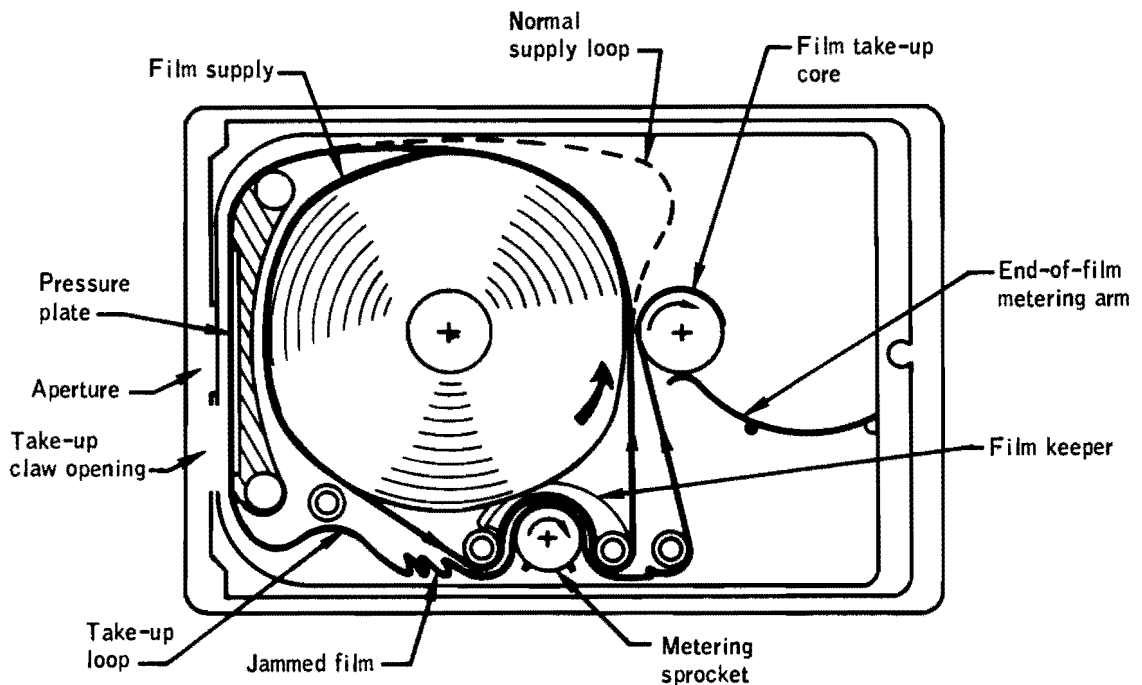
Figure 14-50.- Lunar surface 16mm camera magazine.

- c. The Lunar Module Pilot's camera did not advance film properly near the end of the second extravehicular activity. The camera failed again during the third extravehicular activity after six pictures had been taken. (See section 14.5.4 for further discussion.)
