APOLLO 6 MISSION REPORT

MANNED SPACECRAFT CENTER
HOUSTON, TEXAS
MAY 1968

MSC-PA-R-68-9

Prepared by: Apollo 6 Mission Evaluation Team

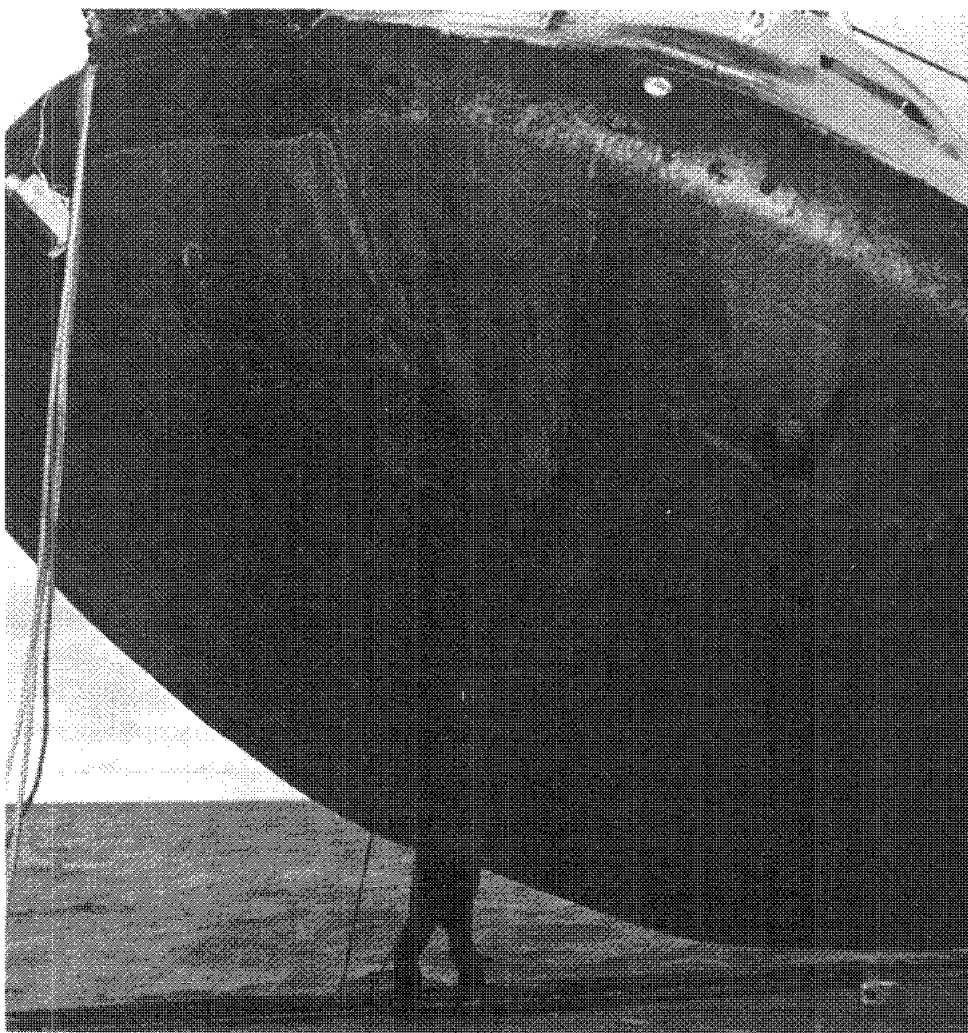
Figure 5.4-4.- Char condition of aft heat shield.

(a) Overall view.

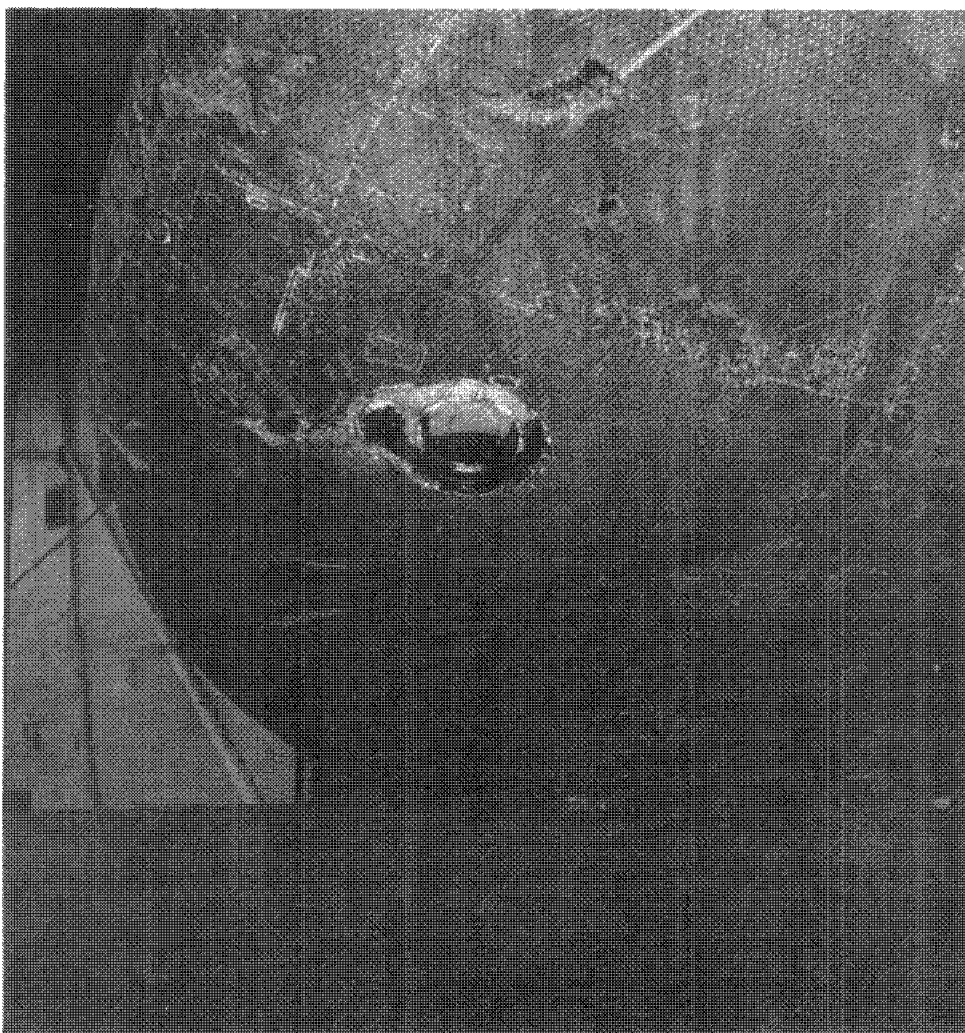
Figure 5.4-4.- Continued.

(b) Typical shear compression pad showing tension-tie rod.
