MSC-00126

APOLLO 10 MISSION REPORT

MANNED SPACECRAFT CENTER
HOUSTON, TEXAS
AUGUST 1969

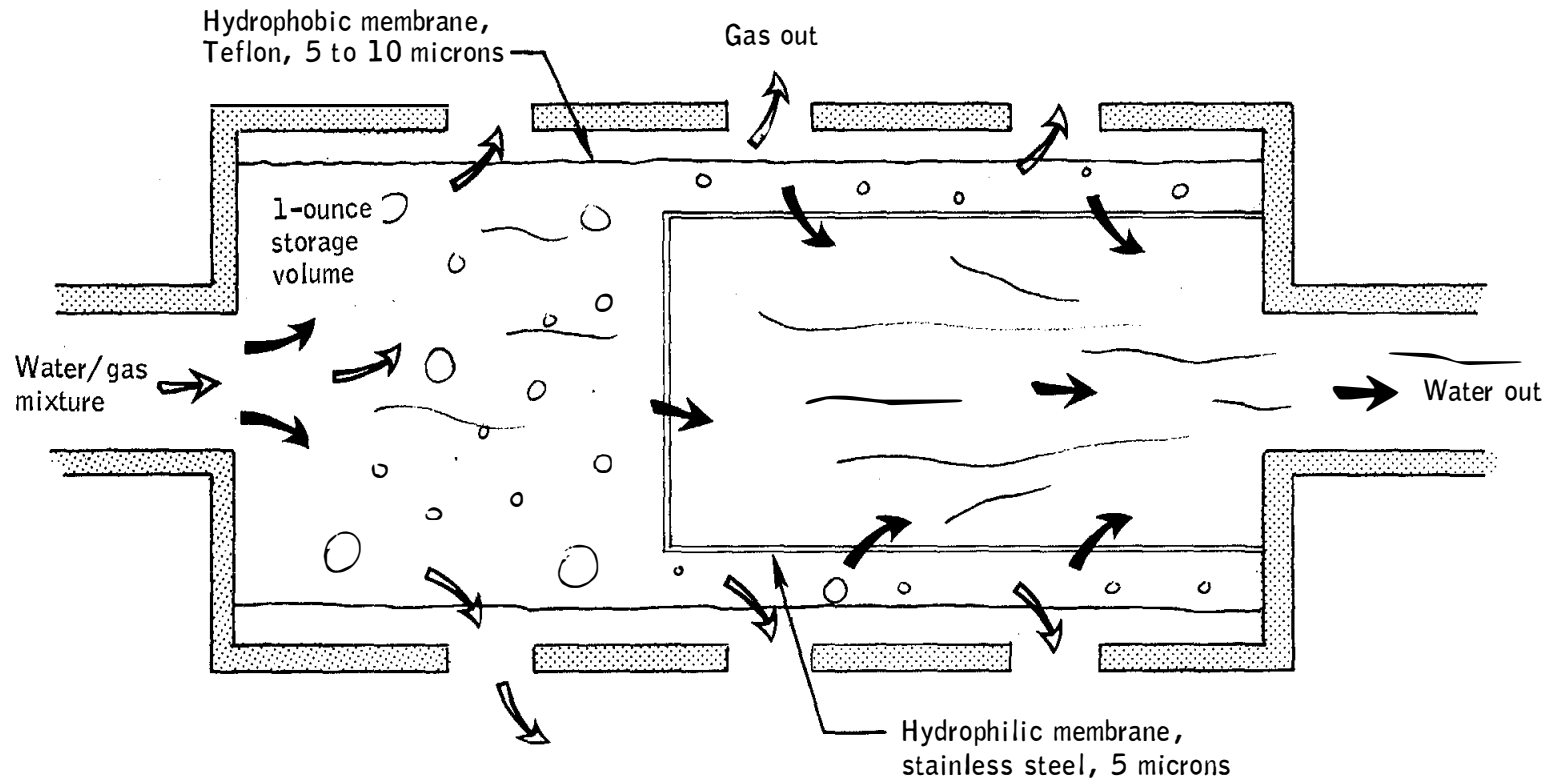
Figure 15-13.- Water/gas separation membrane.

The potable water tank was serviced with water prior to lift-off to provide a maximum amount of hydrogen-free water. However, the crew found that there was too much gas in the preflight-loaded water (see section 15.1.14).

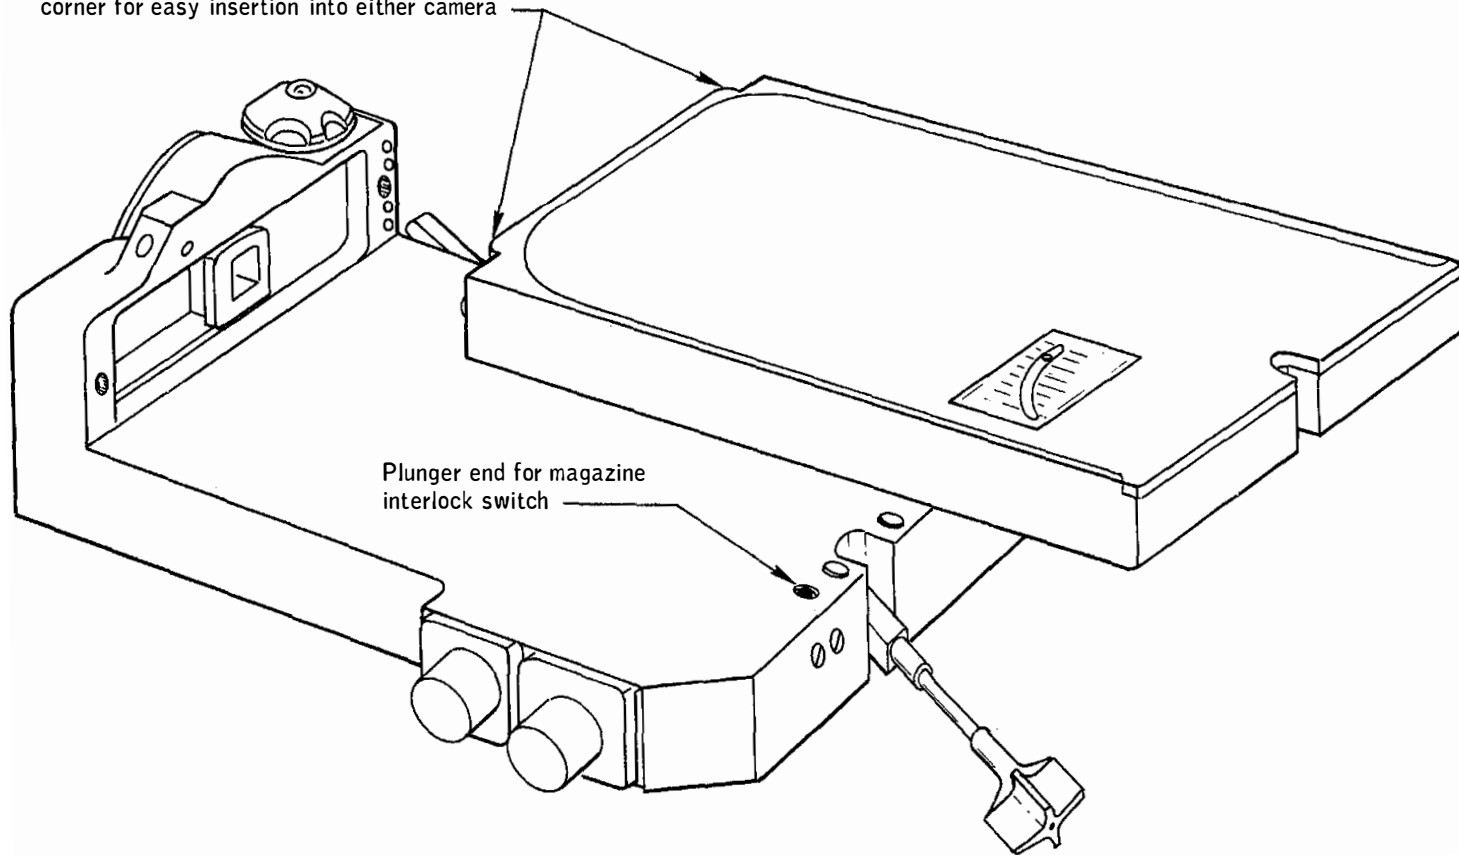
Figure 15-46.- Magazine installation in 16-mm cameras.

Radii on edges to be large enough to relieve corner for easy insertion into either camera
