NASA TN D-7992

APOLLO EXPERIENCE REPORT -
GUIDANCE AND CONTROL SYSTEMS:
MISSION CONTROL PROGRAMMER FOR
UNMANNED MISSIONS AS-202,
APOLLO 4, AND APOLLO 6

Gene F. Holloway
Lyndon B. Johnson Space Center
Houston, Texas 77058

NATIONAL AERONAUTICS AND SPACE ADMINISTRATION • WASHINGTON, D. C. • JULY 1975

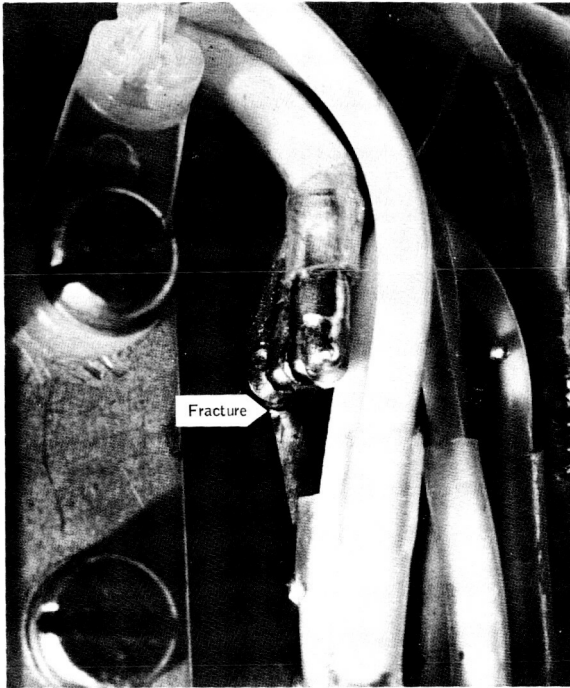
Figure 14.- Fractured solder terminals.

The MCP production unit 3 (qualification test unit 1) entered the vibration environment portion of the qualification test on April 2, 1966. The vibration effects to be investigated were the resonances of each package (resonance search) and the susceptibility of the MCP to random vibration. The postvibration physical inspection of the MCP indicated 35 instances of fractured solder joints on the pins of the SCC control assembly connector boards (fig. 14). The GCC had 10 loose or broken solder joints around similar pins. However, no functional test failures were attributed to the solder fractures around the pins. The corrective action for the cracked-solder-joint problem included soldering the terminals on both sides of the circuit strip (fig. 15) and adding a bracket to improve the wire-bundle routing. The corrective action was successful, and the problem did not recur during future vibration tests.

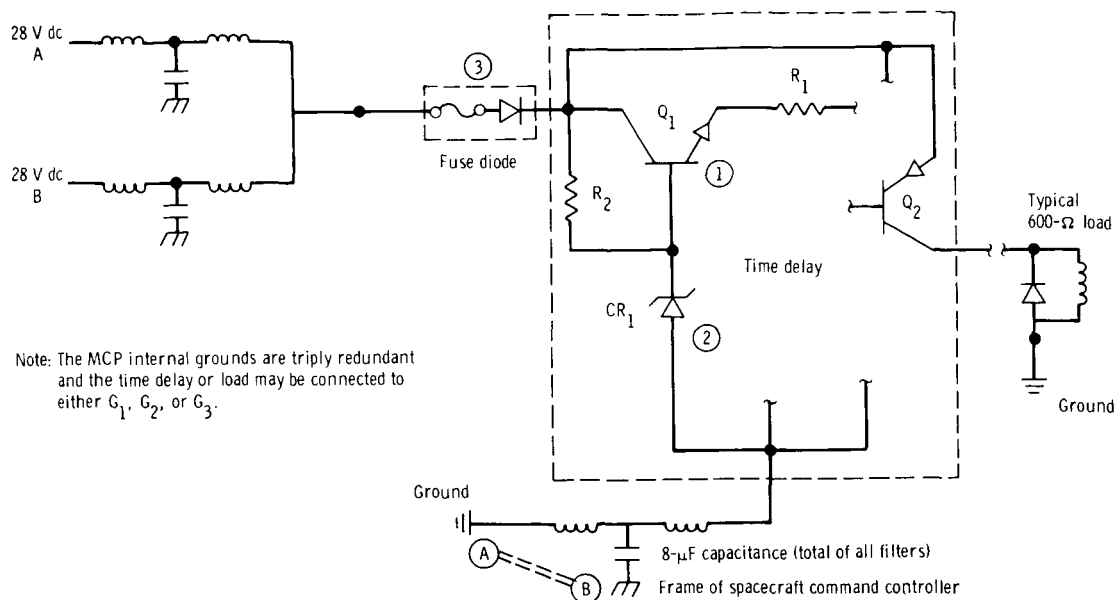
Figure 17. - Time-delay circuit schematic.

For a 14-month period ending in April 1967, NASA and various aerospace industry representatives combined their efforts to resolve the MCP time-delay and fuse-diode failures. The failure mode was readily established shortly after the first time-delay circuit failed. Transistor Q_1 (fig. 17) of the time-delay circuit shorted (collector to base) causing zener diode CR_1 to overload, exceed the thermal rating, and fail, so that

the fuse diode on the time-delay input was overloaded and failed (open circuit). Numerous attempts were made to establish the cause of the failure. The following list of significant events in the investigation indicates the amount of study on this problem.

The extensive engineering investigation to resolve the time-delay failures revealed that this failure, as well as several others, resulted from the transients caused by the 500-V dc megohm portion of the unit-level test at the vendor's facility. Failure of 8 diodes, 4 capacitors, 22 fuse diodes, and 14 time delays could be attributed directly to these transients. The listed failures were of an induced nature. During factory test, components were stressed beyond their capacity by an action of the test operator, who was not aware of the consequences. The action consisted of shorting an internal ground (G_1 , G_2 , or G_3) to the frame of the SCC after the megohm test. (Refer to points A to B in fig. 17.) This action was taken by the test operator to avoid electrical shock from filter capacitors that had been charged to several hundred volts when the megohm test voltage was applied to the frame of a control assembly in the SCC. The control assemblies were insulated from the frame, and this insulation was tested each time by the megohm test unit. The test specification required that 500 V dc be applied across a test point on the control assembly to the SCC frame for 2 minutes, then the insulation resistance would be read. During this 2-minute period, the filter capacitors were charged through the multitude of relay, time-delay, and differentiator paths.

Laboratory tests of transistor Q_1 , used in the time-delay circuits (fig. 17), were performed to determine the collector-to-base breakdown strength under pulse conditions. The test consisted of superimposing a positive pulse on a 28-V dc signal on the collector of transistor Q_1 in a time-delay circuit. The circuit was repeatedly pulsed, increasing amplitudes in 10-volt increments to 228 V dc (maximum pulse amplitude plus 28 V dc) or until failure, whichever occurred first. Fifty-six transistors were tested in the laboratory under these conditions, and 35 transistors failed. Each time a transistor failed, zener diode CR_1 was also overstressed and failed. The failed

transistor and zener diode had degraded or shorted junctions that were essentially the same as the failed parts in the SCC units of the MCP. During the laboratory test, the lowest pulse input to cause failure was at 108 V dc (28 V dc plus an 80-volt pulse). Six failures occurred at input signals of less than 150 V dc, 10 at less than 170, 20 at less than 198, and 35 at less than 228. Thirty of the transistors failed on the first voltage pulse at the failure level, five transistors failed by the fifth pulse. The 21 transistors that did not fail were ultimately pulsed 170 times at 228 V dc. After the cause of failure had been determined, it remained to be proved that the components that had not failed were not degraded by the megohm tests, even though they seemed to function satisfactorily. Three of the 21 transistors were selected at random and were pulsed for a minimum of 43 000 cycles without a failure. Therefore, the misapplication of the megohm test could cause immediate failures but would not cause the components to be degraded and susceptible to subsequent failure.

18. In February 1967, the insulation-resistance megohm test used during acceptance testing was determined to be the cause of the failures. After the megohm test was eliminated and a multimeter was used to check the insulation resistance, no more time-delay failures occurred.

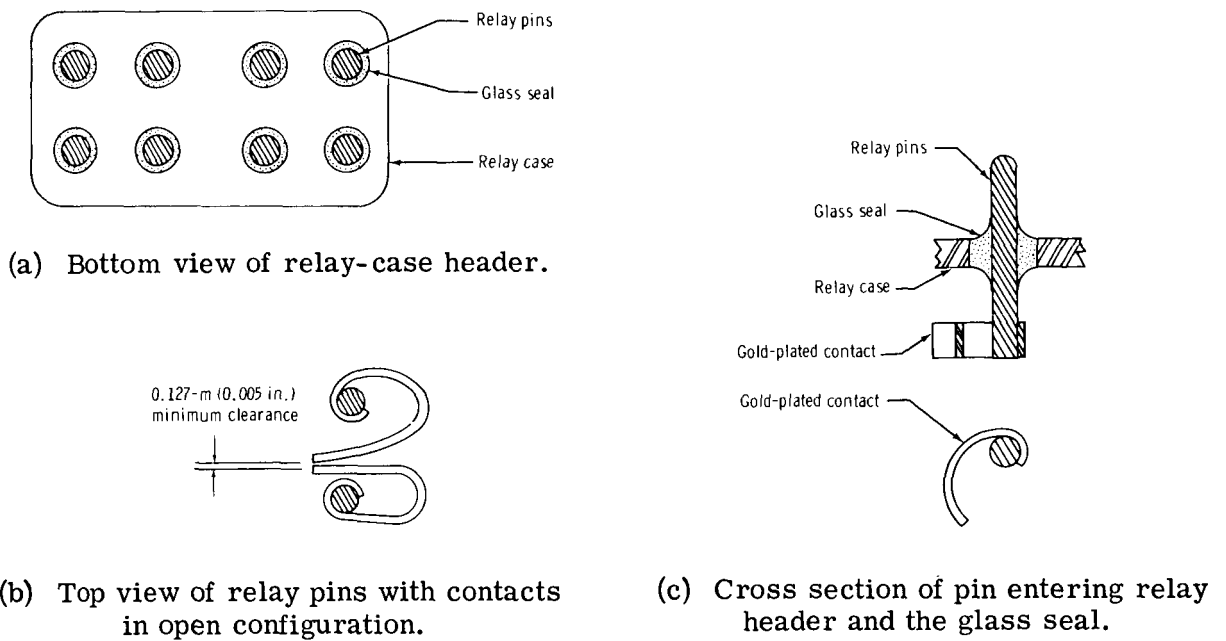
Figure 18. - Relay schematics to describe glass-seal problem.

The problem involving cracked glass seals did not adversely affect a program or a spacecraft, because the only two failures occurred in qualification unit 1 during the postflight test of spacecraft 011. The specification required that all component leads that mount on printed circuit boards shall not protrude through the board more than 0.76 millimeter (0.030 inch). The relays, diodes, transistors, and other electrical components using glass-to-metal seals around their leads (or pins) were discovered to be subject to a shock wave during the process of clipping the pin. This shock wave was transferred down the pin and could possibly crack the glass seals. (The wire cutters, diagonal-cutting pliers, or side-cutting pliers use a wedge or chisel effect to separate the wire.) At the instant of final metal separation, rather severe forces (or shock waves) were transferred along the wire.

The problem with the MCP relays was a result of the vendor's fabrication techniques, which required the leads to be clipped. The relays, including the pin seals, were first inspected and then inserted in the circuit boards; the leads were clipped, the cut pins were soldered, and the solder was inspected. (At this time, the relay-pin seals could not be seen.) The clipping operation mechanically stressed the relay pins and cracked some of the glass seals.

Whenever a glass seal cracked or the relay pin became loose in the glass seal, the pin was free to rotate; merely the wrist action of the technician clipping the pin could rotate the pin and alter the critical relay contact alinement (fig. 18). The manufacturing alinement procedures required that the contacts first be set at a minimum 0.127-millimeter (0.005 inch) clearance. An overtravel adjustment was then checked and established at 0.0635 millimeter (0.0025 inch) to effect the proper wiping action of the relay contacts and then the proper electrical transfer. Alinement of the contacts had to be within $\pm 3^\circ$. A projected viewgraph, which magnifies the contacts many times

their actual size, was used by the manufacturer to inspect and check these adjustments. Failure or improper action of the relays could occur for insufficient contact gaps or for contact gaps with too great a clearance. To prevent future problems, the vendor eliminated the relay clipping during the manufacturing process. An NASA Flight Safety Information Bulletin was published to notify all Apollo Program participants of the hazards of clipping terminals with glass-to-metal seals.
