# GEMINI PROGRAM MISSION REPORT

# GEMINI V

## AUGUST 1965

NATIONAL AERONAUTICS AND SPACE ADMINISTRATION  MANNED SPACECRAFT CENTER

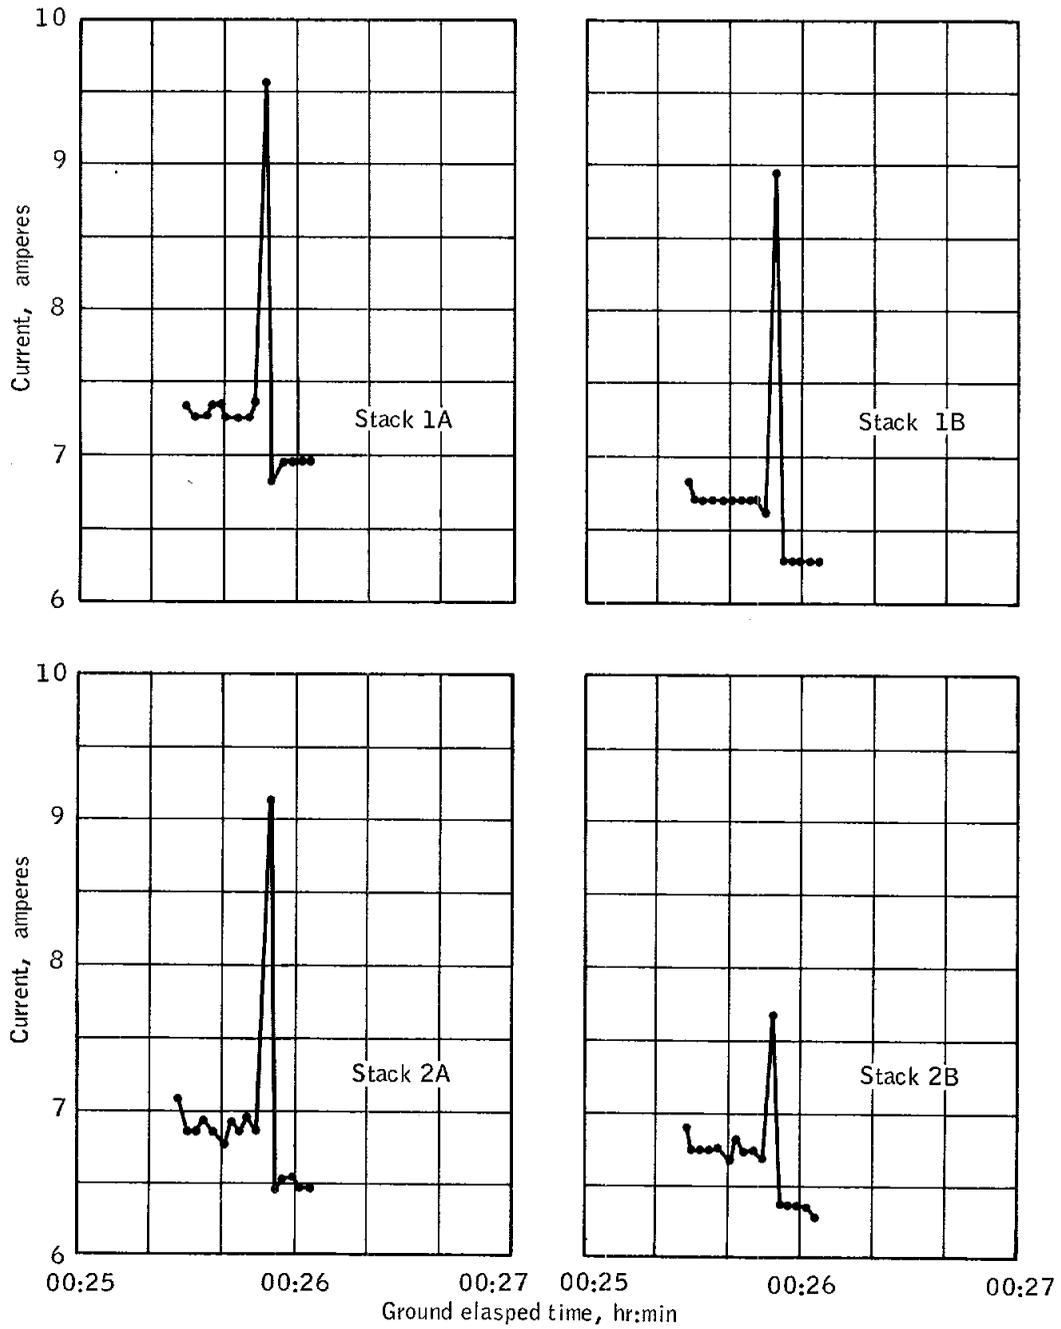
Figure 5.1.7-4: - Stack currents during time of RSS oxygen heater failure at 00:25:51 g.e.t.

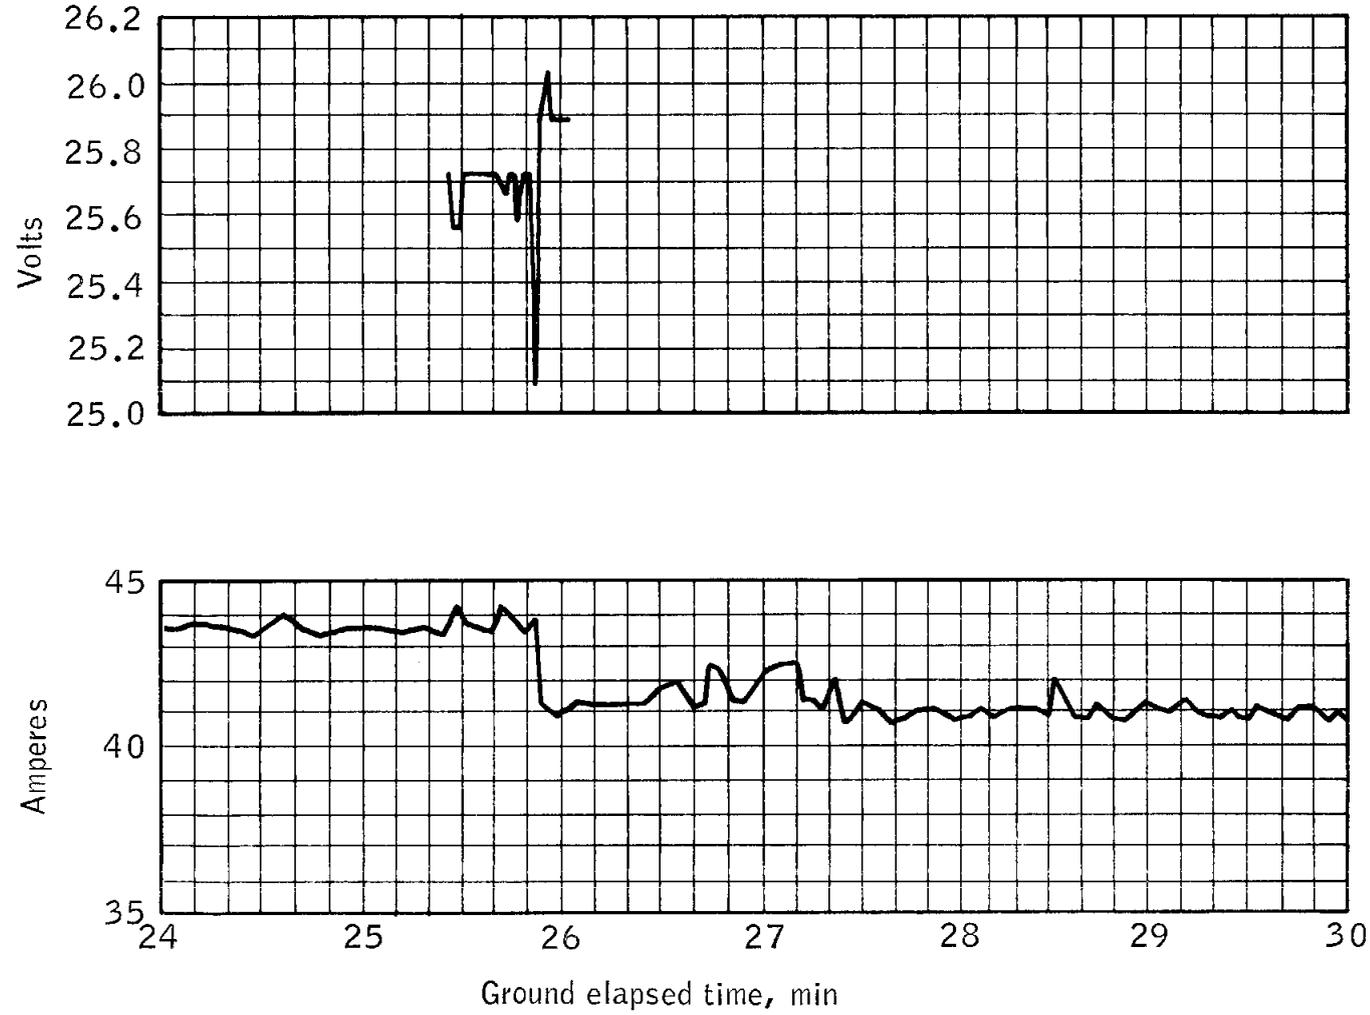
Figure 5.1.7-5. - Main bus voltage and current during time of RSS oxygen heater failure at 00:25:51 g.e.t.

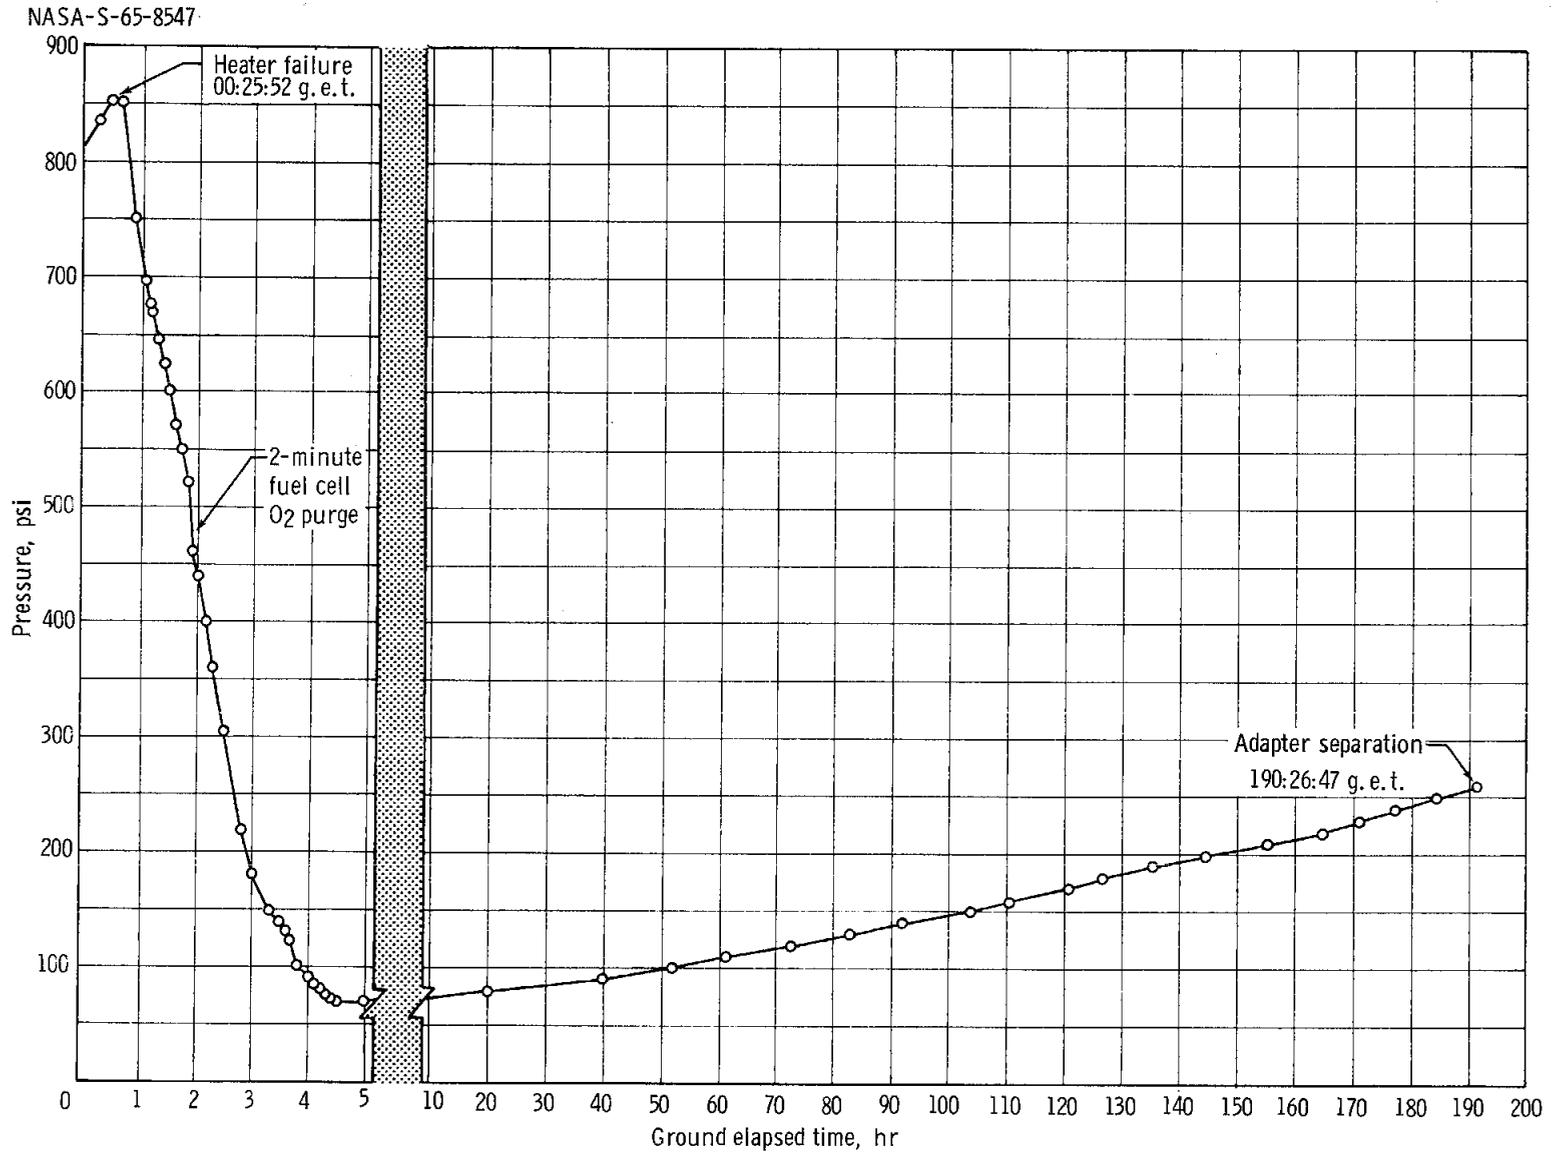
Figure 5. 1. 7-6. - RSS oxygen supply pressure.

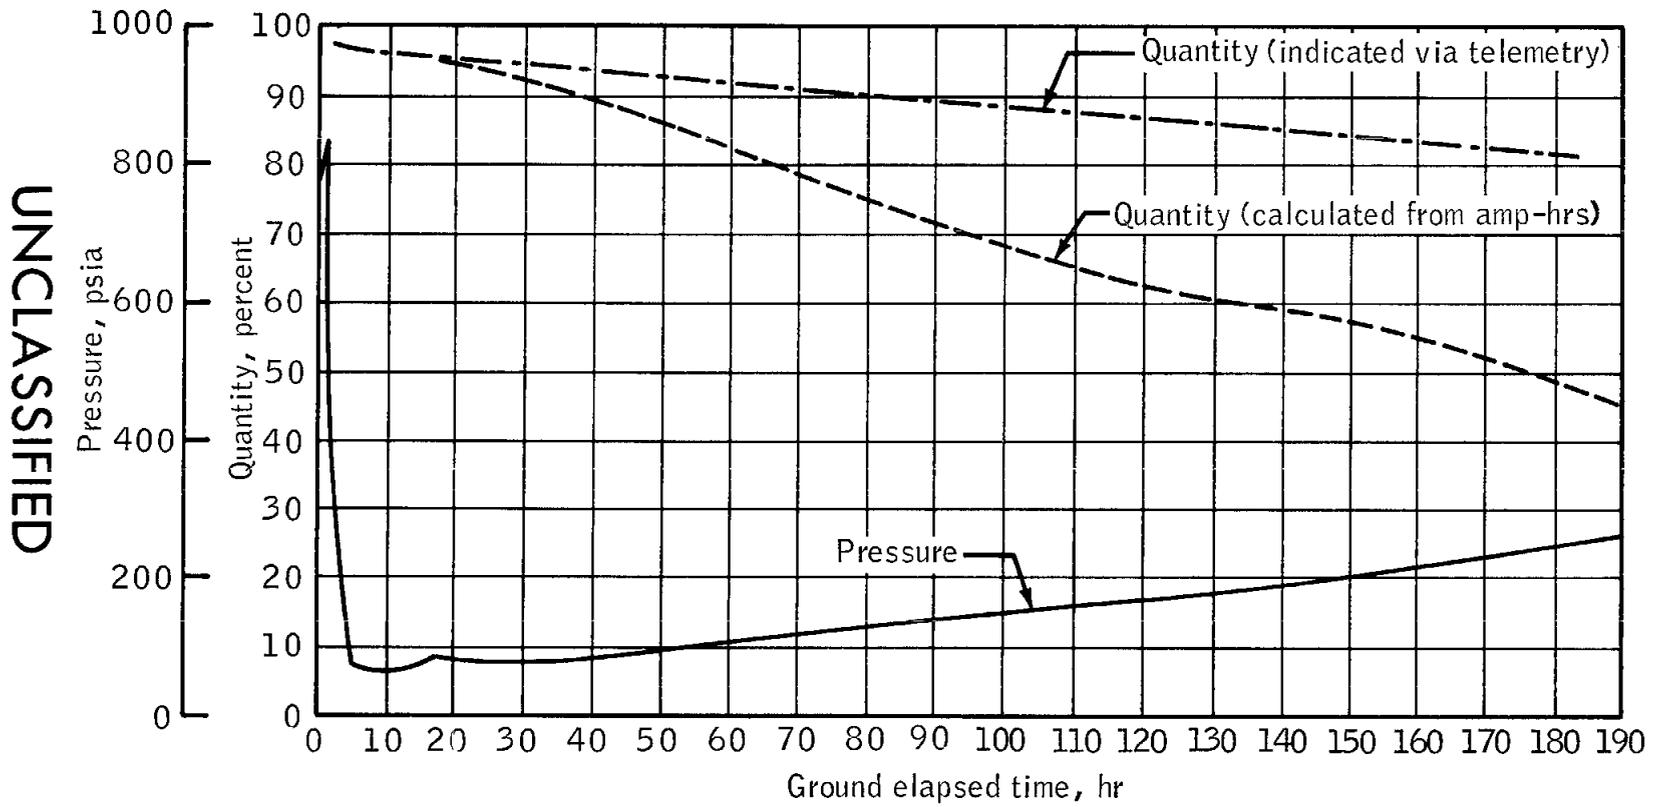
Figure 6.1-1.- Real - time data concerning the fuel-cell oxygen supply.
