# MIT/IL SOFTWARE ANOMALY REPORT

PS 1085  
 MSC REPORT NO. 1-1B-10  
 PROGRAM LUMINARY 1B  
 PROGRAM REVISION 116

1.1 ORIGINATOR <b>G. R. Kalan</b>	1.2 ORGANIZATION <b>MIT/IL</b>	1.3 DATE <b>10/23/69</b>	1.4 ORIGINATOR CONTROL NO.
--------------------------------------	-----------------------------------	-----------------------------	----------------------------

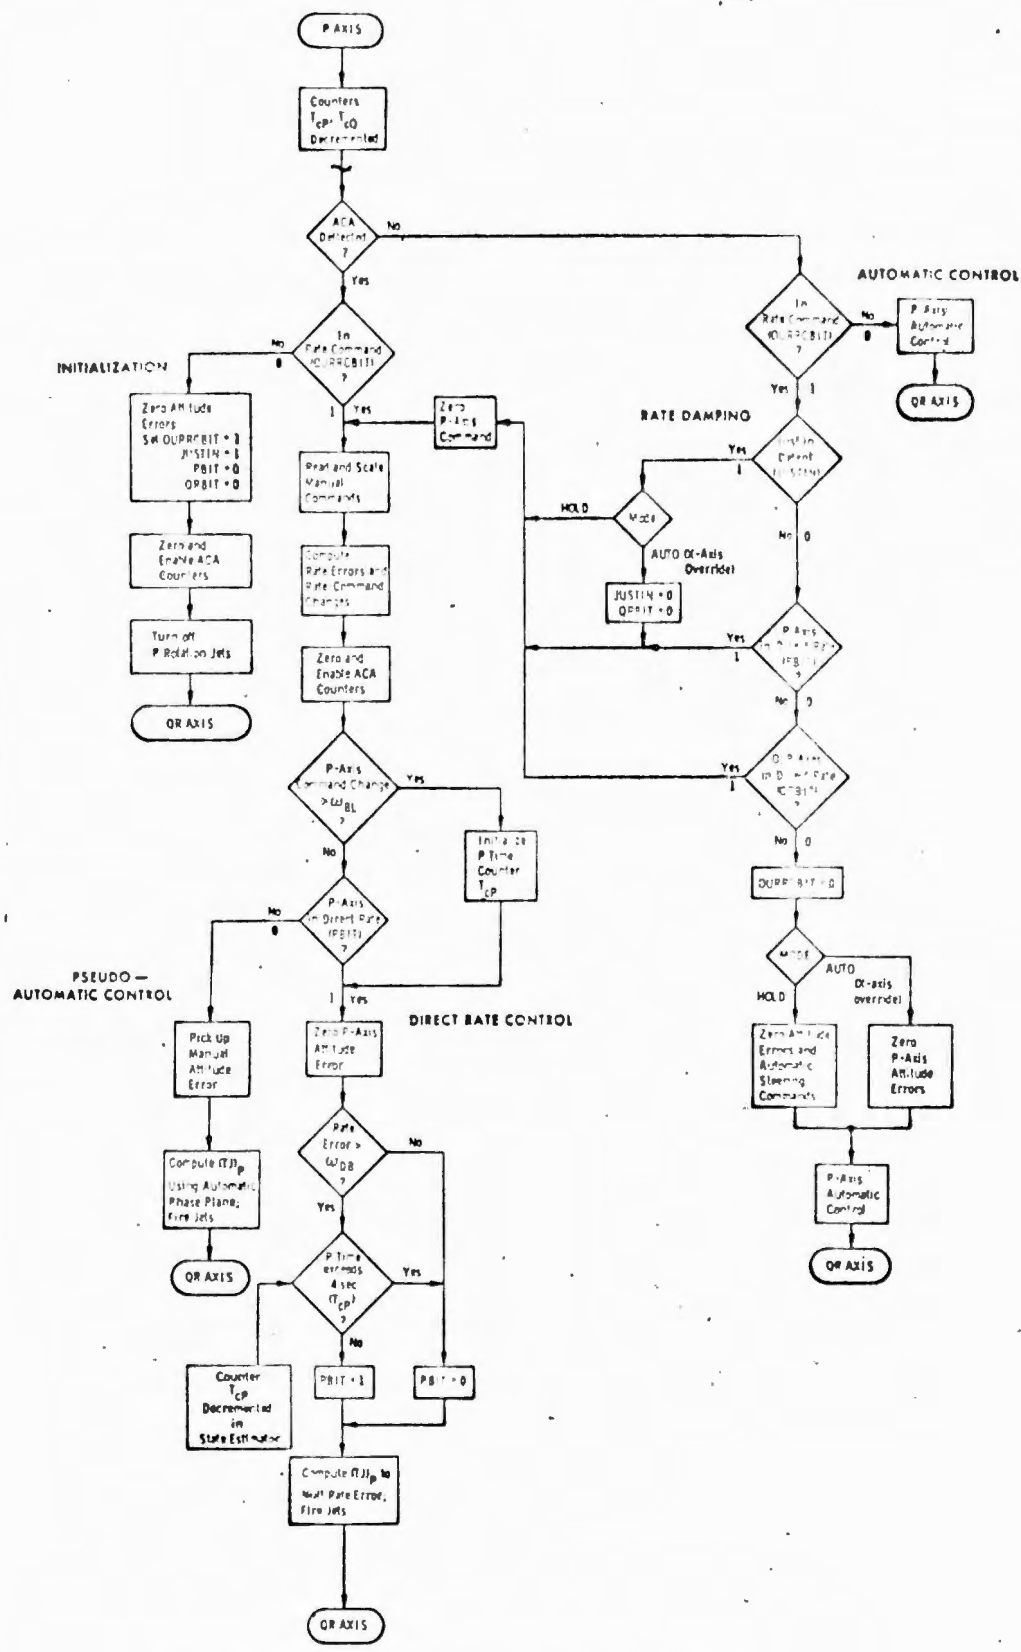
Fig. 3.4-16. Manual rate control logic for the P axis.

When the stick is returned to detent as detected in P axis (Fig. 3.4-16), OURRCFLG is tested and since it is 1, JUSTIN is tested. Since JUSTIN is also 1, the routine would continue on to Q, R -Axis (Fig. 3.4-17). Here the condition of the stick (as determined by a check of CH31 in P-Axis and buffered in CH31TEMP) is checked.

Since it is in detent OURRCFLG is checked and being found set, JUSTIN is reset. Assuming rate command changes and prime axes rate errors greater than the break out level and the rate deadbands respectively, Direct Rate Control will be established by setting RCSFLAGS B11, QRBIT. On the next P-Axis pass with the stick still in detent OURRCFLG is still set but though JUSTIN is reset, transfer is made to Q, R - Axes without resetting OURRCFLG (see Fig. 3.4-16) because QRBIT is set.

However, if the stick is returned to detent after Pseudo - Auto has been established (QRBIT reset) then after the test of OURRCFLG (refer to Fig. 3.4-16) the tests on JUSTIN and QRBIT will find them both reset so OURRCFLG will be reset. Now in Q, R - axes, when OURRCFLG is tested and found to be reset, the program flow will be transferred to Automatic Control.

Set JUSTIN to 1 each time the ACA is found out of detent in Fig. 3.4-16.
