MIT/IL PROGRAM CHANGE ROUTING SLIP

MIT/IL SOFTWARE ANOMALY REPORT

PG 1 OF 5
 MSC REPORT NO. L-18-10
 PROGRAM LUMINARY 1B
 PROGRAM REVISION 116

When the ACA is returned to the detent position after being recycled in and out of detent in the manual rate command mode, the DAP may enter the attitude hold mode immediately, rather than first damping the spacecraft rates as desired.

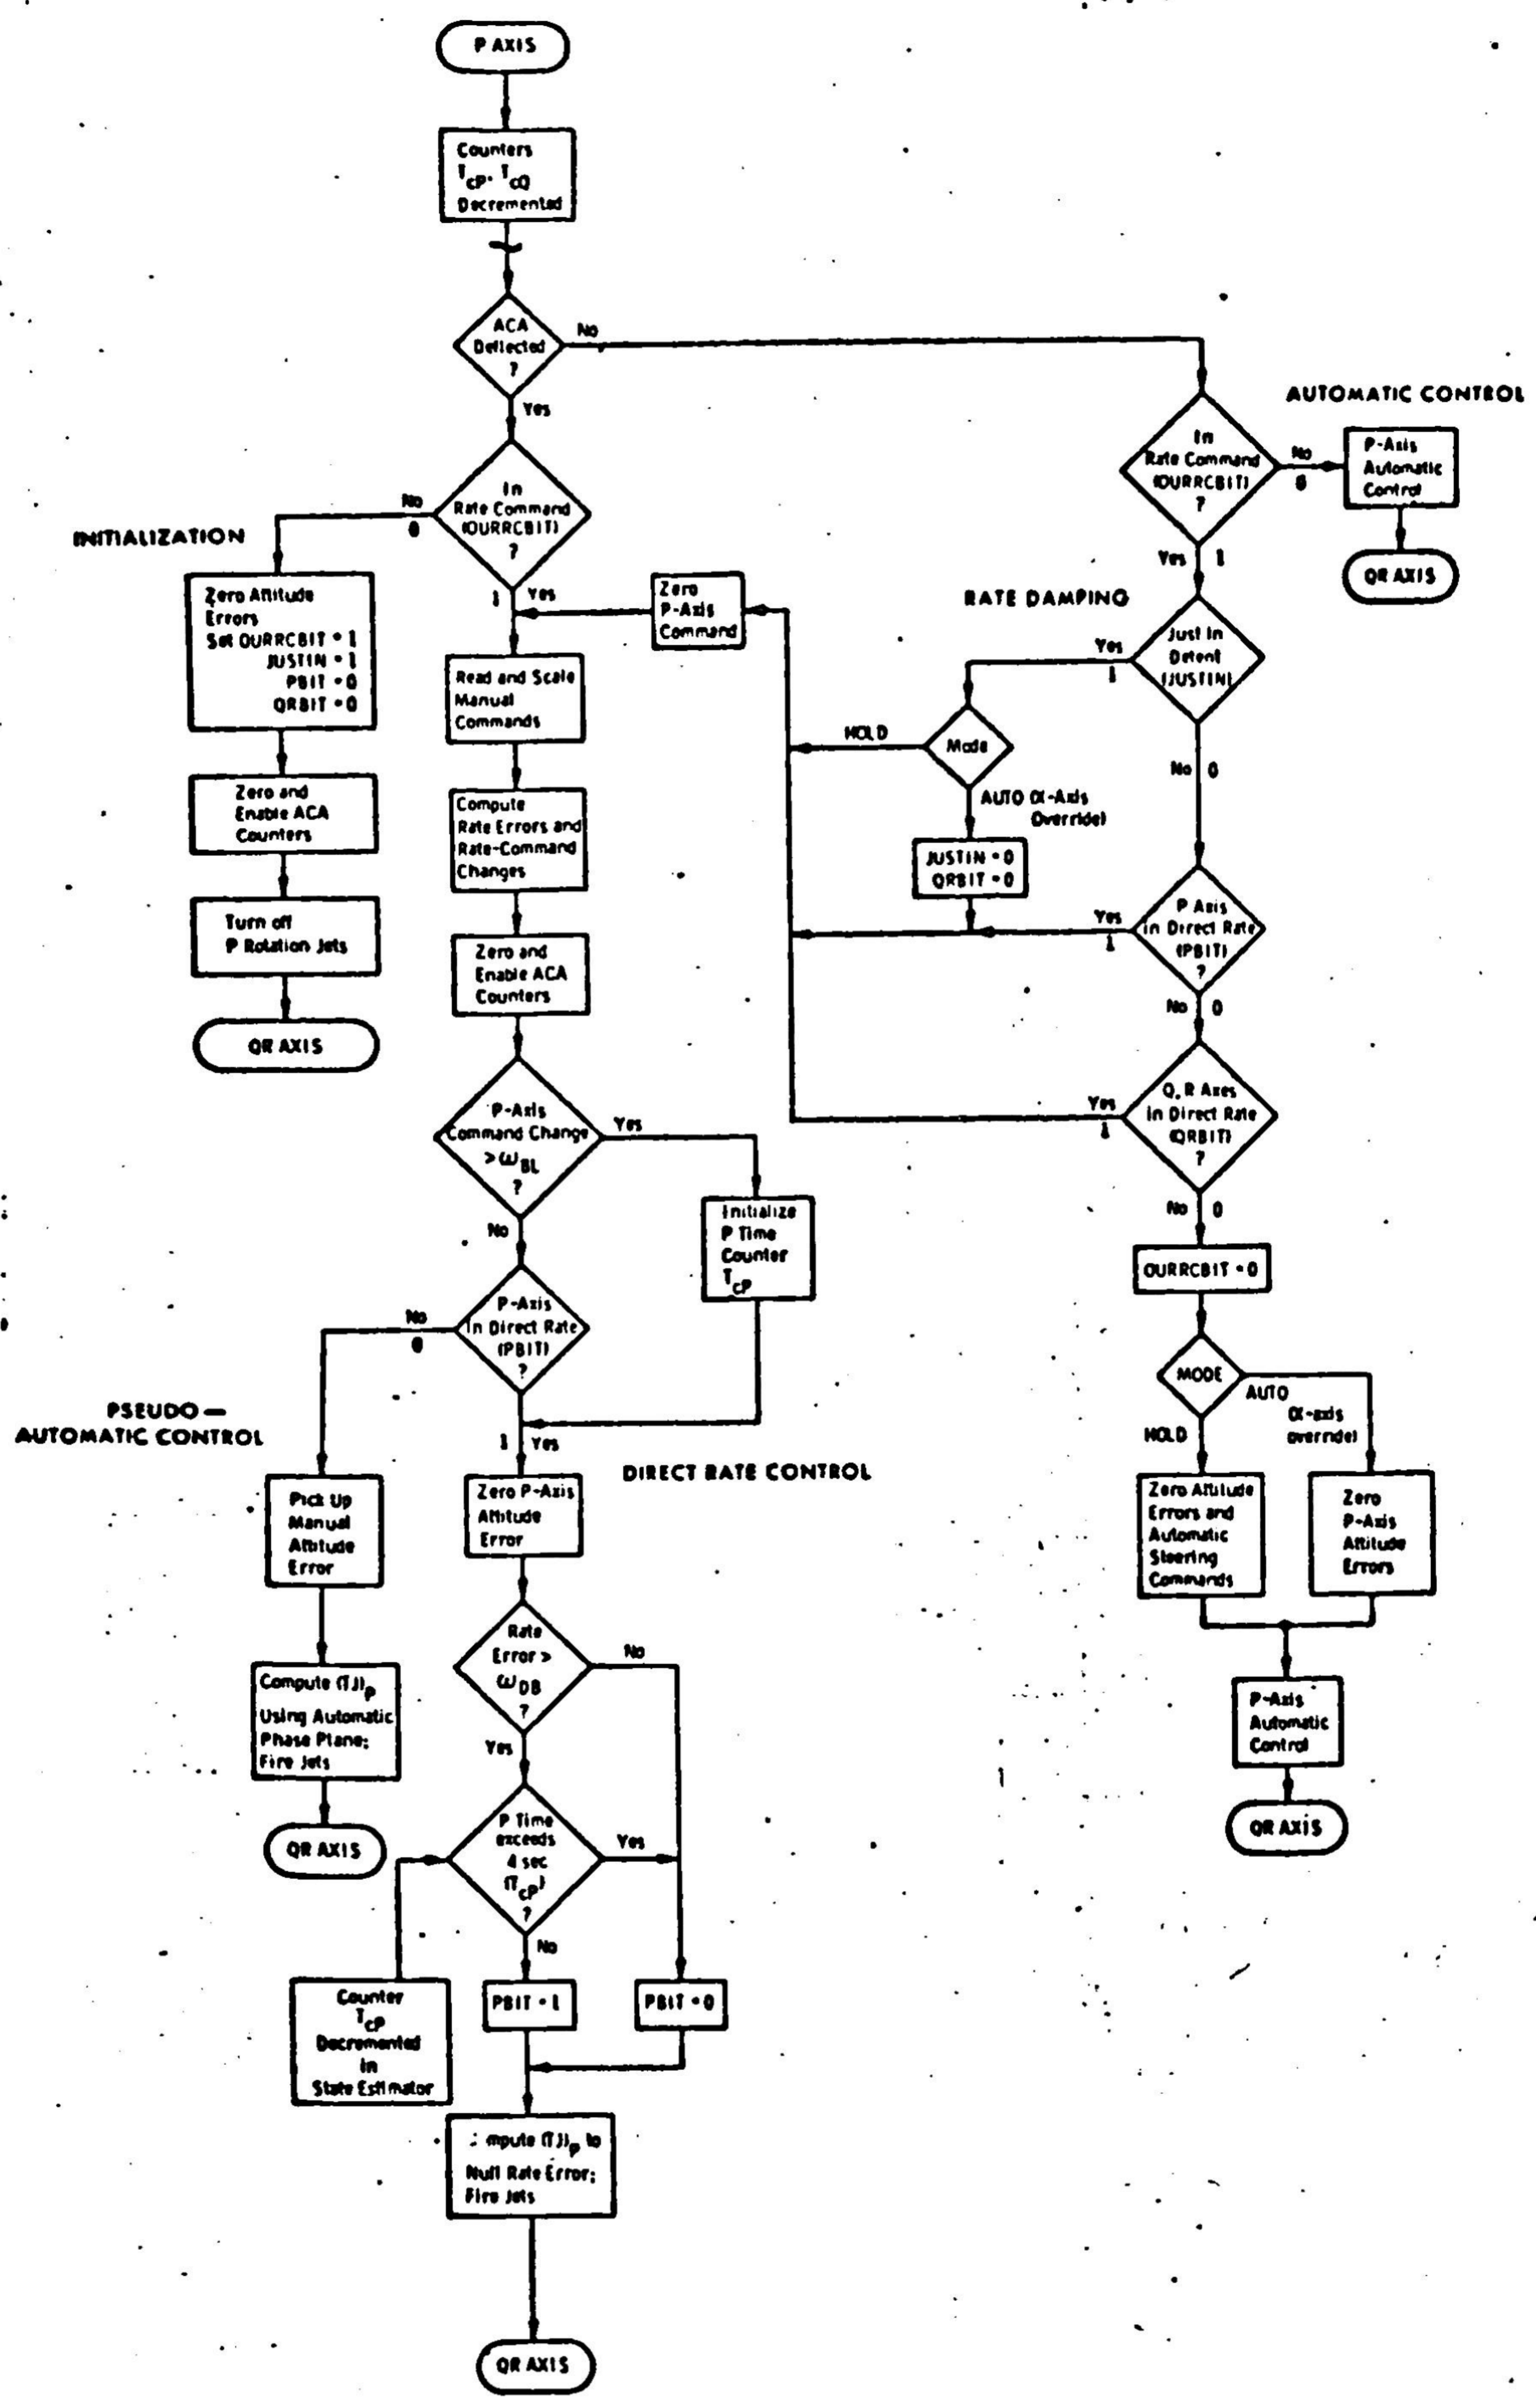
Fig. 3.4-16. Manual rate control logic for the P axis.

" The effect is related to the handling of RCSFLAGS B09, JUSTIN. What happens can be seen by following the history of RCSFLAGS and DAPBOOLS B12, OURRCFLG, thru the above sequence, with the aid of Figure 3.4-16 and -17 of Section 3 of the GSOP (attached). When the stick is just moved out of detent OURRCFLG is tested and since it is 0 an initialization pass is made in P-Axis. It is at this point that OURRCFLG and JUSTIN are set (made equal 1).

When the stick is returned to detent as detected in P axis (Fig. 3.4-16), OURRCFLG is tested and since it is 1, JUSTIN is tested. Since JUSTIN is also 1, the routine would continue on to Q, R -Axis (Fig. 3.4-17). Here the condition of the stick (as determined by a check of CH31 in P-Axis and buffered in CH31TEMP) is checked.

Since it is in detent OURRCFLG is checked and being found set, JUSTIN is reset. Assuming rate command changes and prime axes rate errors greater than the break out level and the rate deadbands respectively, Direct Rate Control will be established by setting RCSFLAGS B11, QRBIT. On the next P-Axis pass with the stick still in detent OURRCFLG is still set but though JUSTIN is reset, transfer is made to Q, R - Axes without resetting OURRCFLG (see Fig. 3.4-16) because QRBIT is set.

However, if the stick is returned to detent after Pseudo - Auto has been established (QRBIT reset) then after the test of OURRCFLG (refer to Fig. 3.4-16) the tests on JUSTIN and QRBIT will find them both reset so OURRCFLG will be reset. Now in Q, R - axes, when OURRCFLG is tested and found to be reset, the program flow will be transferred to Automatic Control.

Set JUSTIN to 1 each time the ACA is found out of detent in Fig. 3.4-16.
