LUMINARY MEMO # 155

DATE: 1 June 1970

SUBJECT: Luminary 1D re-release

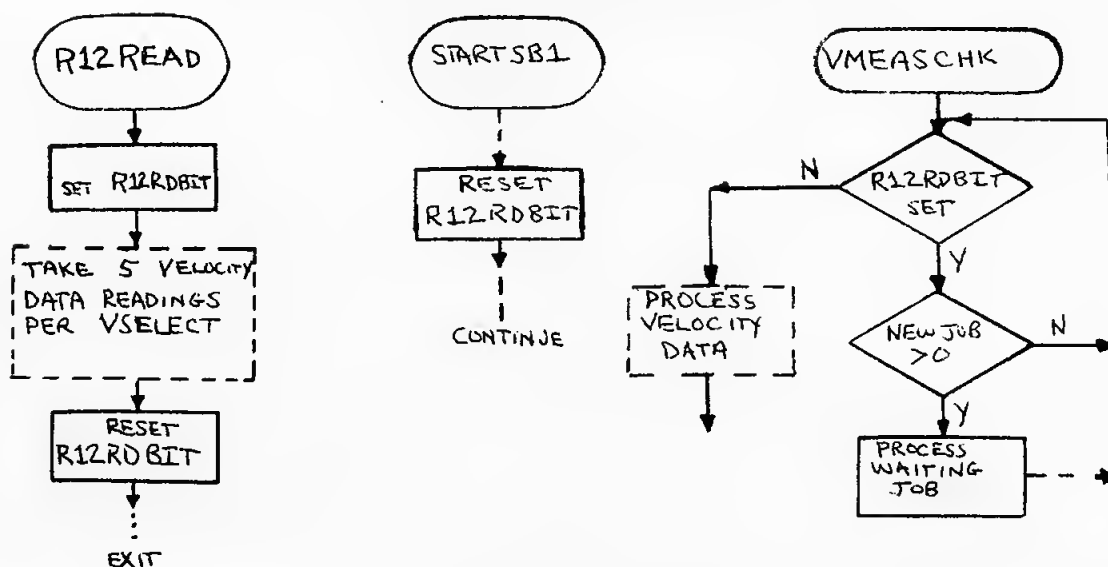
1. Implementation of ACB L 20-
An error was made in reading assembly card numbers: 2234 vs 2334. By coincidence, they are concerned with the same noun (60) in the NOUN Tables (output and input scaling). The fix makes the output scaling 0.5571 fps/bit and the input scaling the way it was originally, though it is not intended for use.
2. Implementation of PCR 988-
The Restart point in P66 was moved down four places to (1) prevent the AstrPro flag from being set by a Restart if it had been reset to turn off RCS jets (2) prevent a possible 1466 alarm if a P66 omission occurred with a Restart.
3. Implementation of PCR 896-
(LMS/KSC). The landing Radar Velocity Reasonableness test could fail erroneously due to Service being too fast. It starts to process LR velocity data before the complete set of radar readings are taken for a particular velocity beam. The fix is flowed below.

R12RBIT is flagword 11 bit 3. This was concurrently discovered by Robert Force, NASA (LMS/MSC) but has not to this date been seen on the FMES at GAEC. A special case, i. e. no alt data good and a V68 terminating the a priori terrain model computations, produced 9 failures at MIT/CSDL.

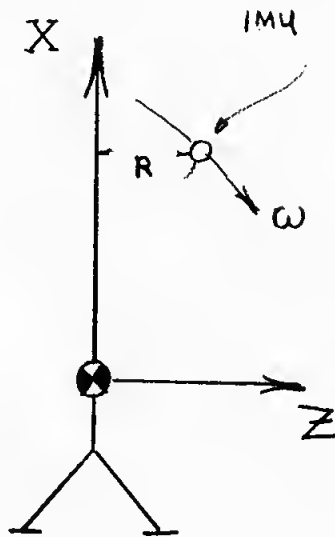
PCR 1052 was implemented into the re-release to account for the IMU sensing vertical acceleration in P66 when the PIPA's are read while Spacecraft attitude rate is present. The result before the PCR implementation was throttle oscillation commonly referred to as "throttle castellation." Now, when the present acceleration due to thrust is computed (i. e. the PIPA's are read in P66) the pitch rate as determined by the DAP (OMEGAQ) is multiplied by the offset distance the IMU is from the X axis in the Z direction. This quantity is a measure of the Delta Velocity sensed by the PIPA's due to the IMU rotating ("bobbing") around the center of gravity and is subtracted from the total Delta V measured by the PIPA's for that P66 one-second pass. Navigation is in no way affected by the bobbing or the correction.

$$\Delta V_x = \Delta V_x - \omega \cdot R$$
