LM ENGINEERING MEMO

LMO 541-108
18 June 1968

Subject: DETAIL DATA EVALUATION REPORT, LM-3 OCP 61018, RUN
BETWEEN 11 MAY AND 13 MAY 1968

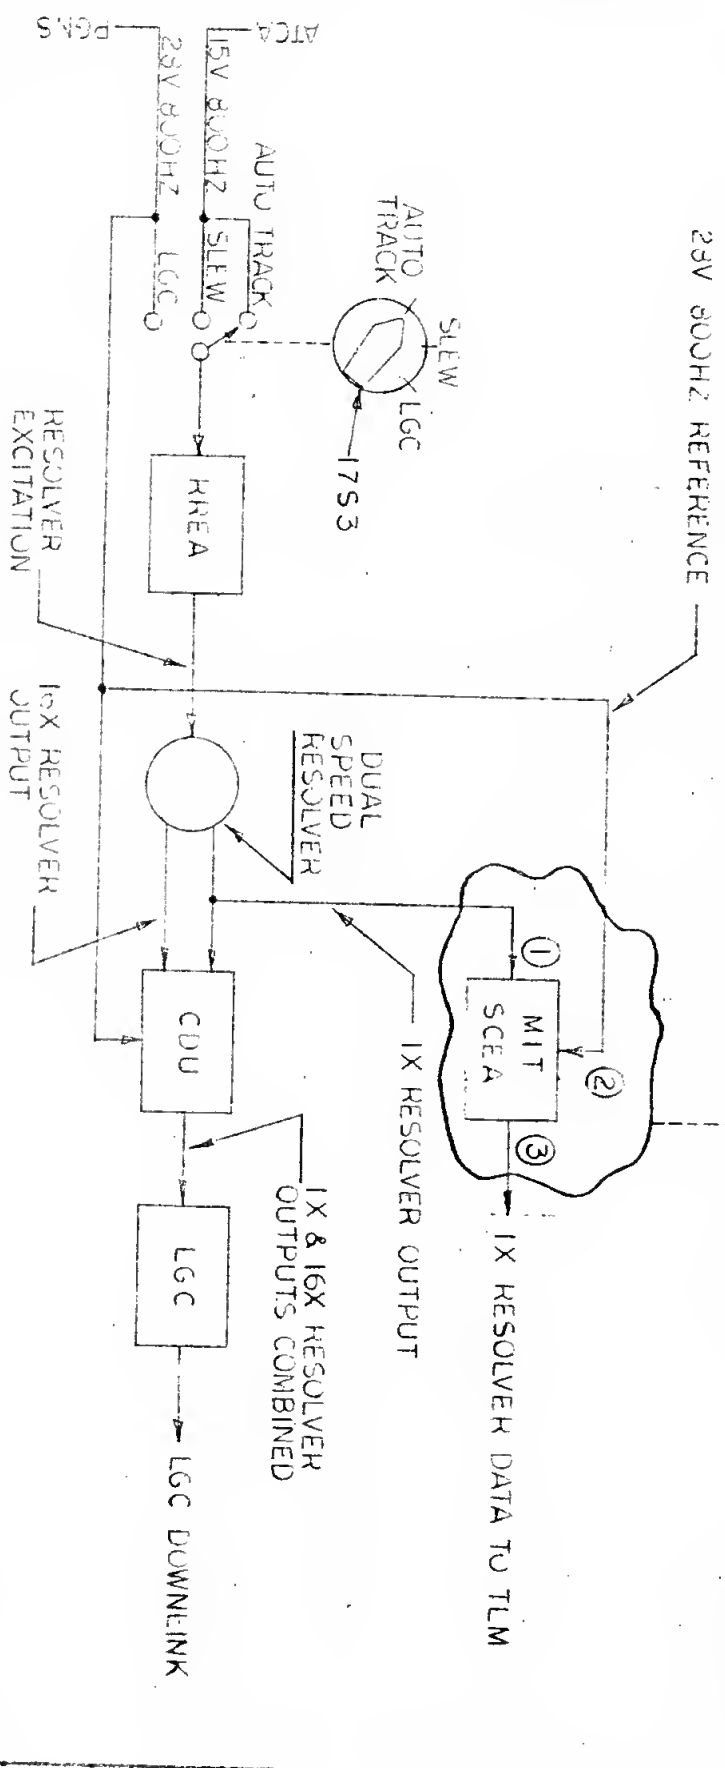
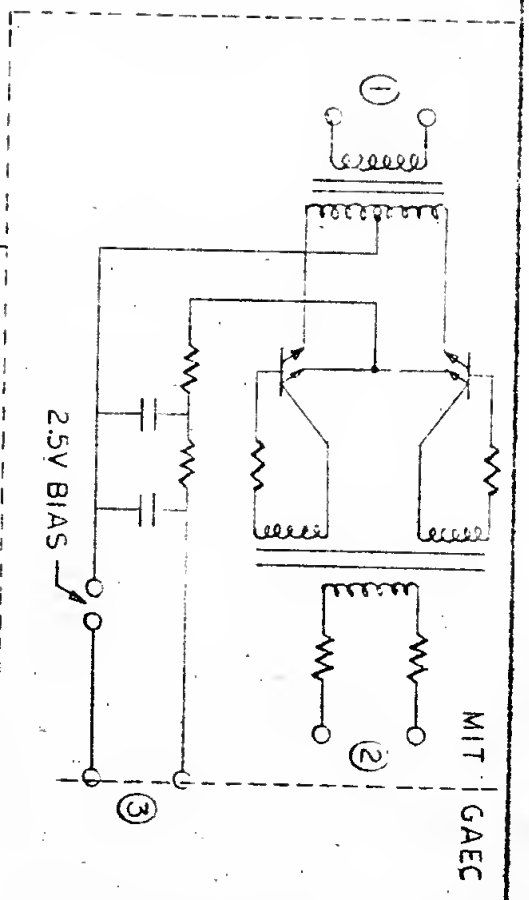
RENDEZVOUS RADAR RESOLVER SIGNAL FLOW

The slew rates in the Manual Slew Mode were in error because of an incompatibility between the MIT Signal Conditioning Equipment and the ATCA 15V 800 Hz Resolver Excitation (See Enclosure 2). The PGNS and ATCA 800 Hz signals are not phase synchronized to each other, and hence a random phase difference exists between the resolver output and the demodulation reference signal in the MIT SCEA (Manual slew mode). In the LGC mode the MIT/SCEA and the Resolvers references are from the same supply, precluding an incompatibility. Consequently, the LX Resolver data is only meaningful with 17-S-3 in the LGC position.
