NATIONAL AERONAUTICS AND SPACE ADMINISTRATION

APOLLO 8 MISSION REPORT

MANNED SPACECRAFT CENTER
HOUSTON, TEXAS
FEBRUARY 1969

Mission Evaluation Team

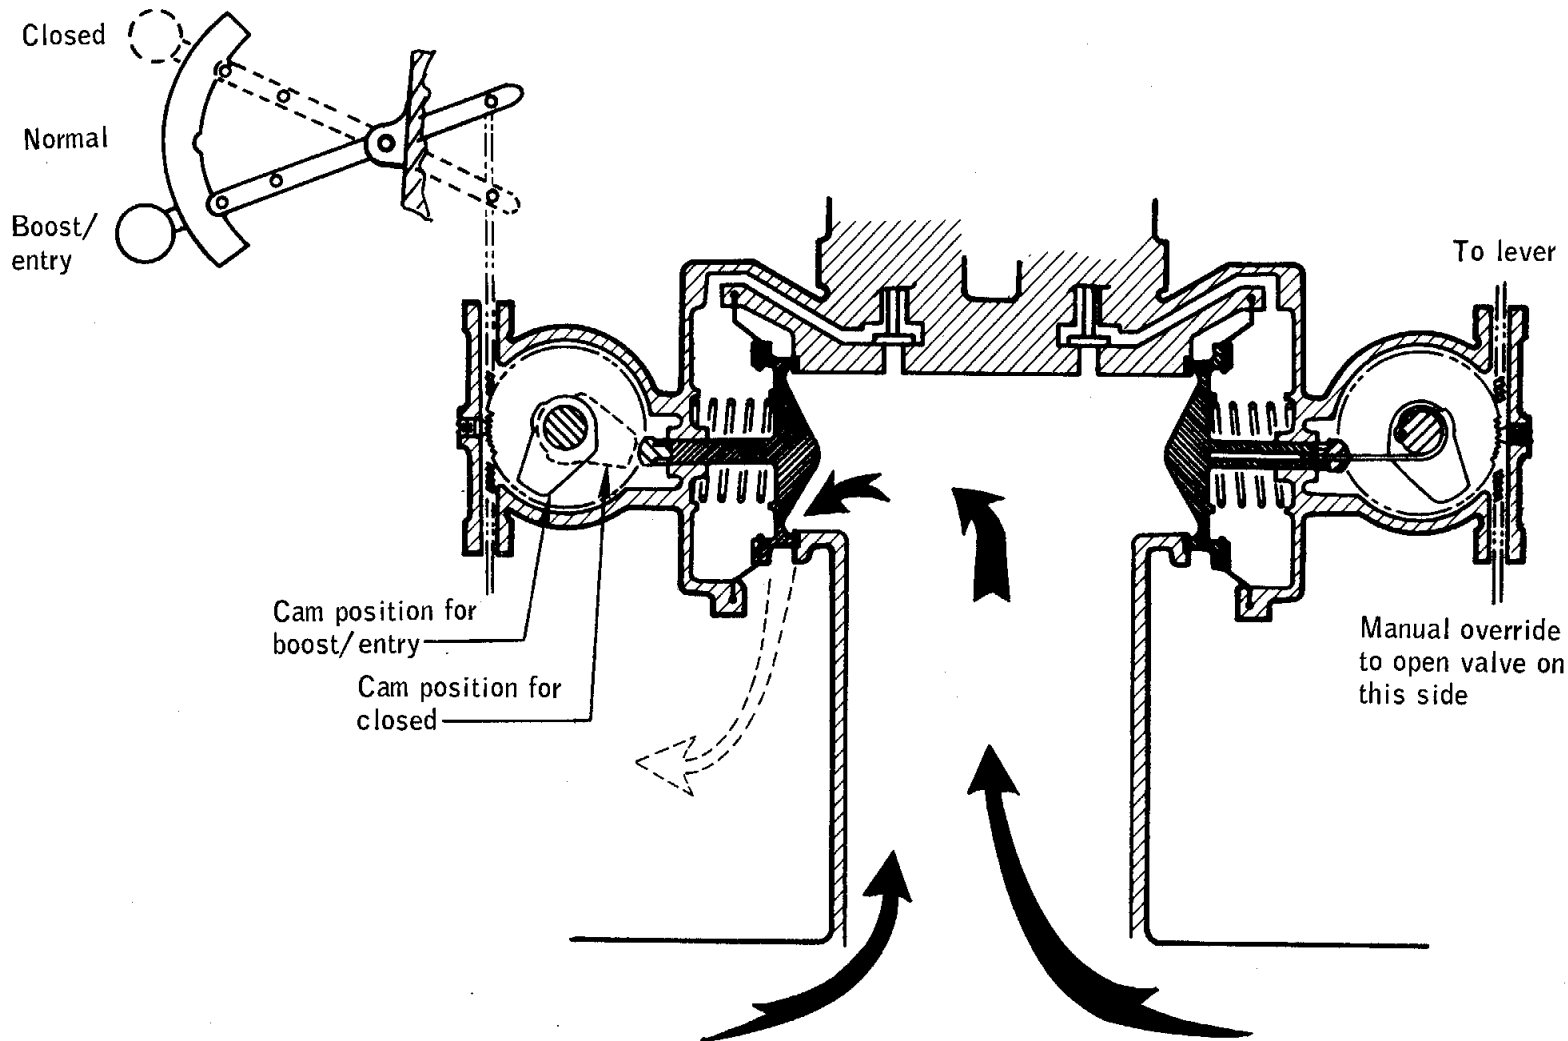
Figure 12-4.- Cabin pressure relief valve.

The crew estimated 2 to 3 quarts of water entered the cabin through the cabin pressure relief valve at landing. Postflight tests were conducted on the valve installed in the spacecraft. Test results indicate that, with both sides of the valve in the closed position, gaseous leakage through the system is 60 scc/min at a differential pressure of 18 inches of water. The differential pressure was increased up to 13 psi, with no significant increase in leakage. Test results indicate that the valve operated as designed and would not have allowed water ingestion if properly closed.
