NASA SP-238

APOLLO 11

Mission Report

PREPARED BY
MISSION EVALUATION TEAM
NASA MANNED SPACECRAFT CENTER

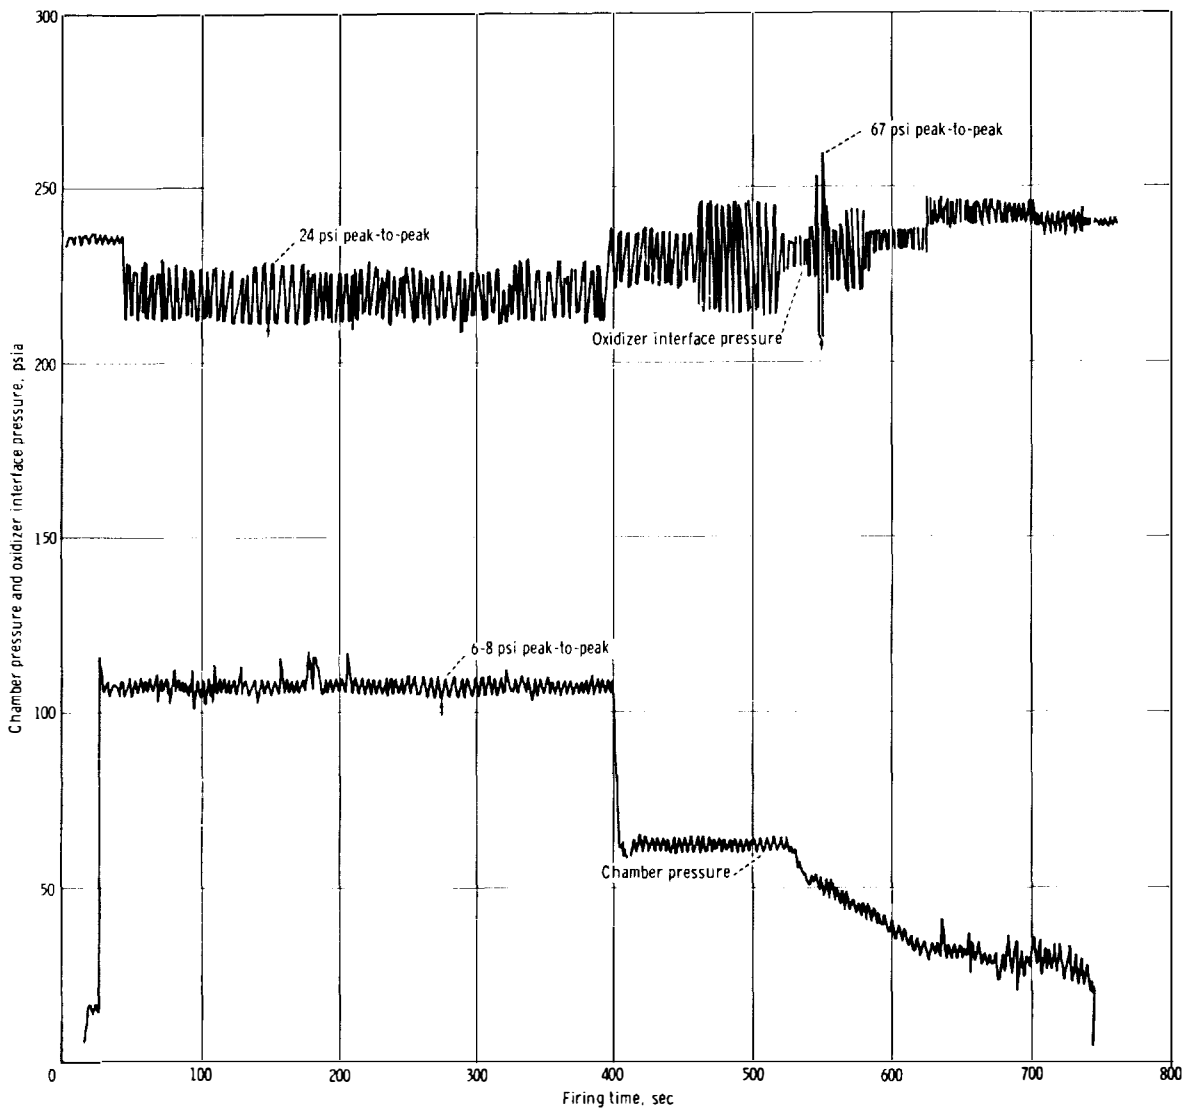
Figure 9-5.- Oxidizer interface pressure and chamber pressure oscillations.

During the powered descent maneuver, the oxidizer interface pressure appeared to oscillate as much as 67 psi peak to peak. The pressure continued to oscillate throughout the firing, although over a smaller range (fig. 9-5); the oscillations were most prominent at approximately 50-percent throttle. The fact that oscillations of this magnitude were not observed in the chamber pressure or the fuel interface pressure measurements indicates that they were not real. Engine performance was not affected. Oscillations of this type have been observed at the White Sands Test Facility on similar pressure measurement installations on numerous engines. The high-magnitude pressure oscillations observed during the White Sands Test Facility tests were amplifications of much lower pressure oscillations in the system. The phenomenon has been demonstrated in ground tests where small actual oscillations were amplified by cavity resonance of a pressure transducer assembly containing a tee with the transducer on one leg of the tee and a cap on another leg. This assembly is similar to the interface pressure transducer installation. The resonance conditions will vary with the amount of helium trapped in the tee and with the throttle setting.

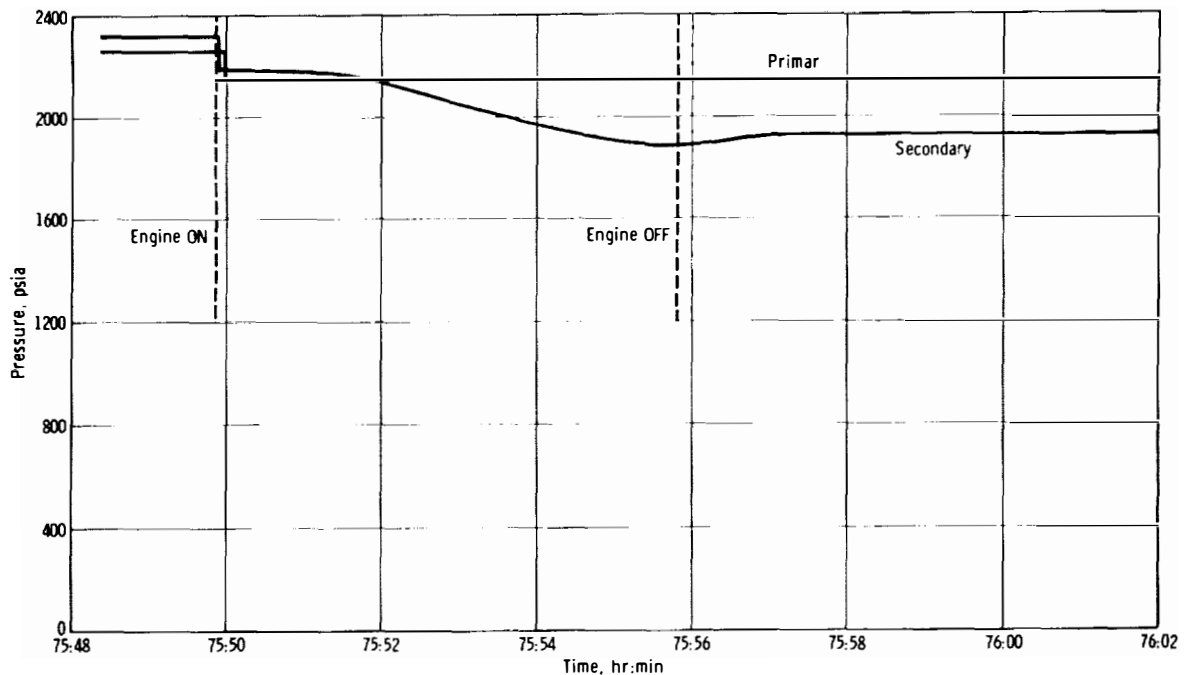
Figure 16-1.- Nitrogen pressure during initial lunar orbit insertion firing.

Service propulsion nitrogen leak.- During the lunar orbit insertion firing, the gaseous nitrogen in the redundant service propulsion engine actuation system decayed from 2307 to 1883 psia (fig. 16-1), which indicated a leak downstream of the injector prevalve. The normal pressure decay as experienced by the primary system is approximately 50 psia for each firing. Only one system was affected, and no performance degradation resulted. This actuation system was used during the transearth injection firing, and no leakage was detected.

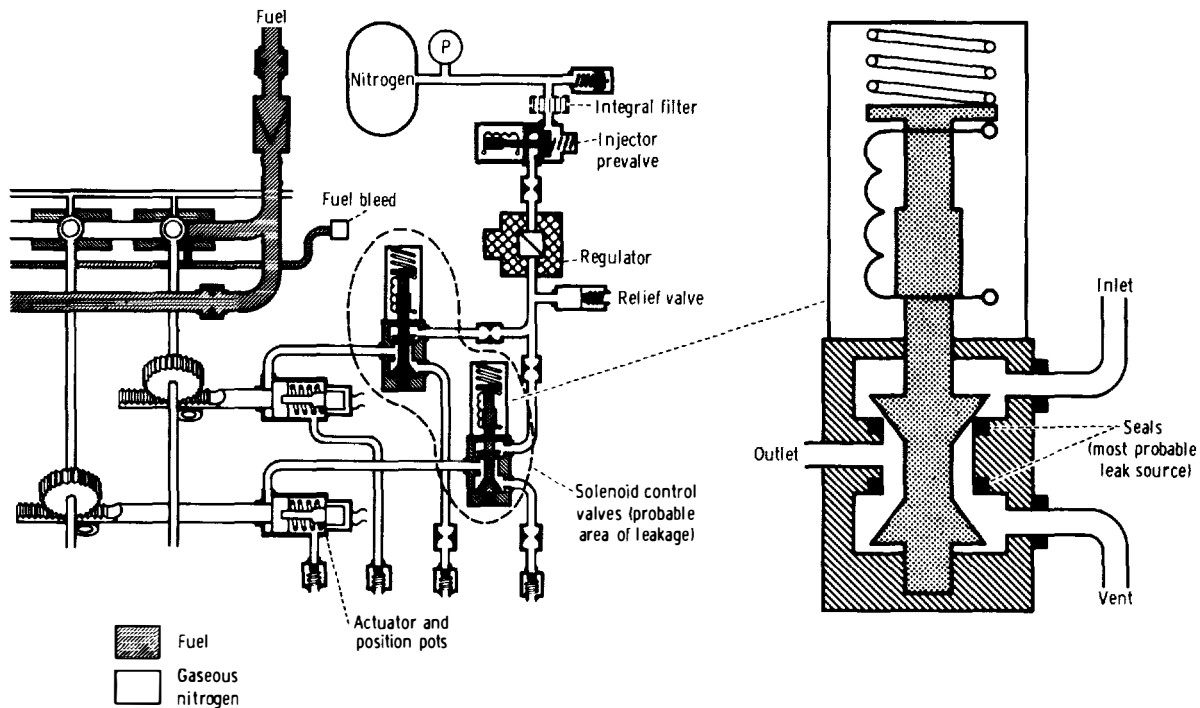
Figure 16-2.- Control for service propulsion propellants.

The fuel and oxidizer valves are controlled by actuators driven by nitrogen pressure. Figure 16-2 is representative of both nitrogen control systems. When power is applied to the service propulsion system in preparation for a maneuver, the injector preclude is opened; however, pressure is not applied to the actuators, because the solenoid control valves are closed. When the engine is commanded on, the solenoid control valves are opened, pressure is applied to the actuator, and the rack on the actuator shaft drives a pinion gear to open the fuel and oxidizer valves. When the engine is commanded off, the solenoid control valve vents the actuator and closes the fuel and oxidizer valves.
