DATE: SEP 16 1969

In reply refer to:
69-FS55-31

SUBJECT: Apollo Mission G Post-flight Summary - AGC support (console 37, Flight Dynamics SSR)

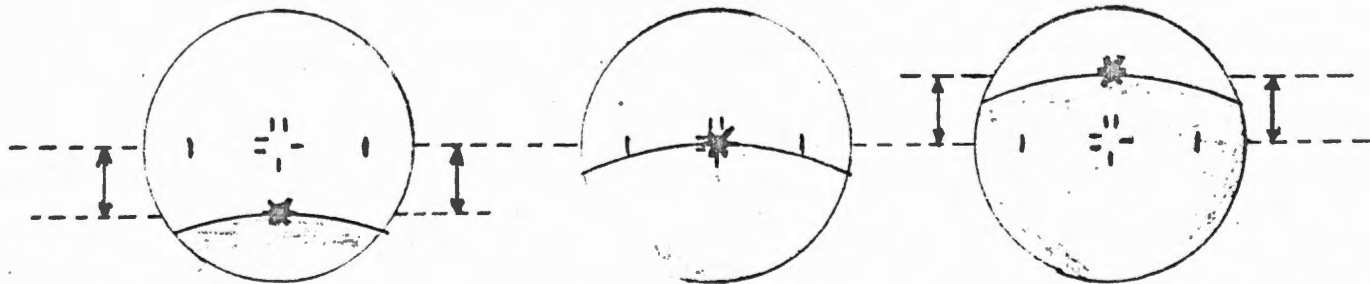
- I. A TRUNNION BIAS DETERMINATION SHOULD BE DONE PRIOR TO AND AFTER THE P23 SEQUENCE.
NOTE: BIAS SHOULD BE INCORPORATED (A PRO ON N87) AFTER TWO CONSECUTIVE EQUAL ($.003^\circ$) MEASUREMENTS. THE TRUNNION SHOULD BE MOVED OFF A COUPLE DEGREES BETWEEN MEASUREMENTS
- II. TO INSURE SUBSTELLAR POINT MARKING: THE SXT M-LINE MUST BE PARALLEL TO THE HORIZON AT THE SUBSTELLAR POINT. NOTE: THE M-LINE IS PERPENDICULAR TO TRUNNION MOTION, AND PURPOSELY IMPLIED IS THE FACT THAT: THE STAR/HORIZON SUPERIMPOSITION MAY BE MADE ABOVE OR BELOW THE M-LINE.
