# APOLLO 14 MISSION H-1

# APOLLO 14

## OPEN G & N PROBLEMS

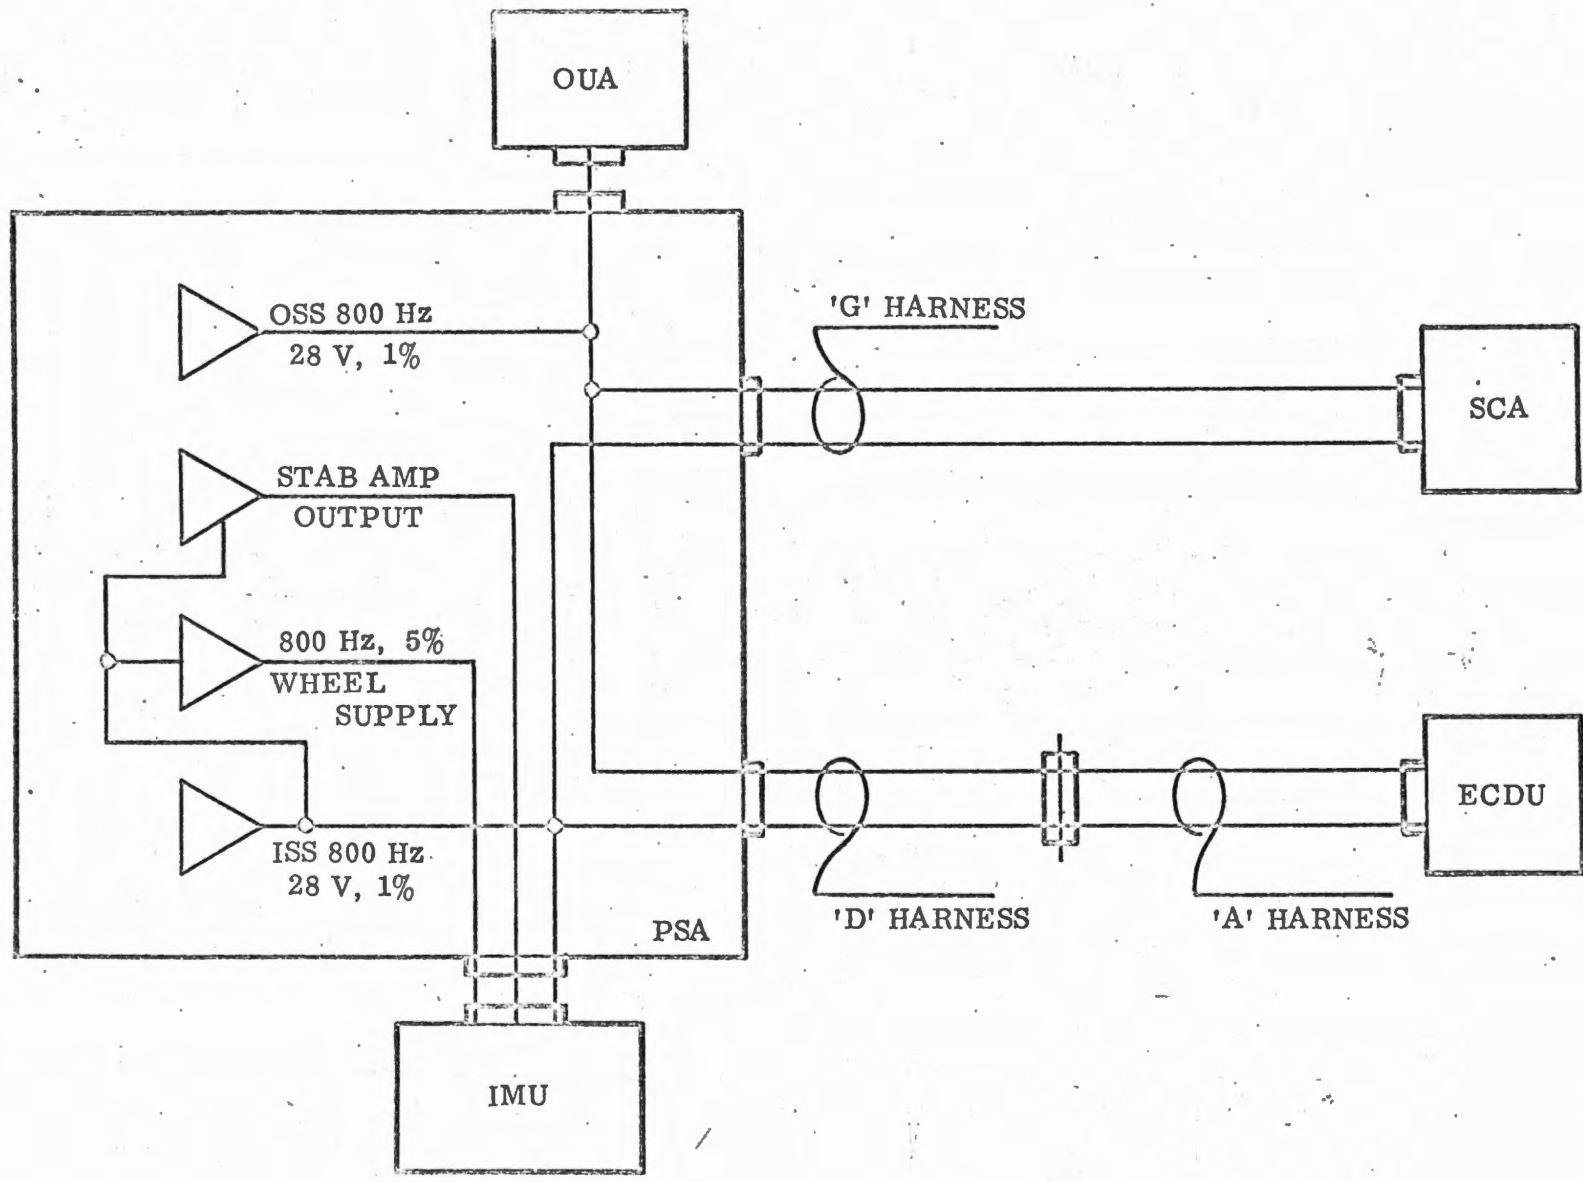
"A" HARNESS  
P/N 2021406, S/N 13

DURING POWER UP OF G&N 214 IN CM-110, OPTICS TURN ON CAUSED 5.25 VOLTS TO BE APPLIED TO THE IMU OPERATE BUSS. APPLICATION OF IMU OPERATE POWER CAUSED 8 VOLTS TO BE APPLIED TO THE OPTICS OPERATE BUSS.

LABORATORY SIMULATION WAS ACCOMPLISHED BY SHORTING THE OUTPUTS OF THE 8002190033 AND 8002190155 MODULES. X-RAY INSPECTION REVEALED AN APPARENT WIRE STRAND BETWEEN PINS 40 AND 41 OF CONNECTOR 56P1 (8002190155/033 SIGNALS). CONTINUITY CHECKS CONFIRMED AN INTERMITTENT SHORT BETWEEN THESE TWO CIRCUITS.

CONNECTOR WAS SECTIONED AND A METALLIC PIECE WAS VERIFIED AS CAUSE OF SHORT BETWEEN PINS 40 AND 41. OPTICAL MEASUREMENT VERIFIES APPROXIMATE 34 GAUGE SIZE OF FOREIGN MATERIAL (SAME AS USED IN WIRES ON PINS 40 AND 41). HOWEVER, ALL STRANDS WERE PRESENT AND INTACT AT CRIMP JOINTS ON WIRES TO PINS 40 AND 41. ANALYSIS OF FOREIGN MATERIAL TO DETERMINE METALLIC CONTENT IS IN PROGRESS.

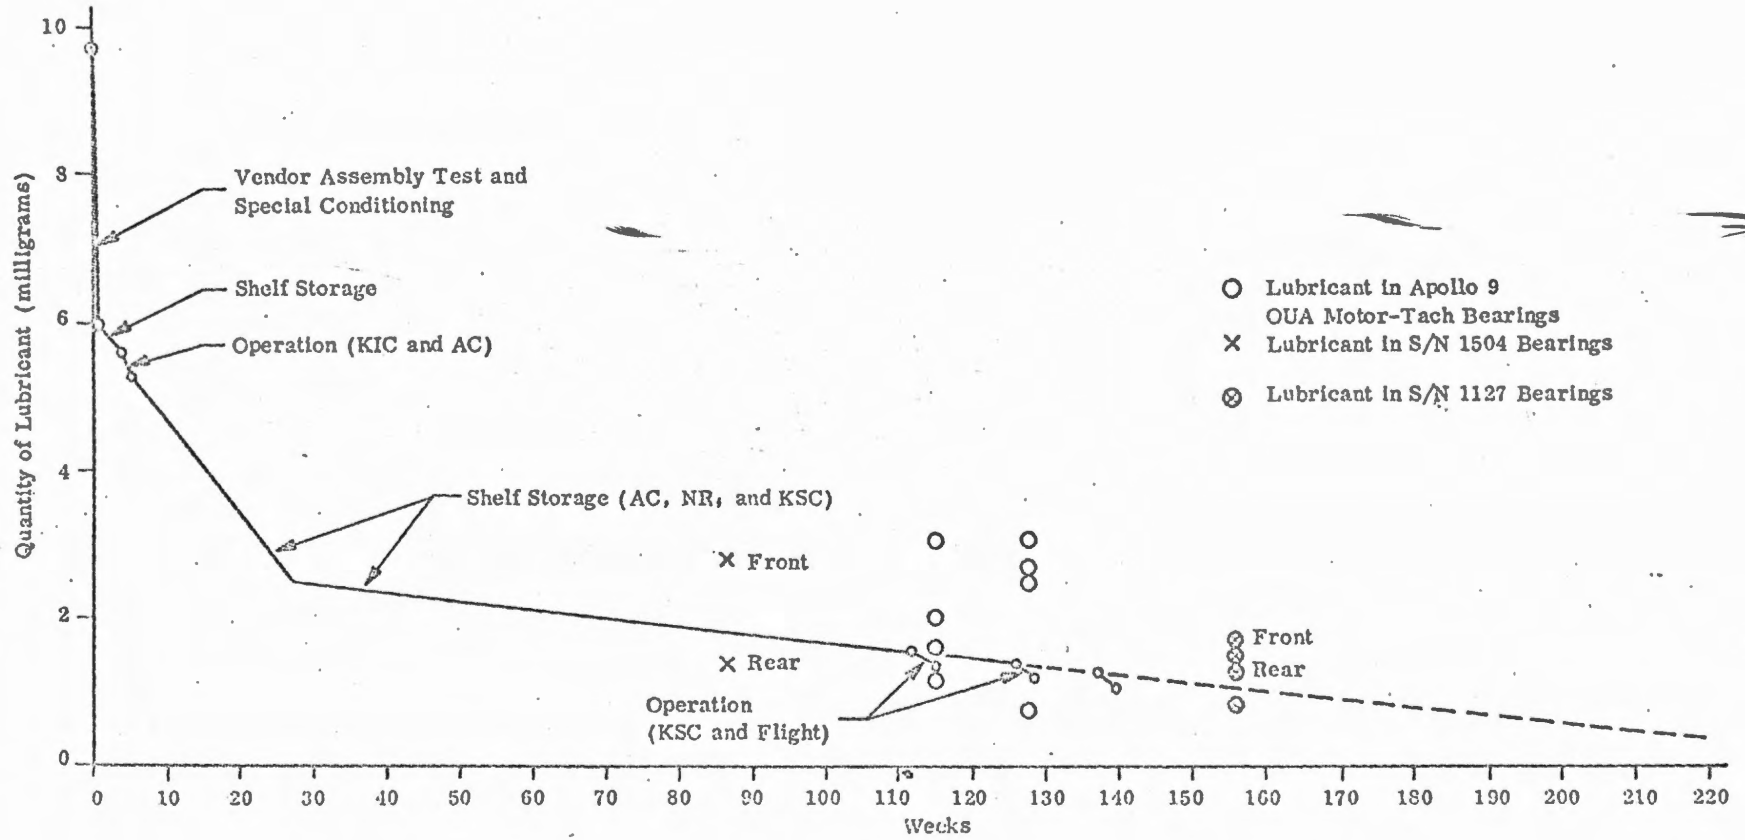
## MOTOR TACHOMETER

LUBRICANT LOSS DURING LIFE OF OUA MOTOR-TACH

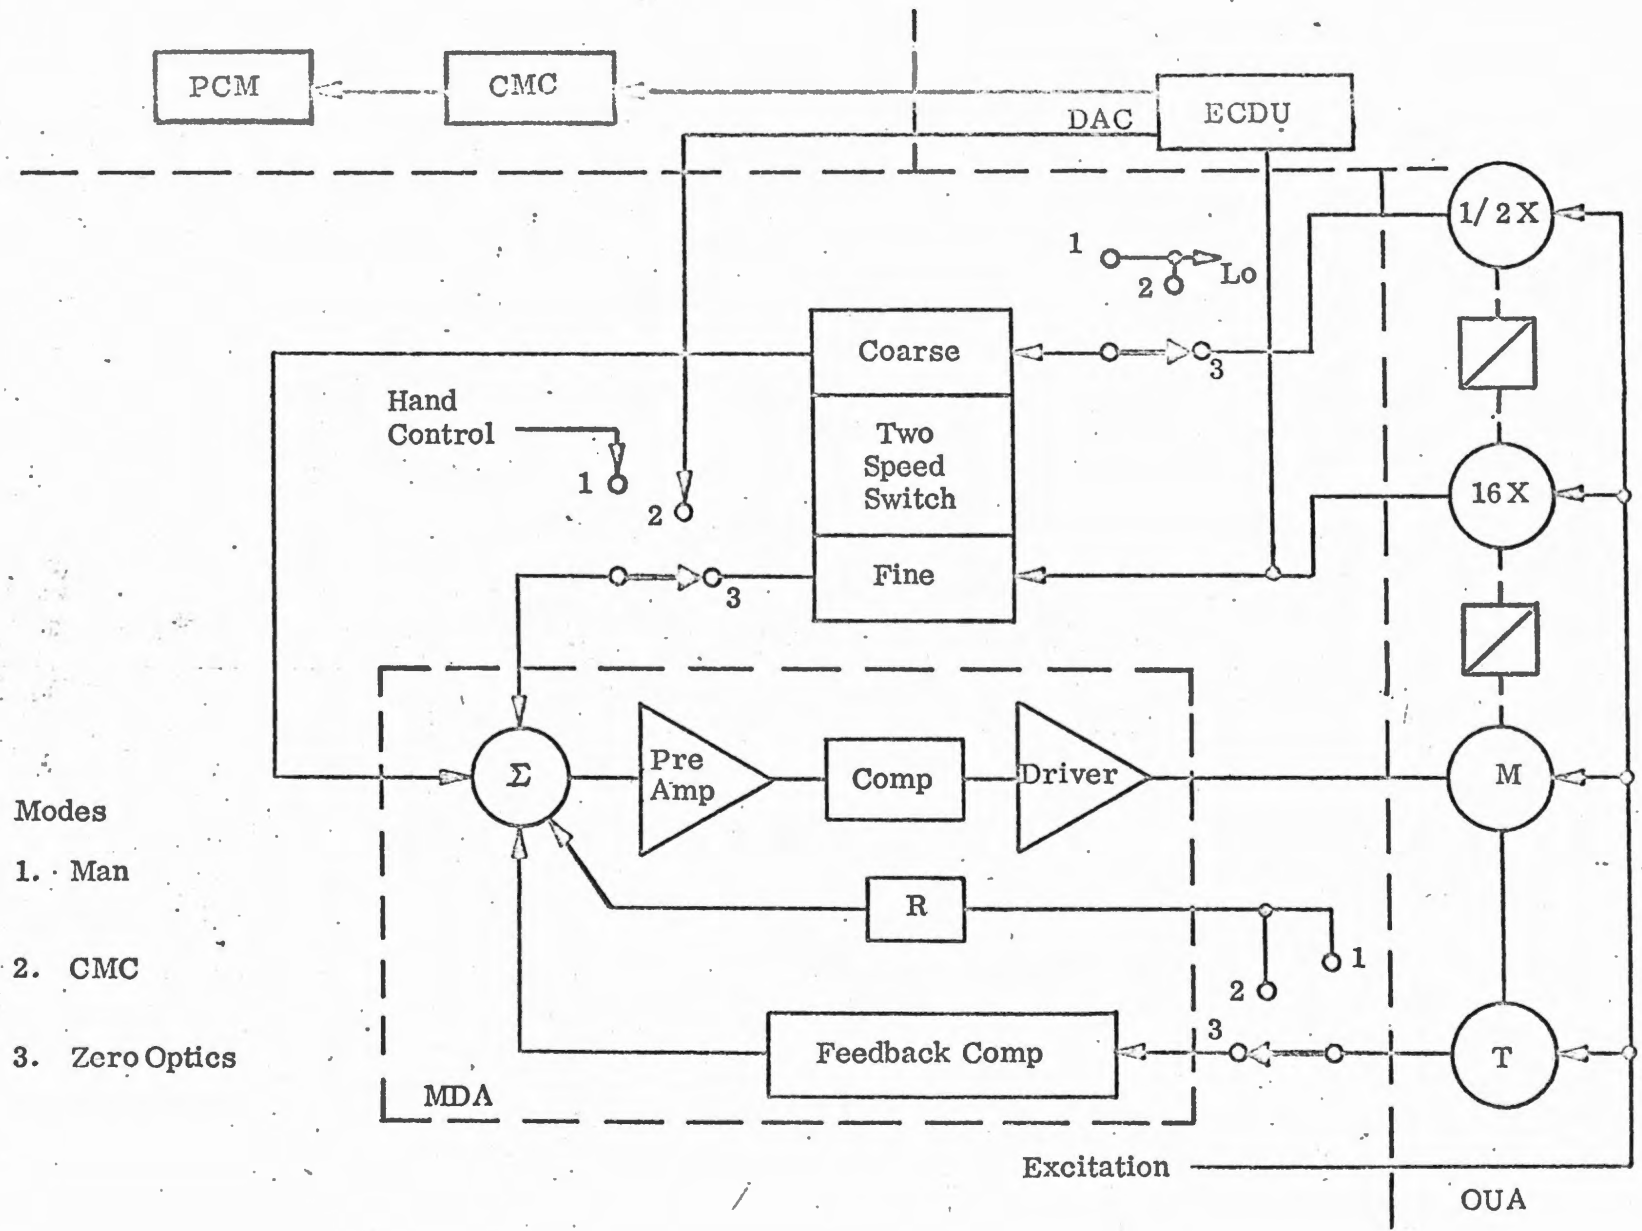
• OPTICS ZERO DRIFT

- 1) OWA "ZERO OPTICS DRIFT

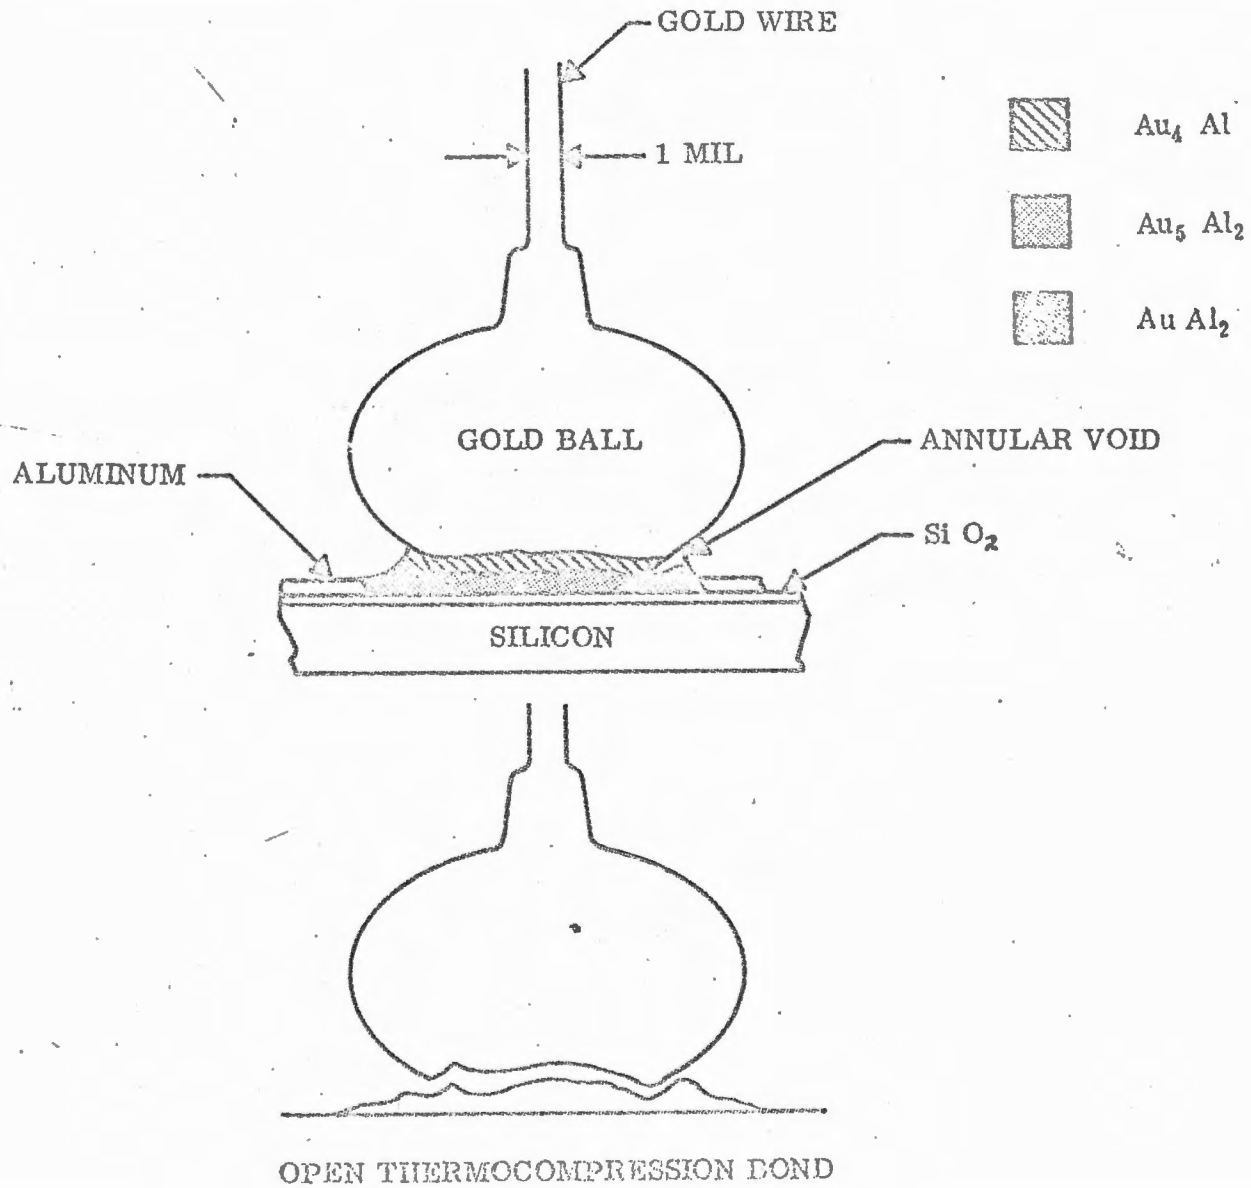
TYPICAL GOLD ALUMINUM THERMOCOMPRESSION BOND

- 1) THE ANALYSIS OF ELECTRICAL TESTS SHOWED AN OPEN AT PIN 1 OF GATE 6-605, AND AN ABNORMALLY HIGH RESISTANCE IN SERIES WITH THE EMITTER OF ABOUT 170 OHMS.
- 2) WHEN THE BONDING WIRES WERE PULL TESTED, THE DIE BALL BONDS ASSOCIATED WITH PINS 1, 5, AND 6 LIFTED AT ZERO GRAMS FORCE. THE VISUAL APPEARANCE OF THE BONDING REGIONS INDICATED THAT FORMATION OF GOLD ALUMINUM COMPOUNDS

(INTERMETALLIC COMPOUNDS) PLAYED A ROLE IN WEAKING THE BONDS, THE BONDS LISTED IN THE GOLD RICH REGION.

TESTED IN PART AT THE MODULE LEVEL. THE  $2^{-10}$  COUNTER STAGE WAS VERIFIED TO BE INOPERATIVE. TESTING OF THE FINE LOGIC D9 OUTPUT SIGNAL APPEARED TO BE NORMAL (1.5V); HOWEVER, THE TESTING WAS NOT COMPLETE. THE MODULE WAS THEN TESTED ON THE MANUAL TEST FIXTURE AND THE FINE LOGIC ANOMALY REPEATED AND ISOLATED TO GATE 6-591. A STATIC INPUT TEST WAS PERFORMED TO ISOLATE THE  $2^{-10}$  COUNTER BIT PROBLEM. TESTING OF CIRCUITRY REVEALED GATE 6-501 WAS NOT FUNCTIONAL. GATE-501 IS THE SISTER GATE TO 591 WHICH HAD BEEN PREVIOUSLY DEFINED AS THE CAUSE OF THE FINE LOGIC PROBLEM. RAYTHEON FAILURE ANALYSIS REPORT STATED THAT THE FLATPACK FAILED DUE TO MULTIPLE OPENS ASSOCIATED WITH PINS 2, 5, 6, 7, 8 AND 10. THE OPENS WERE DUE TO LIFTED GOLD BONDS AT THE DIE. IT APPEARS THAT THE BOND FAILURES WERE RELATED TO THE FORMATION OF GOLD ALUMINUM INTERMETALLIC COMPOUNDS (THE BOND LIFTED IN THE GOLD RICH REGION).

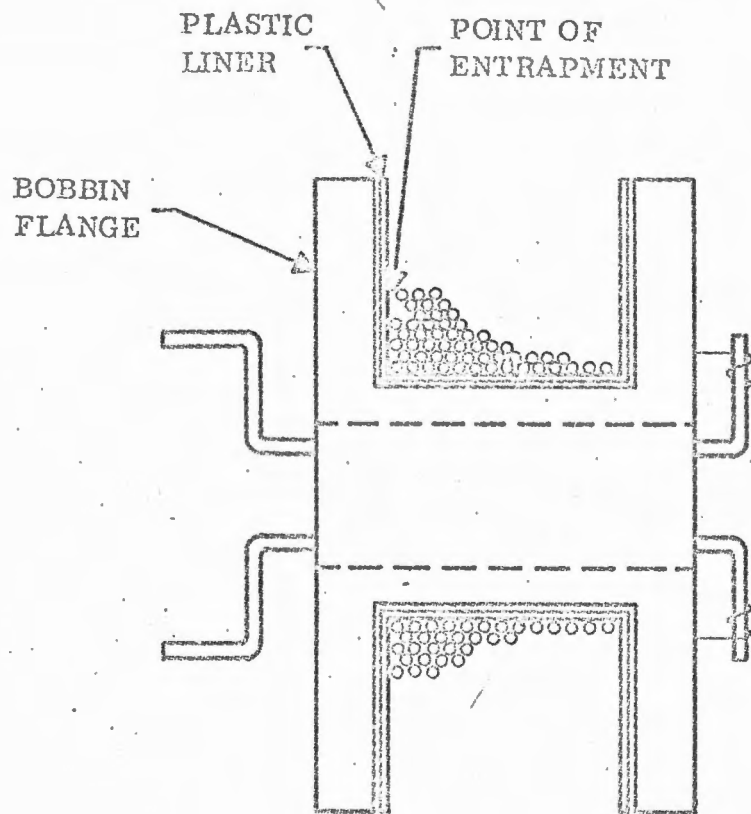
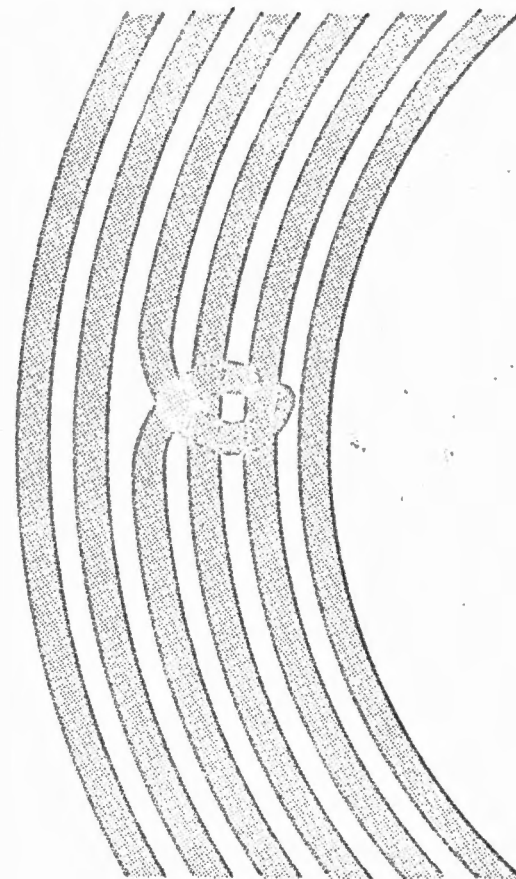
LM 8 FAILURE

MSA AND QUAD REJECT MODULE S/N 127 WAS SENT TO FAILURE ANALYSIS. THE FAILURE WAS CAUSED BY A HIGH RESISTANCE CONDITION BETWEEN TERMINAL NO. 2 AND NO. 3 OF TRANSFORMER T-1, P/N 1010274. THE FAILURE WAS ISOLATED TO AN OPEN CIRCUIT IN THE 2-3 SECTION OF THE PRIMARY WINDING. A FRACTURE AND KINK WERE FOUND AT THE FLANGE OF THE BOBBIN WHERE THE WINDING PROCESS REVERSES. APPARENTLY THE KINK, BEING TRAPPED BETWEEN THE BOBBIN FLANGE AND THE PRECEDING LAYER WIRE, WAS SUBJECTED TO COMPRESSION DURING THERMAL EXPANSIONS OF THE MODULE.

THE REPEATED COMPRESSIONS RESULTED IN THE FRACTURE.

TRANSFORMER, P/N 1010274 ECDU, S/N 26
