SPECIAL REPORT

TITLE: INVESTIGATION OF SXT ST LOS/LLOS PARALLELISM PROBLEM
REFERENCE: ENCLOSED
SITE: NAA, DOWNEY
FILE NO: NAA-6-117
DATE: AUGUST 12, 1966

INVESTIGATION OF SXT STLOS/LLOS PARALLELISM PROBLEM

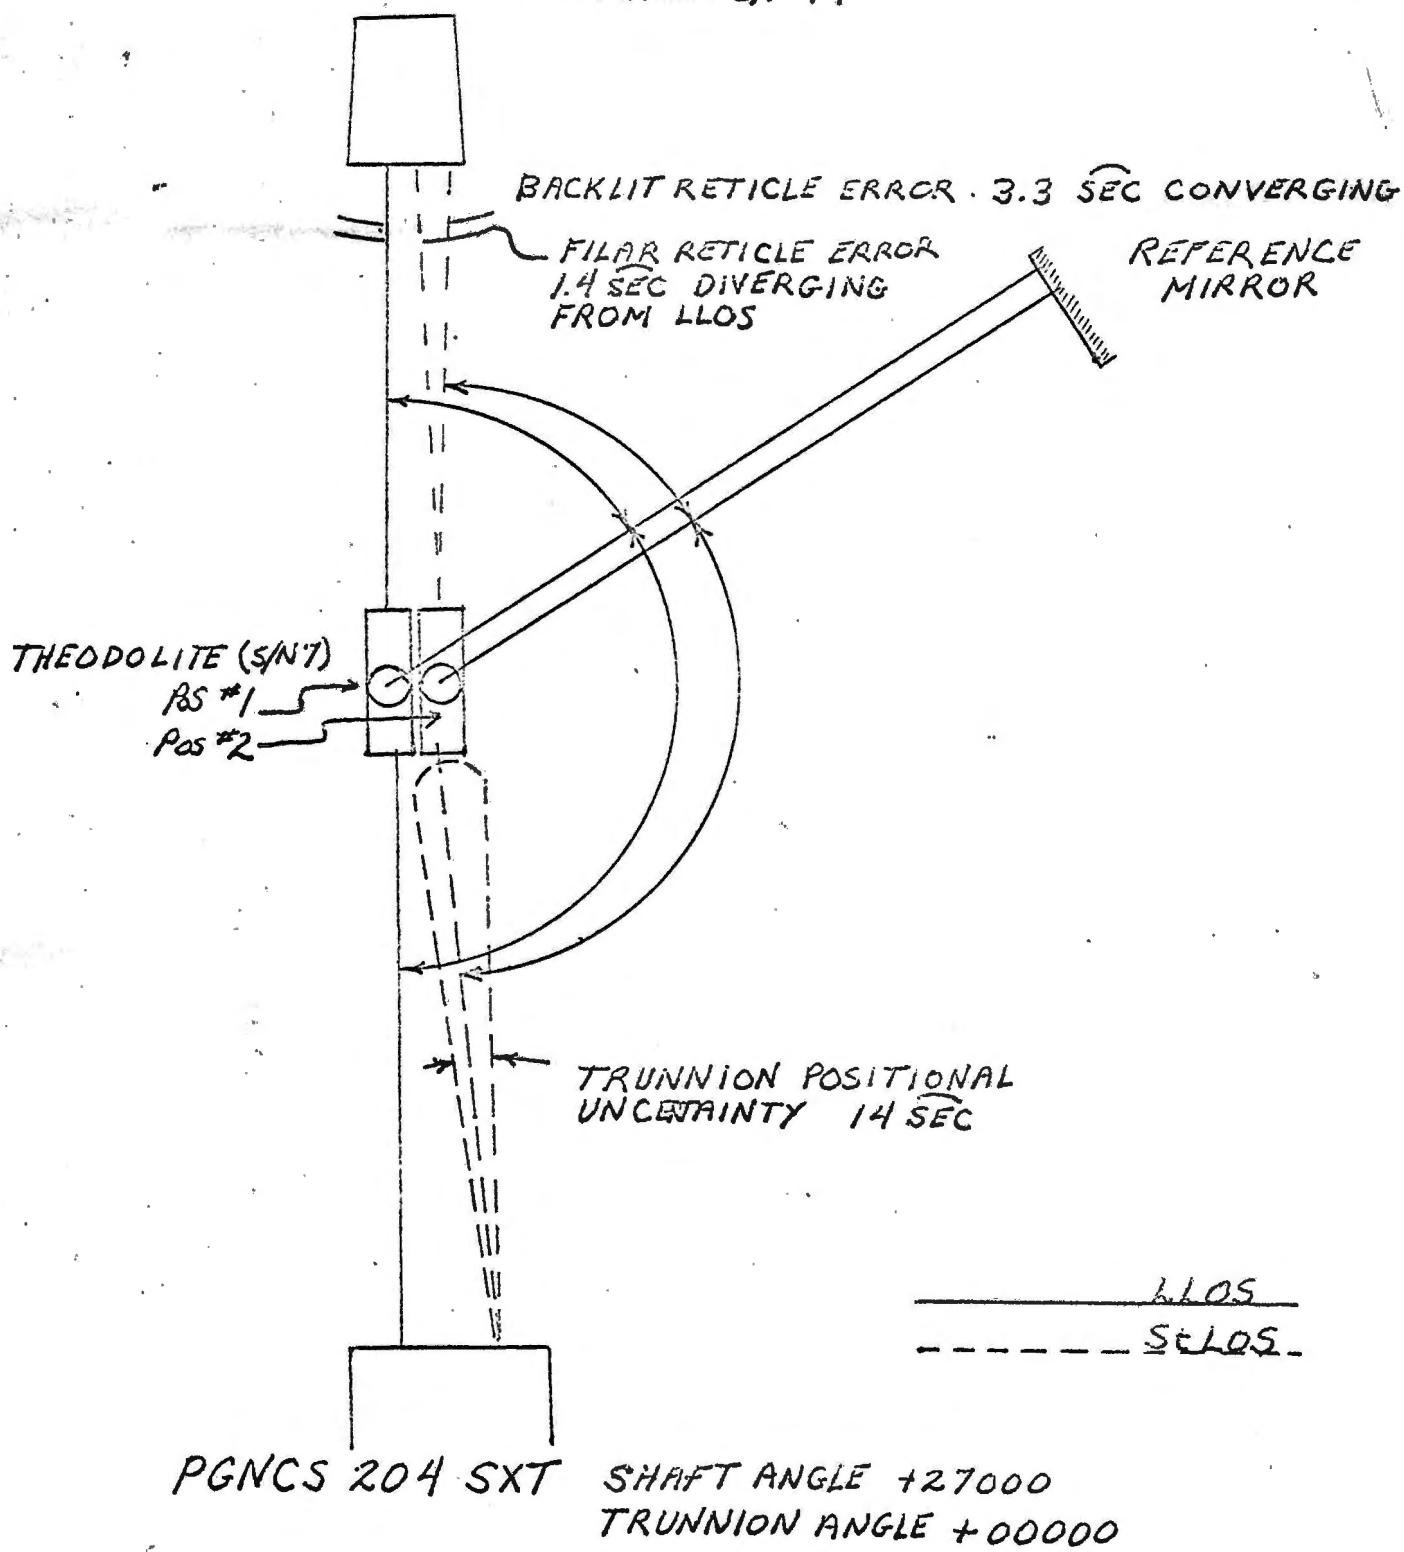
REPRESENTATION OF AUTOCOLLIMATOR ERROR TEST AND TRUNNION POSITIONAL UNCERTAINTY

A theodolite was introduced in the SXT STLOS and the Optics Hand Controller was manipulated so as to move the STLOS to various positions while the DSKY display was maintained at +00000 Trunnion angle and +27000 shaft angle. After each movement, a measurement was taken with the theodolite. It was discovered, after twelve observations, that a 14 arc sec. envelope (Enclosure 2) was available without a change in the DSKY trunnion display.

1. 5" Target #1 autocollimator StLOS to LLOS appertures (backlit reticle) 3.3 sec converging S/N 14.
2. 5" Target #1 autocollimator StLOS to LLOS appertures (filar reticle) 1.4 sec diverging.
3. Uncertainty of trunnion position at +00000 DSKY trunnion display 14 sec.
