Technical Solutions

Initialization Error “Cannot detect Andor camera. Please connect camera and restart software.” displayed when starting SOLIS.

Products Affected – iXon EMCCD with PCIe controller card (Model: CCI-24)

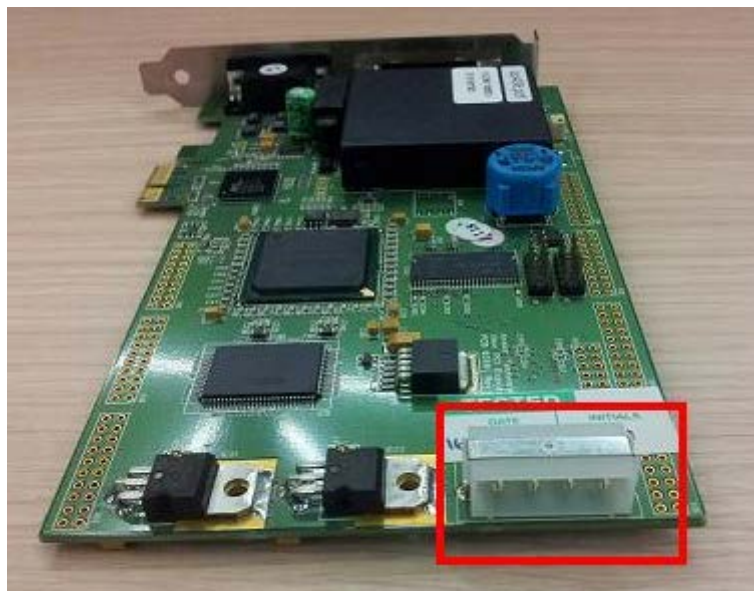
This problem will occur if the PC internal power supply has not been connected to the card molex power connector. Connecting the power supply will ensure the camera receives sufficient voltage to initialize (*Figure 2*).

Figure 2 – Molex connector required to draw voltage from the PC

Ensure that the flylead from the molex connector is connected to a suitable point from the power supply of the PC.
