Shamrock Grating Turret – Failure to Initialise / Reset Correctly

Products Affected – Shamrock Spectrographs SR-303 / SR-500 / SR-750

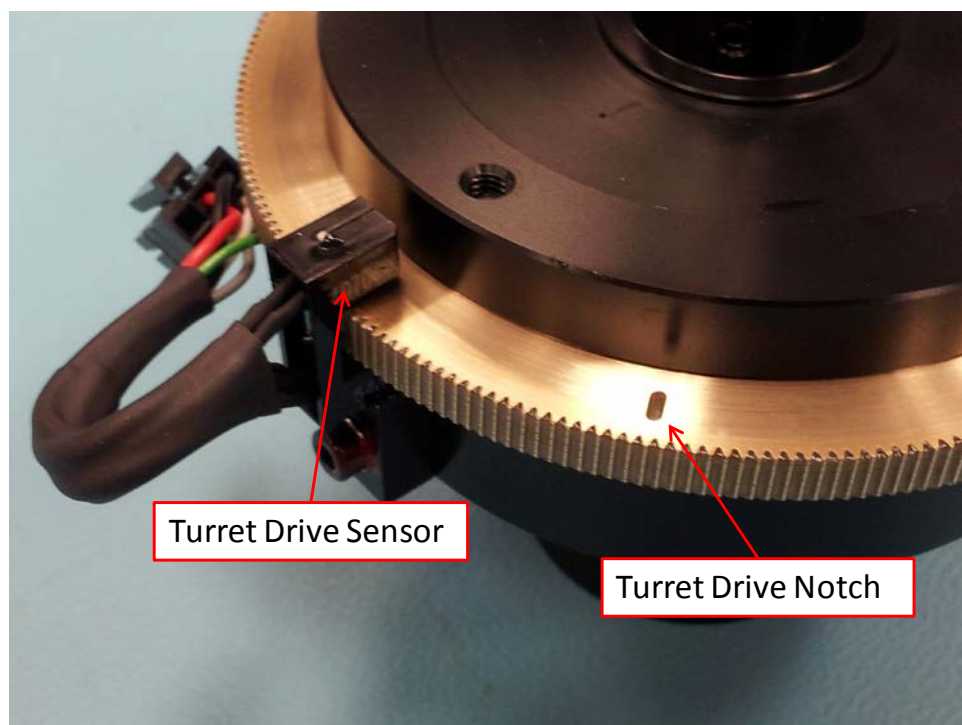
Figure 1 –Wavelength drive

If your Shamrock is failing to initialise correctly or not finding the correct grating position, the probable reason for this is that the mechanical zero position cannot be located. **Note:** No error message may be shown.

If the notch is free from obstruction, check if the sensor is loose or if it has been knocked off the turret drive. The sensor is a black plastic C-shaped component and will be noticeable if it is not in position.

If necessary, it may be best to remove the grating turret from the mechanical drive in order to view and gain access to the position sensor (*Figure 1*).

Action – Carefully remove any obstruction, using a pin or cotton wool bud if necessary, and clean the surrounding area with optical tissue and a small amount of methanol.

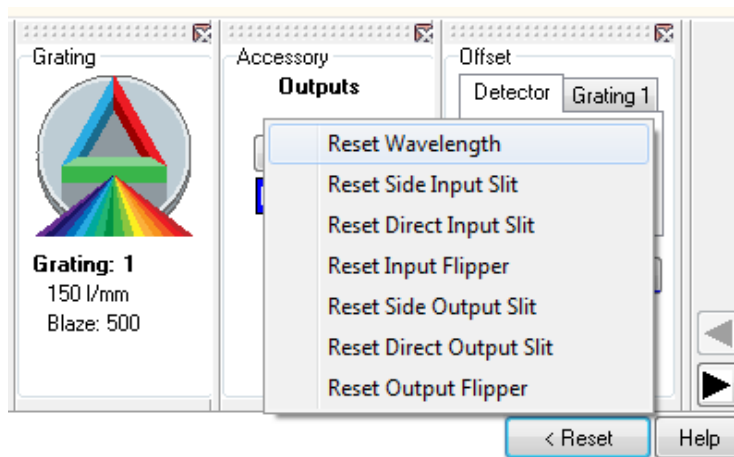
Figure 2 – Reset Wavelength can be selected through the Reset Button in Solis

- Have you performed a Wavelength Drive Reset? (Figure 2)

Action – Resetting the wavelength drive through the software will drive the grating turret to the mechanical zero position.

This will take a few moments to perform and the wavelength drive should now be accurate, please confirm this with a known calibrated light source. If turret position is incorrect or the turret drive fails to stop at all, please continue to follow the procedure below.
