Case study

Root cause analysis of bowl-mill pinion shaft failures

Metallurgy Department, Corporate Research & Development Division, Bharat Heavy Electricals Limited, Vikasnagar, Hyderabad 500093, India

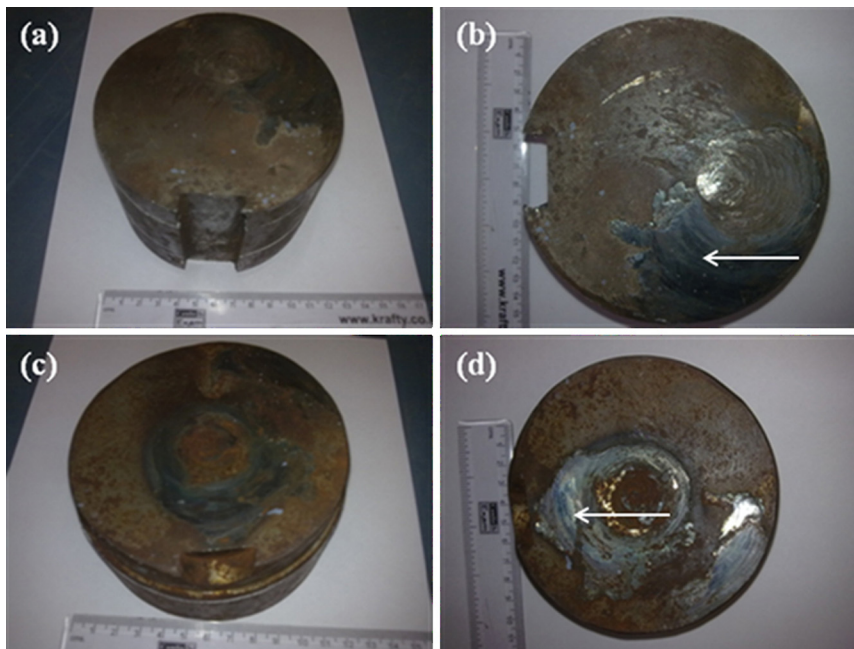
Fig. 2. As-received samples. (a and b) Fractured portion towards coupling side. (c and d) Fractured portion towards gear box side.

The samples were observed carefully for any failure features using an illuminated low power magnifying glass. It was observed that fractured surfaces of the as-received samples were rusted. They also had rubbing marks over them (Fig. 2). Blue color marks on the sheared surfaces might have occurred due to excessive heating as a result of rubbing of the specimen surfaces after failure. Rubbing of the fractured surfaces led to the destruction of finer and elite evidence required for failure analysis.

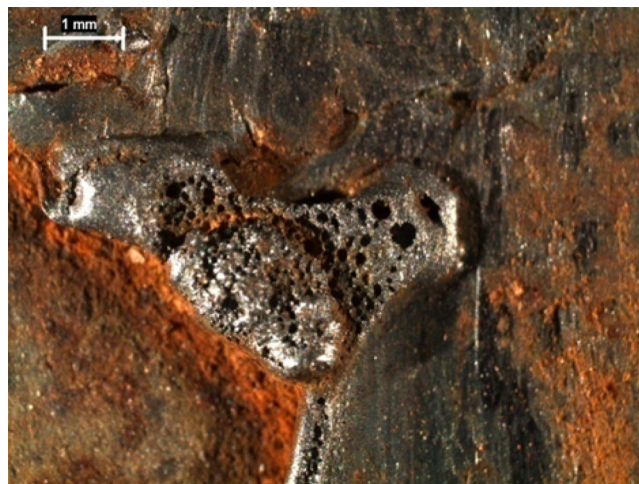
The results for the fractured surface of the gear box side specimen indicate the molten and re-solidified metal regions (as shown in Fig. 3). A small region resembling the final fractured region (overload fracture) was found inside the shaft towards gear box side as shown in Fig. 4. This suggested that this failure could possibly be due to low stress but high stress concentration torsional failure [5].

Fig. 3. Molten and re-solidified regions on the gear box side fractured surface.

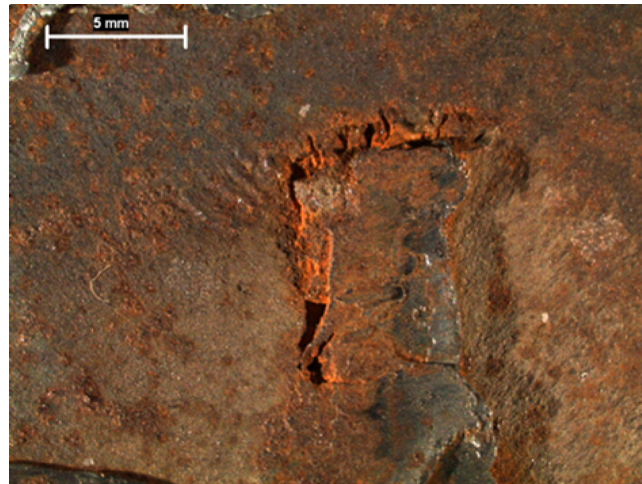
Fig. 4. Possible final fracture region on gear box side fractured surface.

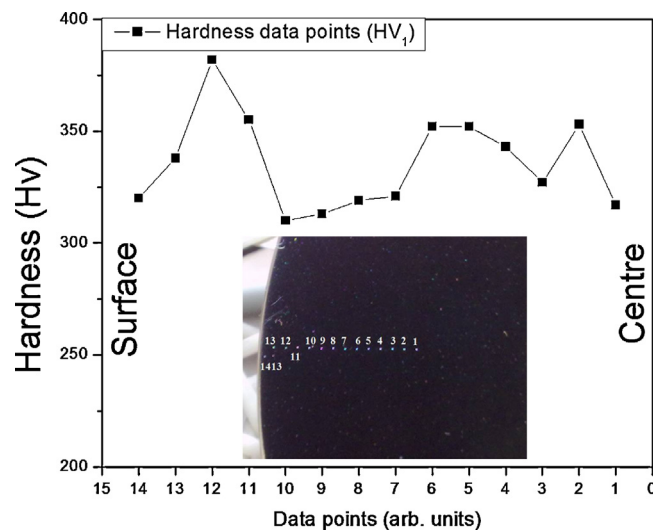
Hardness measurements were conducted on the shaft specimen towards coupling side from center to the periphery. The hardness profile obtained from center to periphery is shown in Fig. 5. The average hardness observed was 335 HV₁ while the standard deviation was 21 HV₁. It was observed that the hardness at regions closer to the surface (points 13 and 14 as shown in Fig. 5 inset) was not varying much as compared to the interiors which depicted that there is no case hardening/ softening. The microstructure of the same specimen showed similar microstructure on surface as well as in the interior, i.e., tempered martensite as shown in Fig. 6, complementing the hardness results.

Fig. 5. Hardness profile from center to surface on the transverse section towards coupling side (inset: actual image of the indents).

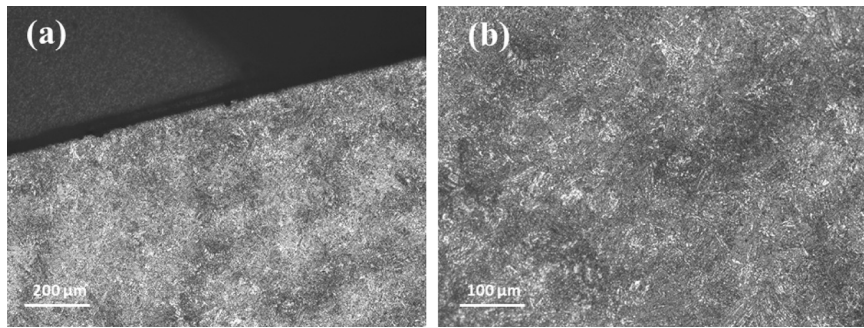
Fig. 6. Optical micrographs of the (a) surface and (b)interior.

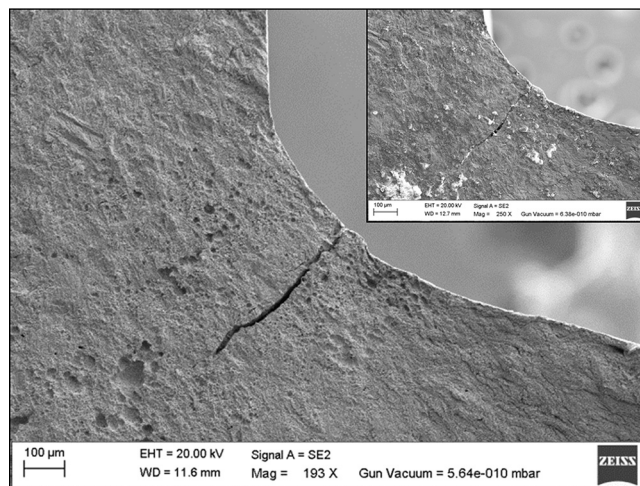
Fractured surfaces towards the coupling side and gear box side were cut and ultrasonically cleaned twice in ethanol. The regions of interest were keyway corners as they are usual stress raisers in shafts [2,6]. Fractographs of the coupling side fractured surface indicated the presence of a crack at a keyway corner (Fig. 7 inset). After ultrasonically cleaning the sample in 1% HCl, it was evident that this crack originated from the corner of the keyway (Fig. 7) and deposits found earlier were removed

Fig. 7. Fractographs indicating crack origination from keyway corner after ultrasonic cleaning with 1% HCl solution (inset: after ultrasonic cleaning with ethanol).

from the crack. The crack was approximately 430 μm in length. Neither the other corner of the keyway for this surface nor keyway corners of gear box specimen had cracks before and after ultrasonication in 1% HCl solution.

Keyway corner regions in shafts usually act as stress concentration raisers (sometimes up to 10 times) due to the presence of torsional stress [2]. This leads to initiation of cracks which might further progress under fluctuating (dynamic) loads leading to a fatigue failure. The keyway corners in this case were not sharp. They had a generous radius made as per design to avoid stress concentration. After a detailed examination of the operating history, it was observed that at the time of the failure, hard, rock-like lumps were present in the inlet coal discharge and they were struck in the bull ring segment as they could not be crushed. One of the bowl mill roll also was damaged as a result of this blockage (Fig. 8). This led to locking of the bull ring segment, which led to sudden overloading of the entire mechanism. This overloaded the pinion shaft, thus favoring the initiation of the crack at one of the keyway corners. Moreover, the material having yield strength and UTS lower than specified values, has yielded and favored the crack initiation due to sudden application of load.

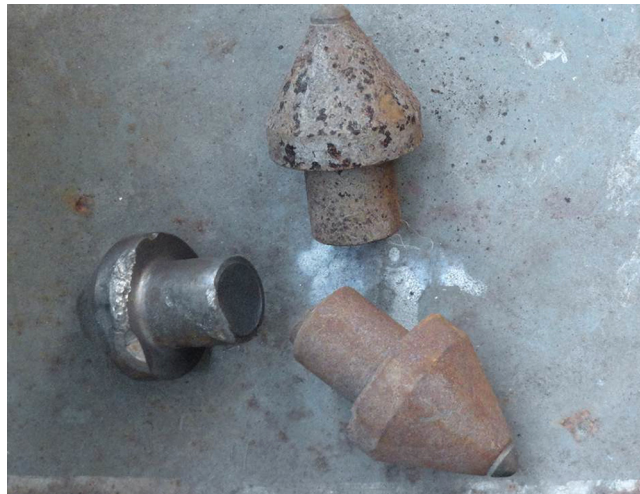
Fig. 8. Image of the actual damaged bowl-mill rolls after failure.

On the basis of the metallurgical and mechanical investigations carried out as mentioned in previous sections, it can be concluded that the pinion shaft had failed due to overload despite the keyway and its corners manufactured as per the design specifications. This overload consequentially arose from the sudden restriction of motion of the bull ring segment due to the presence of hard lumps in the ingress (coal feed) which could not be crushed. Yielding of the material was also favored as the yield strength of the material is lower than the specified value. This led to the initiation of the crack at keyway corner which progressed over a period of time and caused failure. Also, as observed from the stereo-micrographs, the small region inside the shaft resembling the final fracture region or overload fracture region also corroborates the fact that this could possibly happen due to low stress, high stress concentration torsional fatigue although fatigue marks were not observed as the fractured surfaces rubbed against each other after failure. Hence, this failure was a consequential failure.
