Case Studies in Engineering Failure Analysis

Case study

Internal reversible hydrogen embrittlement leads to engineering failure of cold drawn wire

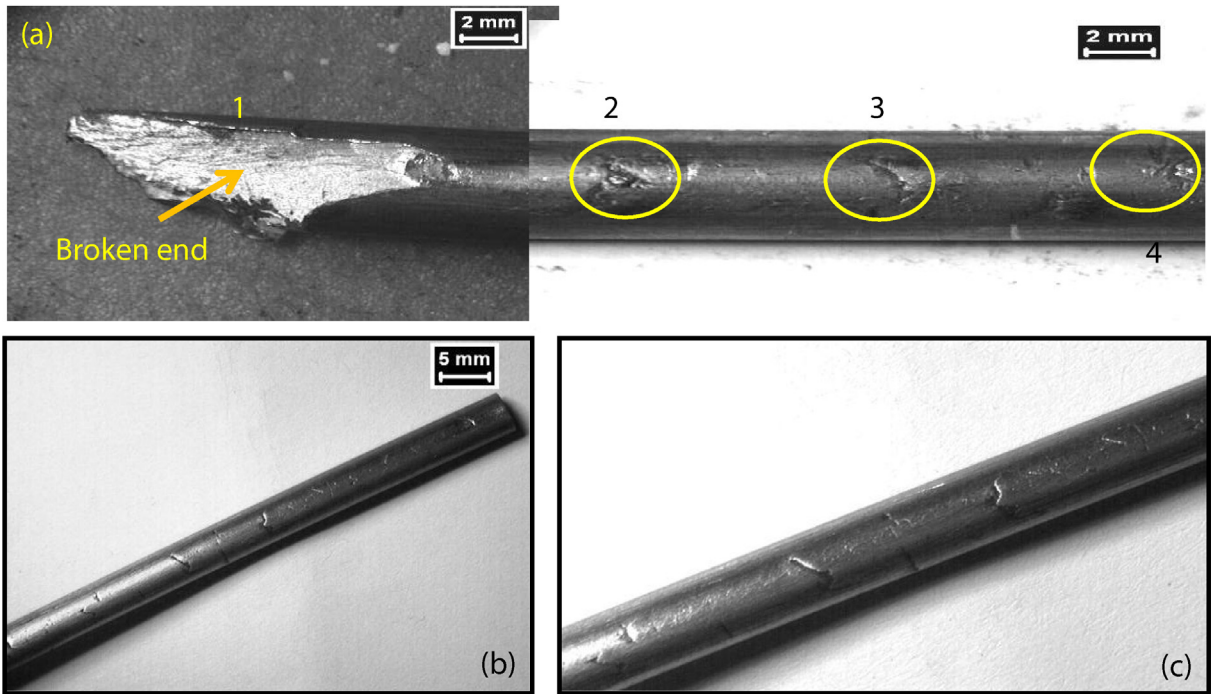
Failed wire samples were observed visually under macro dual zoom microscope (see Fig. 1a). In the case of drawn wire samples, finger nail fractures were observed at the broken ends. The fresh fracture surfaces were very shiny, indicating the possibility of hydrogen embrittlement [1]. Deep surface tearing was also observed from the above figure in all the wire samples. Point 2, 3 and 4 are showing the transverse crack on the drawn wire piece.

Fig. 1b and c reveals the transverse cracks on the surface that may be due to the huge pressure build-up of hydrogen in interstitial sites. The present investigation was carried out to confirm embrittlement either due to metallurgical problems or due to the H concentration in material. Further, metallographic investigation was also done to characterize the failure.

Fig. 1. (a) The broken wire samples; (b) and (c) the transverse crack on the wire samples at different magnifications.

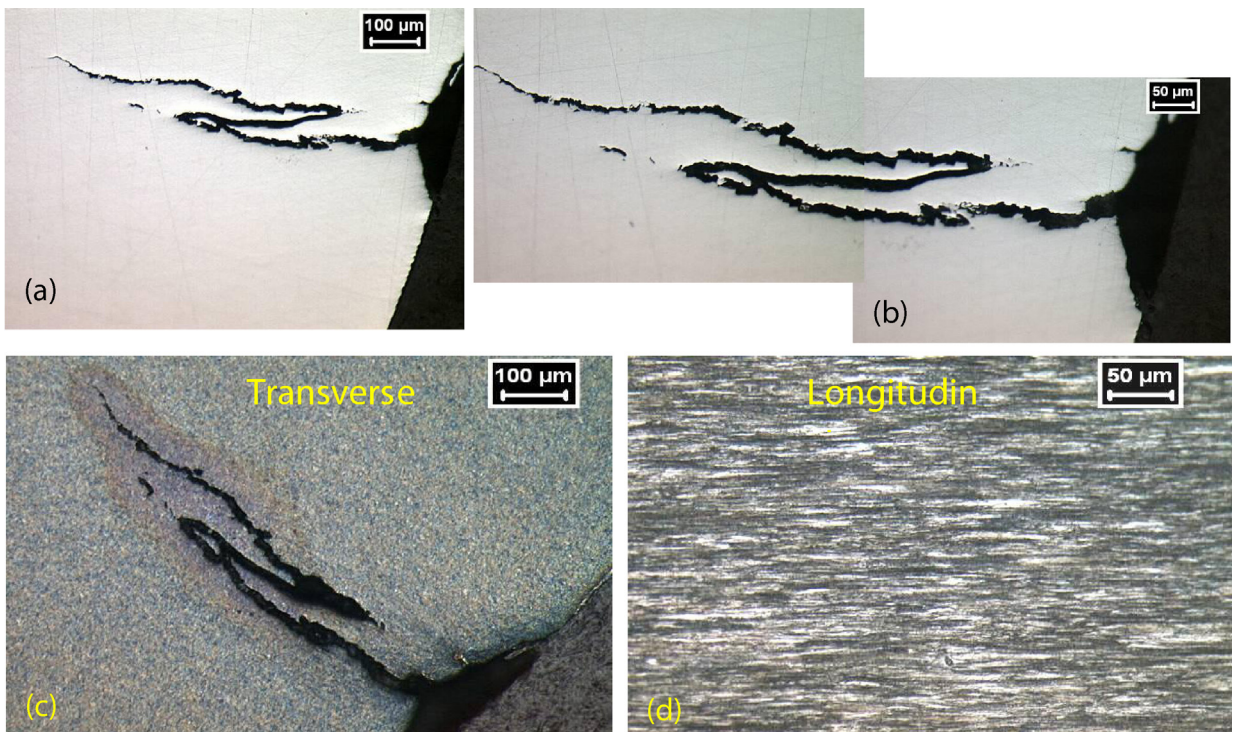
Fig. 2. (a) and (b) Zigzag crack at un-etched conditions in different magnifications, (c) etched structure in transverse section and (d) etched structure in longitudinal section.

Microscopic examination was conducted to observe microstructural features of defect area. Fig. 2a and b reveals zigzag cracks in transverse microstructure at un-etched condition. Typical image of un-etched microstructure was taken at 100 \times and 500 \times magnification. It may be noted that all cracks were almost perpendicular to the axis of the wire. The morphology of the crack propagation may indicate the absorption of hydrogen.

A cold deformed pearlitic microstructure was observed in Fig. 2c and d after etching with 3% Nital in both transverse and longitudinal samples. The microstructure did not indicate the presence of decarburization in the vicinity of cracks. It depicts

that the crack was not generated at the stage of high temperature operation. Basically it is a phenomenon of intergranular cracking. A fibrous appearance comprising elongated shaped pearlite was formed during cold drawing (Fig. 2d).

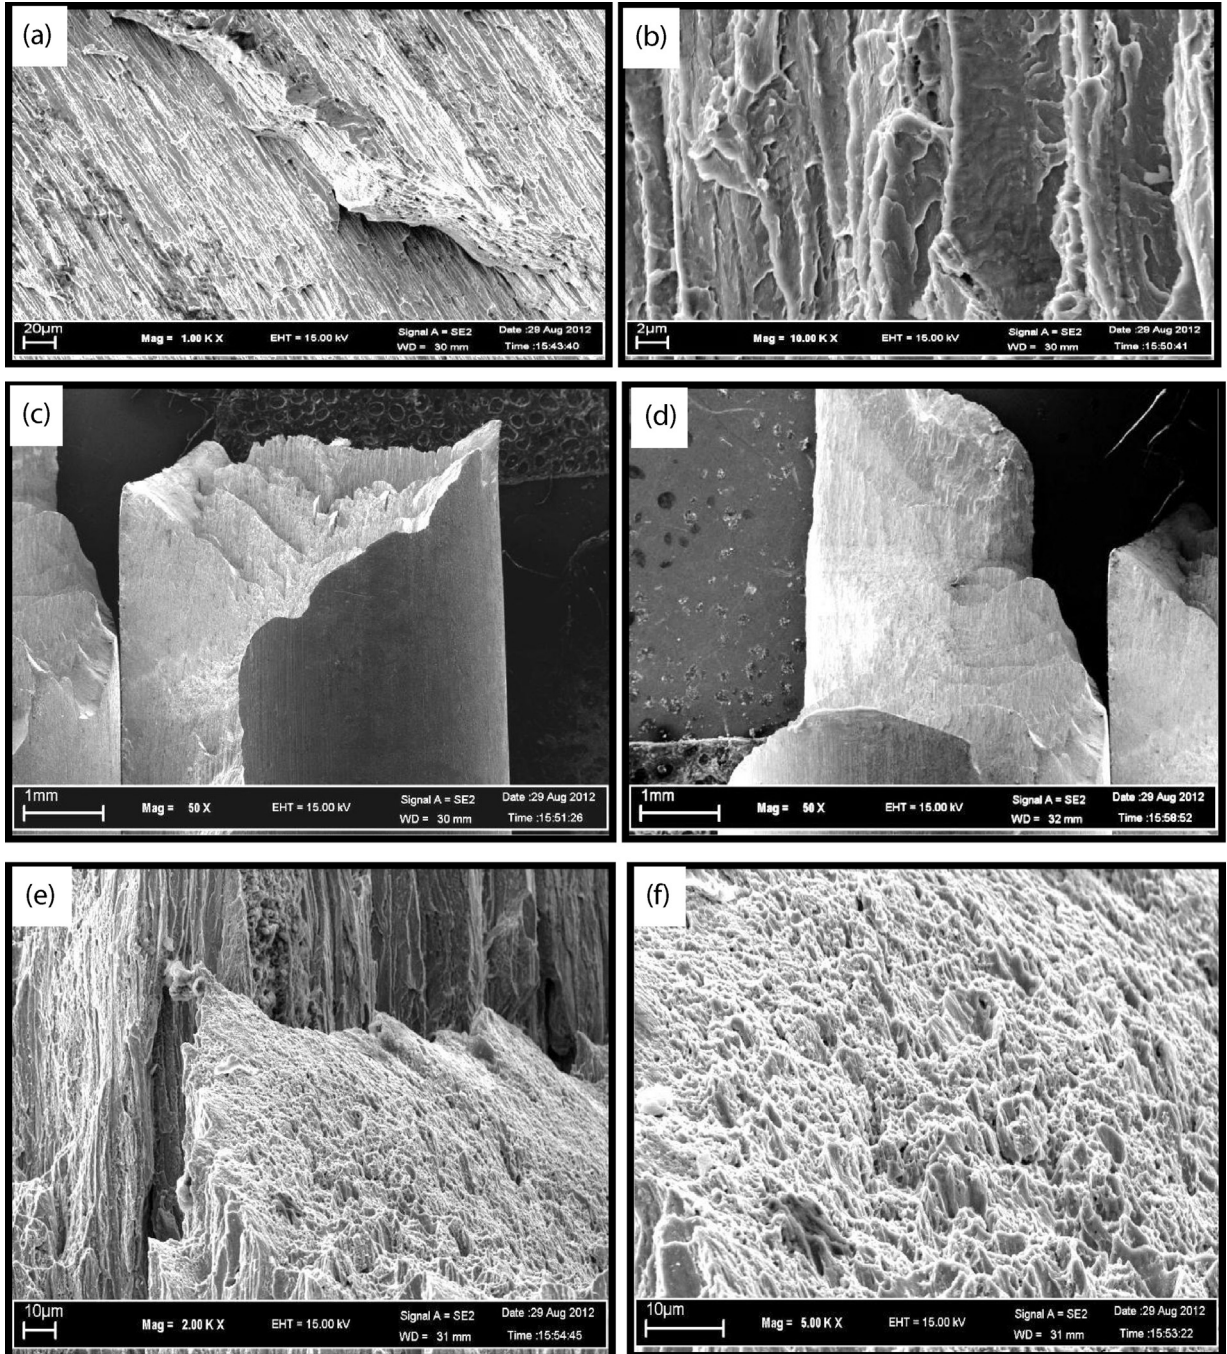
Fig. 3. (a) and (b) The fracture surface of the failed sample (as received conditions) at different magnifications, (c) and (d) the fracture surface of the failed sample (baked) after tensile testing and (e) and (f) the fracture surface of the failed sample (after tensile testing) at different magnifications.

A comparative study was entitled on the fracture surfaces of as-received material with baked material (45 min). About 1.5 cm of longitudinal as-received sample with a fracture surface was taken for fractographic analysis under the SEM. This showed a fibrous appearance with secondary cracks (see Fig. 3a) at a magnification of 20 μm [5]. However, a detailed looked at higher magnification (see Fig. 3b) revealed brittle fracture with some dimple appearance, which clearly conforms the hydrogen attack of some form or other.

To diminish the effect of hydrogen, the sample was then baked at a temperature of 200 °C for 45 min and was then broken by tensile overload. Sample failed in a typical shape as seen in Fig. 3c and d. Both longitudinal and transverse fracture surfaces were visible in the sample.

The fracture surface revealed the fibrous ductile fracture morphology on the longitudinal cracked surface. Dimple appearances on the both transverse and longitudinal fracture surfaces were also seen (see Fig. 3e). A closer view of the transverse fracture surface (Fig. 3f) shows a dimpled appearance.

Fractography analysis is used here to help determine the root cause of this particular failure. As discussed above, that hydrogen was removed from the samples by baking. A comparative study of the fracture surface of as-received and baked sample demonstrates the difference of surface morphology [7]. The as-received fracture surface showed a fibrous structure which means a brittle in appearance. On the other hand, the baked sample revealed a dimples fracture surface. This demonstrated that the removal of hydrogen could reduce the susceptibility of the material to fracture.

On the basis of the above experiments, it was determined that the failure had occurred due to the hydrogen embrittlement. It is likely that the hydrogen came from the HCl solution at the stage of pickling operation and the subsequent baking was not carried out properly. That led to the retention of hydrogen atom in the interface and during the drawing operations failure resulted. Therefore, minimizing of the pickling operation time and proper baking should prevent this type of industrial failure.
