Preliminary Insights from Surveys of Bridges at High Scouring Risk in West Piedmont

# Preliminary Insights from Surveys of Bridges at High Scouring Risk in West Piedmont

Mauro Aimar<sup>a</sup>, Marco Civera<sup>a\*</sup>, Sebastiano Foti<sup>a</sup>, and Bernardino Chiaia<sup>a</sup>

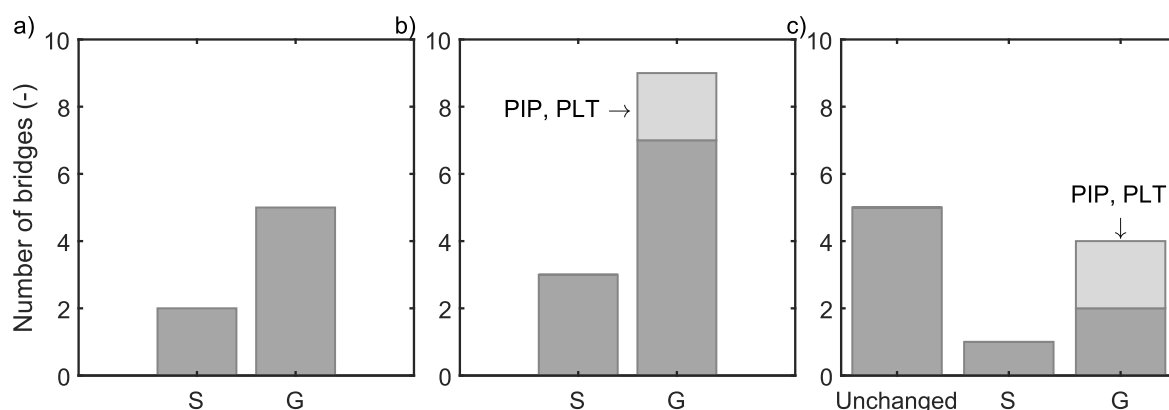
Fig. 3 summarizes the main results, showing the number of bridges characterized by peculiar structural and geotechnical conditions (labels “S” and “G”, respectively), that may require attention and further investigation. Specifically, Fig. 3a refers to the 2003 survey, whereas Fig. 3b results from the current inspection study (i.e., year 2023). To facilitate the comparison, Fig. 3c shows the number of considered bridges with unchanged conditions versus the number of those with peculiar structural and geotechnical conditions not originally identifies in the 2003 survey. The graphs also include the Lanzo Torinese and the Inverso Pinasca bridges (PLT and PIP, respectively), denoted through a different colour as not included in the 2003 study. In general, geotechnical-related issues are more frequently observed than structural problems. Indeed, notwithstanding the different age, the superstructure conditions are generally good or even excellent. Instead, foundations are often affected by flood-induced erosion. On the other hand, no relevant changes in the conditions were identified for most of the bridges from 2003 and 2023, despite the intense floods occurred in this time period. An increase in the foundation erosion was observed in the Crescentino and the Rivarolo Canavese bridges (PCR and PRC, respectively, in Fig. 2). Furthermore, the Castiglione Torinese bridge (PCT in Fig. 2) underwent a significant change in the structural conditions, which will be discussed in detail below.

Figure 3. a-b) Bar plots showing statistics for bridges with structural issues (label “S”) and geotechnical issues (label “G”) for years 2003 (a) and 2023 (b). c) bar plot showing the number of bridges with unchanged conditions and variations in structural and geotechnical conditions. Data related to the Lanzo Torinese and the Inverso Pinasca bridges (PLT and PIP) are colored differently because they were not included in the 2003 survey.

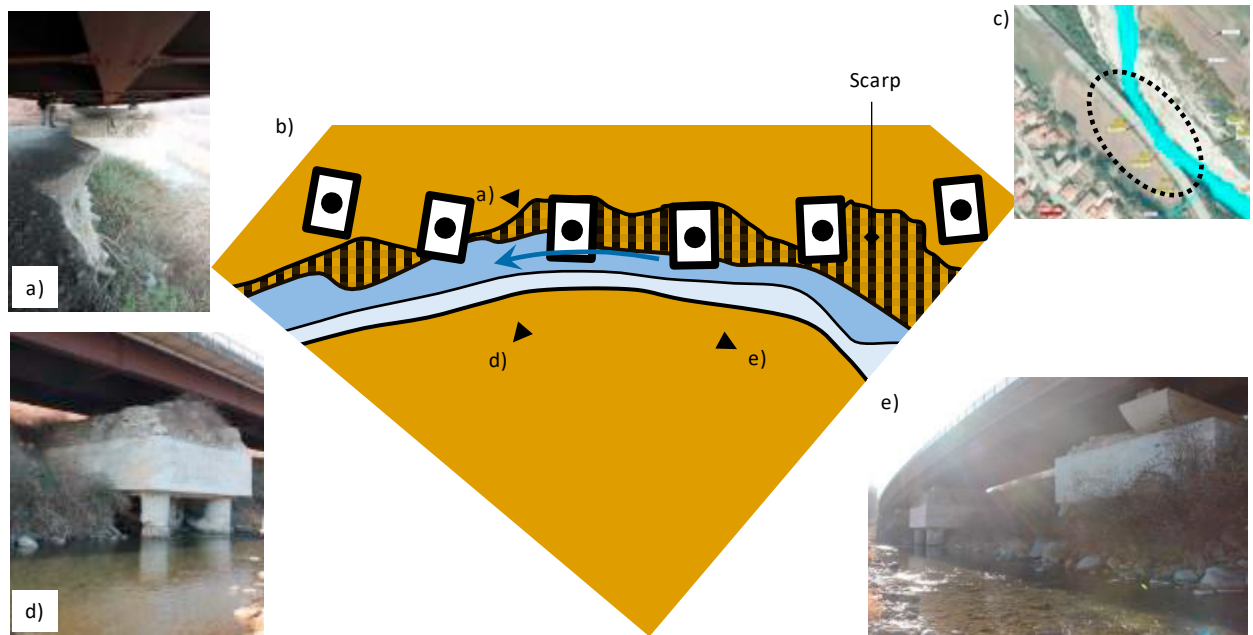
On the one hand, the Inverso Pinasca bridge (PIP) is part of a thalweg road running parallel to the Chisone river, in the Western part of the Metropolitan City of Turin. The superstructure is characterized by a continuous, composite steel-concrete deck with excellent conditions, also due to the relative short age of this structure – the construction year is 2005. However, the river main channel has gradually shifted towards the road axis, thus inducing significant lateral scouring on the foundations of part of the piers (Fig. 4). As each pier is supported by deep, large-diameter piles, foundation scour should not dramatically affect the safety conditions of the bridge, in this case. On the other hand, the different entity of erosion from pier to pier may induce some asymmetry in the structural response. To avoid further extension of the erosion, the infrastructure manager planned a retrofit intervention, consisting in a restoration of the original morphology, soil improvement through jet grouting injections and protection through rock walls. For this reason, this bridge will be further investigated to better understand its behaviour and have an insight into the effects of such an intervention.

Figure 4. Plane view of the portion of the Inverso Pinasca (PIP) bridge affected by foundation scour (c, d). For simplicity, in (c) only the piers and the foundation pads are represented. The sketch is integrated with photos taken below the deck (a) and from the other side of the river (d, e).

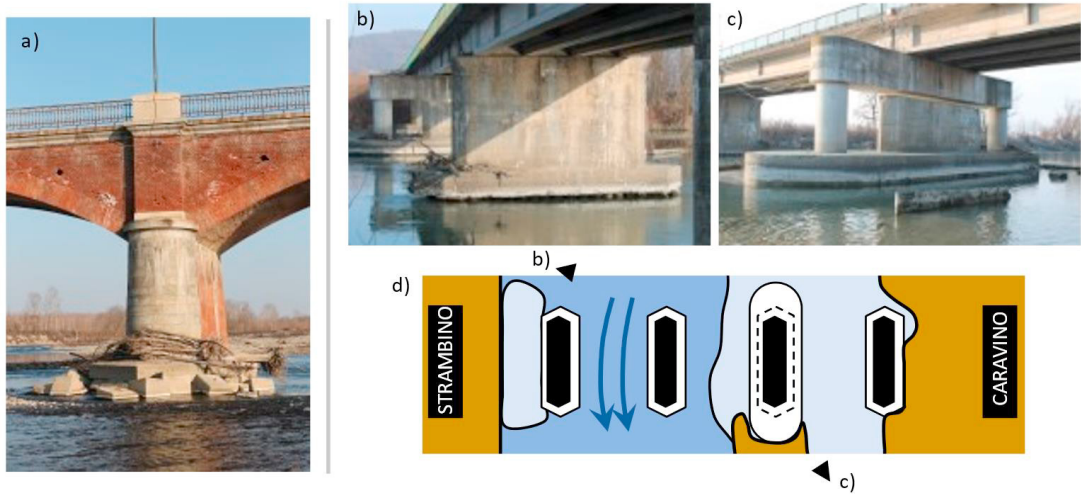
As stated above, also other bridges are affected by foundation scour, whereas the structural conditions are excellent. For instance, the Crescentino bridge (PCR in Fig. 2) is a multi-span masonry bridge crossing the Po river, where the spans crossing the main river channel are quite significantly scoured (Fig. 5a). Nonetheless, no damage was observed on the superstructure. Similarly, scouring is relevant at the Strambino bridge (PST in Fig. 2), on the Dora Baltea river (Fig. 5b-d). This case study is peculiar because it was retrofitted after the 2003 survey (specifically, in 2004). Indeed, the strong erosion induced by the 2000 flood urged for a reinforcement of the foundations of one of the central piers (Fig. 5c). This intervention and its effectiveness were addressed in detail (Nemry & Demirel, 2012). As shown in Fig. 5d, the 2023 survey highlighted a migration of the main river channel towards the Strambino side, worsening the foundation conditions of part of the remaining piers. Instead, the retrofitted pier seems not to be any longer affected by the main river flow. Therefore, the benefit of the retrofit intervention has been counterbalanced by the increased erosion on other piers due to river migration.

Figure 5. a) Photo of a pier at the Crescentino (PCT) bridge. The presence of concrete blocks indicates that the pier is affected by foundation scour; b-d) Survey results for the Strambino (PST) bridge: photos of original piers (b) and of the retrofitted one (c) and plane view of the piers with the location of the main river channel (d).

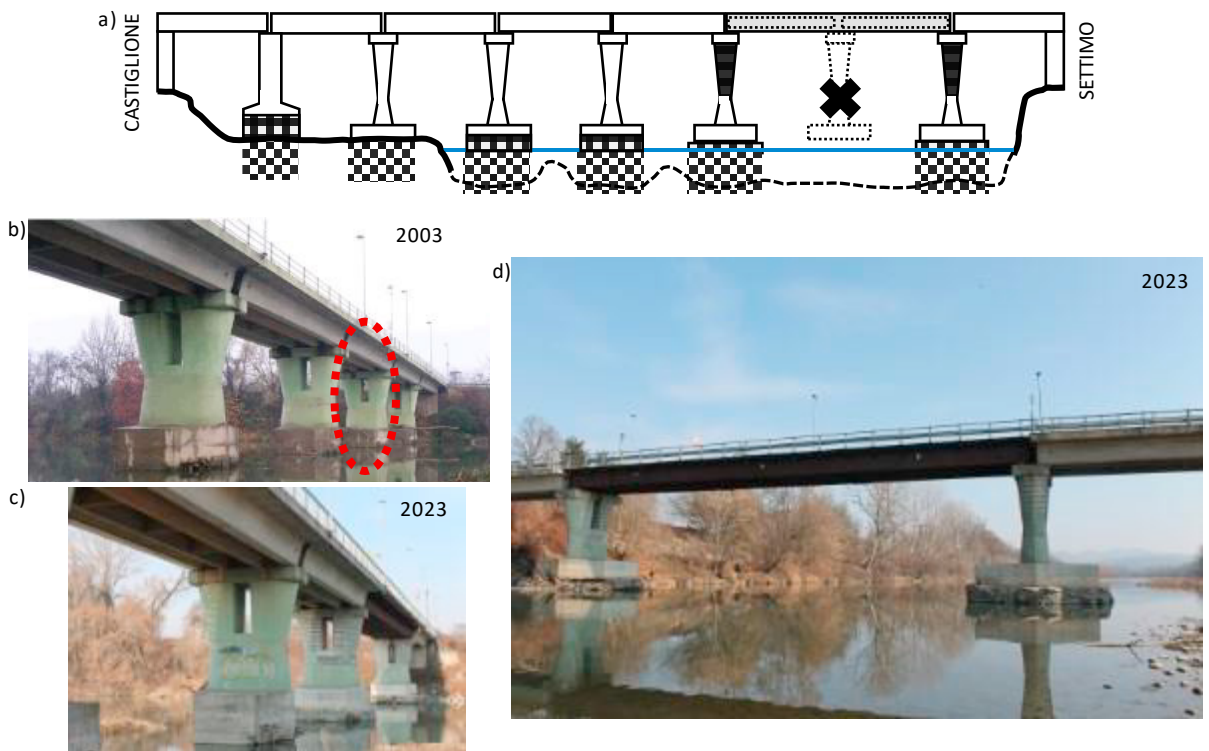
Finally, the survey highlighted that the Castiglione Torinese (PCT in Fig. 2) bridge on the Po River is characterized by both peculiar conditions, from both the structural and the geotechnical viewpoints. Indeed, in the aftermath of the 2016 flood in Piedmont, the bridge needed massive retrofit interventions as one pier was affected by strong erosion. For this reason, the pier was demolished and the corresponding spans were replaced with a longer, steel girder beam span (Fig. 6). This resulted in a significant change in the loading conditions of the nearby piers, as demonstrated by the addition of a reinforcement cage at the pier caps to mitigate the effects of the amplified compression. For this reason, PCT represents the only case characterized by a deterioration of structural conditions, not because of material degradation but as a consequence of the significant variation in the static configuration. However, also the foundation conditions play a relevant role, due to the historical and the current evidence of foundation scour.

Figure 6. Castiglione Torinese (PCT) bridge: a) Side view, with the removed pier highlighted; b-d) Photos of the portion affected by the retrofit, before (b) and after (c-d).
