# Capture of images in inaccessible areas in an underground mine using an unmanned aerial vehicle

**GR Freire** AngloGold Ashanti Ltd, Brazil **RF Cota** AngloGold Ashanti Ltd, Brazil

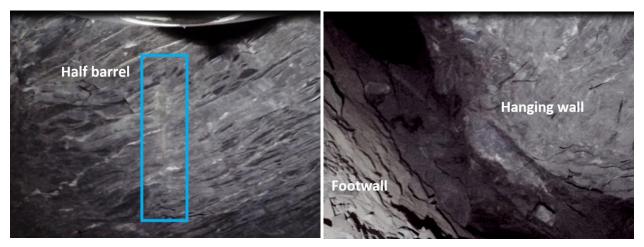
The Zeppelin was able to capture all the information required according to the initial scope of the project. In this section, it will be demonstrated how the information obtained was used to make important decisions at the mine. In this case, a stope was presented with low overbreak and underbreak, mined in a region with failure of the sill pillar. A prominent fault was identified that may affect the stability of the regional pillar (Figure 8). Despite the good results from the CMS, showing no underbreak, the amount of ore blasted was not retrieved from the stope. According to the Zeppelin images, the blasting was done well, considering the integrity of the hanging wall, footwall and 'half barrels' (Figure 7). It was clearly seen that ore remained on the footwall in some areas, explaining the loss of blasted ore (Figure 8). For the next stages stope mining, the dip of the footwall and the drill and blast designs will be reassessed to ensure that blasted material rills down the footwall.

Figure 7 (a) Half barrel in the hanging wall; (b) Intact hanging wall with cables and the ore on the footwall

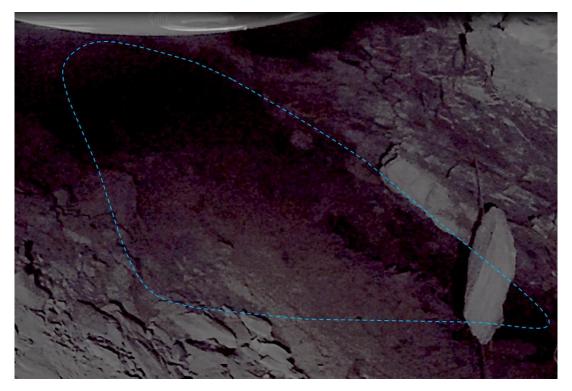
Figure 8 Snapshot from a video recorded inside the stope showing the ore trapped on the footwall

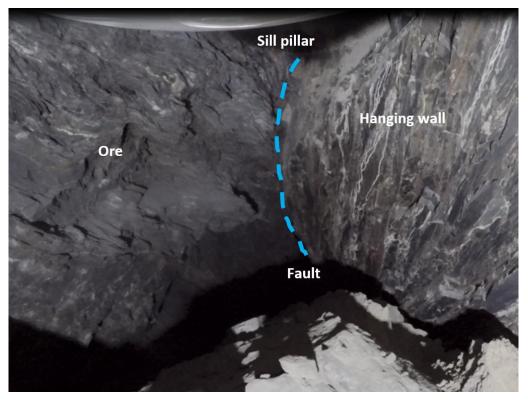
Finally, the images show clearly the fault in the sill pillar and that, locally, there was no collapse of the pillar (Figure 9).

Figure 9 Snapshot from a video recorded inside the stope show the sill pillar with no collapse
