NASA TN D-7859

**APOLLO EXPERIENCE REPORT -
GUIDANCE AND CONTROL SYSTEMS:
COMMAND AND SERVICE MODULE
ENTRY MONITOR SUBSYSTEM**

Ben Reina, Jr., and Herbert G. Patterson

Lyndon B. Johnson Space Center

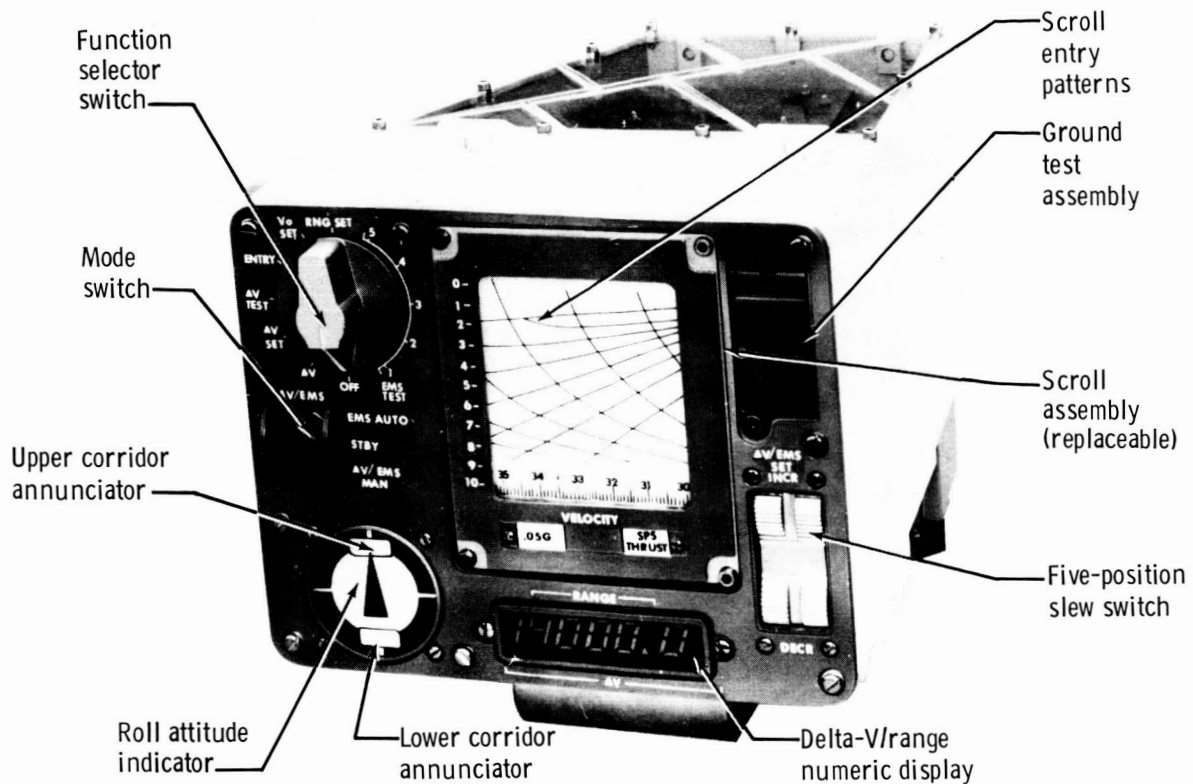
Figure 2. - Entry monitor subsystem.

The EMS display is composed of five functional components essential to entry trajectory monitoring and flight control. The five components are the RAI, the entry threshold indicator (0.05G), the corridor verification indicator, the delta-V/range-to-go counter, and the flight monitor or scroll.

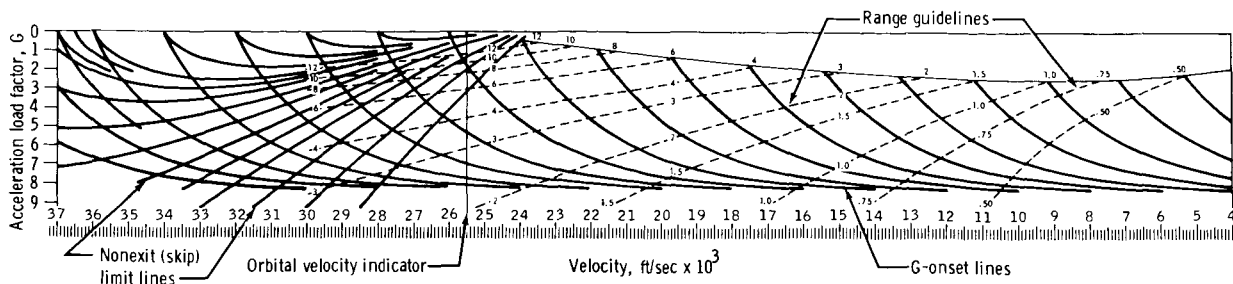
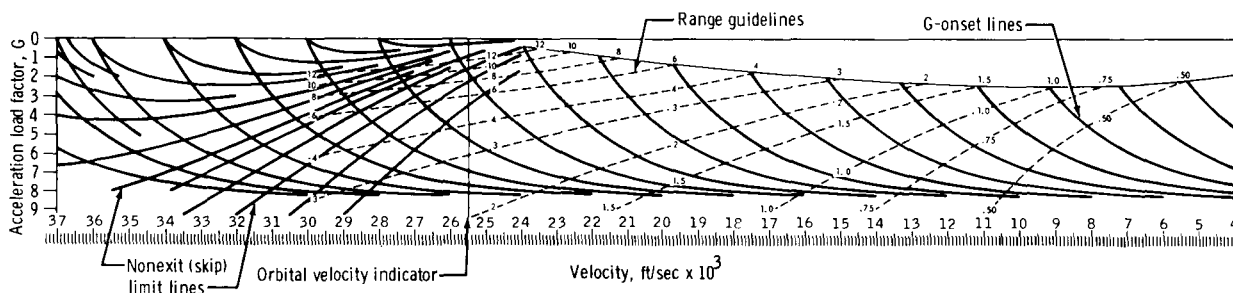
Figure 3. - Entry monitor subsystem scroll patterns for lunar-return entries.

Flight-pattern limit-line generation and developmental criteria. - The procedures are outlined for the three types of flight limits incorporated into the EMS software. The flight limits and the associated procedures for their development may be generated to any criterion that can be defined as a function of velocity and acceleration variables. The procedures presented herein pertain only to criteria that have been specifically defined for the Apollo lunar missions. The EMS scroll patterns for Apollo lunar-return entries are shown in figures 3(a) and 3(b).

The results of the first simulation indicated that the G-onset and G-offset lines on both scroll patterns are valid for all cases in which the pilot delay time in recognizing a violation is less than the design value of 2 seconds. Simulation results also indicated that the EMS monitoring task of judging the slopes of two lines (one of which is dynamic) within 2 seconds of the actual tangency is a feasible pilot task but requires close attention and a critical pilot attitude.

1. The EMS G-onset limit lines, the EMS 3500-nautical-mile range limit lines, and the EMS skip limit lines were correctly developed. Therefore, the scroll patterns investigated can be used to monitor PGNCS performance during all Apollo entries.
2. The EMS range guidelines, with one exception, were correctly developed. The one exception can be accounted for during manual ranging so that, in the event of a PGNCS malfunction during entry, the range guidelines can be used in backup ranging.
3. The EMS criterion for manual takeover is based on the pilot's evaluation of a tangency condition between the G-V trace and the flight limit lines.
