APOLLO

E-2280

SOLID STATE DSKY STUDY

L. David Hanley

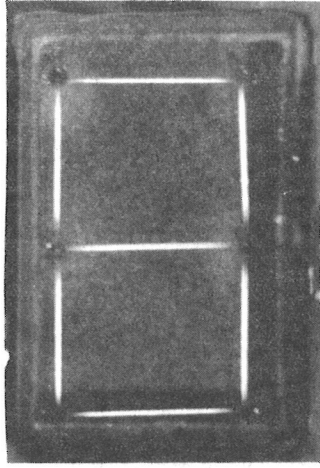
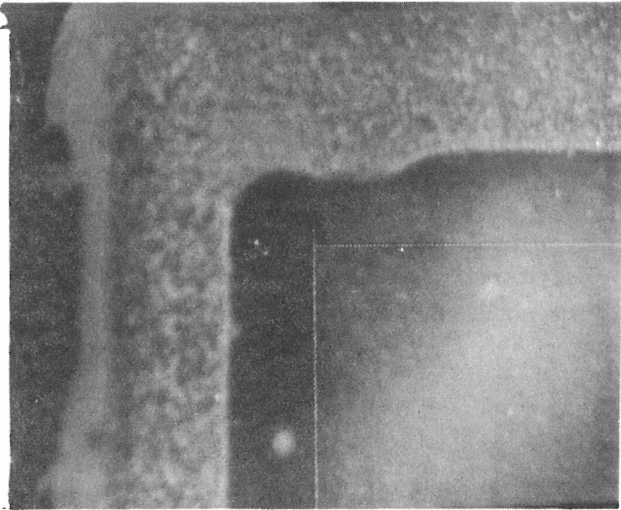
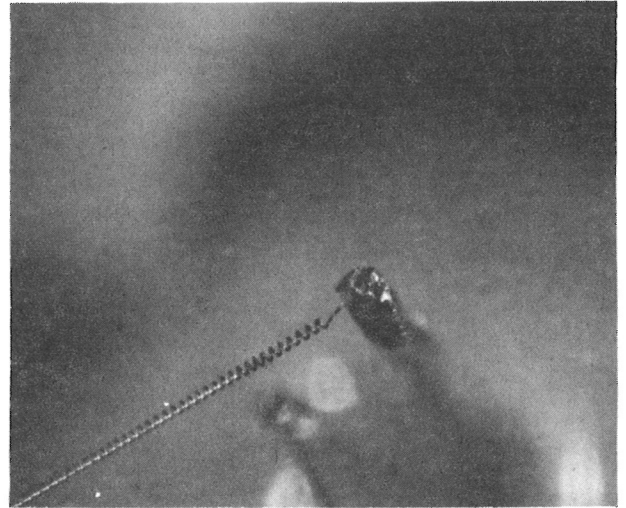
Fig. B.1 Pinlite

The Pinlite unit consisted of long helical filaments strung between support pins to form the numerics segments. Because the long filaments are particularly vulnerable to mechanical stress, an extensive vibration test was performed (section B.2). Figure B.1 shows the Pinlite construction.

This effect may have been produced by a traveling wave progressively
shorting one turn to an adjacent turn.

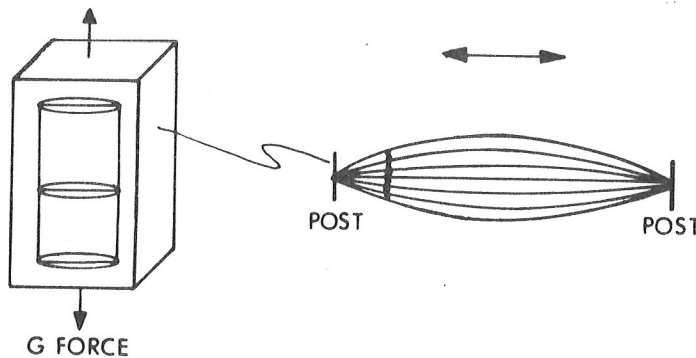
<u>Run</u>	<u>Freq (cps)</u>	<u>G Force (rms)</u>	<u>Lamp Voltage</u>
1)	20-2000	5 G's	2.5 volts
No adverse effects noted.			
2)	2000-20	10 G's	2.5 volts
Observed a dark spot that moved slowly back and forth on the top segment of Fig. A, at approximately 850, 650, and 475 cps.

Again observed dark spot that rippled along top segment Fig. A at 600 cps, and at 359 down to 100 cps.

Vibrating string pattern on vertical segments as well as horizontal segments Fig. A. Dark spot appeared - 700 to 425 cps.

15)	2000-20	35 G's	No Filament Voltage
16)	20-2000	35 G's	3.0 volts
Dark spot at 22 to 100 cps top segment Fig. A. Also on lower left segment Fig. B. This effect remained after G force reduced to 0. Permanent damage.

17)	2000-20	35 G's	No Filament Voltage
18)	20-2000	35 G's	3.5 volts
Dark spot again top segment Fig. A with additional dark areas seen Fig. B, both top segments.

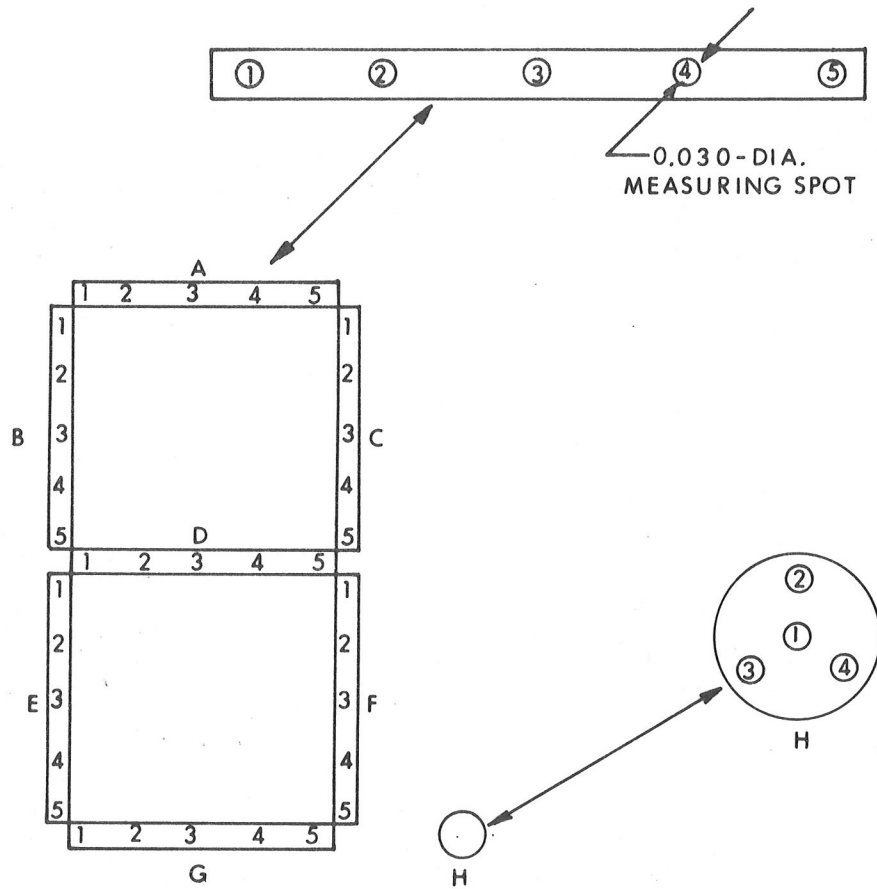
Fig. B.3

Figure B.3 tabulates the brightness at five points in each segment. The data indicates large variations in average brightness from segment to segment (5.0 fL to 13.5 fL) and a large variation within each segment.

Segment uniformity varies considerably. All segments were of low brightness (B_{low}) at one or both ends. The uniformity ratio (B_{high}/B_{low}) for each segment should not exceed 1.5. The uniformity ratio for the numeric (7 segments) should never exceed 2.0 where B_{low} is the dimmest point measured and B_{high} is the brightest point measured.

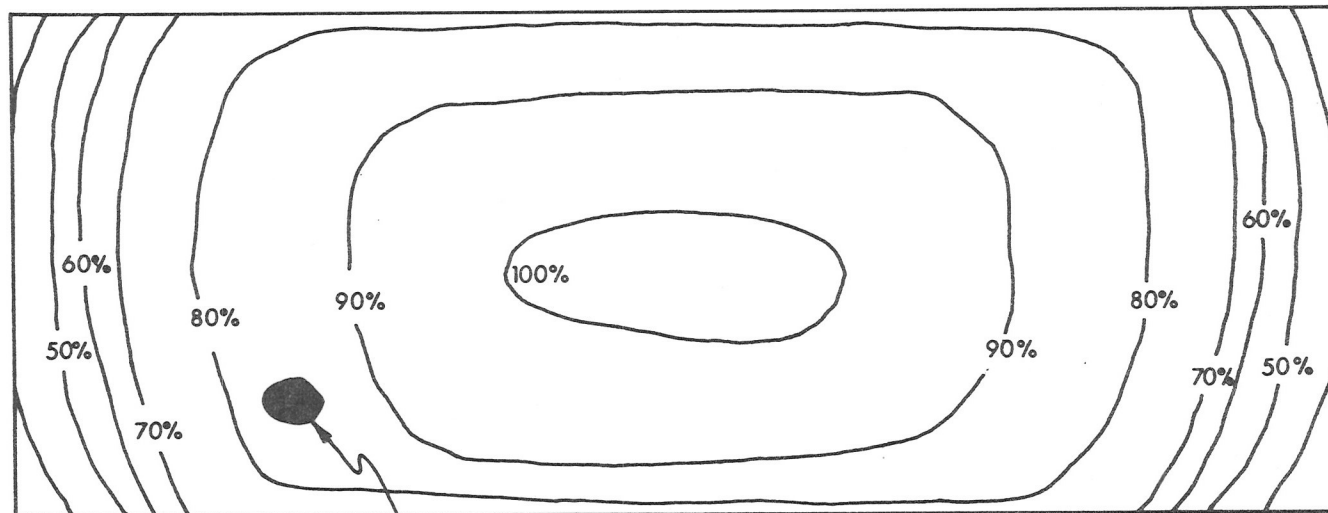
Fig. B.8 Isobrightness of Tungsol Status/Caution Annunciators

*NOTE: Brightness values tabulated are for one energized display only. Energizing additional status/caution displays or IL numerics will cause a significant decrease in display brightness (approximately 5% decrease for each additional display). This may be a series design problem.
