Troubleshooting Andor Zyla USB3.0 and iStar_{sCMOS}

Applicable to Zyla (USB3.0 only) and iStar_{sCMOS}

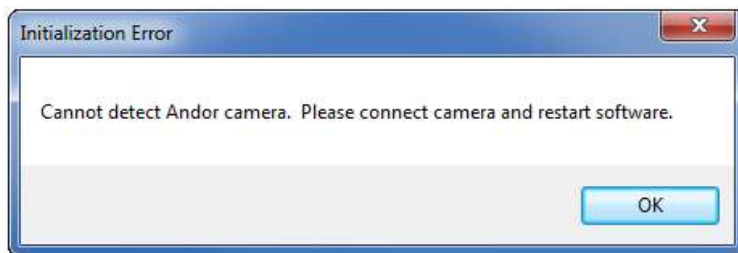
Communication Error

Andor Solis:

AT_ERR_OUTOFRANGE (6)

The out of range error will appear if the handle returned from AT_Open is '-1' indicating that an available camera could not be found.

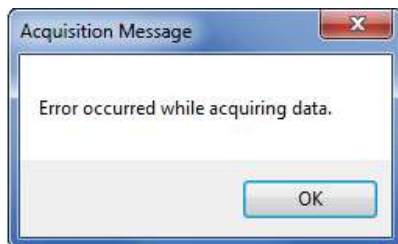
Acquisition Timeout Error

Andor Solis:

AT_ERR_TIMEDOUT (13)

A time out error will return from AT_WaitBuffer if the function times out while waiting for data arriving in output queue. In the context of this document, a timeout error may be related to insufficient bandwidth or HDD/SDD write speeds (if spooling to disk).

If the PC meets the required specification to run the camera, please follow the chart on the next page to diagnose and resolve the problem. (if unsure, please refer to the PC requirements on the camera Specification Sheet^[1] at www.andor.com for this information).

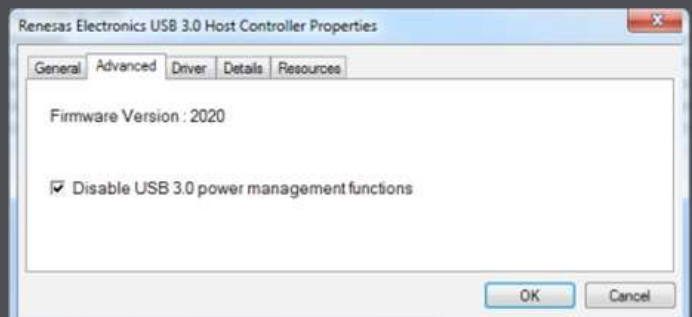
Have the power management settings of the Startech card been disabled?

From Windows *Device manager*, select *Properties* from the *Renesas USB 3.0 Host Controller*, go to the *Advanced* tab and ensure the check box is selected
