DESIGN SURVEY OF THE APOLLO INERTIAL SUBSYSTEM

Edited by
William A. Stameris

MARCH 1970

CHARLES STARK DRAPER LABORATORY

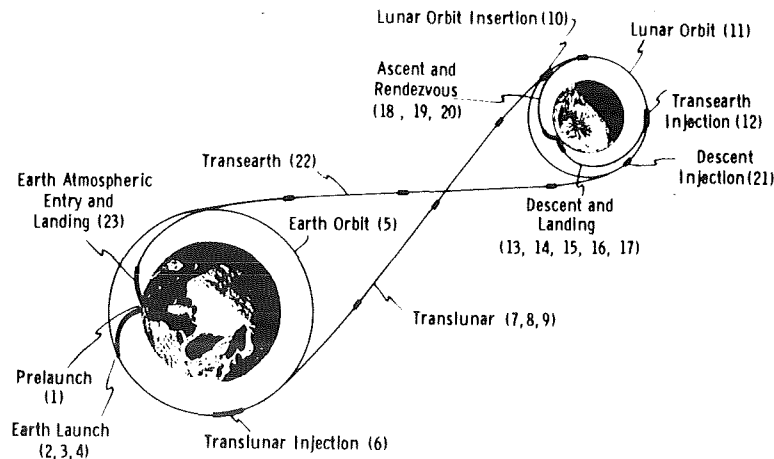
Fig. 2-1 The Overall Apollo Mission

The overall Apollo mission trajectory is summarized in Figure 2-1. The heavy lines in the figure correspond to the short thrusting maneuvers which are separated by the much longer free-coasting phases. The trajectory shown in Figure 2-1 is purposefully distorted to show the features of each phase more clearly.

The numbers relate to the mission-phase subdivisions which are discussed in detail in the following paragraphs.

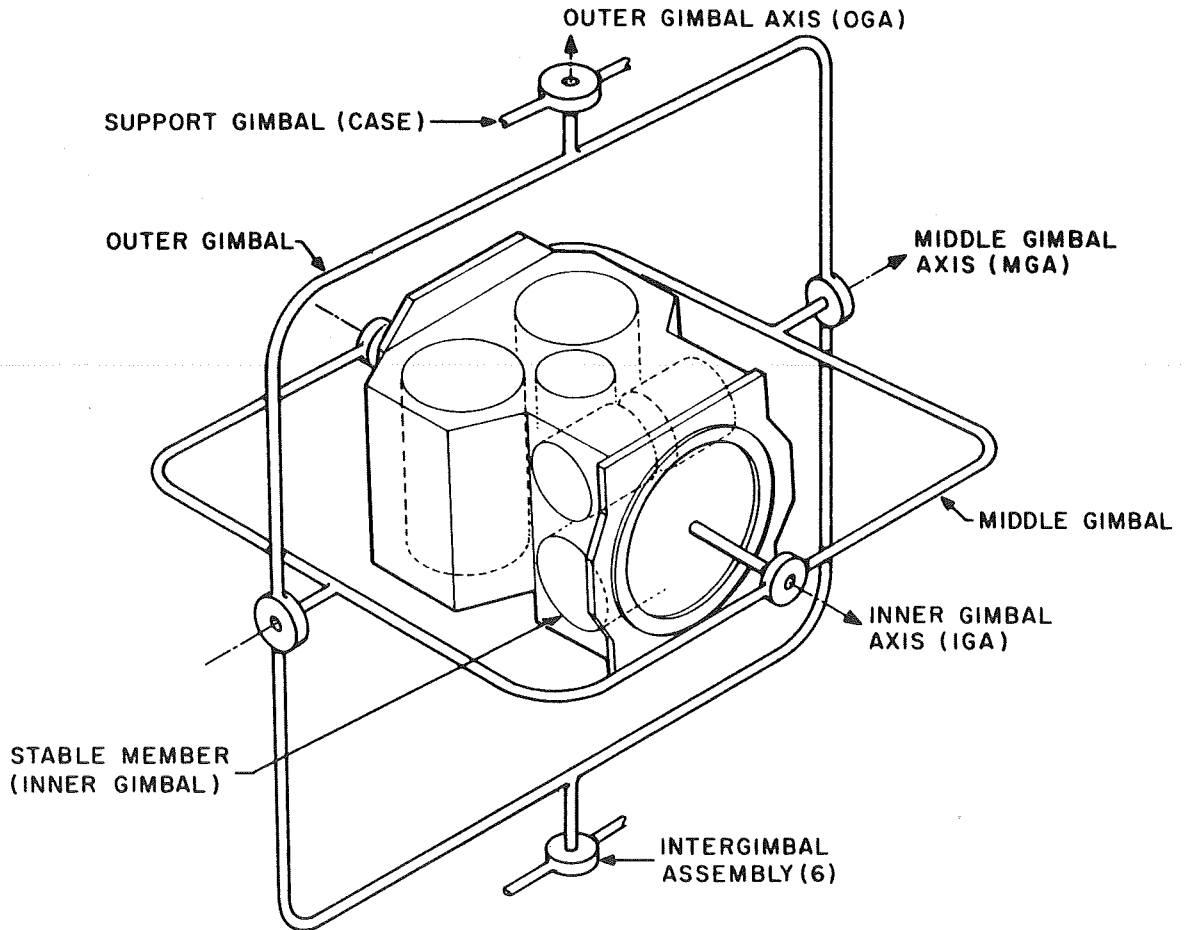
Fig. 3-1 Schematic of Inertial Measurement Unit

orientation in spite of base motion angles and rotational rates was well known. The Polaris IMU was a three degree-of-freedom gimballed structure such as shown in the "stick and wire" schematic form in Figure 3-1, and the proposed Apollo IMU was to be the same. Structural features of the gimbals that were developed for Apollo can be seen in Figure 3-2.

The third effect, resulting from outer gimbal inertia, comes into play only with large middle gimbal angles away from the zero orientation. See Figure 3-1. In the extreme situation, large middle gimbal angles cause the effect called "gimbal" lock. This subject is so extensive that the ensuing section has been devoted to its exposition.

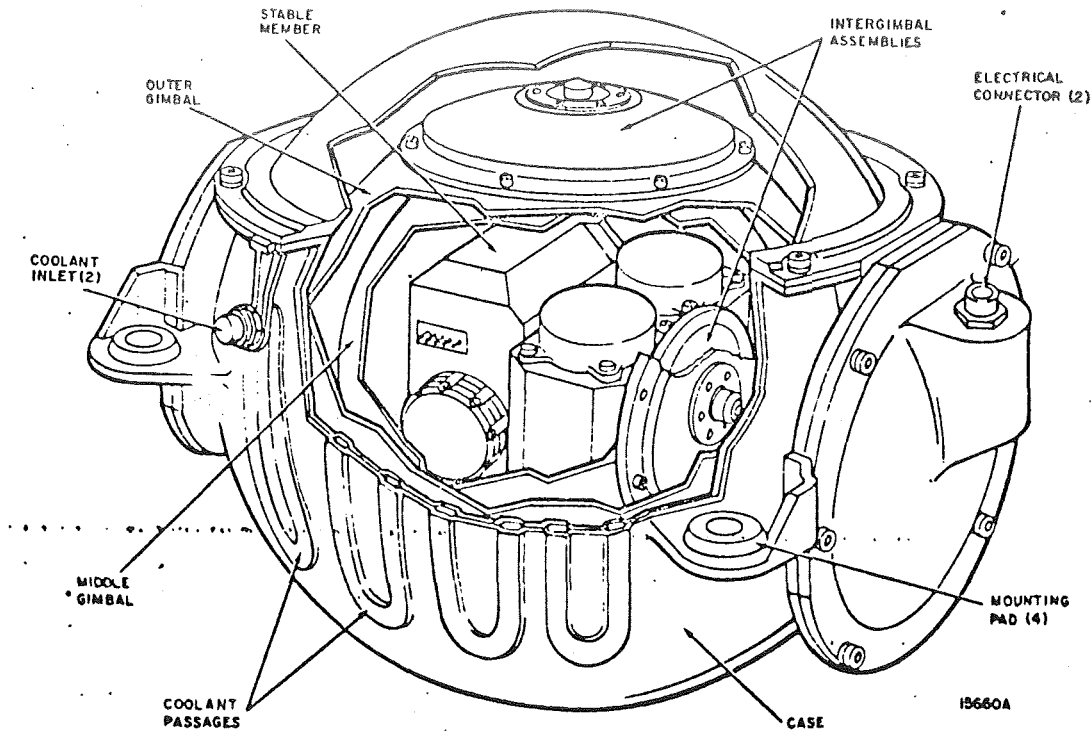
Fig. 3-2 Inertial Measurement Unit

Each gimbal axis of the proposed IMU had the servo torque motors and electromagnetic data transducers directly coupled to the two adjacent members without operating through a gear train such as is common in many gimbal designs. This operation without gears had a multifold advantage. Most obvious was the elimination of concern about gear wear and accuracy of mesh which were critical factors in making a reliable servo of the necessary high performance. Equally important was elimination of the requirement for the servo to provide torque to accelerate gear train inertia when no angular velocity was desired of the driven gimbal. Without gear trains the inertia of the stable member would tend to hold itself stationary without any help from the servo against any magnitude of base rotation motion except for the effects of (1) bearing friction, (2) motor "back emf" and (3) outer gimbal inertia. Discounting these last two effects for the moment, the servo would need to overcome only the small bearing friction of the Apollo IMU gimbals, even for extremely violent base or vehicle rotations. There are none of the limitations resulting from high angular rates or accelerations of the vehicle

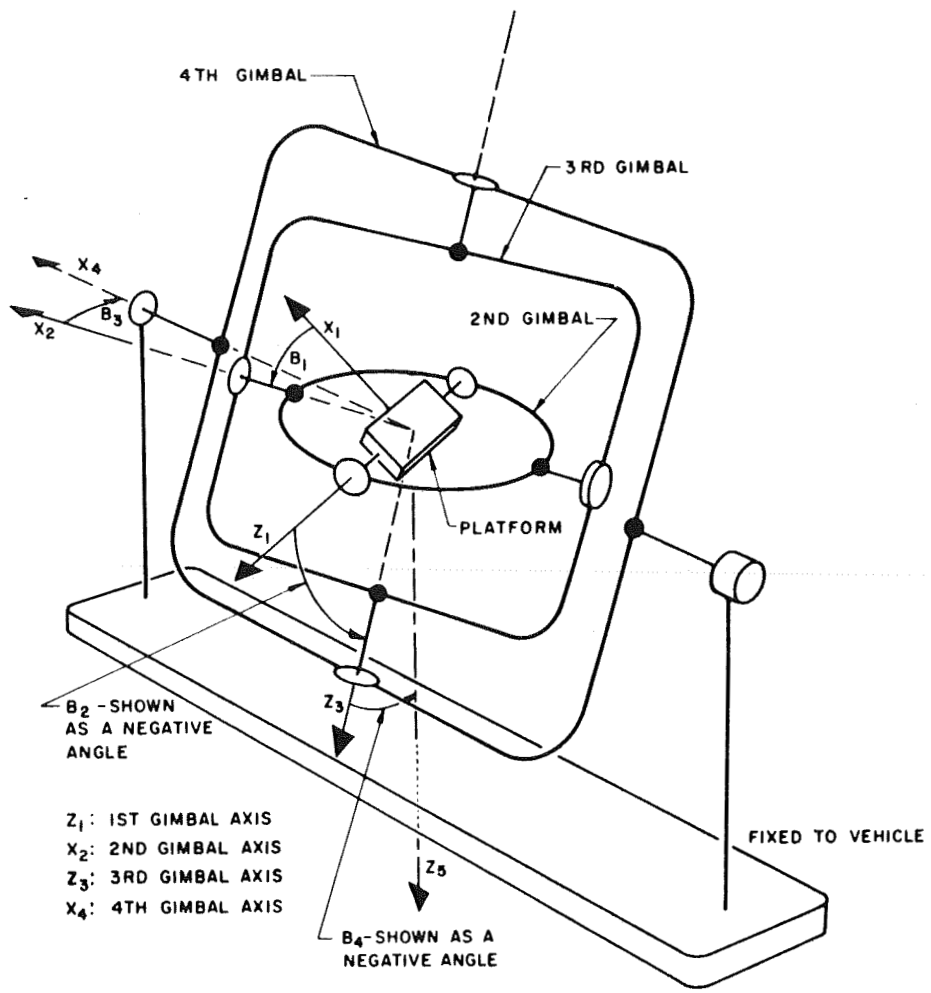
Fig. 3-3 Four Degree-of-Freedom IMU

The disadvantages of using a four degree-of-freedom IMU were considered significant. To execute the fourth gimbal would have required an extra servo different from the other three servos in dynamic design. Extra data transducers, or the equivalent, on the middle and outer axes to determine the redundant gimbal commands would have also been required.

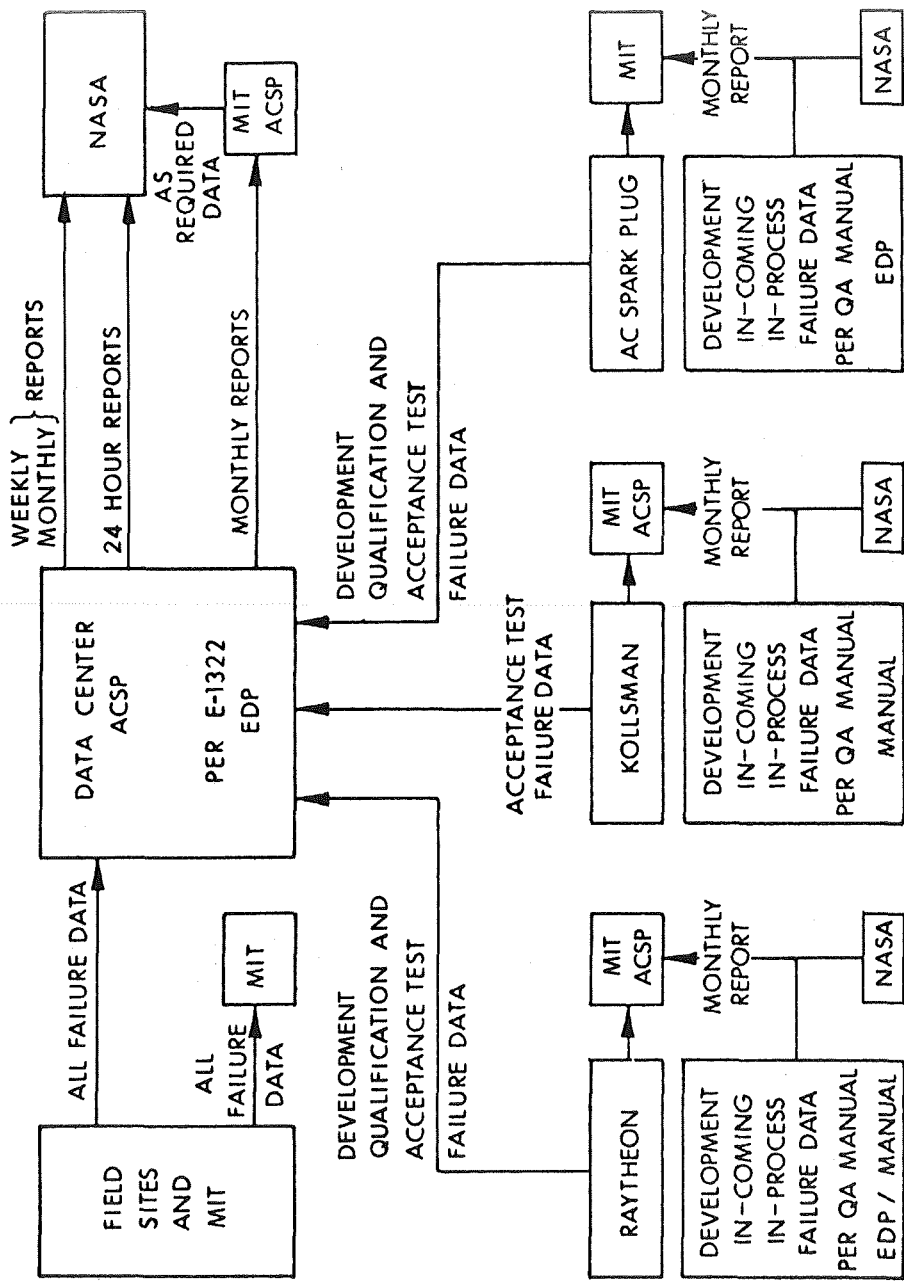
Fig. 3-4 G&N Failure Data System

Failures occurring during the design and development phase at MIT were reported to the MIT reliability group on the short form (see Fig. 3-5) for cataloging and following proper corrective action. Information pertaining to significant development failures was transposed by the Reliability Group to the G&N failure form as required by the G&N failure reporting and corrective action system (E-1322) and transmitted to the G&N data center for processing as part of that system. As a result, all significant failures occurring during design verification tests, qualification tests, and tests on deliverable end items or spares were included in this system. Not necessarily included, unless of special importance, were data from breadboard evaluation, and part and material design evaluation.

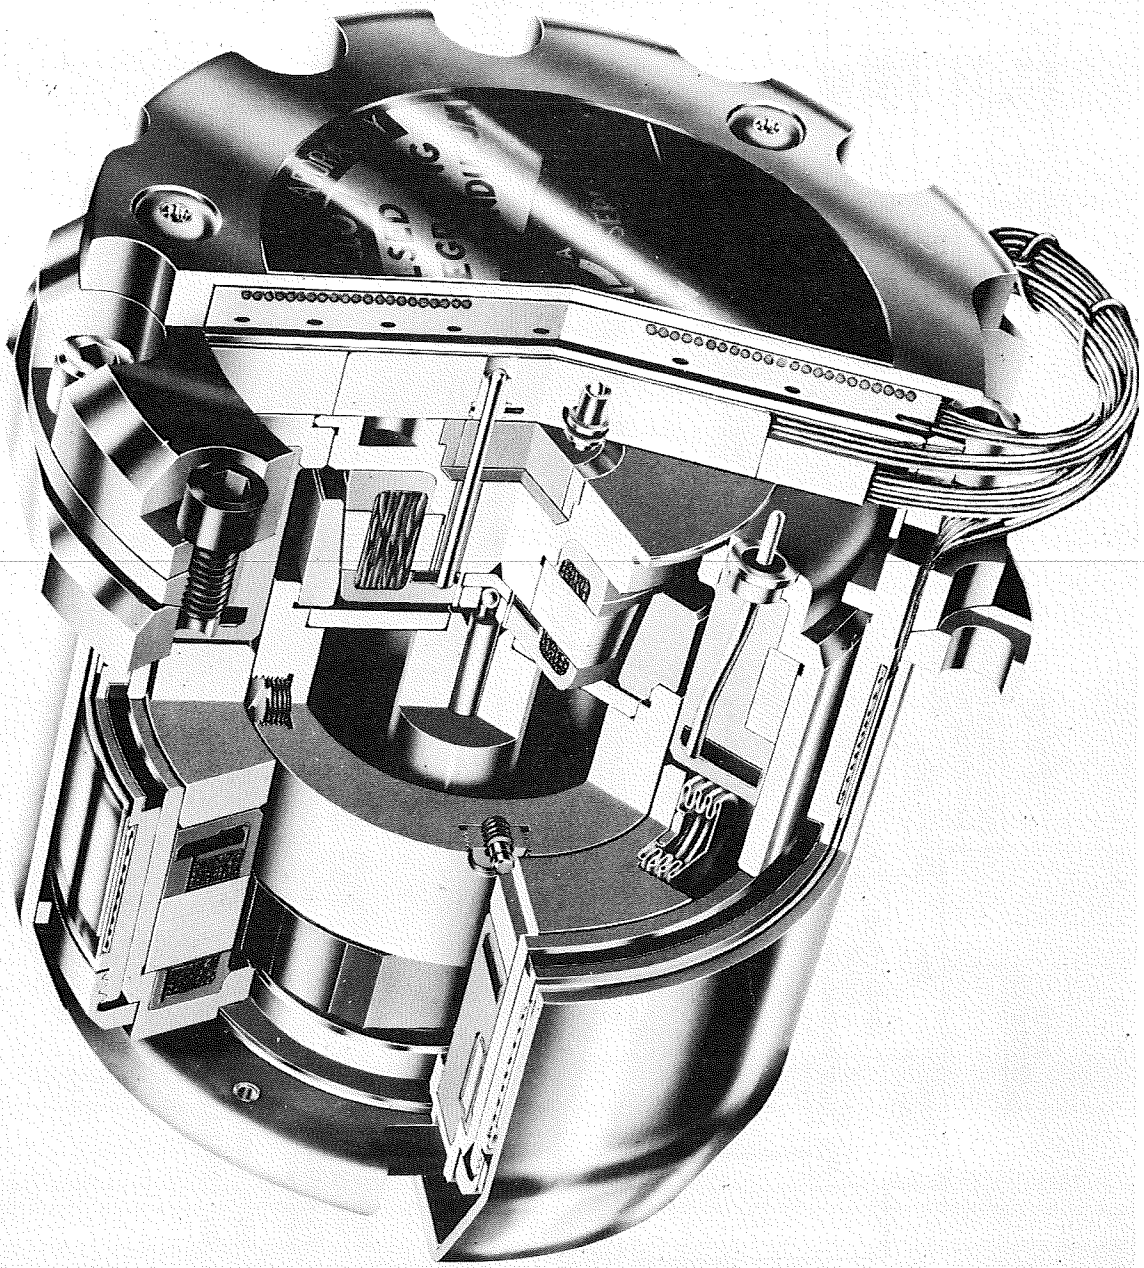
Fig. 4-2 16 Pulsed Integrating Pendulum, Mod D

A cutaway view of the complete pendulum is shown in Figure 4-2. The pendulous mass was mounted on the periphery of the float and extended into a small groove in the damping block. The width of the groove allowed a maximum float rotation of $\pm 1^\circ$ of arc. The magnetic suspension stators were positioned opposite the inside portions of the rotors and formed part of a coaxial structure with the torque generator on one end of the instrument and the signal generator on the opposite end. Four bellows provided for volumetric compensation of the damping fluid between 10°C - 71°C . Two alignment rings on the end of the instrument permitted accurate positioning of the input axis of the PIPA relative to the mounting surface. The instrument was aligned to the mounting ring before incorporation in the IMU.

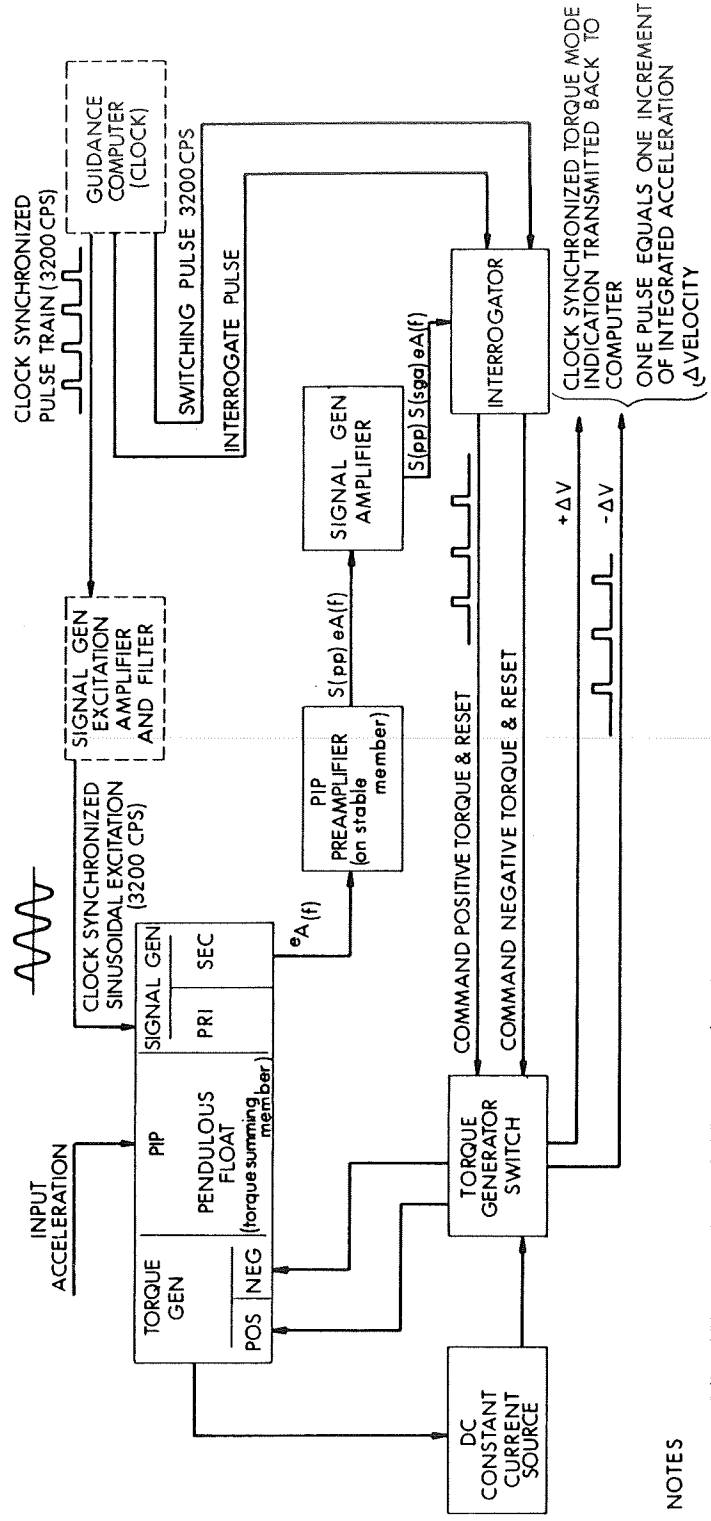
Fig. 4-3 PIP Accelerometer Block Diagram

The overall block diagram showing the pendulum within its control loop is presented in Figure 4-3. The signal from the signal generator was amplified and used as an input to a sampler (called the interrogator) which sampled the signal at discrete times determined by the guidance computer. If the signal exceeded either

1. PIP (PULSED INTEGRATING PENDULUM) 16 SIZE SINGLE DEGREE OF FREEDOM PENDULOUS UNIT
2. WAVE FORMS SHOW CONDITION FOR NEGATIVE INPUT ACCELERATION OF PIP CASE

4.1.2.5 Electronics. A functional description of the electronics involved with PIPA operation is depicted in the control-loop block diagram, Figure 4-3. The filtered SG signal was amplified by the preamplifier and ac differential amplifier and sent to the interrogator. The interrogator utilized a dual channel peak detector that was synchronized by the interrogator pulse train from the computer or system clock to determine the polarity of the signal from the ac amplifier. The outputs from the peak detector controlled the state of two multivibrators that commanded either positive or negative torque from the switch.

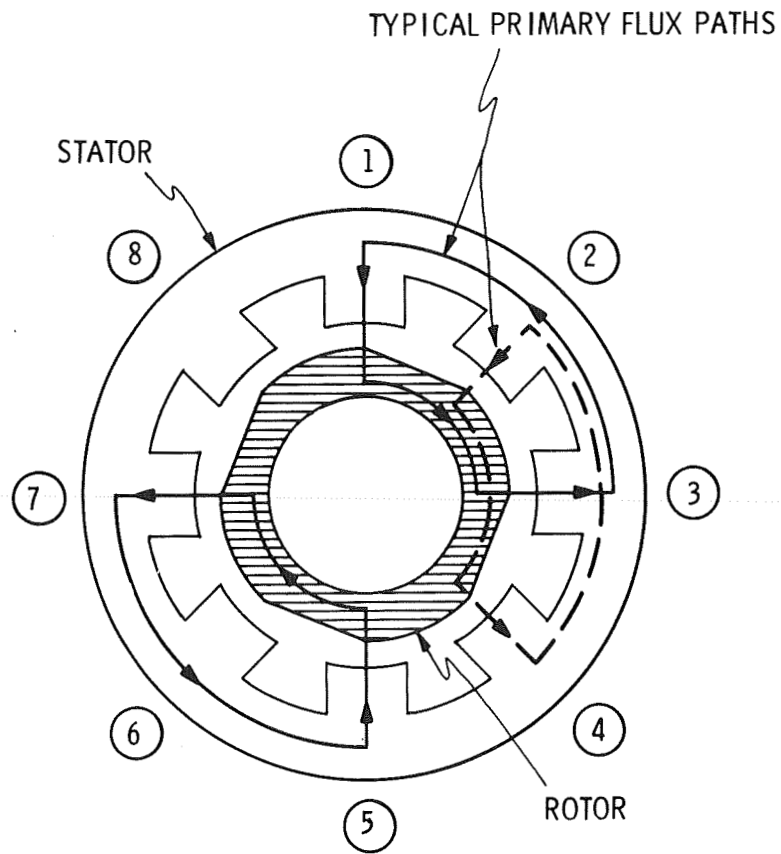
Fig. 4-5 Apollo PIP Signal Generator Cross Section

4.1.2.2 Signal Generator. Float rotations were sensed by an angle-to-voltage transducer called a signal generator. A cross sectional view of the signal generator stator and rotor is shown in Figure 4-5. The primary coil of the signal generator (SG) was wound in series around each of the eight stator poles. The flux paths set up by these poles were typified by the flux paths shown in the figure. The SG secondary coils were wound such that the even-numbered poles were 180° out of phase. If the contoured outside diameter of the rotor was perfectly centered and at zero rotation relative to the stator (as shown in Figure 4-5), the total signal induced in the secondary of the SG would be zero. If a rotor (float) rotation occurred in either the positive or negative direction, a corresponding in-phase or out-of-phase output was obtained across the SG secondary, since the reluctance seen by the positive secondary poles was no longer equal to that seen by the negative poles.

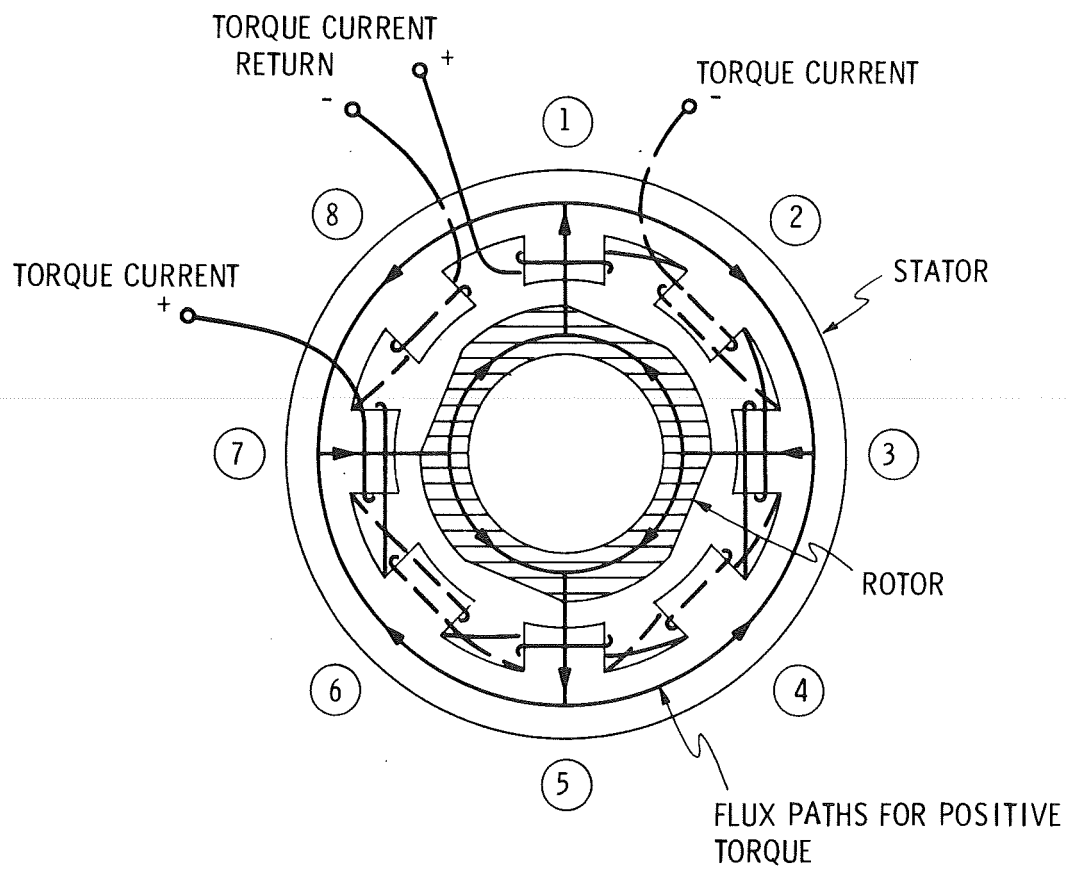
Fig. 4-6 Apollo PIP Torque Generator

4.1.2.3 Torque Generator. Except for the way the coils were wound, the torque generator (TG) cross section was identical to that of the SG. The position of the TG coils and resultant flux paths for positive torque are shown in Figure 4-6. Since only one torquer was on at any time, there were two minimum-energy rotor positions: one for positive torque, and one for negative torque. The rotor always tended to line up at the minimum-energy position opposite the working poles. However, the frequency of switching allowed only a minute oscillation about a center point midway between the minimum energy points. The torque produced was proportional to the square of the flux linking the rotor poles and thus was a function of the square of the torquer current.

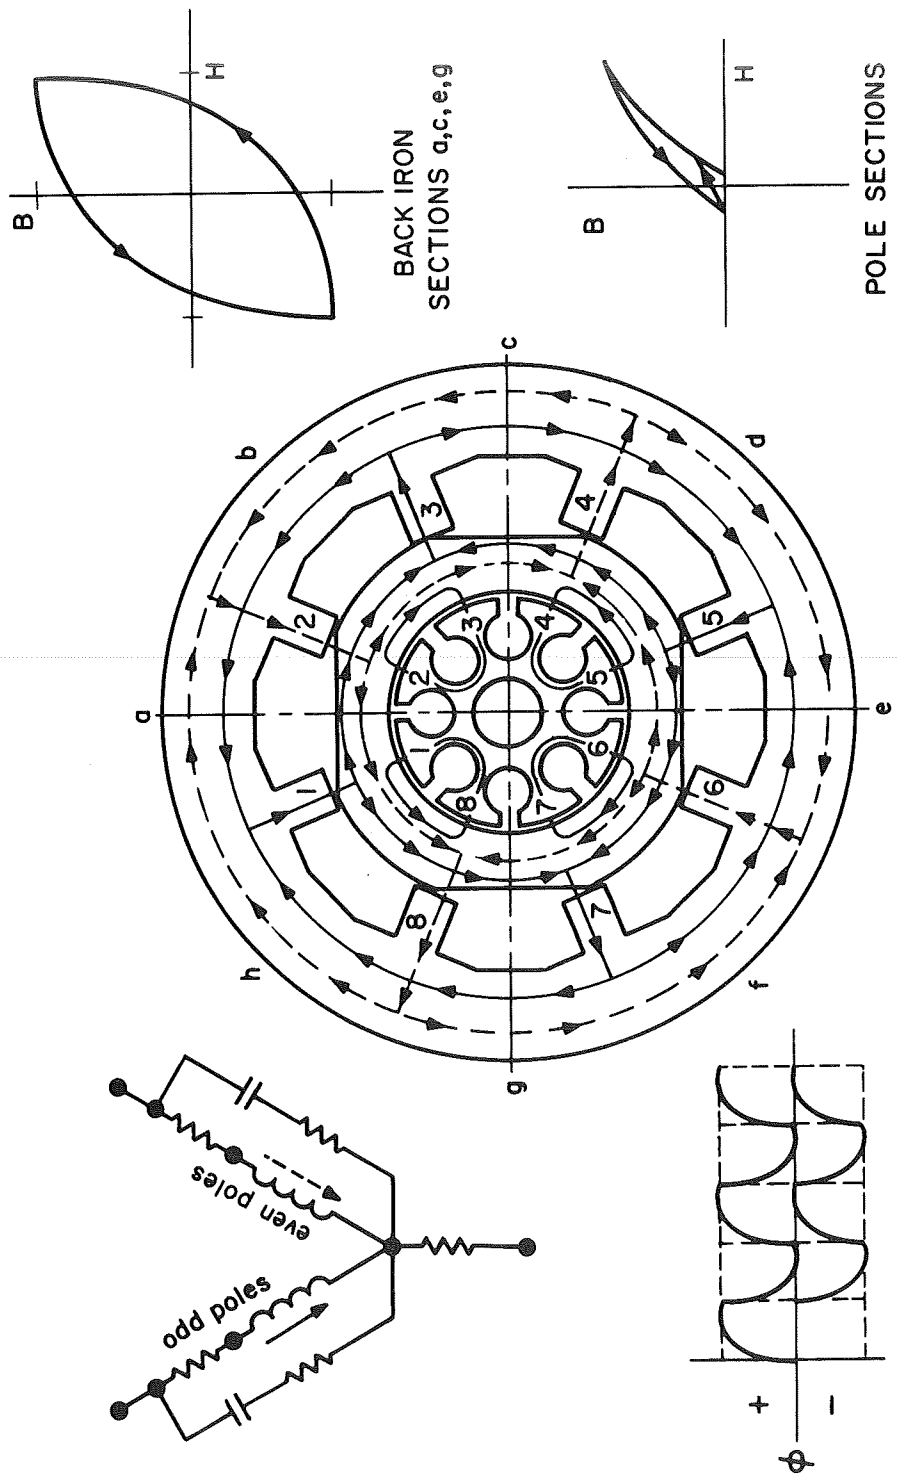
Fig. 4-7 PIP Ducosyn Torquer Magnetic Paths

Three different conditions of flux were present in the stator. The flux existing in the poles was the on-off type, as shown. The flux in the back iron section, b, d, f and h, reached a dc level once the unit was turned on. (This condition remained constant except for a slight transient that occurred at switching intervals.) The flux in sections a, c, e and g was an alternating one. The stator flux magnitude should not have changed regardless of the torquer winding that was being energized; only the duty cycle of the positive and negative pulses should have changed. Changes in the permeability of the ducosyn materials would cause variations in the flux magnitude resulting in changes to the scale factor and bias. Permeability changes could have occurred as a result of transient overshoots in the torquer or suspension currents at system turn-on and by stresses incurred as a result of slow curing of microsyn encapsulating materials.

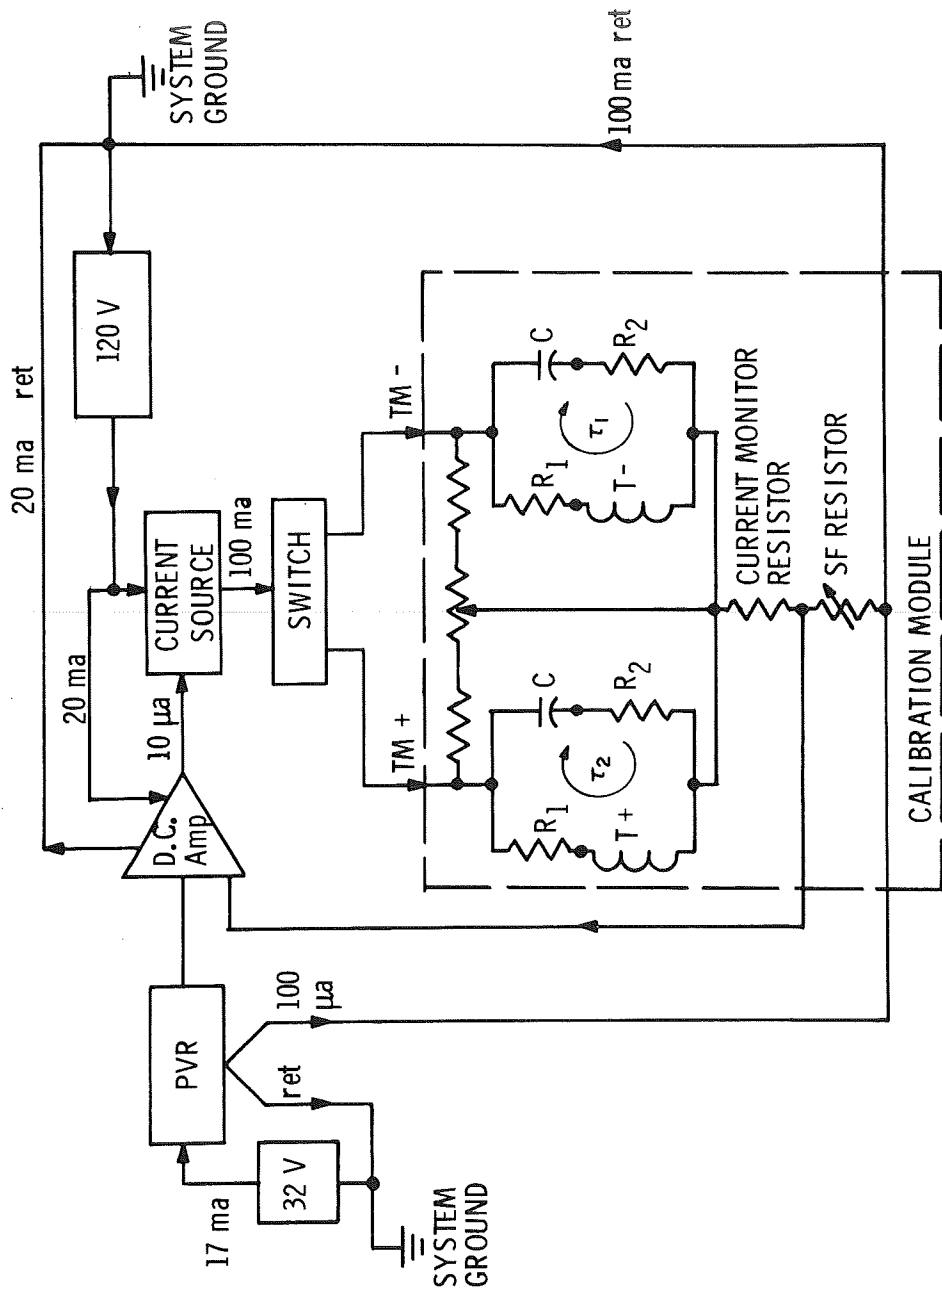
Fig. 4-8 Apollo PIPA dc Current Loop

4.1.2.6 Mode of Operation. Initially, the Block I Apollo torquing loop was designed as a three-state or ternary loop with no torquing pulses applied to the float if the output of the ac amplifier was less than the interrogator threshold. This approach was taken to conserve spacecraft power. Testing of the early PIPAs revealed that, as a result of the magnetic hysteresis of the torquer stator and rotor material, a significant residual flux remained in the core when the torquing current was removed and caused the instrument to show large bias variations that were dependent on the polarity of the last applied torquing pulse. It was further determined that the residual effects could be largely eliminated if alternate torquing were imposed continuously on the torquers thus creating a nearly constant average magnetic state in the materials. Consequently, a decision was made to establish a binary loop to neutralize the effects of the hysteresis.

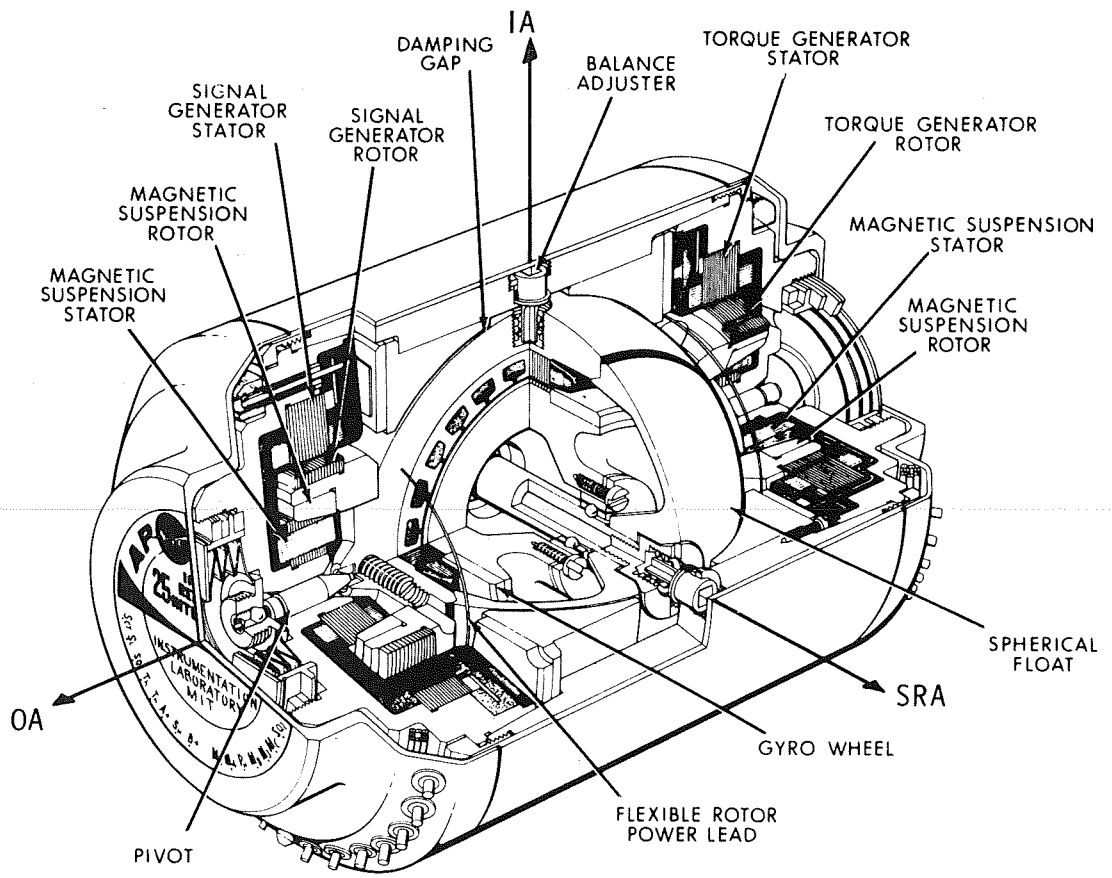
Fig. 4-9 Apollo IRIG

Figure 4-9 is an illustration showing the main features of the gyro instrument. During final IRIG assembly, a prealignment package was added to the signal generator end of the gyro case. Addition of this package made the gyro a prealigned unit. The package contained the following components:

- (1) Suspension capacitors for ducosyn suspension.
- (2) Temperature sensor normalization.

- (3) End mount heater prealigned to the gyro input axis.
- (4) Torque generator normalization.
- (5) Signal generator preamplifier with normalized gain.

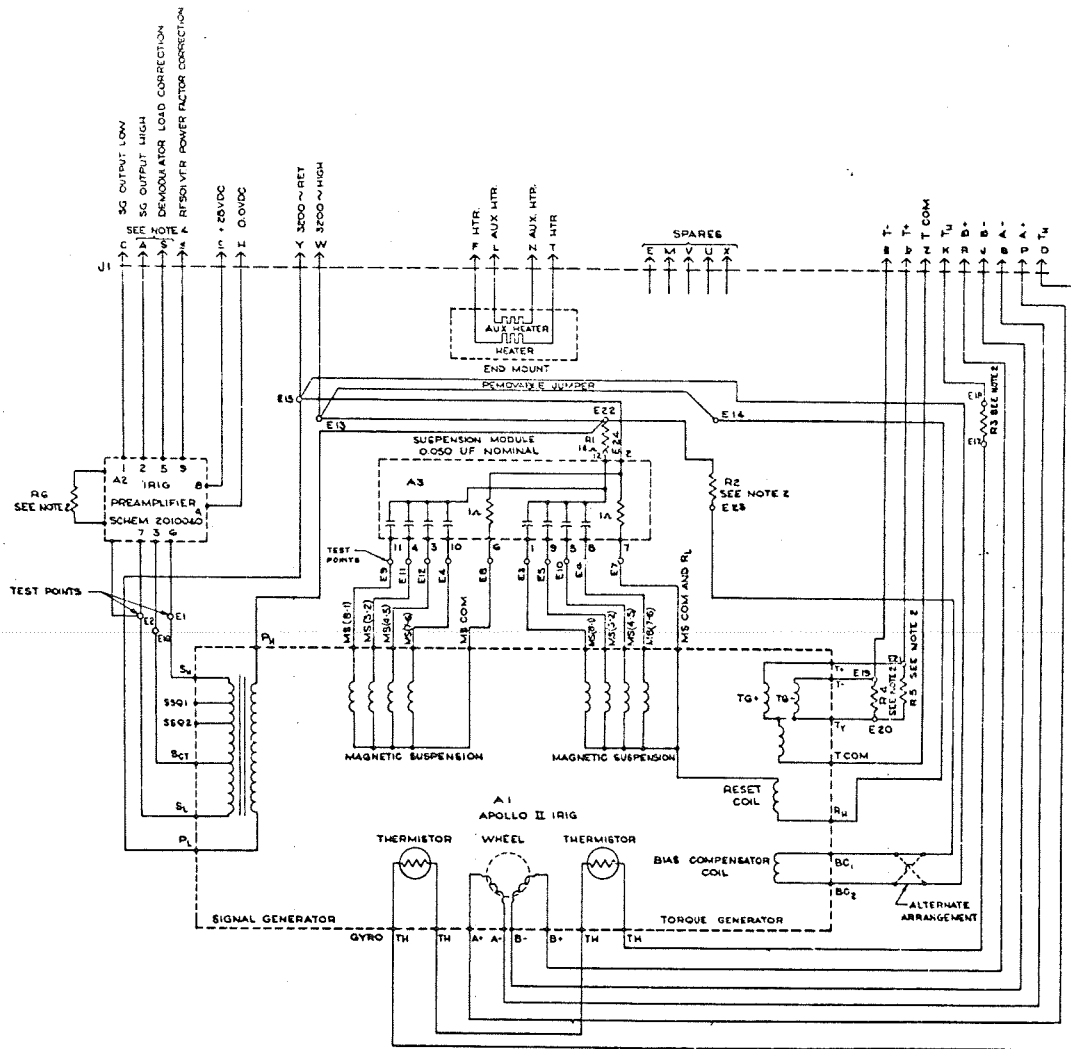
Fig. 4-10 Apollo II IRIG Prealignment Network

The prealignment hardware consisted of a heater and end mount assembly, signal generator preamplifier, and normalization networks (See Figure 4-10). The heater and end mount assembly maintained the gyro at proper operating temperature and performed the task of accurately maintaining input axis alignment with respect to the IMU stable member or test stand. The preamplifier amplified the signal generator output and normalized the signal generator-preamplifier gain product for the instrument.

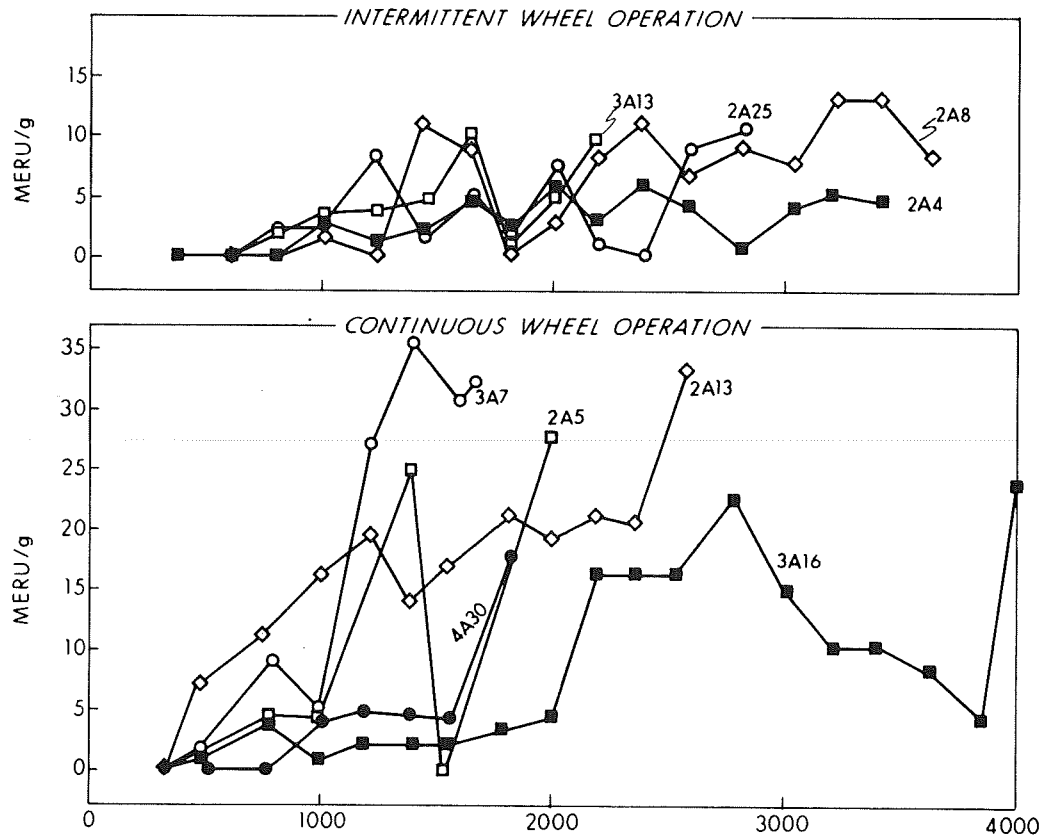
Fig. 4-11 Wheel Operating Hours

Figure 4-11 compares the acceleration sensitive drift about the input axis (ADIA) data for units that were run continuously with units that were run intermittently. For the same operating time, the intermittently operated units resulted in the more stable performance. Therefore, the intermittent mode of operation in the system did not result in a performance penalty. There were no differences in the BD and ADSRA terms for the two modes of operation.

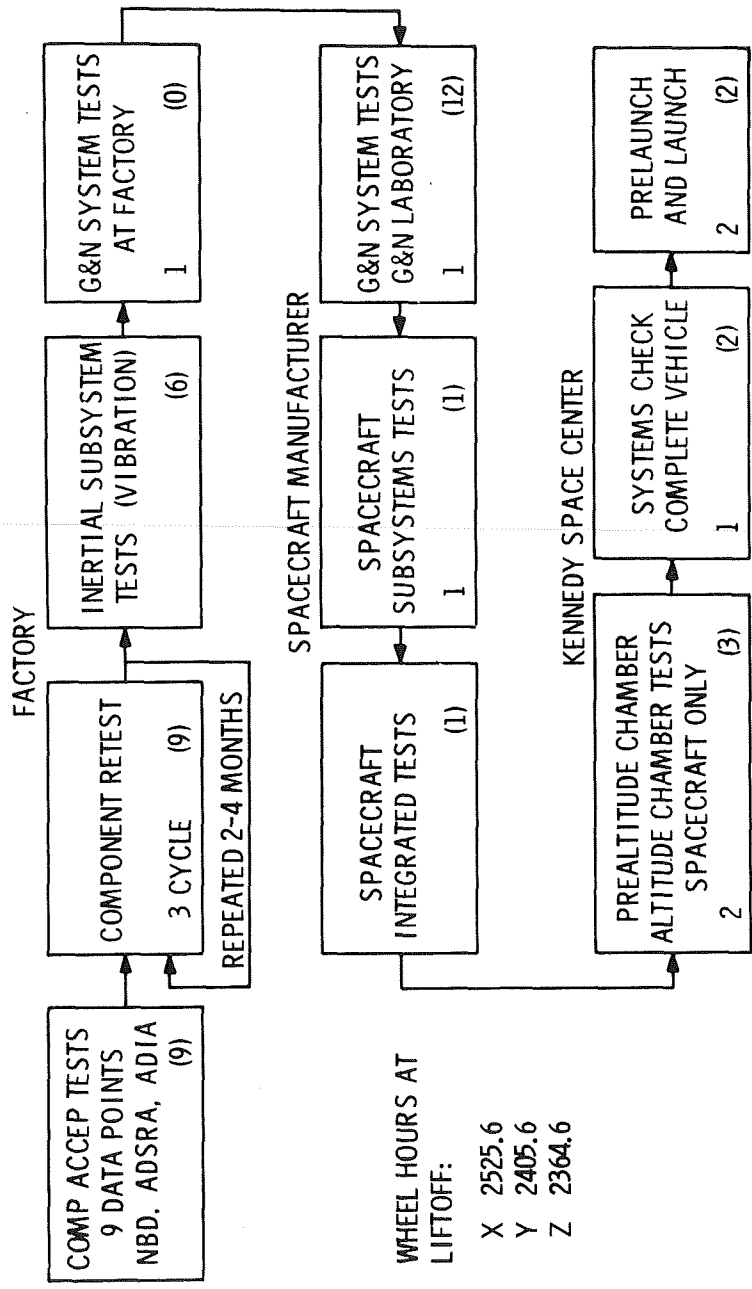
Fig. 4-12 Inertial Component Performance Data Sequence

S/C 011 Z GYRO DATA TAKEN INDICATED BY NUMBERS IN PARENTHESES. OTHER NUMBERS REPRESENT NORMAL PERFORMANCE EVALUATION DATA POINTS.

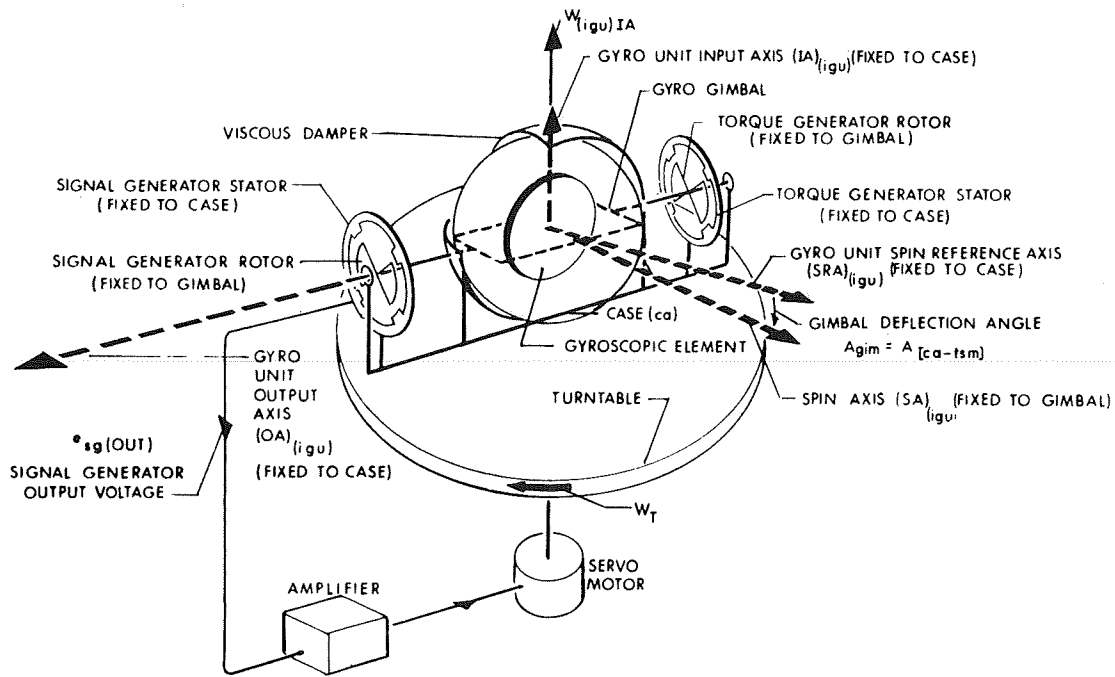
Fig. 4-14 Line Schematic Diagram of the Apollo IRIG Operating in a Single-Axis Orientation Control System

(1) Drift Performance Tests & System Tests -- Drift performance data were generally obtained utilizing an inertially stabilized loop (See Figure 4-14). The gyro instrument was mounted on a test table such that the input axis was parallel

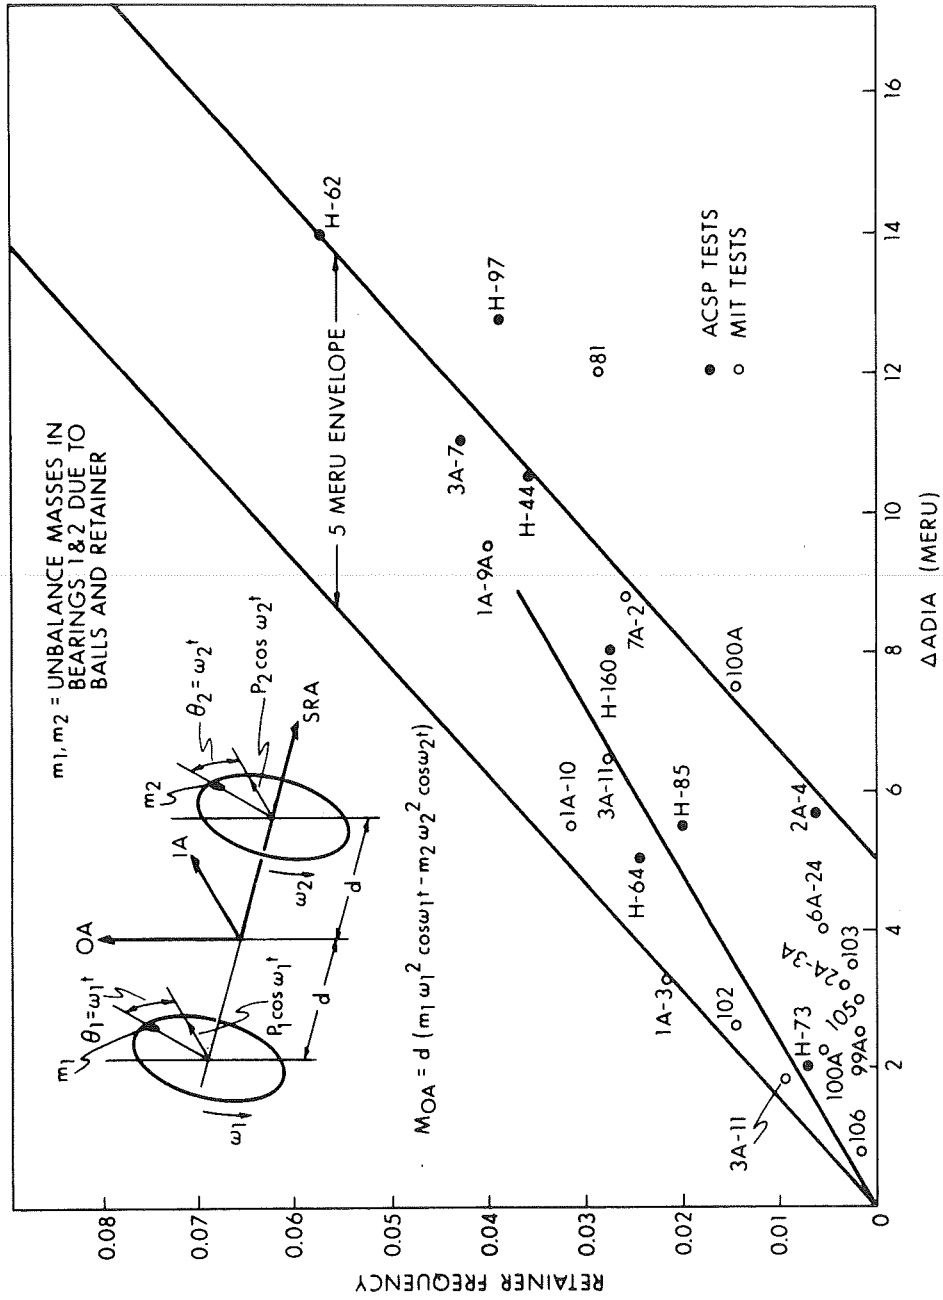
Fig. 4-15 Change in Retainer Lap Frequency vs ADIA for 25 Units

(2) Performance Indicators -- The rotating ball-bearing retainers produced a sinusoidal torque about the gyro output axis at a frequency corresponding to the rotational velocity of the retainer, but since the average value of this sinusoidal torque was zero, there was no resulting drift error. The torque was detectable at the gyro signal output as a sideband of the signal generator frequency (3200 HZ) and the retainer frequency (243 Hz). The magnitude of this signal varied periodically as one retainer lapped or passed the other retainer. A change in the lap frequency was caused by a change in speed of one of the retainers. This frequency stability was found to be related to the ADIA stability. Figure 4-15 shows data for ADIA deviation versus retainer beat frequency for 25 gyro units. The data for each unit were obtained from 12 hour inertially stabilized drift runs with the gyro input axis vertical. Data points for most units fell close to a linear relationship line. This technique was developed during the Apollo gyro production program. Evaluation of this technique indicated significant advantages over many methods now in use; it's simple and easily implemented.

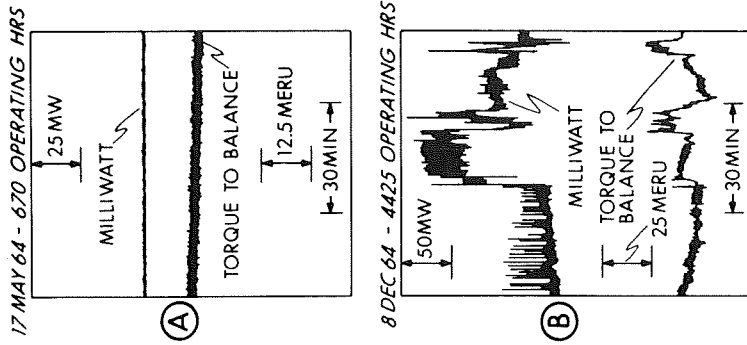
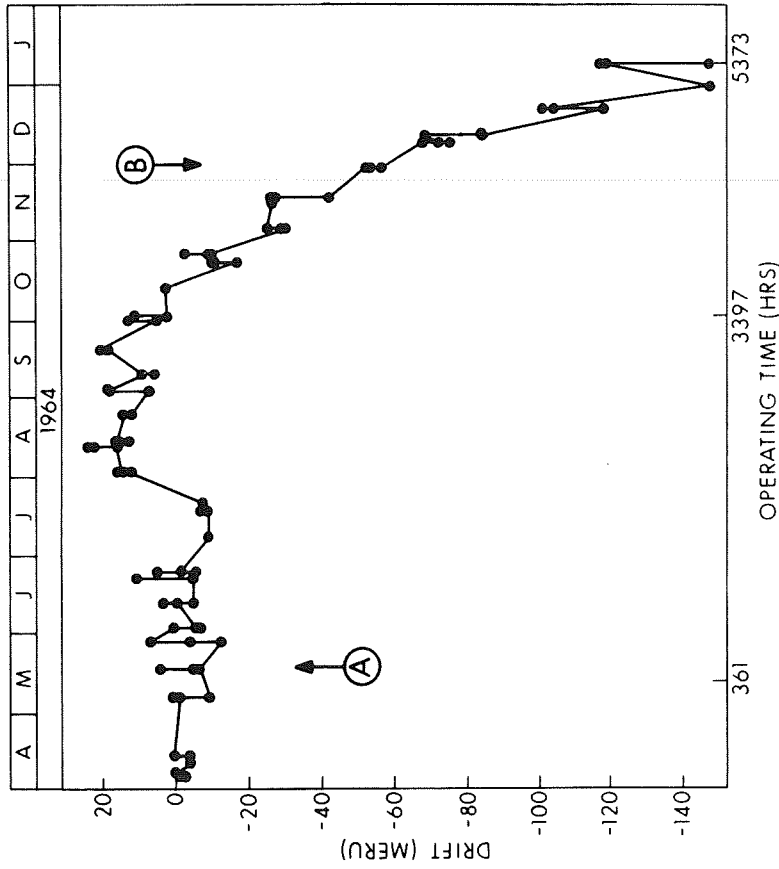
Fig. 4-16 ADIA Drift and Wattmeter Sample Traces vs Operating Time

The stability of the power required to operate the gyro motor indicated its condition relative to such variables as frictional torques and gyro wheel bearings. A good power trace has excursions of 5 mW, or about 0.1% of total wheel power. Figure 4-16 shows traces taken at two times during the life of a gyro. At time A, the power excursions were low, but at time B, a significant decrease appeared in the stability of bearing torques. Finally, the wheel failed to reach synchronous speed and bearing failure occurred. The milliwattmeter was used both to screen bearings before they were installed in gyros and to determine whether there was bearing deterioration on completed instruments. Power monitoring was performed at component-level testing and on gyros installed in the IMU.

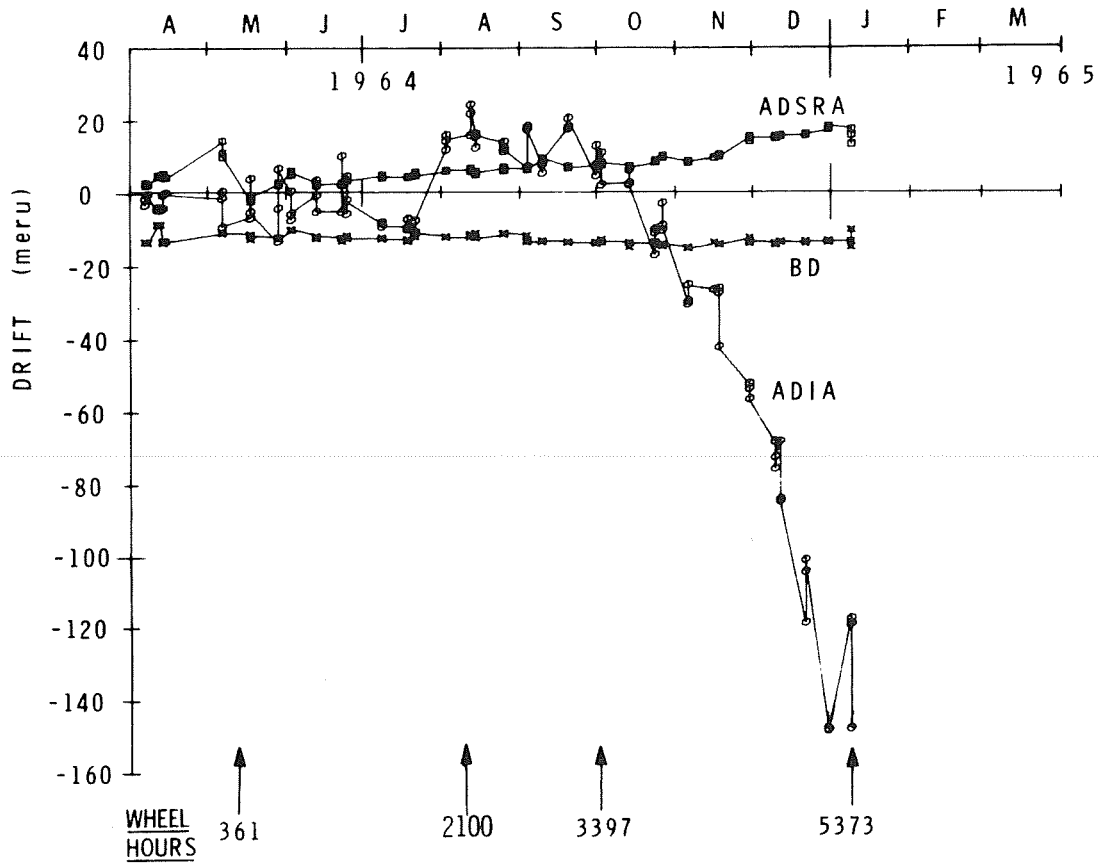
Fig. 4-17 25 IRIG-3A-16 Drift Coefficients

Figure 4-17 is a plot for unit, serial no. 3A16. The bearings of this particular unit failed in the reliability program. At approximately 2100 wheel hours, the ADIA changed by more than 25 meru/g. The gyro was in the same location, and the performance change was verified by a second test. At this point, it was predicted that this gyro would fail. For the next 1500 hours, its performance was very respectable in that the total acceleration-sensitive drift along the input axis was less than
