DESIGN SURVEY OF THE APOLLO INERTIAL SUBSYSTEM

Edited by
William A. Stameris

MARCH 1970

CHARLES STARK DRAPER LABORATORY

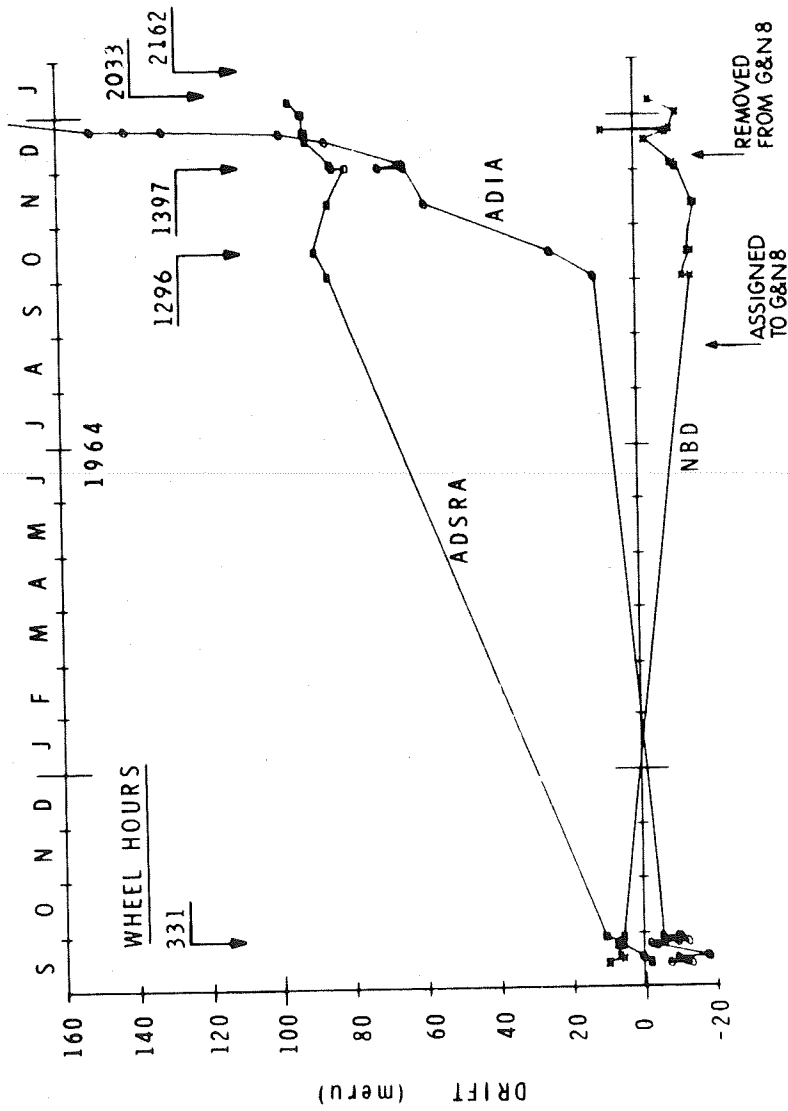
Fig. 4-18 25 IRIG 2A-11 Drift Coefficient

Figure 4-18 is an example of prediction of system performance for a gyro installed in the guidance system. The ADSRA term changed by more than 25 meru/g at the time of installation into the system. Subsequent tests verified this change. The Delta-25 criterion would not have picked up this parameter on that instrument since it changed location. After installation in the system, a subsequent ADIA change of more than 25 meru/g occurred and was verified. Upon this indication of a potential failure, the gyro was removed from the guidance system and was tested until the wheel failed. The wheel time accumulated after the Delta-25 criterion was equivalent to 80 lunar missions. Again, the BD and ADSRA terms remained stable until the gyro failed completely.

Figure 4-19 shows rmssd versus wheel hours for unit 2A5, which exceeded the F criterion at 1500 wheel hours. 500 hours later it failed to start at the application of wheel voltage. These hours would have been sufficient time to complete two preflight tests and missions. Gyro 2A11 (Fig. 4-20) exceeded the F criterion during acceptance testing (300 wheel hours), later was requalified, then exceeded the F criterion again at 1200 hours. It had stable ADSRA and BD performance even after it had exceeded the F criterion for ADIA data. It was run intermittently for another 800 hours before failure; again, there was adequate warning to have allowed a successful completion of the mission.

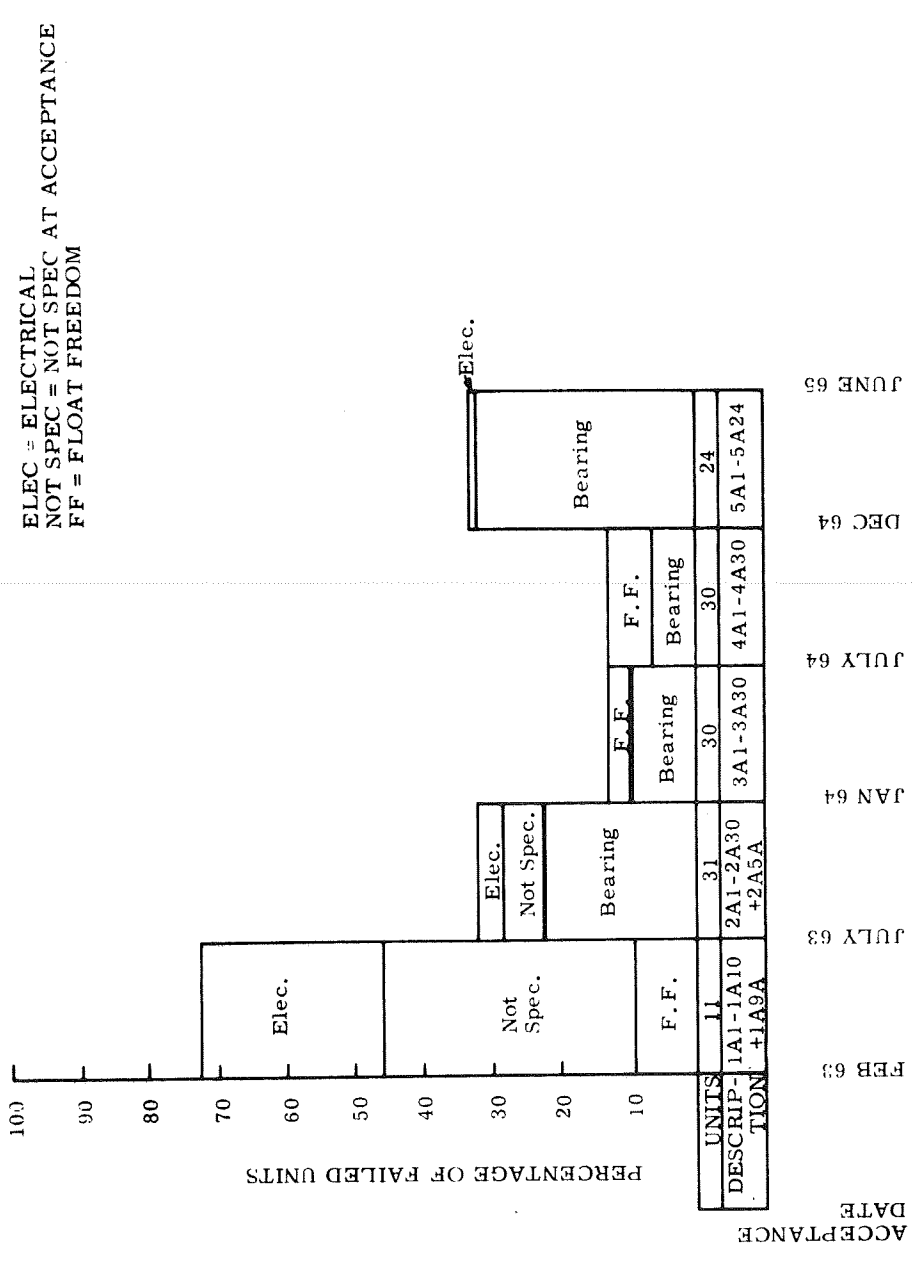
Fig. 4-22 Apollo I Gyro Failure

The Apollo I gyros were subdivided during manufacture into five groups according to the date of manufacture. Most of the discrepancies in drawings and procedures were corrected during the construction of the first two groups. The failure rate for each failure cause was plotted for each group (see Figure 4-22). Induced failures were not included as failures in this plot. The large number of failures, 73 percent in Group I, was attributed to the changes required and to start-up problems. Groups II to IV show a continuing improvement in the percentage of failures, a low of 13 percent for Group IV. Figure 4-23, a plot of the average wheel hours for each group, shows that the average operating hours for the last four groups had decreased slightly. This could partly explain the decreasing number of failures for Groups III and IV and should have resulted in fewer failures for Group V.

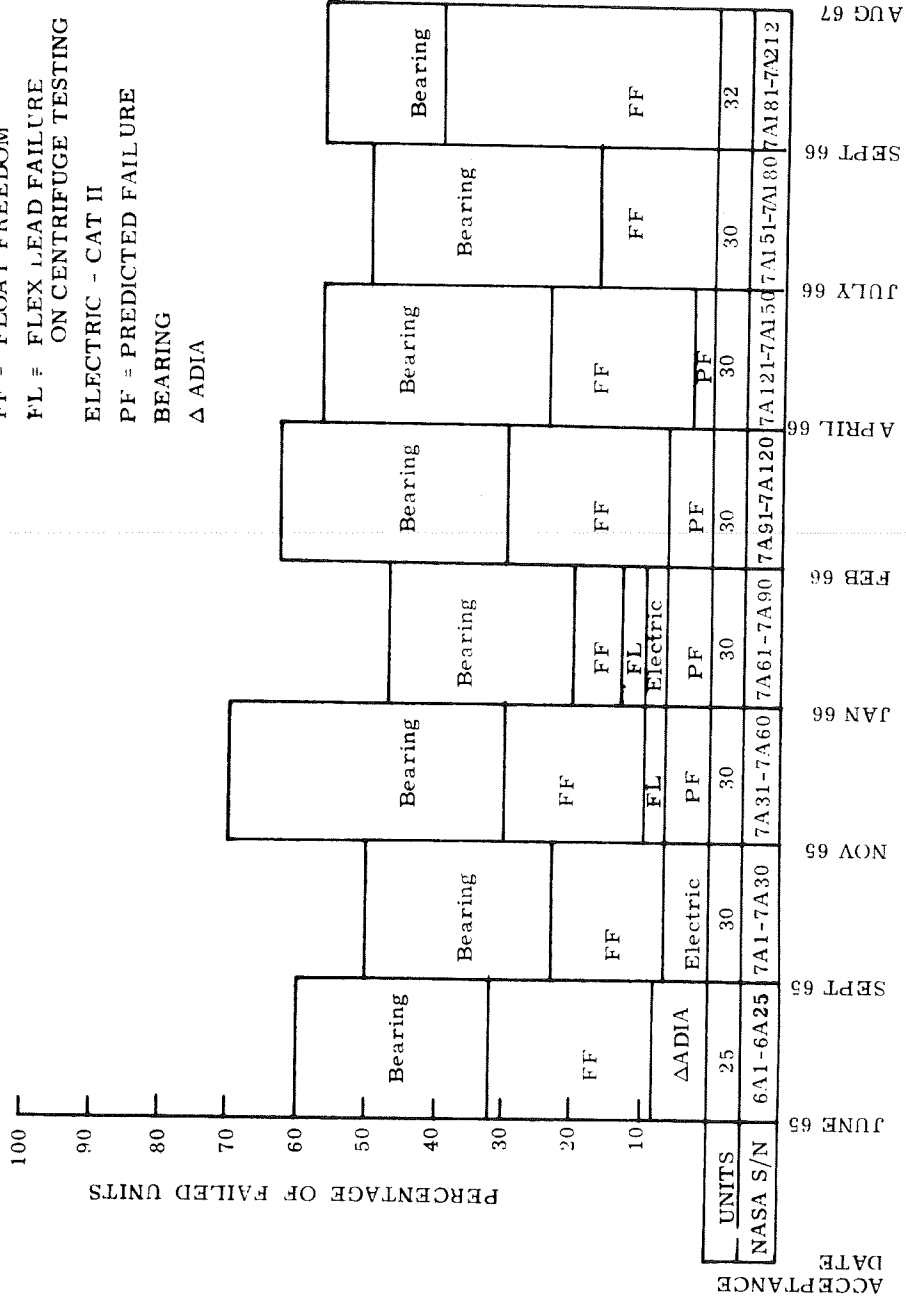
Fig. 4-24 Apollo II Gyro Failure and Predicted Failures

A similar study of Apollo II assembly results was made and plotted as shown in Figure 4-24. The groups were determined by dividing the total Block II build program into eight groups of about 30 units per group according to their acceptance date. The results compared to the Block I experience were startling. The failure rate in the first group was 60 percent and succeeding groups varied from that rate by only 20 percent. Bearing failures were a consistent percentage, 25 percent of each total; and float-freedom failures, which were almost negligible in Block I, were a steady contributing factor at about a 20 percent failure rate. Even the first group, which was expected to be of lower quality because of production start up effects, was typical of the entire production run.

Again, the results in the last group were atypical. The float-freedom failures rose to 40 percent, double the incidence in the earlier groups, while bearing failures were drastically lower. The lower bearing failure rate for this last group could have been caused by a lower average operating time for that group. As in the Apollo I analysis, the average wheel hours per group were plotted. The result, shown in Figure 4-25, indicates that the wheel hours for Group 8 were lower than for the other groups. If this was the cause of the improvement in Group 8, bearing failure rather than operating hours, could result in the last group being the worst of Apollo II gyros.

FF = FLOAT FREEDOM
 FL = FLEX LEAD FAILURE
 ON CENTRIFUGE TESTING
 ELECTRIC - CAT II
 PF = PREDICTED FAILURE
 BEARING
 Δ ADIA

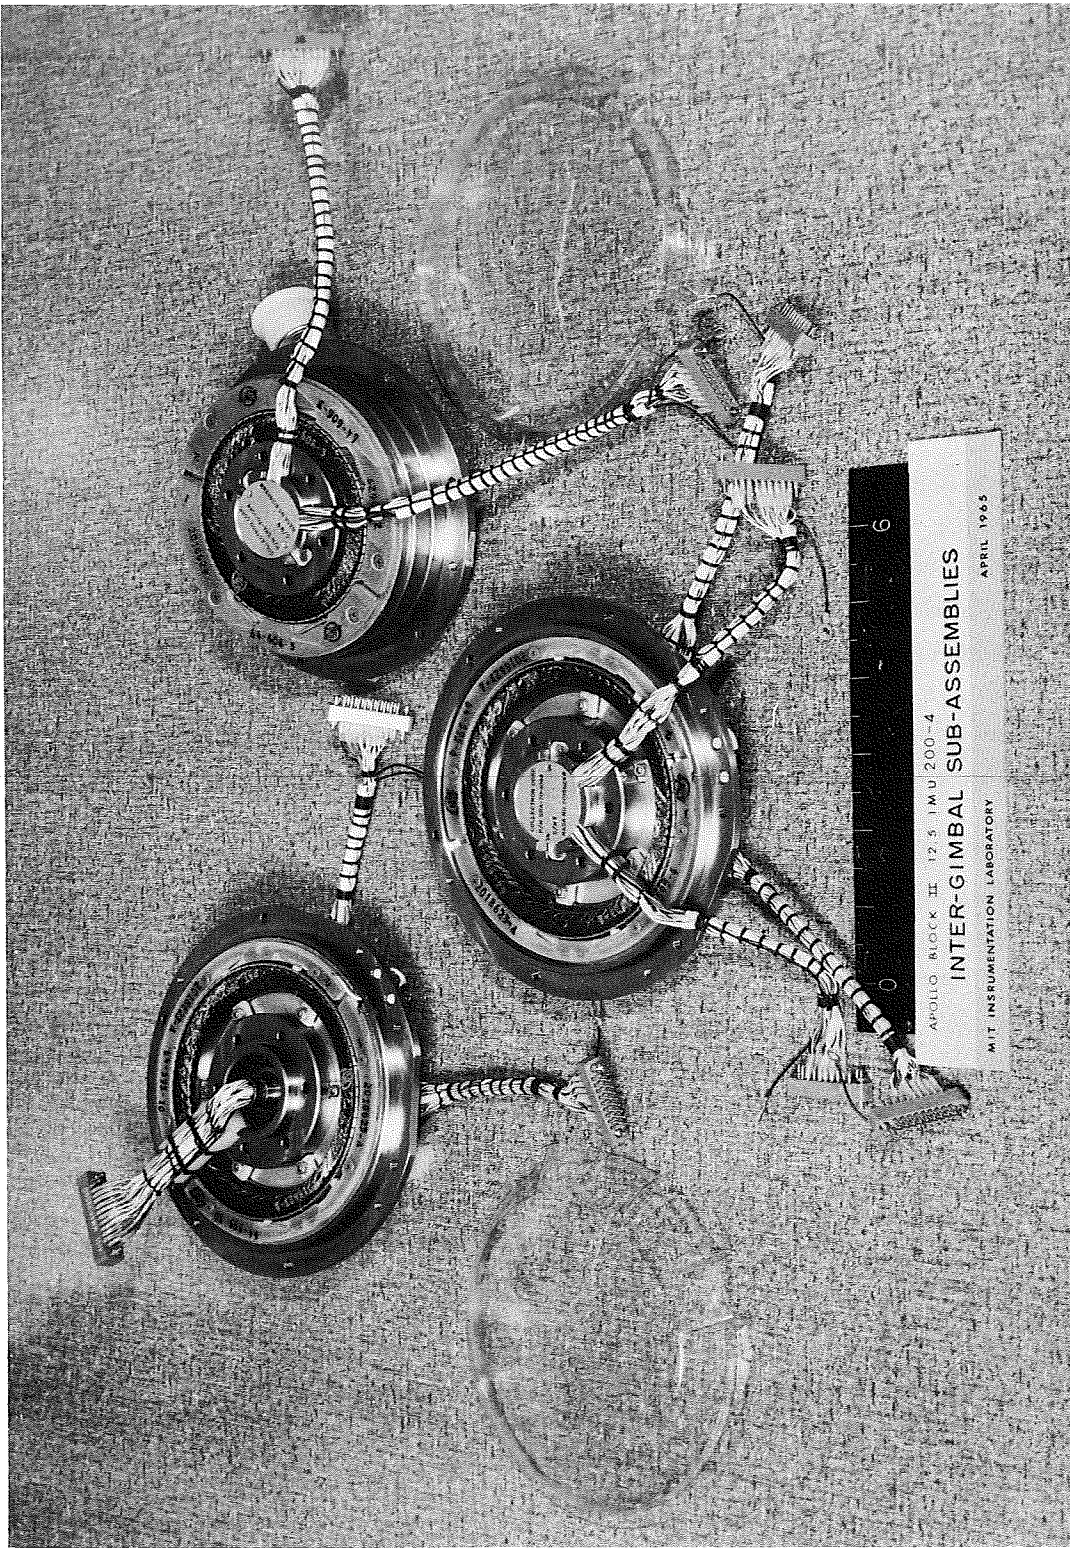
Fig. 4-26 Inter-Gimbal Sub-Assemblies

4.4.1.2 Components on the Inner Axis. The stable member was supported on the middle gimbal by a pair of preassembled inter-gimbal assemblies, one on each end of the axis. Figure 4-26 depicts typical inter-gimbal assemblies.

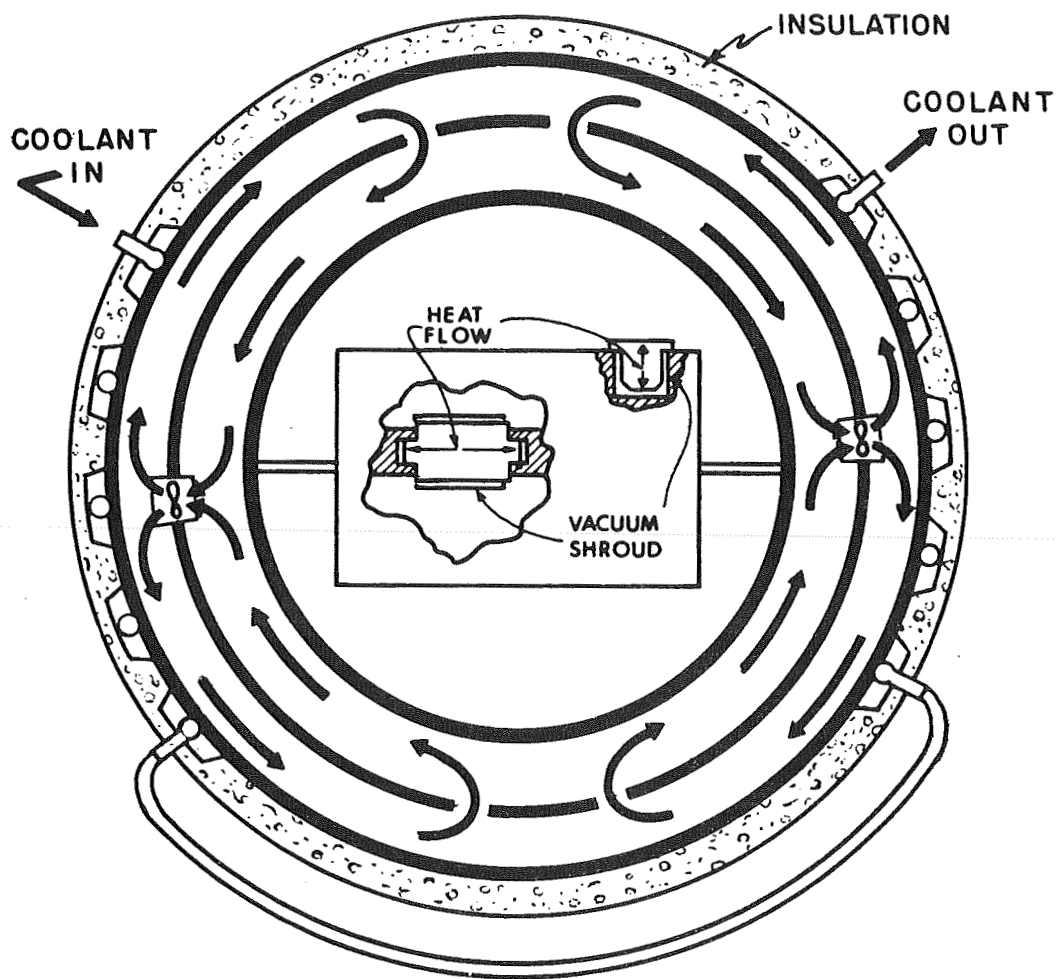
Fig. 4-27 IMU Heat Transfer Diagram

The use of thermal heat of fusion materials to serve as a heat reservoir was considered early in the design. This approach was taken to conserve electrical power. A thermal study, one of the first to define system operation for a lunar landing mission, showed that though this concept was sound, the use of these materials was unworkable based on IMU time line usage. This approach was abandoned and an electronic temperature control system was designed.

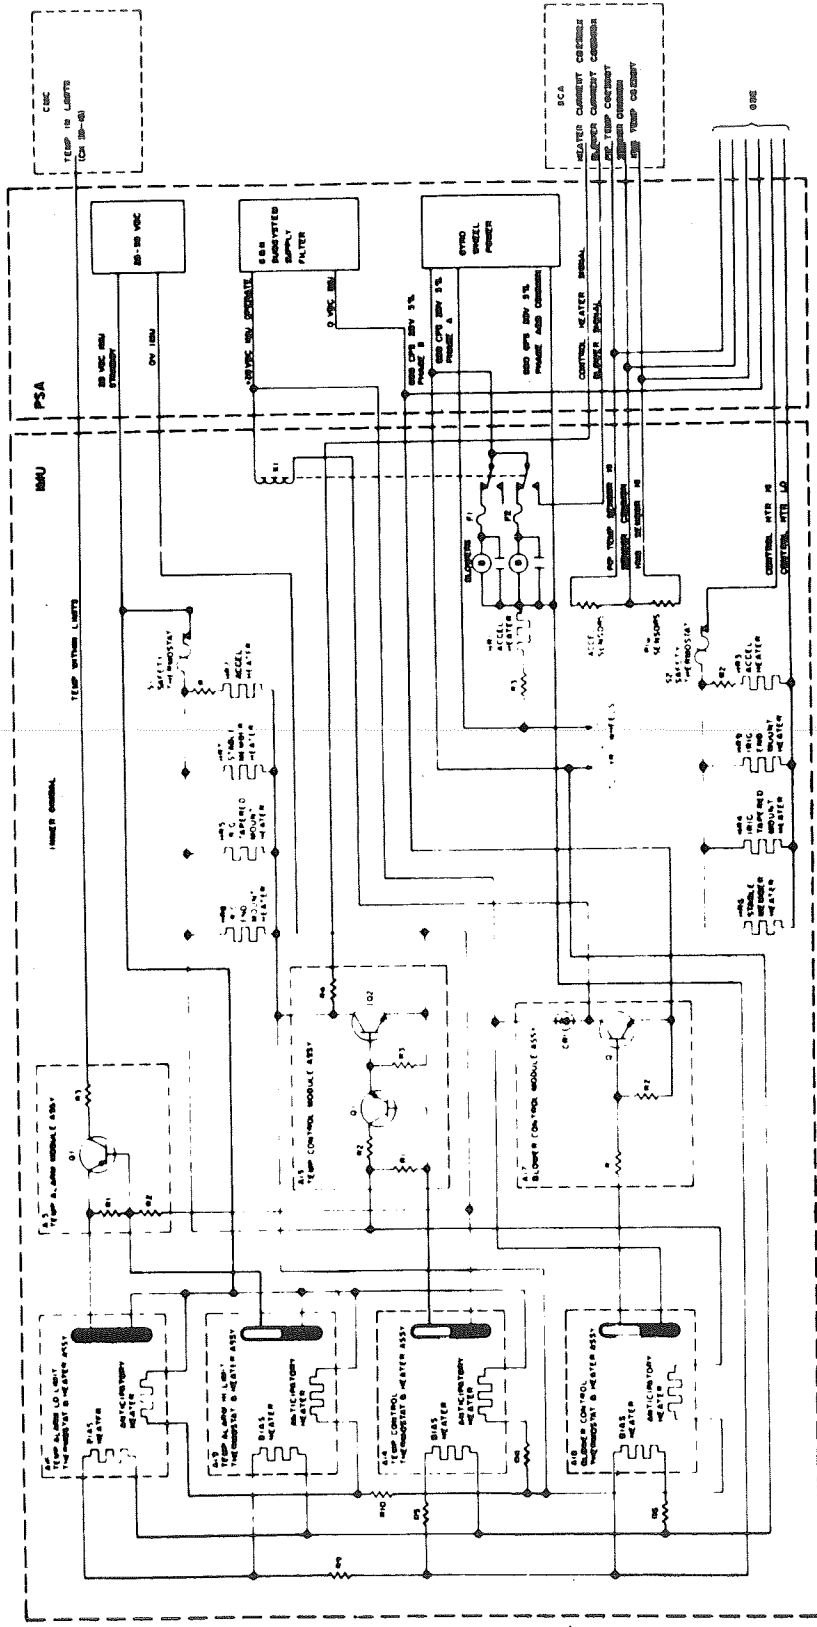
Fig. 4-28 Block II IMU Temperature Control System Schematic Design

Temperature control of the Block II was accomplished by using a mercury thermostat as the temperature sensing element in bistable temperature control system. Additional mercury thermostats were used to provide an out-of-limits temperature alarm indication and for control of the two blowers. A sensor of this type was used in the Block I IMU for emergency control. It proved to be accurate, stable, extremely reliable and had a very small dead band. Figure 4-28 is an electrical schematic diagram of the Block II temperature control system.

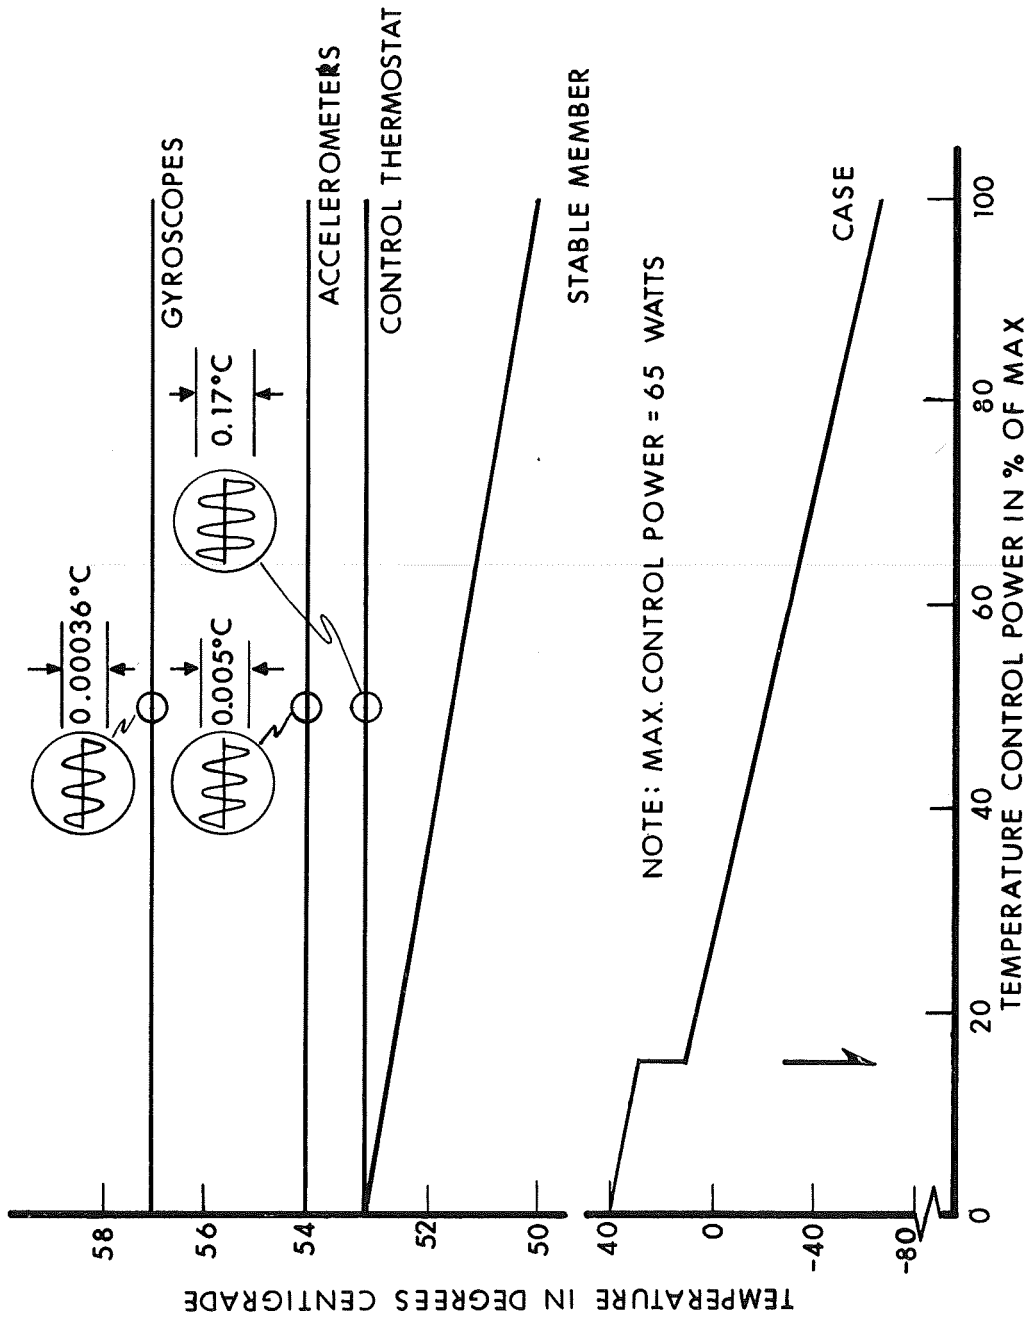
Fig. 4-29 IMU Temperature Profile vs Temperature Control Power

The performance characteristics of the temperature control system are shown in Fig. 4-29. The thermostat cycle of operation at 50% duty cycle was 0.3 while at the same time the gyroscope limit cycle was attenuated to 0.00065 degree F and that of the accelerometers to 0.009 degree F. The stable member temperature continued to drop as the control power was increased, as one might expect, but the inertial component temperature remained constant throughout the power range. The blower extended the dynamic range of operation, was infrequently used and was limit-cycled by a thermostat. There were two separate sensors to detect temperature extremes and alert the astronauts. In addition, high limit mechanical thermostats were used in every heater power line to prevent an over heated condition. These were set to open the heater power at a temperature of about 10°F over the normal control temperature. These were rarely used but when necessary prevented damage to valuable equipment.

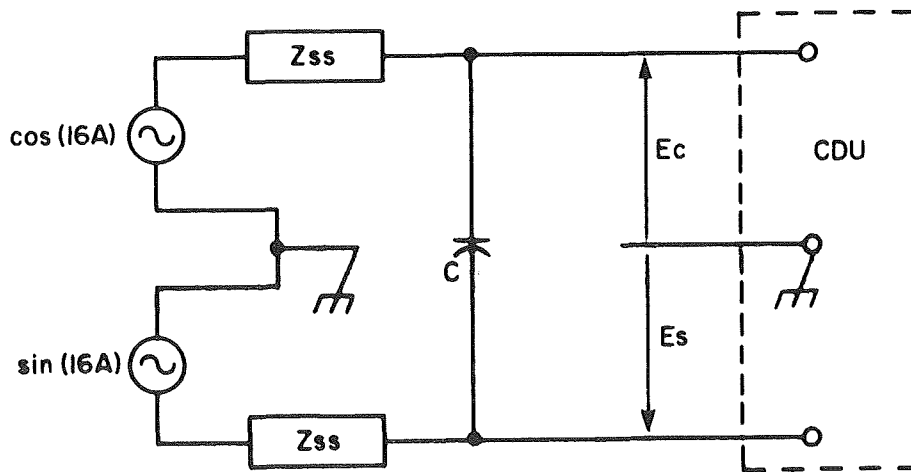
Fig. 4-30 Effects of Stray Capacitance

The principal problem in applying this resolver was attributed to the requirement imposed by the Block II CDU that the low side of the 16X sine and cosine winding be made common to ground. There was a distributed stray capacitance between the two secondary phases that caused a circulating current via the common low. A suitable equivalent circuit to illustrate the effects of the stray capacitance at 800 Hz is shown in Figure 4-30.

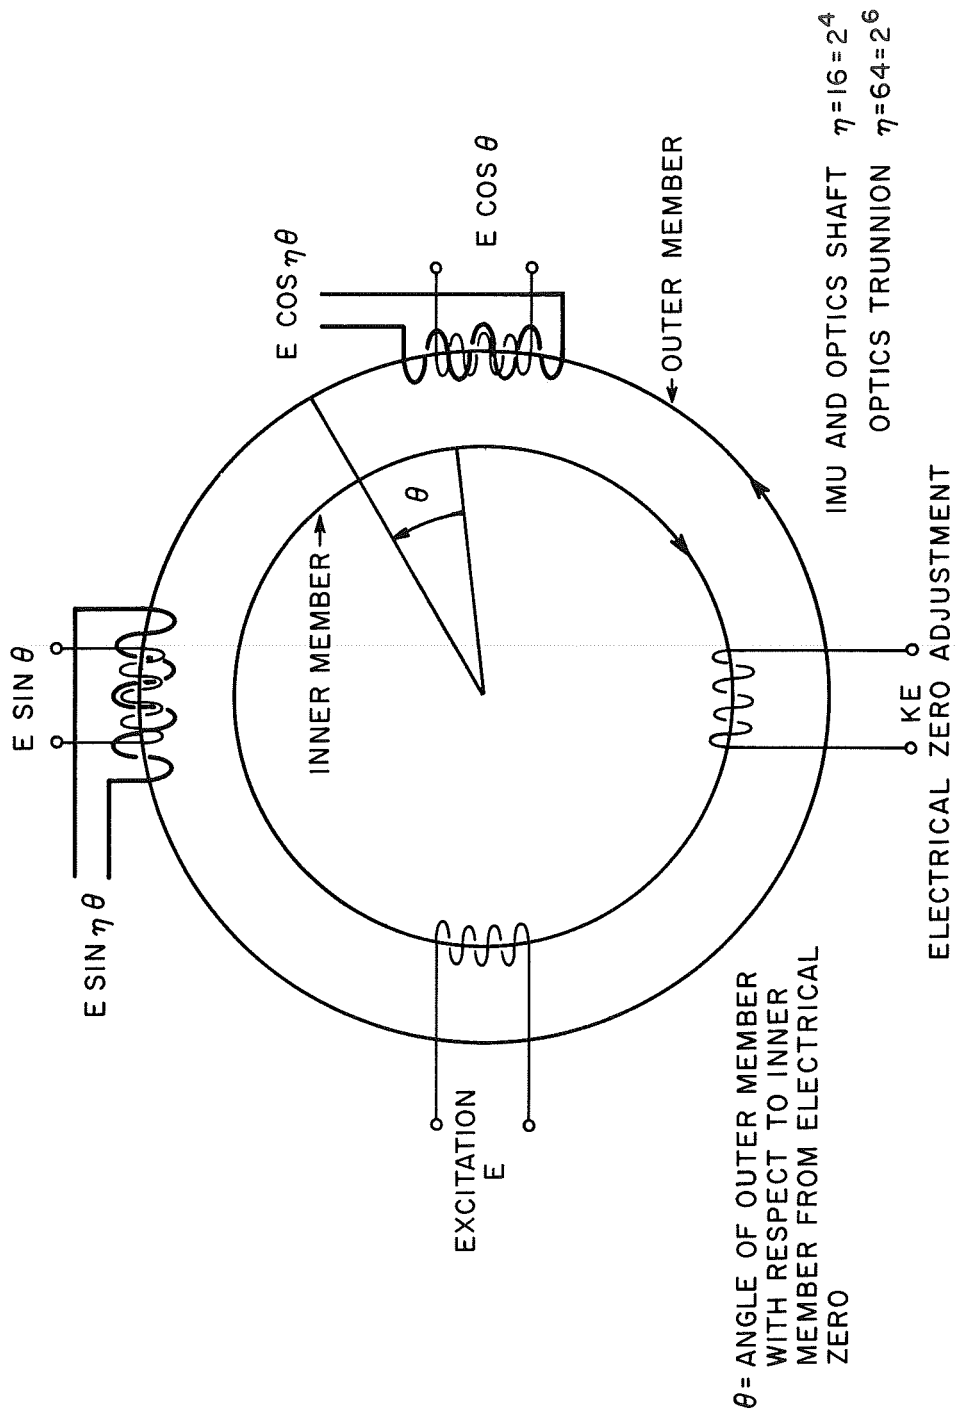
Fig. | 4-32 Resolver Schematic

Analog multiplication of the resolver $\sin \theta$ and $\cos \theta$ voltage was accomplished by the use of an ac operational amplifier with the ratio of the feedback resistor to the input resistor equal to the cosine of the angle ψ_1 . S was an ac transistorized switch gated closed or opened by contents of the angle counter resistor. The switch was in series with the feedback resistor to take advantage of the high impedance open condition and low impedance closed condition which made the impedance

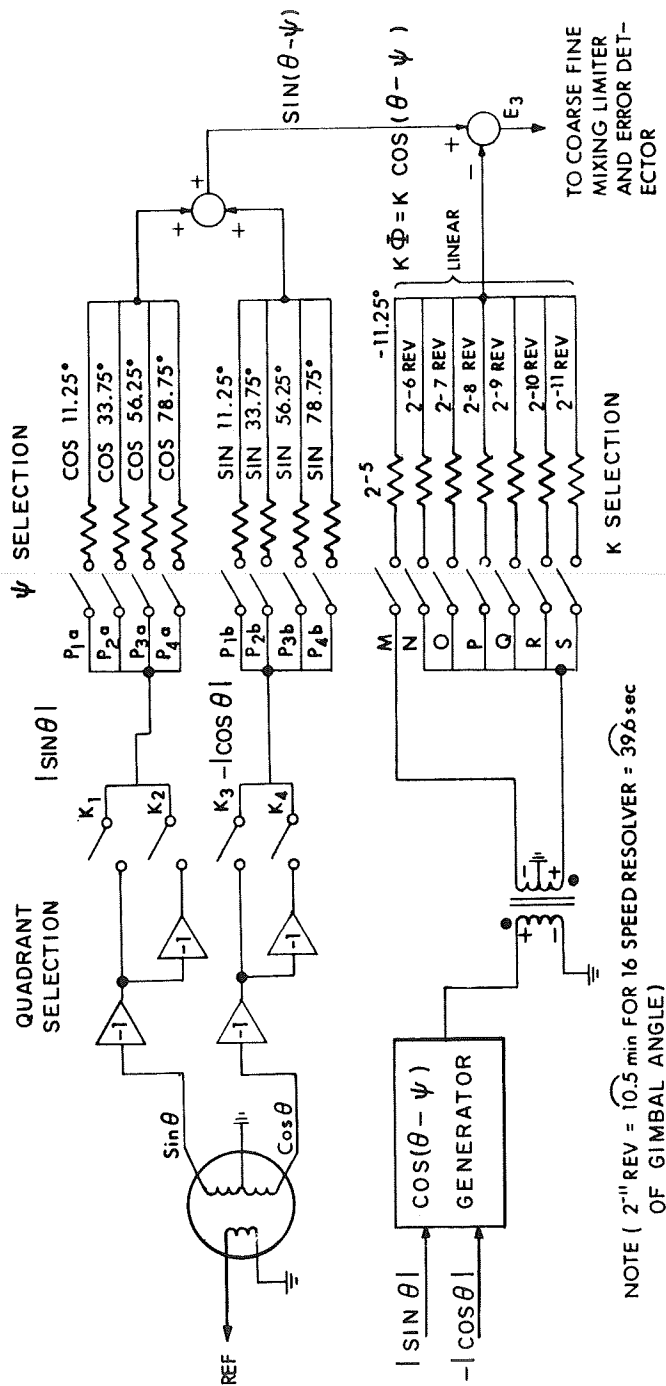
Fig. 4-33 Selection Logic - 16 Speed Resolver Digitizing Loop

As shown in Figure 4-33, this output was summed with a quantized linear interpolation of difference between $\sin (\theta - \psi)$ and θ . The selection of the quantized angle and the quantized linear interpolation angle ϕ , was based upon the contents of an angle counter register. The angle counter inputs were gated by the phase of the summed voltages. Thus when the contents of the counter were equal to the control member angle:

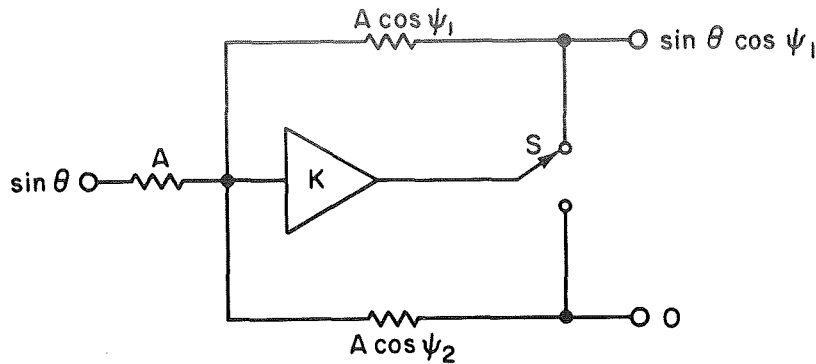
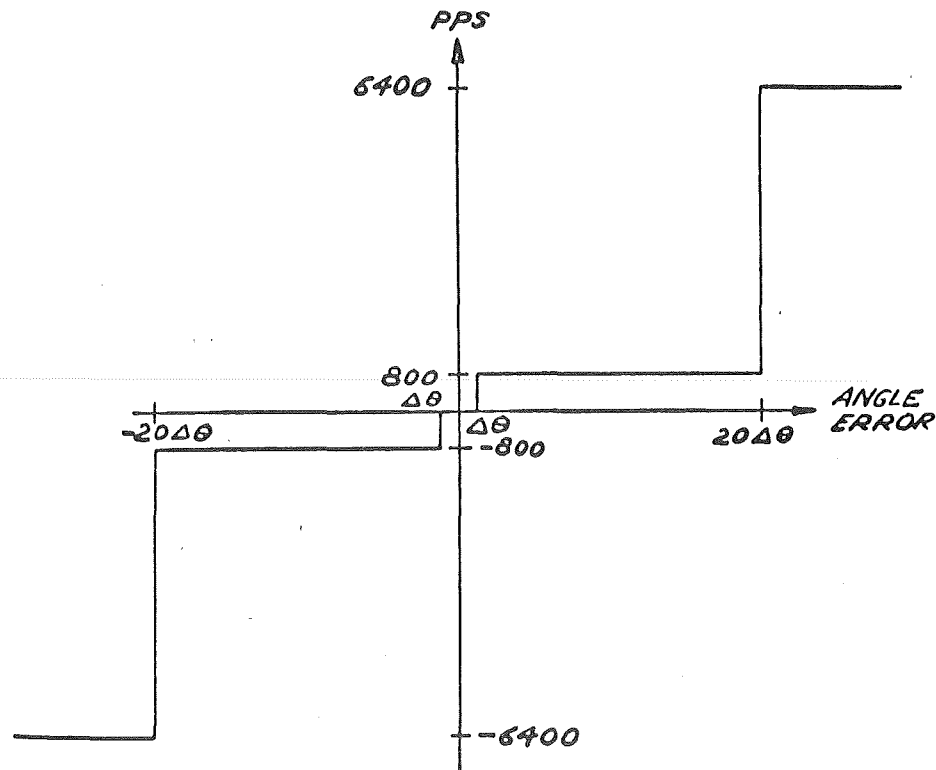
Fig. 4-34 Coarse-fine Mixing (1 and 16 Speed Resolver)

Referring to Figure 4-34, the input to the error detector was the sum of the single speed multiplication, the sixteen speed multiplication and the linear interpolation. There was a coarse-fine mixing network to assure synchronization and angle measurement using the precision resolver. The error detector contained an active feedback quadrature rejector network which for large error signals would not introduce dynamic errors for reading the angle, but for small errors

would yield the proper precision. The output of the error detector was fed to both the rate selection logic and up-down counter logic. The contents of the counter were used to control the ac switches for the multiplication of the resolver voltages and the linear interpolator.

The error detector had three-state or ternary logic. The lowest order pulse rate command to the counter was 800 pulses per second. Using this as the lowest order assured switching of equal multiples of the resolver carrier frequency, 800 Hz, which prevented rectification of the switched signal and altering of the dynamic operation of the read system.

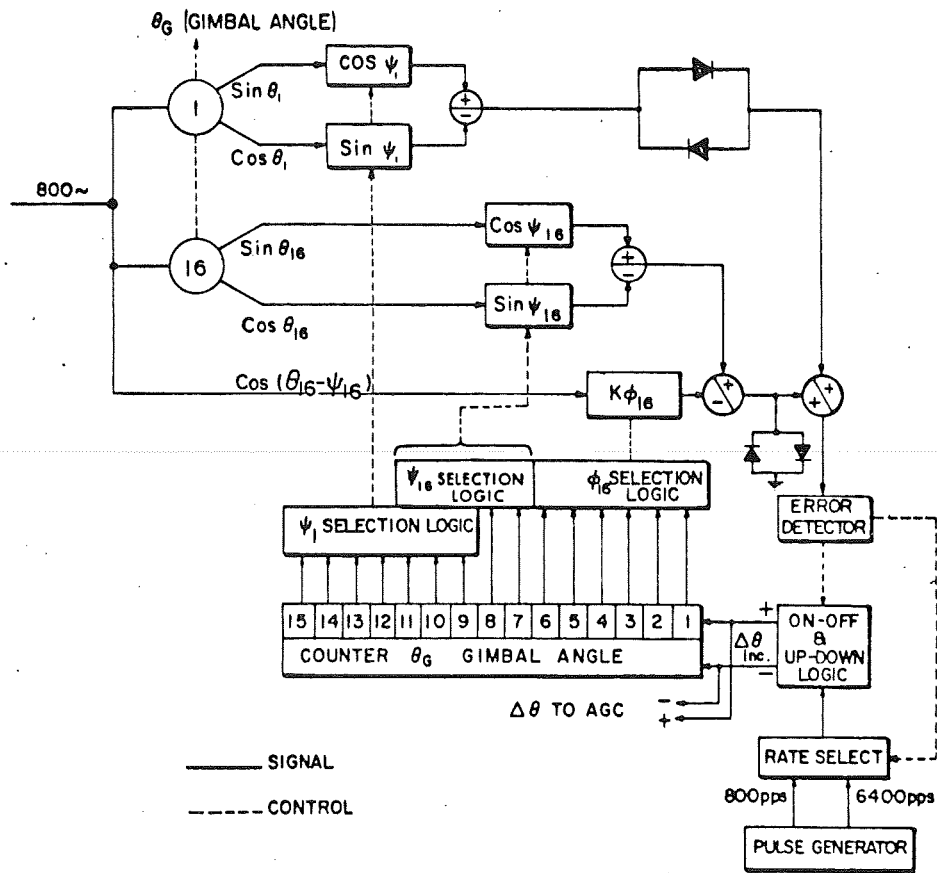
By suitably choosing K , the error for the speed resolver system could be reduced to less than 10 arcseconds. For a 64 speed system as used on the optics trunnion, this error was reduced to less than 3 arcseconds.

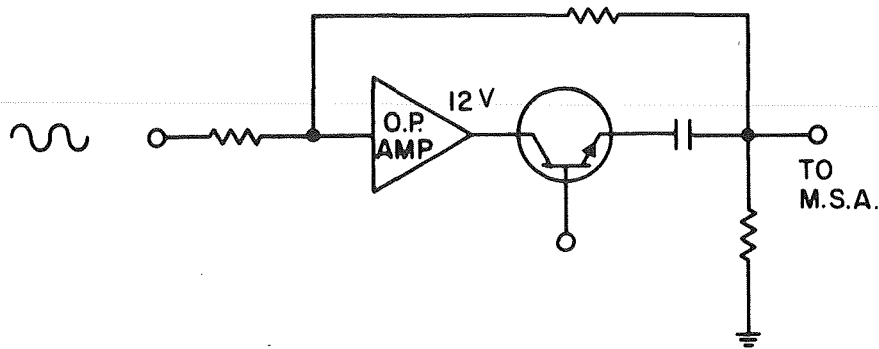
(2) The CDU contained capacitor-coupled transistor switches as shown. Immediately following power application or after long periods of inactivity, the dc charge that would normally accumulate on the capacitor would not be present or would have "leaked off."

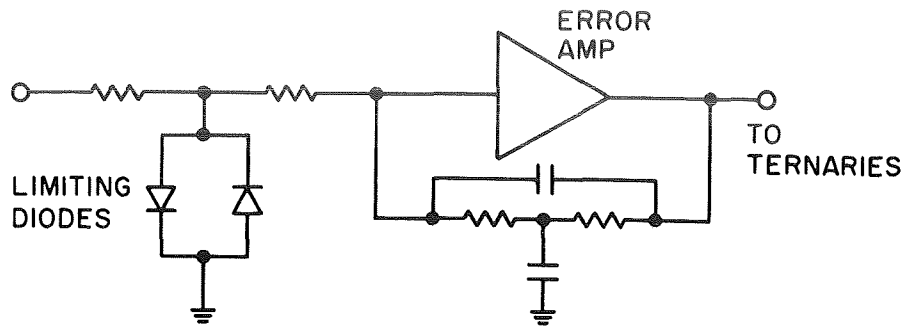
When switching action was initiated, the charging action of the coupling capacitor in conjunction with the frequency response of the operational amplifier would create a low frequency "bounce" on the output of the switch. The cumulative effect of several switches being activated during coarse alignment of the IMU would cause the input limiting diodes of the error amplifier to be driven into the active region and effectively short out the ac error signal to the amplifier. See following illustration.

With the loss of this error signal, the read counter would not increment and the feedback pulses to the DAC error counter would not be present. The AGC would "load" the DAC error counter to perform the coarse alignment, and in the absence of the feedback pulses to subtract the "loaded" angle, when the gimbals moved, the error counter would overflow on subsequent computer commands producing a loss of information to the CDU and a failure to achieve the commanded CDU angle.

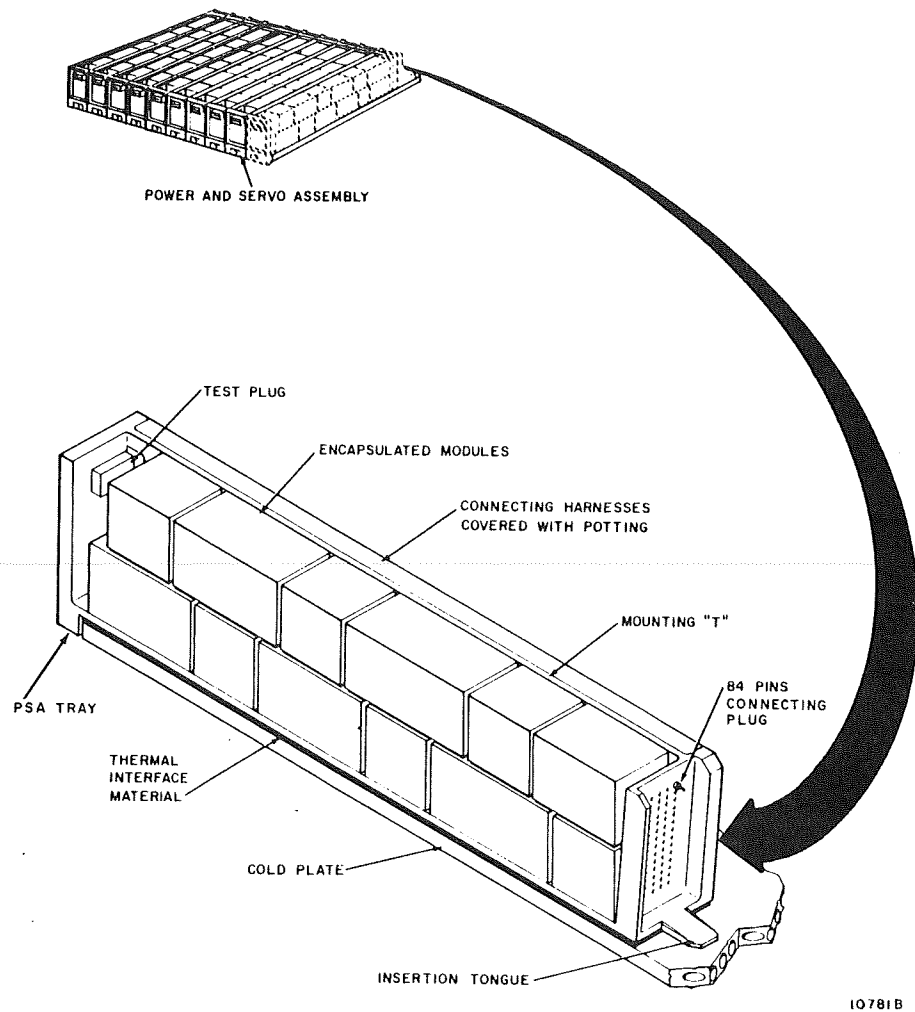
Fig. 4-35 Power and Servo Assembly

The CDU for Block II and LM contained two separate header assemblies. The long modules mounted across the width and bolted into the header. The two headers were bolted together with modules back to back. A gasket between the

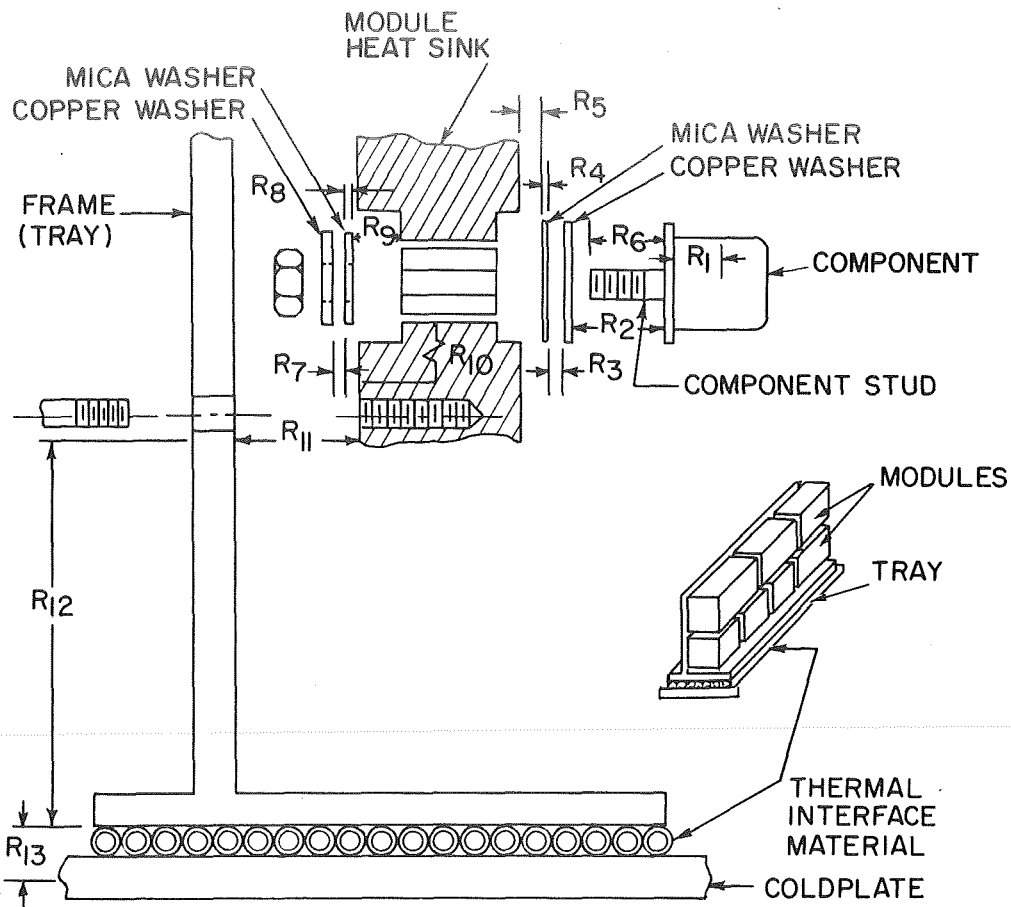
Figure 4-36 shows a typical component mounting method and the resistances considered in the thermal analog. A nodal network was written for each tray, which included spreading within the tray down to the coolant. Solving this network gave the component temperature. For high component reliability, junction of silicon devices were not allowed to exceed 105°C. These measures insured control of the interface temperature at the tray base with NAA to not exceed certain temperature limits. These limits varied from 90°F to 120°F for the ten trays that comprised the Block I PSA.

- R_1 JUNCTION TO CASE THERMAL RESISTANCE
- R_2 - R_9 SERIES/PARALLEL RESISTANCES THAT MAKE UP THE CASE TO HEAT SINK THERMAL RESISTANCE
- R_{10} RESISTANCE THRU HEAT SINK
- R_{11} HEAT SINK TO TRAY CONTACT THERMAL RESISTANCE
- R_{12} THERMAL RESISTANCE THRU TRAY
- R_{13} TRAY TO COLDPLATE THERMAL RESISTANCE

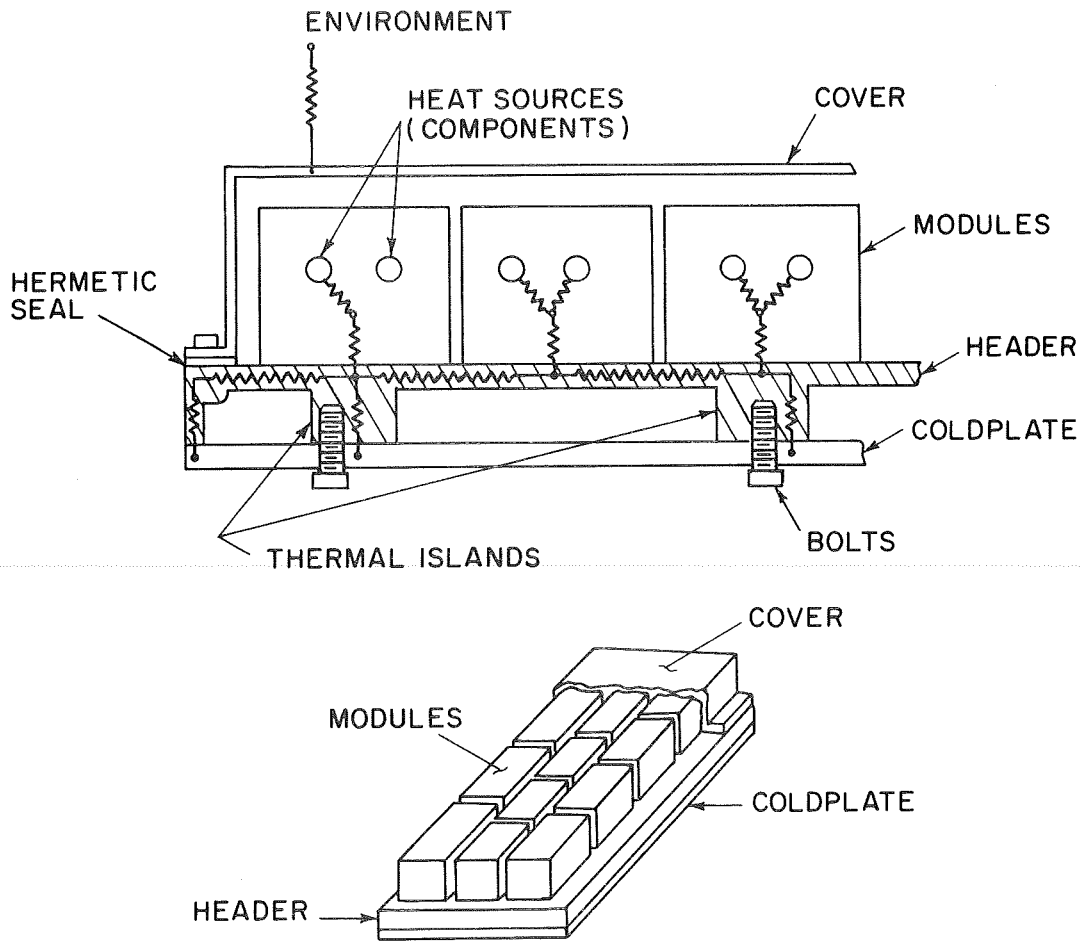
Fig. 4-37 Typical Block II Packaging

4.6.9.3 Block II Thermal Design. The Block II thermal design had the modules mounted directly to a header which in turn was mounted to the coldplate. Figure 4-37 shows the typical packaging arrangement used and the heat flow paths from components in the modules to the coldplate. Header contact with the coldplate was through thermal islands. The cutaway material between islands was used for module-to-module interconnecting wire runs and power lines as well as for weight reduction. Sizing of the islands was based on a heat density not to have exceeded 3 Watt/in.² in order not to have excessive ΔT 's into the coolant from the header so that high coolant inlet temperatures could be used.

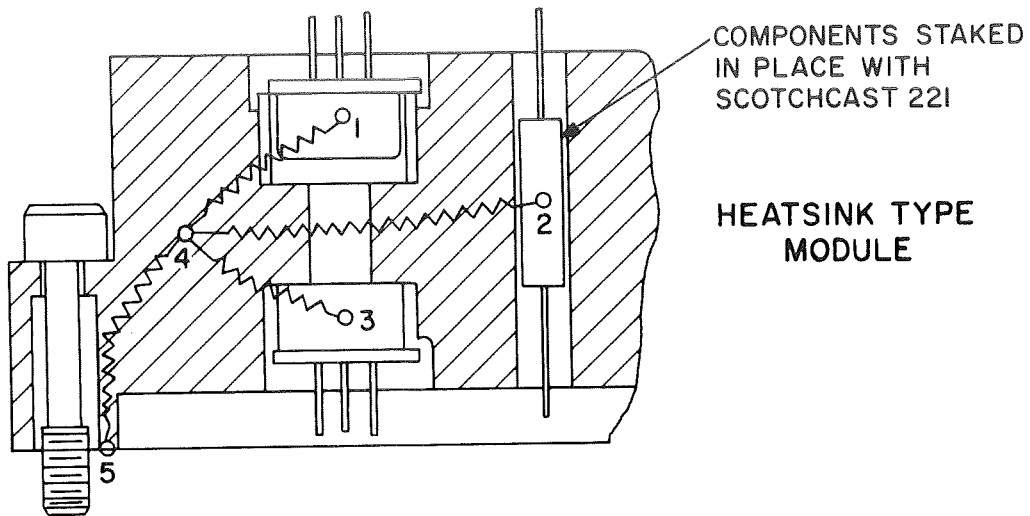
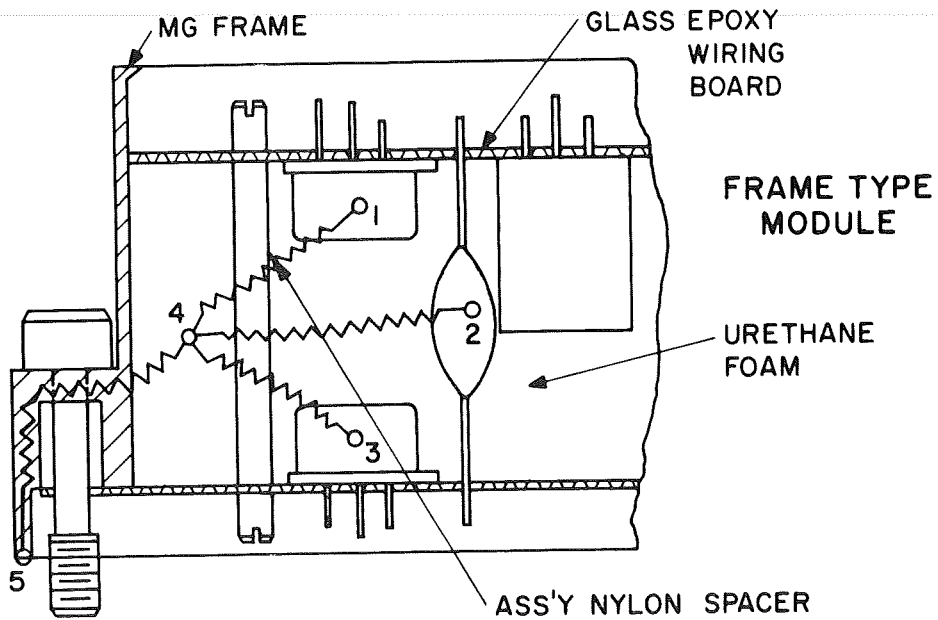
$R_{1-4}, R_{2-4}, R_{3-4}$ COMPONENT TO HEAT SINK RESISTANCE PATHS.
 R_{4-5} THERMAL RESISTANCE THRU HEATSINK.

Fig. 4-38 Typical Module Packaging

Module packaging is shown in Figure 4-38. Two different modules were used: a metal heat sink type to package high power dissipating components, and an open frame type for low power dissipating components. For equal volumes, the open frame type was considerably lighter, but the thermal resistance through foam was two orders of magnitude greater than that of a metal heat sink.

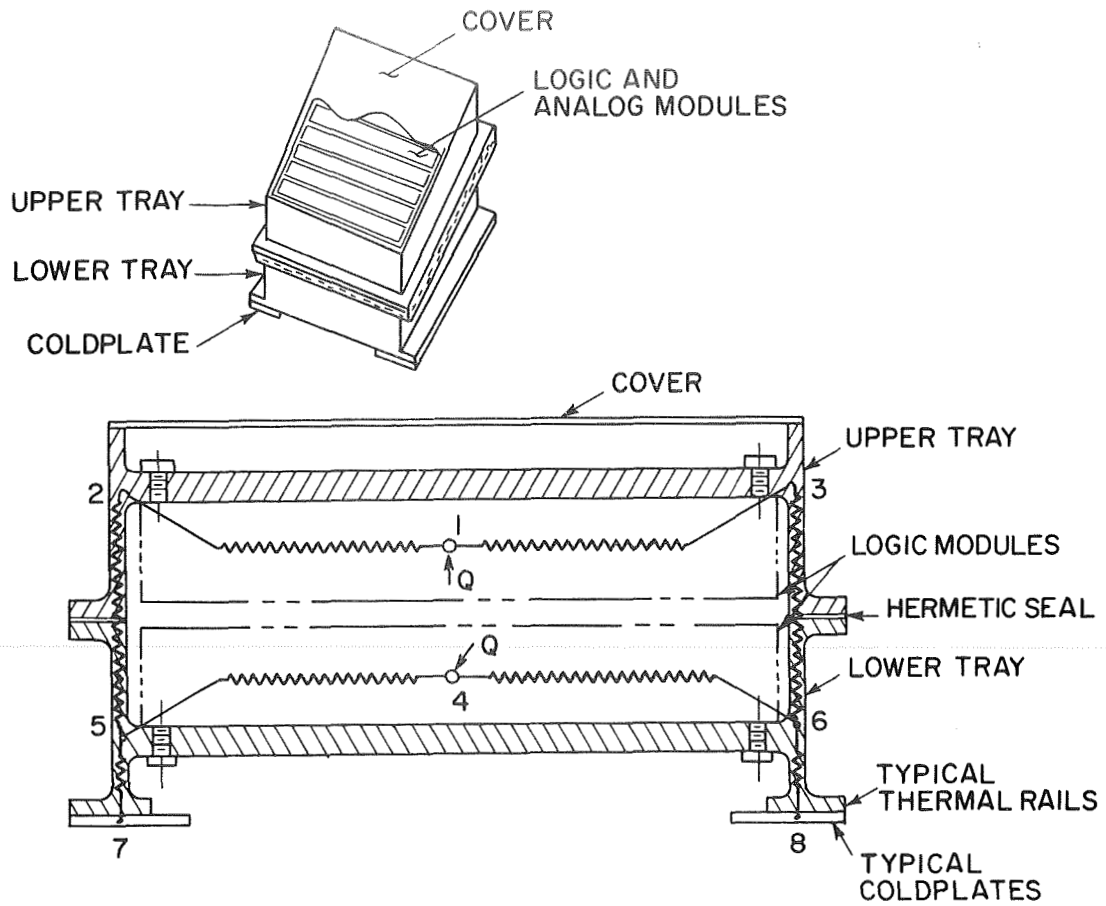
- R_{1-2}, R_{1-3} RESISTANCE FROM LOGIC ELEMENT JUNCTION
- R_{4-5}, R_{4-6} TO TRAYS
- R_{2-5}, R_{3-6} INTER-TRAY RESISTANCE
- R_{5-7}, R_{6-8} RESISTANCE FROM TRAY THERMAL RAILS TO COLDPLATE

Fig. 4-39 CDU Packaging

4.6.9.4 CDU Thermal Design. The CDU heat flow paths are shown in Figure 4-39. This design had two tiers of logic and analog modules. The heat flows from each module into the trays, down to the thermal rails and into the coldplate.

A thermal analog was assembled that coupled the modules and trays to the coldplate and local thermal environment. The indications were that the thermal rail temperature was not to exceed 110^oF if the logic element junction of 158^oF (70^oC) was not to be exceeded.
