DESIGN SURVEY OF THE APOLLO INERTIAL SUBSYSTEM

Edited by
William A. Stameris

MARCH 1970

CHARLES STARK DRAPER LABORATORY

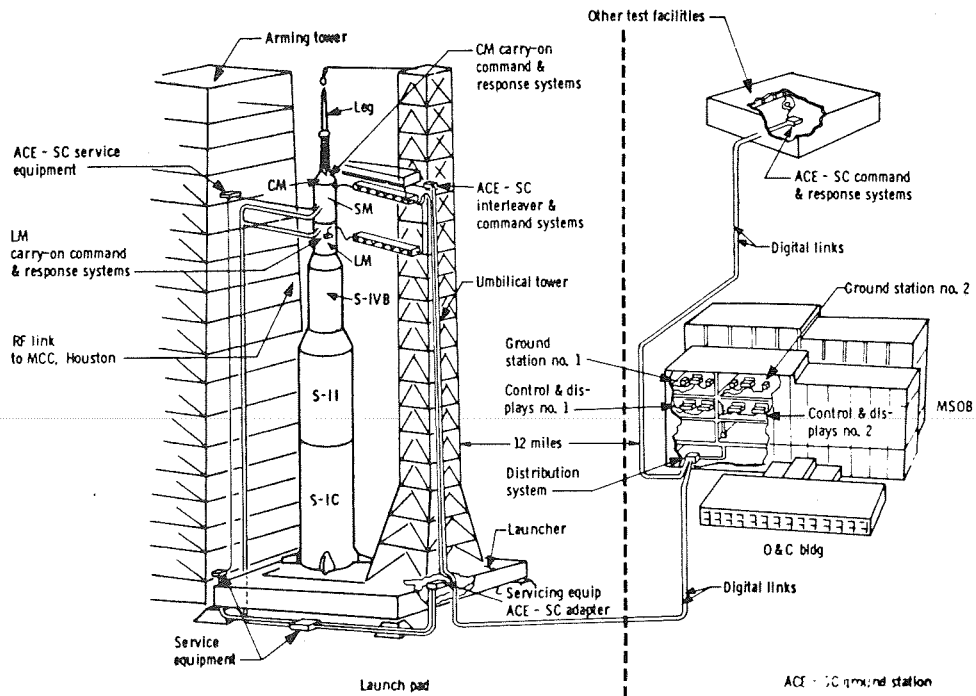
Fig. 5-1 Apollo Prelaunch Operations

The control room for the spacecraft checkout and launch was located twelve miles from the launch site in the MSOB (Manned Spacecraft Operations Building Figure 5-1). In the control room, the serial digital data from the spacecraft was processed by the ACE (Acceptance Checkout Equipment) computers which in turn displayed the information to the test engineers as meter and oscillograph readings, event lights or CRT (cathode ray tube) displays. In addition to standard data the telemetry transmitted from the flight computer to the ground was processed to produce a CRT display analogous to the onboard DSKY display that the astronauts were monitoring. The K-START (Keyboard Sequence to Activate Random Testing) command system duplicated the keyboard section of the onboard computer DSKY. The keyboard entry was paralleled with a tape reader allowing for automatic, rapid, error-free command sequences from the control room to the onboard computer.

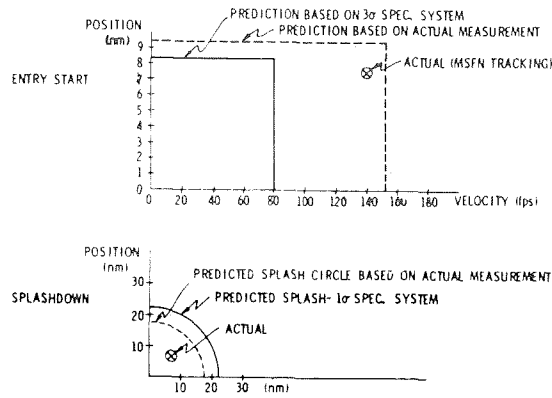
Fig. 5-2 Comparison of Predicted and Actual Entry Errors on Apollo 4

error analysis for each mission. For all missions except Apollo 5, the segmented mission phase approach to error analysis using a linearization technique was entirely adequate and was pursued. An error analysis was conducted using both the specification values, as well as the demonstrated values, for the GN& C system. A comparison of specification, actual ground measurement, and flight results for selected mission phases is presented in the following table and Figures 5-2 through 5-6.

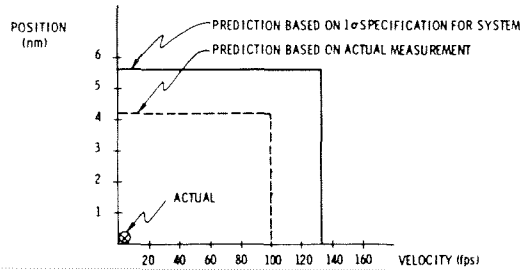
Fig. 5-3 Comparison of Predicted and Actual SIVB Cutoff Errors on Apollo 5

The unmanned Apollo 5 flight was such that known initial conditions for each thrusting phase were not available. As the system guided the vehicle based upon its actual set of initial conditions, the guidance errors could not be treated with linearized perturbations. The resulting position and velocity errors became more nonlinear as the mission progressed. The mission was scheduled for nine earth orbits, and the small-angle assumptions usually used with gyro drift were no longer applicable. The only solution was to conduct a large number of Monte Carlo error analyses of the complete mission.

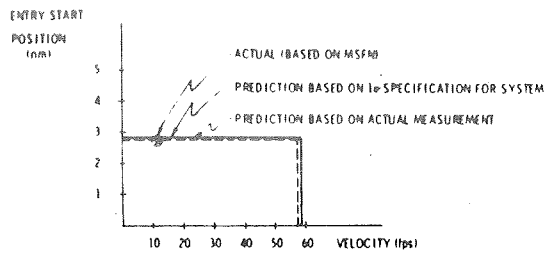
Fig. 5-4 Comparison of Predicted and Actual Apollo 6 Entry Errors

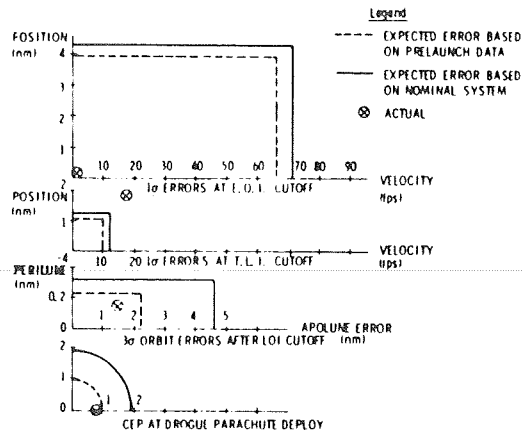
Fig. 5-5 Comparison of Apollo 8 Predicted and Actual System Errors

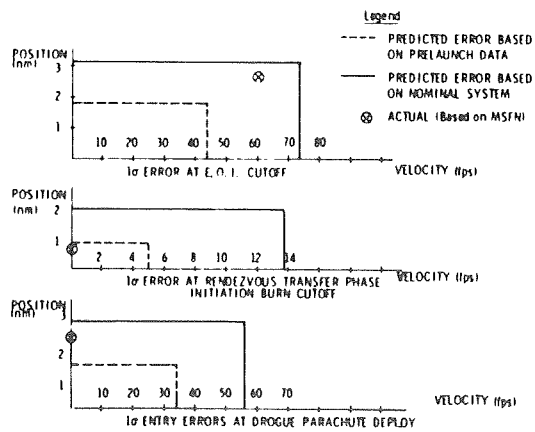
Fig. 5-6 Comparison of Apollo 7 Predicted and Actual System Errors

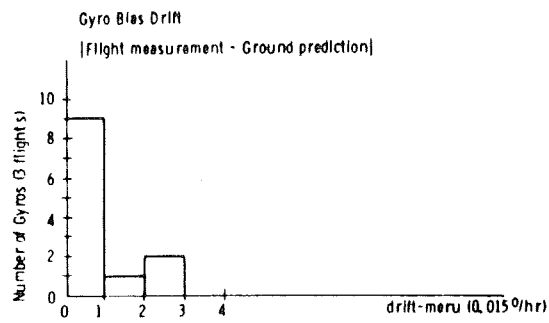
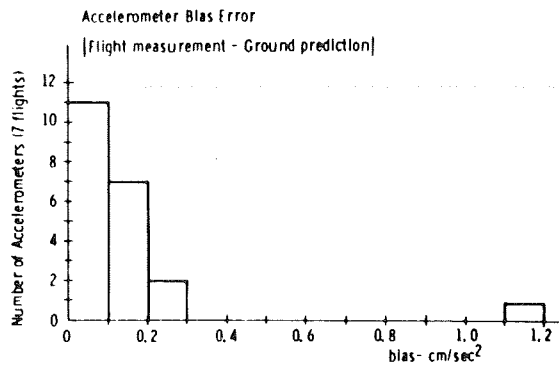
Fig. 5-7 Gyro Bias Drift (NBD) and Accelerometer Bias Flight Data

Onboard measurements to date have indicated excellent performance. The only onboard measurement available for the unmanned missions (Apollo 4, 5, 6) was accelerometer output at zero gravity (a_p). The manned missions also included inertial platform drift at zero gravity (NBD). The inertial component data are presented in the following table and in Figure 5-7.

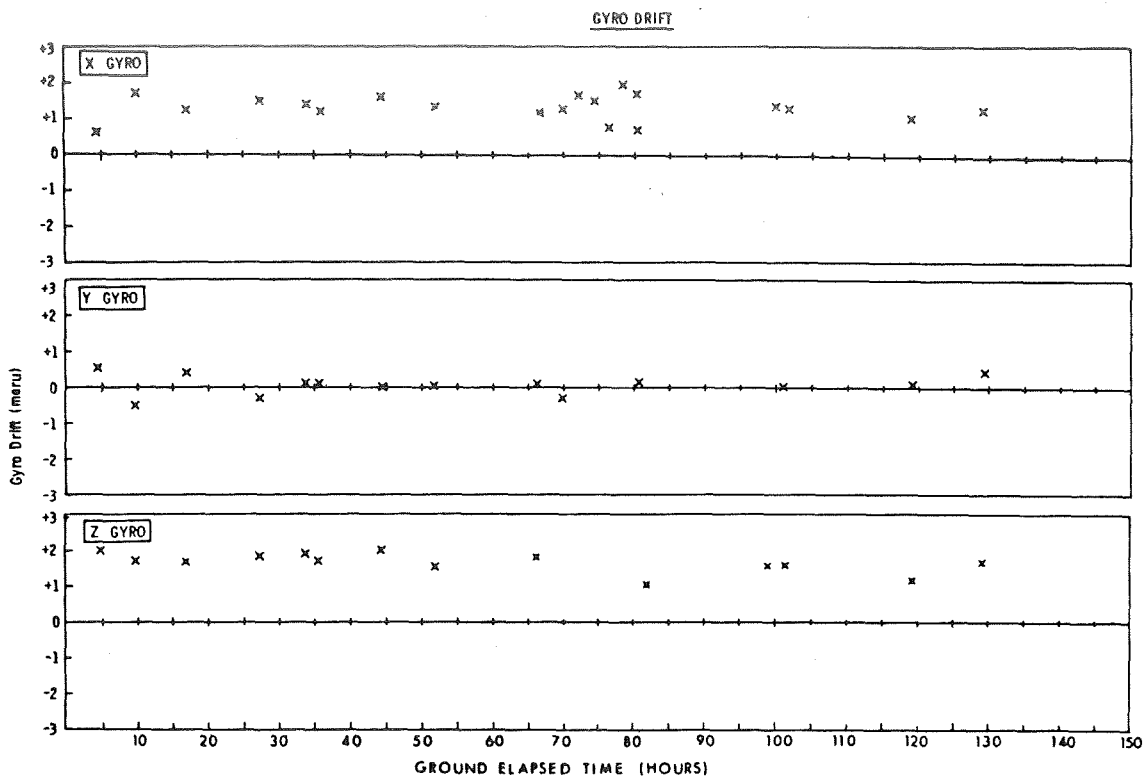
Fig. 5-8 Gyro Drift

Figure 5-8 shows the monitoring of the IMU over a long period of continuous operation. The data indicate that stability of inertial operation was achieved in the design. The entire component data history is presented in Figures 5-8 and 5-9.

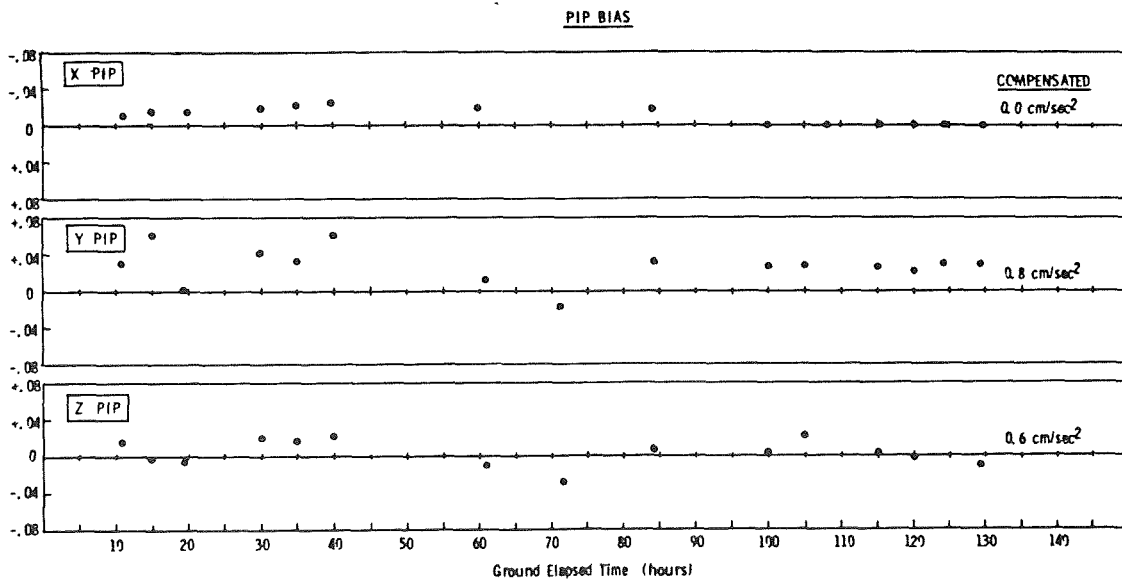
Fig. 5-9 PIP Bias
