MPR-SAT-FE-74-1

SATURN IB LAUNCH VEHICLE FLIGHT EVALUATION REPORT-SA-208

SKYLAB-4

The Saturn IB, SA-208 Launch Vehicle was launched on November 16, 1973 from Kennedy Space Center and placed the Command and Service Module containing three crew members into an 150.10 x 227.08 km altitude earth orbit. No anomalies occurred that seriously affected the mission.

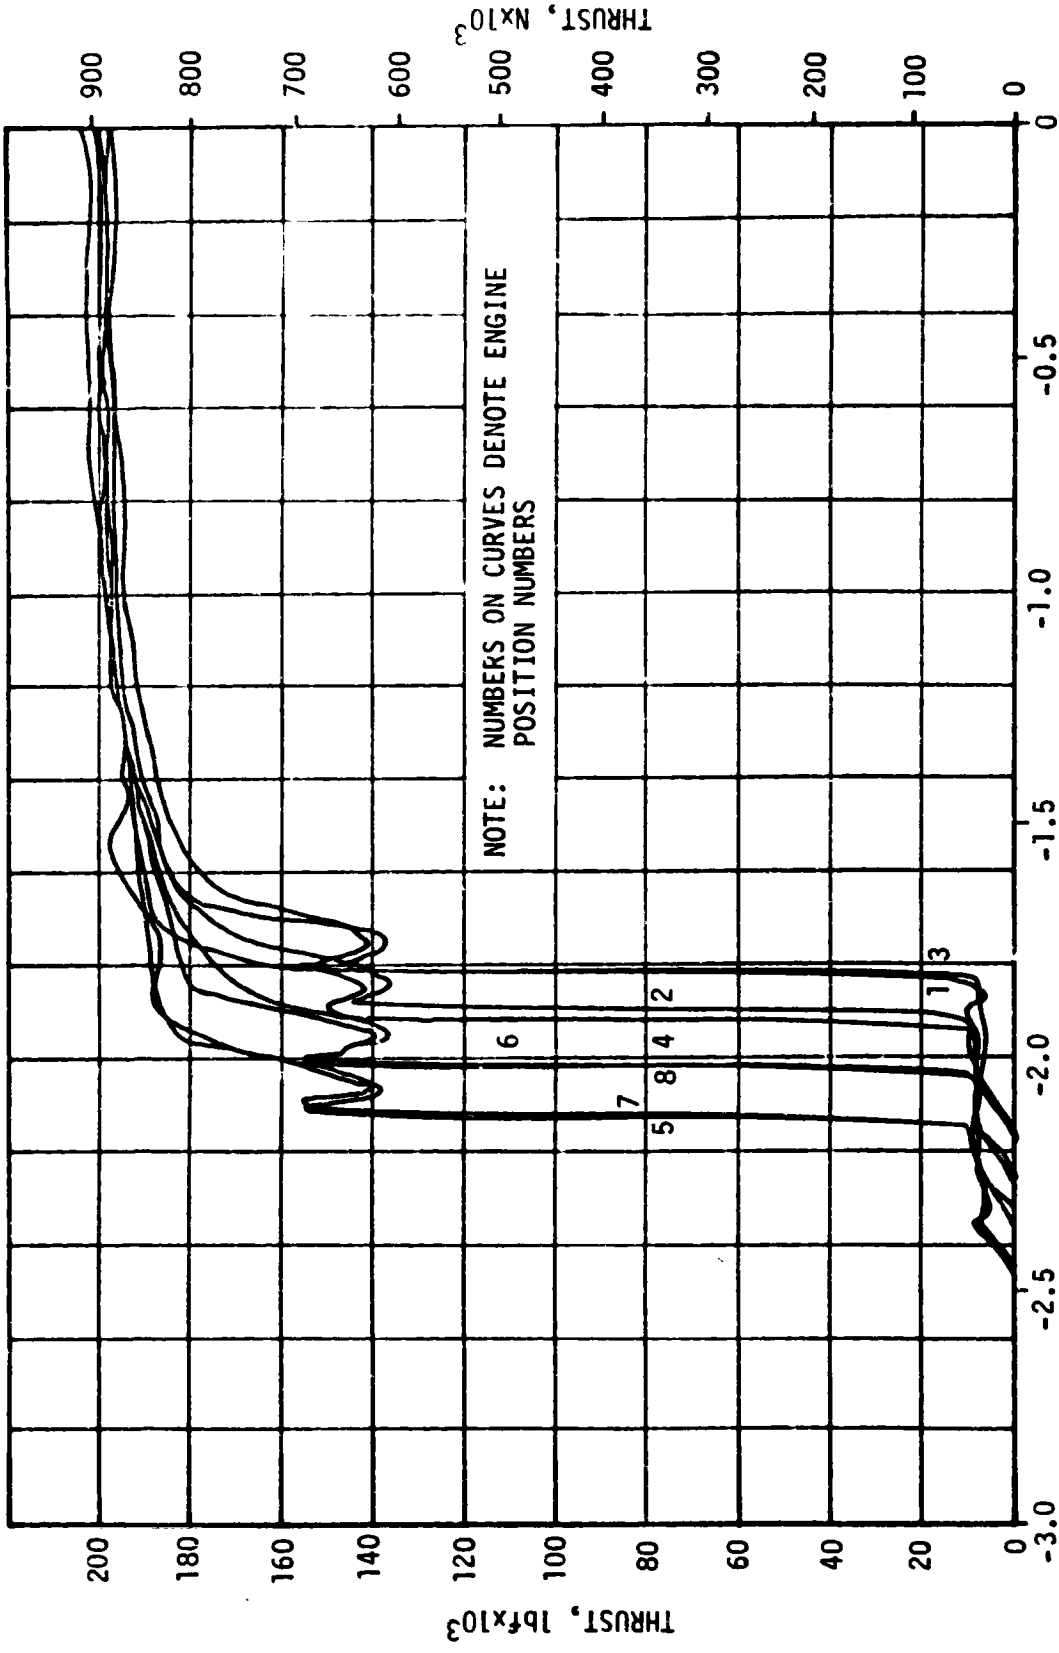
Figure 6-1. S-IB Engine Thrust Buildup

Early IEEO (0.16 seconds earlier than predicted) and late OEEO (0.31 seconds later than predicted) were primarily the result of a greater than predicted level difference between the outboard LOX tank number 2 (O-2), which signalled level sensor actuation and the other four tanks, particularly, the center tank. The lower than predicted level in the O-2 tank caused less LOX to be consumed by the inboard engines before

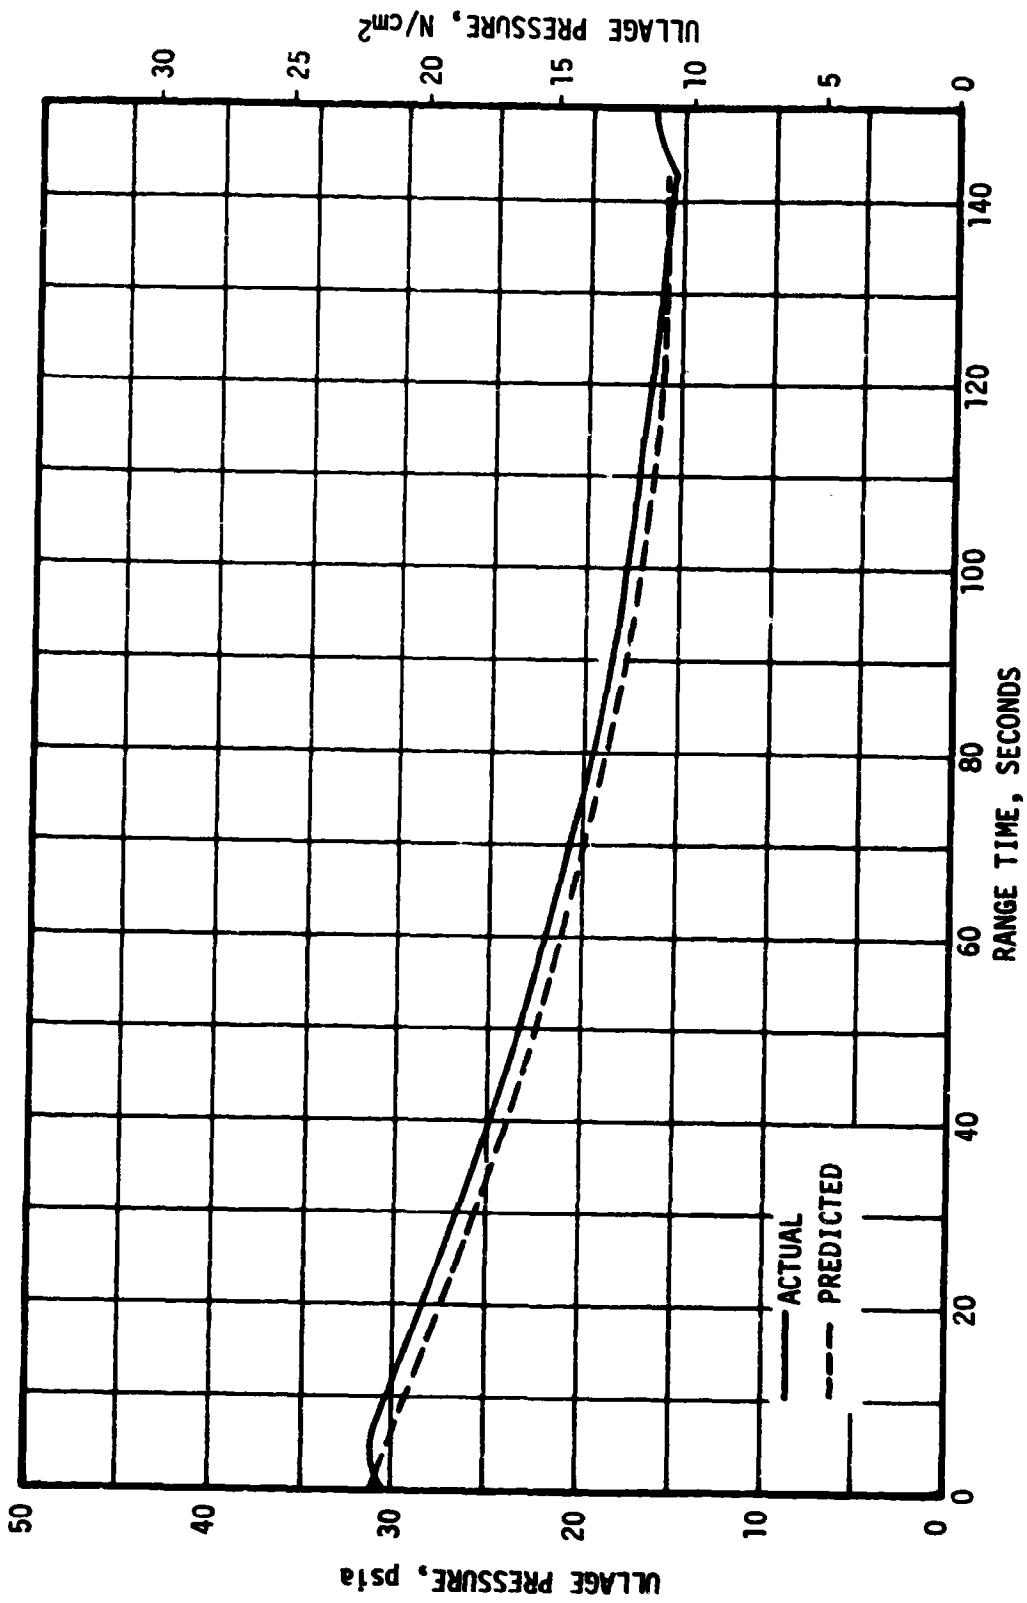
Figure 6-9. S-1B Fuel Tank Ullage Pressure

Tank pressurization began at T-159.86 seconds. The 1527-gallon (3.61 percent) ullage volume was pressurized to 32.2 psia in 2.43 seconds. Due to the ullage cooling, the pressurization valves opened again at T-135.73 seconds for a period of 0.23 seconds to repressurize the fuel tank ullage. This is about 15 seconds earlier than in previous flights and results from the increased ullage pressure decay rate due to fuel vent and relief valve

pilot valve leakage, and from the tighter operating band on the pressure switch.

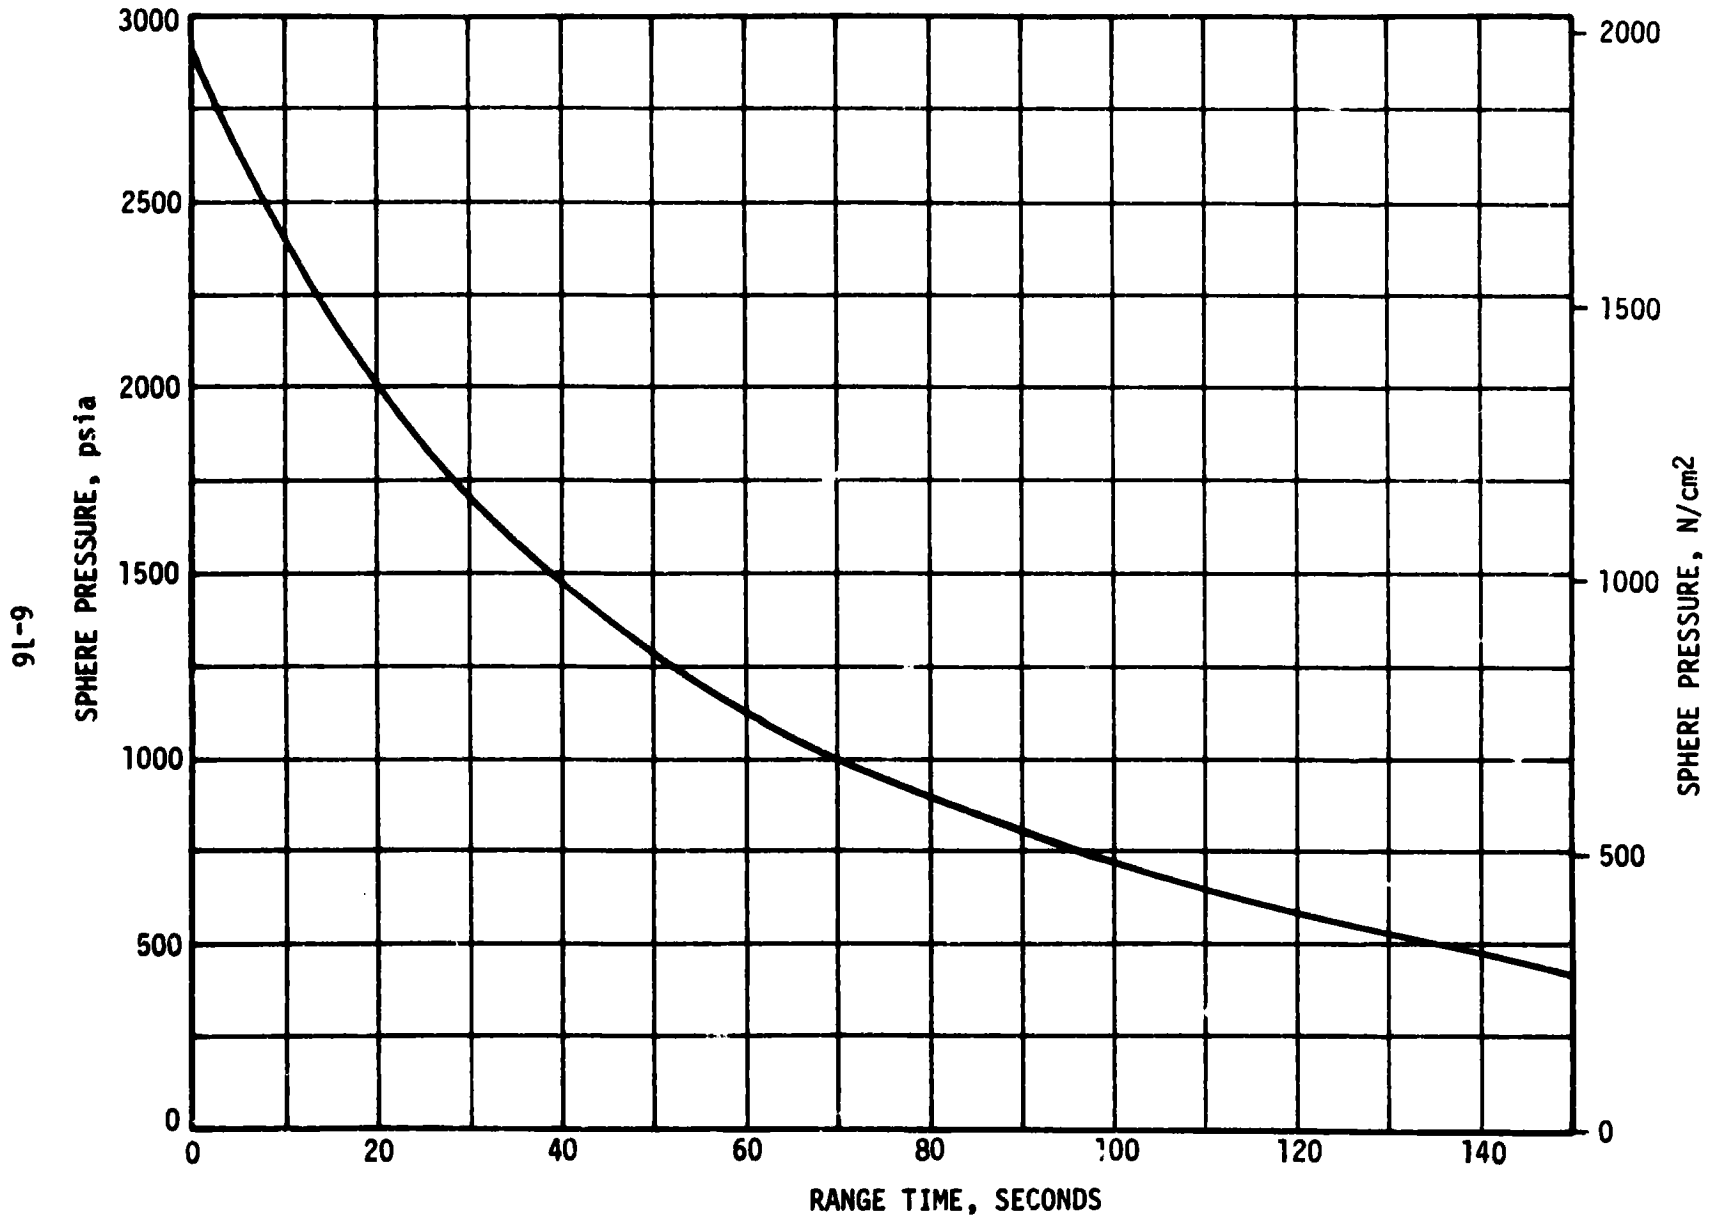
Figure 6-10. S-1B Fuel Tank Helium Pressurization Sphere Pressure

With the additional 18 seconds for ullage decay, the pressure switch cycled 6 times prior to ignition, which is 3 more than S-IB-7. The switch actuated at approximately 57.7 psia and deactuated at 56.2 psia, which is within the switch limits. The bypass orifice flow was initiated at T-2.387

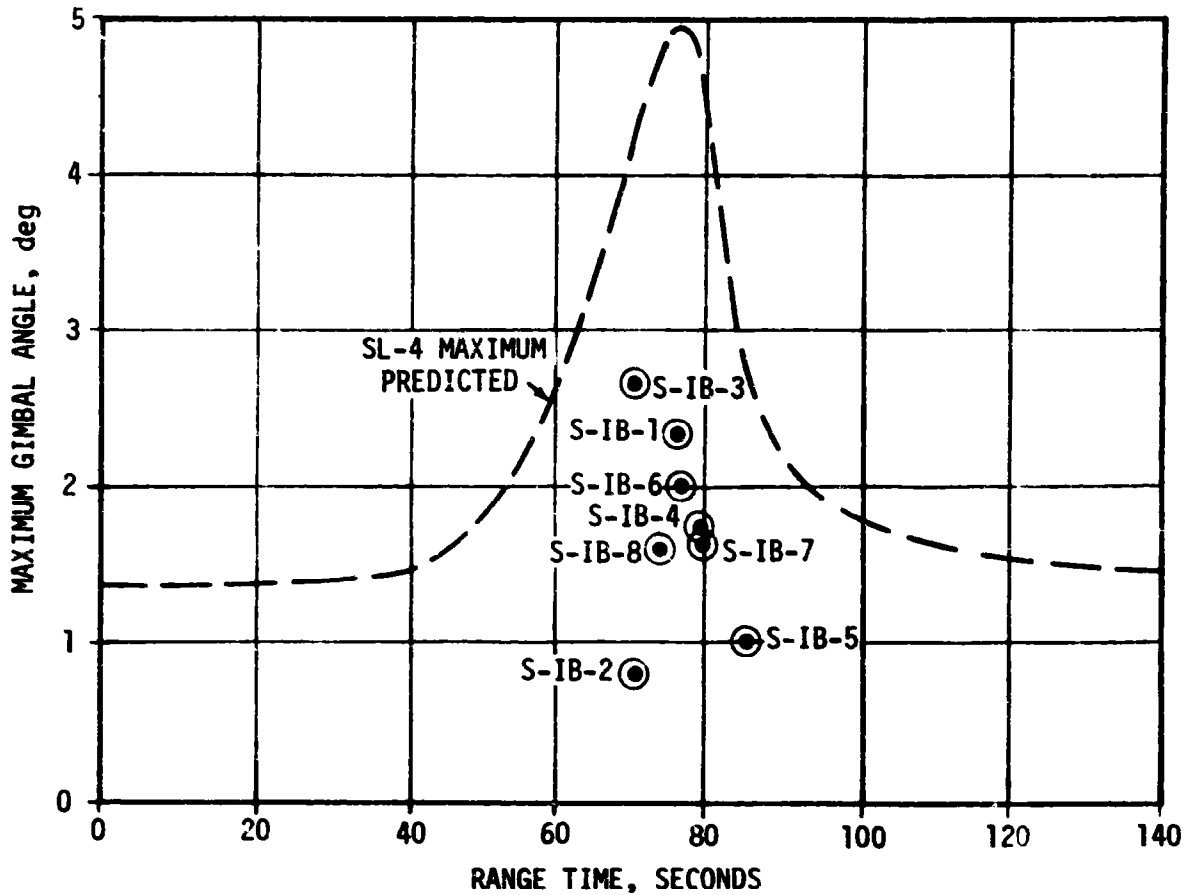
Figure 6-15. S-IB Maximum Gimbal Angle

All eight actuators performed smoothly during S-IB stage flight. In general, individual actuator activity was less than on previous flights. The maximum pitch gimbal angle of 1.5 degrees occurred on engines No. 1 and 3 at 58 seconds, which is approximately 19 percent of the maximum possible deflection. Engine No. 2 yaw actuator represents the largest yaw gimbal angle of 1.6 degrees at 58 seconds or approximately 20 percent of the maximum possible deflection. Figure 6-15 is a comparison of the maximum individual actuator gimbal angles for all S-IB flights. The gimbal rates observed on SA-208 are comparable to previous flights. The greatest gimbal rate observed for SA-208 flight was 1.7 deg/sec on engine No. 1 yaw actuator at 58 seconds. This rate is approximately 5 percent of the actuator's maximum rate.

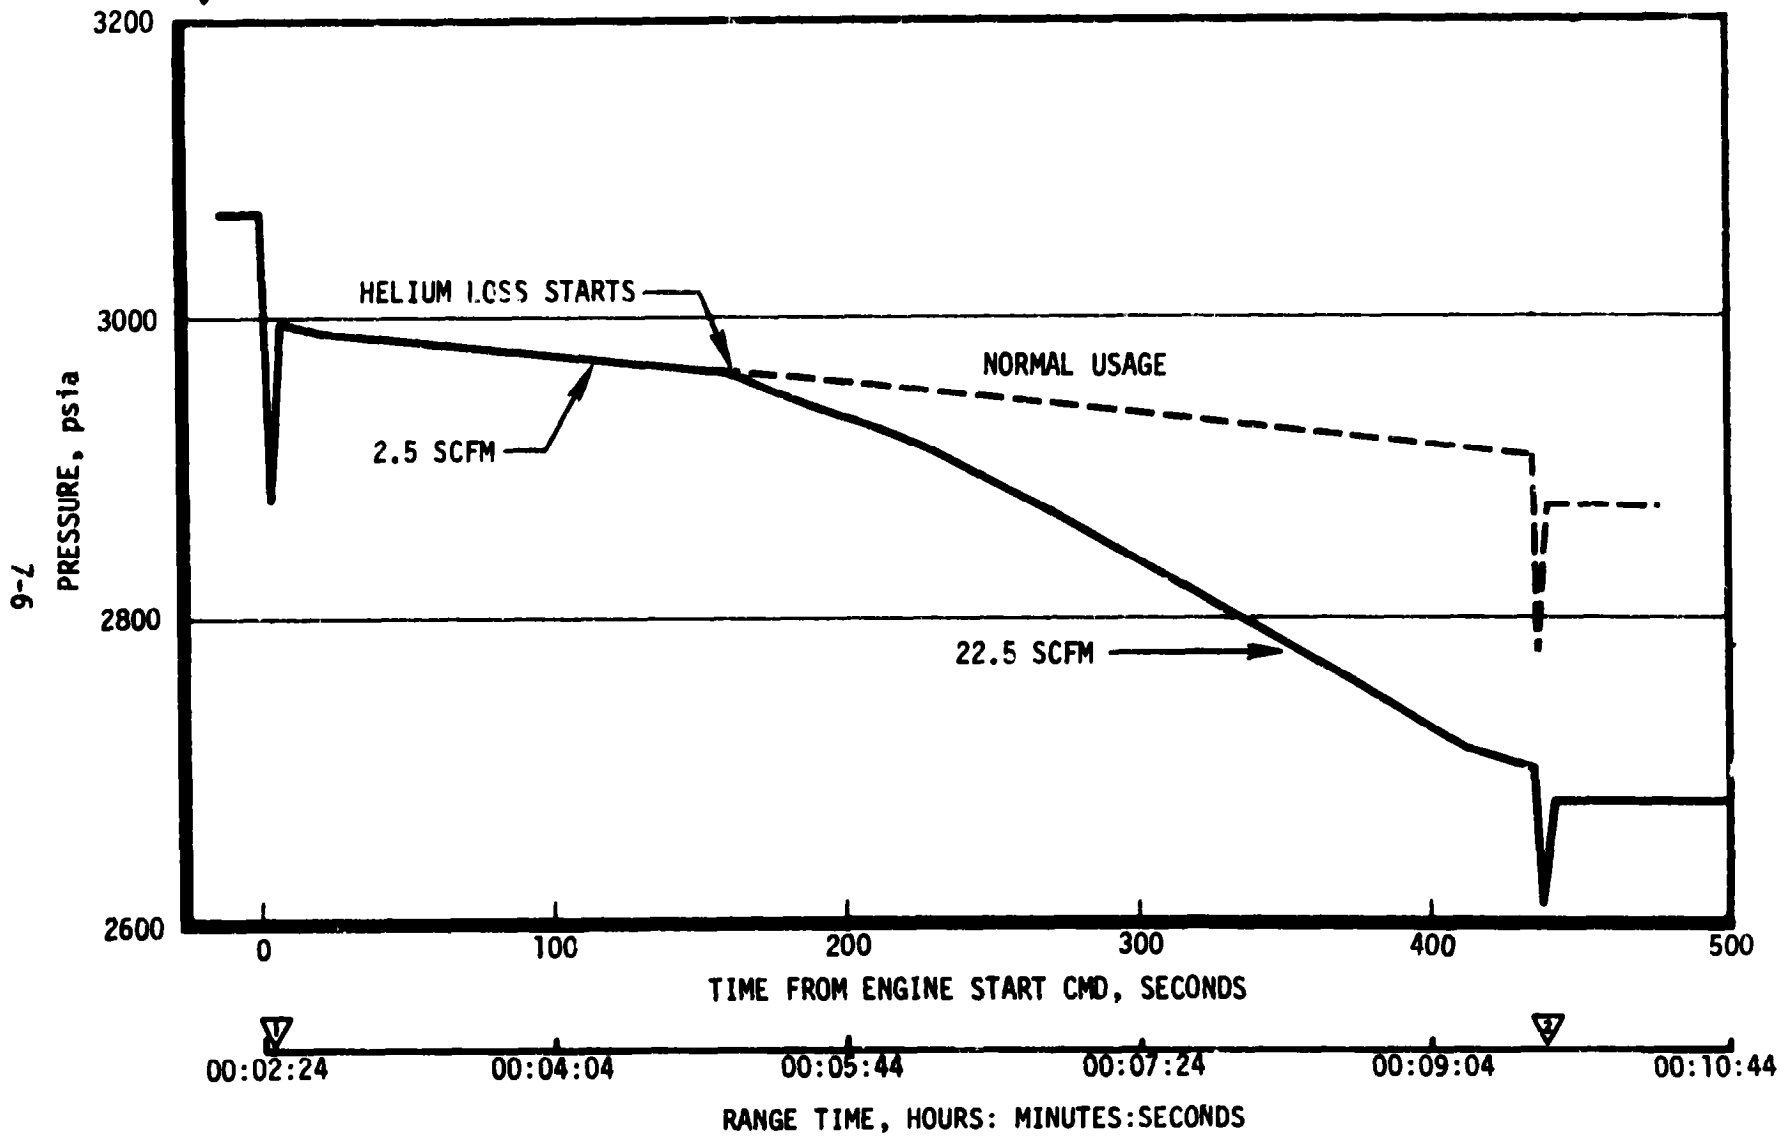
Figure 7-3. S-IVB Engine Control Bottle Pressure

flight temperature differences, the usage rates during flight LOX and LH₂ dumps were found to agree very closely with the rates observed during the Flight Readiness Test (FRT). This indicates that there was no helium leakage during LOX or LH₂ dump. Also, there was no indication of any leakage during orbital coast. Therefore, the leakage appears to only be present during mainstage operation.

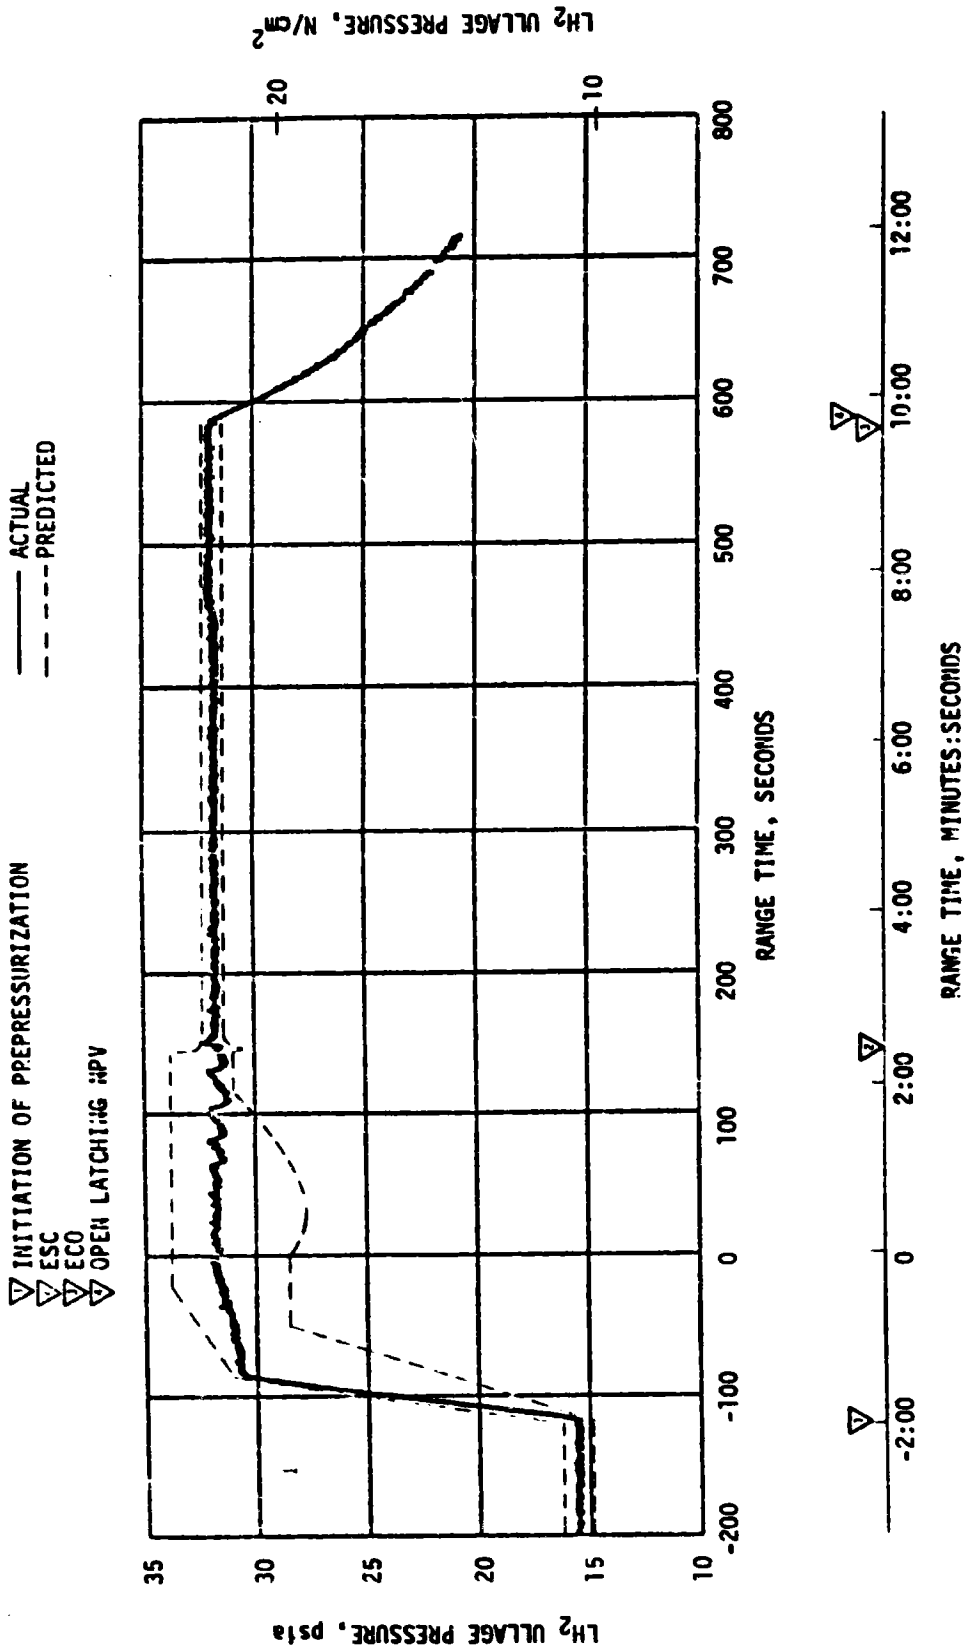
Figure 7-8. S-IVB LH₂ Ullage Pressure - Preliftoff, Boost and Burn

LH₂ tank relief venting during boost included periods of vent valve chatter similar to those which occurred during orbital coast (see Section 7.10.1) and during SA-206 flight. The ullage pressure cycled between 32.1 and 31.1 psia, as shown in Figure 7-8. Chatter of the LH₂ vent and relief valve and the LH₂ latching vent valve occurred during the vent portion of the ullage pressure cycle, as evidenced by the valve position microswitches and the NPV nozzle pressure oscillations. The valves were closed during the self-

pressurization portion of the cycle. The valve chatter during boost had no effect on tank conditions.

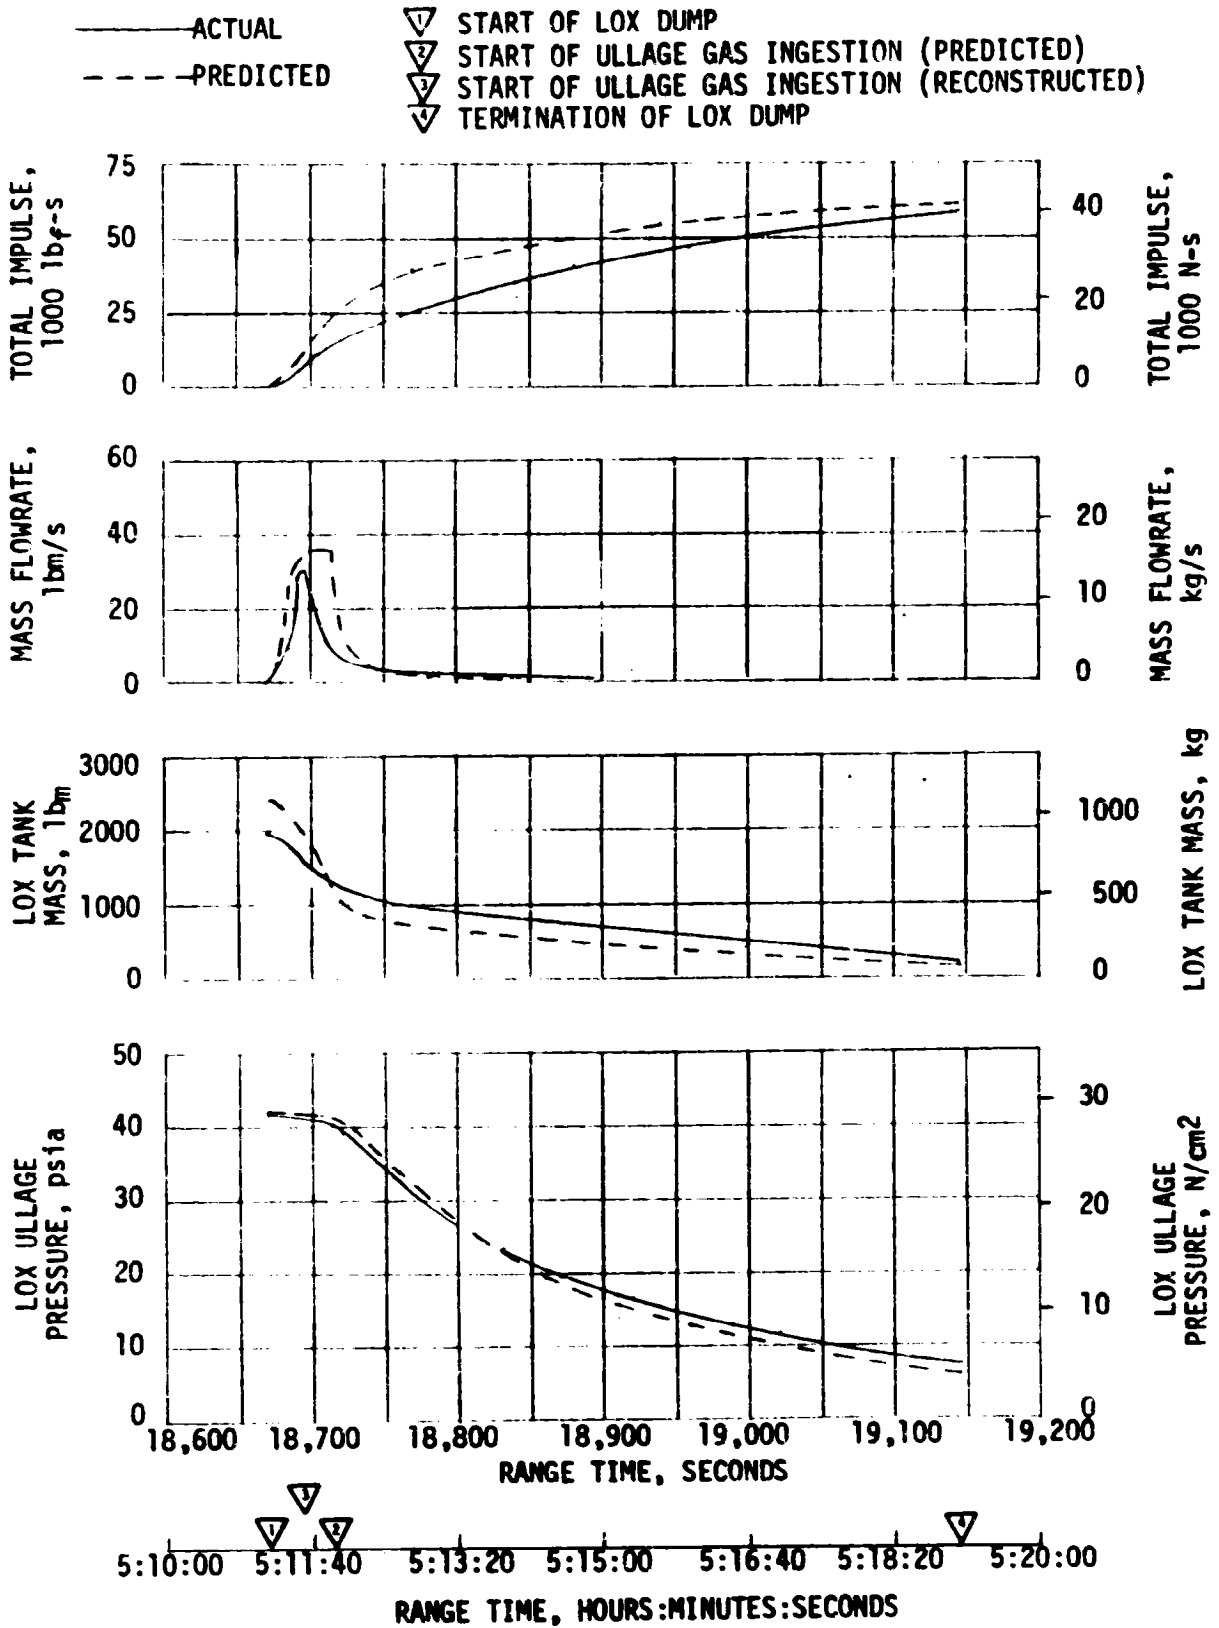
Figure 7-18. S-IVB LOX Dump Parameter Histories

and actual and real-time predicted LOX ullage pressure) are shown in Figure 7-18. The reconstruction corresponds to the best fit on available LOX ullage pressure flight data and the calculated velocity change (determined from LVDC accelerometer data) for LOX dump.

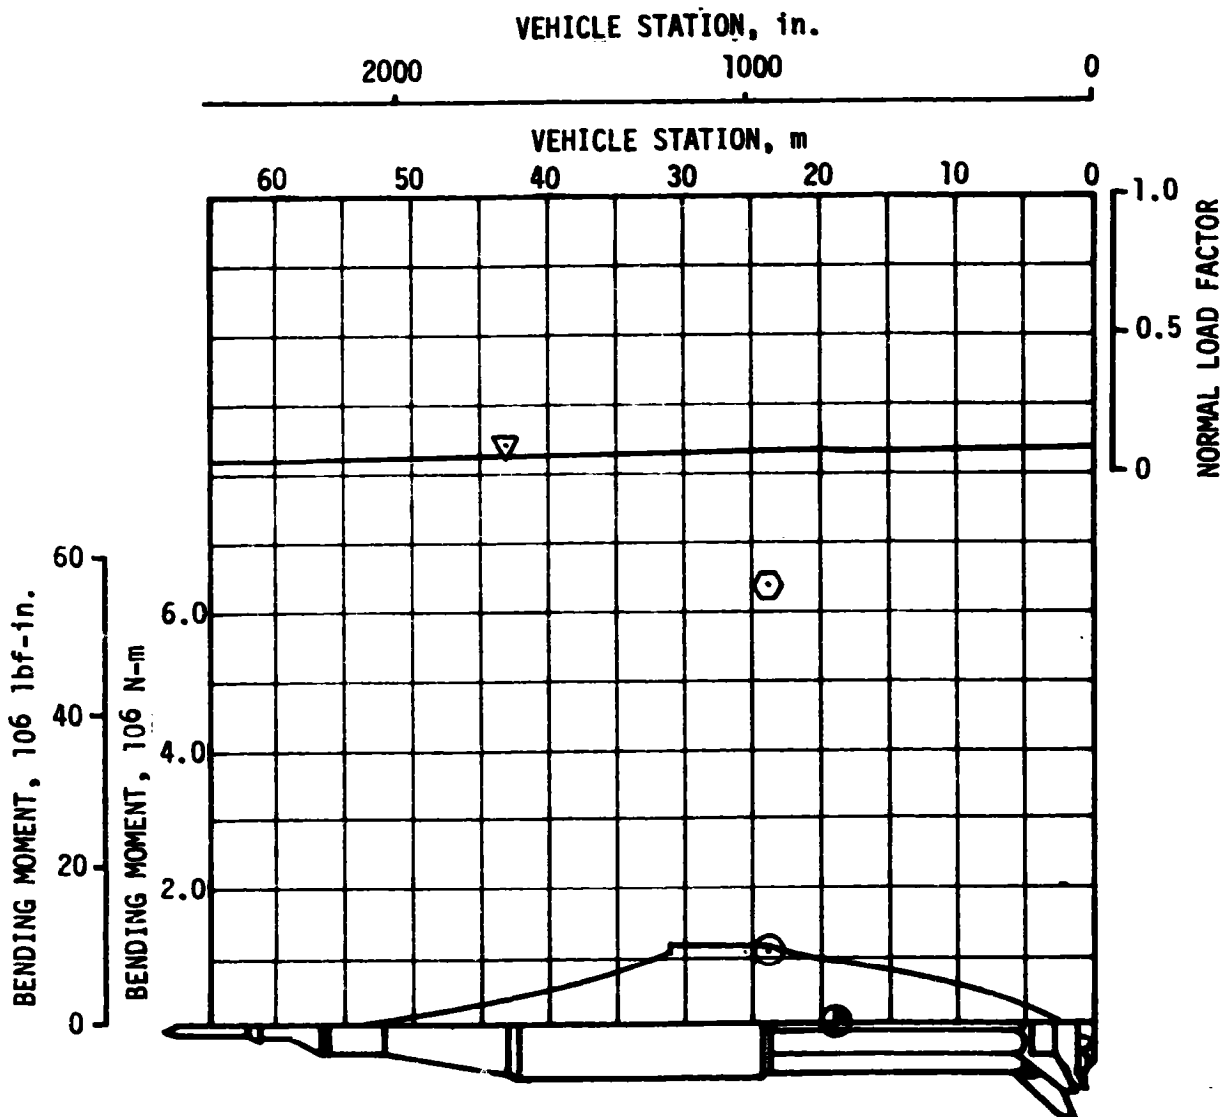
Figure 8-5. Pitch Bending Moment Distributions at Time of Maximum Resultant Moment

- ⊙ BENDING MOMENT DERIVED FROM STRAIN DATA
- ▽ A4-601 ACCELEROMETER DATA
- ⊕ CENTER OF GRAVITY
- ⊙ DESIGN CRITERIA BENDING MOMENT

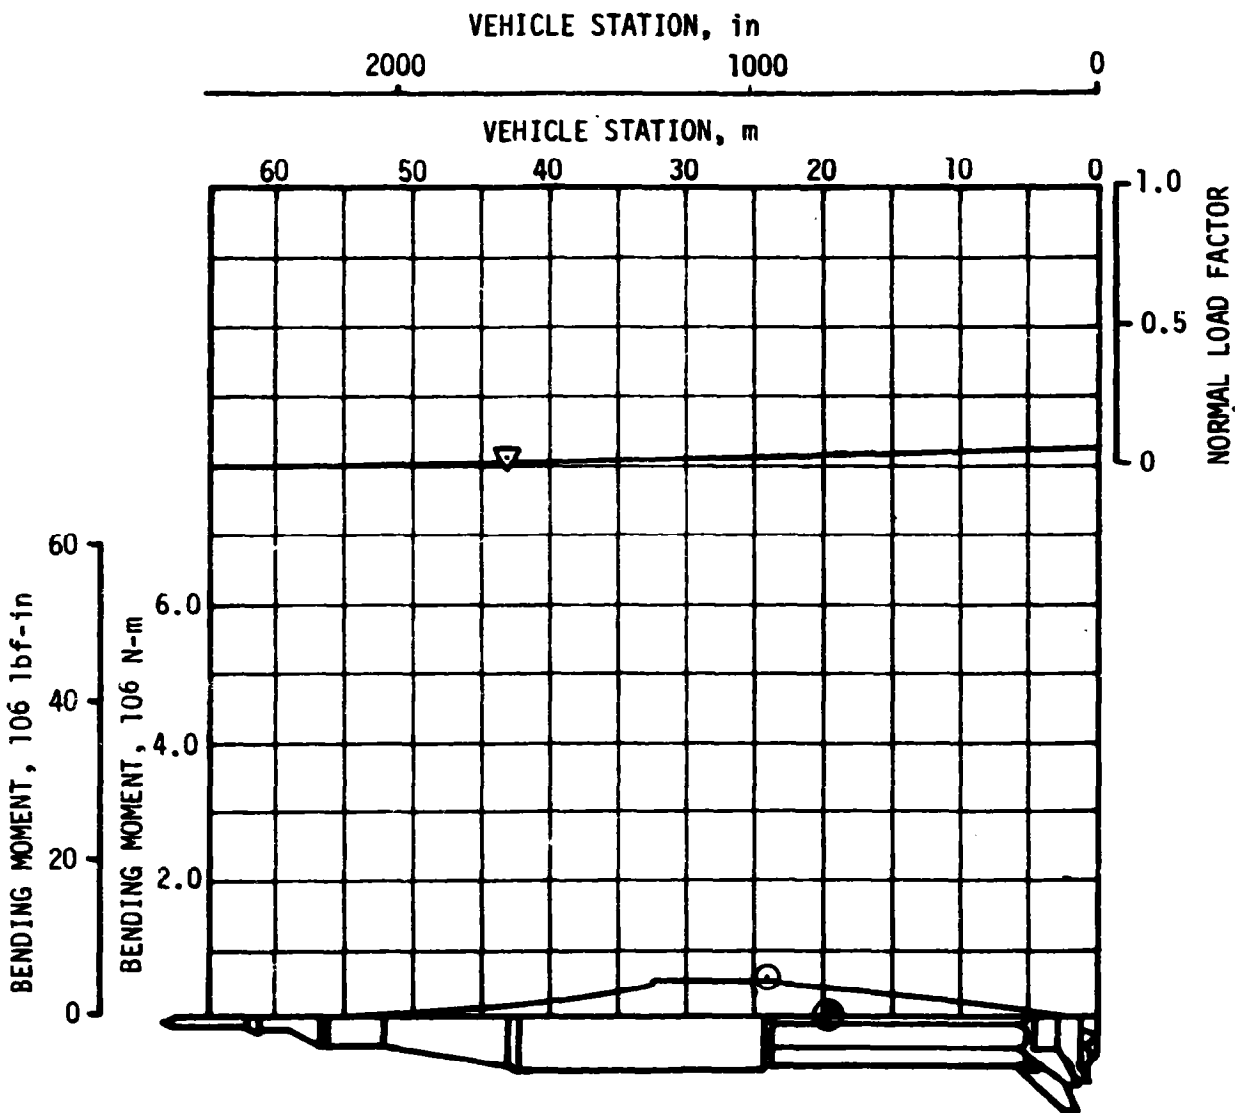
Figure 8-6. Yaw Bending Moment Distributions at Time of Maximum Resultant Moment

- BENDING MOMENT DERIVED FROM STRAIN DATA
- ▽ A5-603 ACCELEROMETER DATA
- CENTER OF GRAVITY

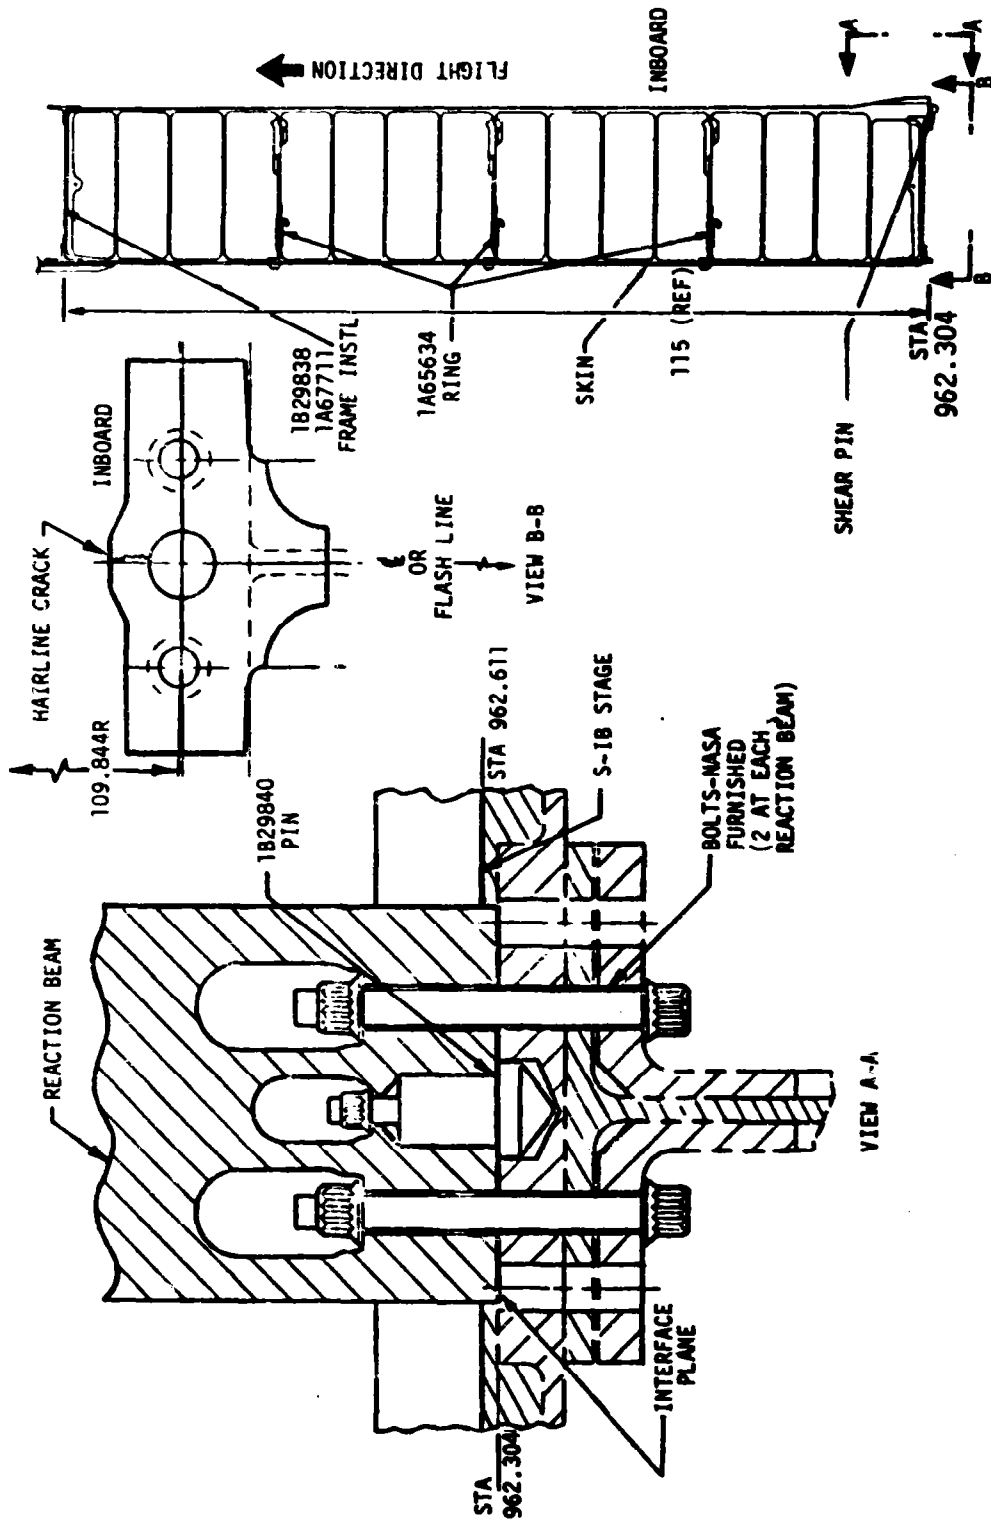
Figure 8-18. S-IB/S-IVB Interstage Reaction Beam

Stress corrosion cracks were also found in seven of the eight S-IB/S-IVB interstage reaction beams (Figure 8-18). The cracks existed at the forged flash line (die parting plane) of the 7079-T652 aluminum alloy forgings from which the beams were machined. A dye penetrant inspection was performed on the inboard and outboard surface of the aft end of the inboard cap of the reaction beams. A one inch wide strip centered on the inboard cap of the beam was also dye-penetrant inspected (all eight beams entire length). No additional cracks were found. A stress analysis of

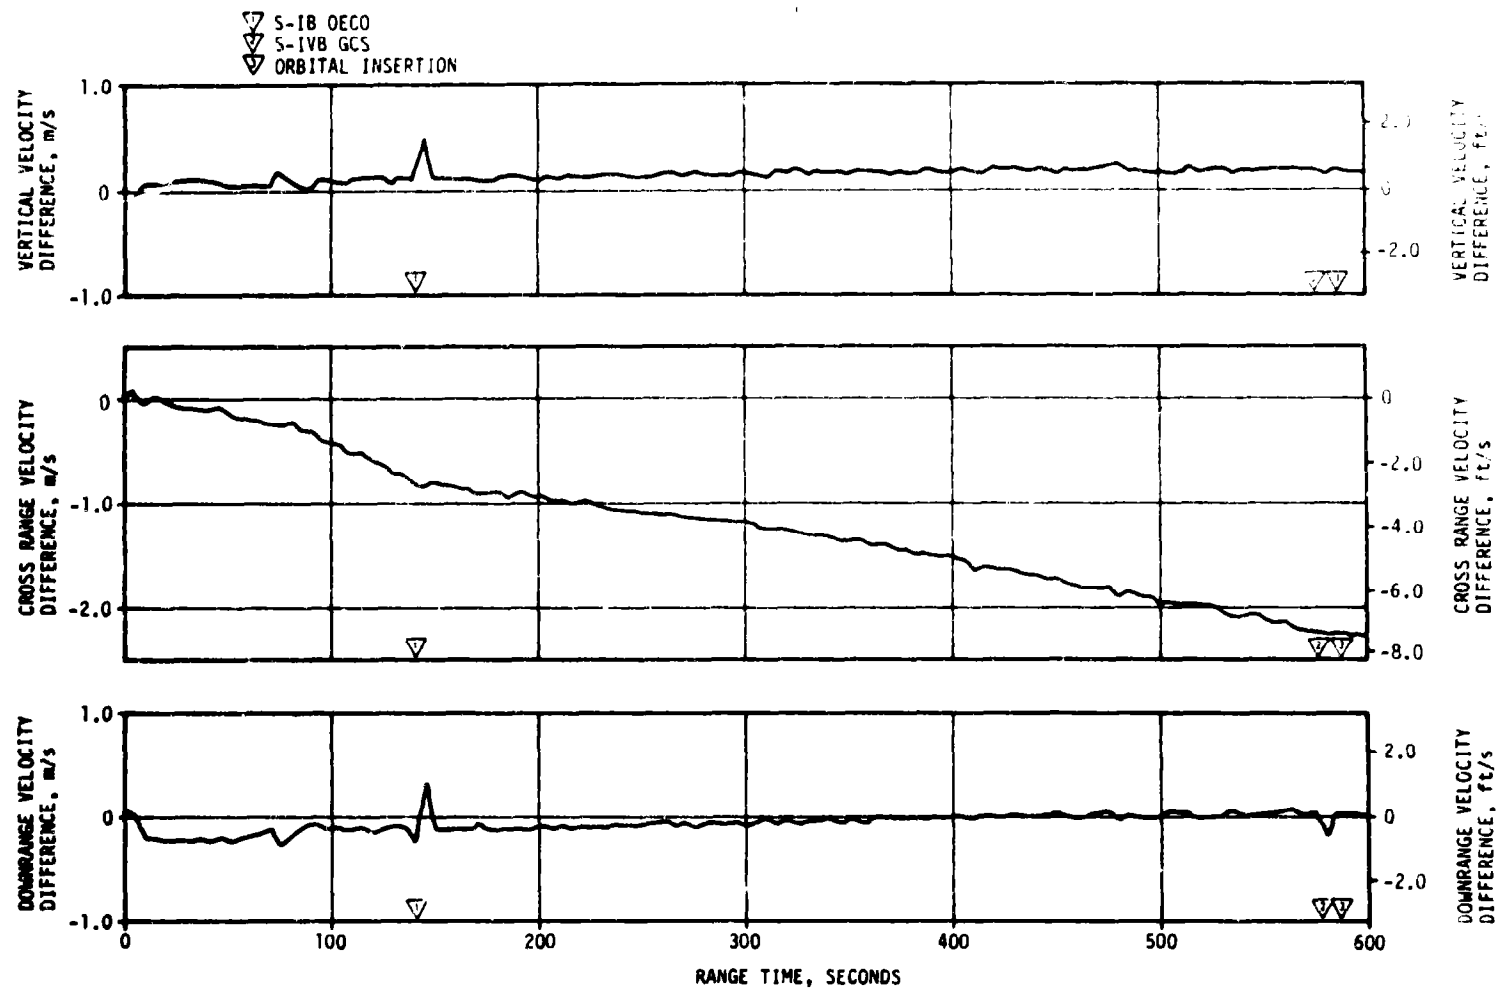
Figure 9-1. SA-208 Trajectory and ST-124M Platform Velocity Comparisons (OMPT Minus LVDC)

Comparisons of navigation (PACSS-13) positions, velocities, and flight path angle at significant event times are presented in Table 9-2. Dif-

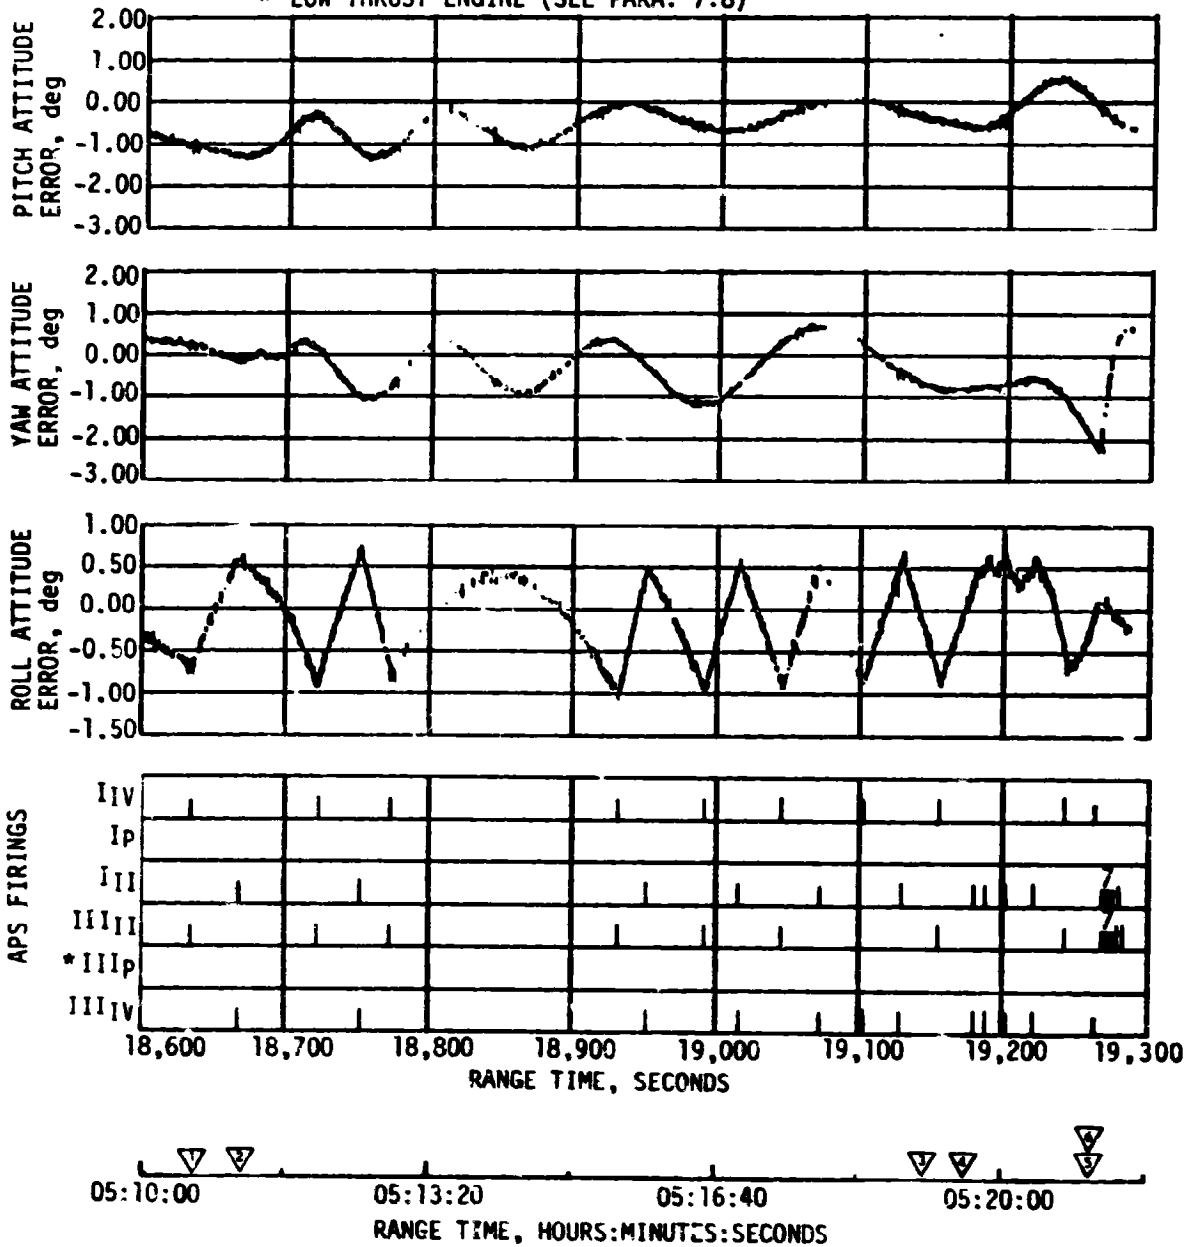
Figure 10-9. Vehicle Dynamics During Deorbit (Sheet 1 of 2)

Satisfactory vehicle stability and control characteristics were observed during the deorbit propellant dump. Thrust Vector Control (TVC) was used for pitch and yaw, while the APS was used for roll control. Attitude error and attitude rate data for the pitch, yaw and roll axes, along with pitch and yaw actuator position data and roll APS firing data, are presented in Figure 10-9. These data cover the 475 second LOX dump and the 86 second LH₂ dump periods. The figure also shows the 30 second period between LOX and LH₂ dump, during which time no TVC control is provided.

- ▽ START OF TIMEBASE 5
- ▽ START LOX DUMP
- ▽ END LOX DUMP
- ▽ START FUEL DUMP
- ▽ END FUEL DUMP
- ▽ FCC BURN MODE OFF "B"
- * LOW THRUST ENGINE (SEE PARA. 7.8)

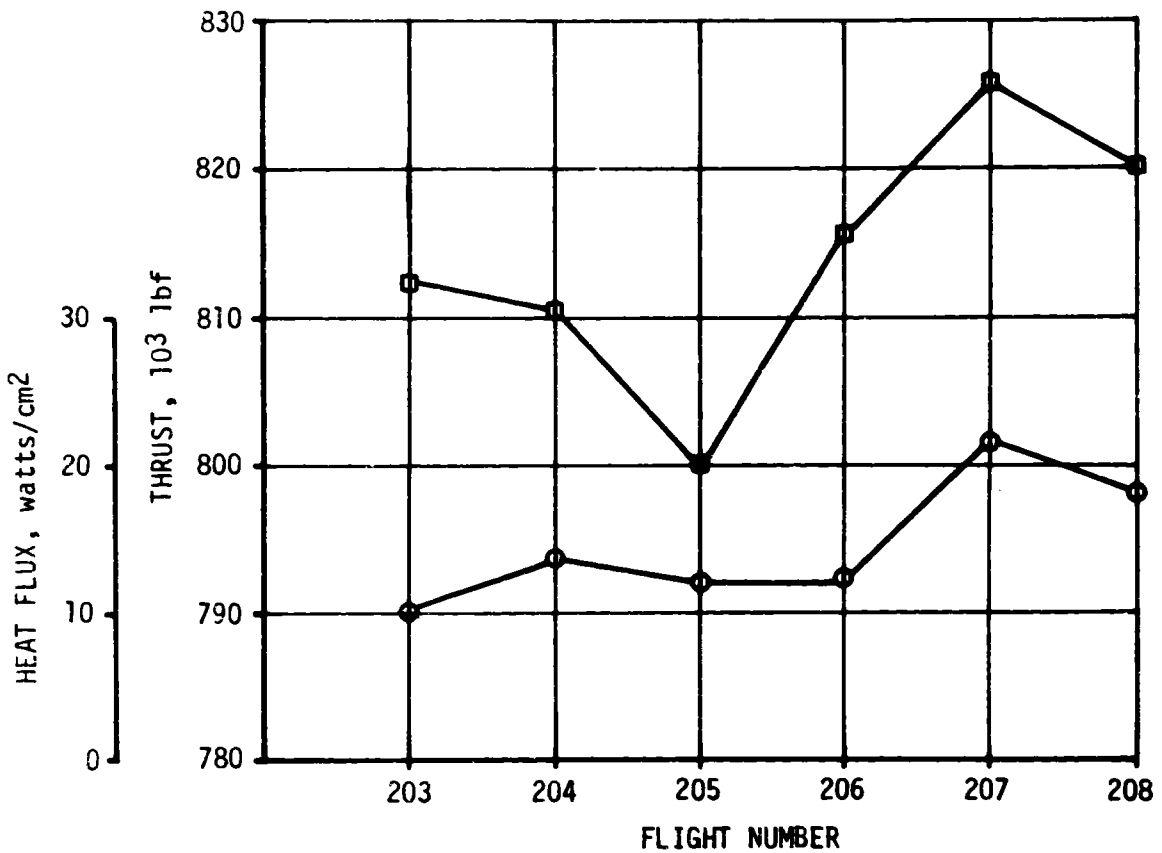
Figure 13-8. Variation of S-IB Flame Shield Radiant Heating with Inboard Engine Thrust

○ FLAME SHIELD
 RADIANT HEAT FLUX
 □ TOTAL INBOARD
 ENGINE THRUST
