MPR-SAT-FE-74-1

SATURN IB LAUNCH VEHICLE FLIGHT EVALUATION REPORT-SA-208

SKYLAB-4

The Saturn IB, SA-208 Launch Vehicle was launched on November 16, 1973 from Kennedy Space Center and placed the Command and Service Module containing three crew members into an 150.10 x 227.08 km altitude earth orbit. No anomalies occurred that seriously affected the mission.

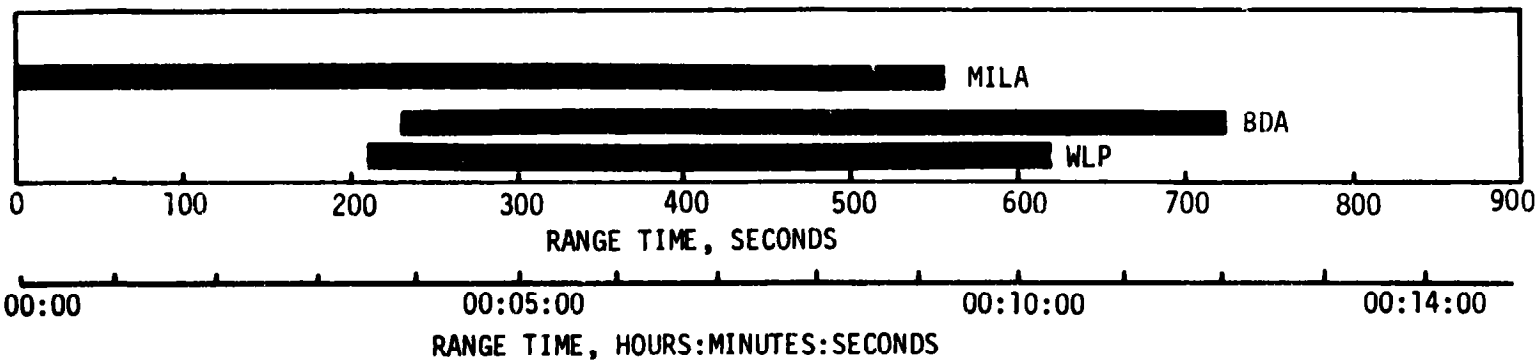
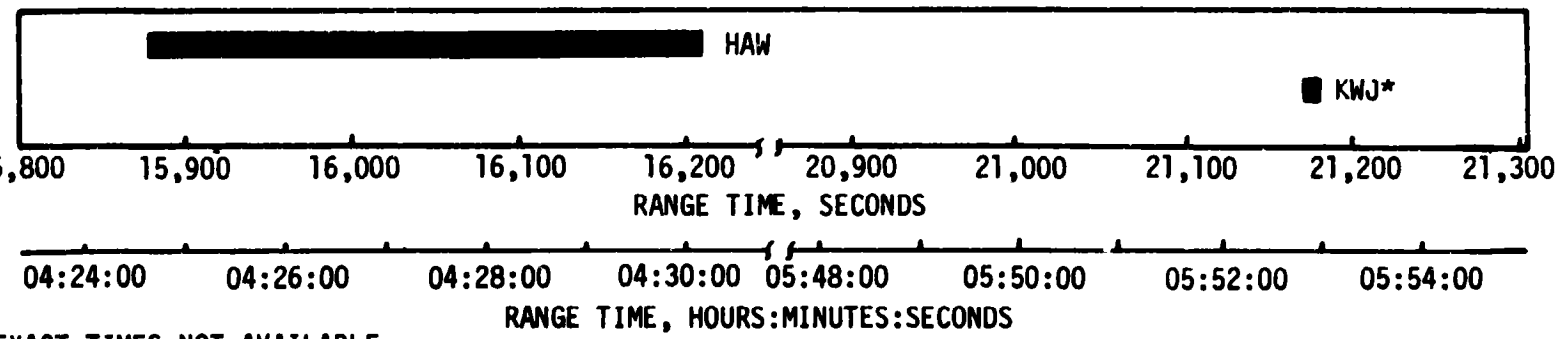
The C-Band radar performed satisfactorily during flight. A summary of C-Band radar coverage time from AOS to LOS for each station is shown in Figure 15-3. As on previous missions, phase front disturbances were observed at Merritt Island Launch Area during boost phase. These phase front disturbances result from severe antenna nulls or distorted beacon returns and cause momentary tracking errors at the ground stations.
