GEMINI PROGRAM MISSION REPORT

GEMINI X

AUGUST 1966

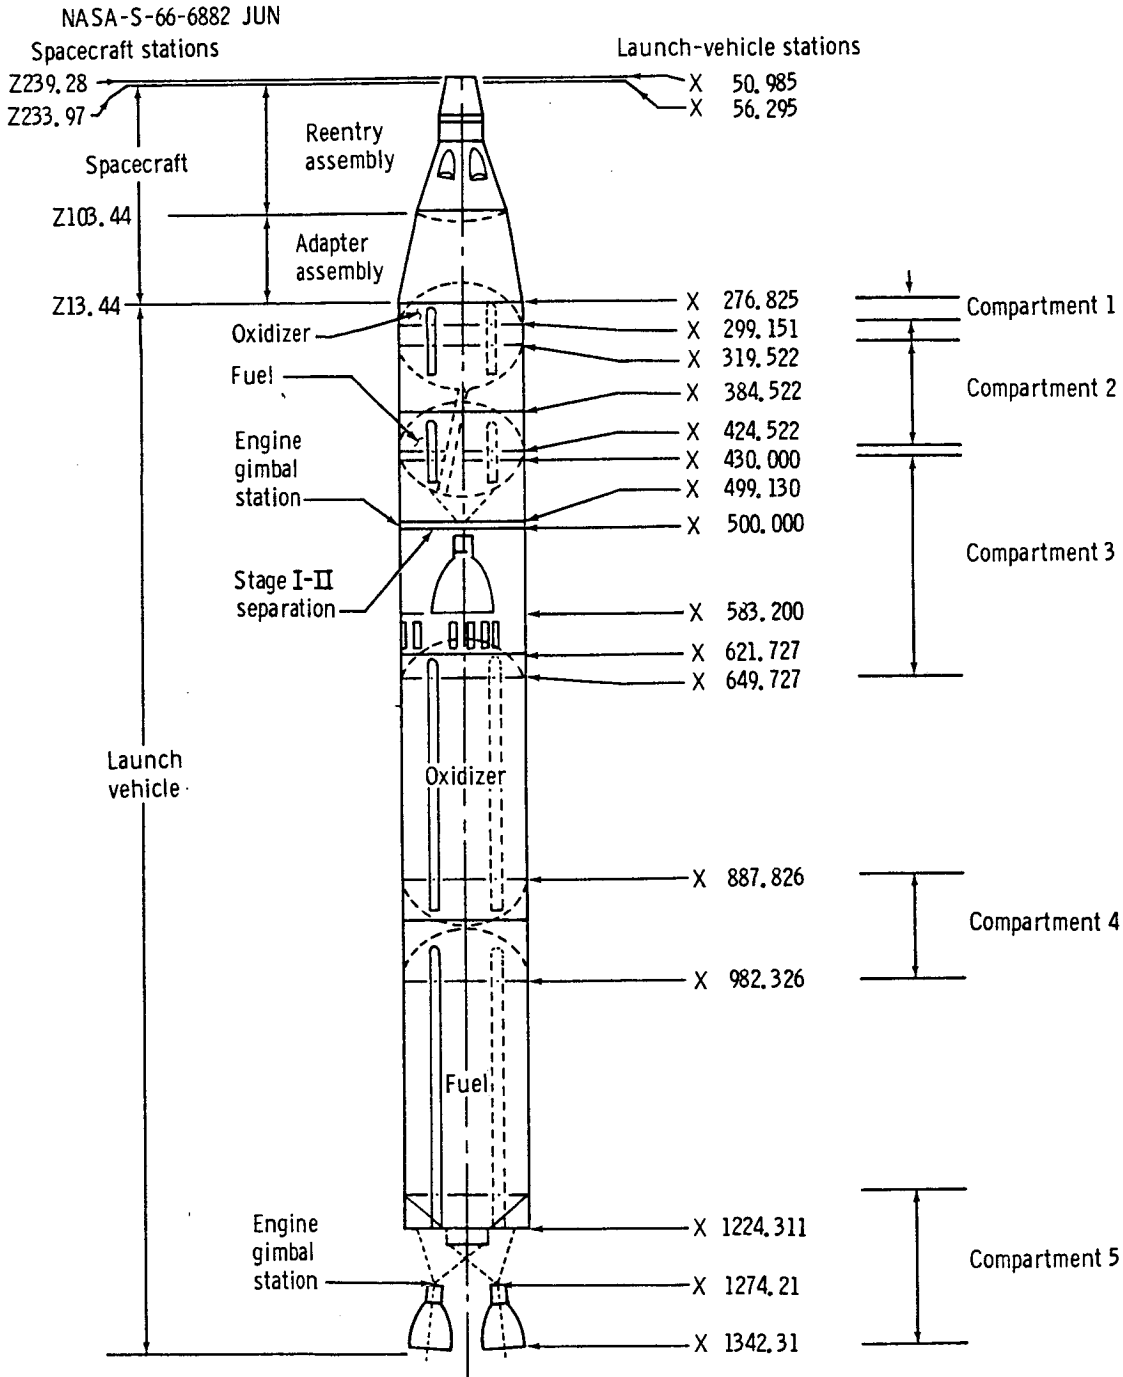
(a) Launch configuration.

Figure 3.0-1. - GLV/spaceship relationships.

The general arrangement and major reference coordinates of the manned Gemini Space Vehicle are shown in figure 3.0-1. Section 3.1 of this report describes the spacecraft configuration, including the Extravehicular Life Support System (ELSS); section 3.2 describes the GLV configuration; and section 3.3 provides the space vehicle weight and balance data. The general arrangement and major reference coordinates of the GAATV are shown in figure 3.0-2. Section 3.4 describes the GATV configuration, including the Target Docking Adapter (TDA); section 3.5 describes the TLV configuration; and section 3.6 provides the weight and balance data of the GAATV.

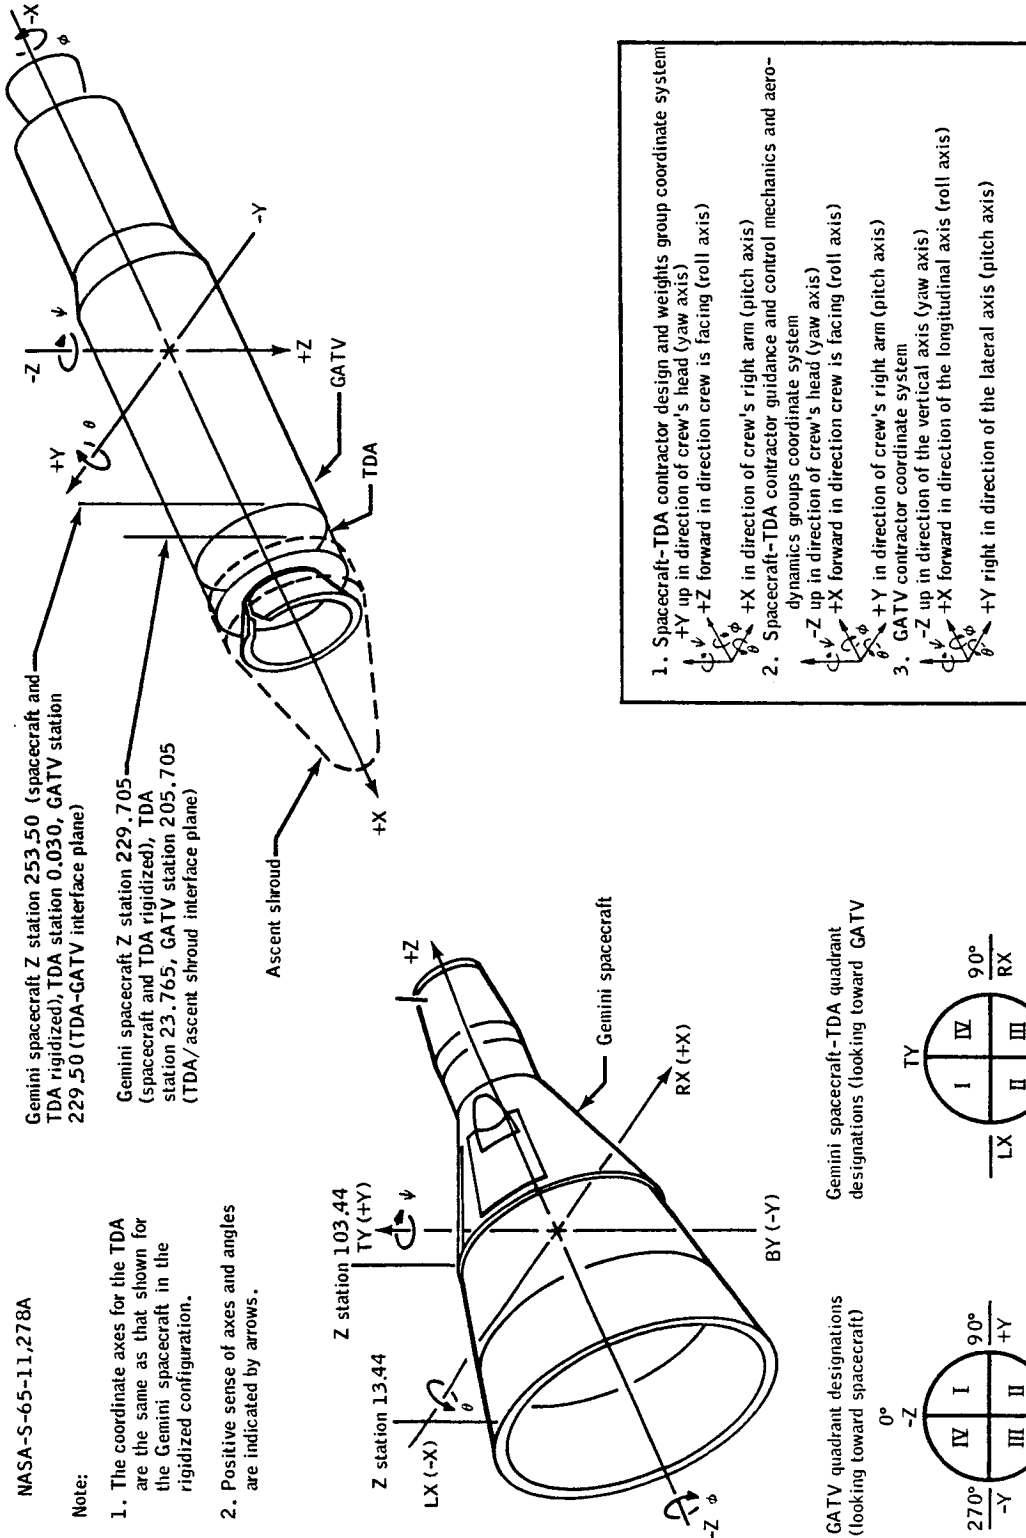
(b) Dimensional axes and guidance coordinates, GATV-TDA.
 Figure 3.0-2. - Continued.

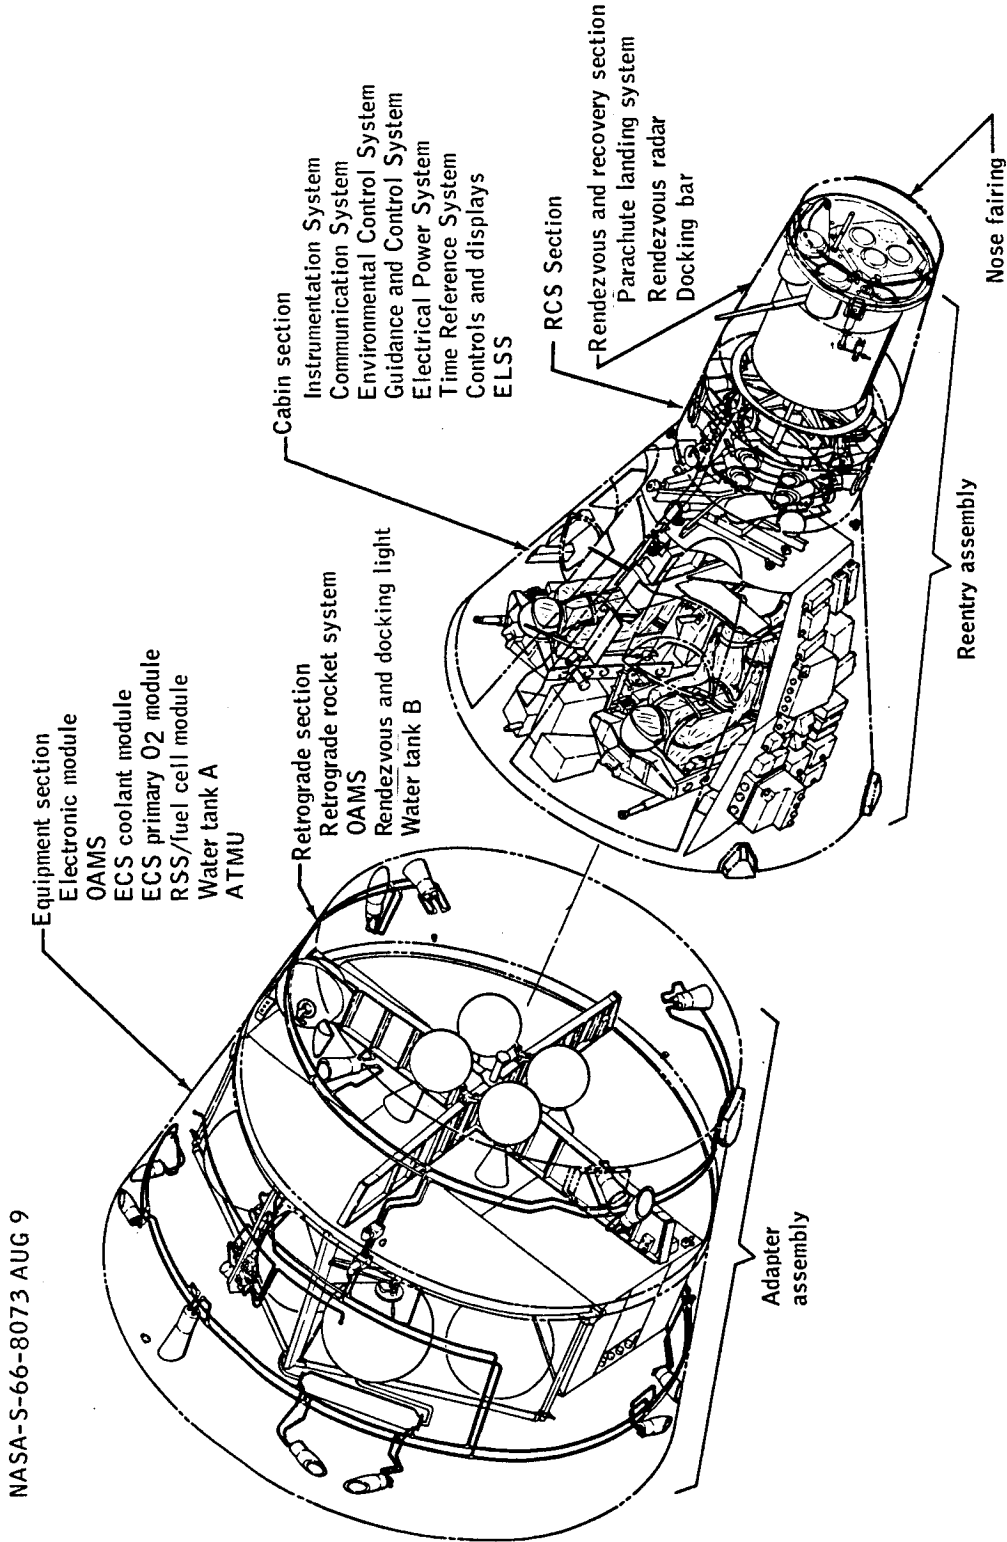
Figure 3.1-1. - Spacecraft arrangement and nomenclature.

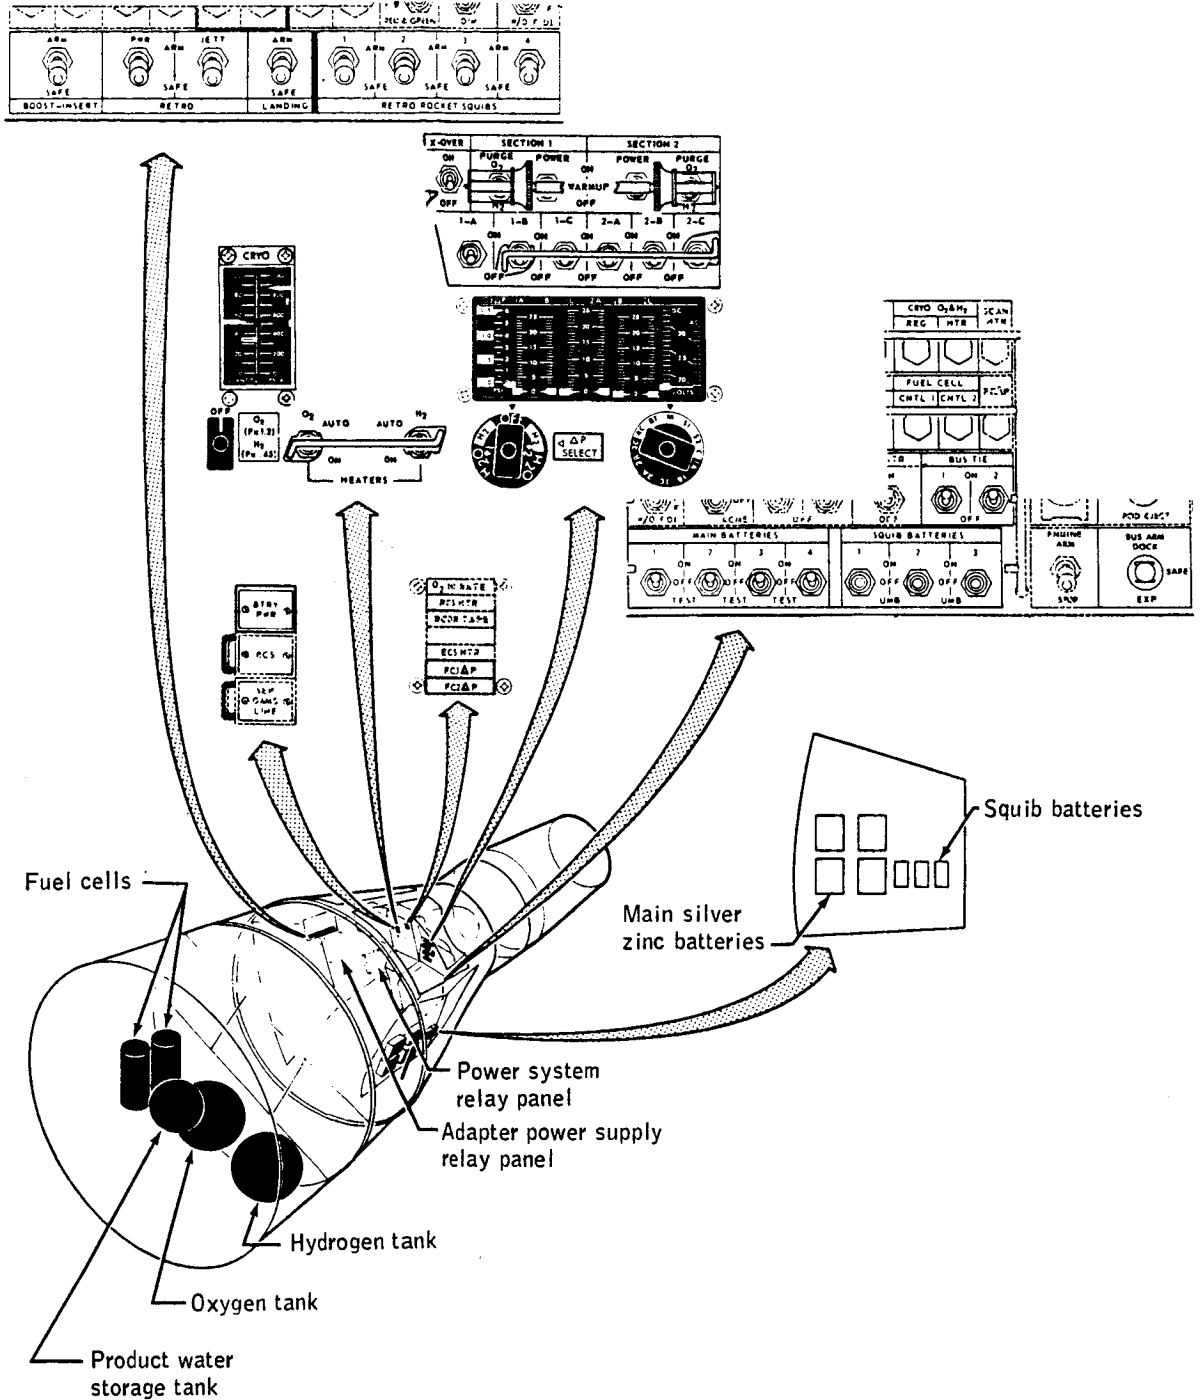
Figure 3.1-2. - Electrical system.

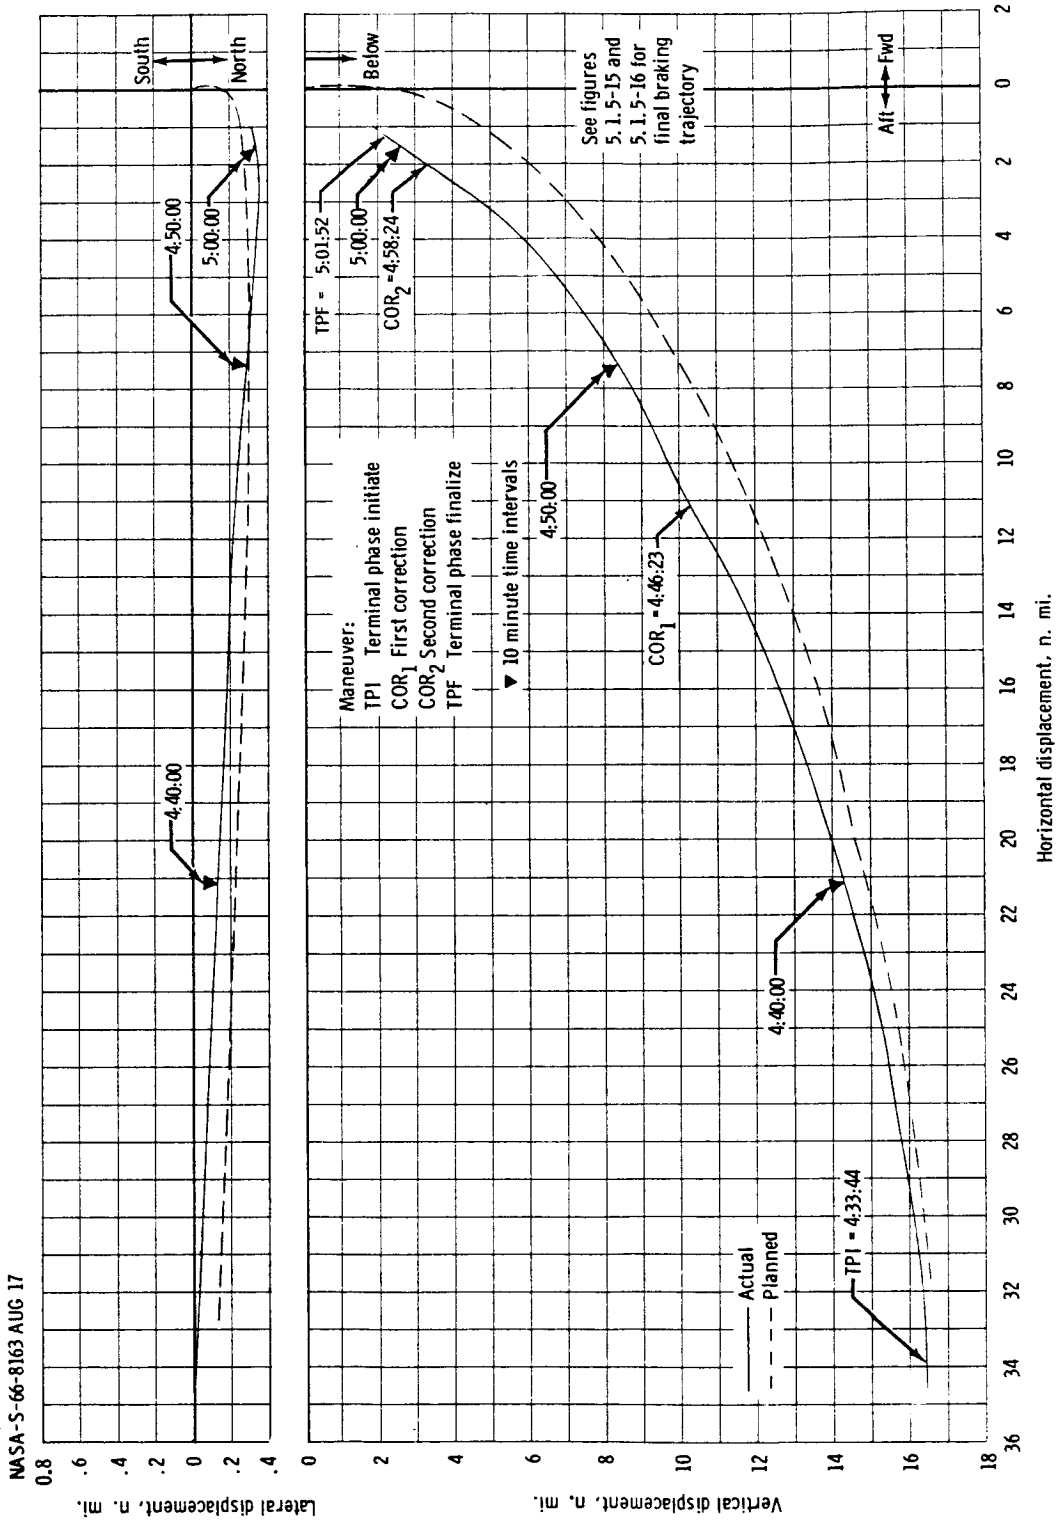
(d) Relative trajectory profile of first rendezvous from TPI to TPF as measured from Gemini X GATV to Spacecraft 10 in curvilinear coordinate system.

Figure 4-5. - Concluded.

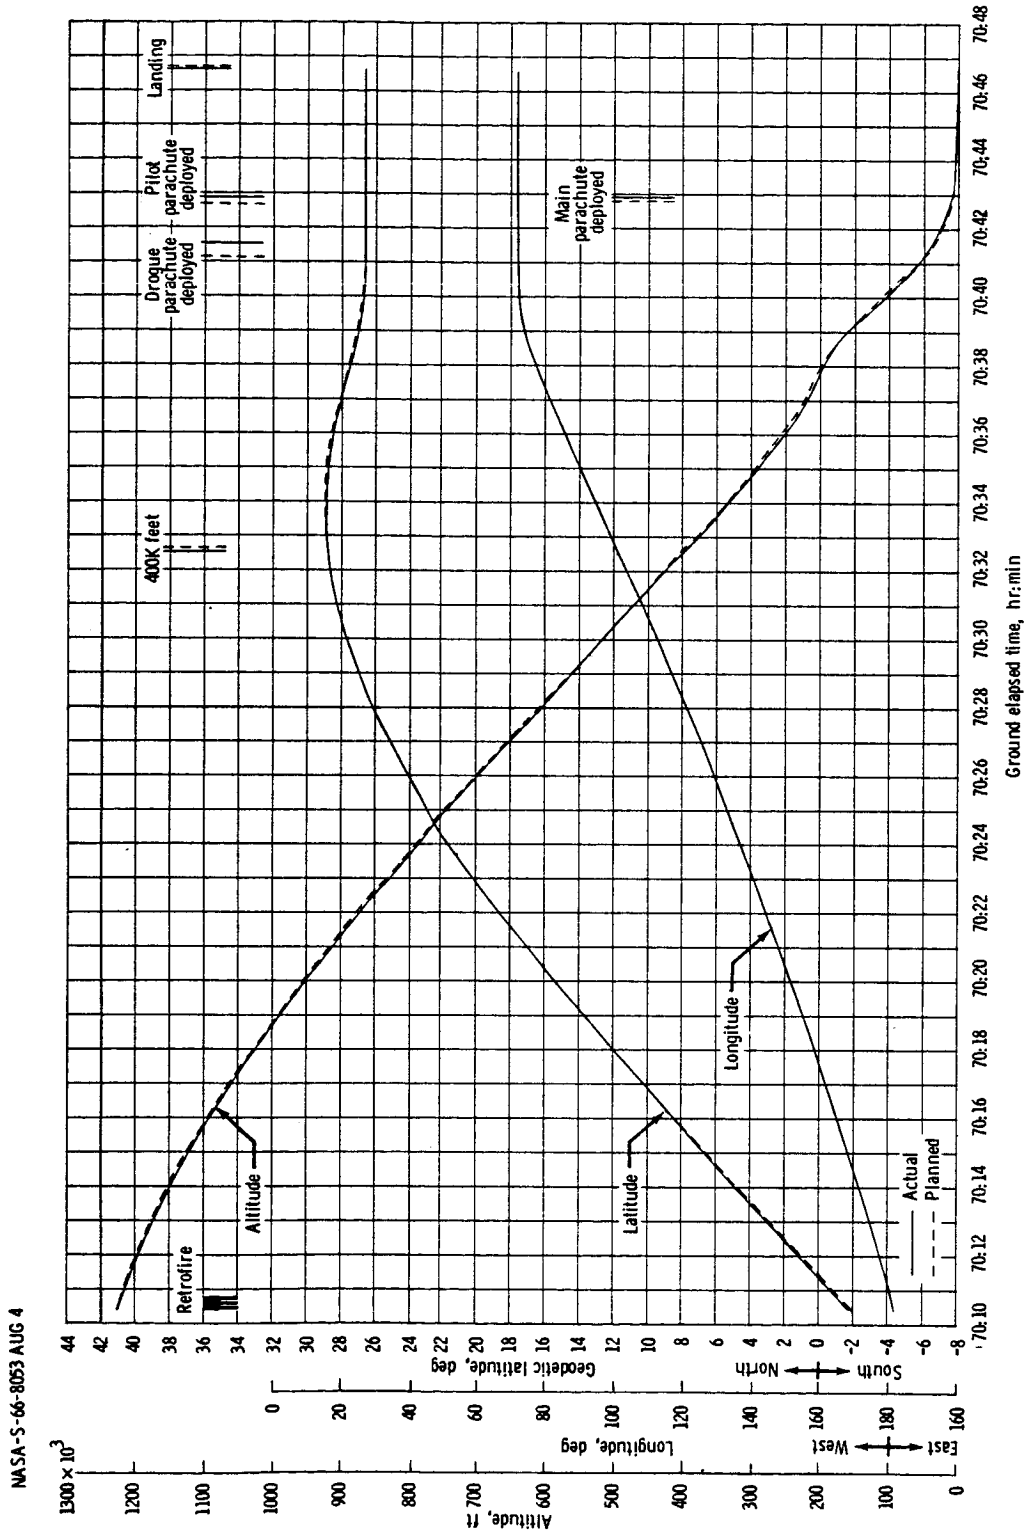
(a) Latitude, longitude, and altitude.
Figure 4-7. - Trajectory parameters for the Gemini X mission reentry phase.

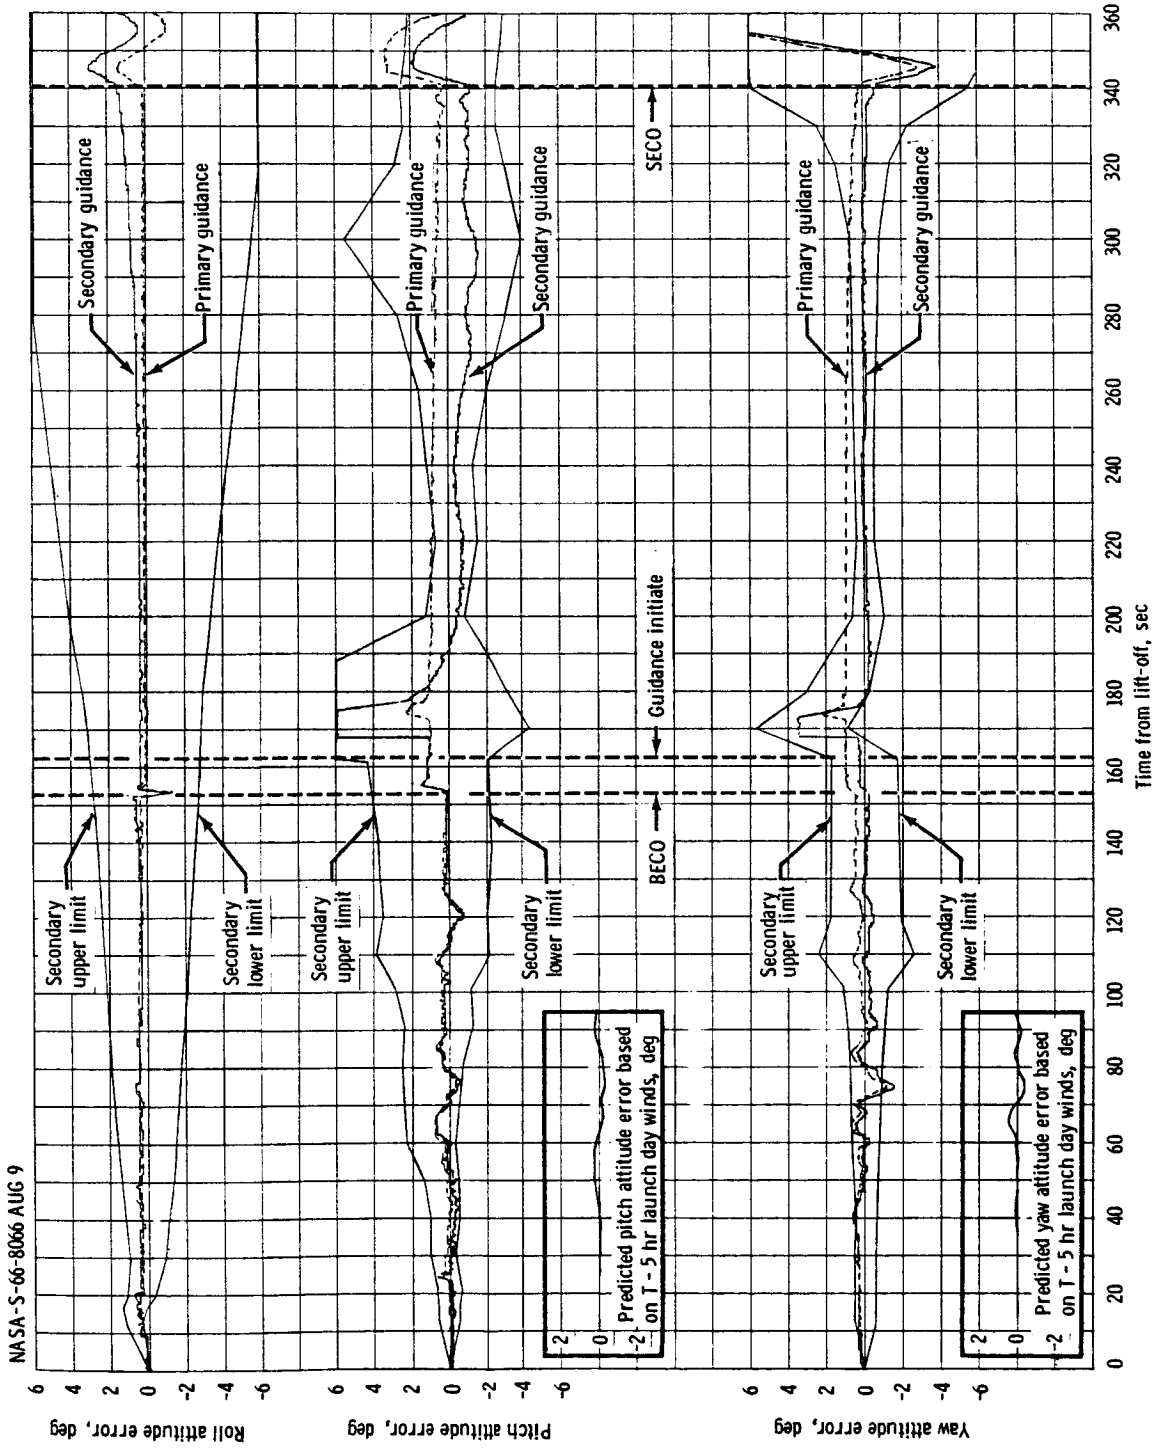
Figure 5.1.5-1. - Comparisons of launch vehicle and spacecraft steering errors.

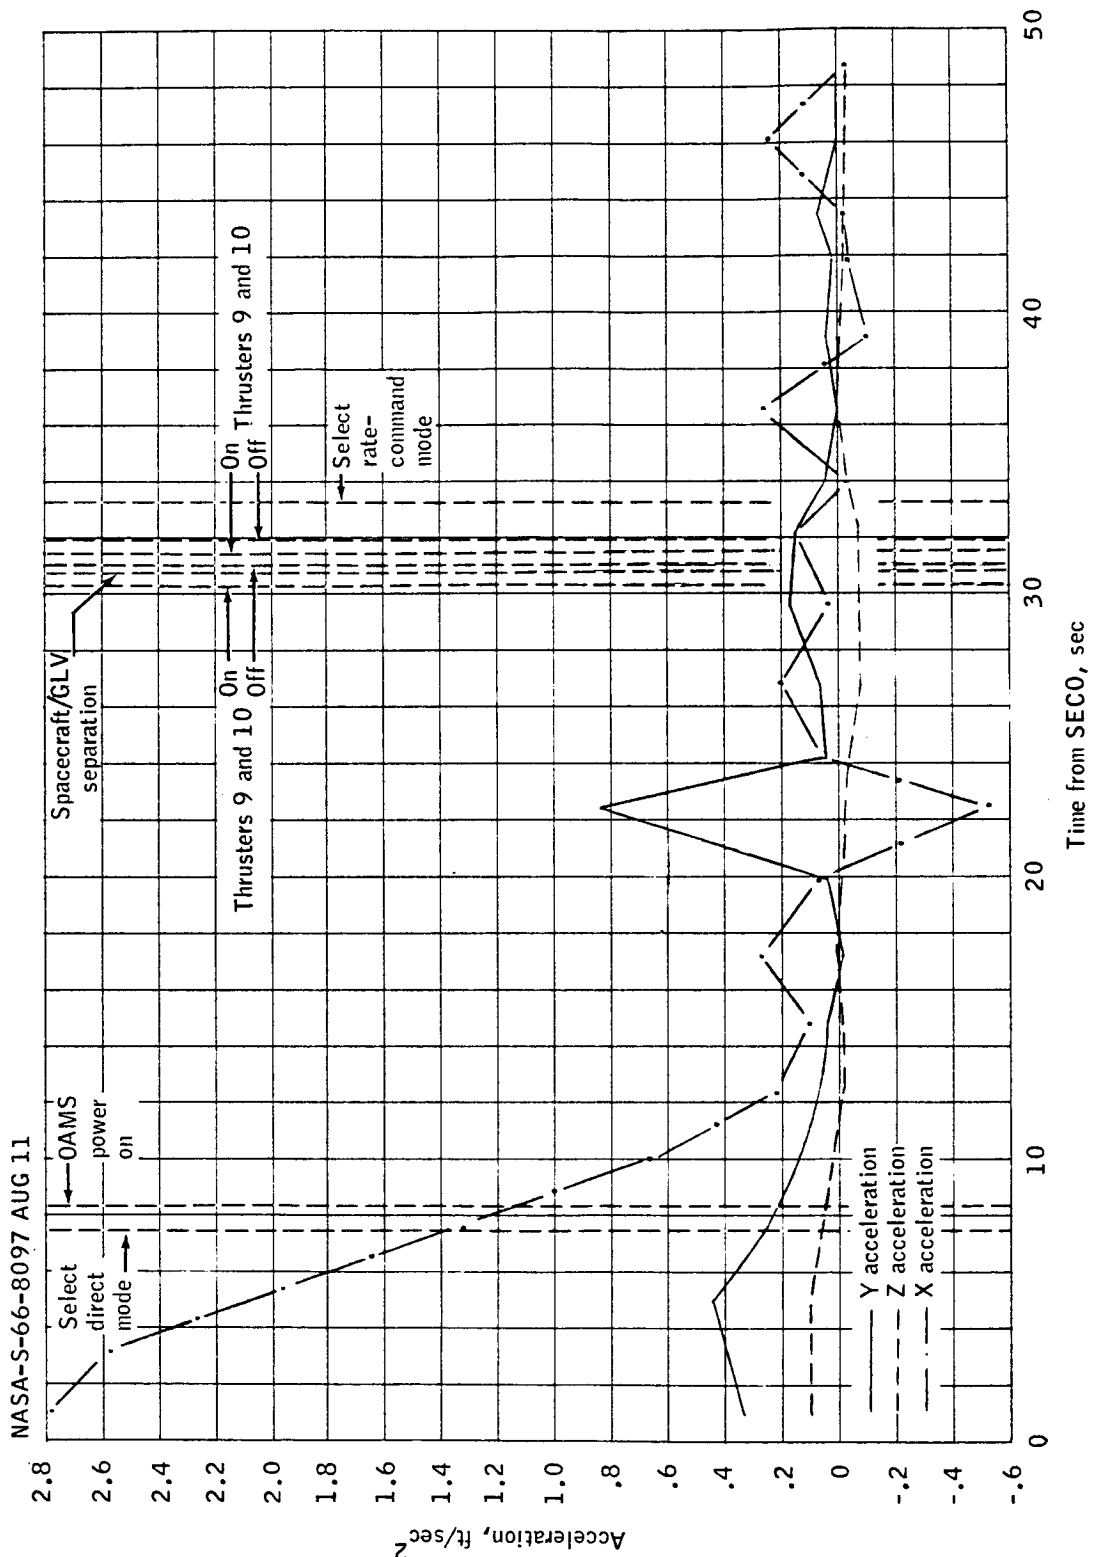
Figure 5.1.5-2. - Spacecraft acceleration measured after SECO.

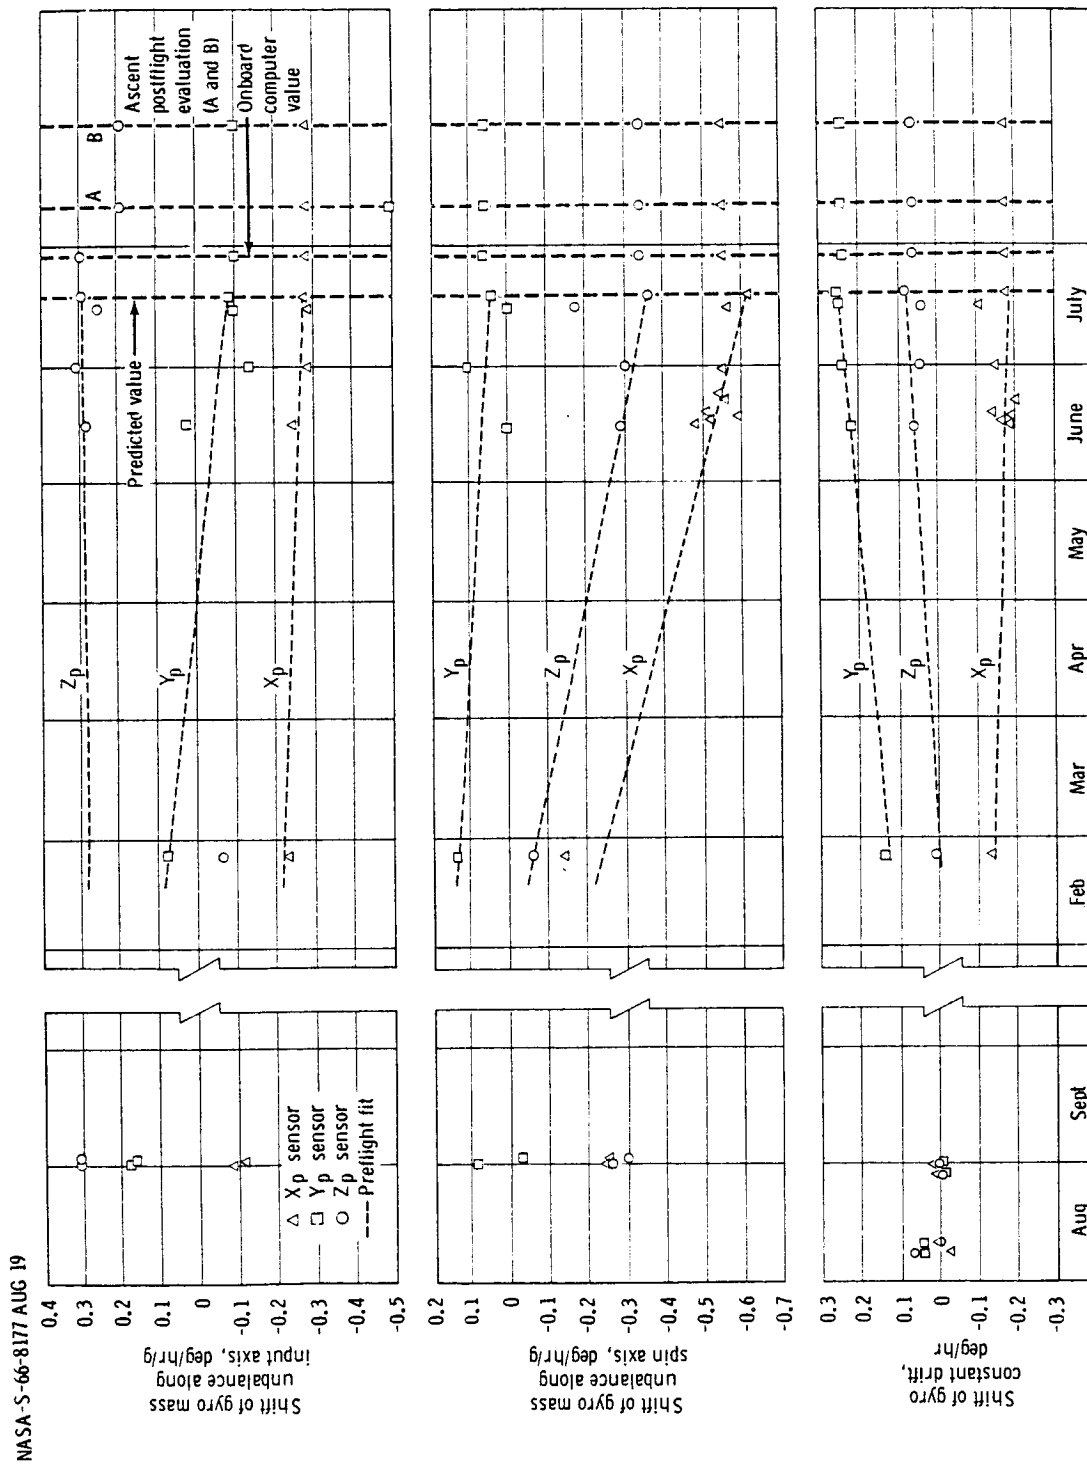
(b) Shift of gyro mass unbalances and constant drifts. Figure 5.1.5-4. - Concluded.

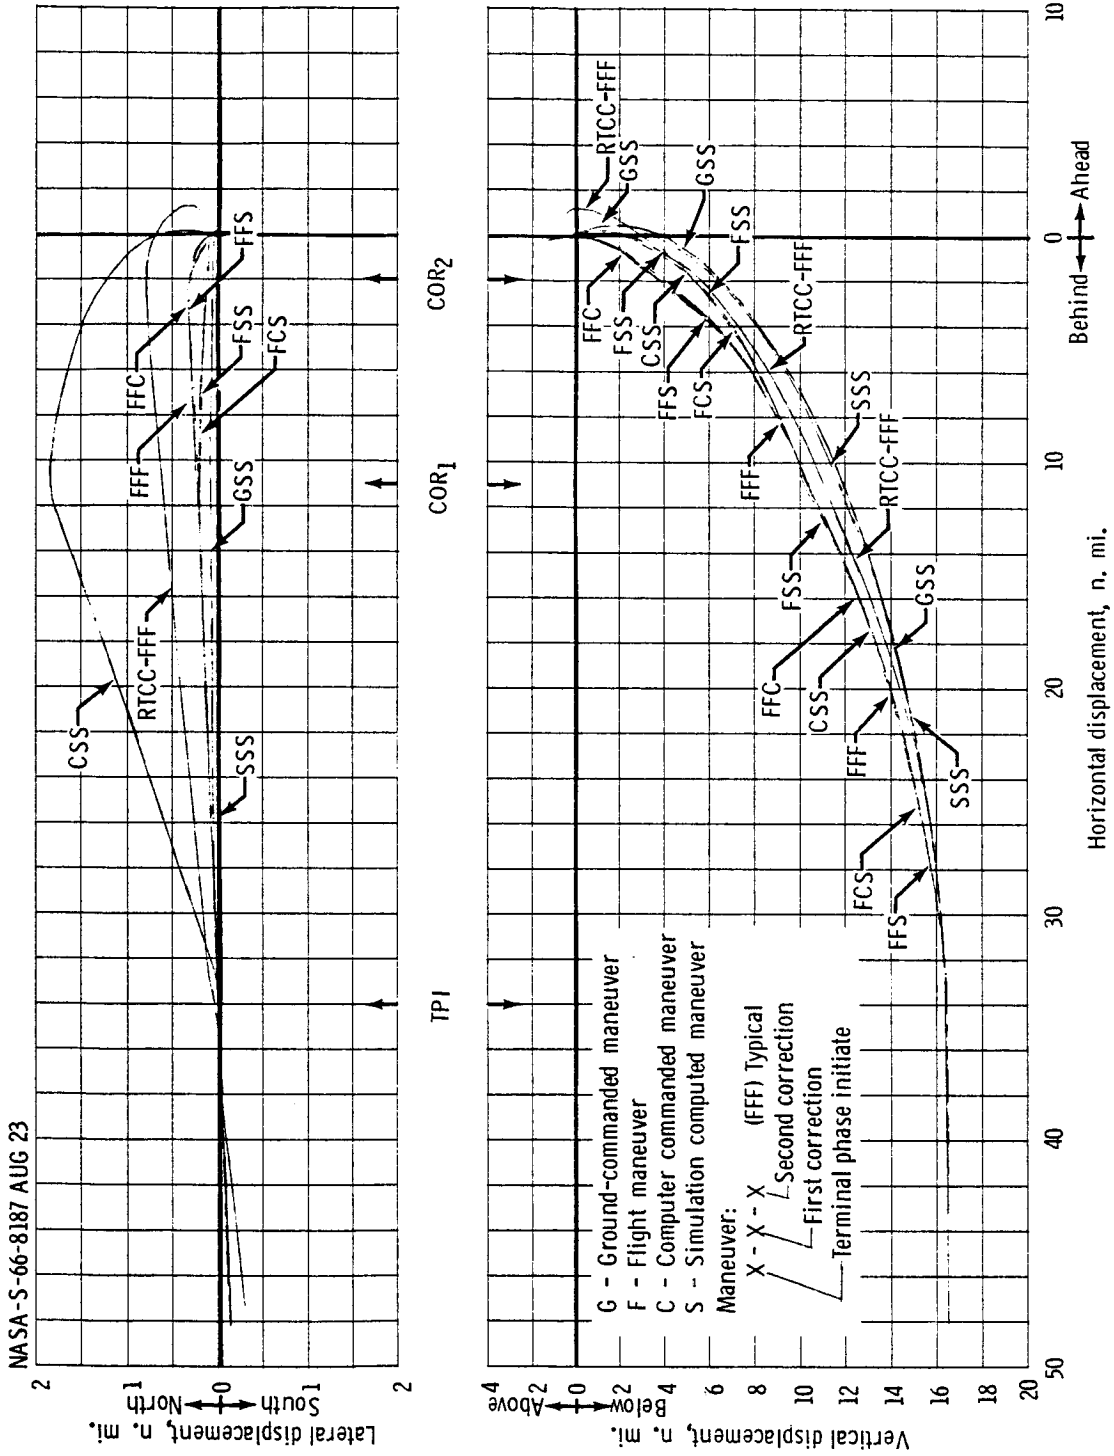
Figure 5.1.5-13. - First rendezvous simulations, no platform misalignment.

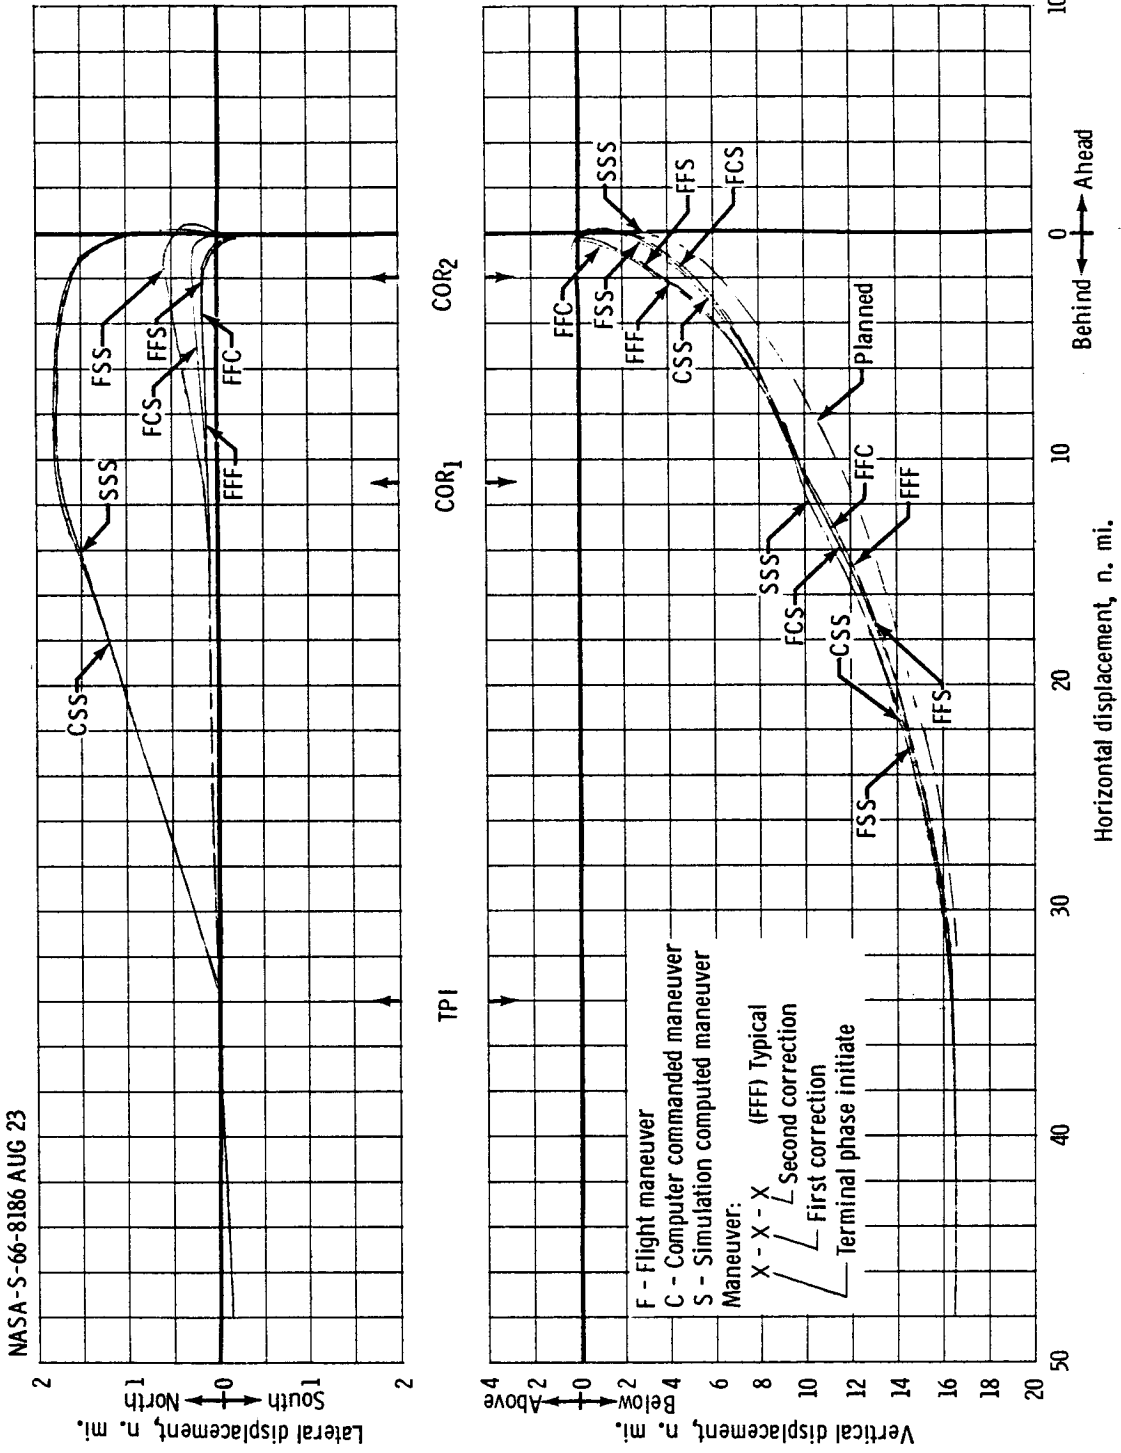
Figure 5.1.5-14. - First rendezvous simulations, with fixed platform misalignment.

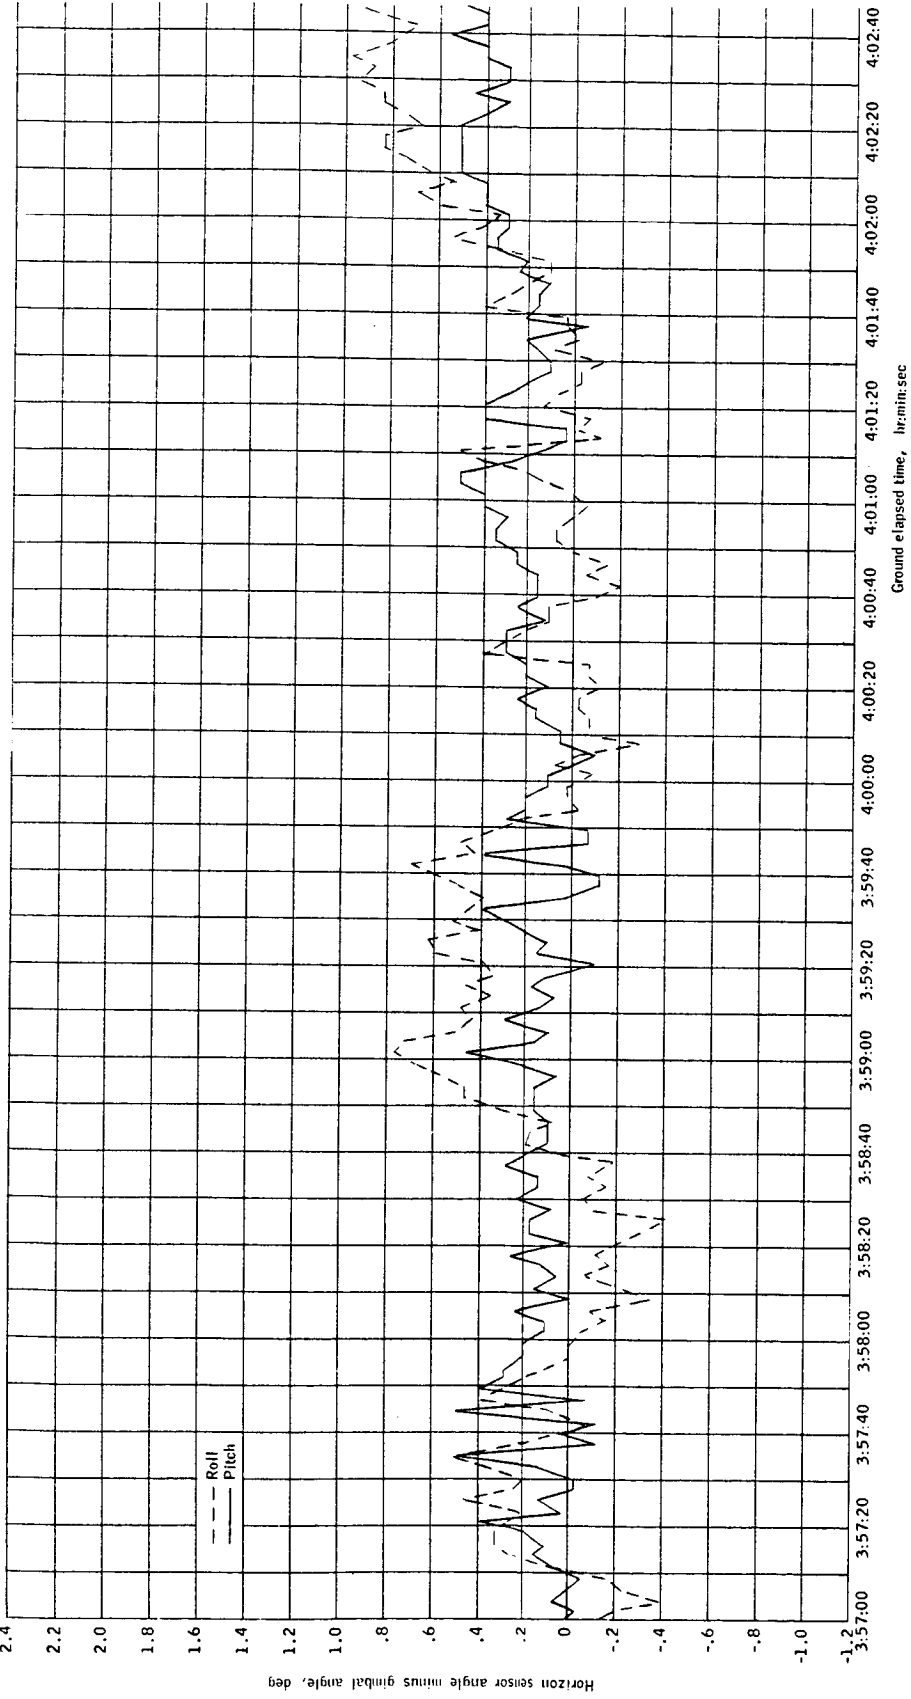
(a) 3:57:00 to 4:05:00 g.e.t.

Figure 5.1.5-21. -Platform alignment prior to TPI of the first rendezvous.

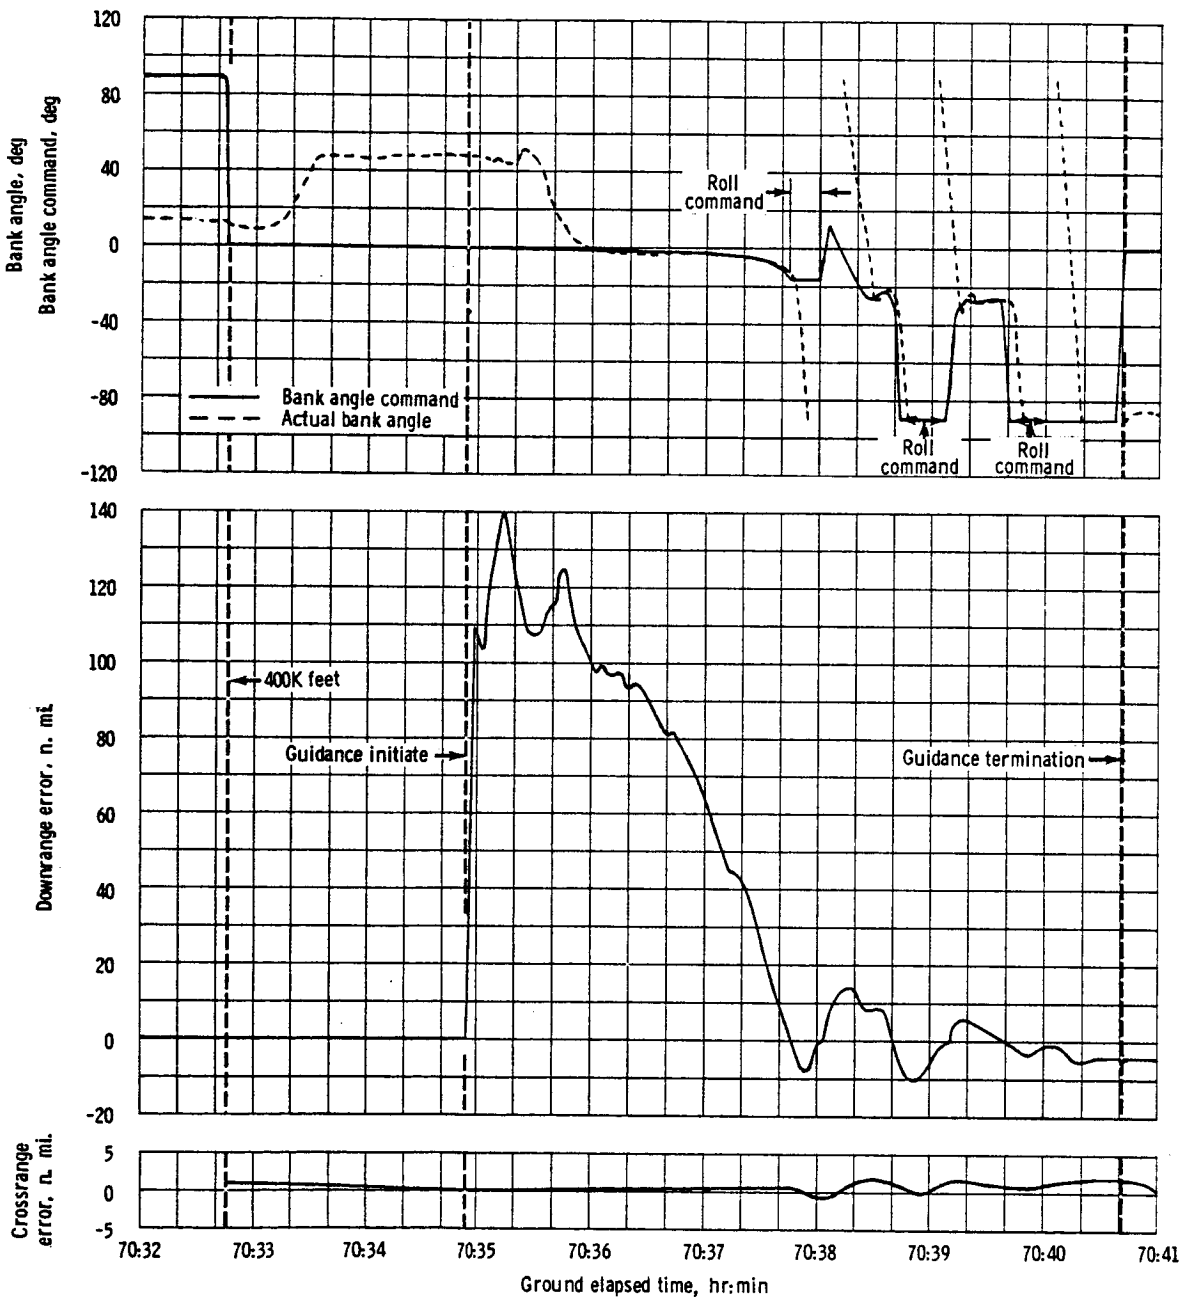
Figure 5.1.5-24. - Reentry guidance parameters.

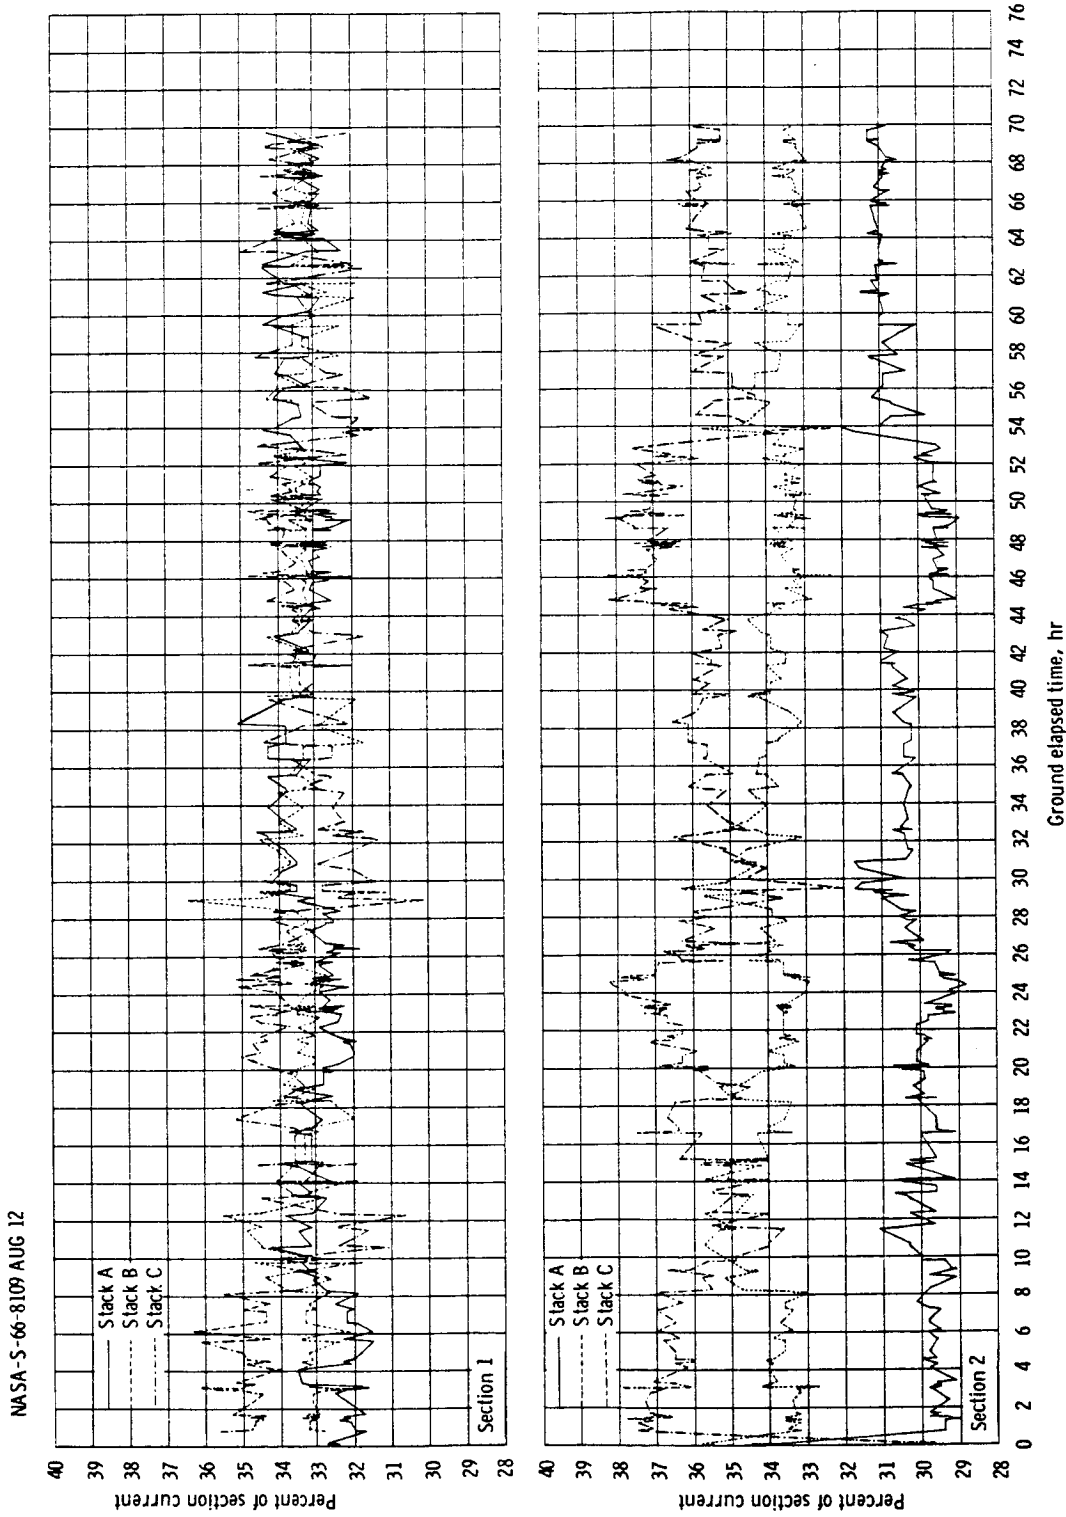
Figure 5.1.7-4. - Load sharing between fuel-cell stacks.
