GEMINI PROGRAM MISSION REPORT

GEMINI X

AUGUST 1966

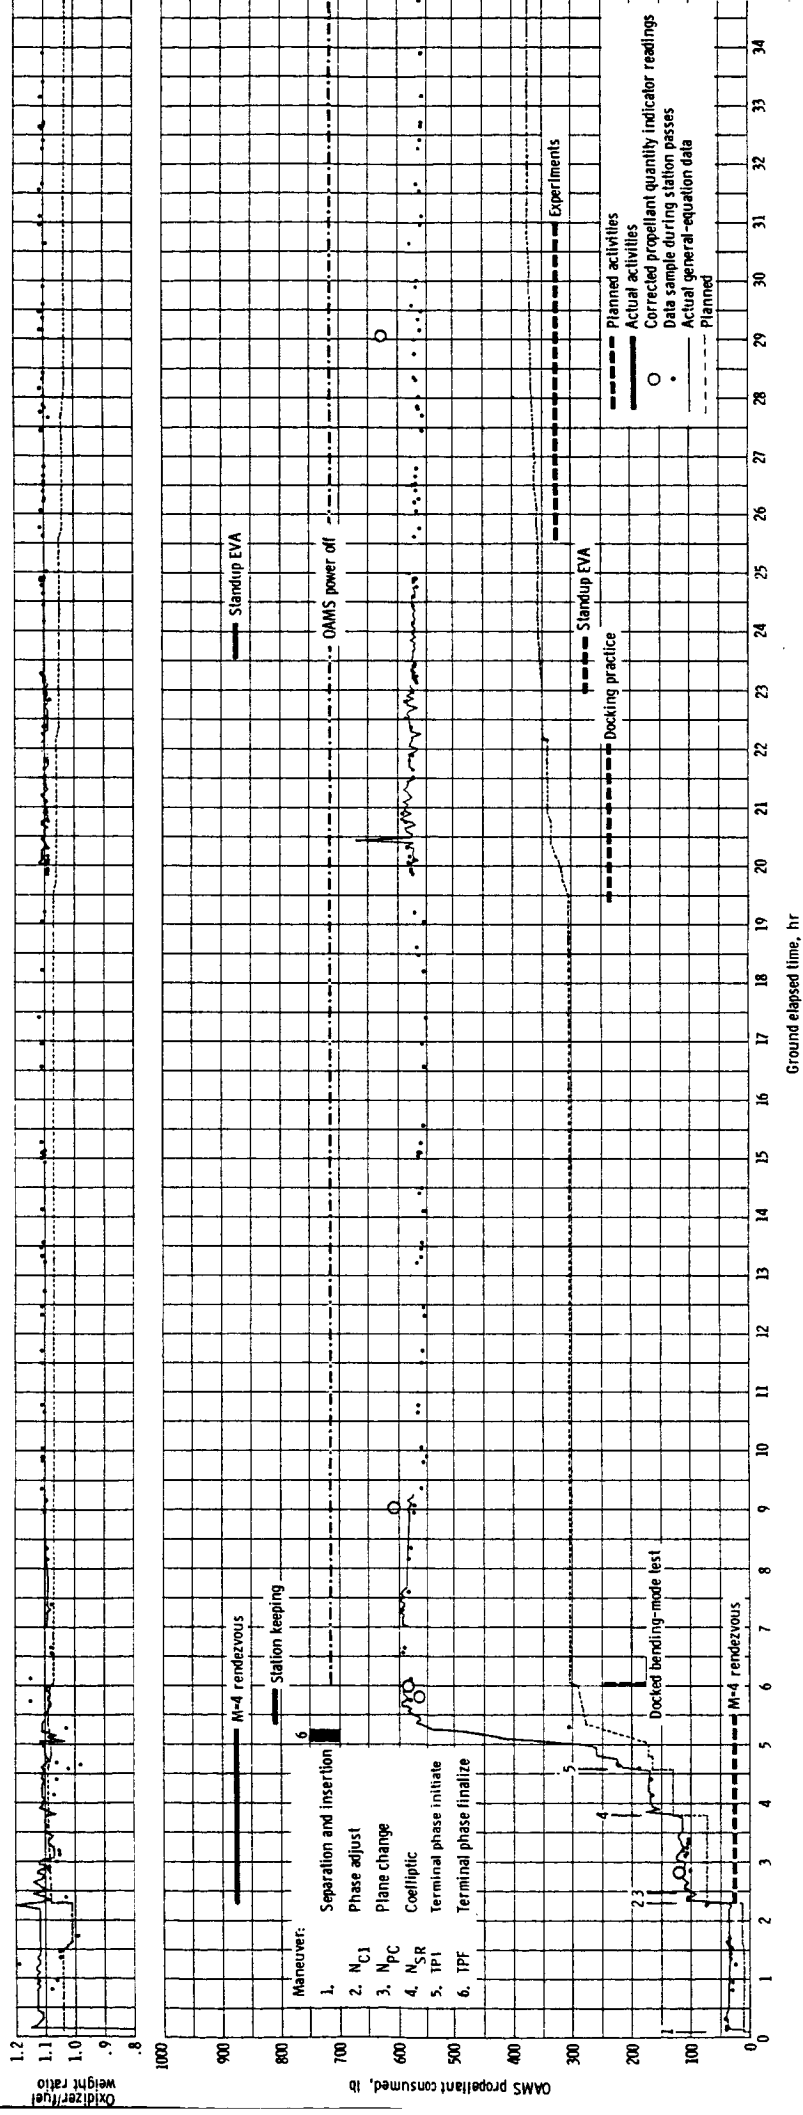
(a) 0 to 35 hours g.e.t.
Figure 5.1.8-1. - OAMS propellant consumption, 5-74-a

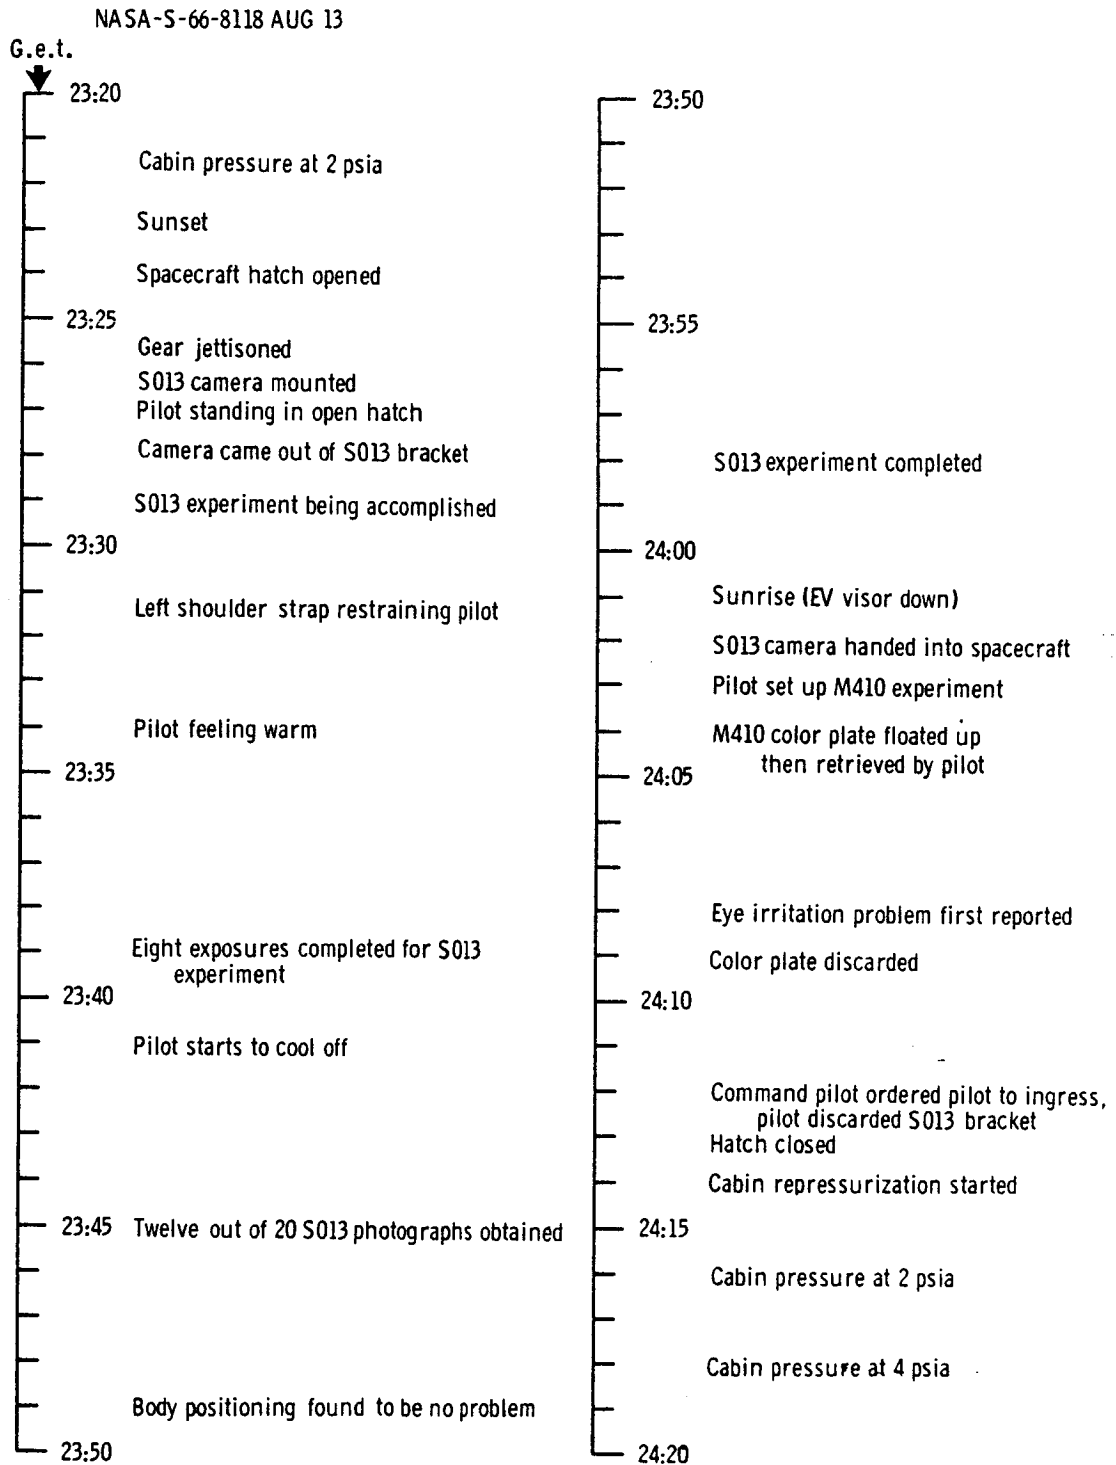
(a) Standup.

Figure 5.1.10-1. - EVA events.

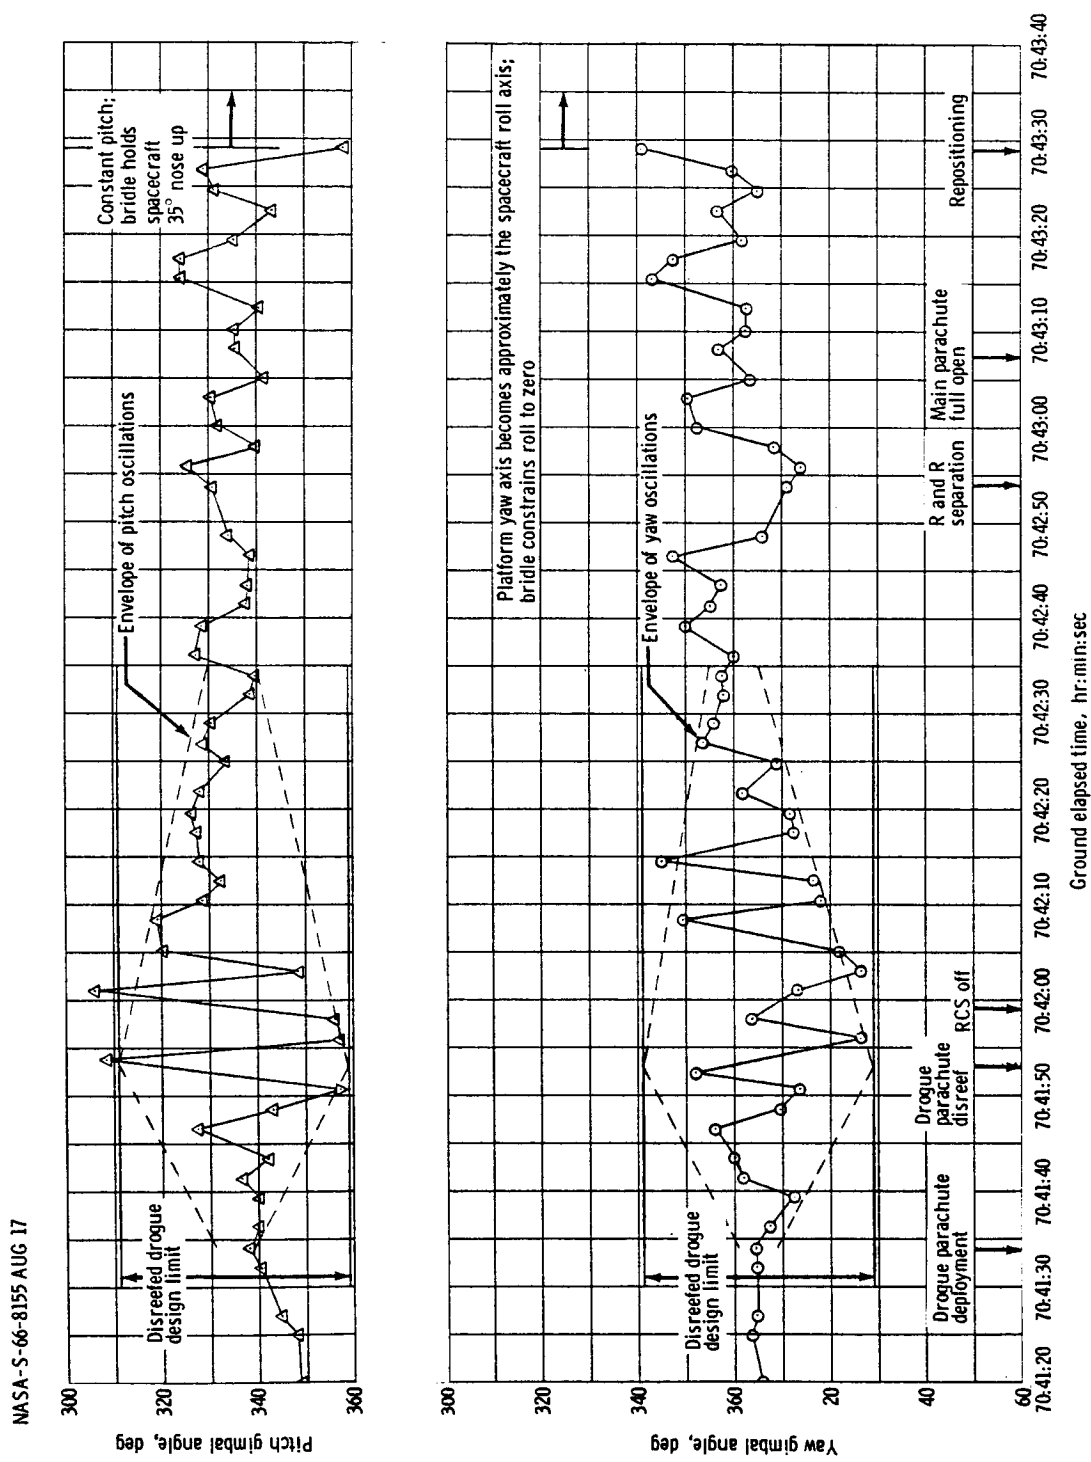
Figure 5.1.11-2. - Spacecraft pitch and yaw gimbal angles during landing maneuver.

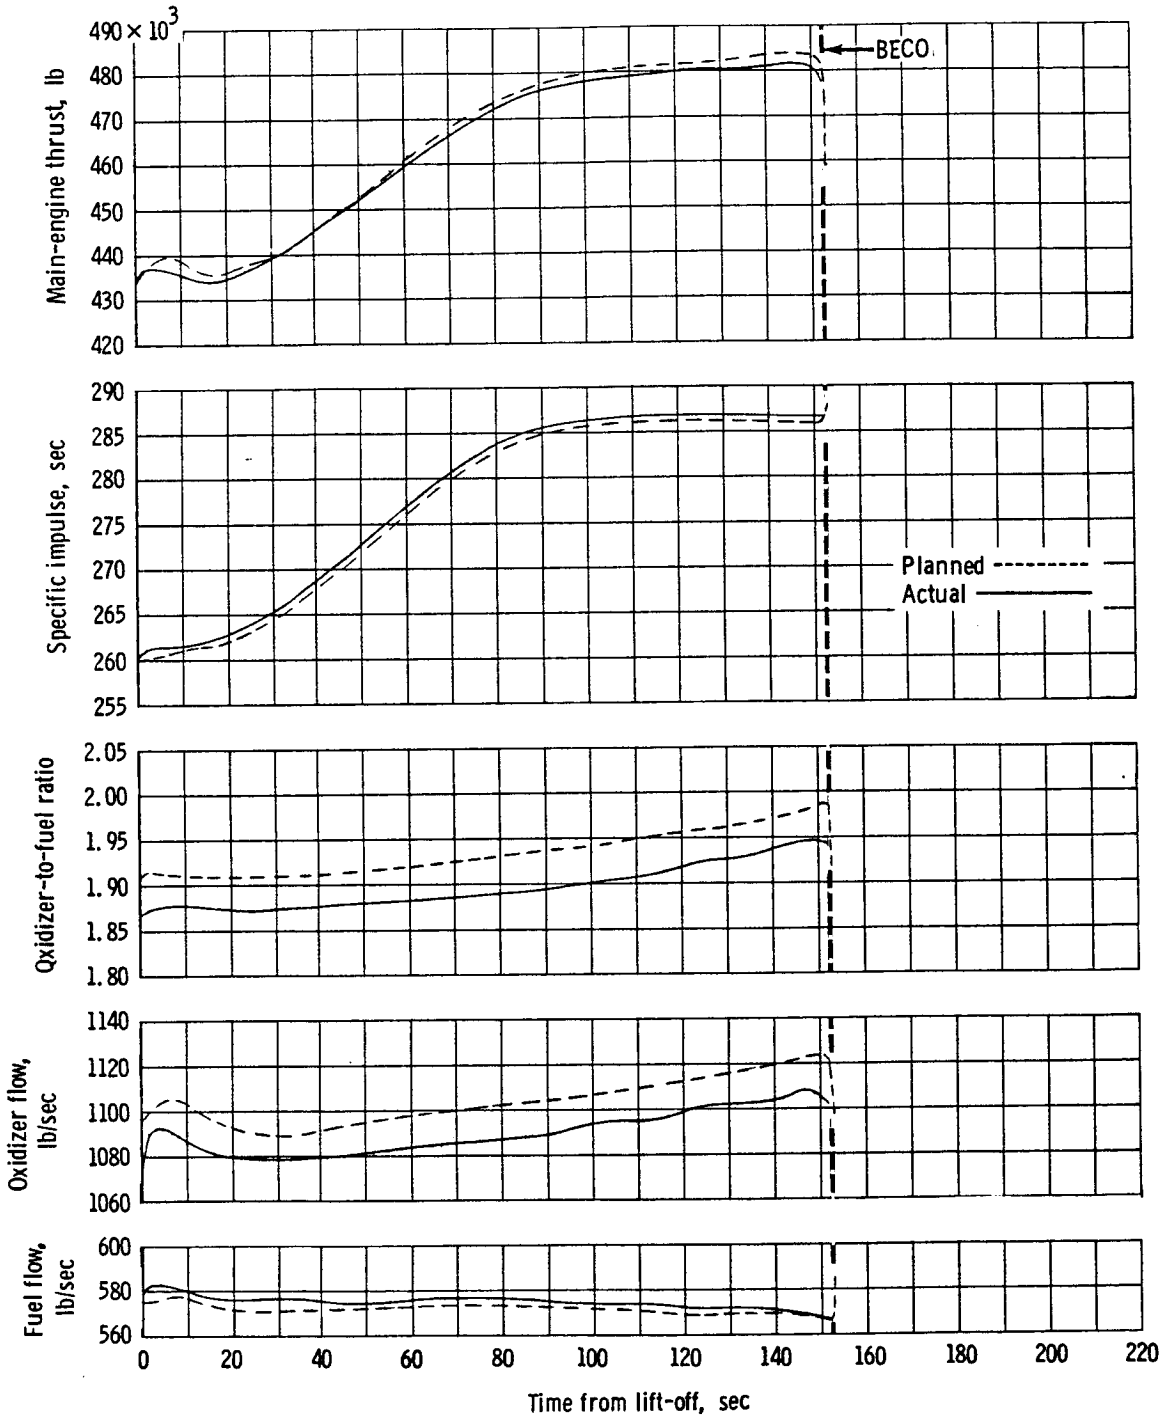
Figure 5.2-1. - Stage I engine performance.

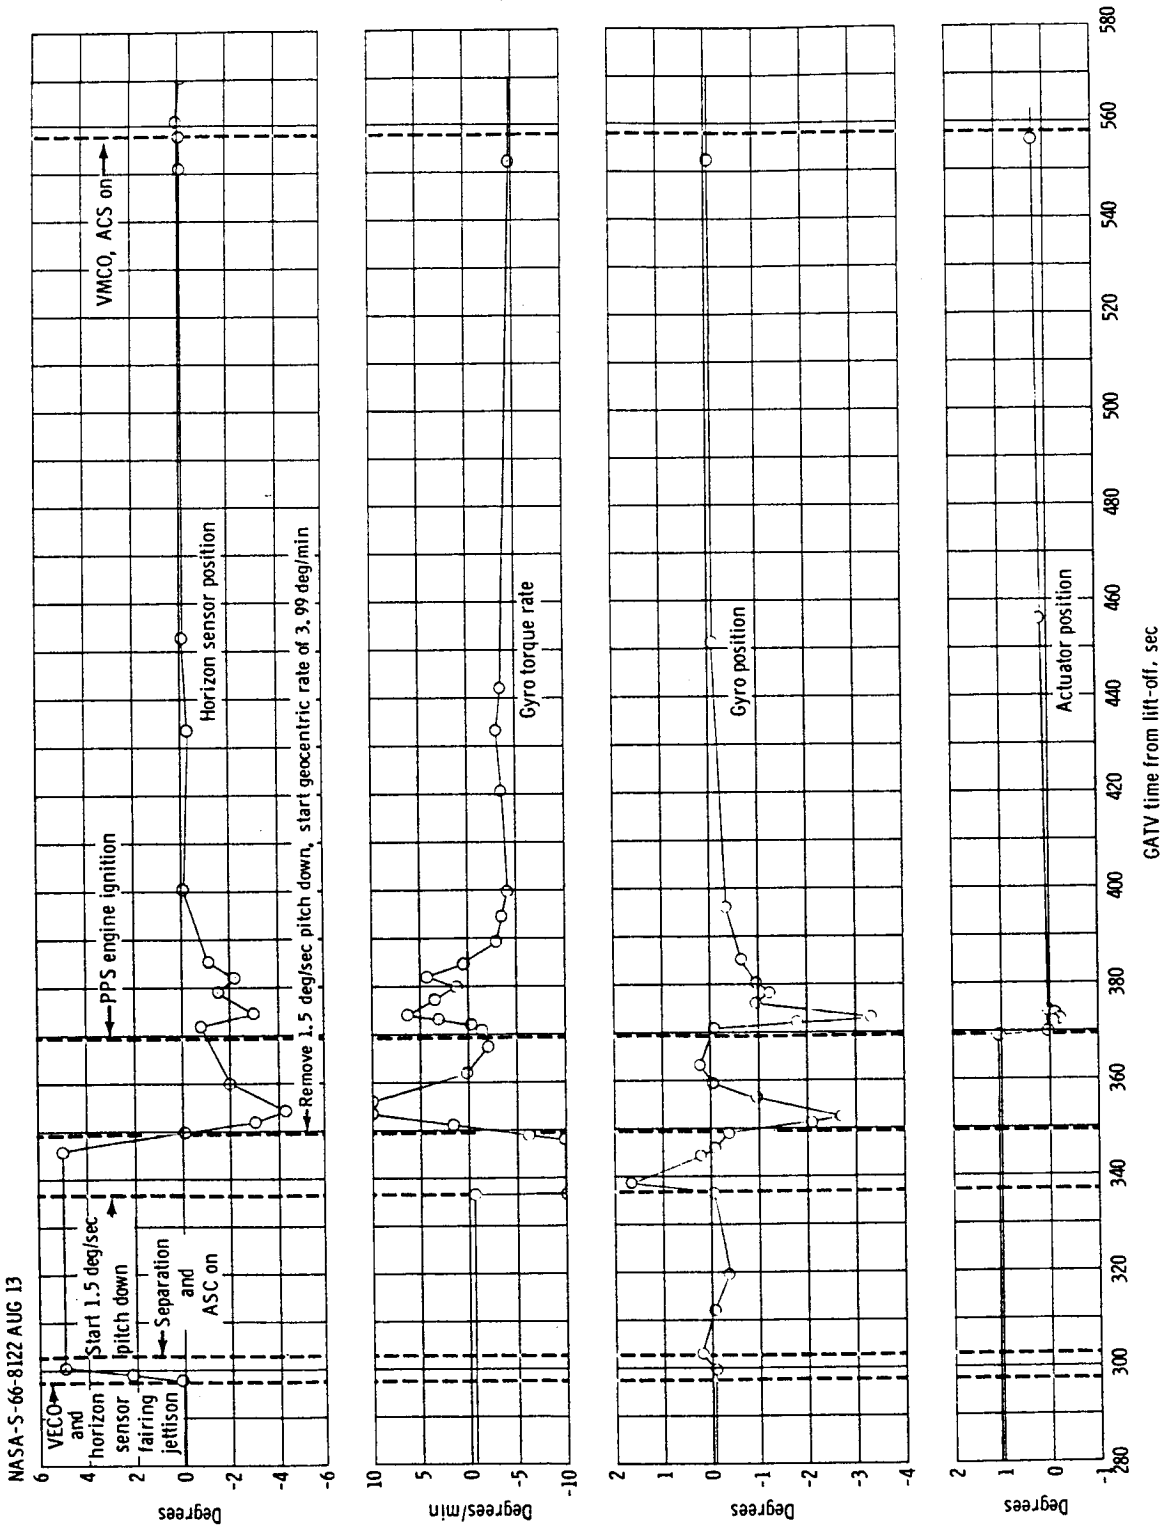
(a) Pitch axis.
Figure 5.4-3. - Ascent guidance performance.

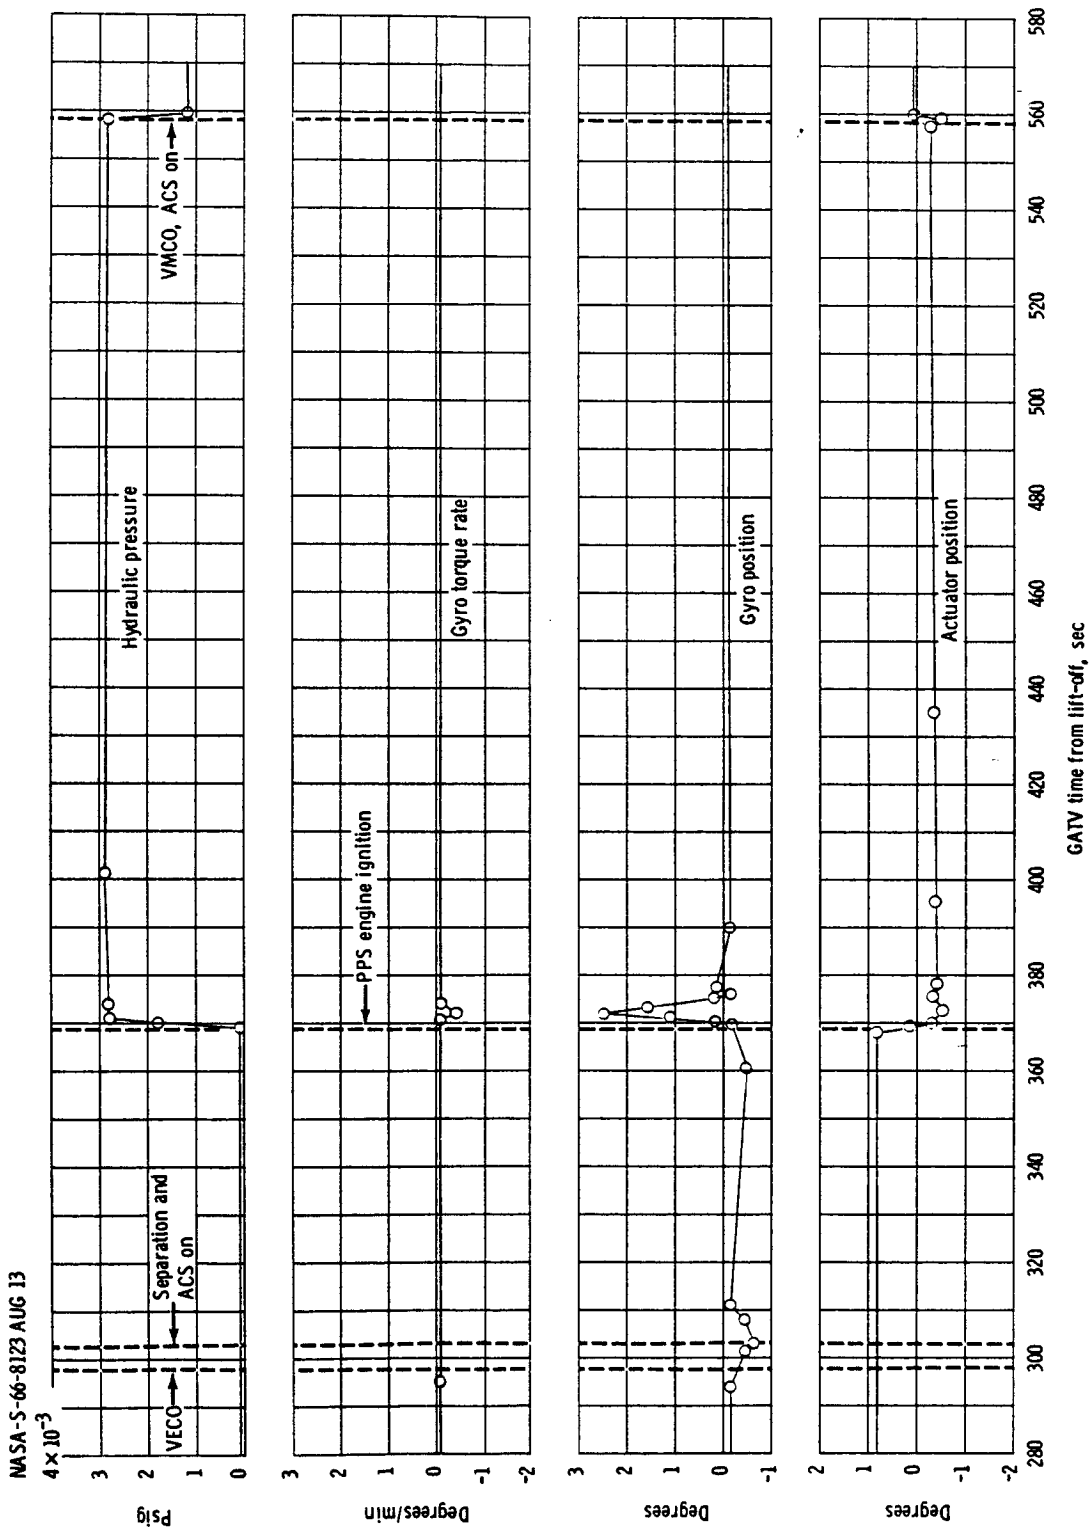
(b) Yaw axis.
Figure 5.4-3. - Continued.

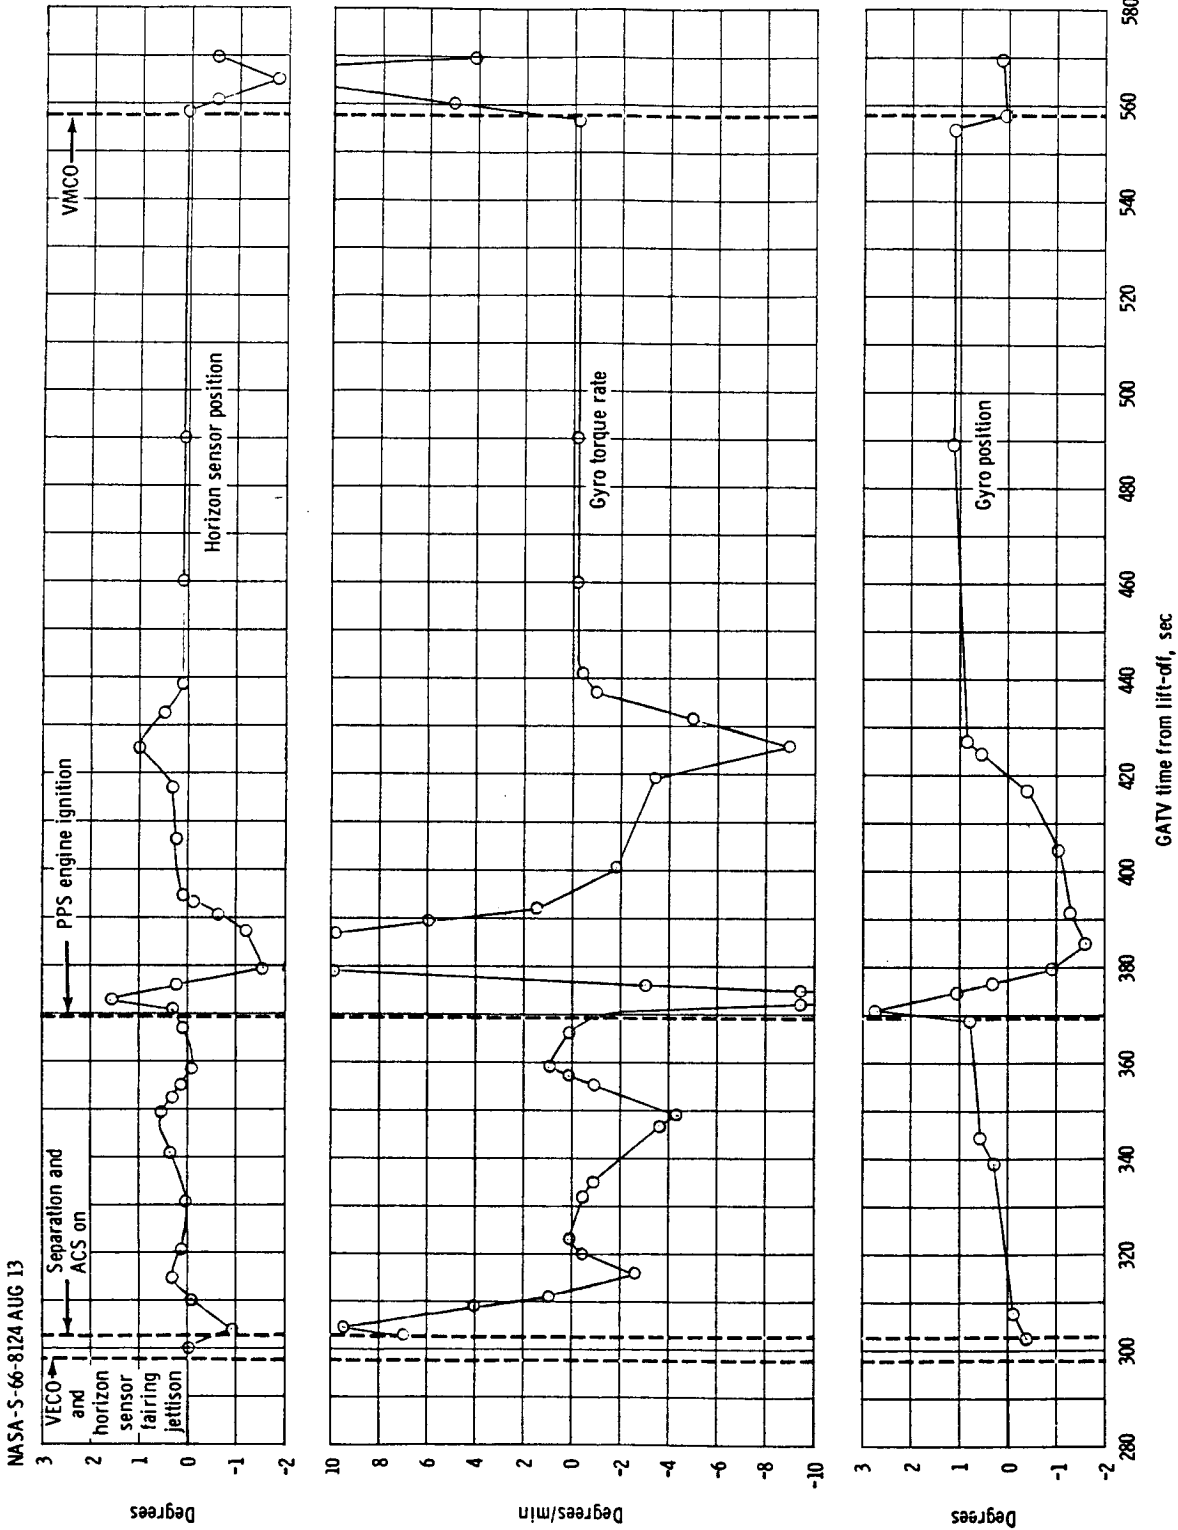
(c) Roll axis.
Figure 5.4-3. - Concluded.

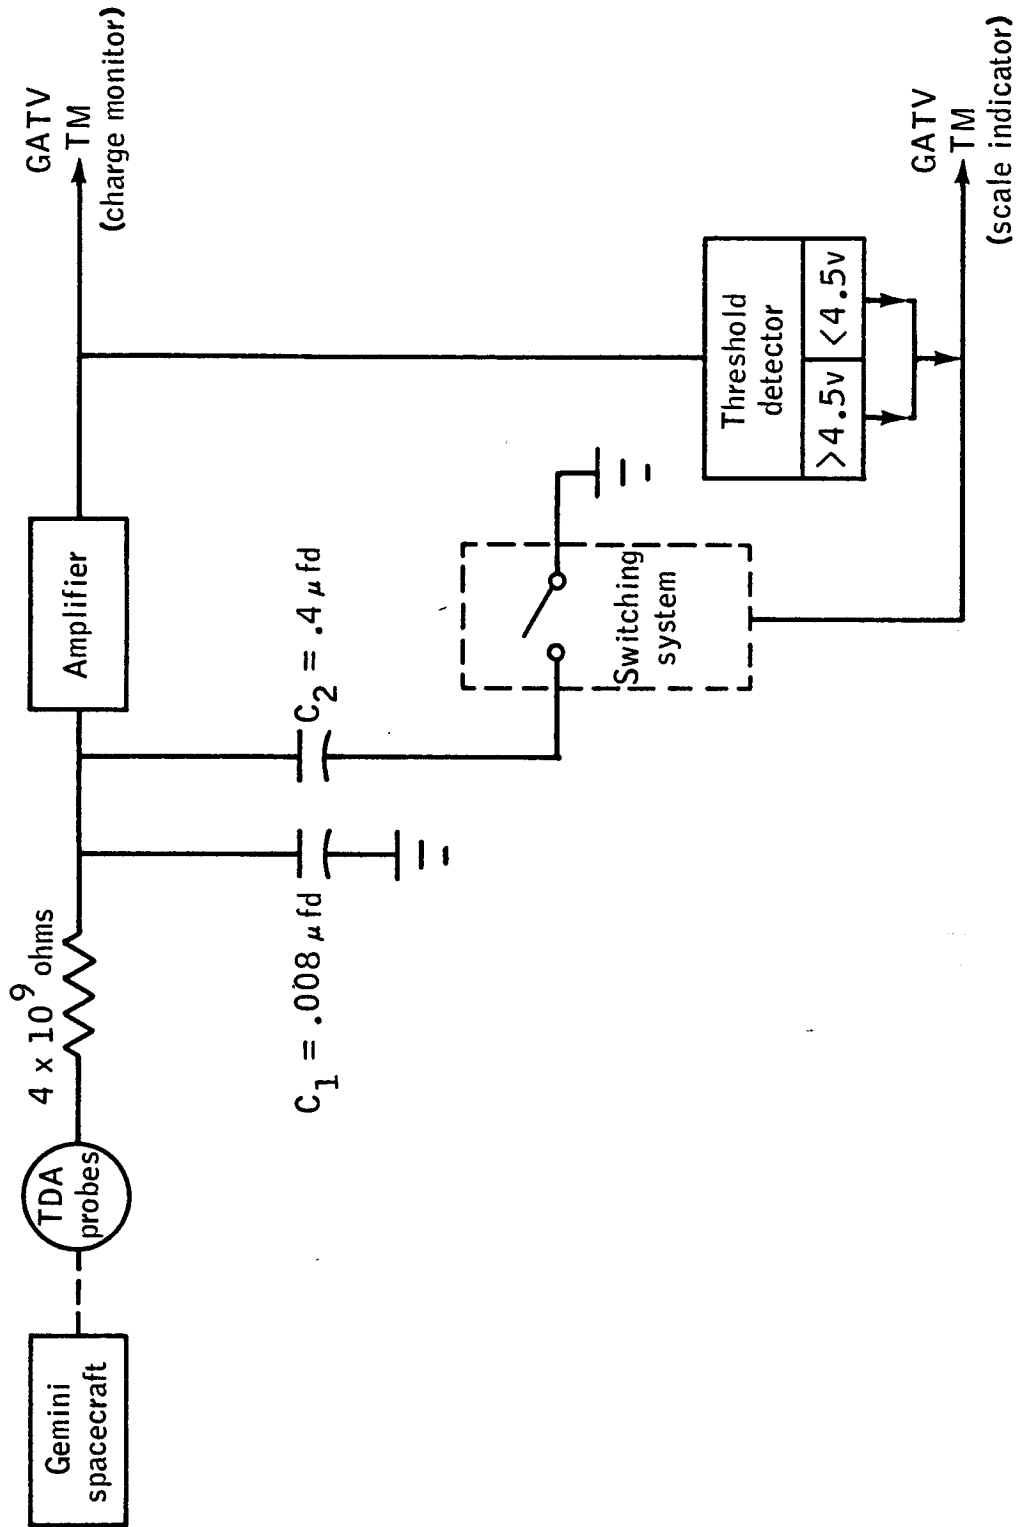
Figure 5.7-1. - Electrostatic charge monitor functional diagram.

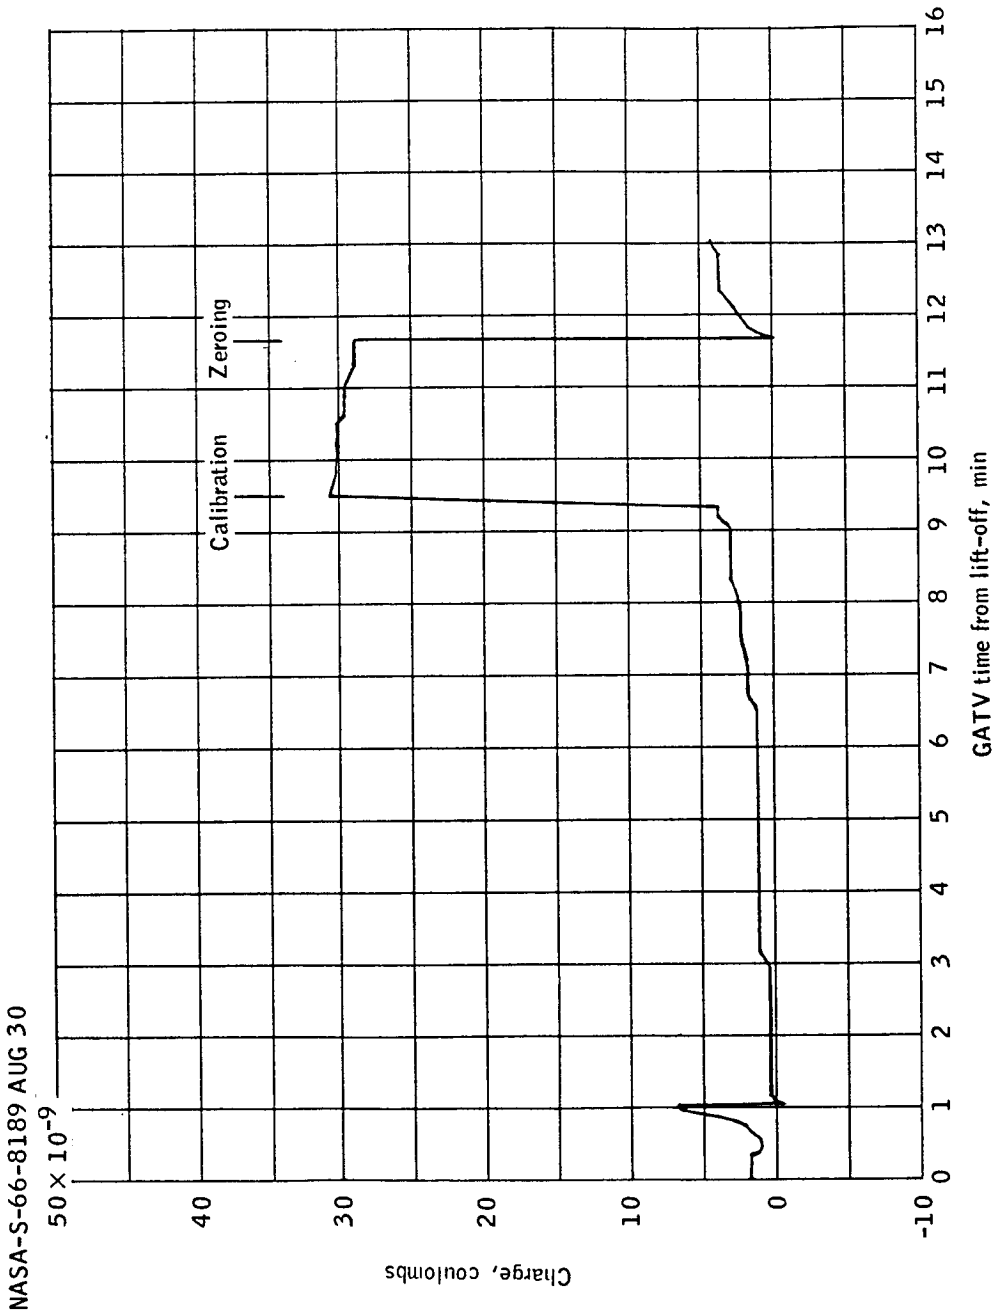
(a) Lift-off to 13 minutes, GATV target elapsed time

Figure 5.7-2. - Charge on capacitor C1.

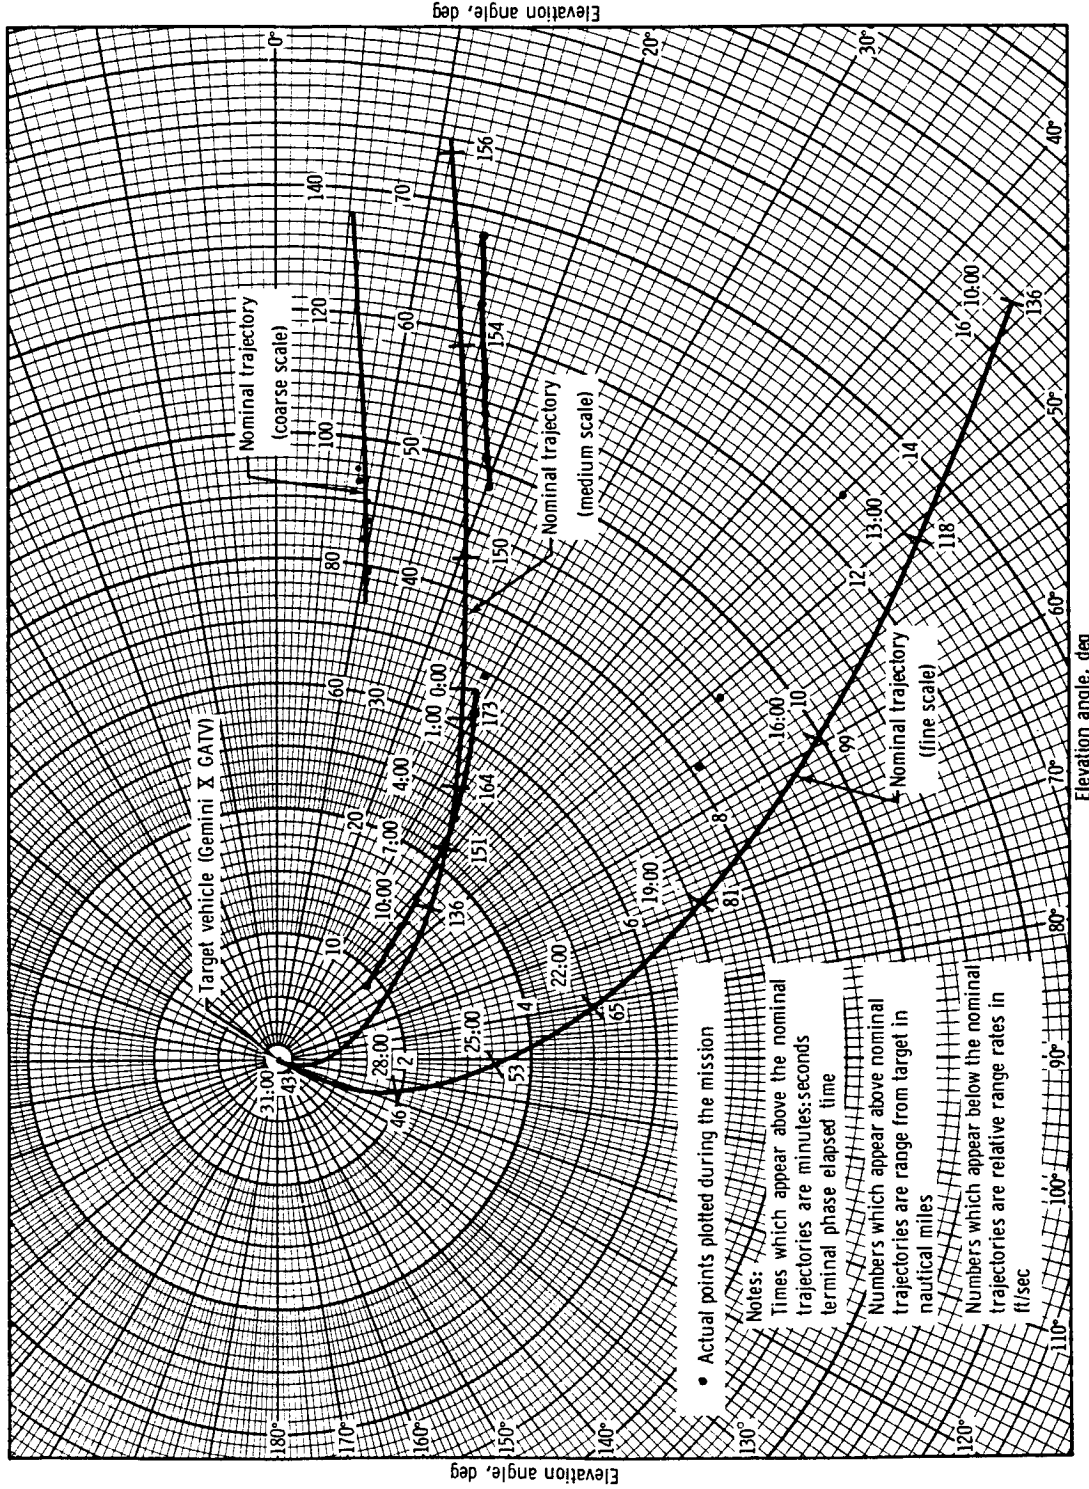
Figure 7.1.2-1. - Onboard target-centered coordinate plot of first rendezvous.

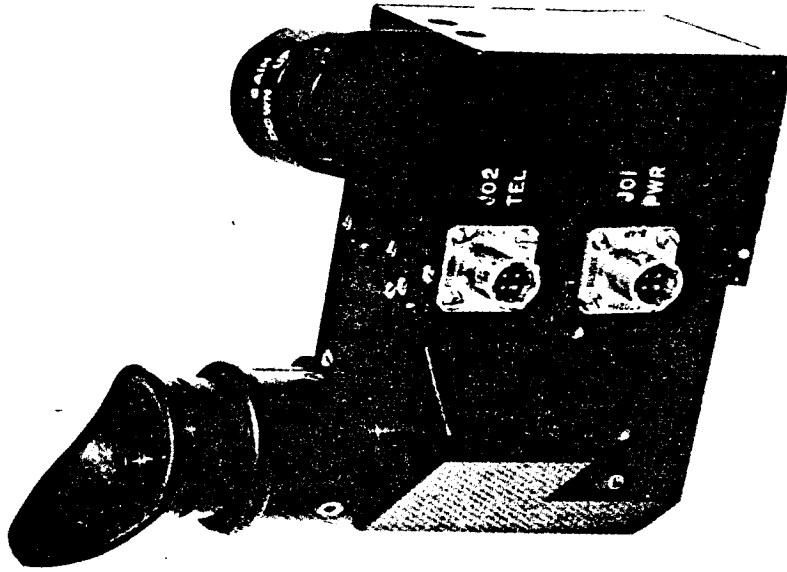
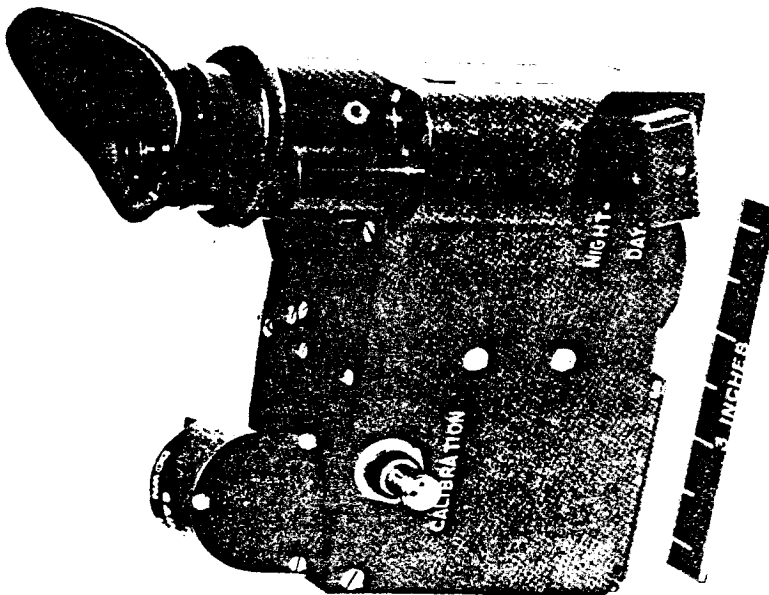
Figure 8.1-1. - Experiment D005, star occultation photometer.

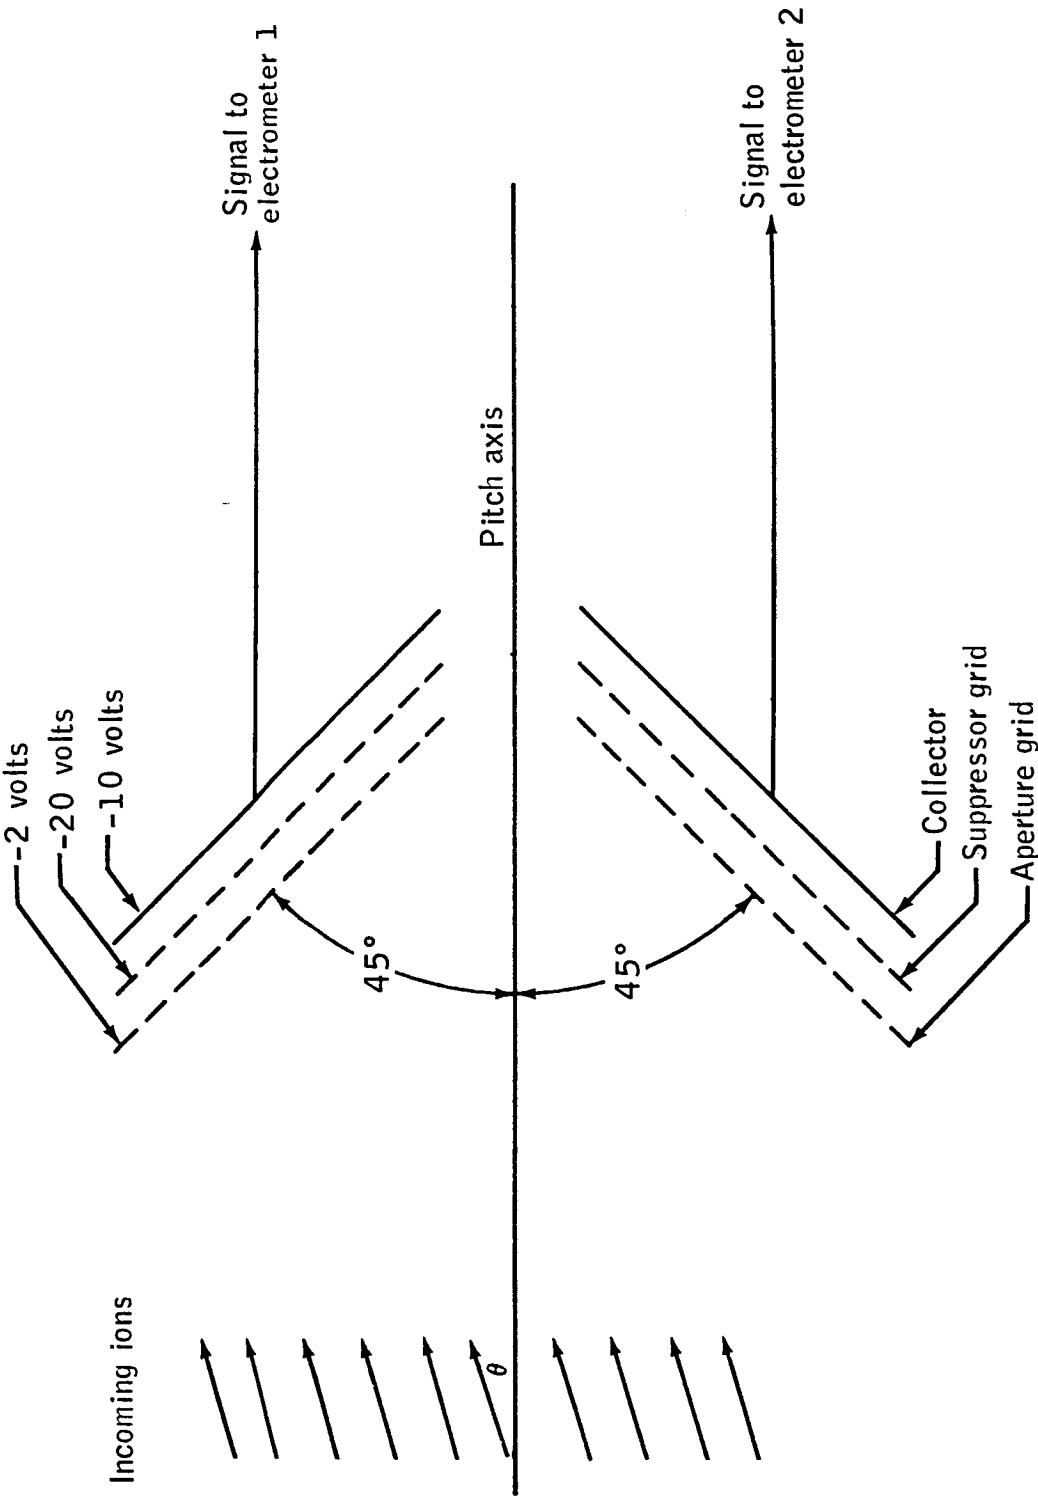
Figure 8.2-2. - Experiment D010, ion-sensing configuration.

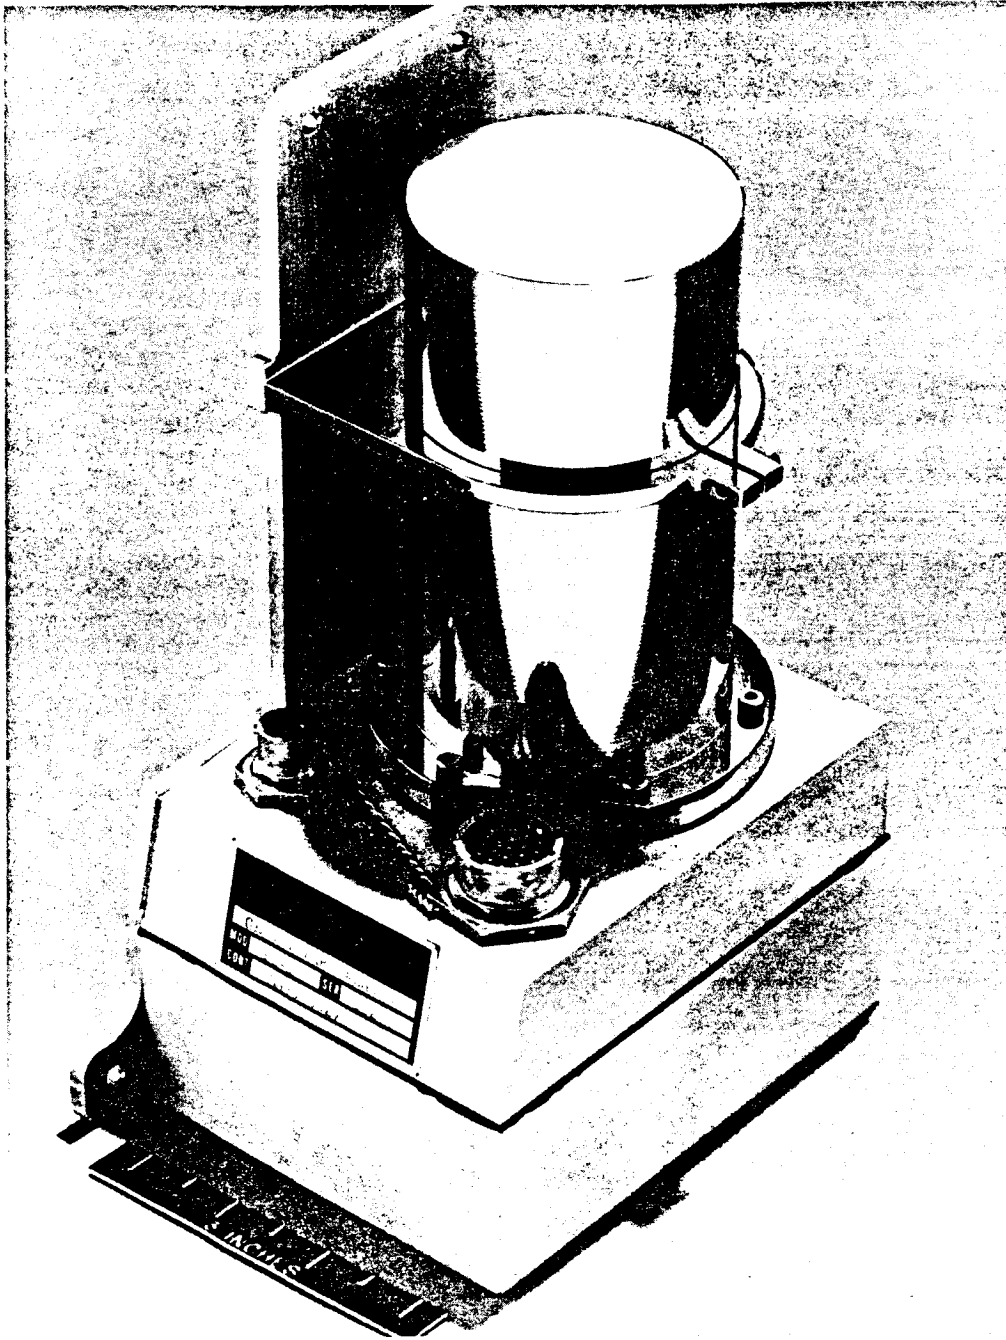
Figure 8.5-1. - Experiment M409, bremsstrahlung spectrometer.

A few spectra were observed during post-pass telemetry dumps at the Hawaii ground station. These spectra indicated that the spectrometer functioned as expected. The computer data processing will consist of reconstruction of spectra as a function of spacecraft time and path. The reconstruction will involve decompressing transmitted numbers, adding sensor efficiency, dead time, and calibration factors, and correlating spacecraft attitude and position. The final results of the experiment will be determined after data from several complete revolutions are processed and analyzed.

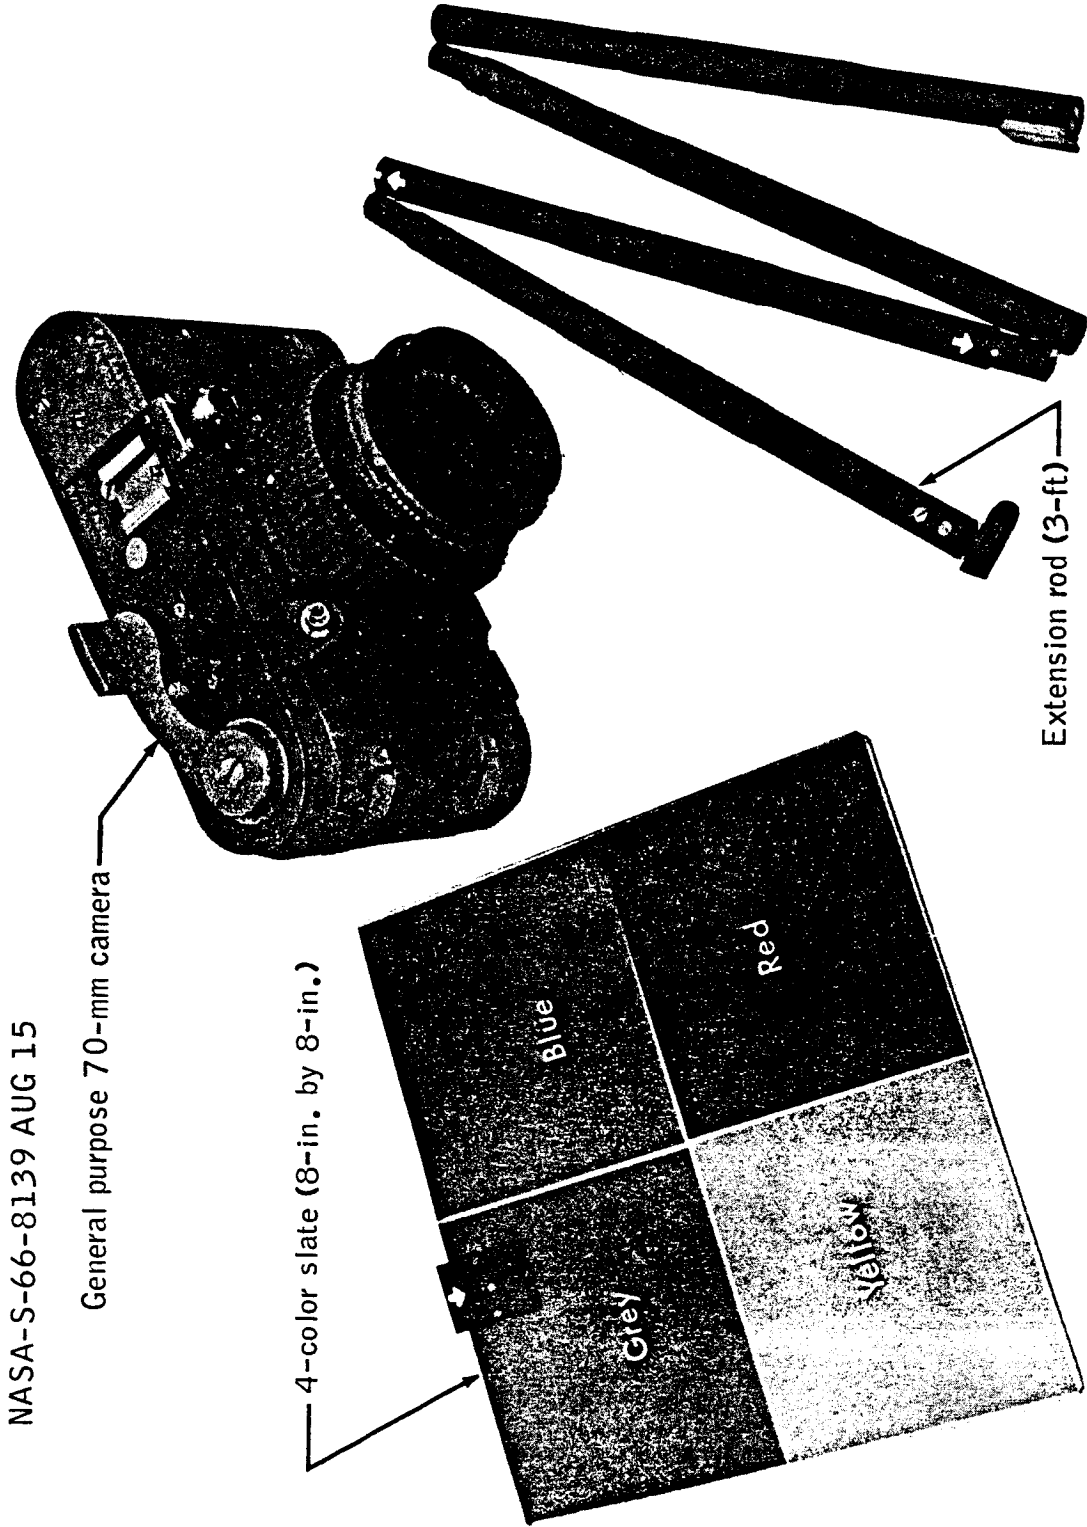
Figure 8.6-1. - Experiment M410, hardware configuration.
