GEMINI PROGRAM MISSION REPORT

GEMINI X

AUGUST 1966

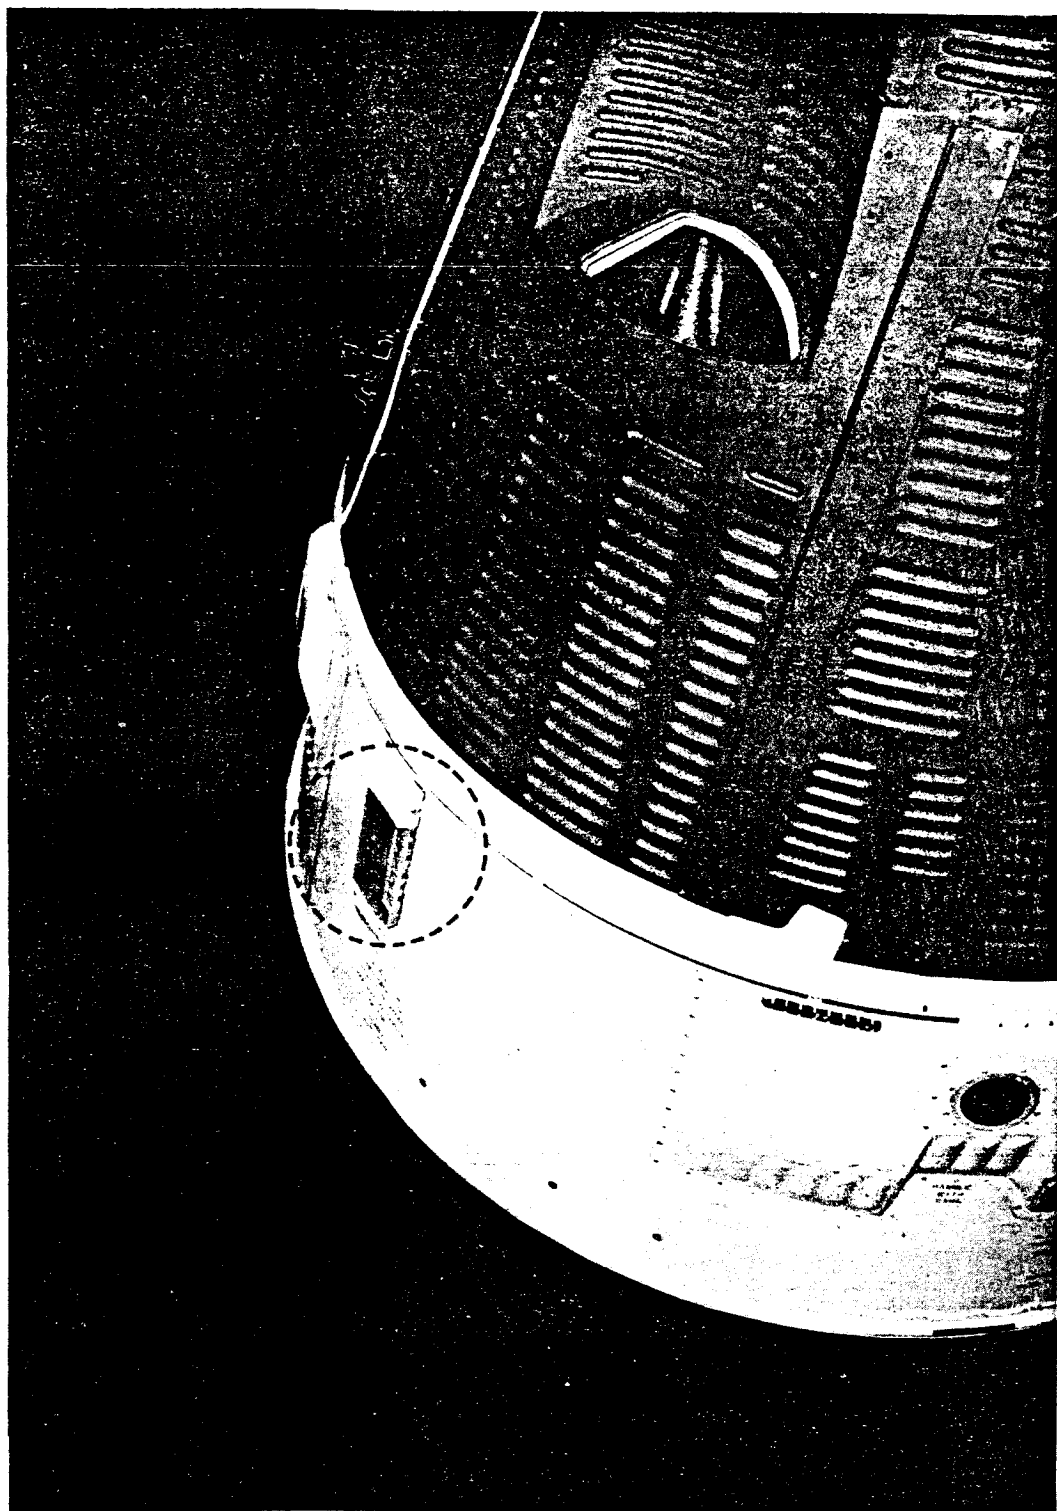
Figure 8.12-1. - Experiment S012, hardware location.

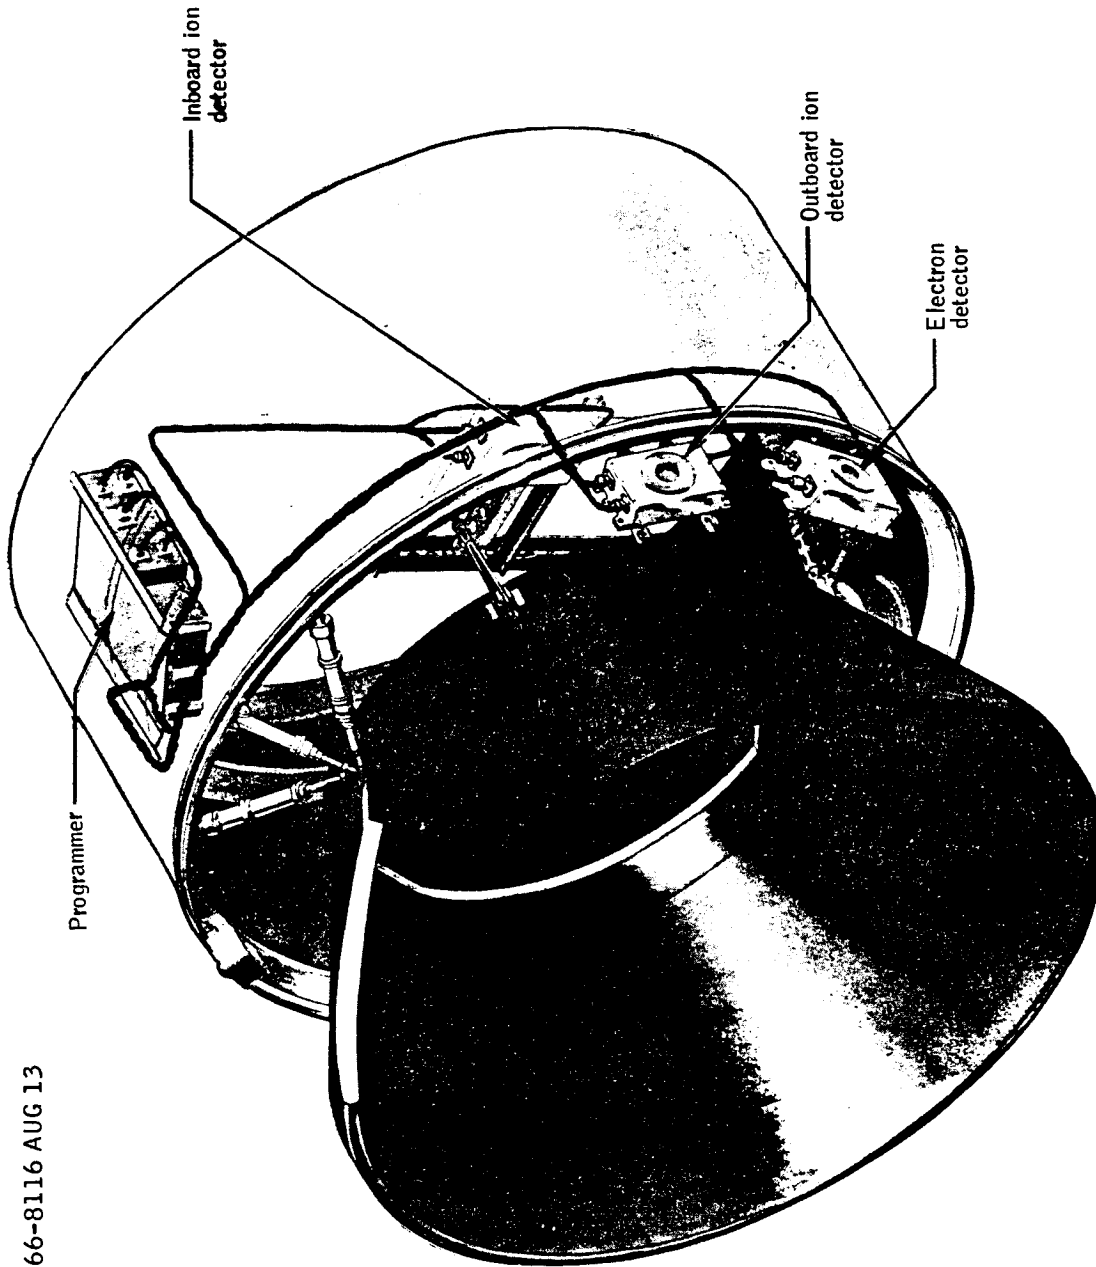
Figure 8.14-1. - Experiment S026, configuration on Target Docking Adapter.

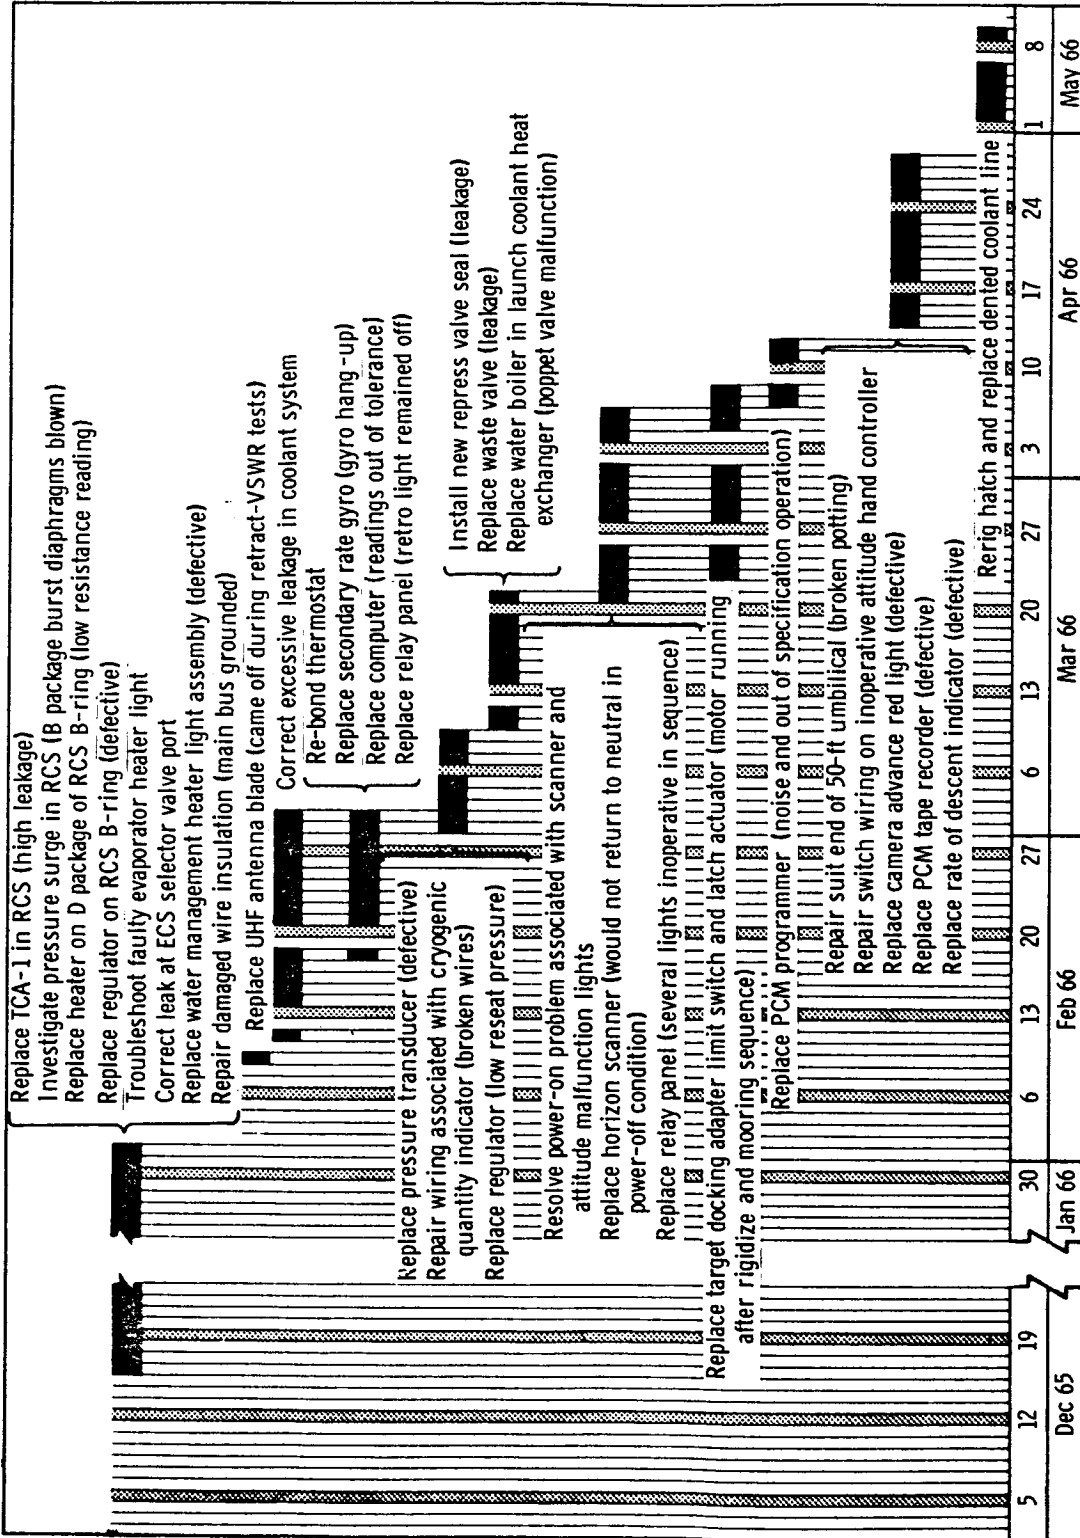
Figure 12.1-2. - Spacecraft 10 significant problems at contractor facility.

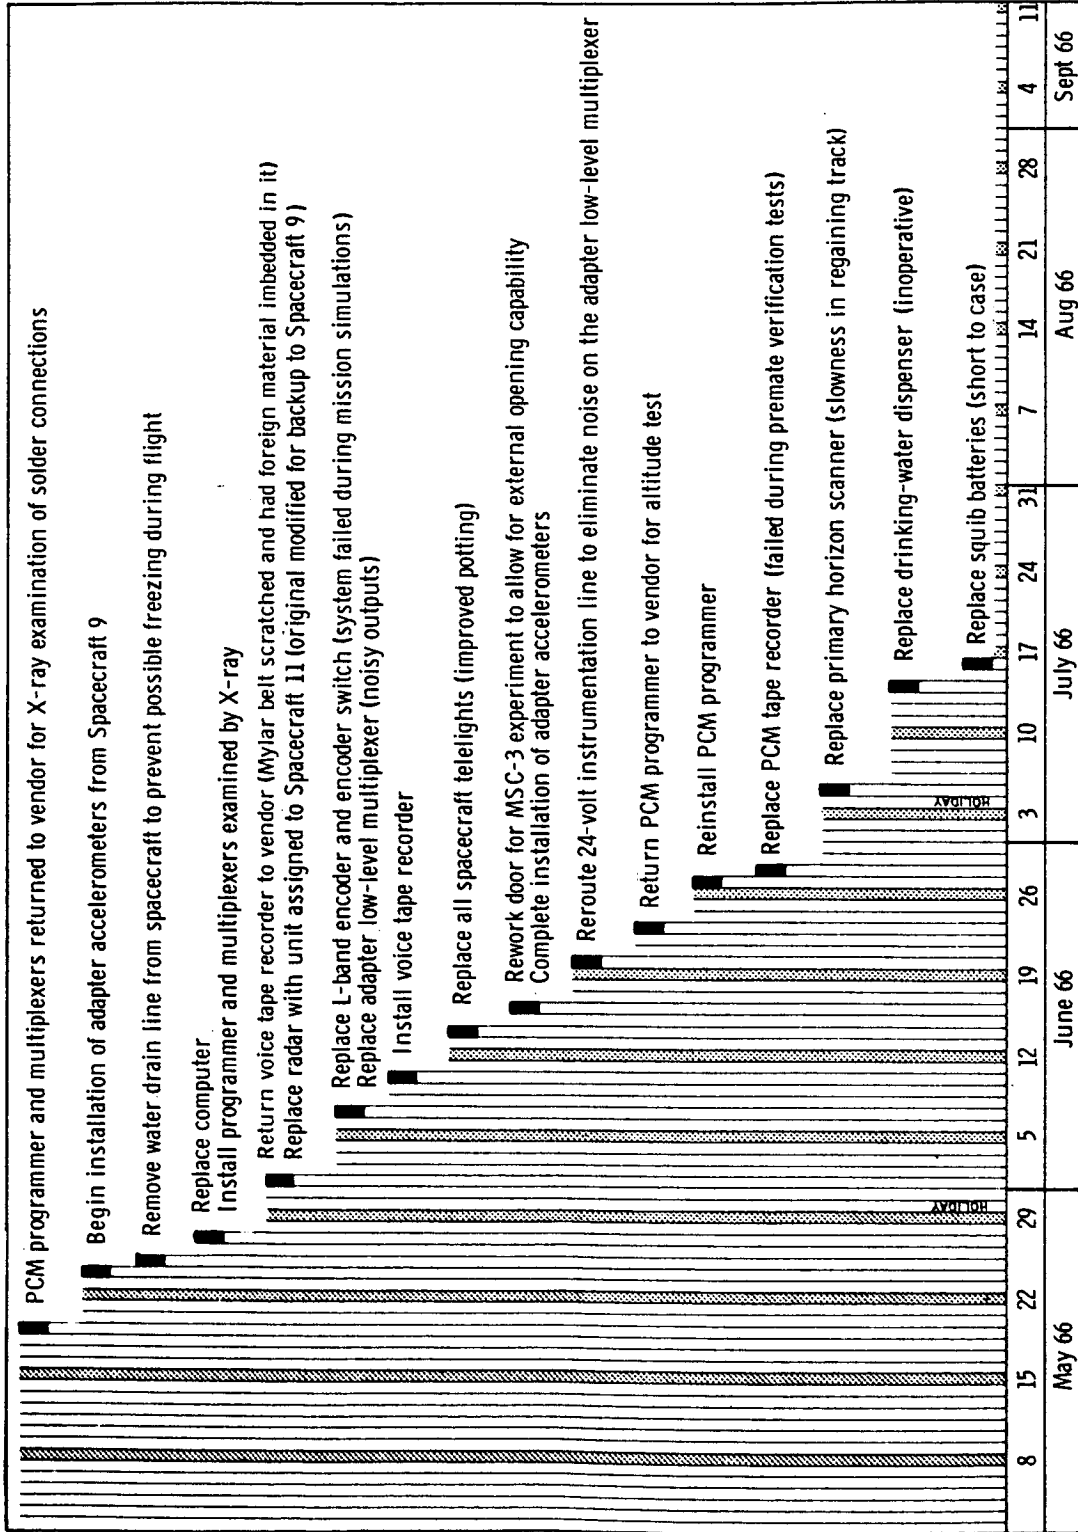
Figure 12.1-4. - Spacecraft 10 significant problems at Cape Kennedy.

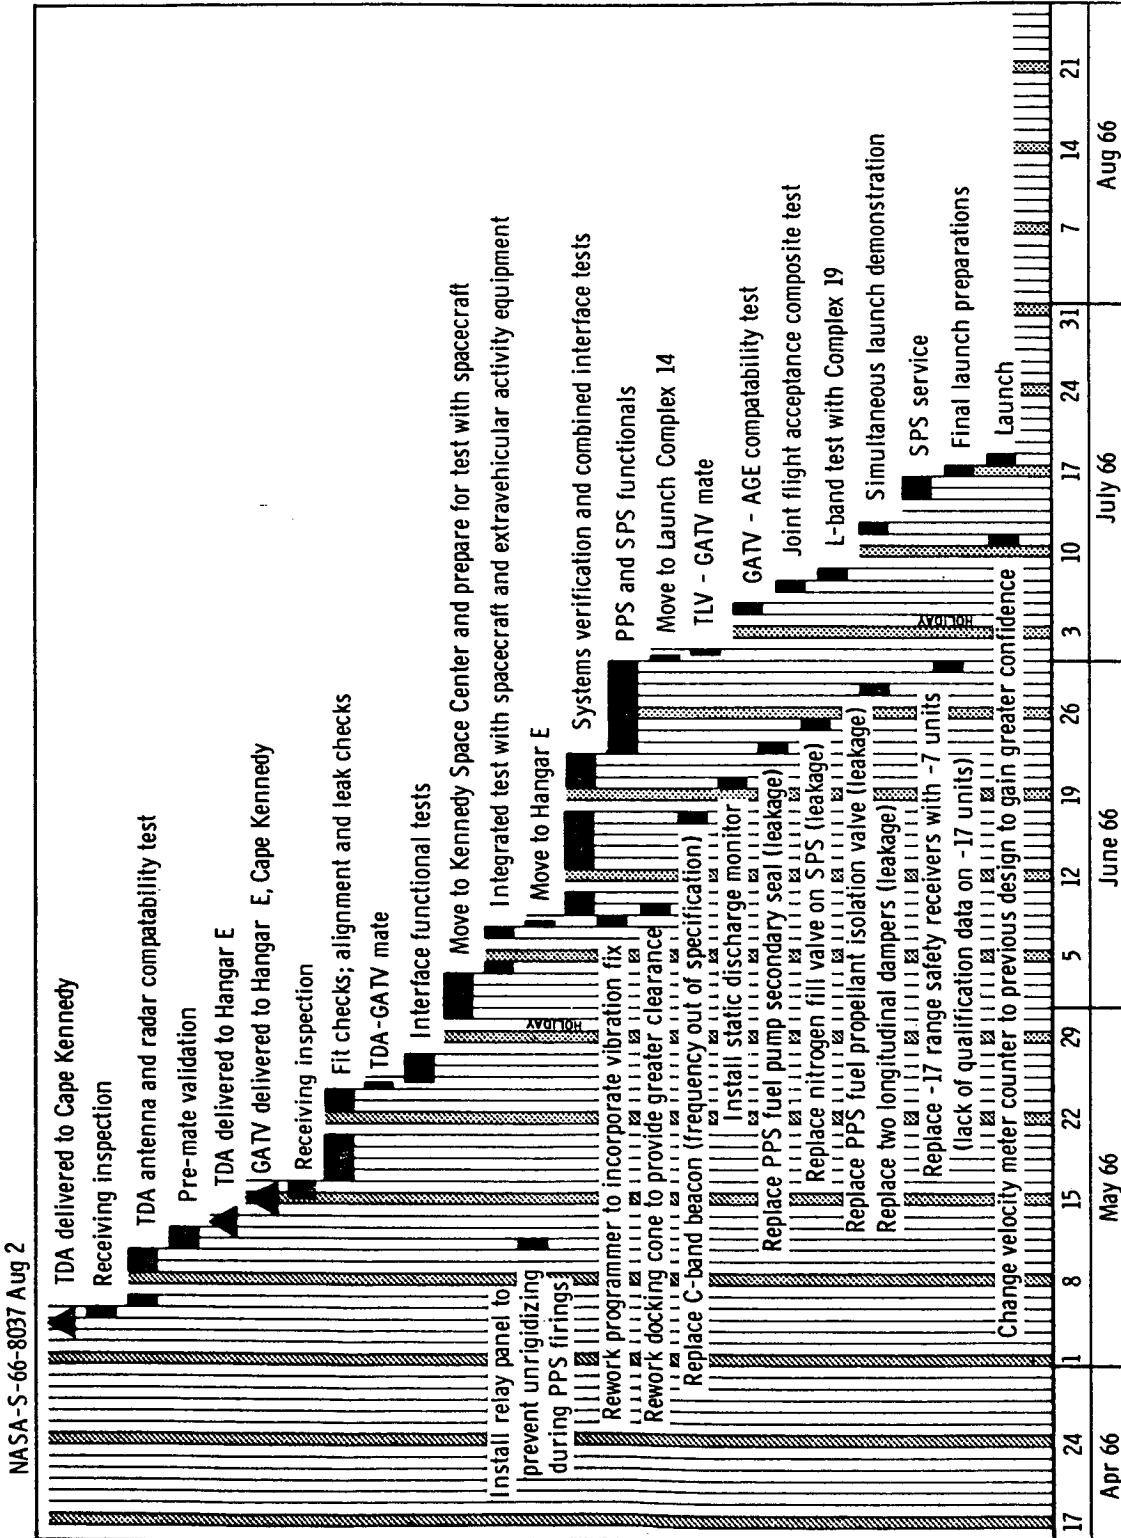
Figure 12.1-8. - GATV test history and significant problems at Cape Kennedy.

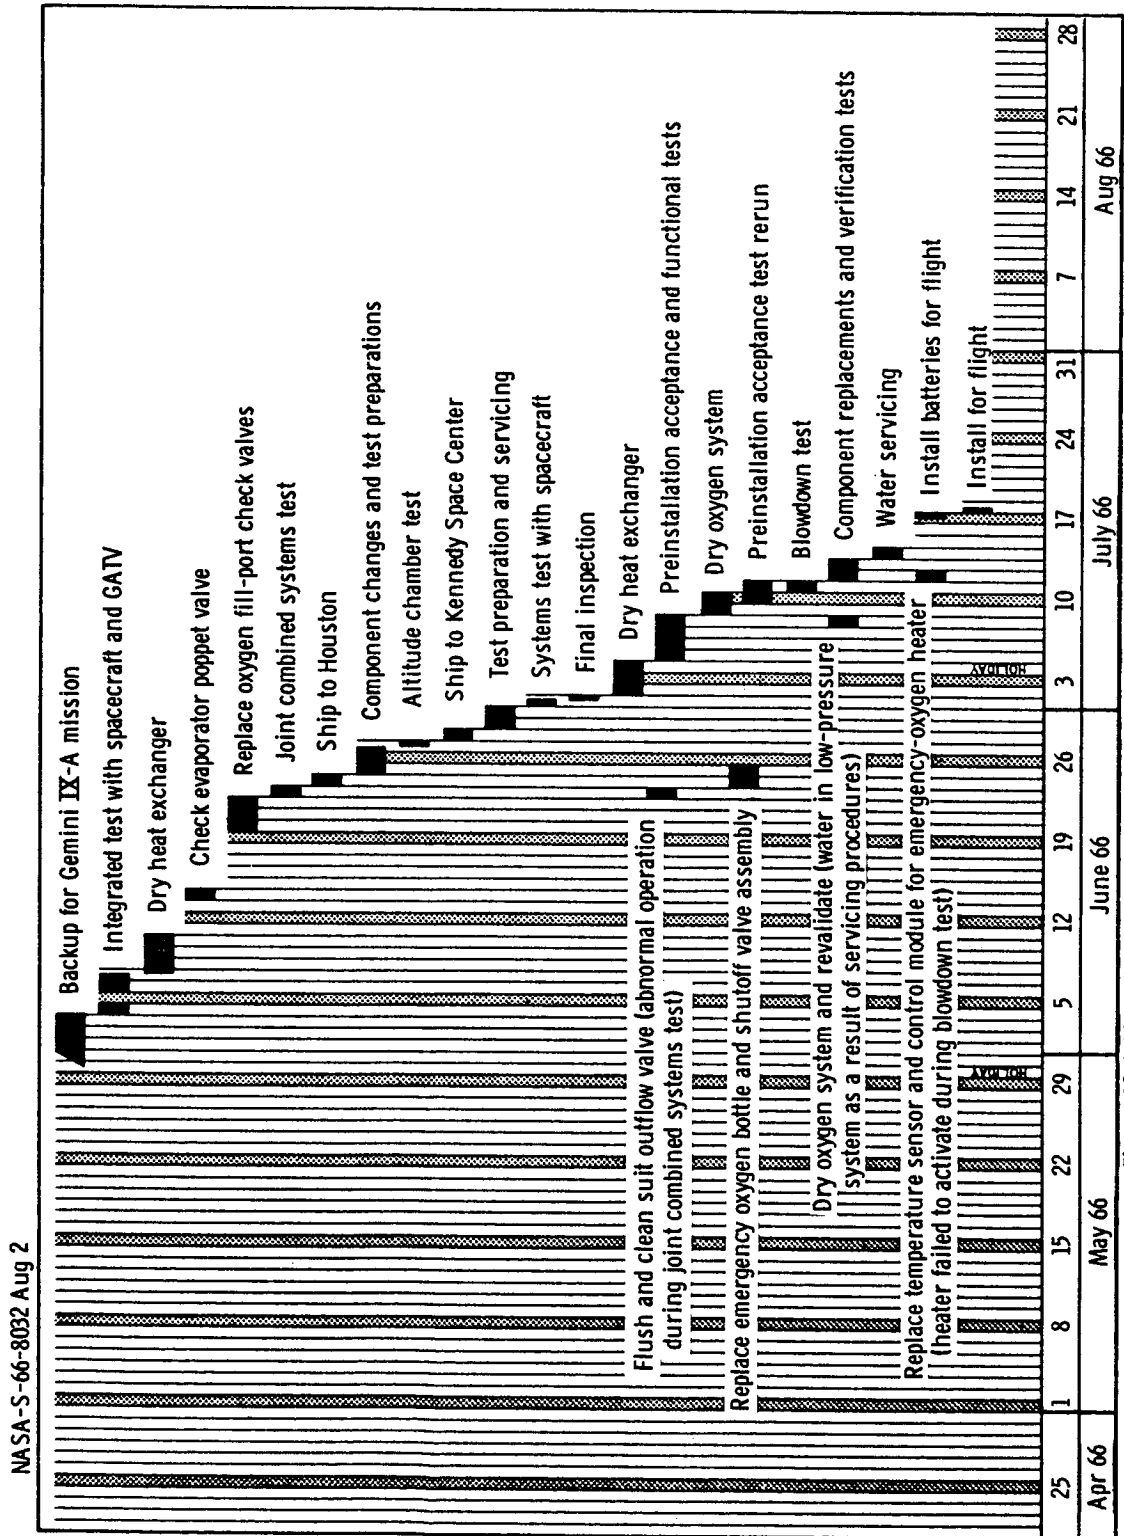
Figure 12.1-11. - ELSS III test history and significant problems at Cape Kennedy.
