APOLLO 4 MISSION REPORT

MANNED SPACECRAFT CENTER

January 1968

MSC-PA-R-68-1

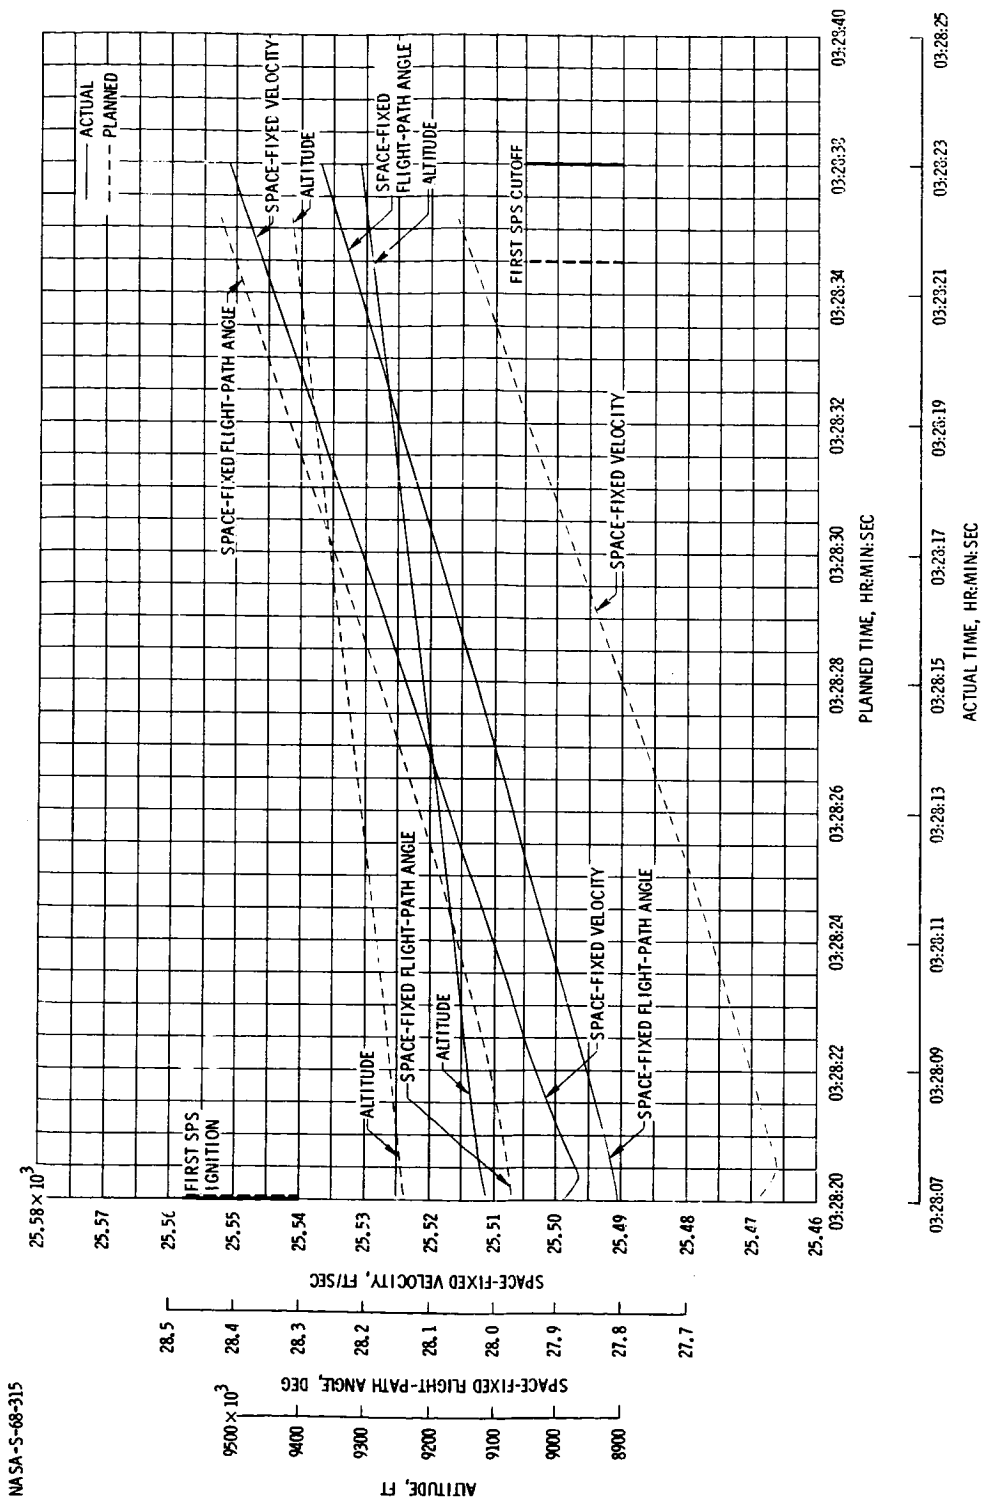
(A) FIRST SERVICE PROPULSION SUBSYSTEM BURN.

3.1-4. - SERVICE PROPULSION SUBSYSTEM BURN TIME HISTORY OF SPACE-FIXED FLIGHT-PATH ANGLE, VELOCITY, AND ALTITUDE.

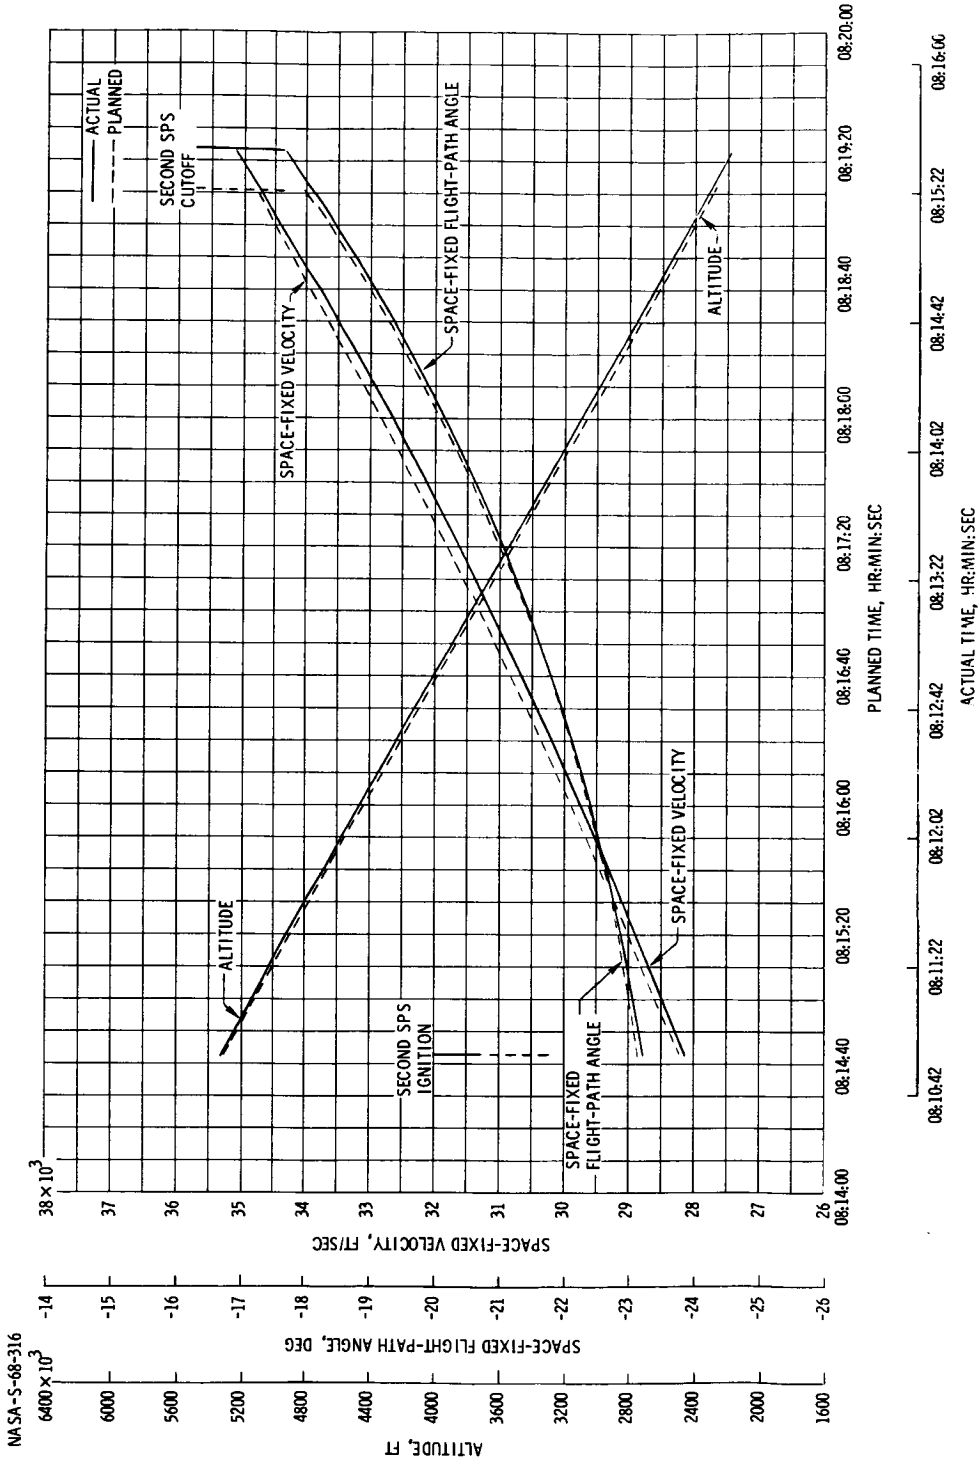
(B) SECOND SERVICE PROPULSION SUBSYSTEM BURN.

FIGURE 3.1-4. - CONCLUDED.

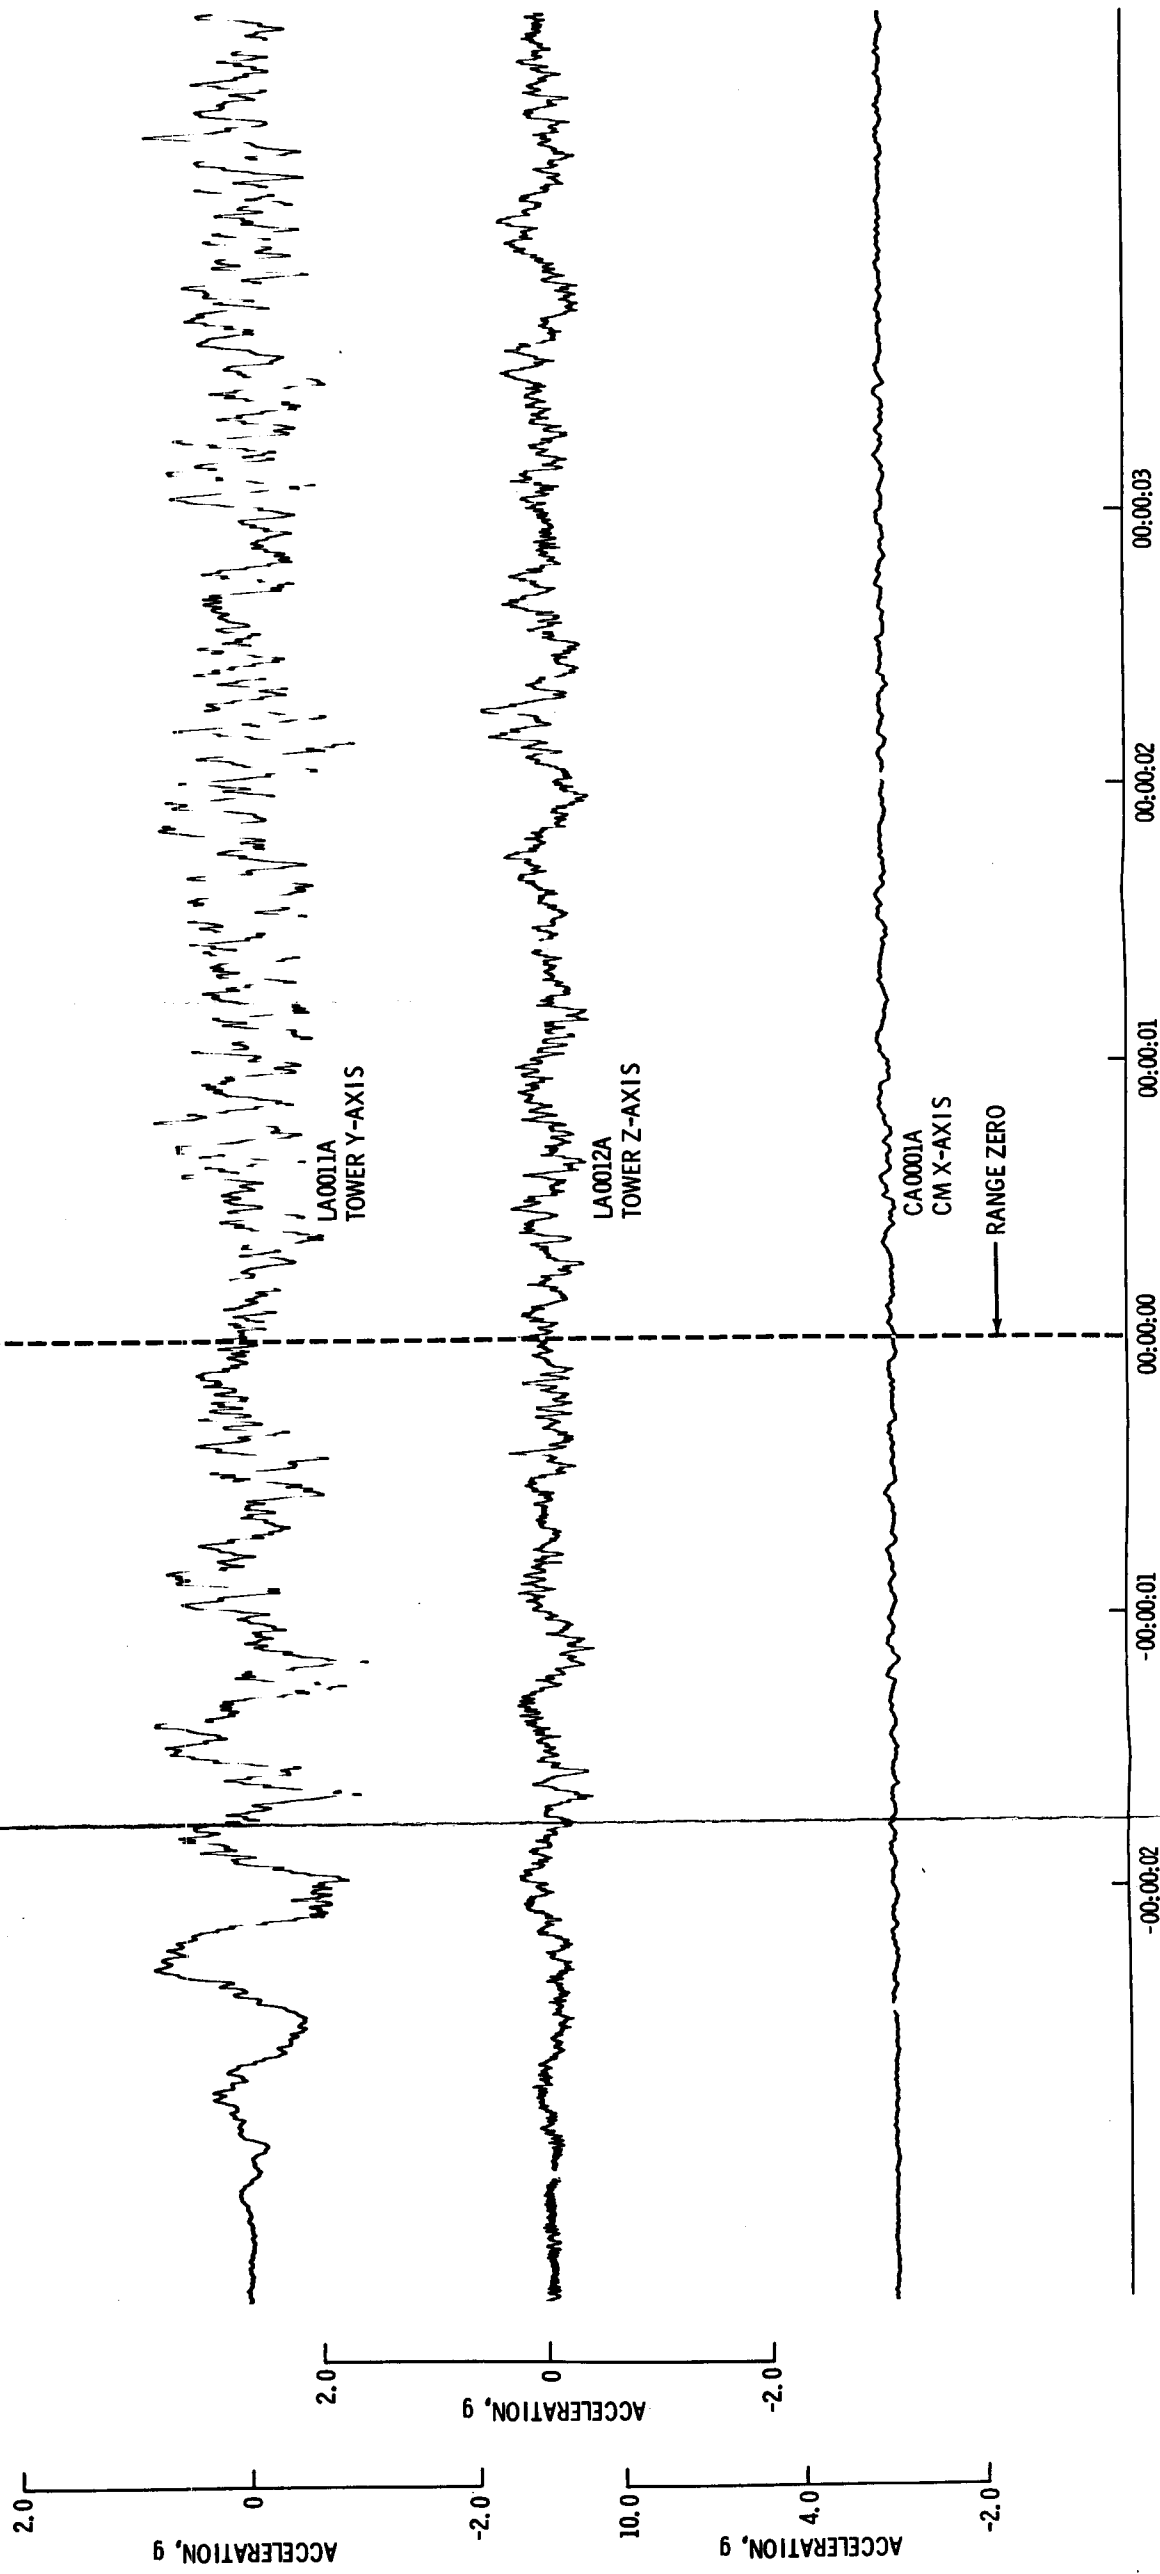
(A) LA0011A, LA0012A, and CA0001A.

FIGURE 5.1-3.- SPACECRAFT ACCELERATIONS AT LIFT-OFF.

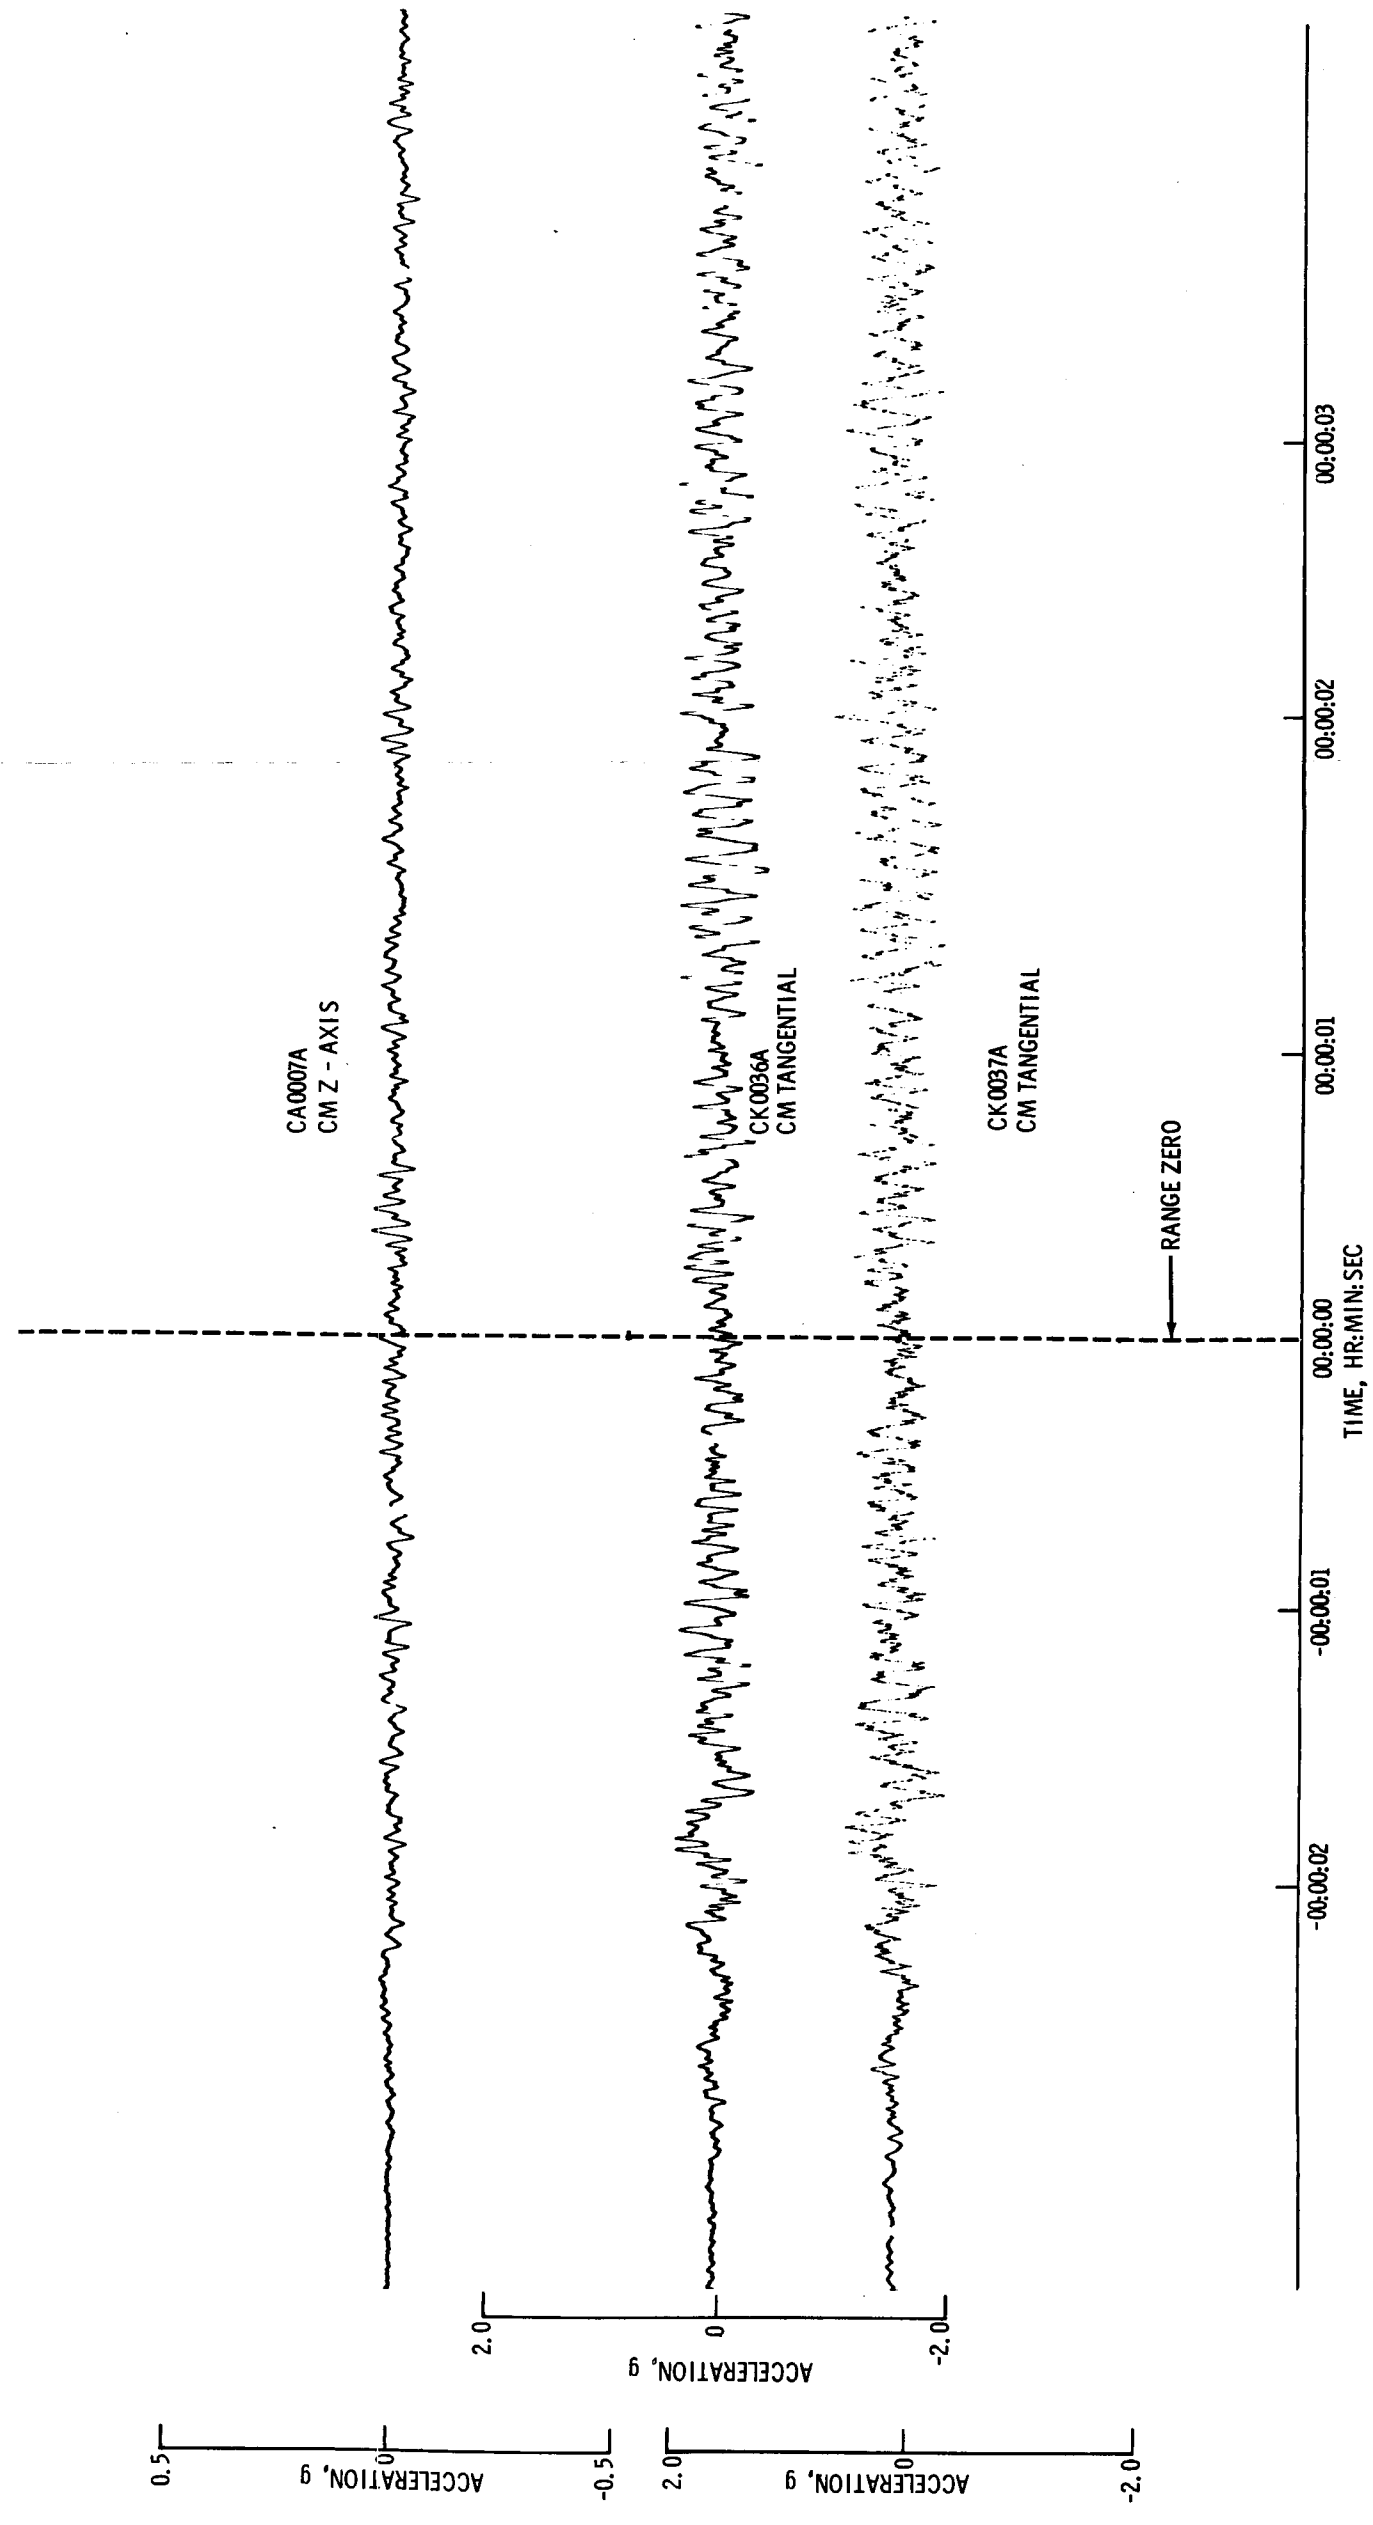
(B) CA0007A, CK0036A, AND CK0037A.

FIGURE 5.1-3. - CONCLUDED.

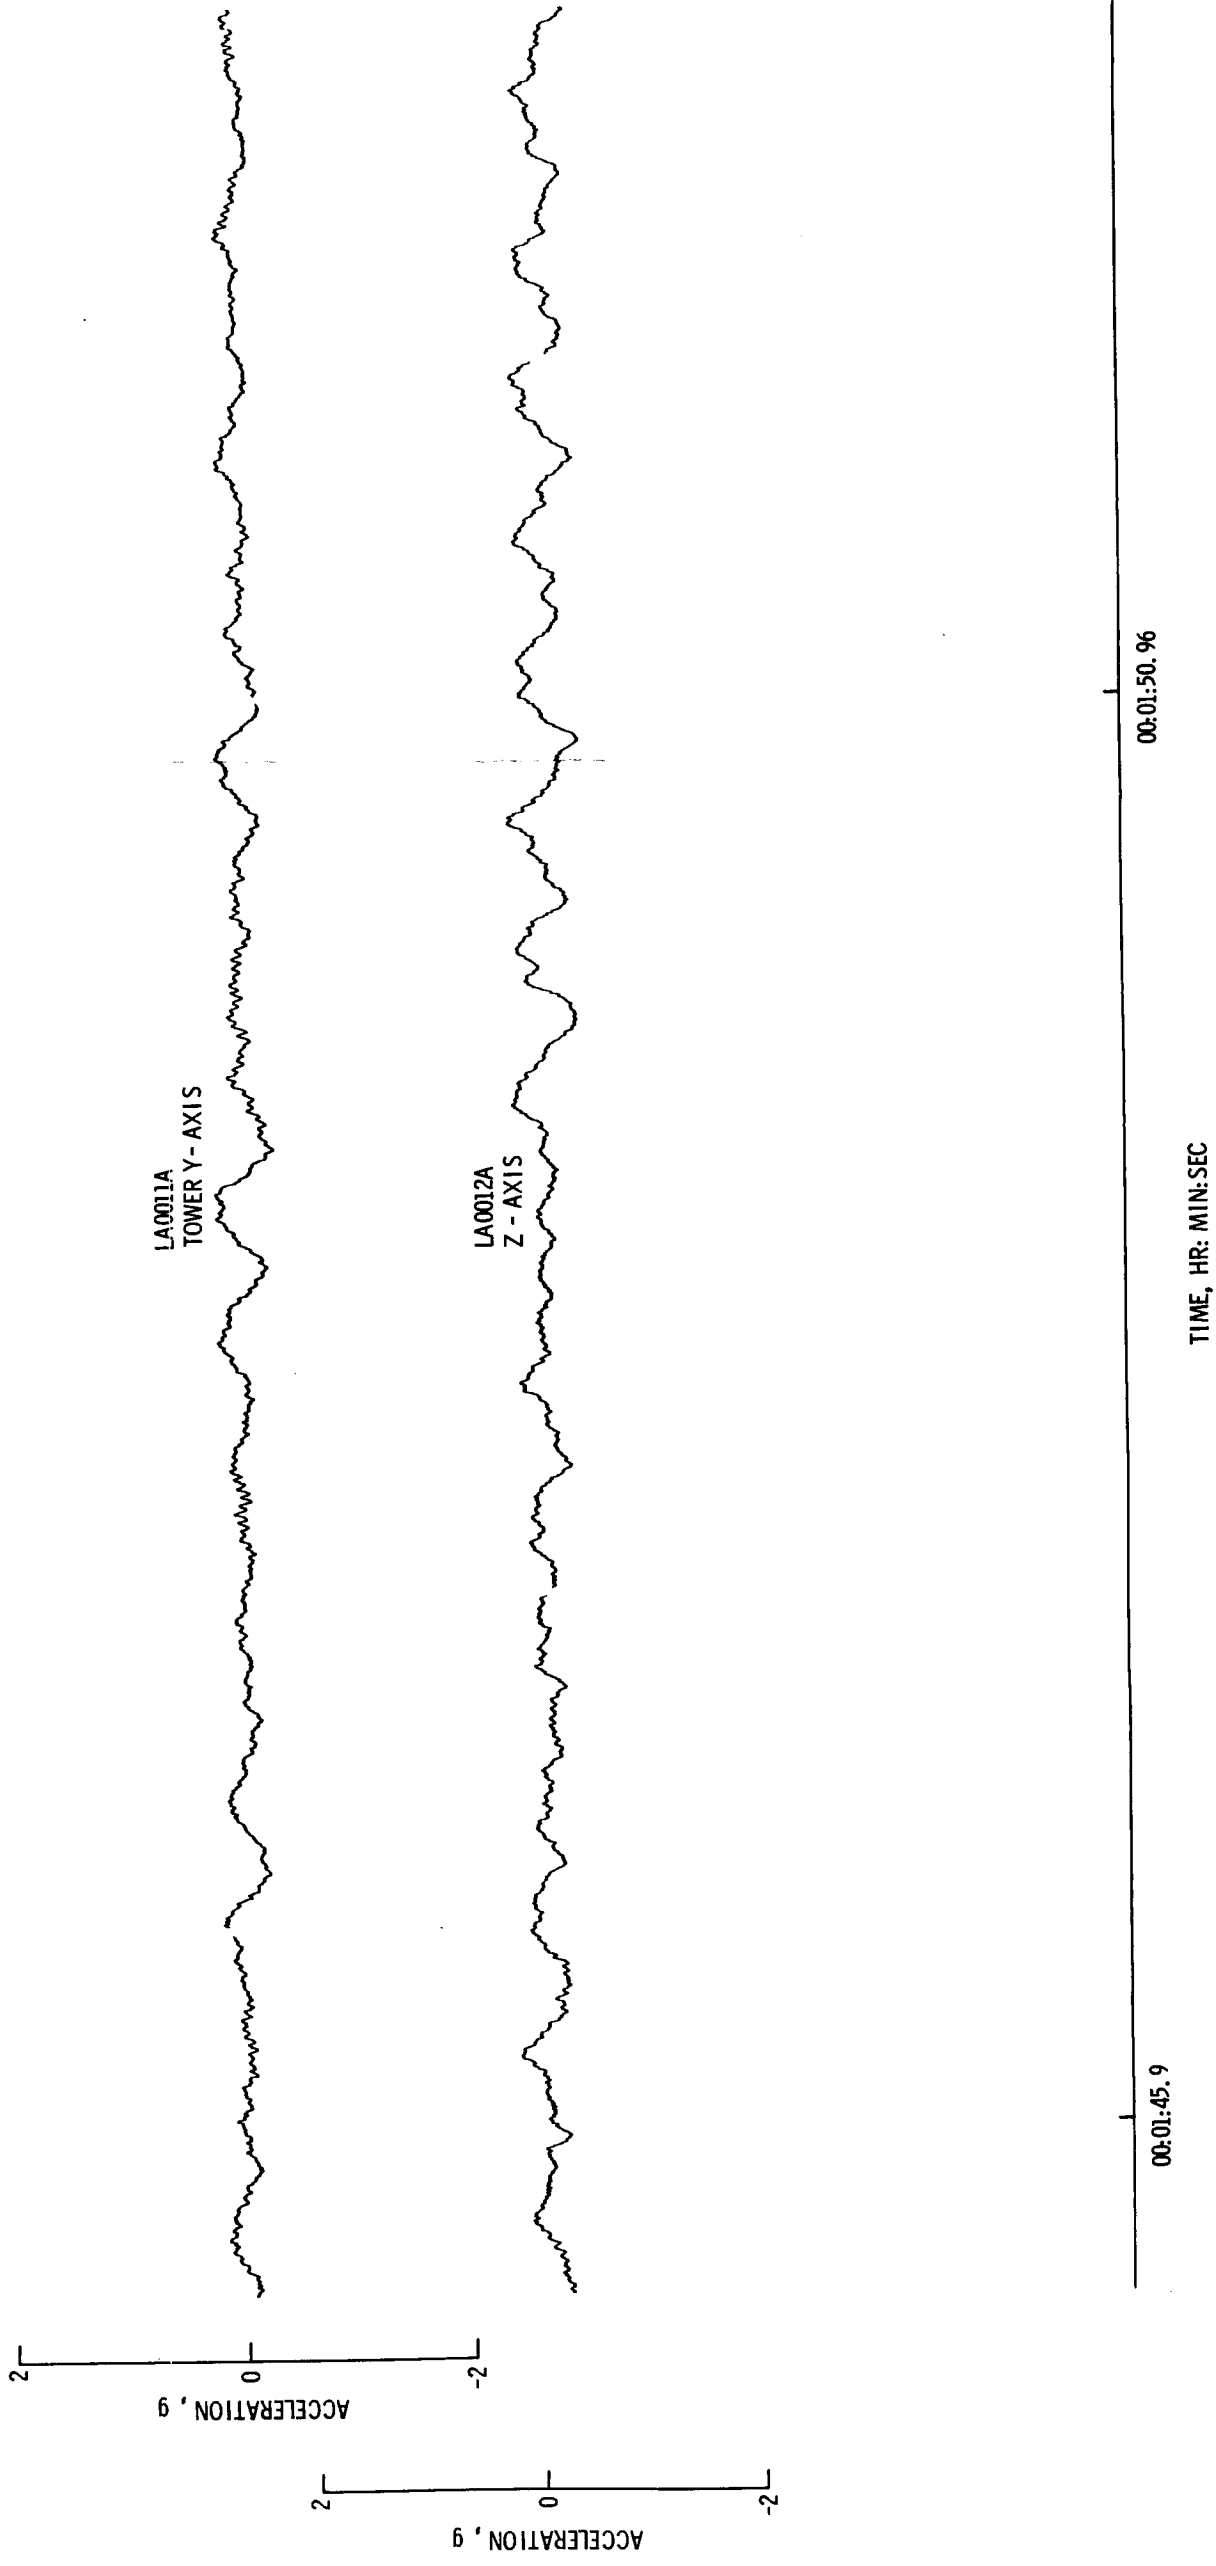
FIGURE 5.1-8. - LAUNCH ESCAPE TOWER LATERAL OSCILLATIONS DURING FIRST-STAGE BOOST.

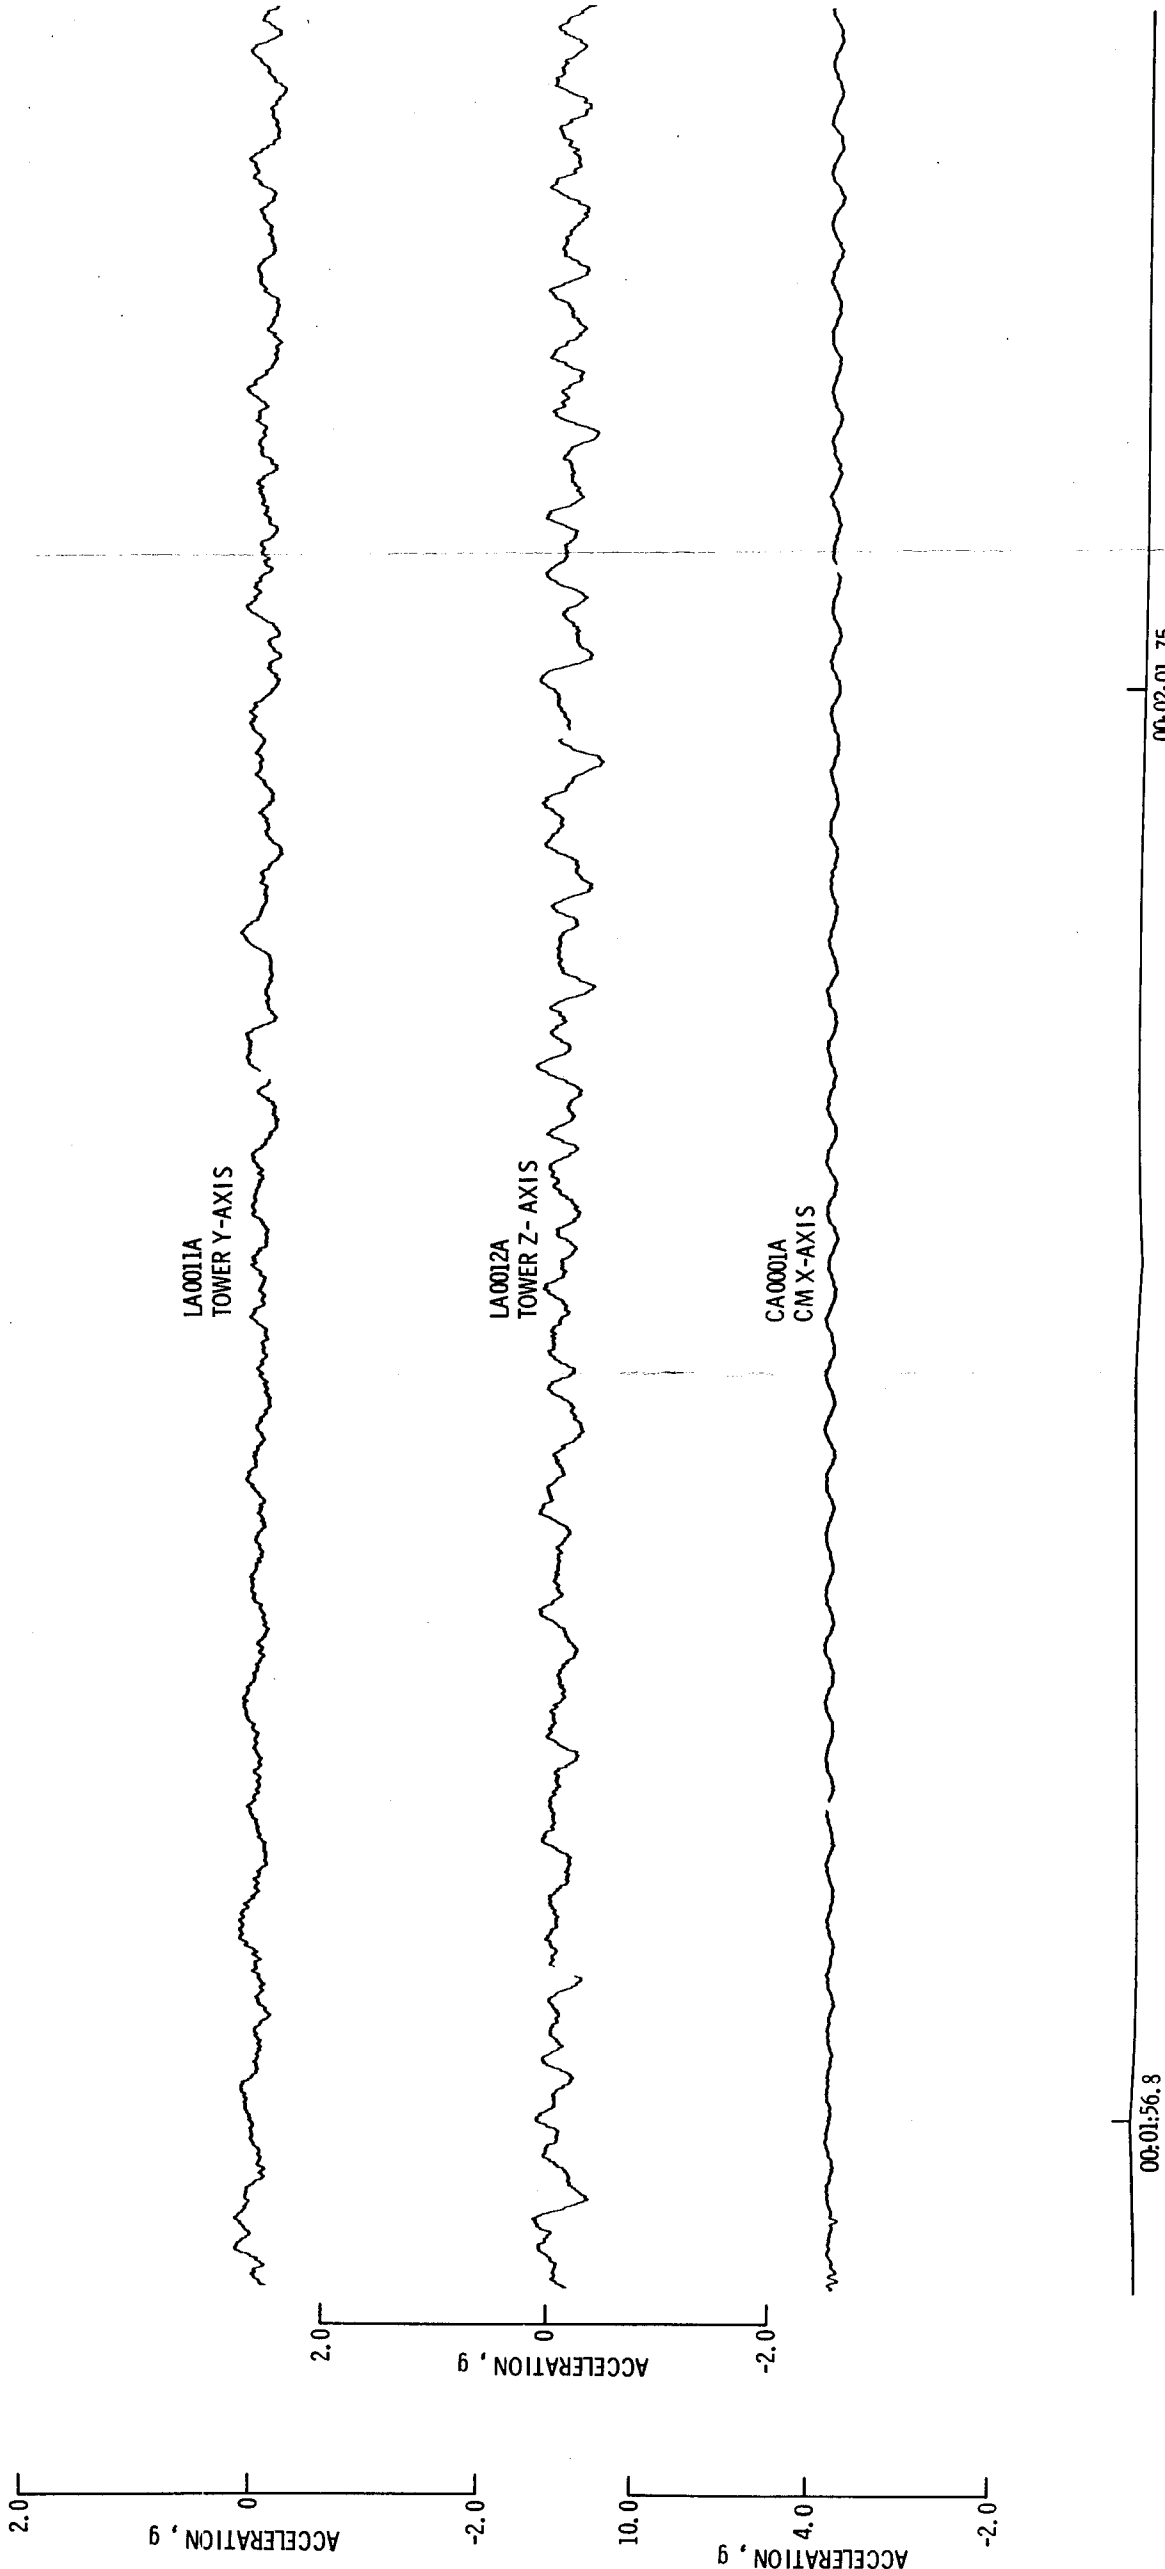
(A) LA0011A, LA0012A, AND CA0001A

FIGURE 5.1-9. - SPACECRAFT ACCELERATIONS DURING HIGH AXIAL ACCELERATION OSCILLATION PERIOD.

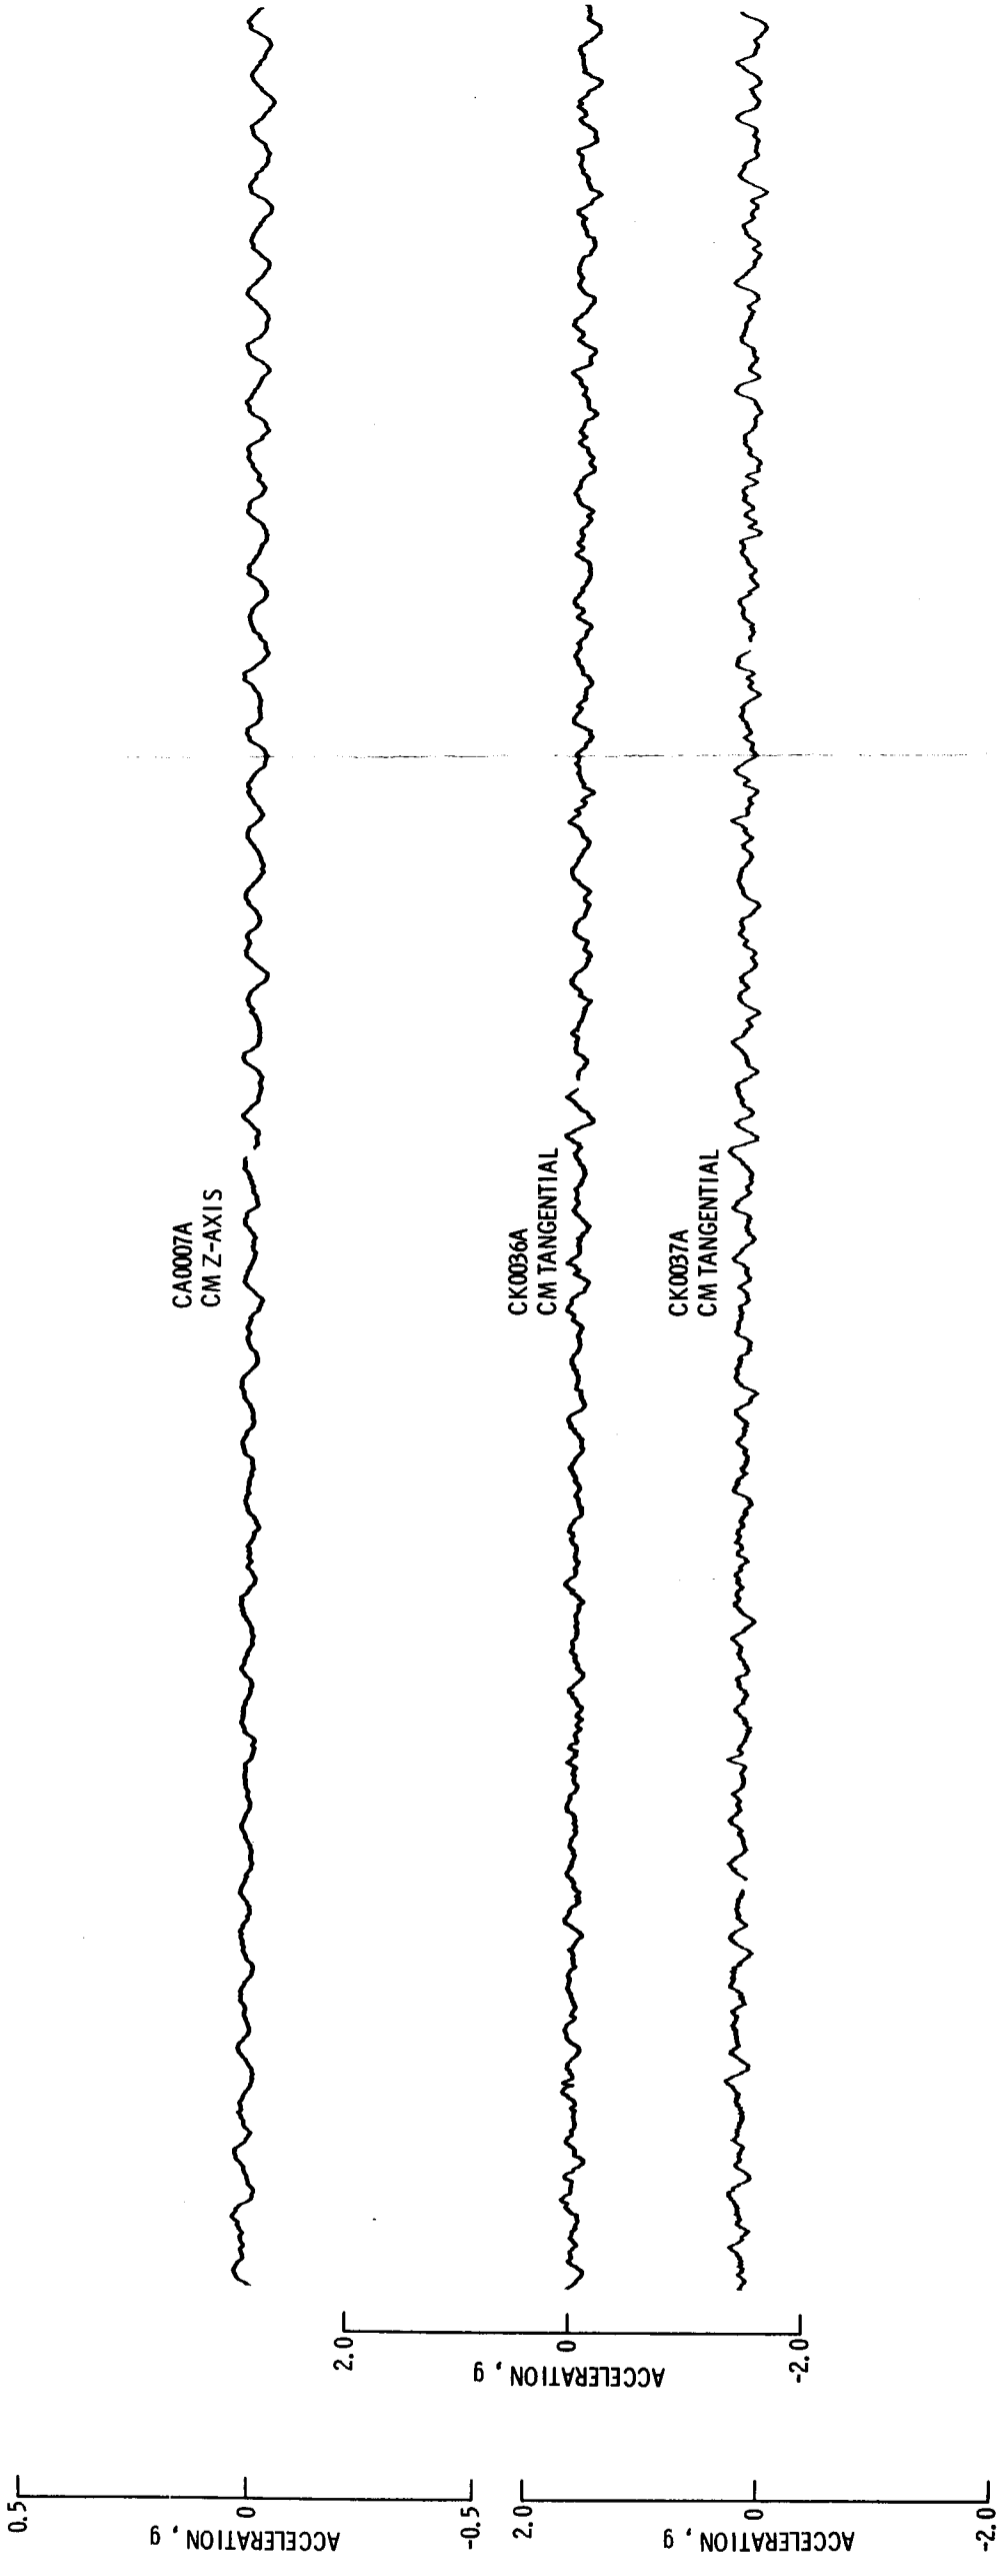
(B) CA0007A, CA0036A, AND CK0037A

FIGURE 5.1-9. - CONCLUDED.

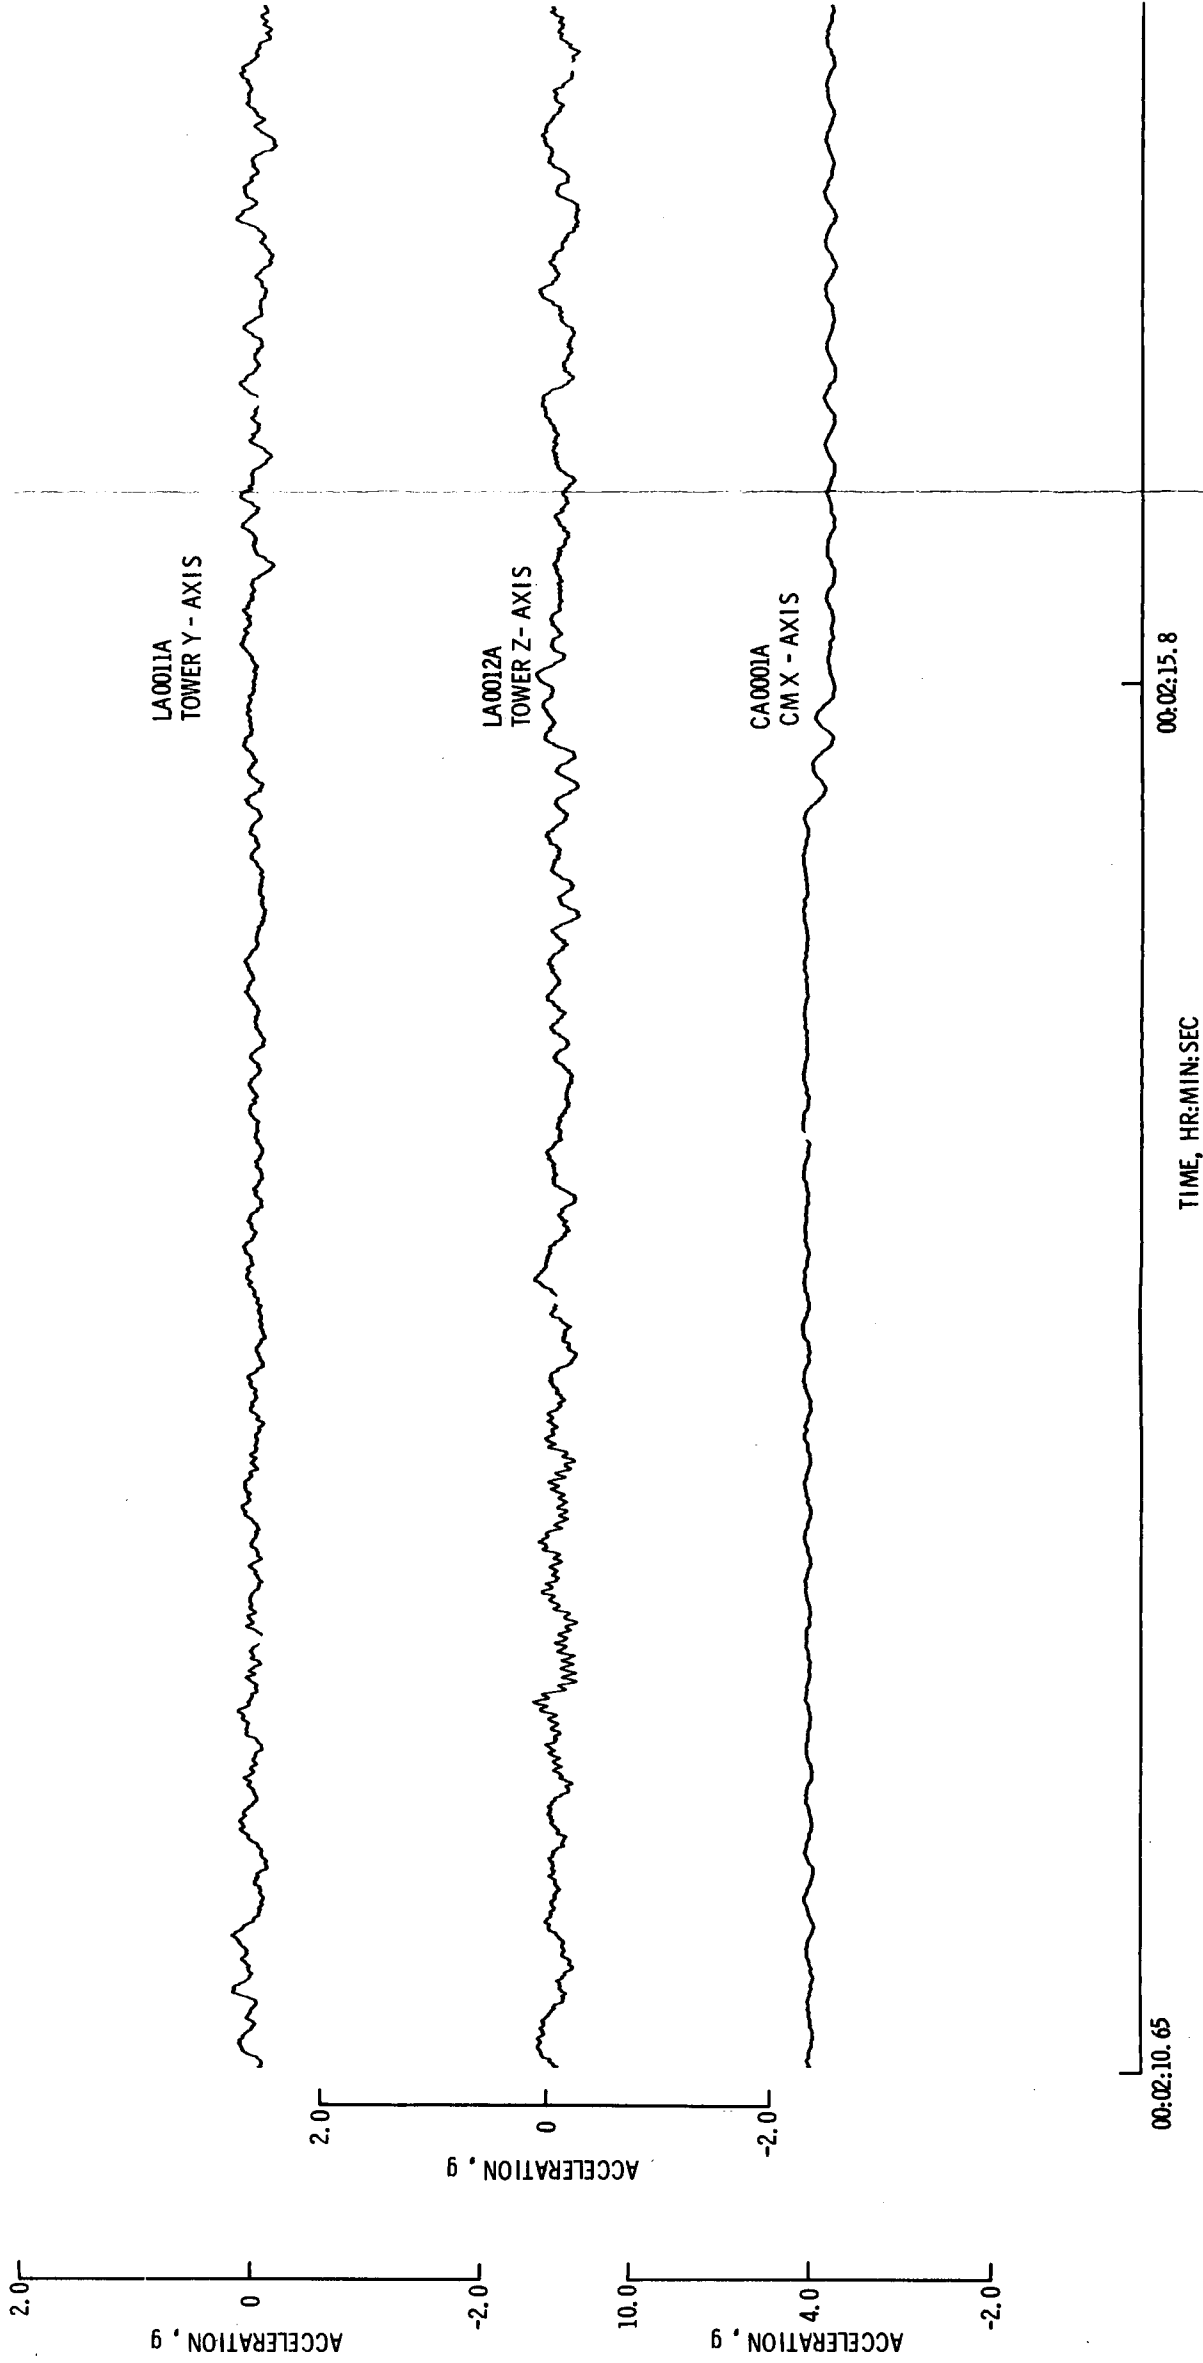
(A) LA0011A, LA0012A, AND LA0001A

FIGURE 5.1-10. - SPACECRAFT ACCELERATIONS AT FIRST-STAGE END OF BOOST.
