APOLLO 4 MISSION REPORT

MANNED SPACECRAFT CENTER

January 1968

MSC-PA-R-68-1

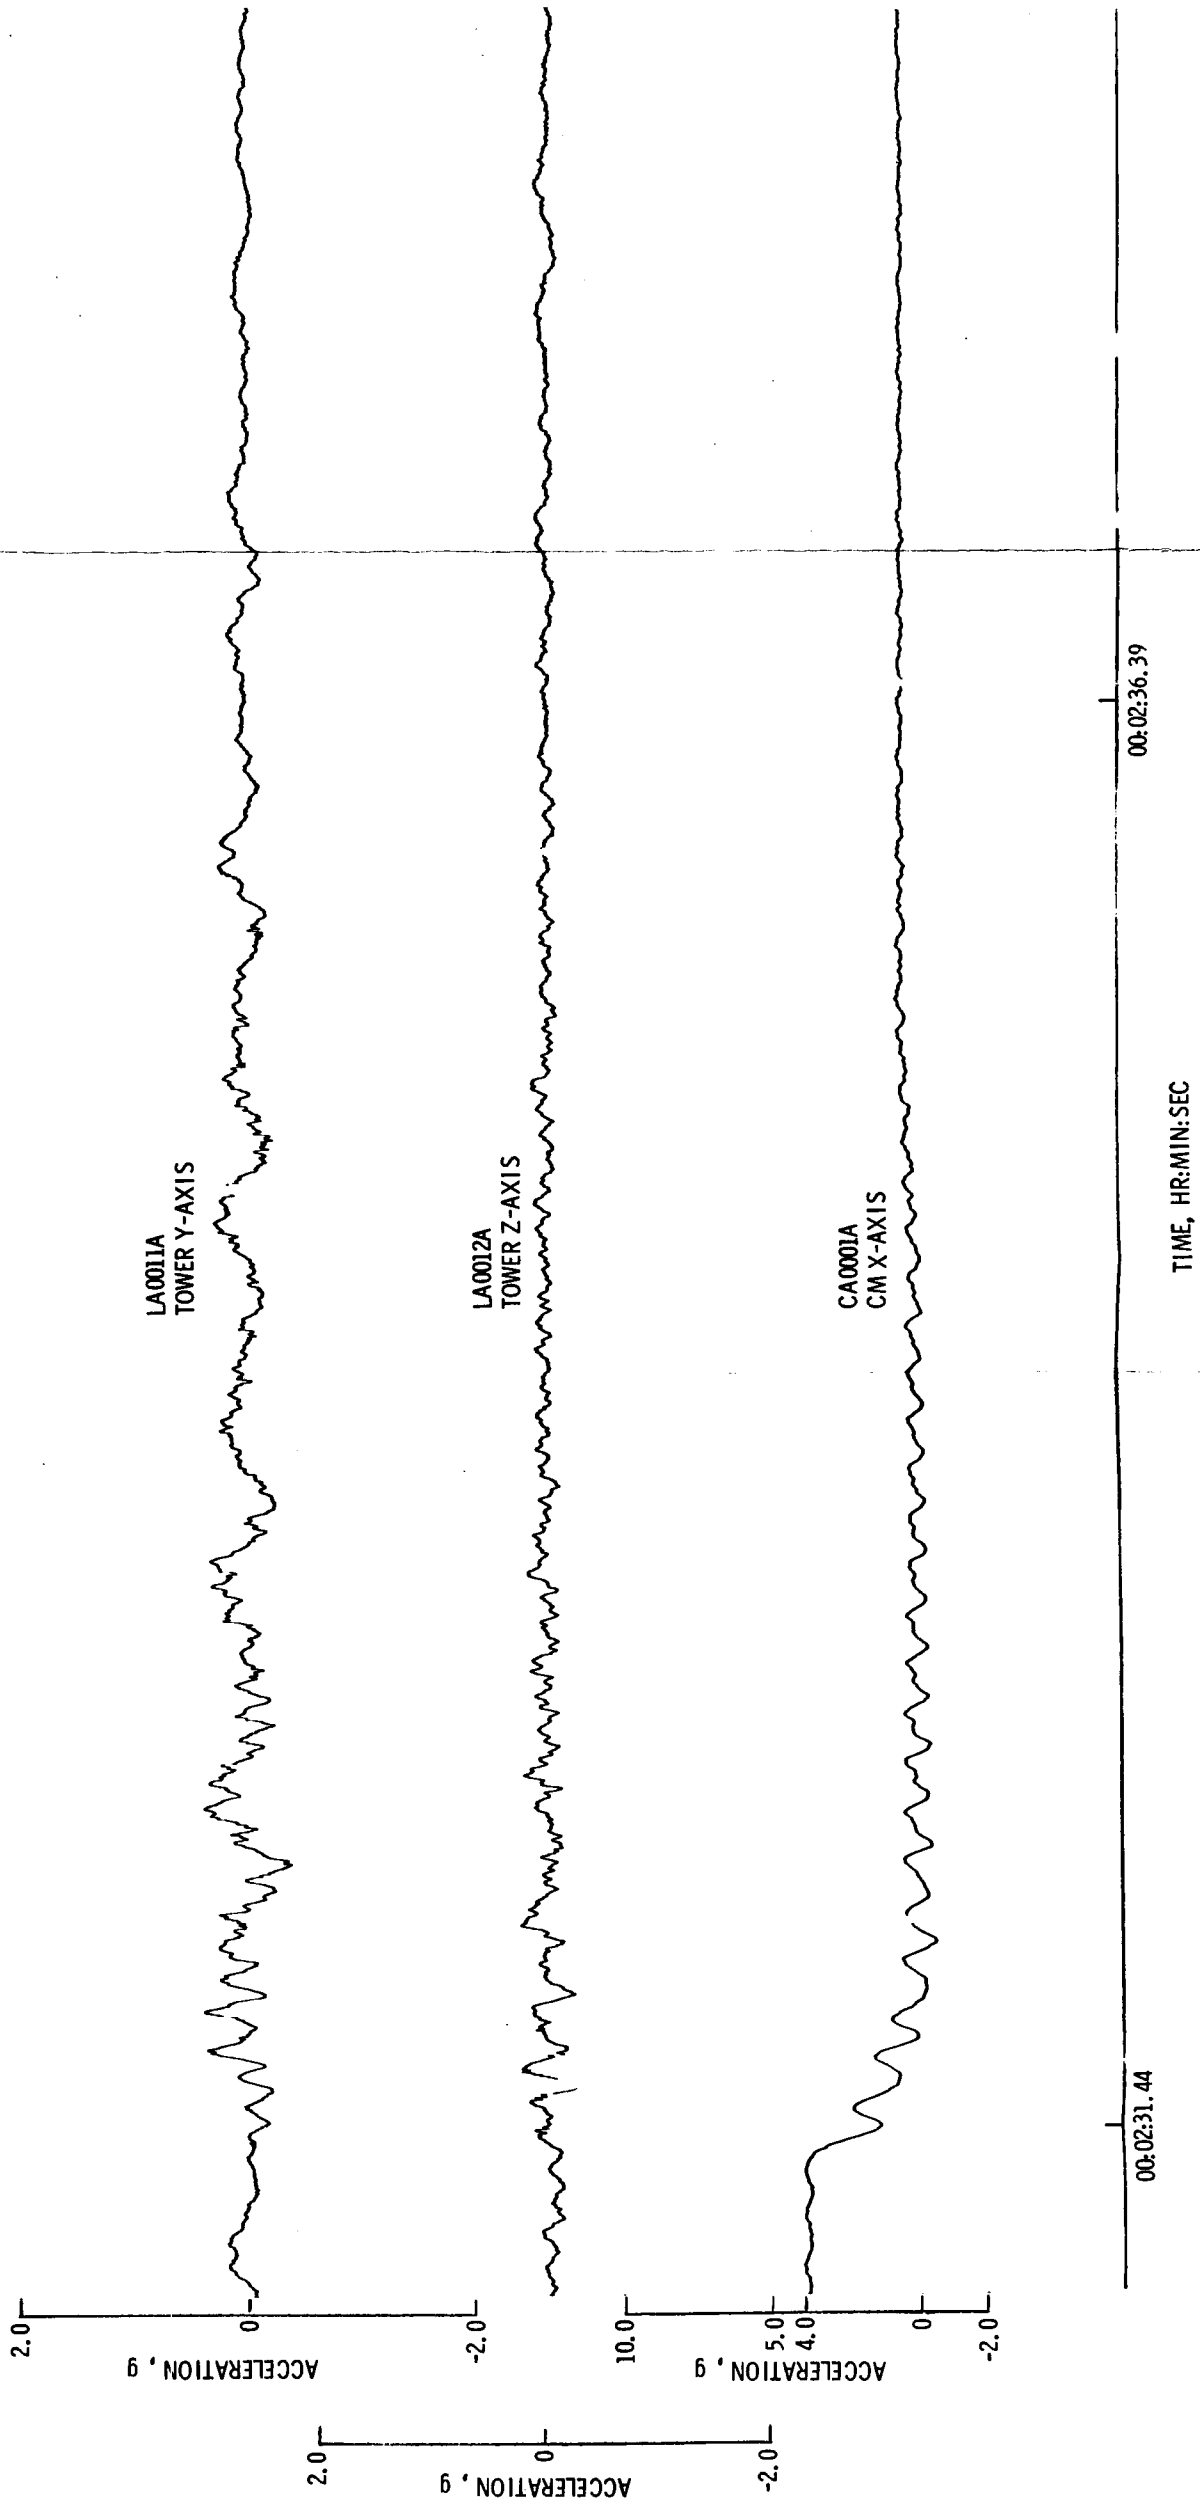
(A) LA0011A, LA0012A, AND CA0001A.

FIGURE 5.1-11. - SPACECRAFT ACCELERATIONS DURING S-IC/S-II SEPARATION.

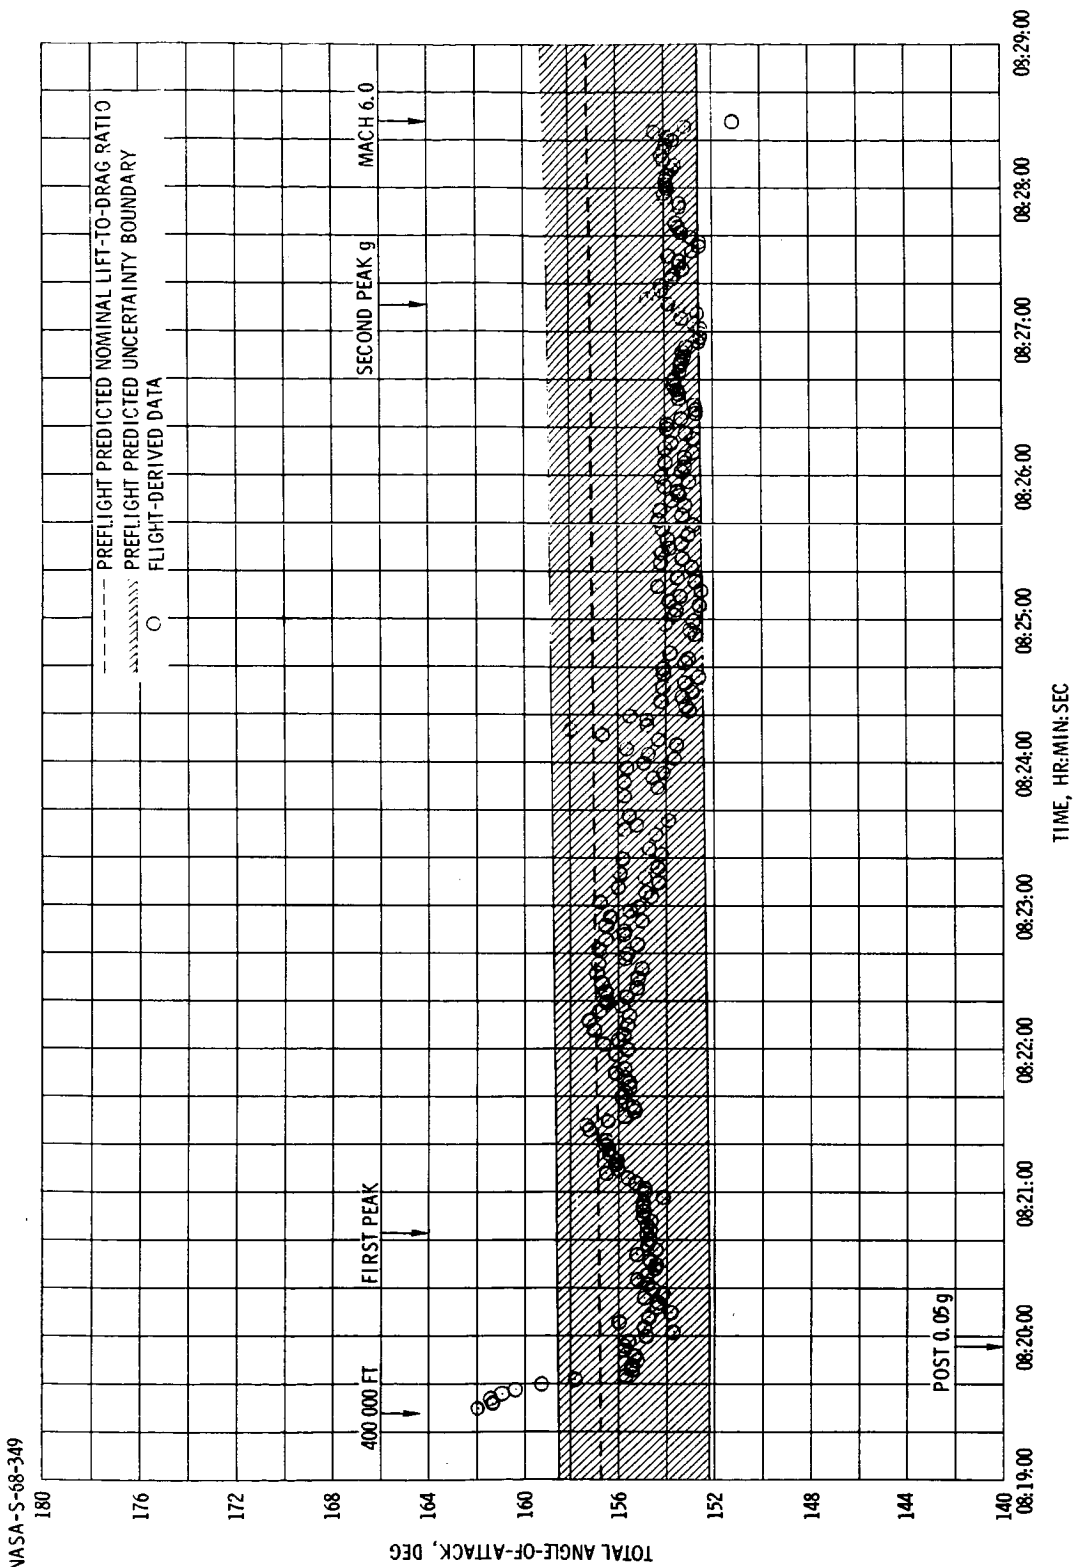
FIGURE 5.2-4. - COMMAND MODULE TOTAL ANGLE-OF-ATTACK.

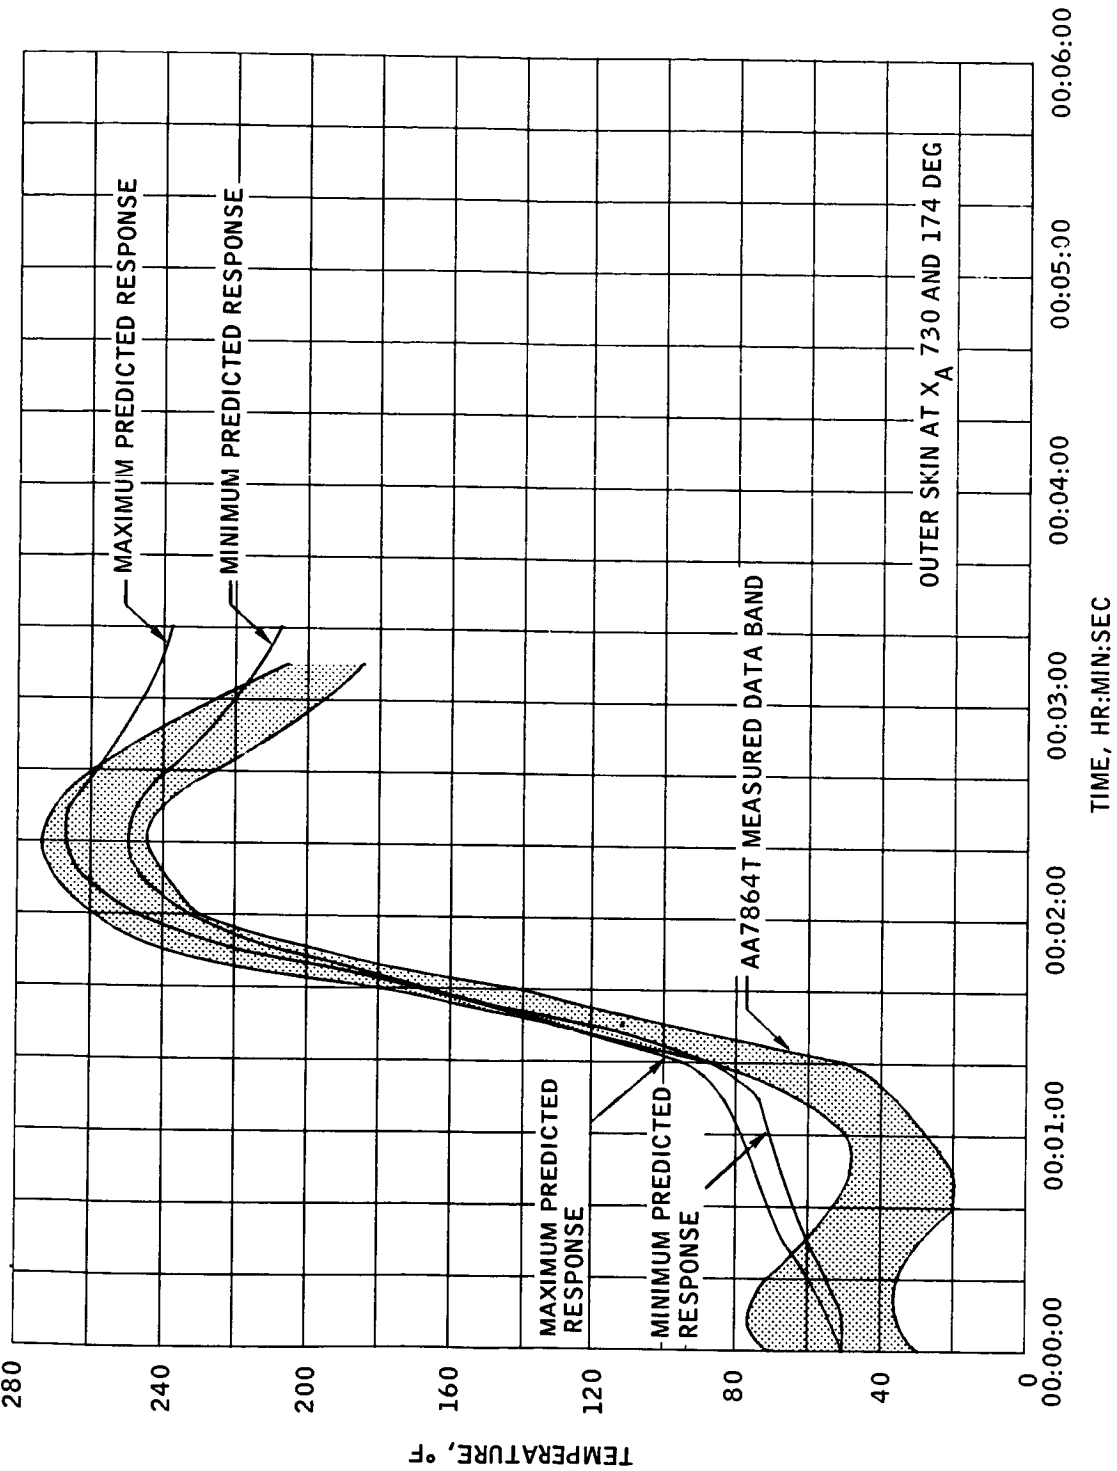
FIGURE 5.3-4.- TEMPERATURE MEASURED BY SPACECRAFT LUNAR MODULE ADAPTER SENSOR AA7864T.

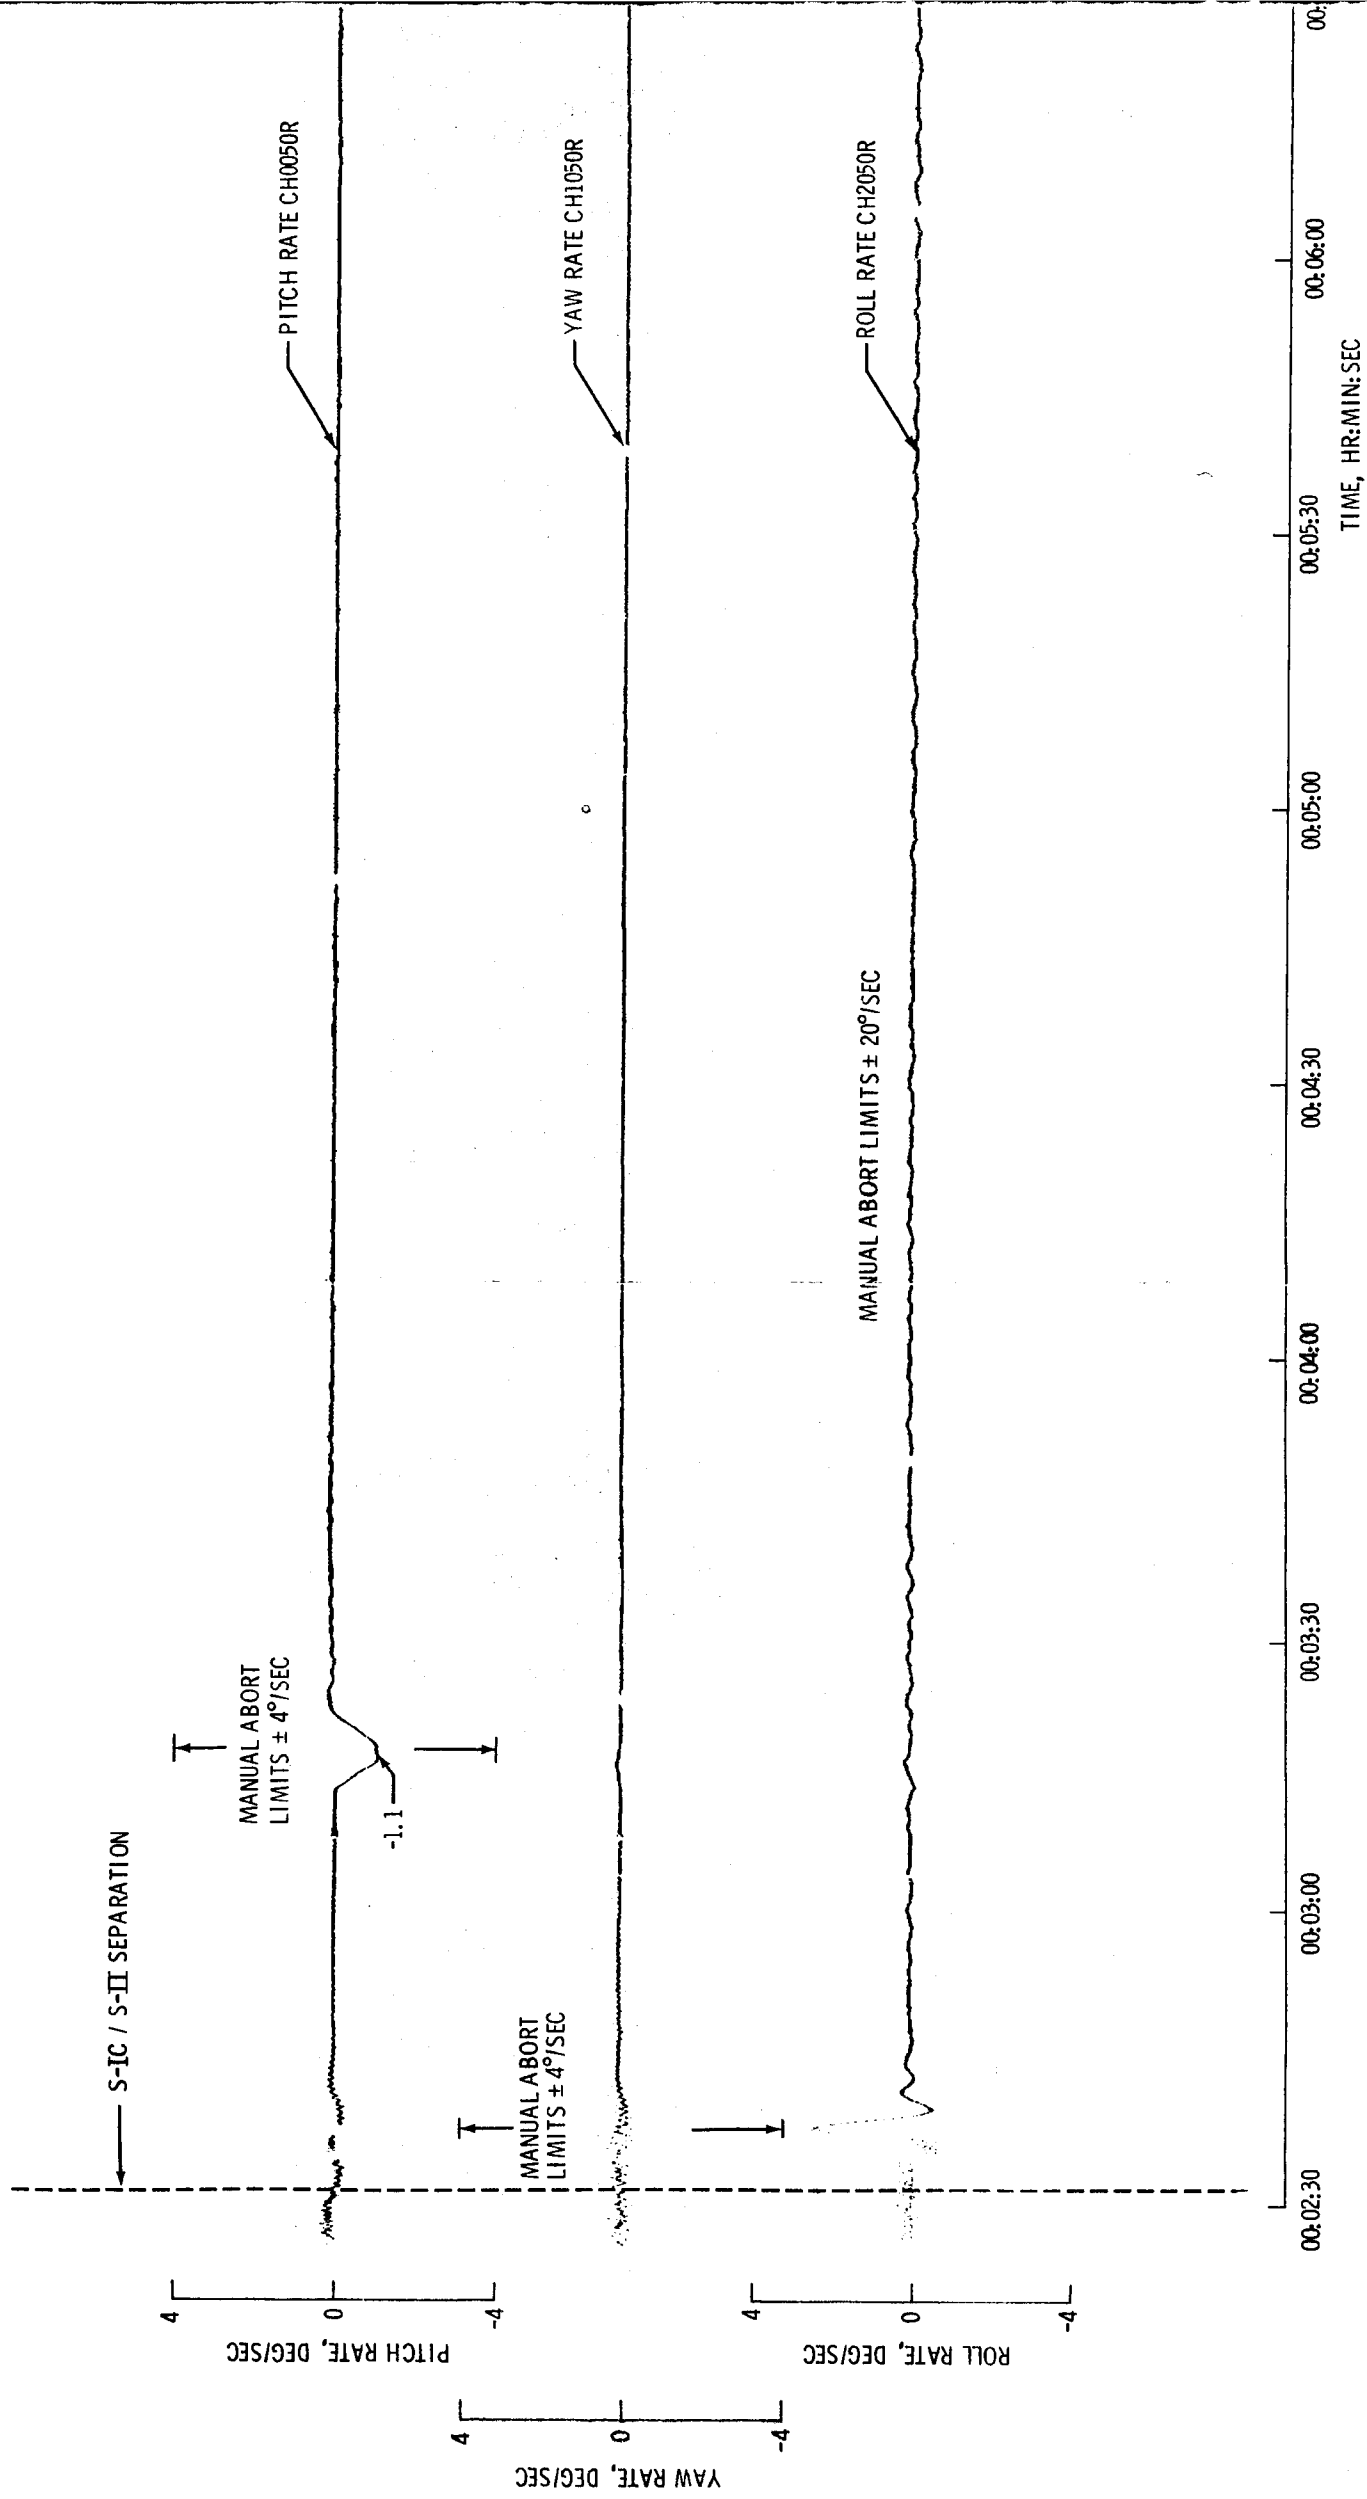
FIGURE 5.12-2. - ANGULAR RATES AND EMERGENCY DETECTION SYSTEM ABORT LIMITS DURING S-II STAGE BURN.

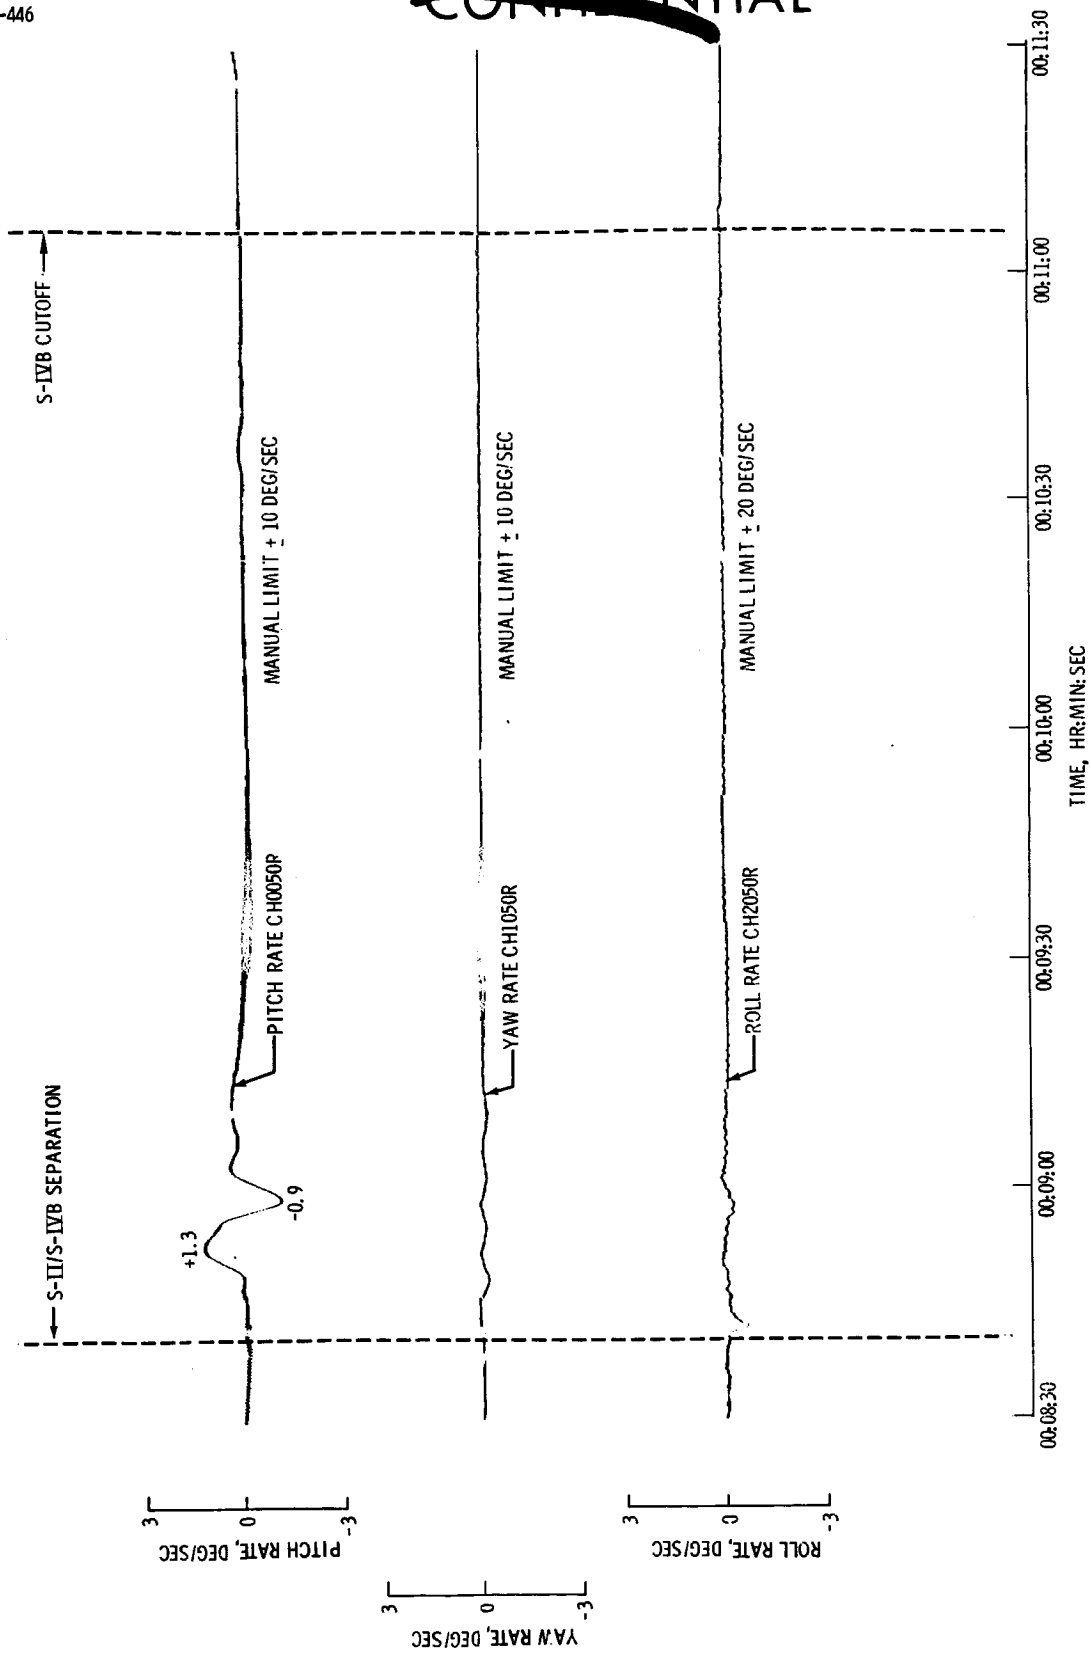
FIGURE 5.12-3. - ANGULAR RATES AND EMERGENCY DETECTION SYSTEM ABORT LIMITS DURING FIRST S-IVB STAGE BURN.

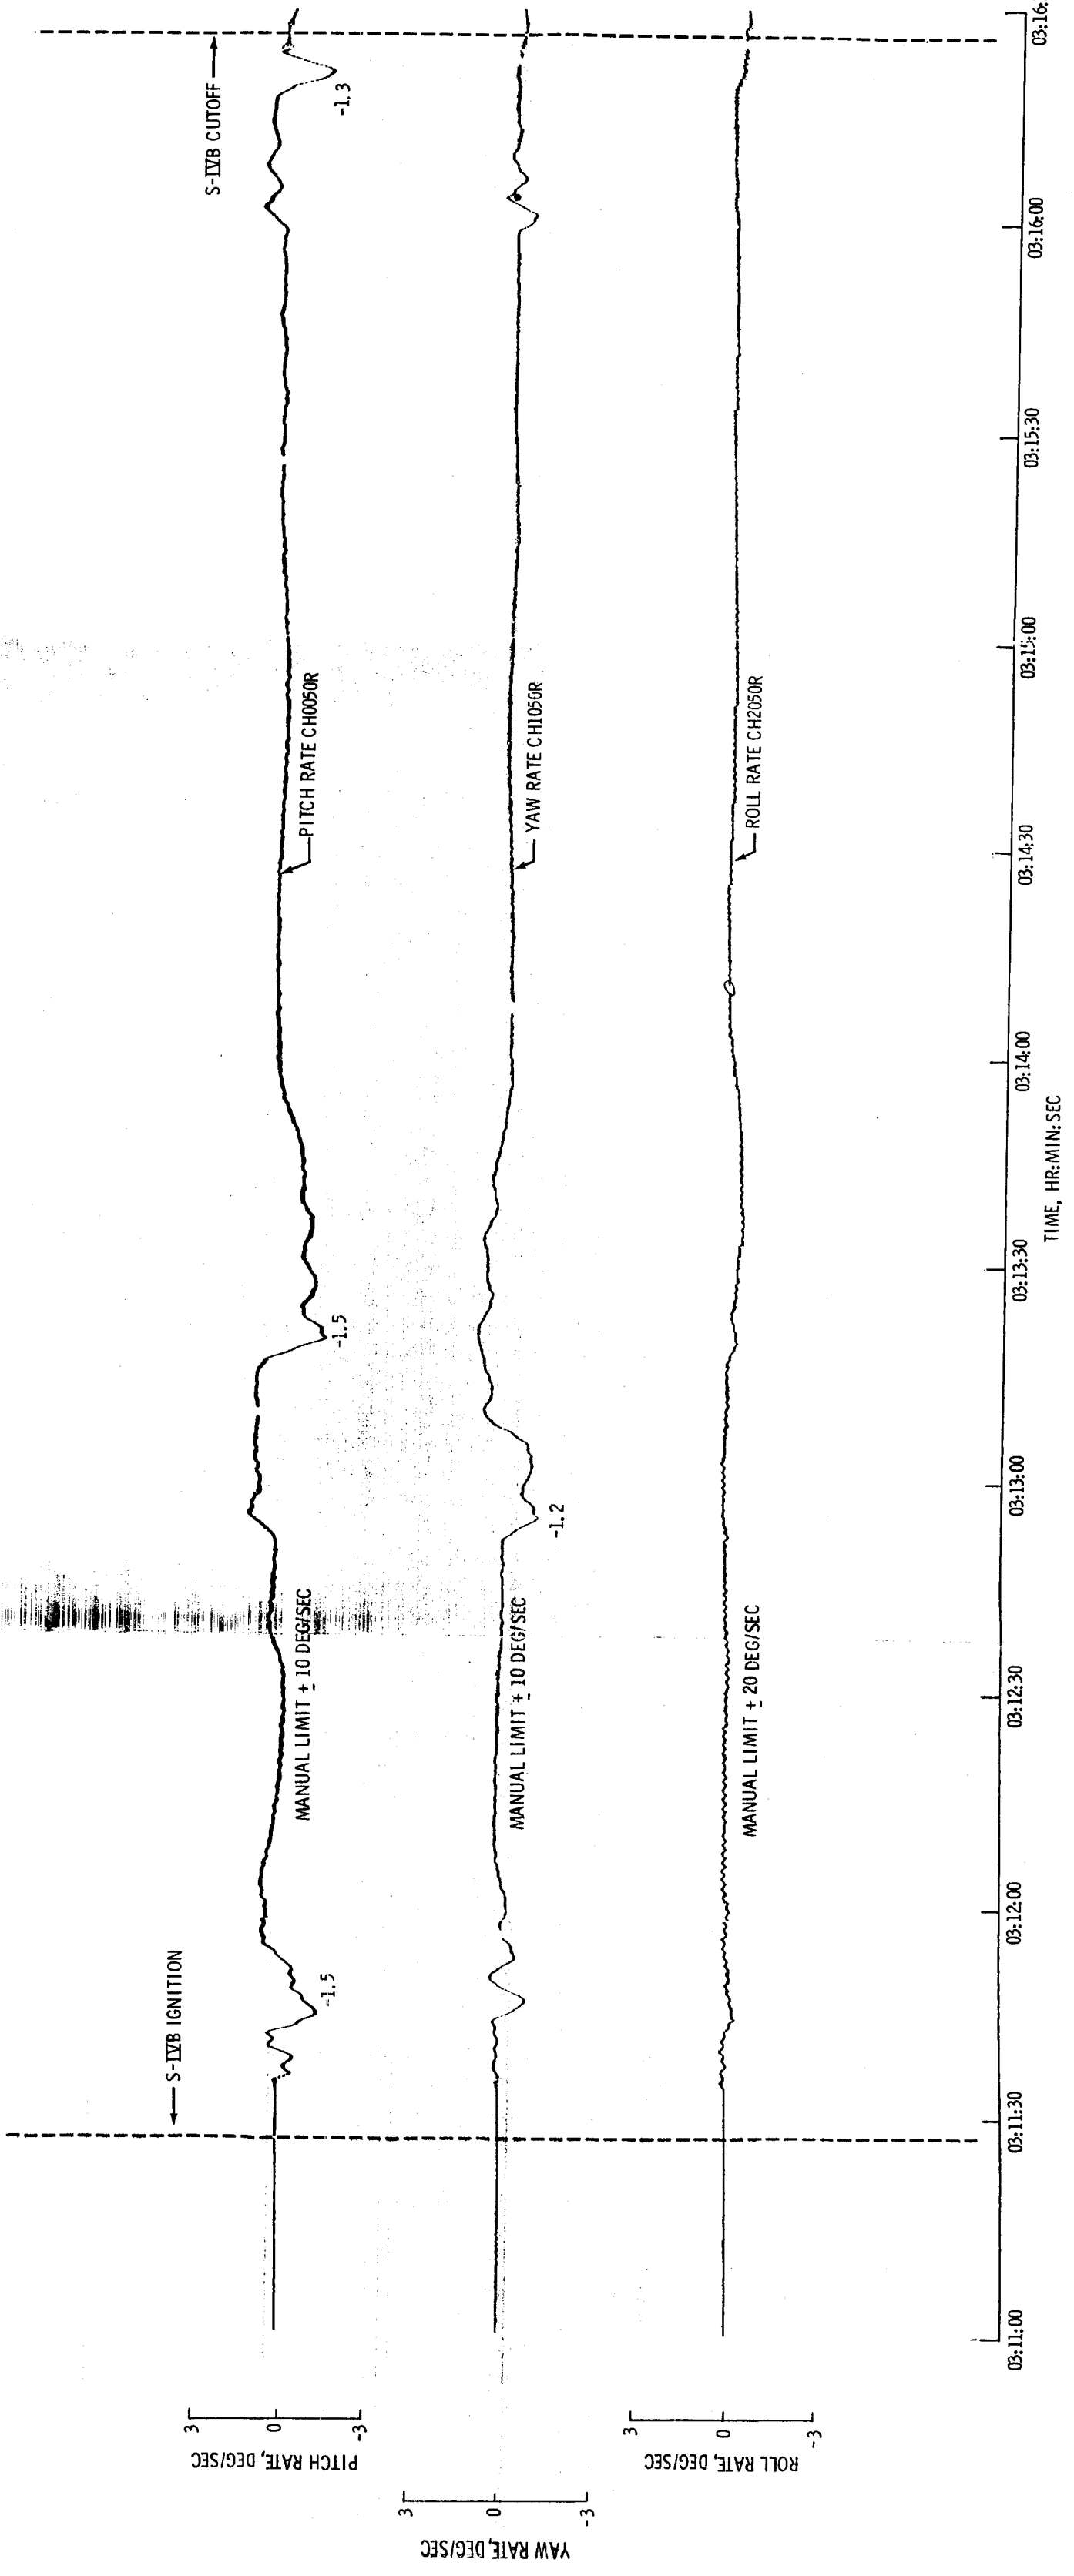
FIGURE 5.12-4.- ANGULAR RATES AND EMERGENCY DETECTION SYSTEM ABORT LIMITS DURING SECOND S-IVB STAGE BURN.

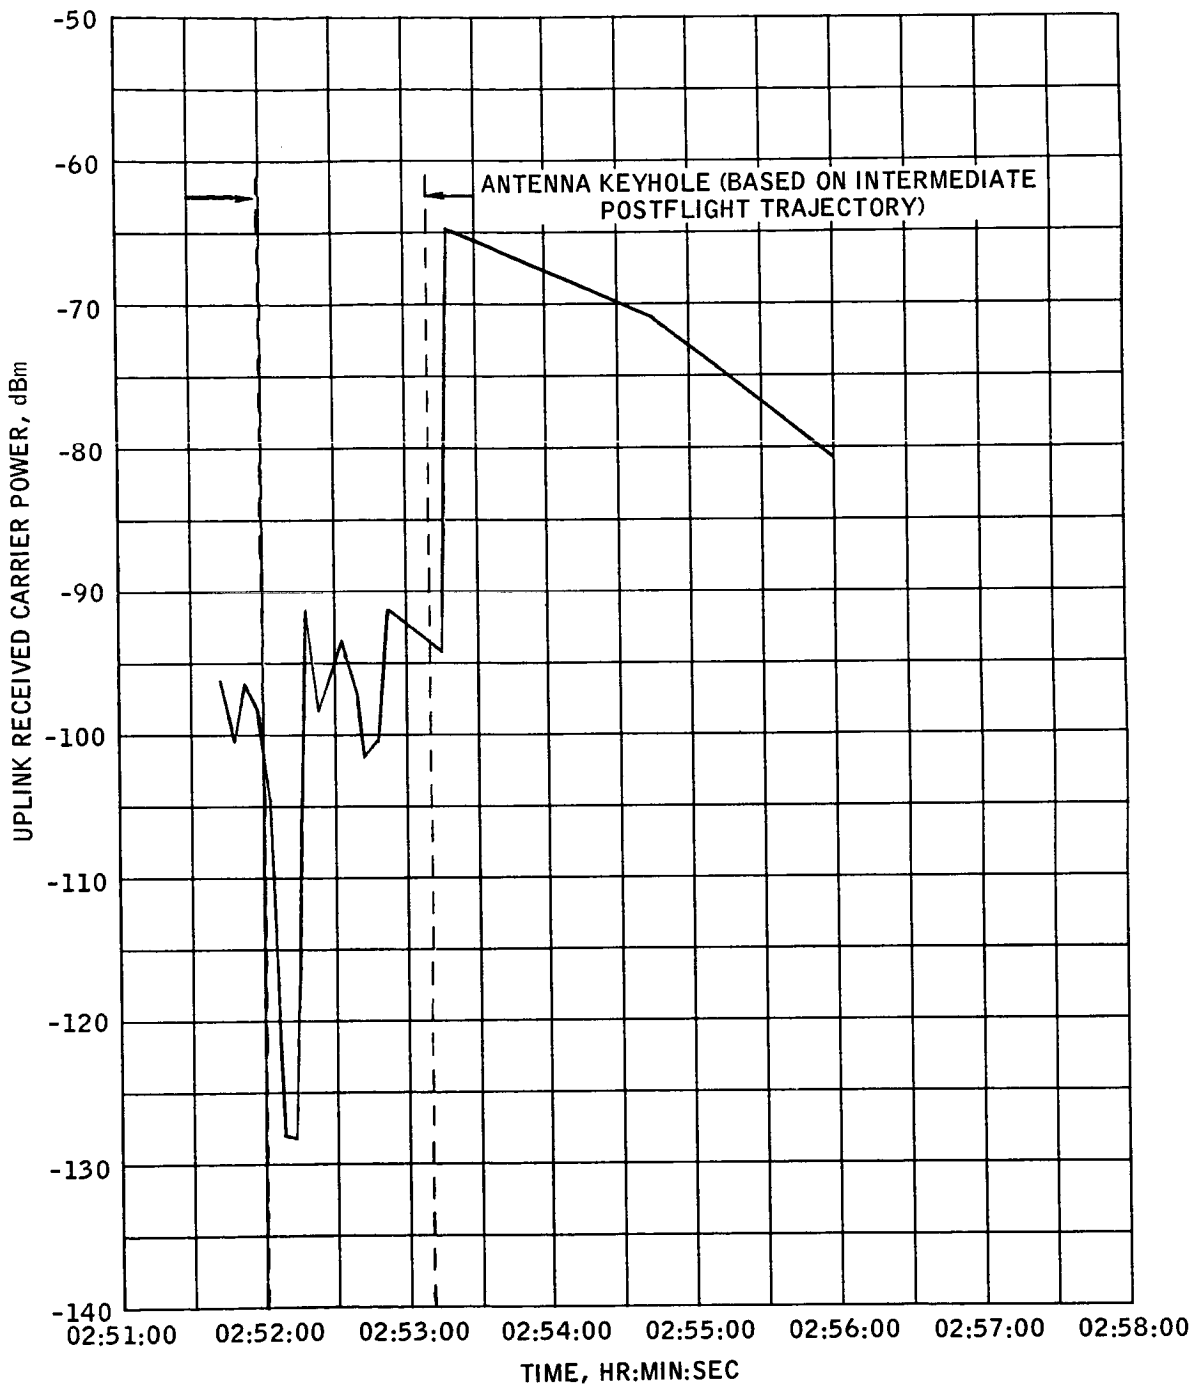
FIGURE 5.13-7.- UPLINK RECEIVED CARRIER POWER AT SPACECRAFT, HAWAII COVERAGE OF SECOND REVOLUTION.

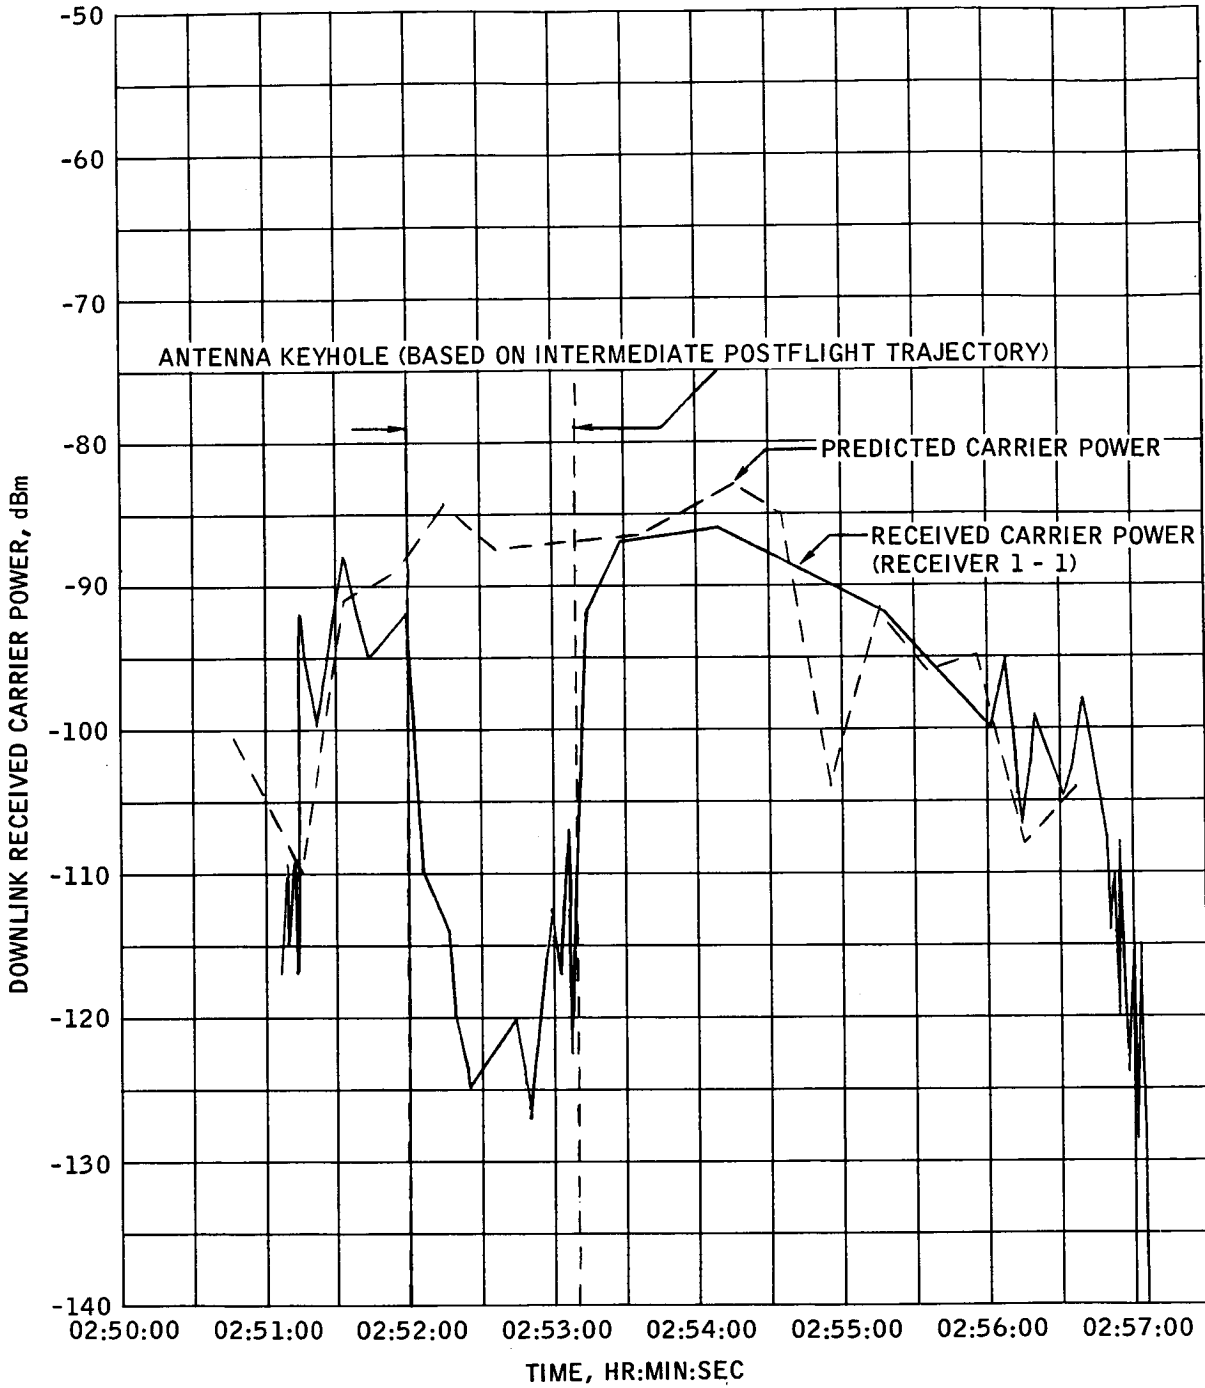
FIGURE 5.13-8.- DOWNLINK RECEIVED CARRIER POWER AT HAWAII, SECOND REVOLUTION.

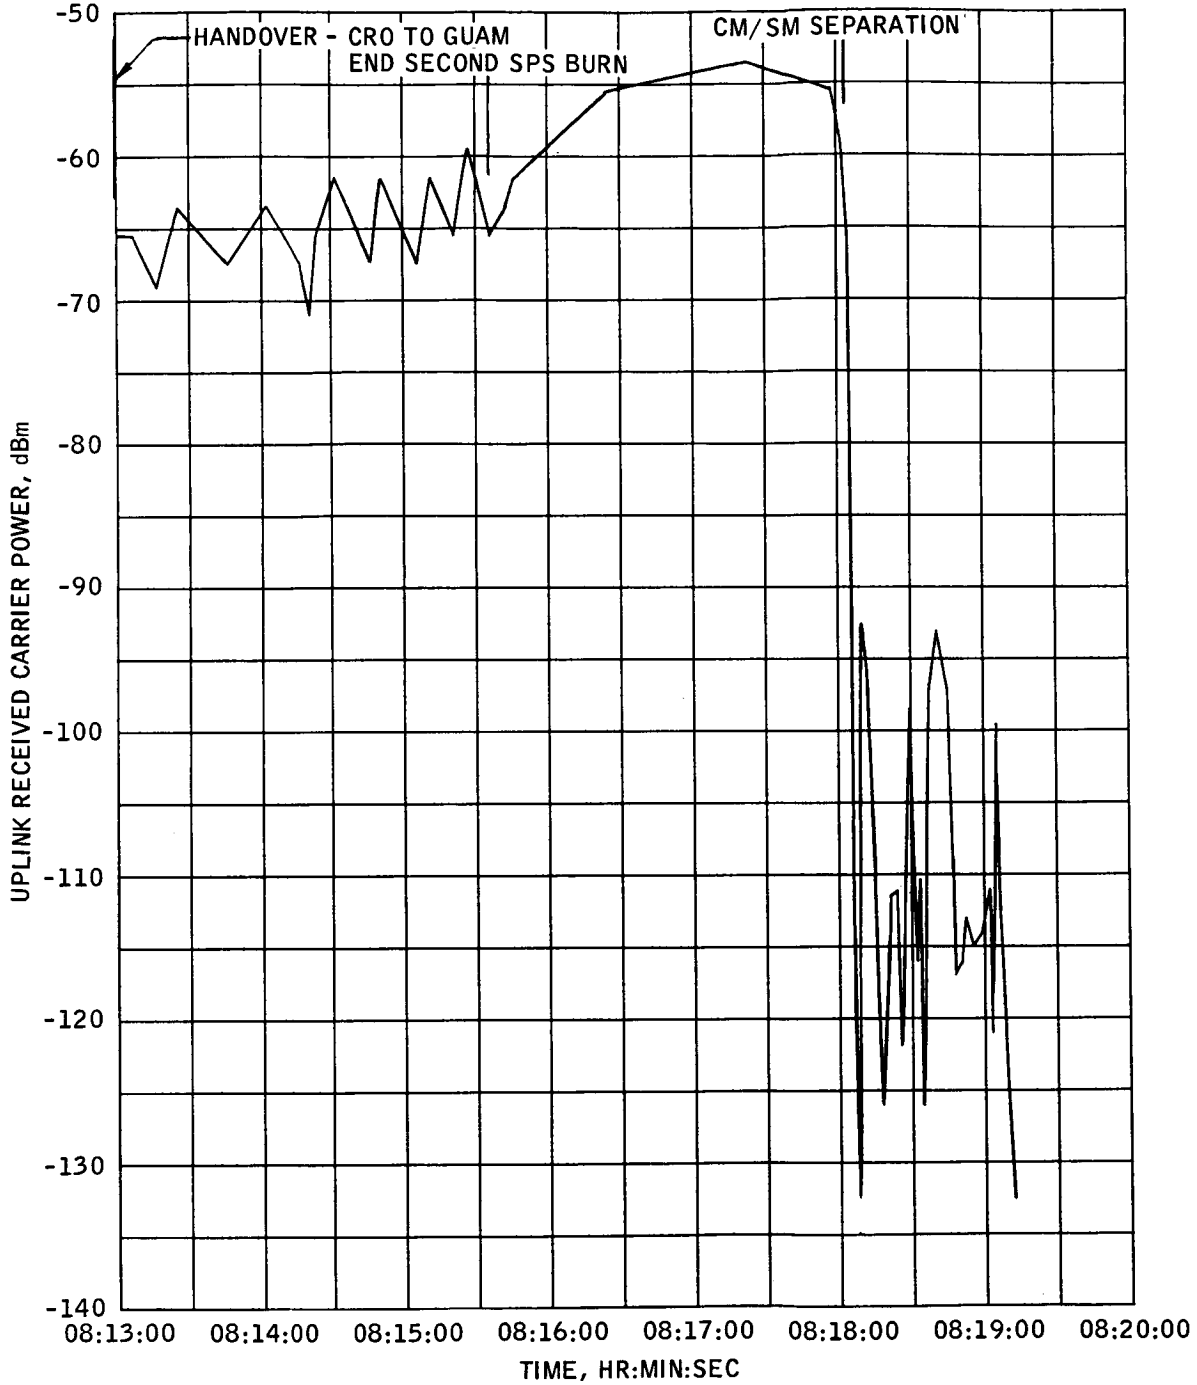
FIGURE 5.13-14.- UPLINK RECEIVED CARRIER POWER AT SPACECRAFT, GUAM COVERAGE OF THIRD REVOLUTION.

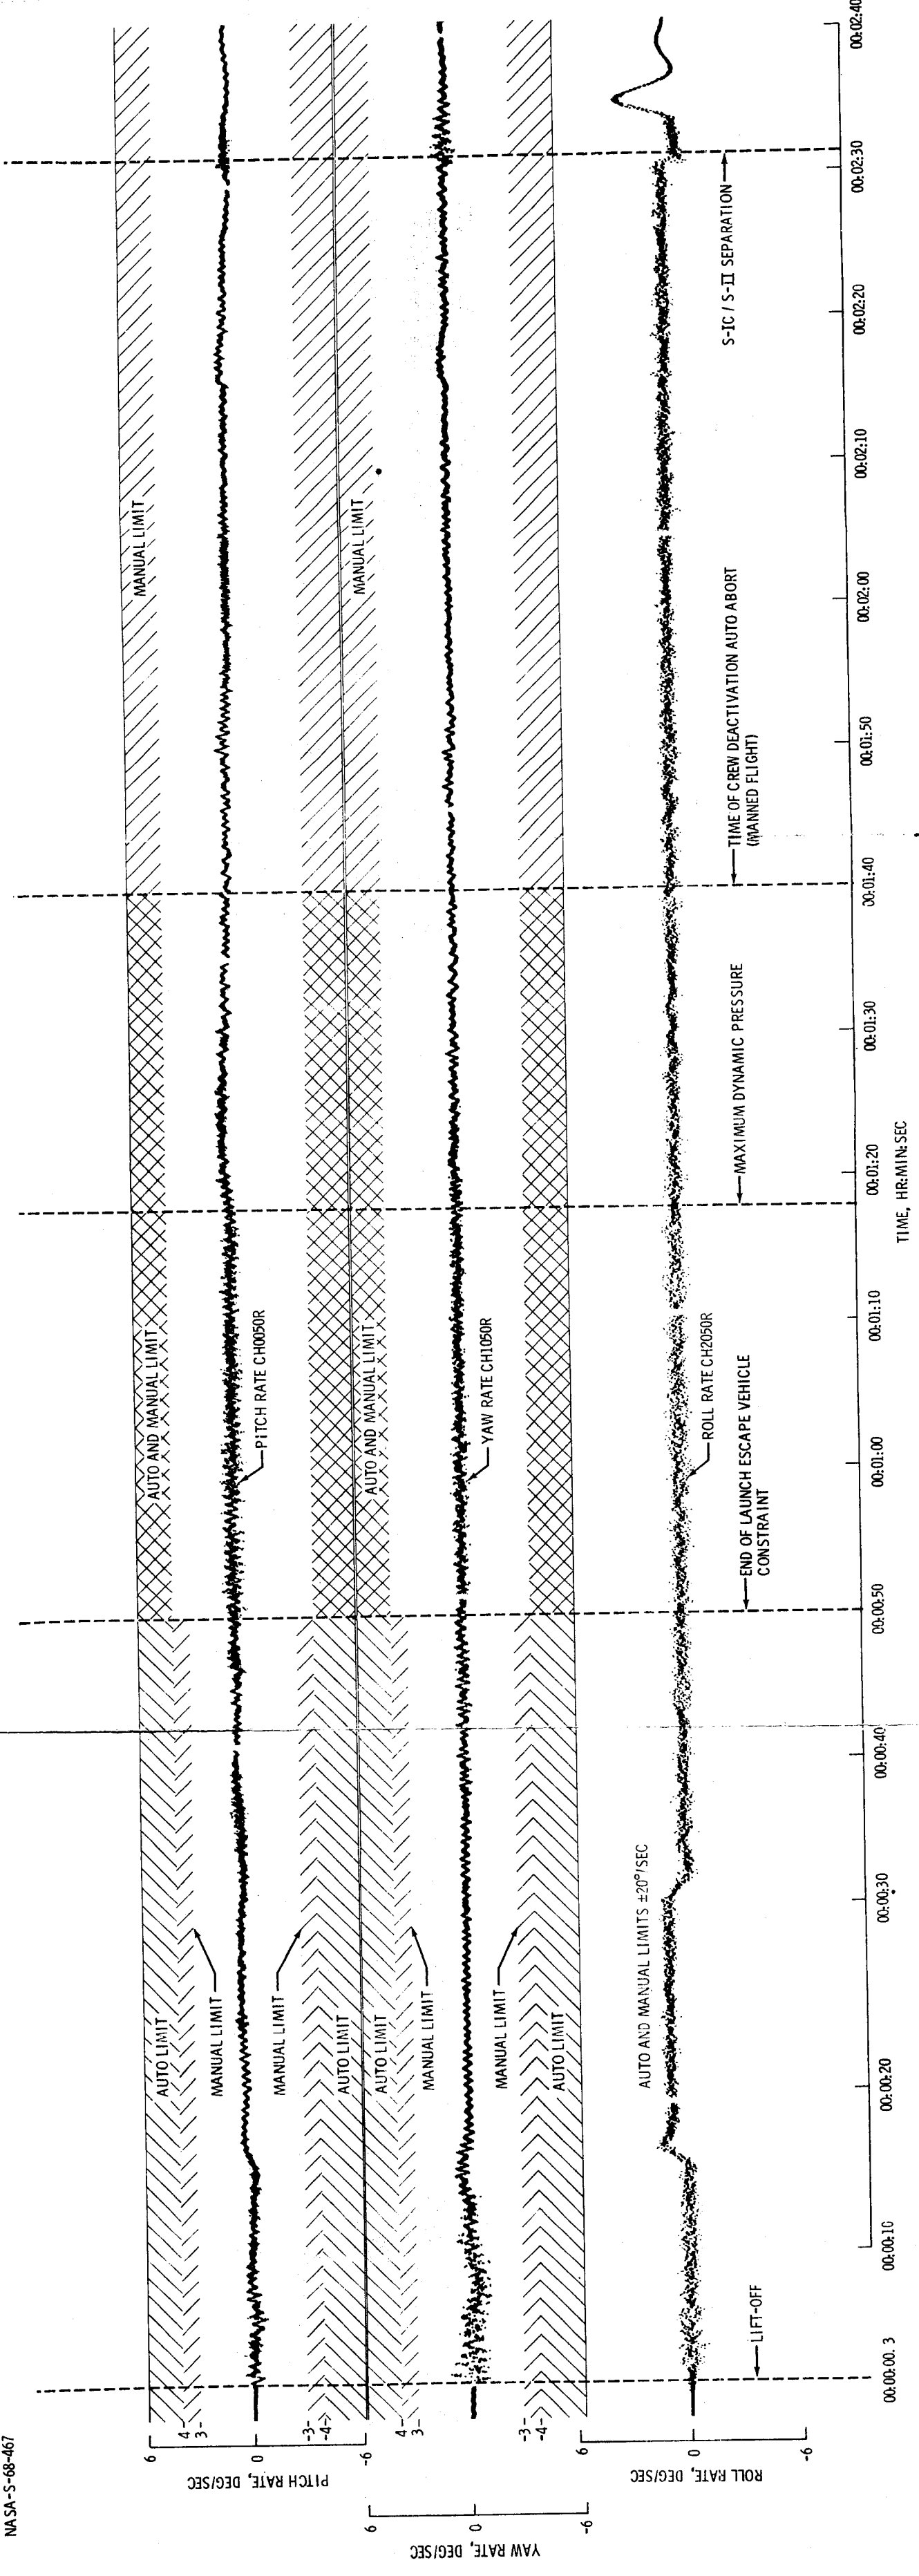
FIGURE 5.15-2. - SPACECRAFT DYNAMICS, ASCENT PHASE.

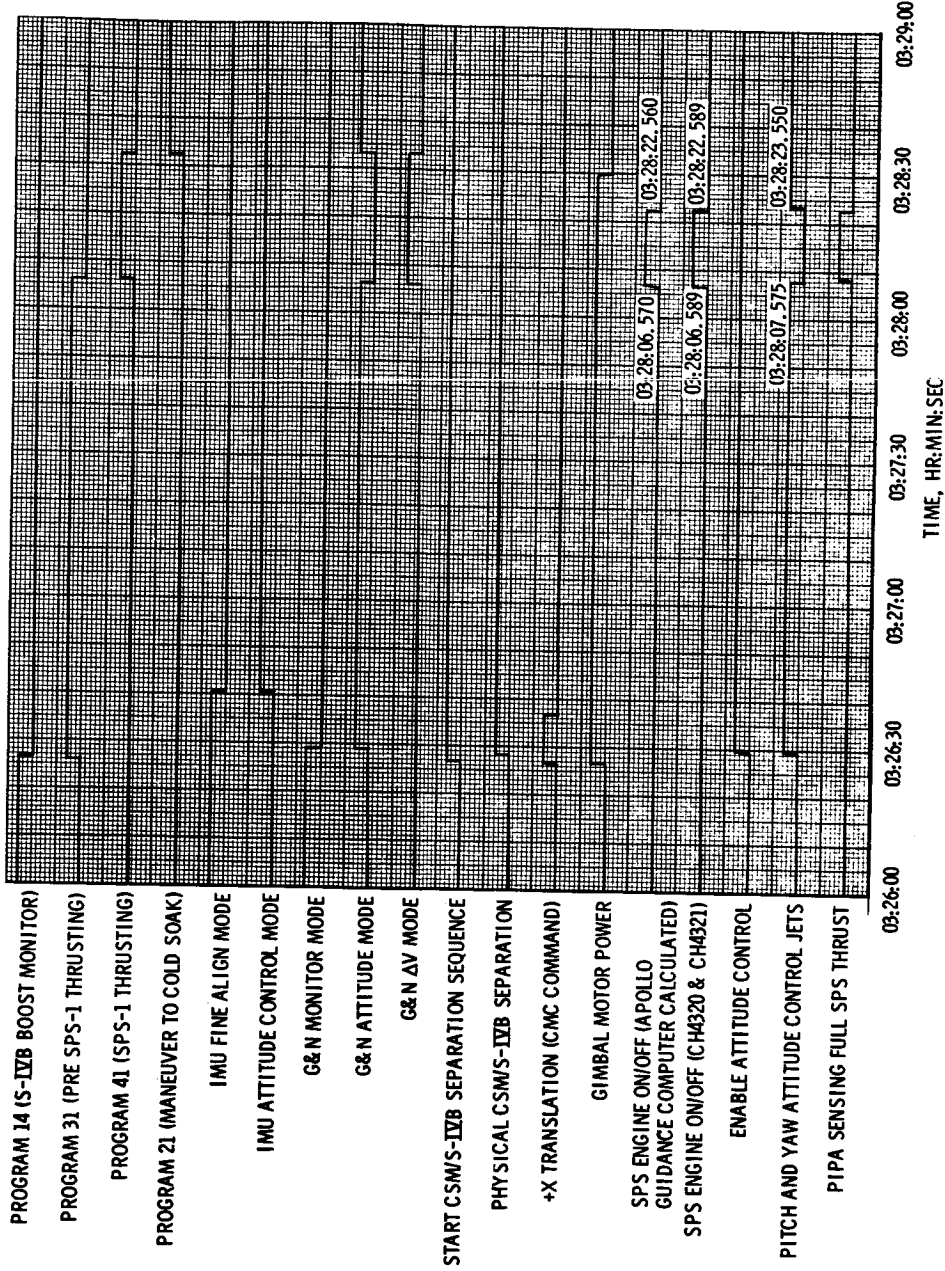
FIGURE 5.15-3 - S-IVB SEPARATION AND SERVICE PROPUSSION  
SUBSYSTEM BURN NUMBER 1 SEQUENCE OF EVENTS.
