APOLLO 4 MISSION REPORT

MANNED SPACECRAFT CENTER

January 1968

MSC-PA-R-68-1

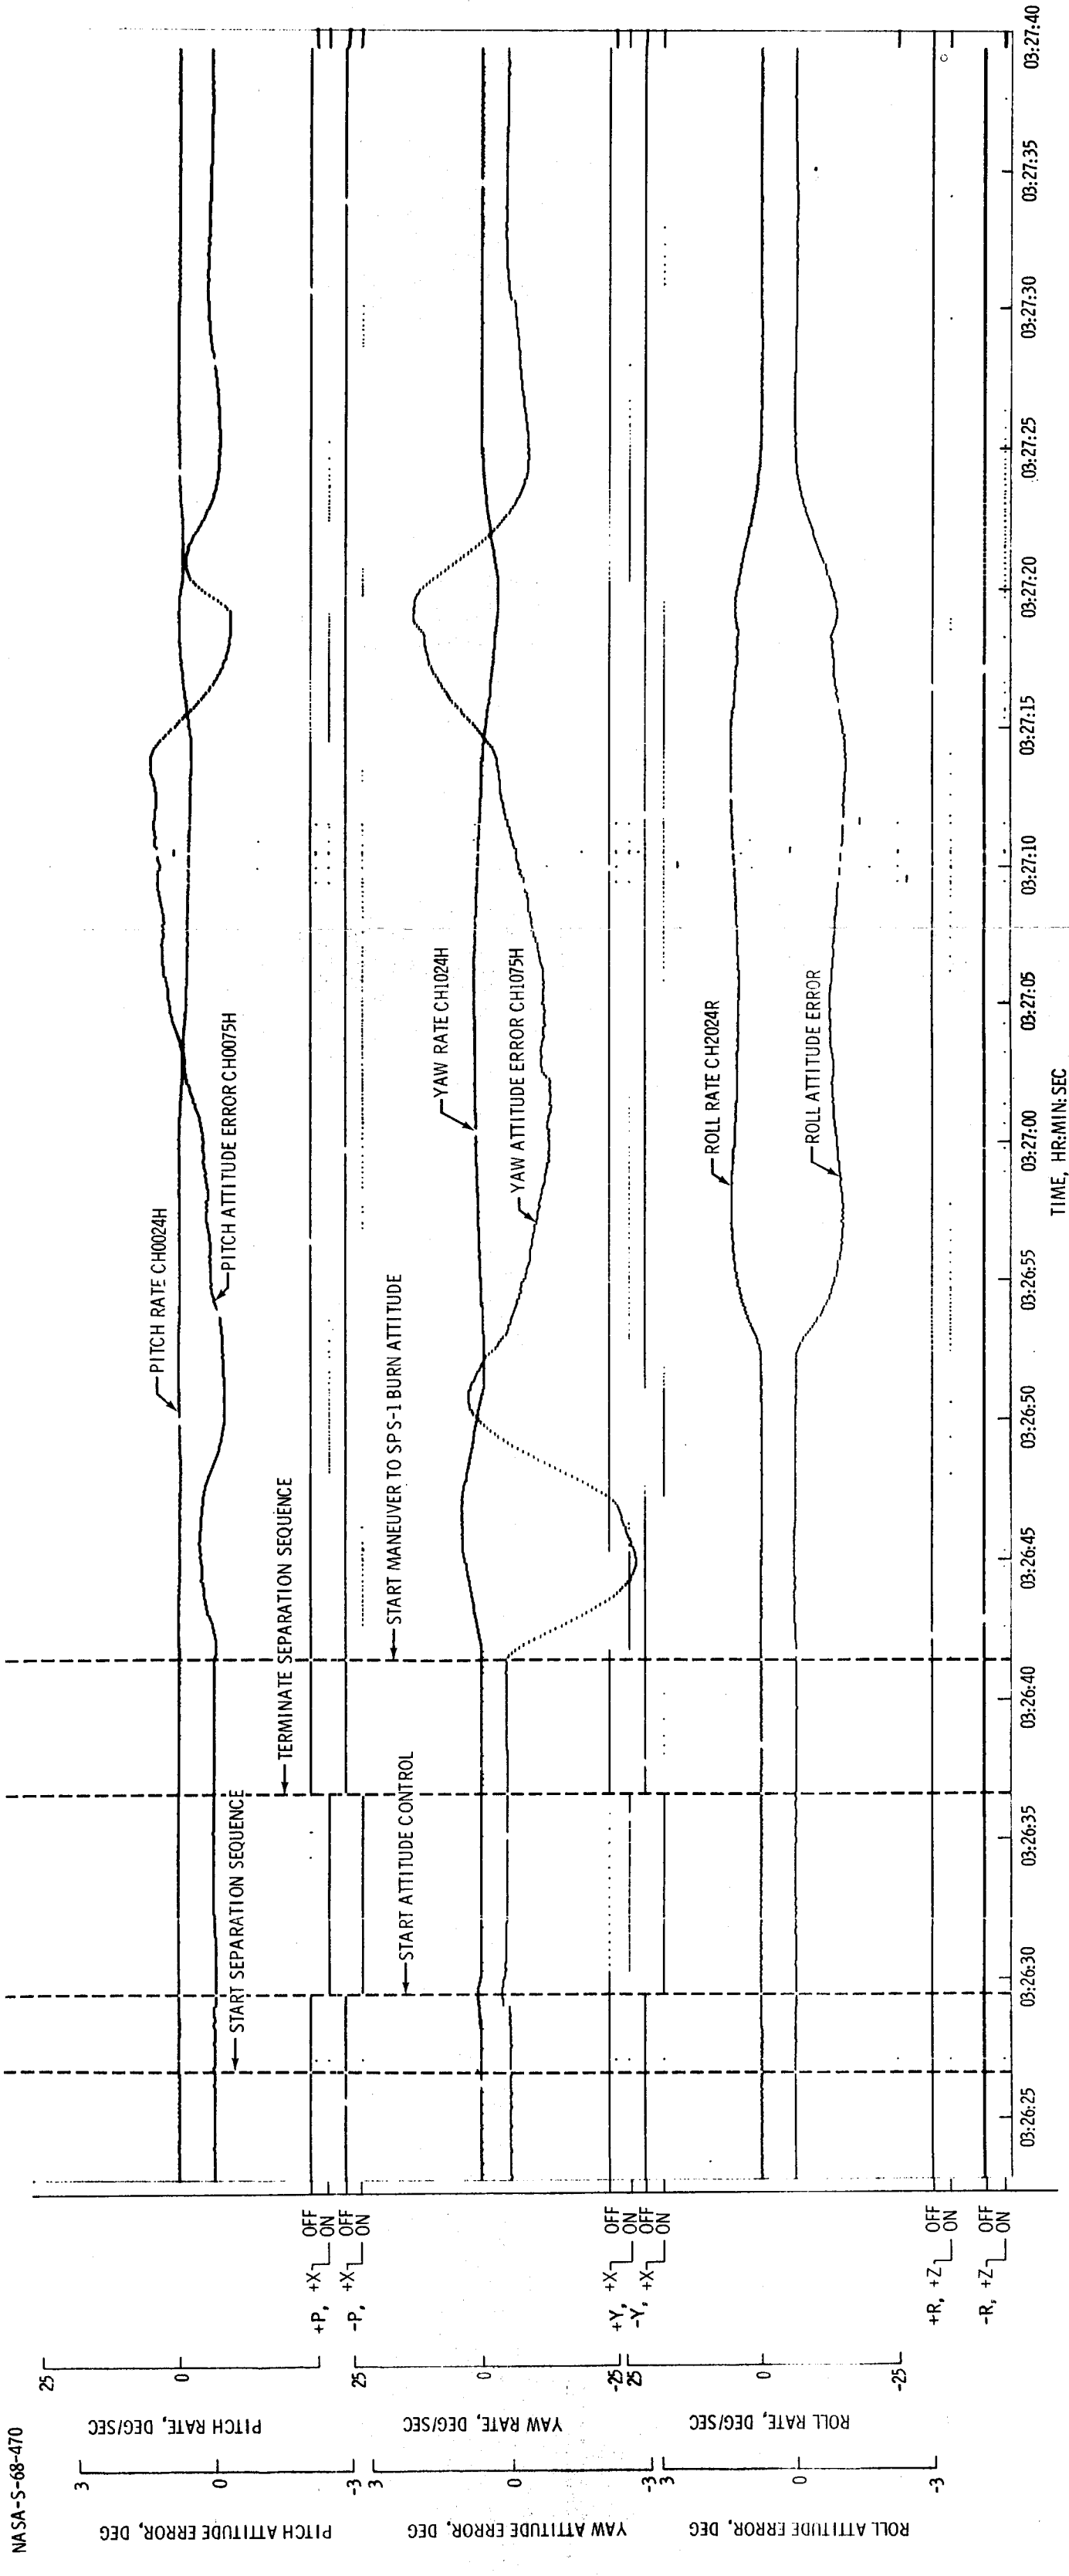
FIGURE 5.15-5. - SPACECRAFT DYNAMICS, S-IVB/CSM SEPARATION AND MANEUVER TO SERVICE PROPULSION SUBSYSTEM FIRST BURN ATTITUDE.

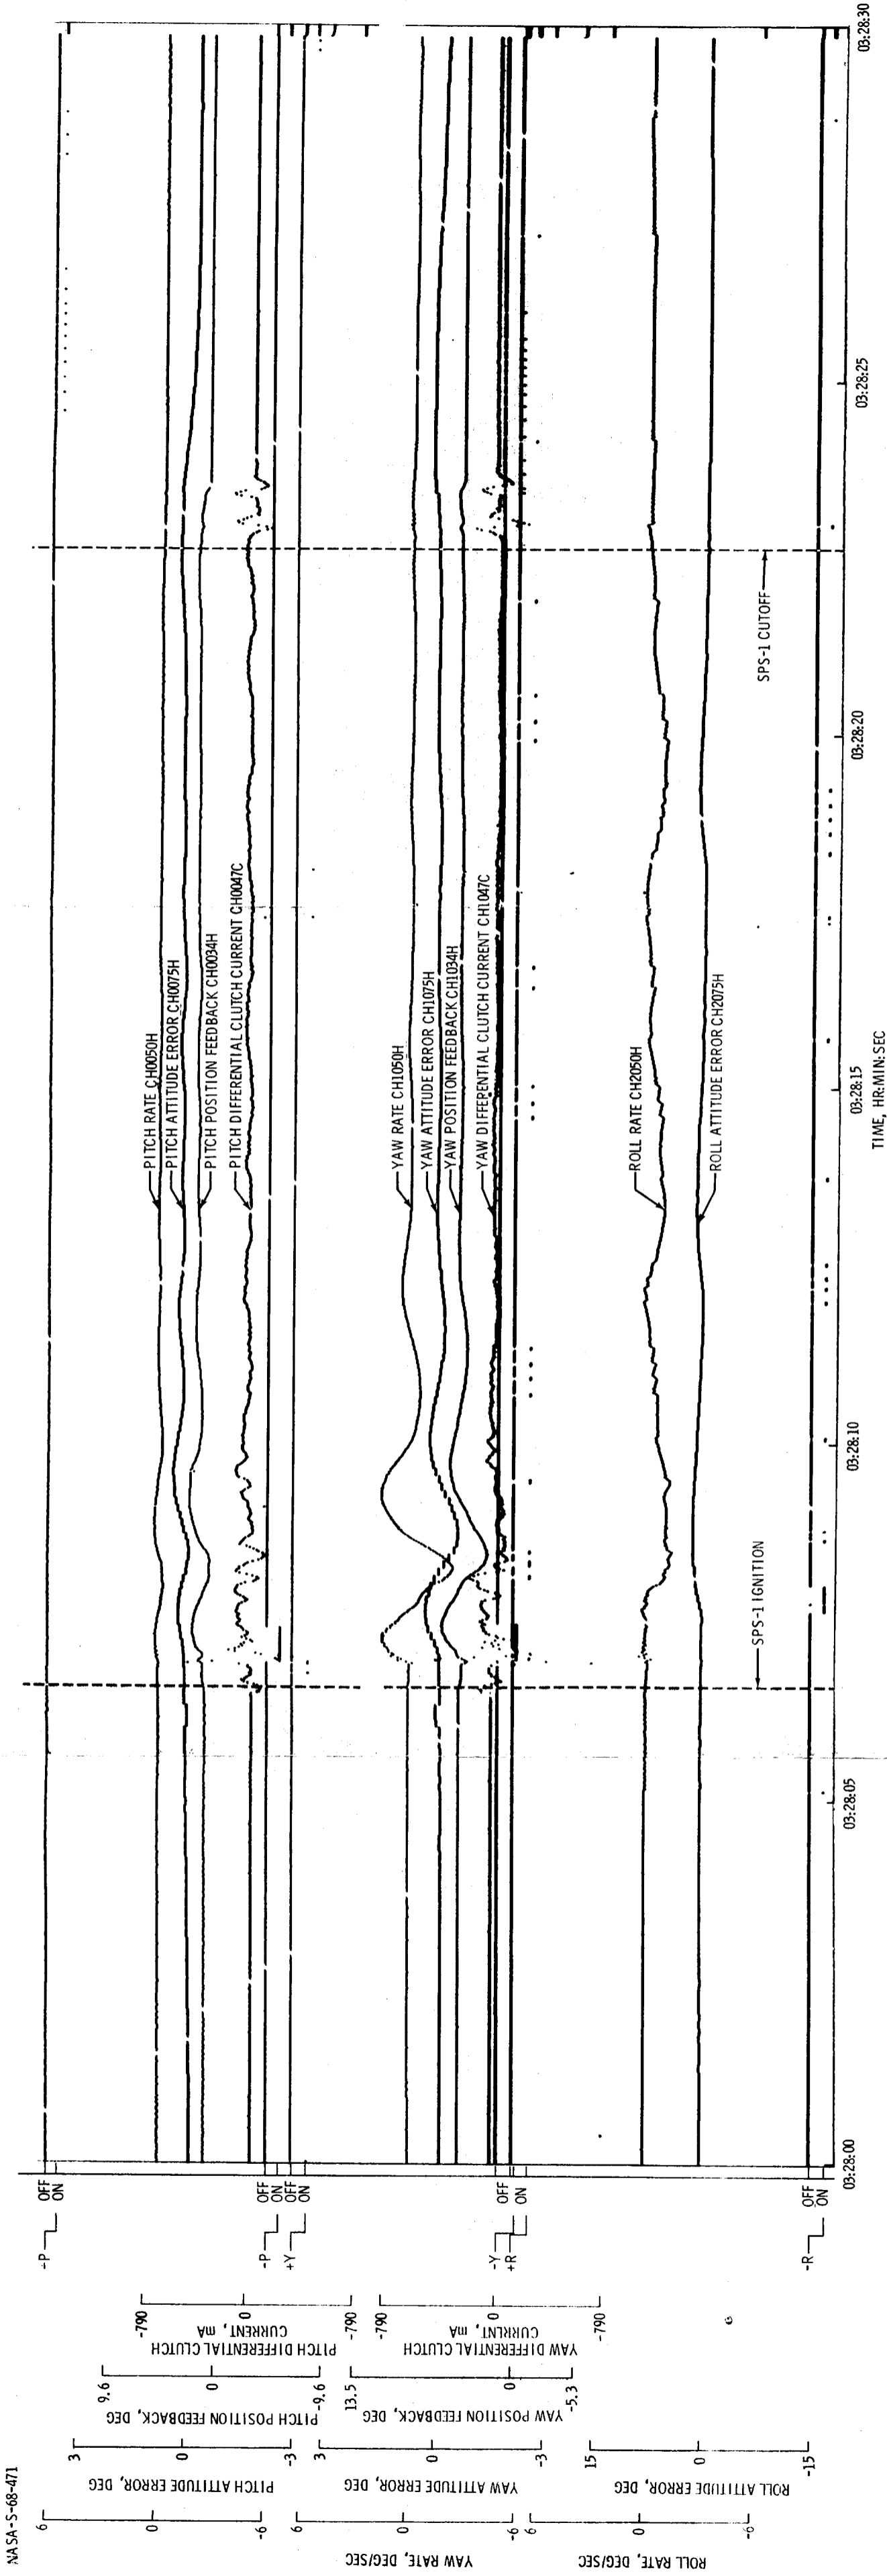
FIGURE 5.15-6. - SPACECRAFT DYNAMICS, SERVICE PROPULSION SUBSYSTEM FIRST BURN.

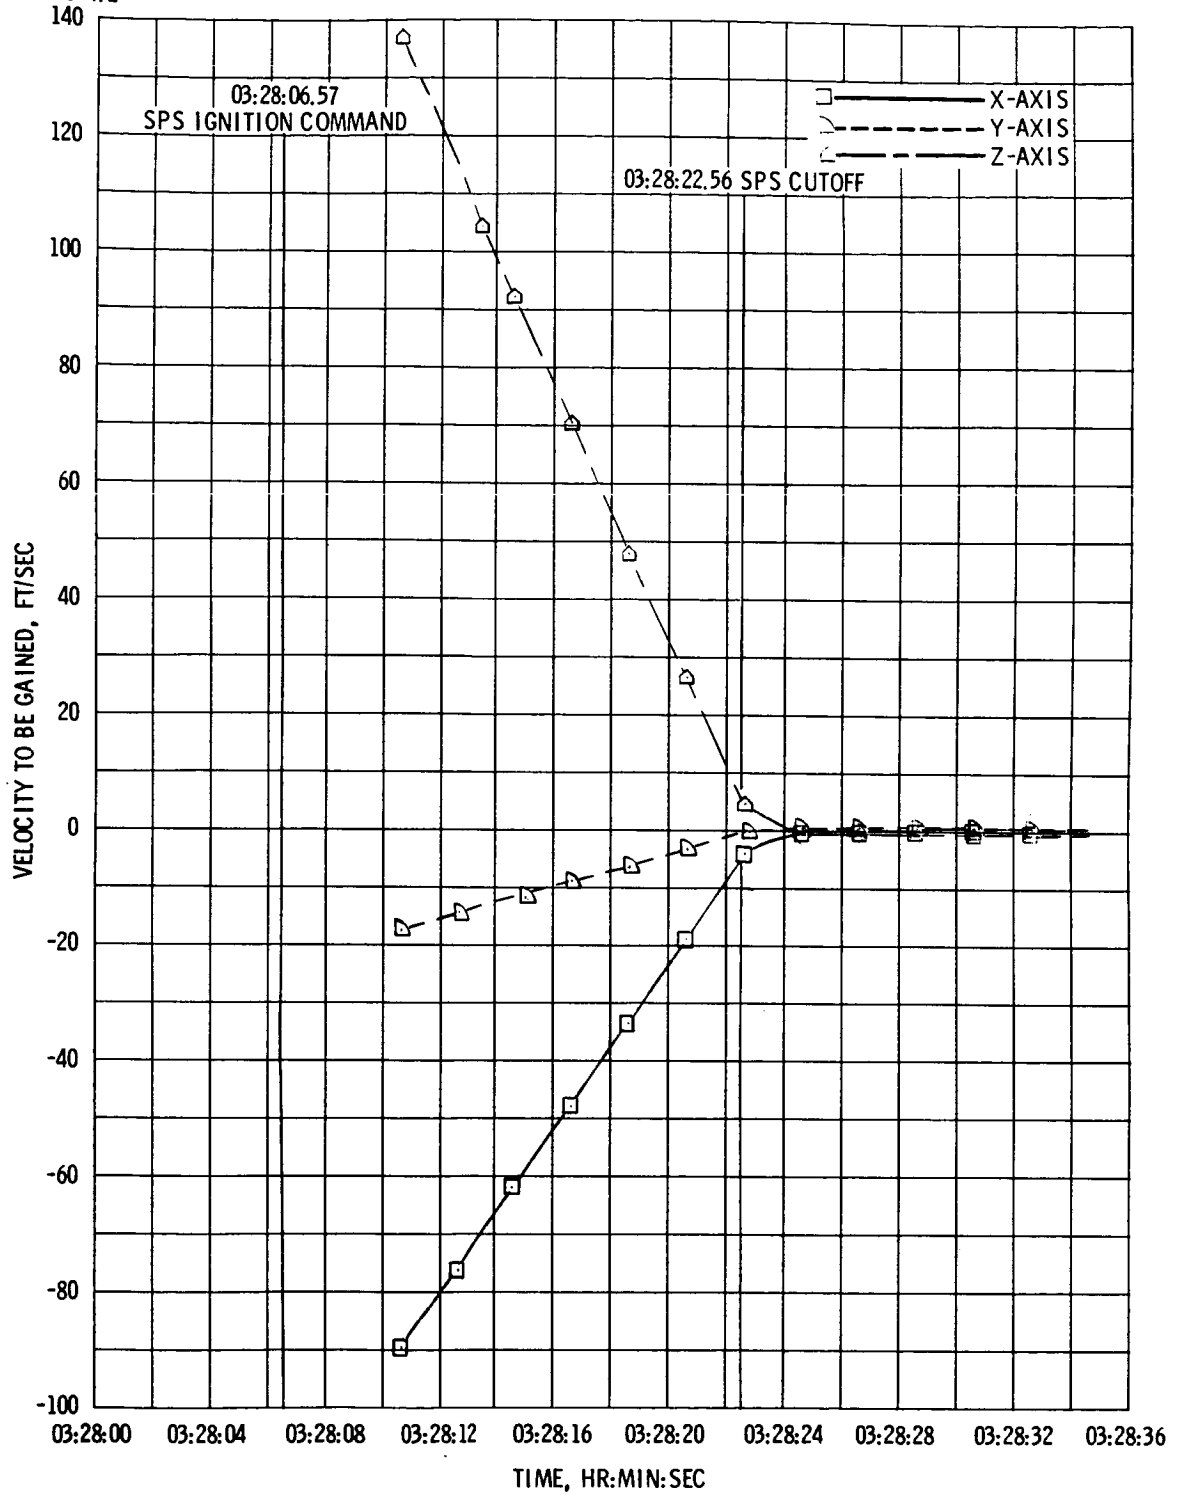
FIGURE 5.15-7. - VELOCITY TO BE GAINED ( $V_g$ ), SERVICE PROPULSION SUBSYSTEM FIRST BURN.

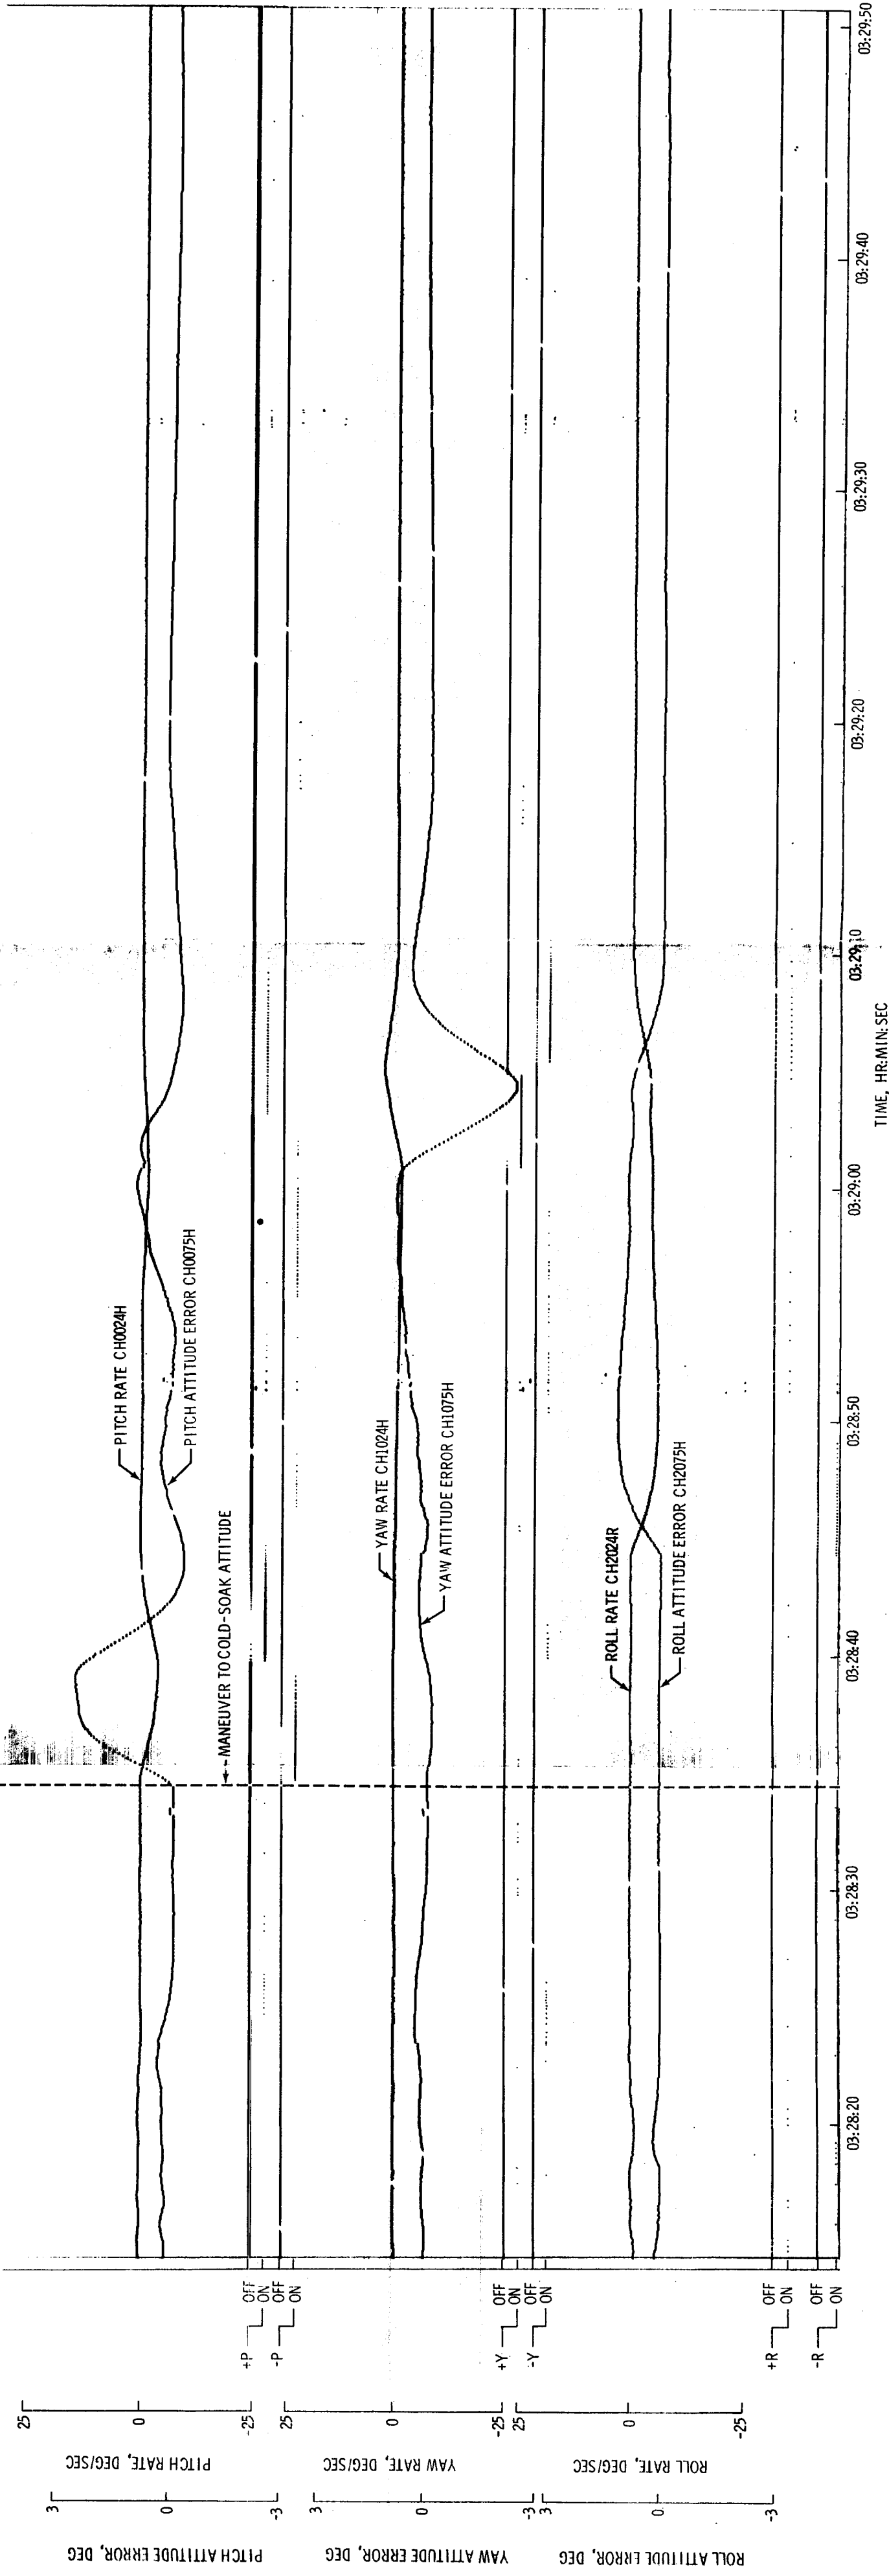
FIGURE 5.15-8.- SPACECRAFT DYNAMICS, MANEUVERS TO COLD-SOAK ATTITUDE.

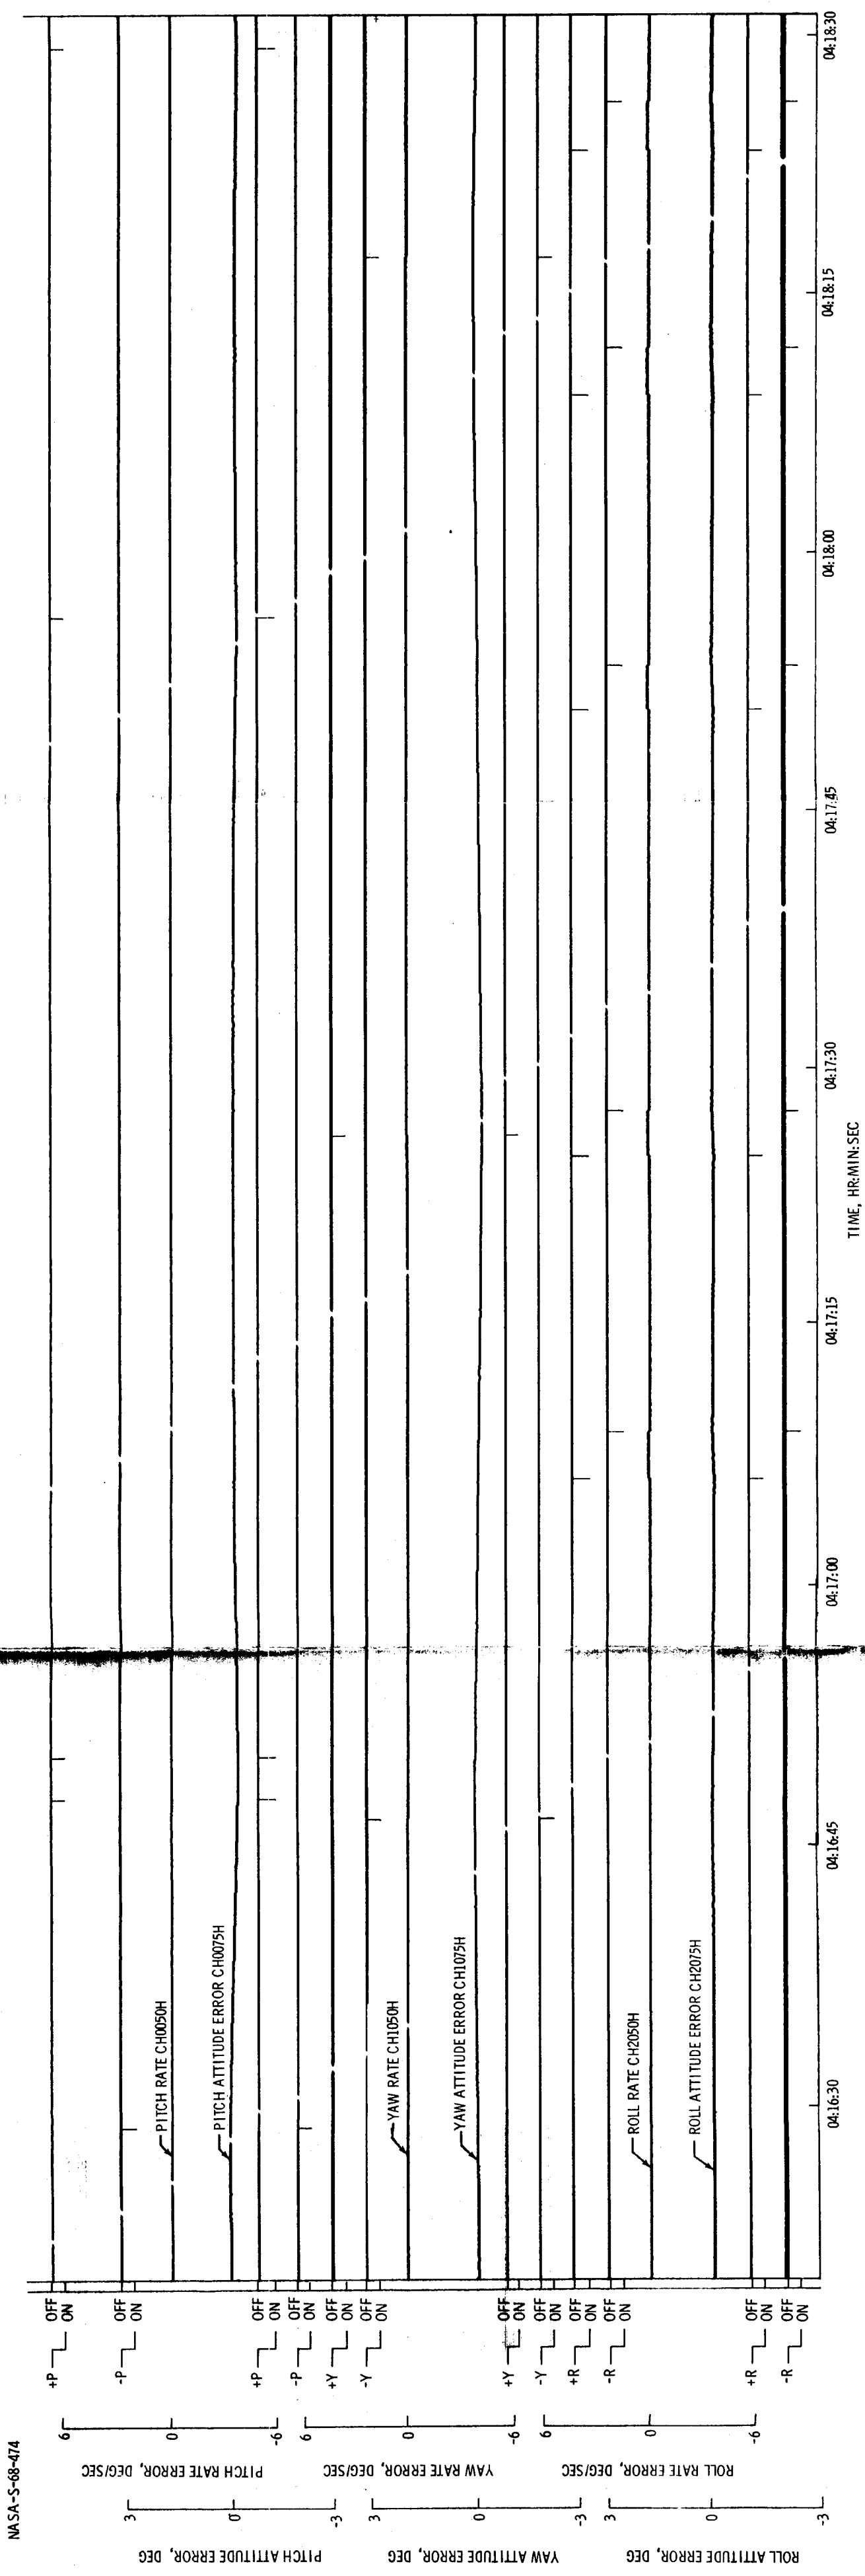
FIGURE 5.15-9. - SPACECRAFT DYNAMICS, TYPICAL COAST PHASE LIMIT CYCLE.

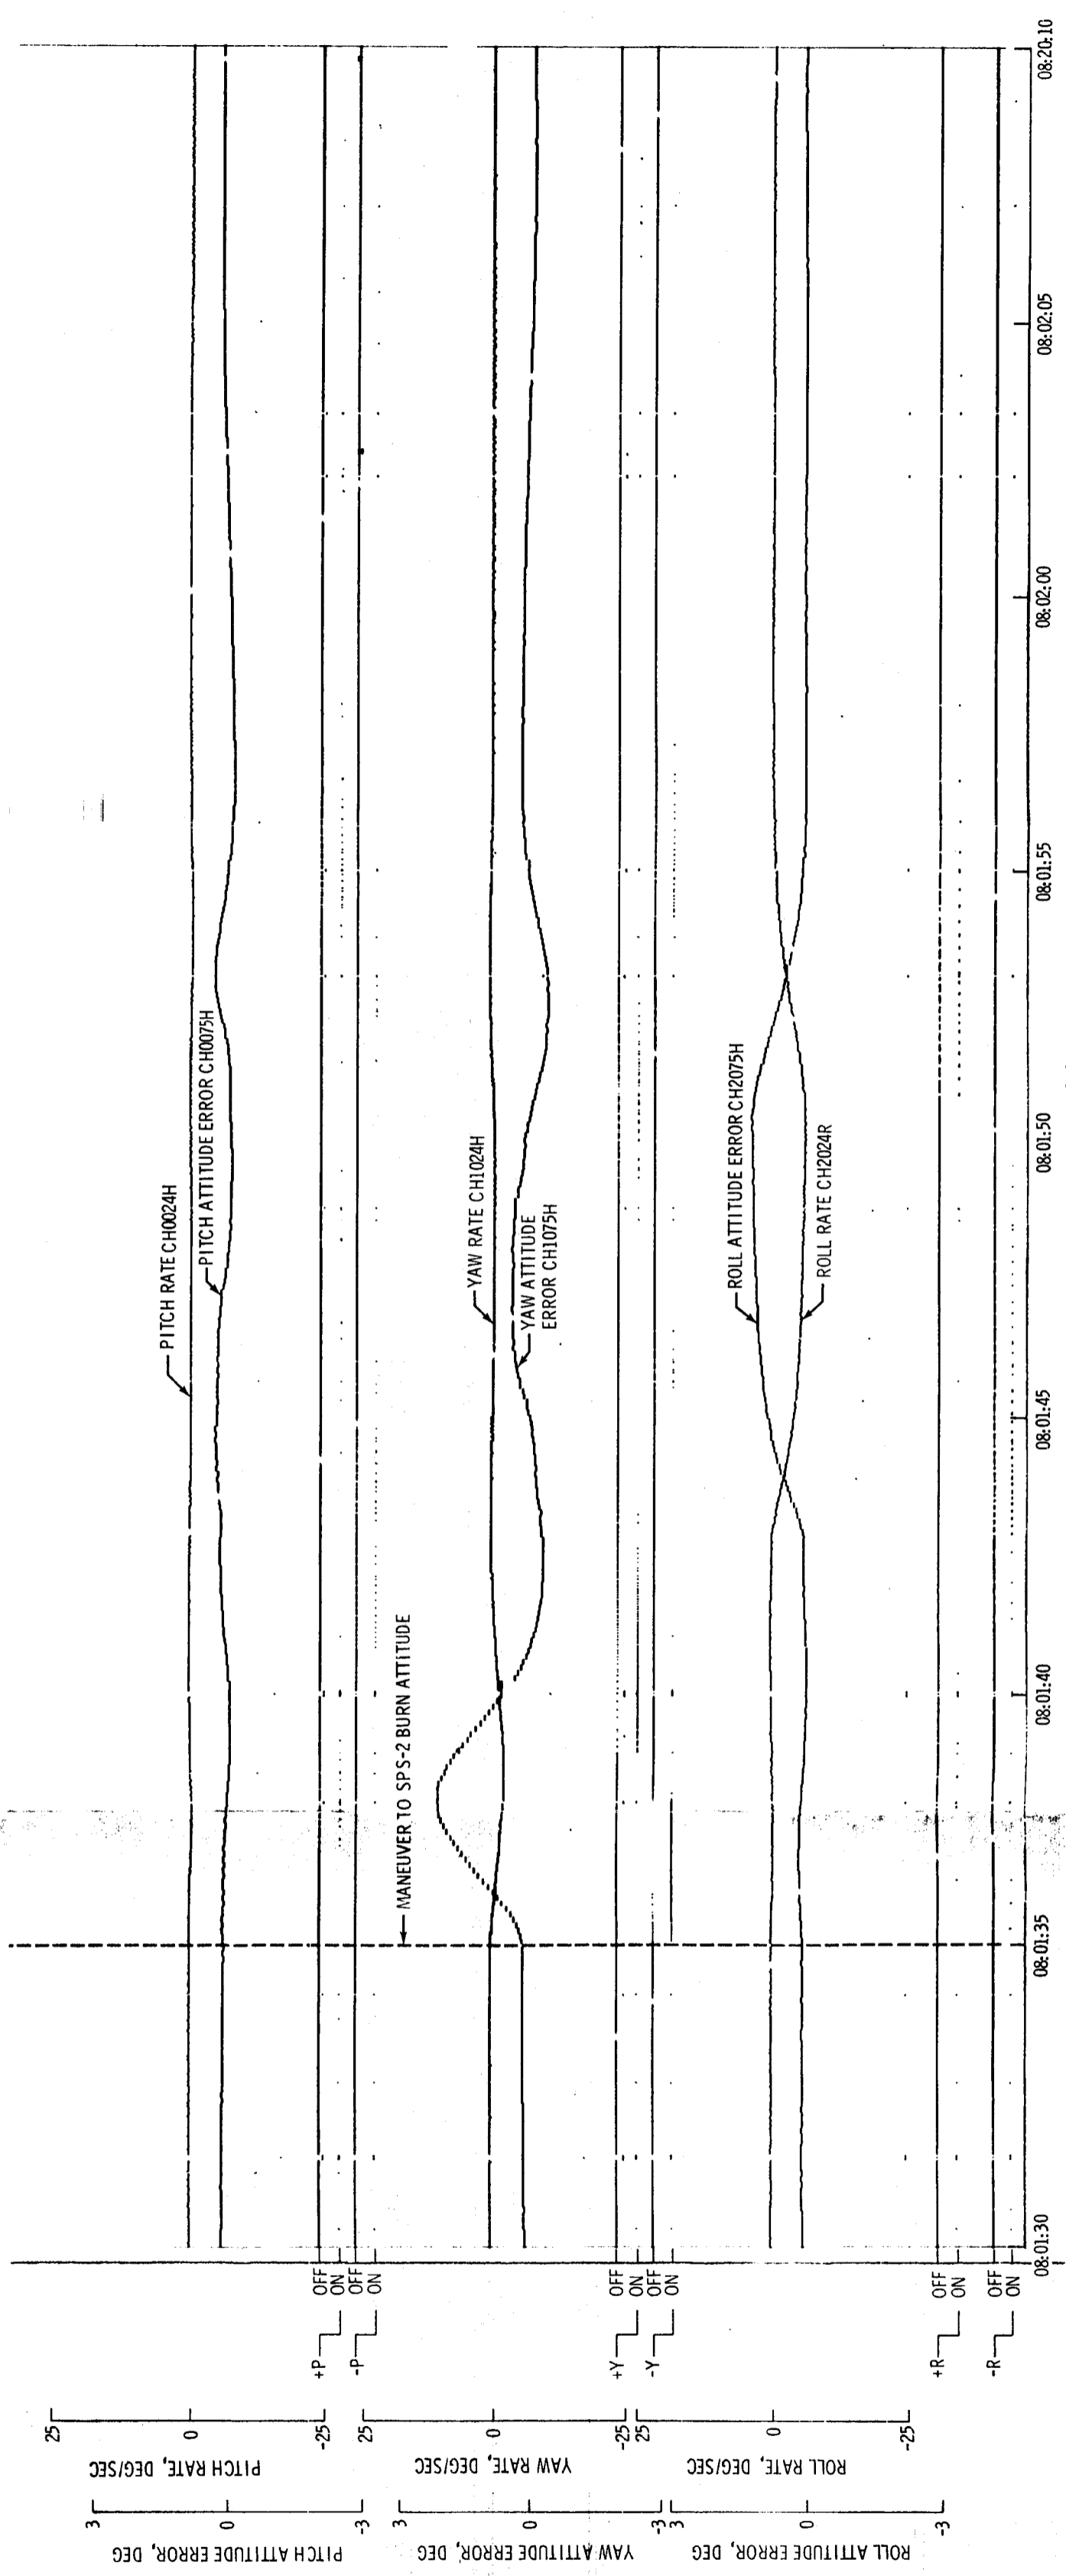
FIGURE 5.15-10. - SPACECRAFT DYNAMICS, MANEUVER TO SERVICE PROPULSION SUBSYSTEM SECOND BURN ATTITUDE.

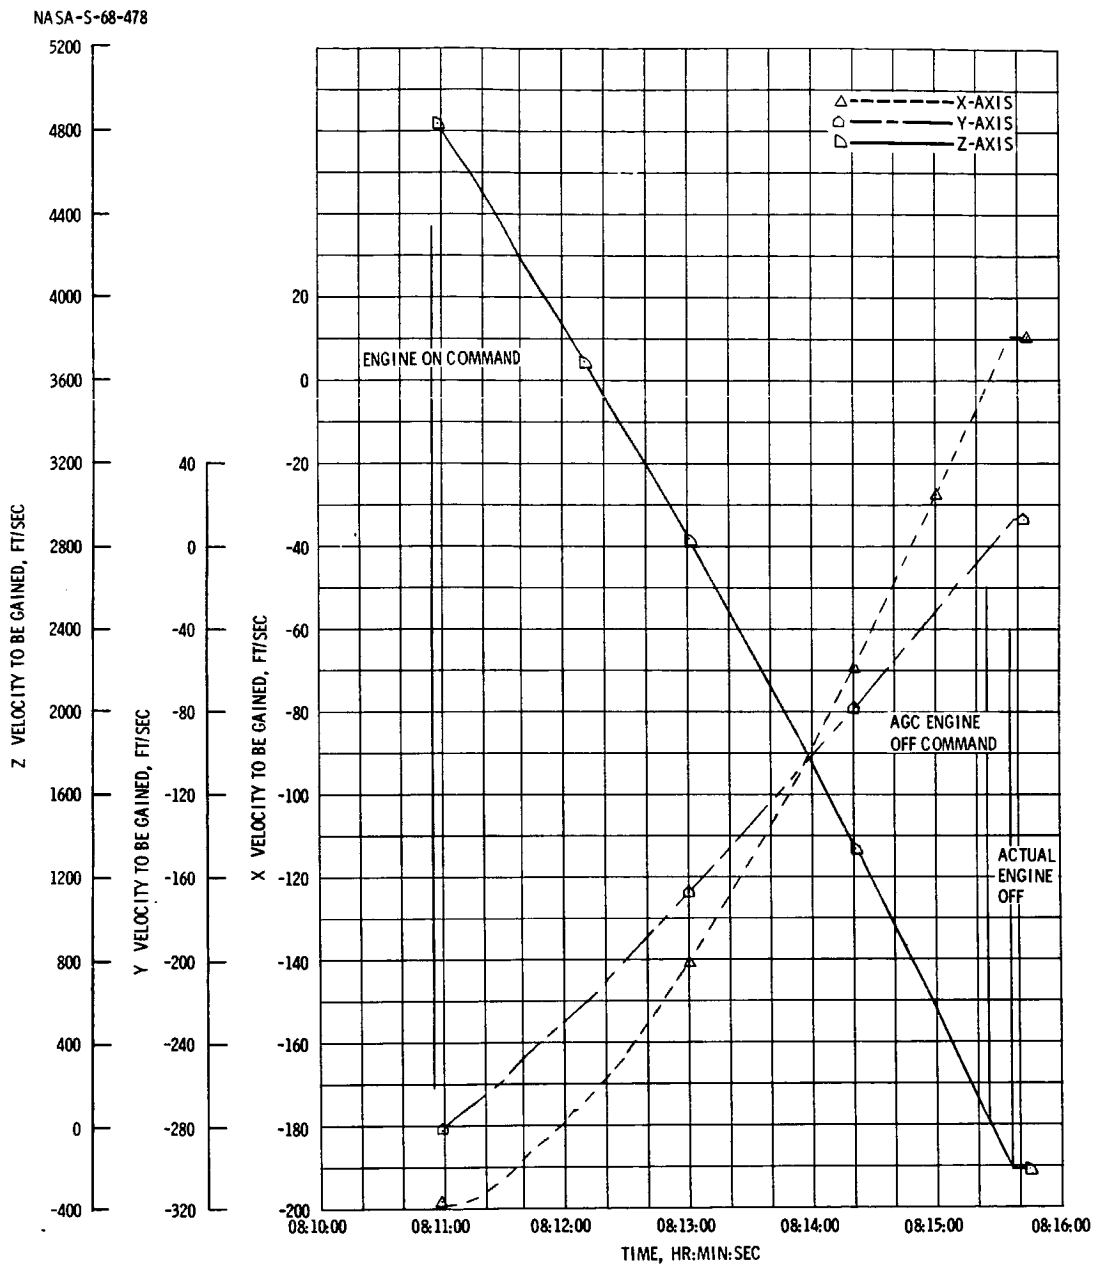
FIGURE 5.15-13. - VELOCITY TO BE GAINED ( $V_G$ ), SERVICE PROPULSION SUBSYSTEM SECOND BURN.

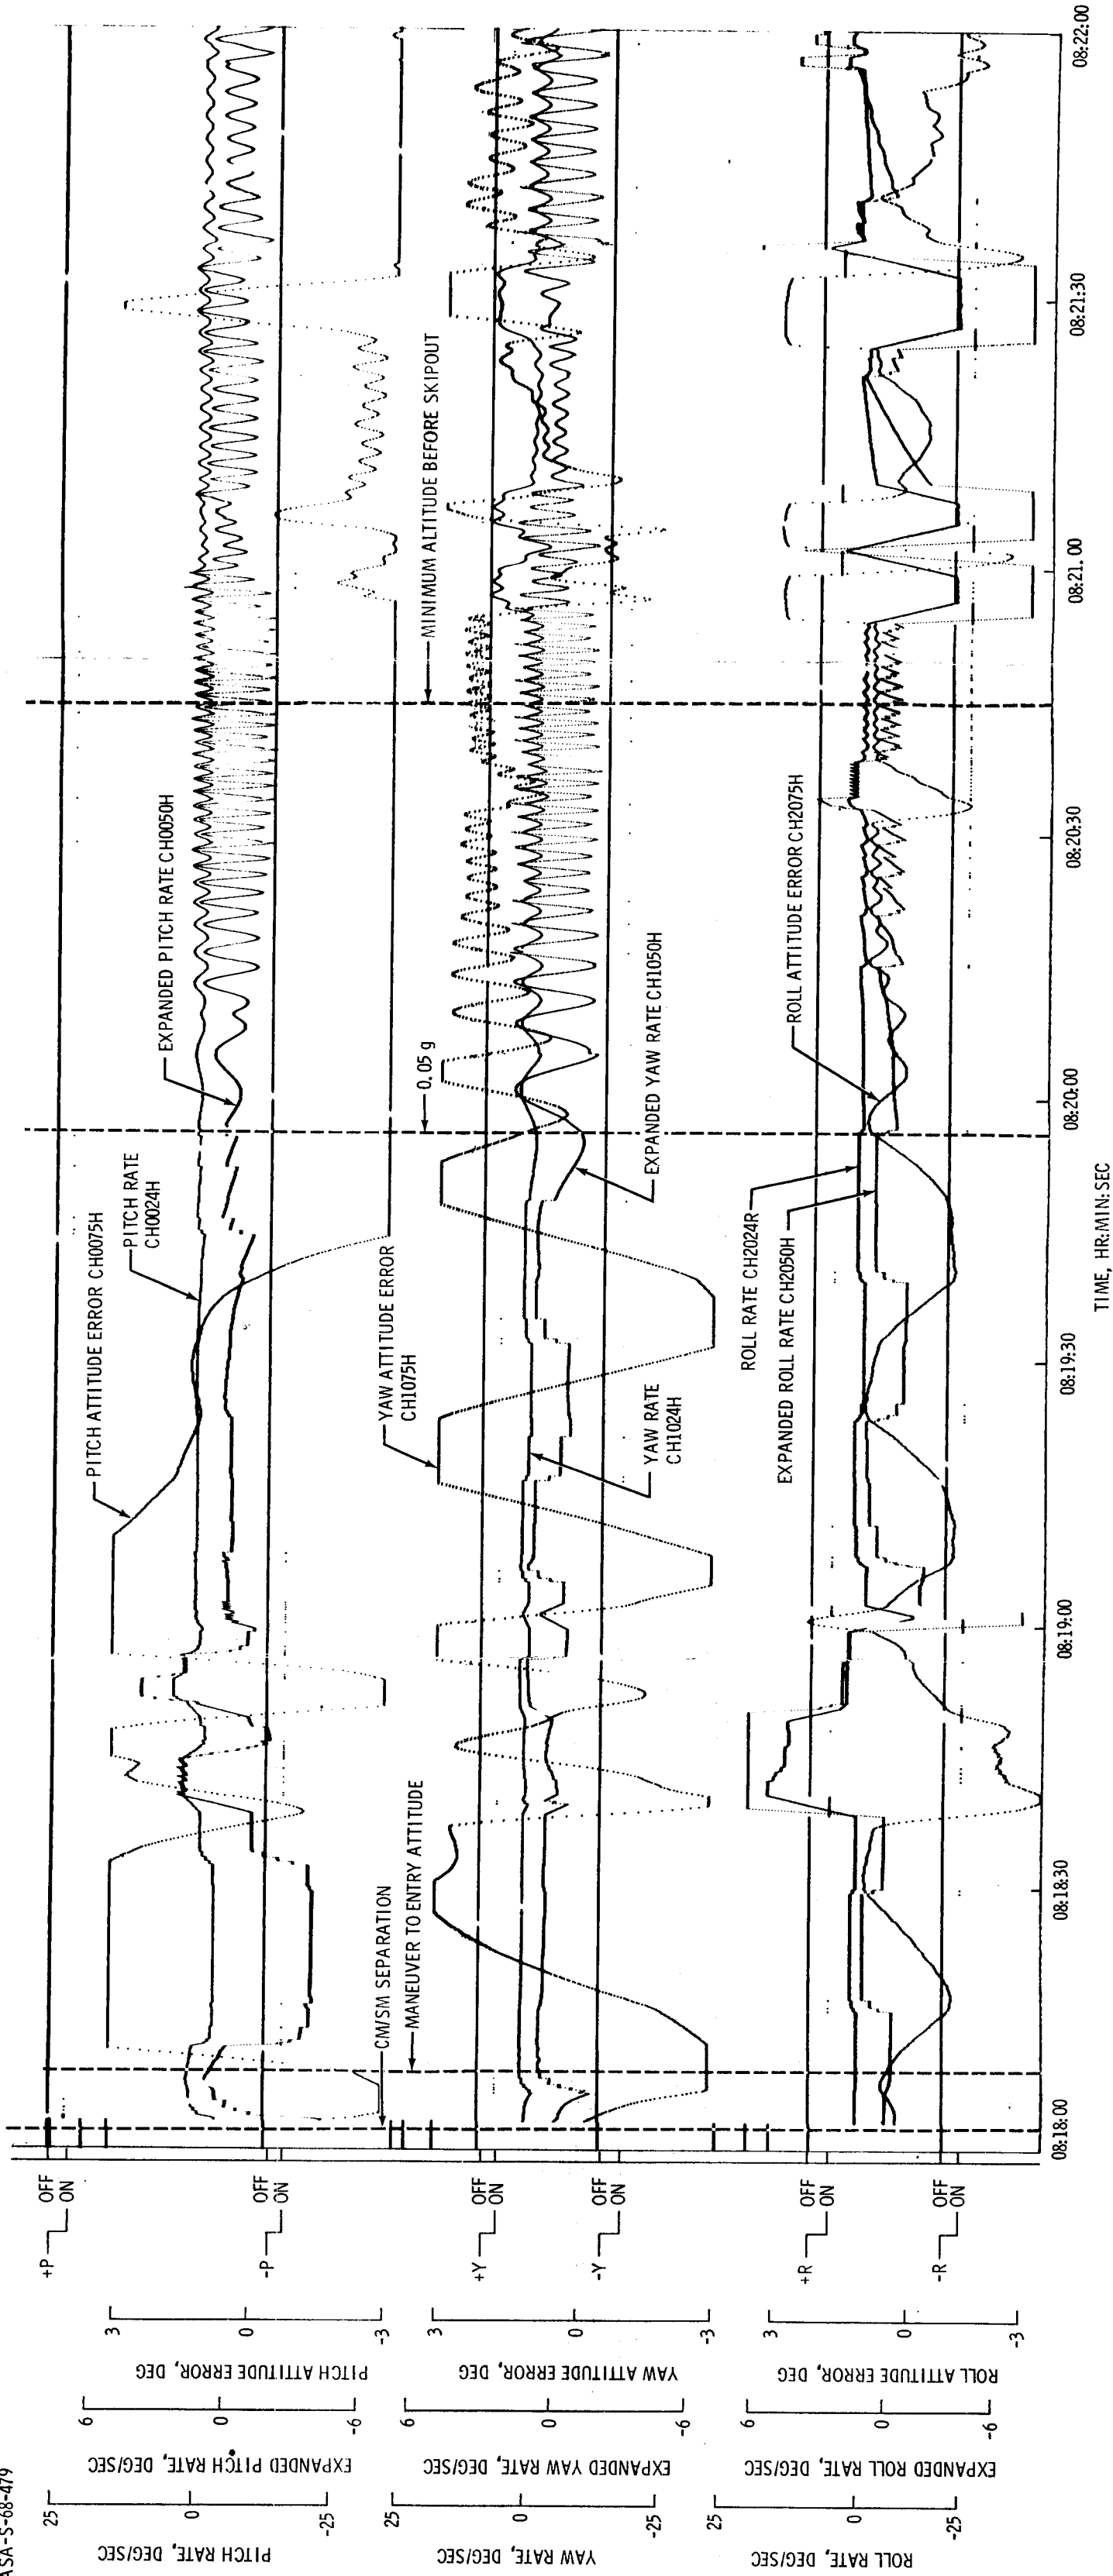
(A) 08:18:00 TO 08:22:00.  
FIGURE 5.15-14.- SPACECRAFT DYNAMICS, ENTRY.

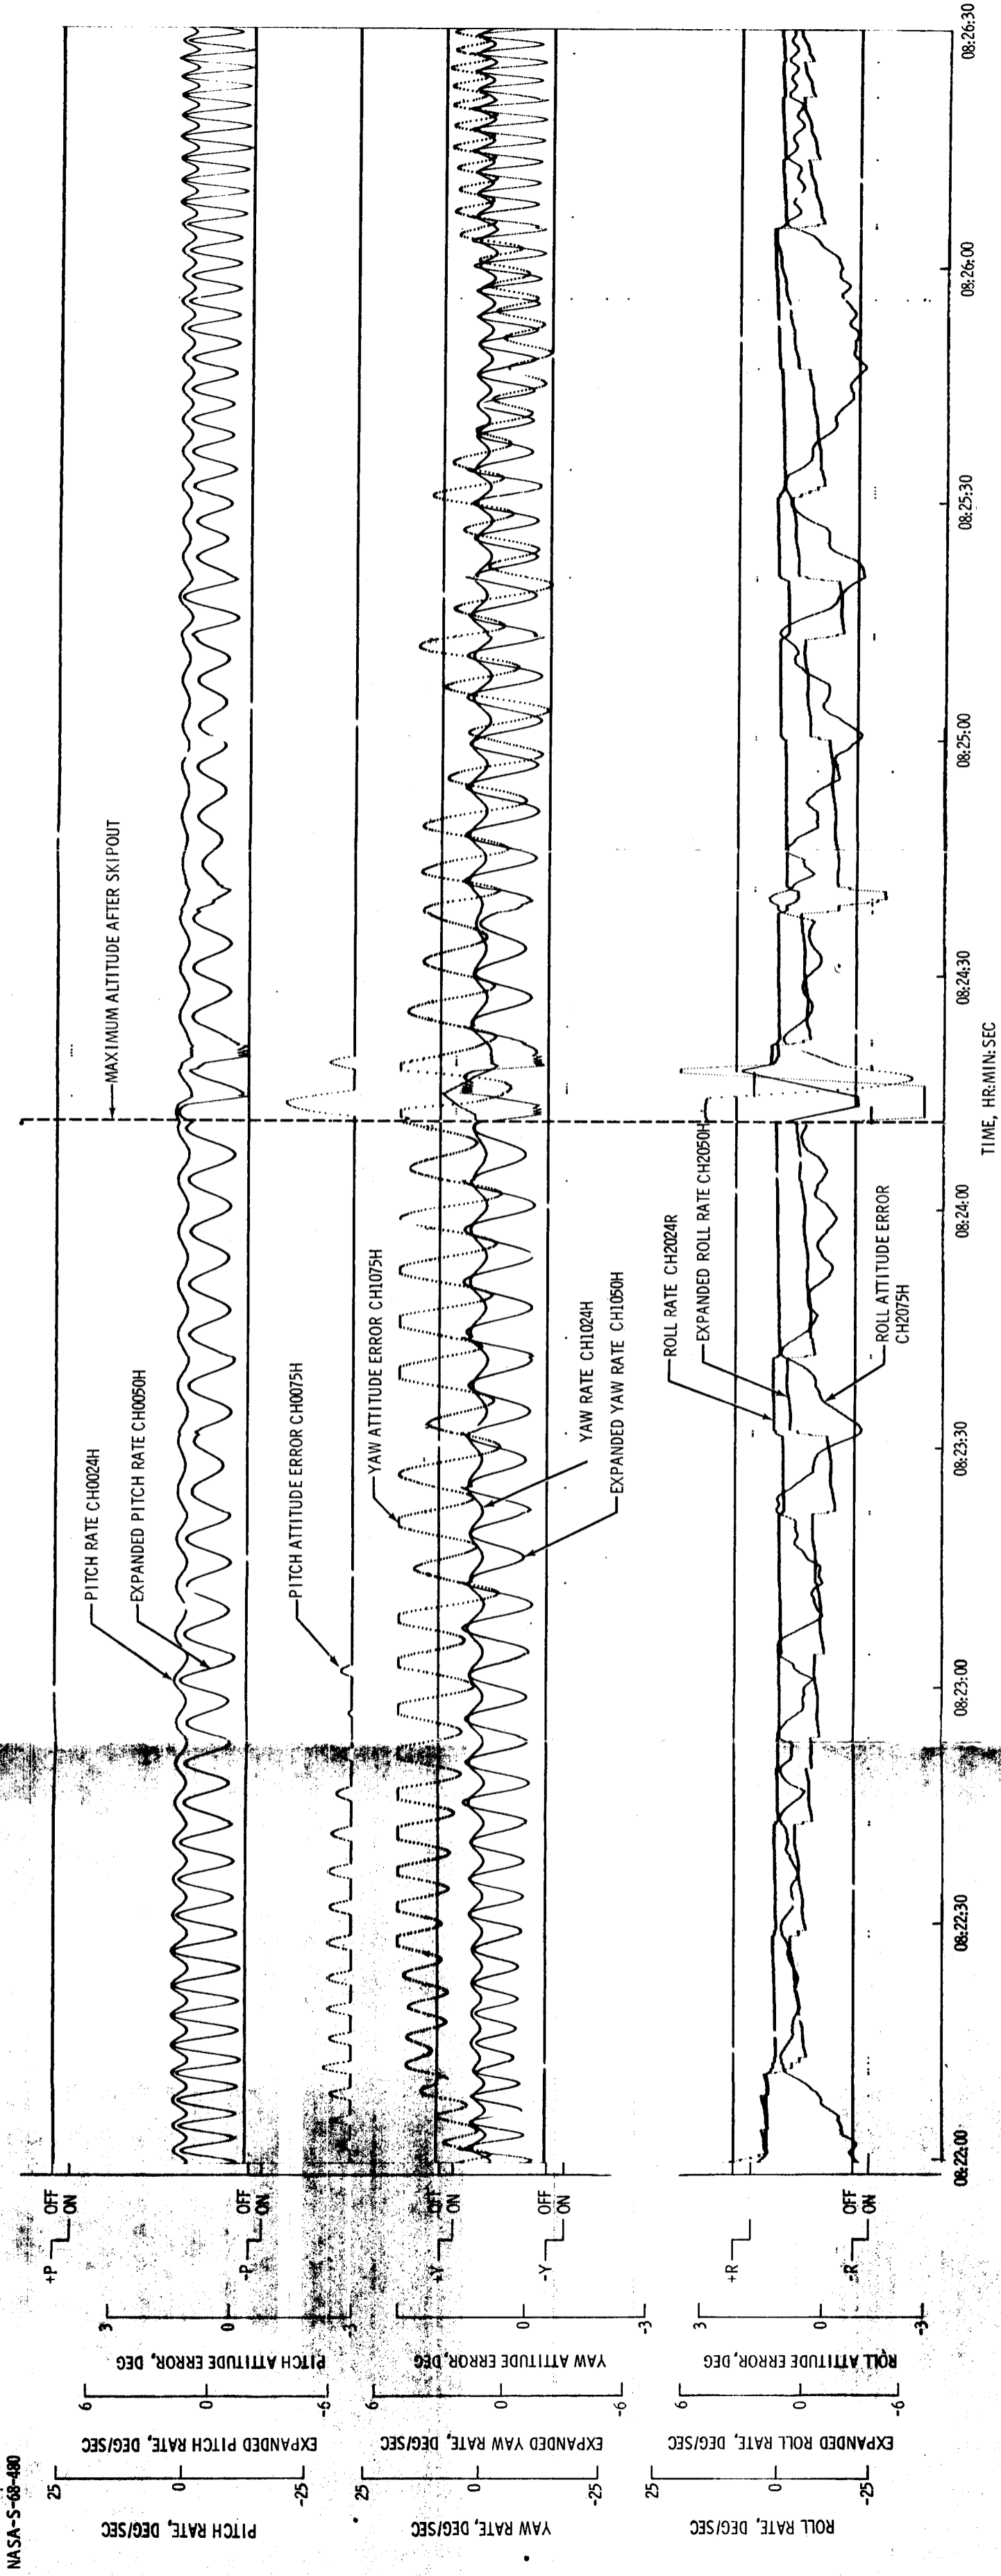
(B) 08:22:00 TO 08:26:30.

FIGURE 5.15-14. - CONTINUED.
