APOLLO 4 MISSION REPORT

MANNED SPACECRAFT CENTER

January 1968

MSC-PA-R-68-1

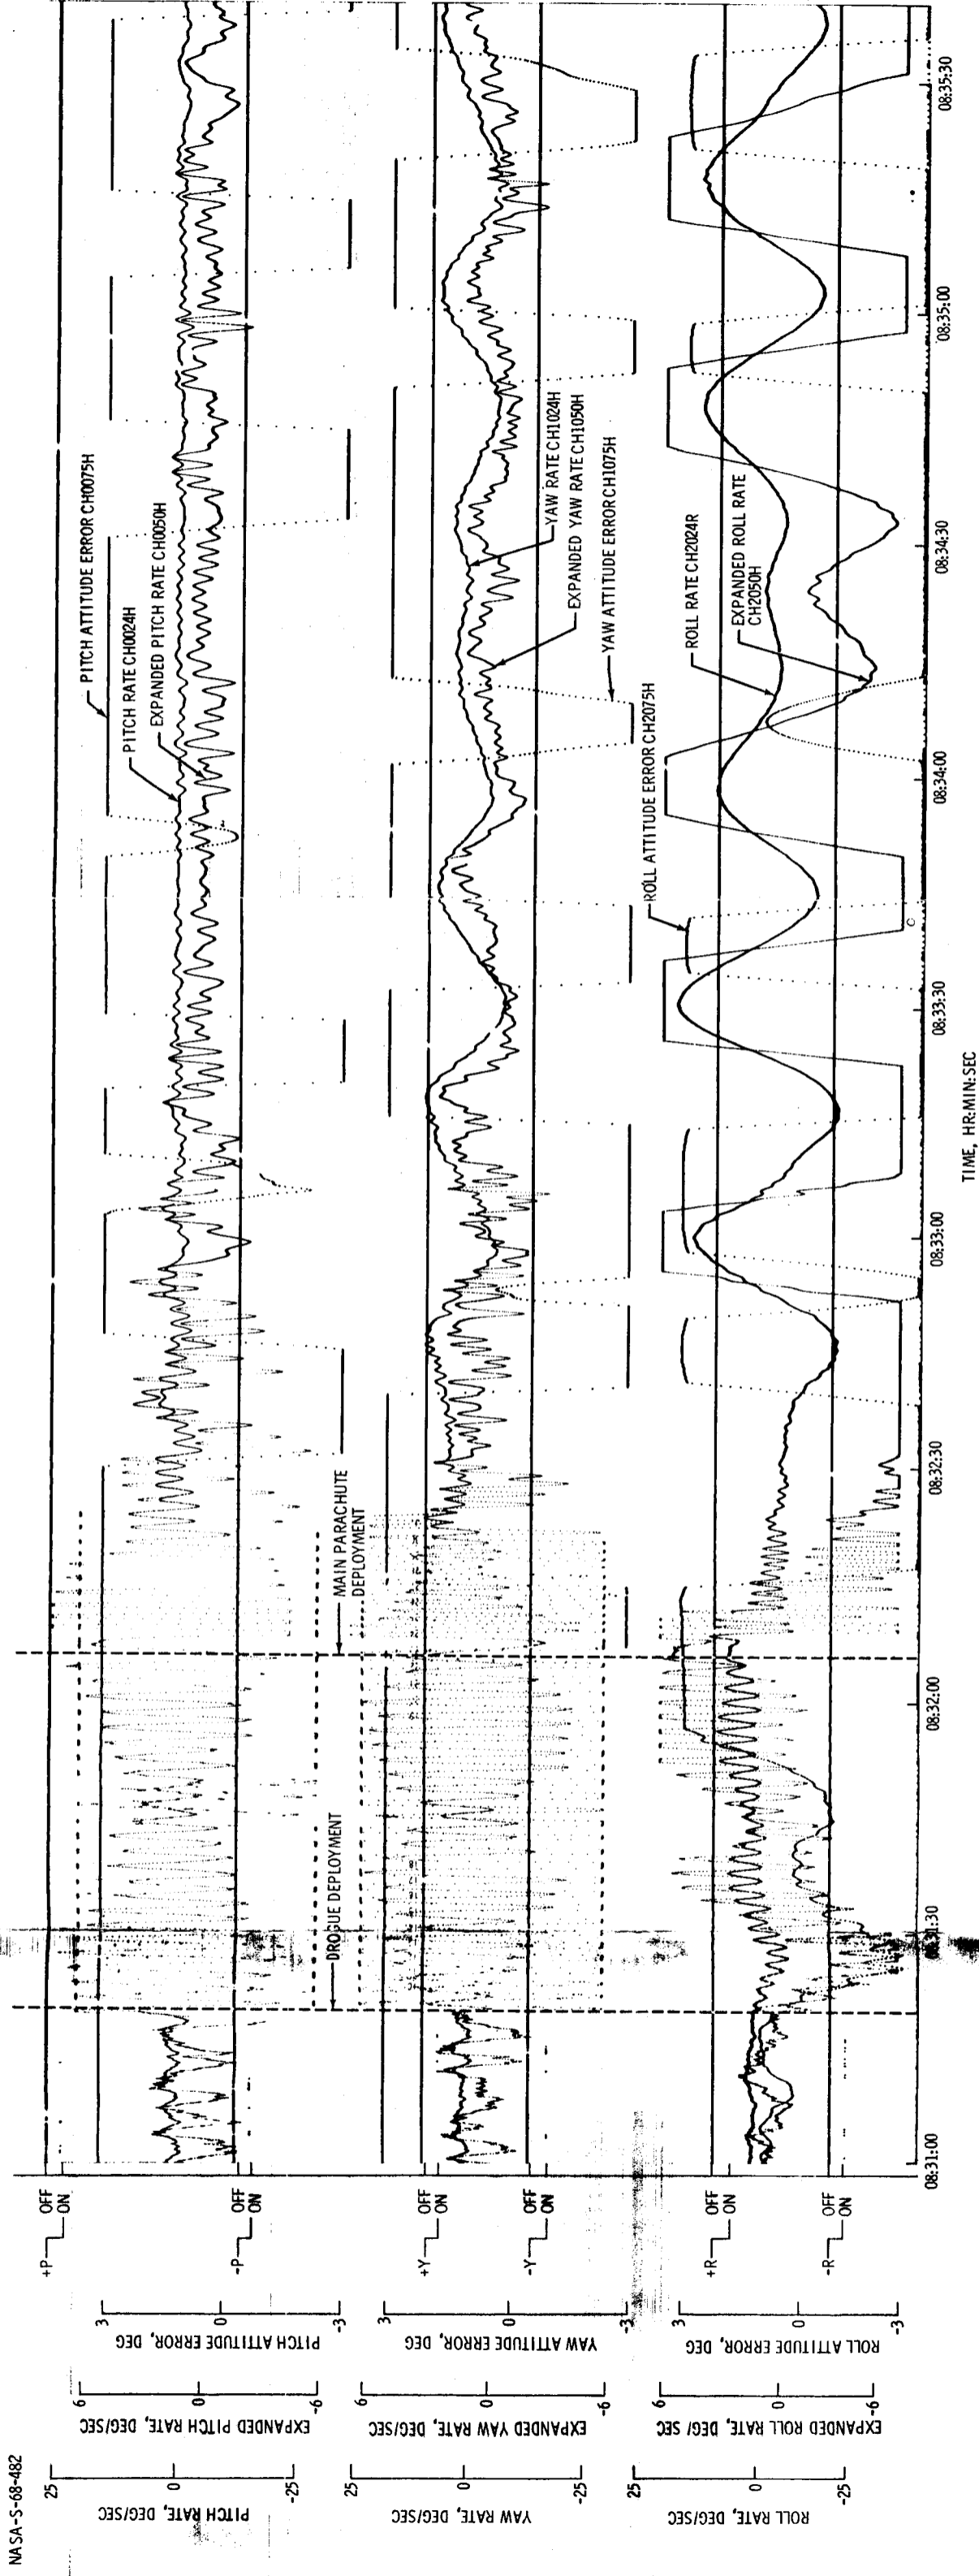
(D) 08:31:00 TO 08:35:40.  
FIGURE 5.15-14. - CONCLUDED.

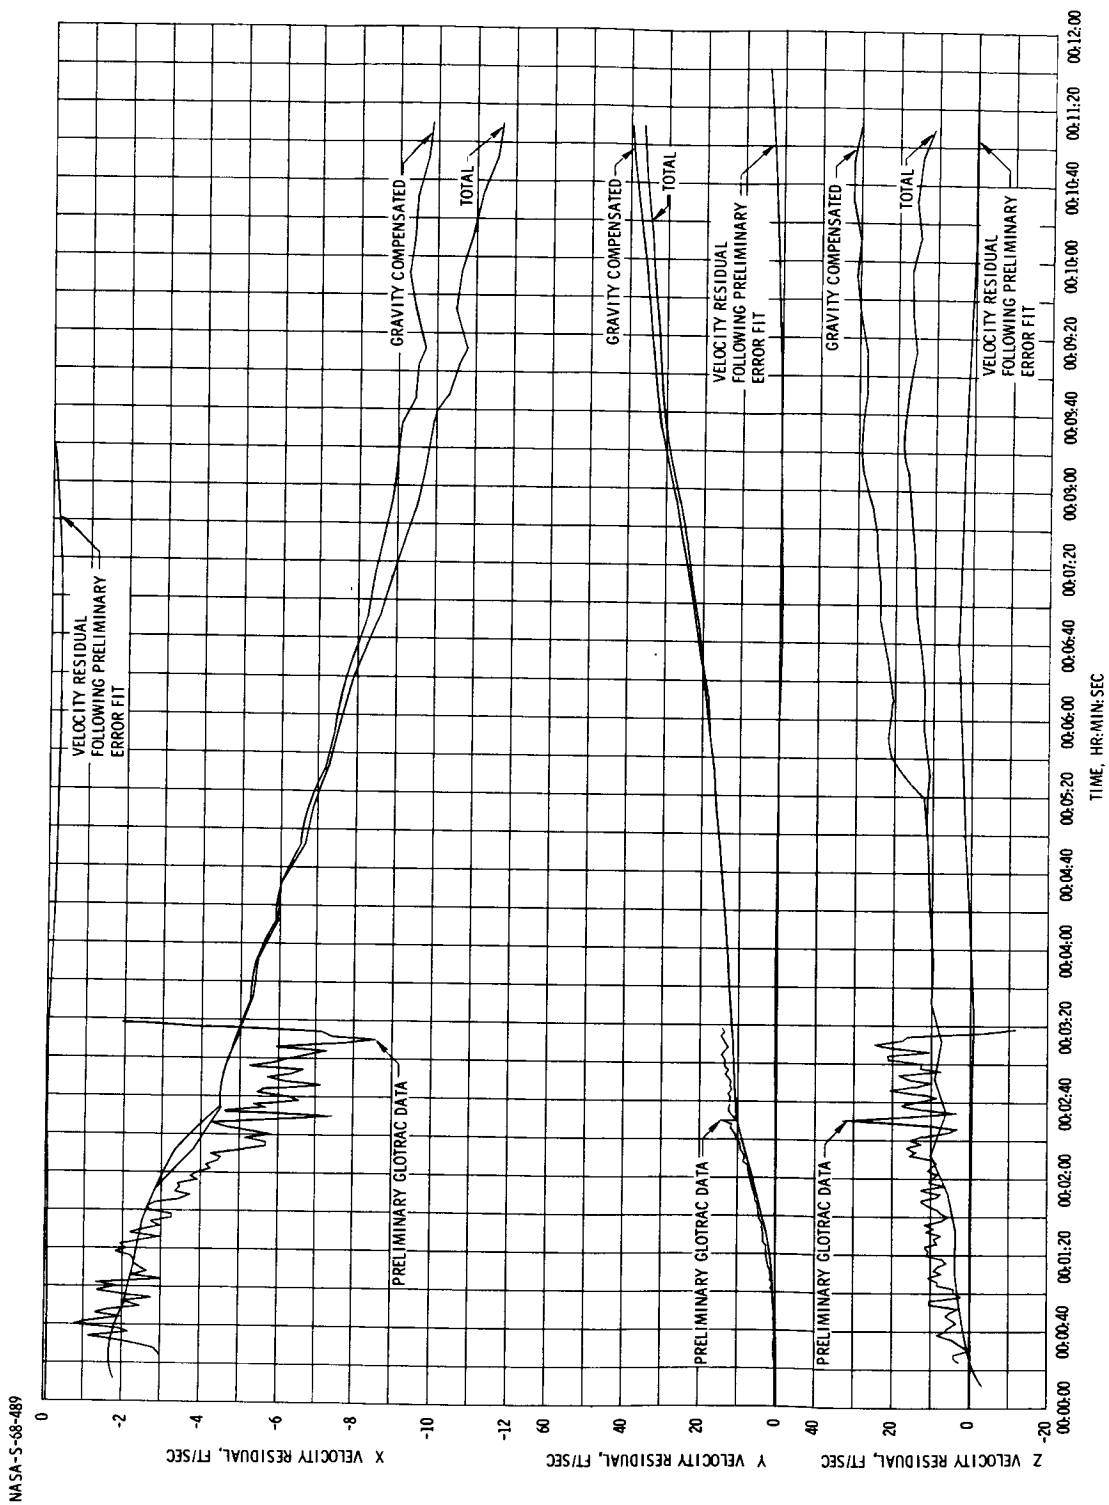
FIGURE 5.15-19. - ASCENT VELOCITY RESIDUALS.

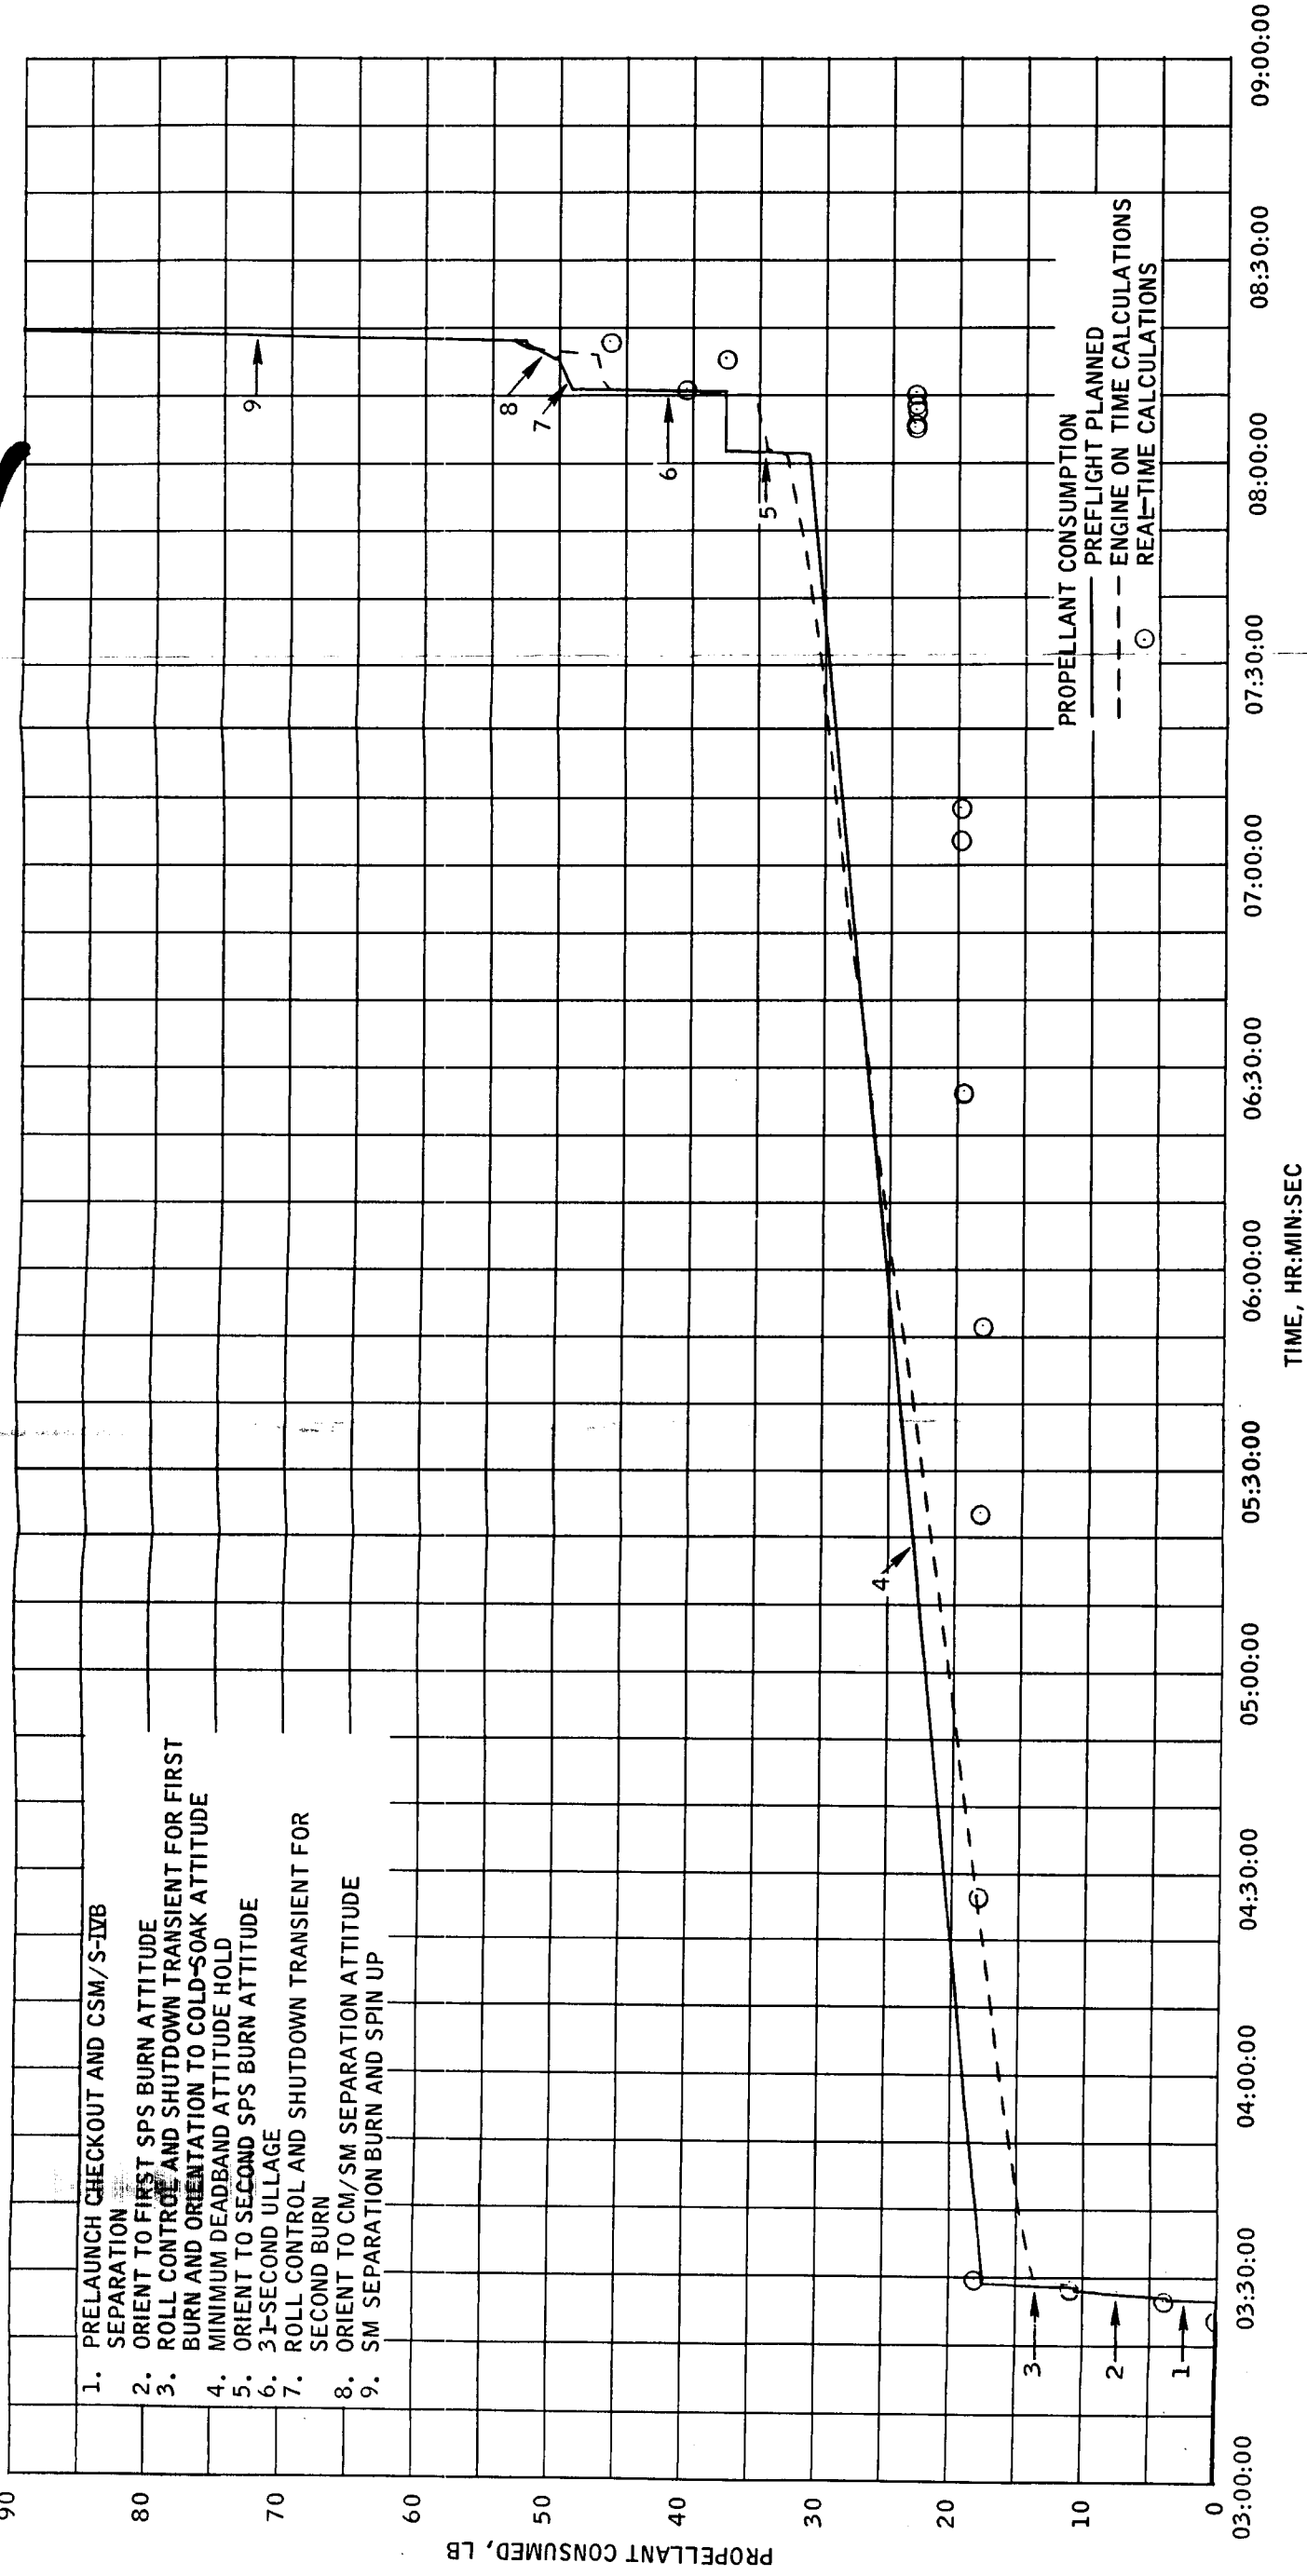
1. PRELAUNCH CHECKOUT AND CSM/S-IVB SEPARATION
2. ORIENT TO FIRST SPS BURN ATTITUDE
3. ROLL CONTROL AND SHUTDOWN TRANSIENT FOR FIRST BURN AND ORIENTATION TO COLD-SOAK ATTITUDE
4. MINIMUM DEADBAND ATTITUDE HOLD
5. ORIENT TO SECOND SPS BURN ATTITUDE
6. 31-SECOND ULLAGE
7. ROLL CONTROL AND SHUTDOWN TRANSIENT FOR SECOND BURN
8. ORIENT TO CM/SM SEPARATION ATTITUDE
9. SM SEPARATION BURN AND SPIN UP

(A) QUAD A CONSUMPTION.

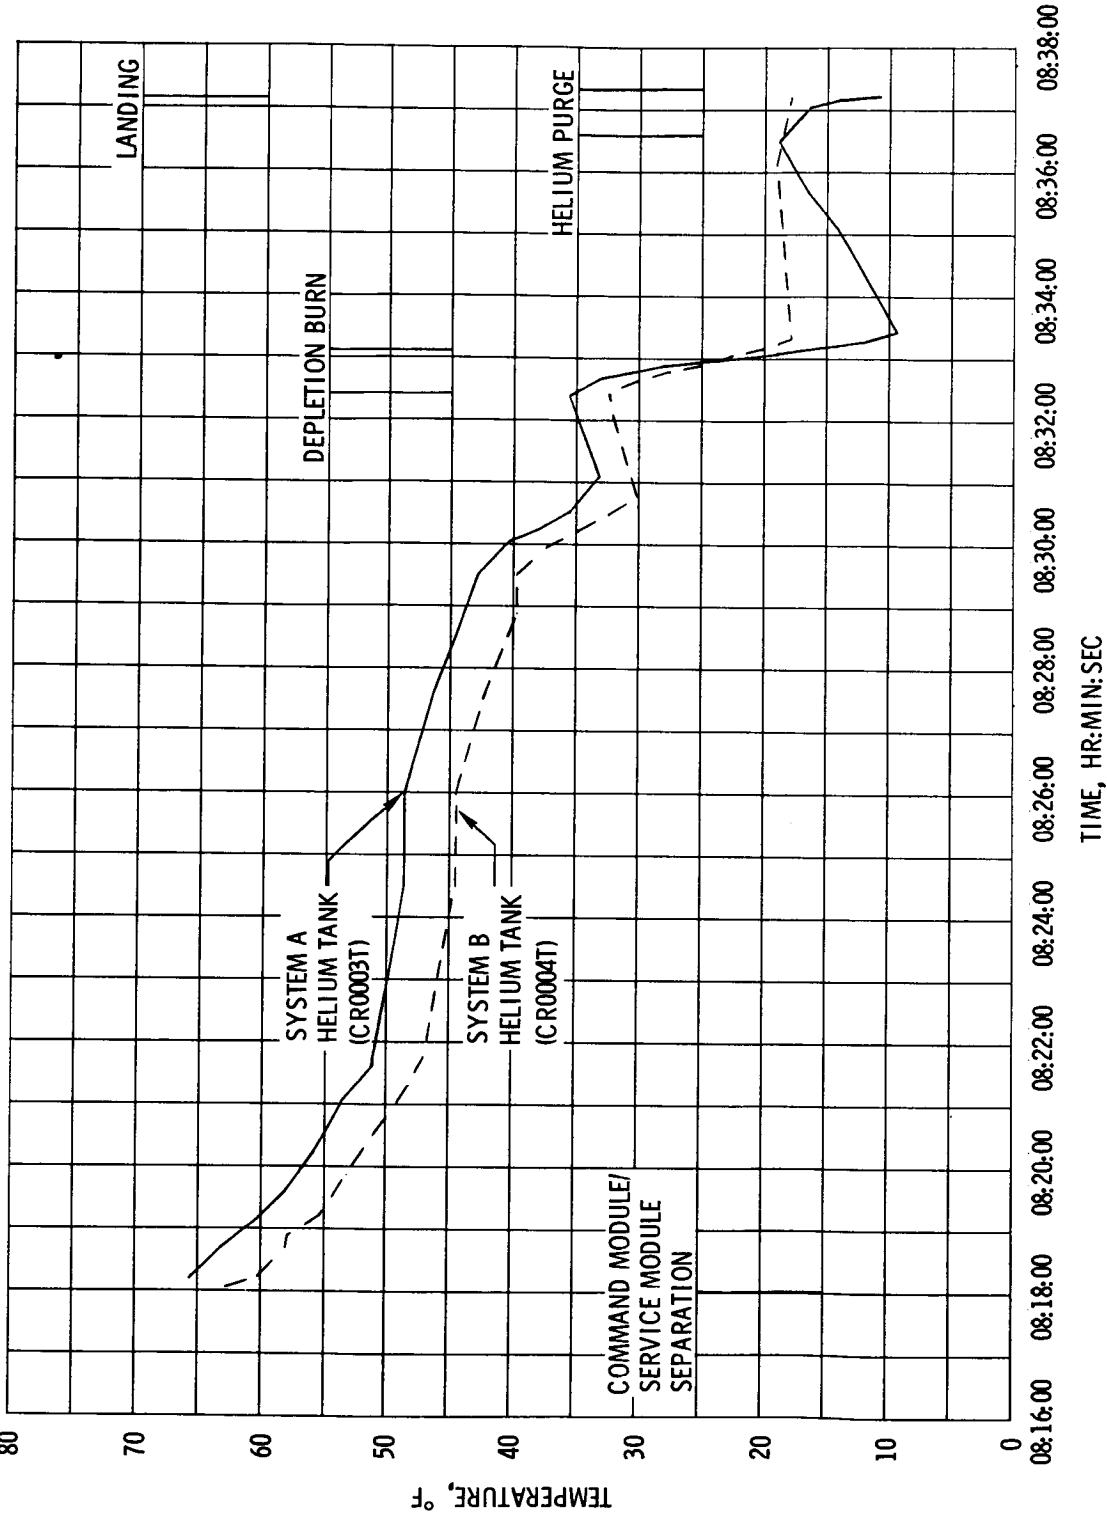
FIGURE 5.16-9. - COMMAND MODULE REACTION CONTROL SUBSYSTEM HELIUM TANK TEMPERATURES DURING ENTRY.

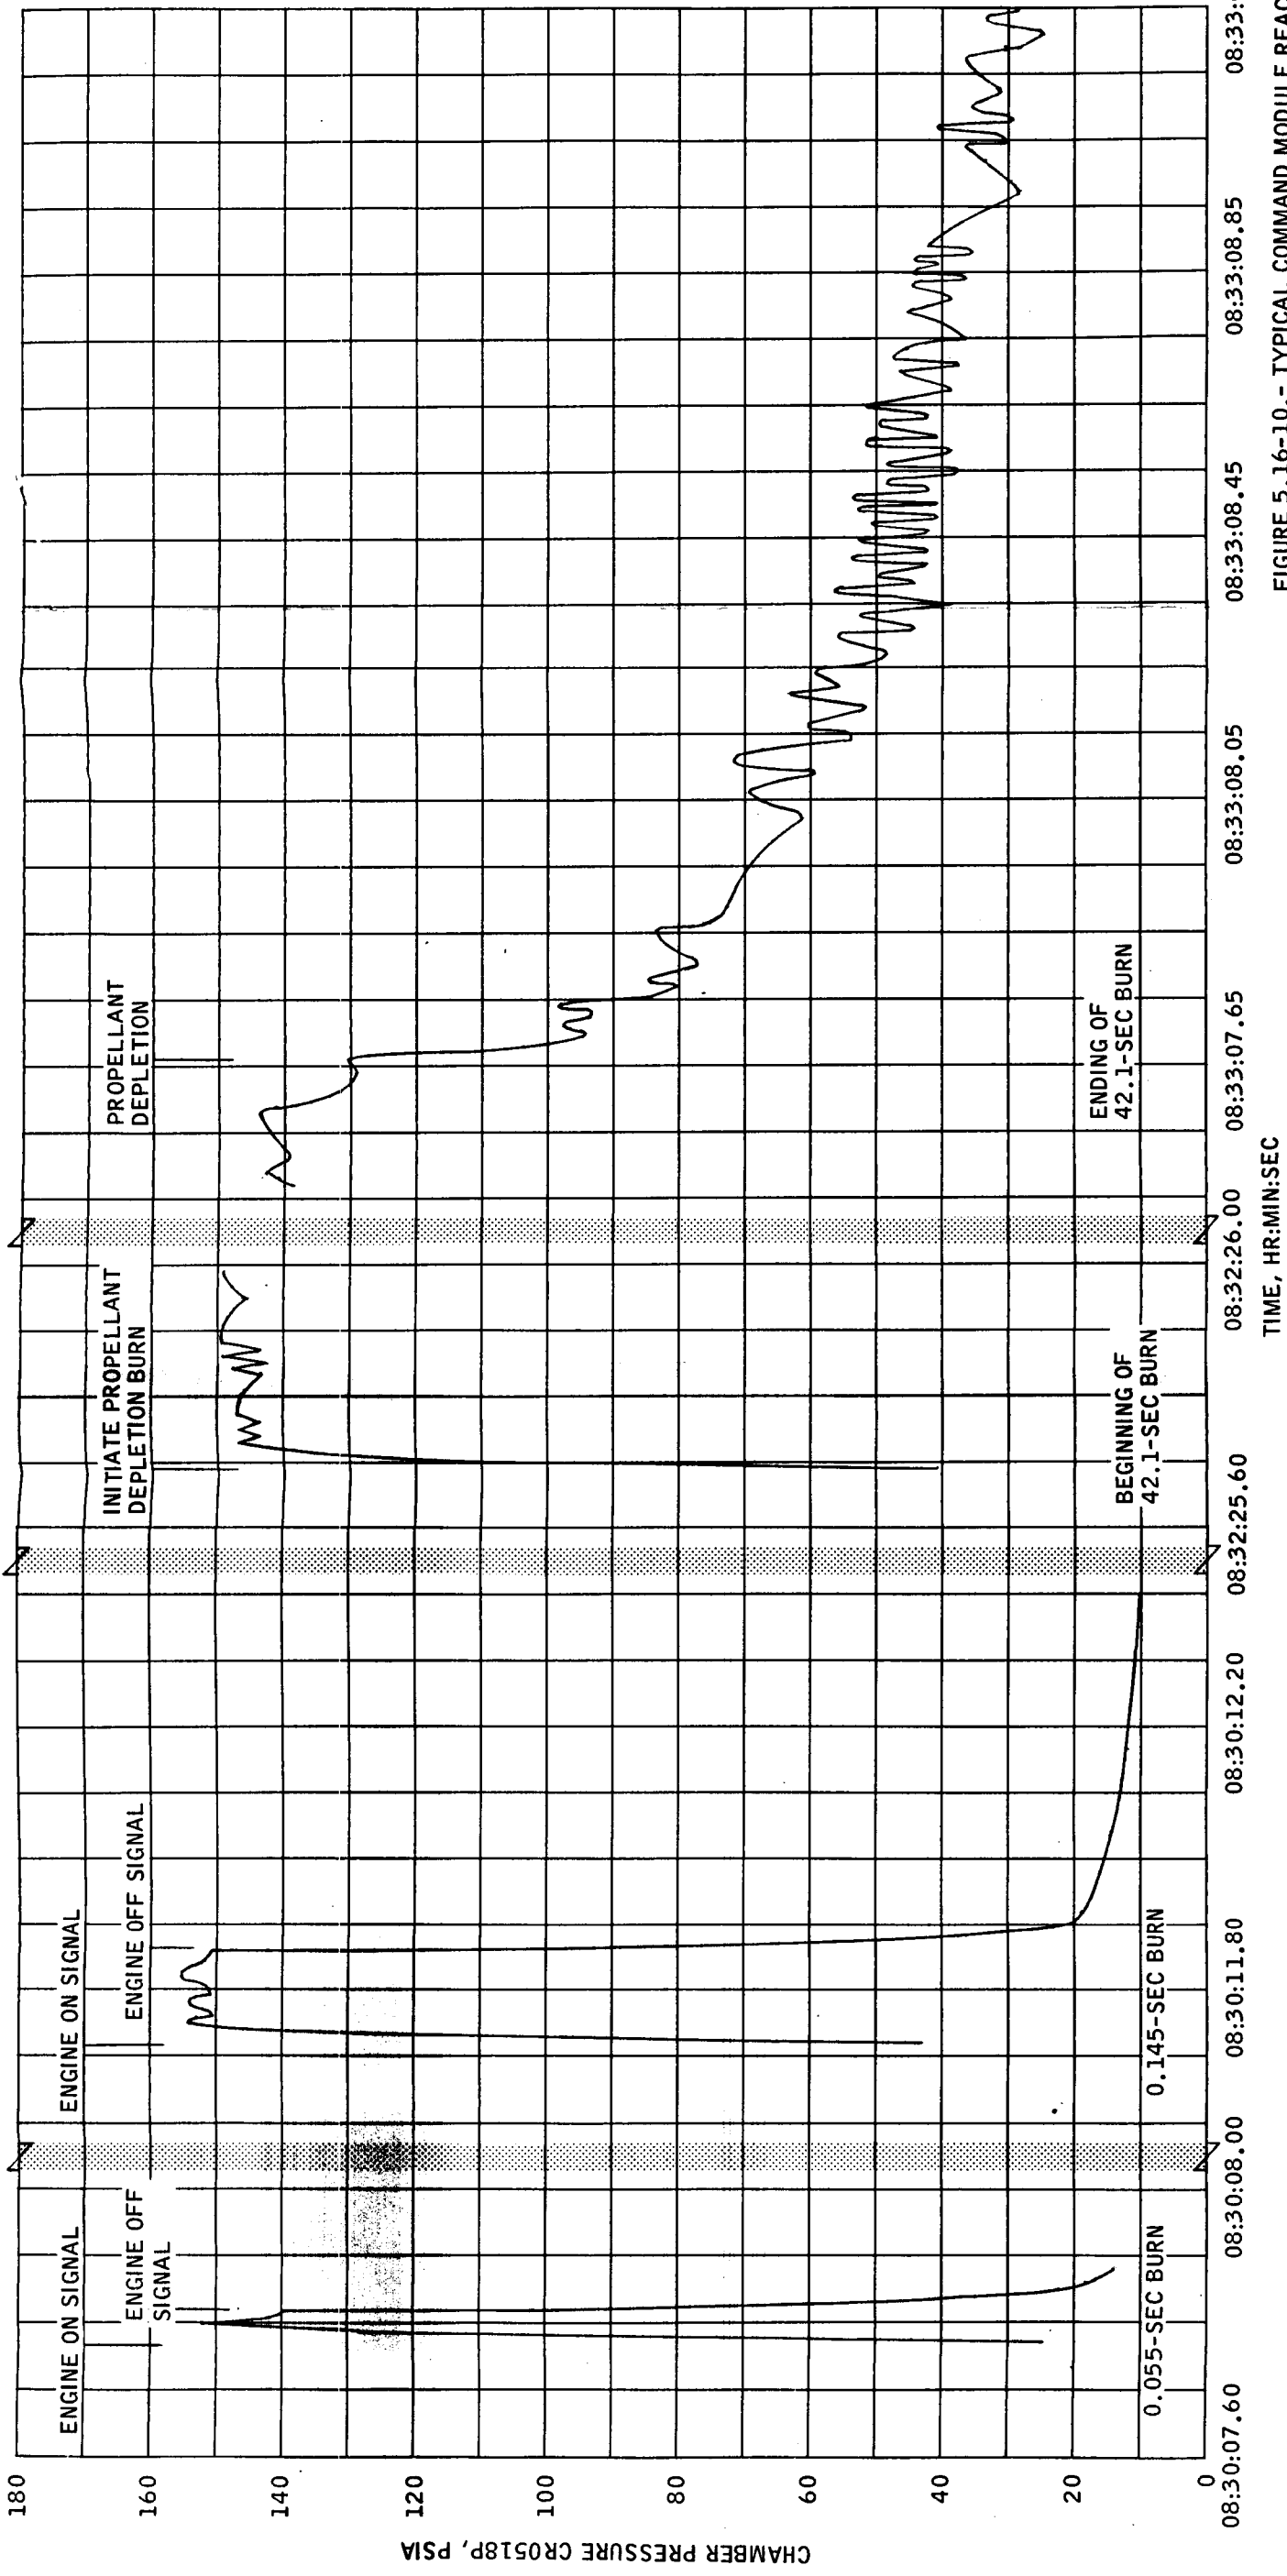
FIGURE 5.16-10.- TYPICAL COMMAND MODULE REACTION CONTROL SUBSYSTEM ENGINE CHAMBER PRESSURE FOR BURNS OF 0.005, 0.145 AND 42.1 SECONDS.

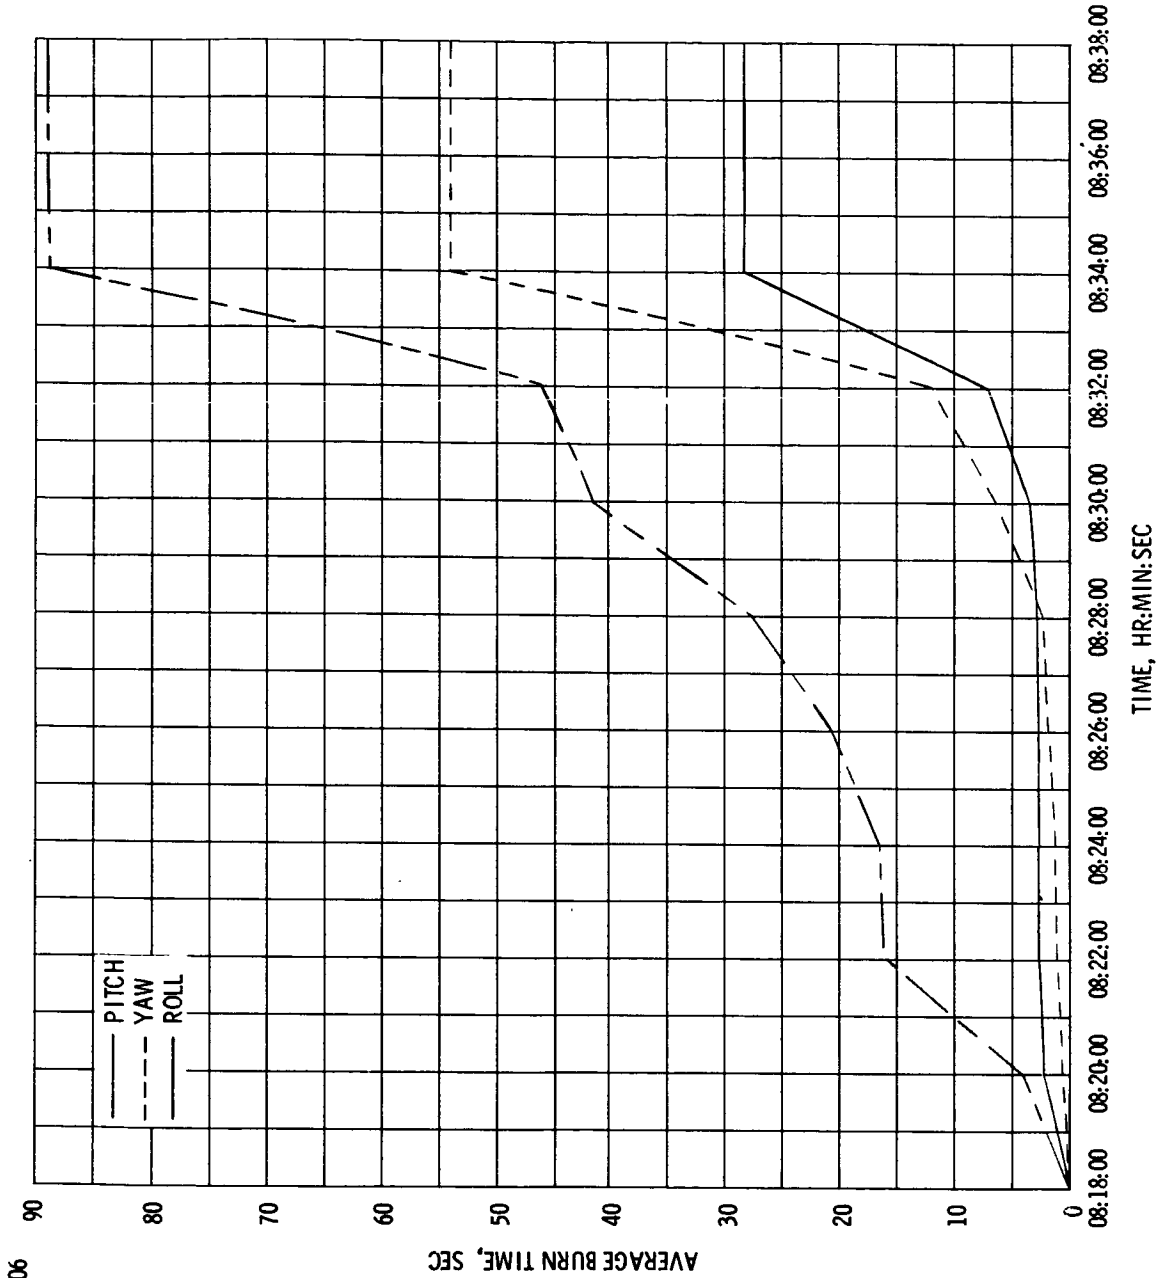
FIGURE 5.16-12. - AVERAGE BURN TIME ACCUMULATED DURING COMMAND MODULE REACTION CONTROL SUBSYSTEM ACTIVITY.

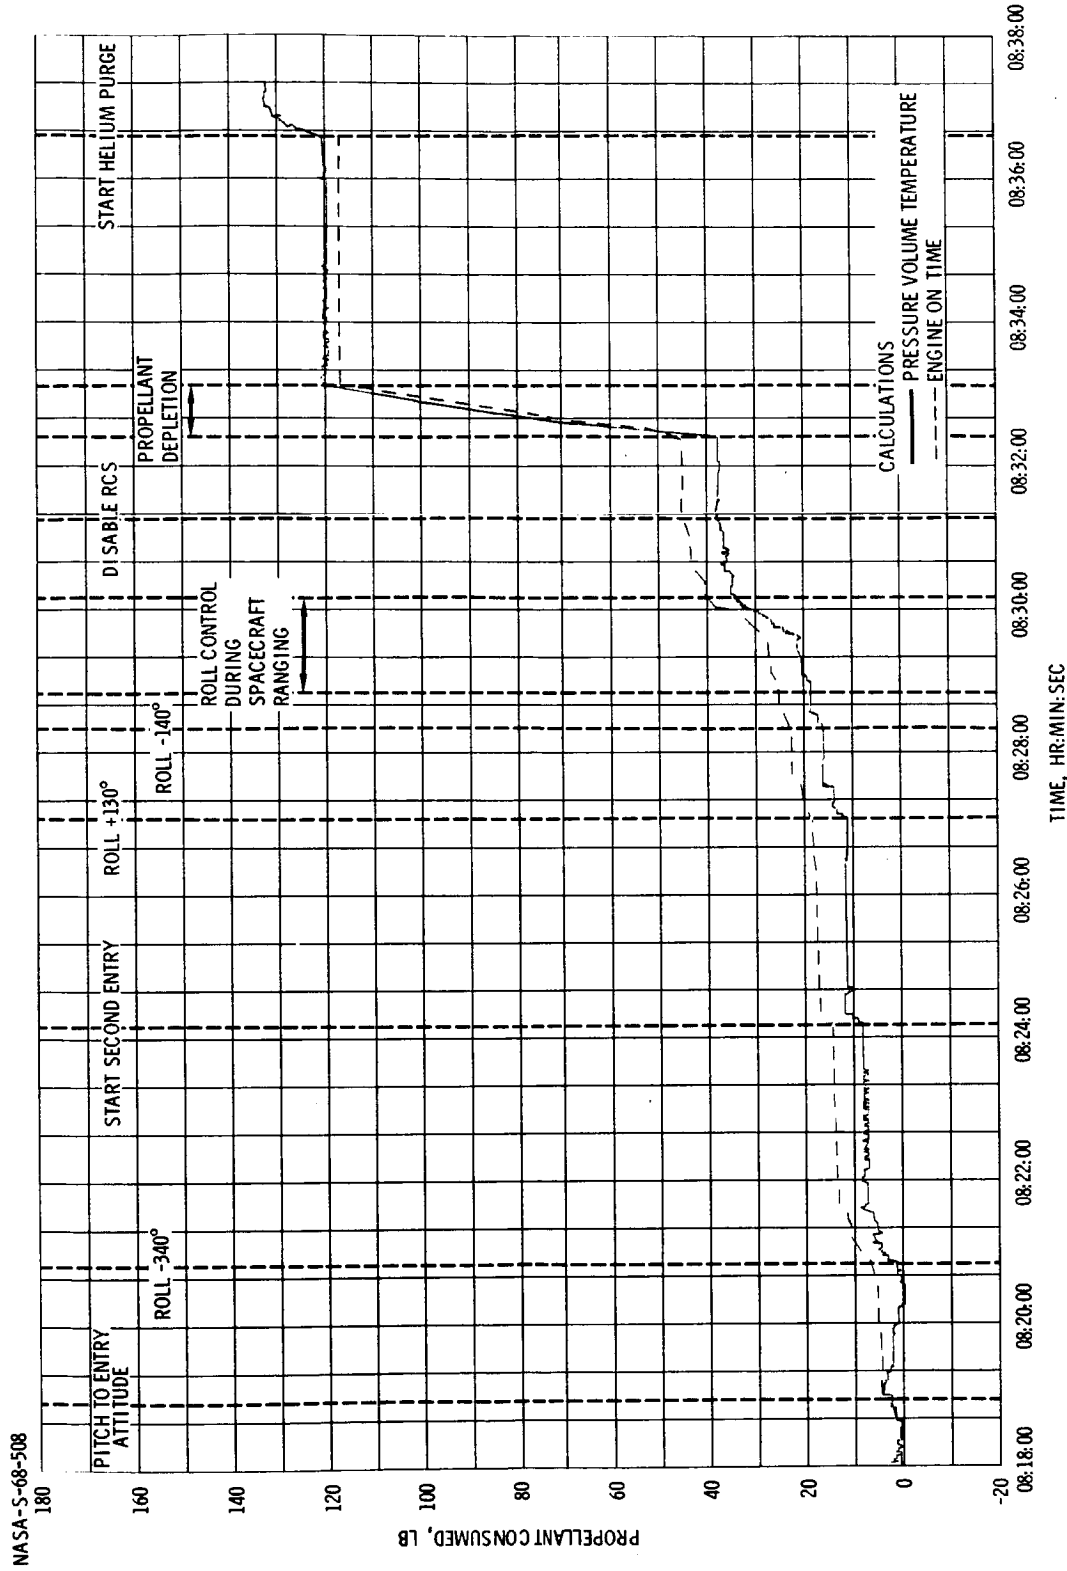
(B) SYSTEM B CONSUMPTION.

FIGURE 5.16-13. - CONTINUED.

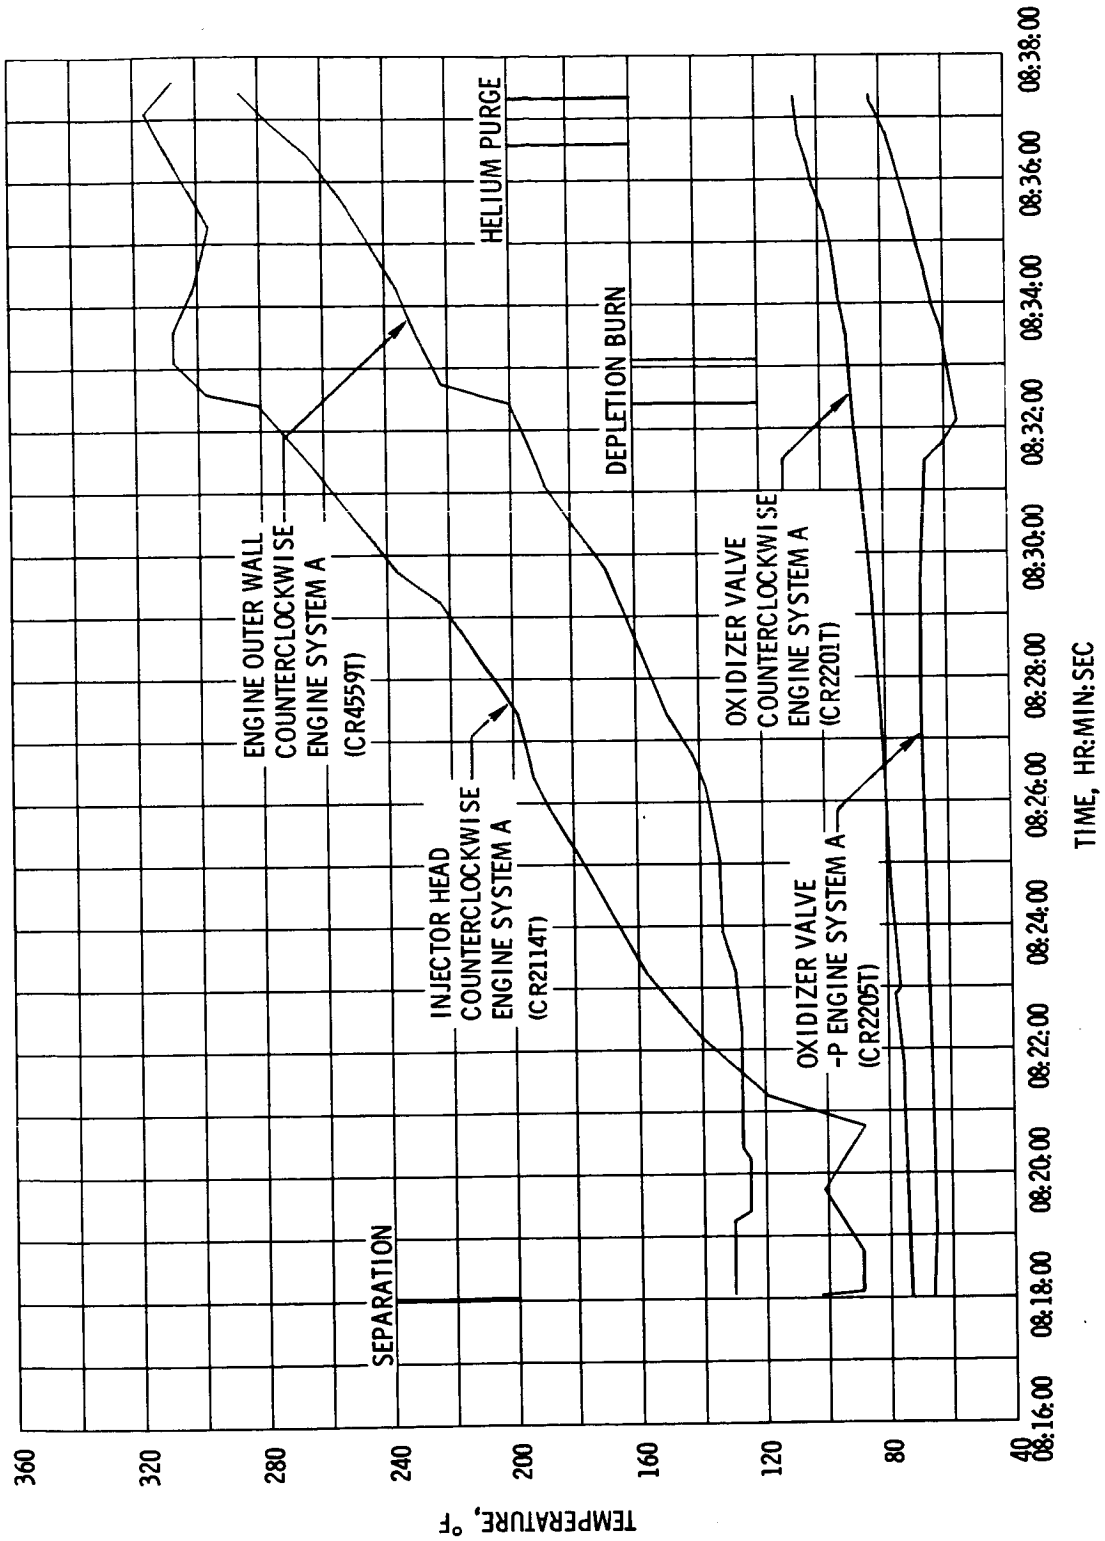
FIGURE 5.16-14. - TYPICAL COMMAND MODULE REACTION CONTROL SUBSYSTEM ENGINE COMPONENT TEMPERATURES DURING ENTRY.

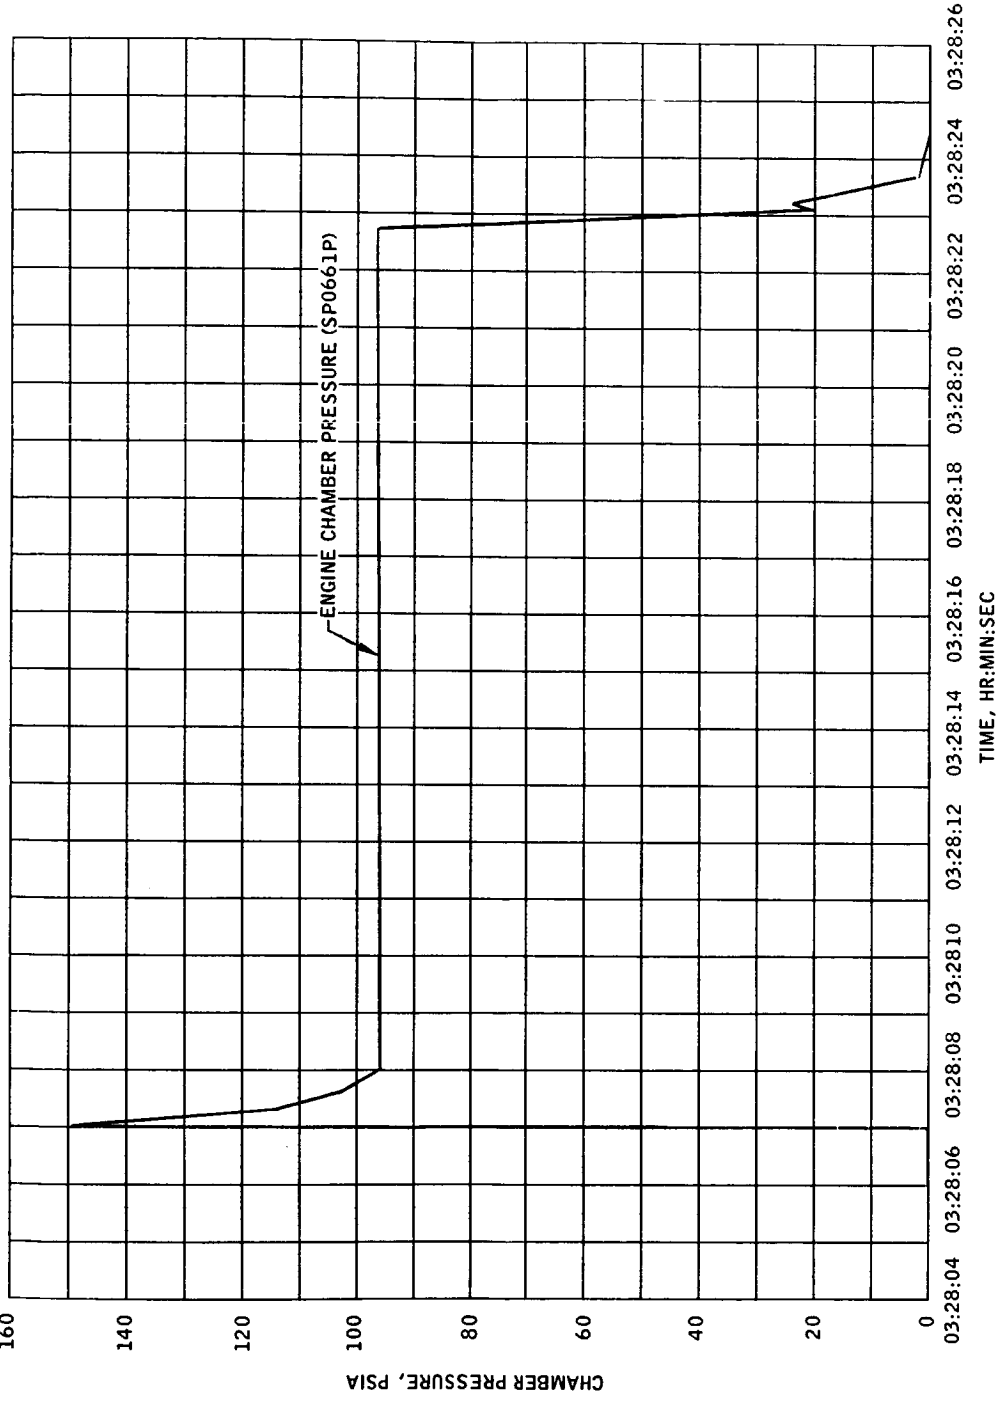
FIGURE 5.17-1.- SERVICE PROPLSION SUBSYSTEM CHAMBER PRESSURE DATA.

(A) FIRST BURN.

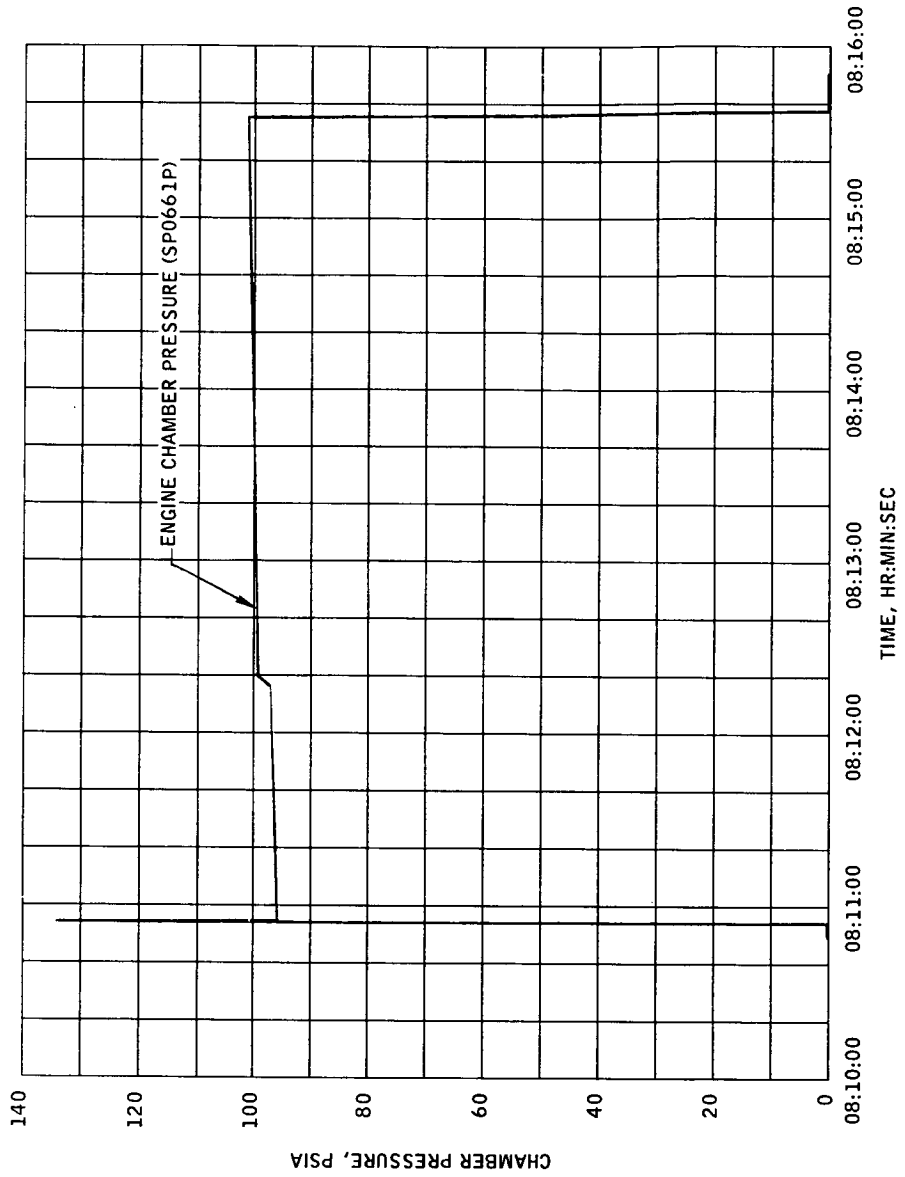
(B) SECOND BURN.

FIGURE 5.17-1.- CONCLUDED.

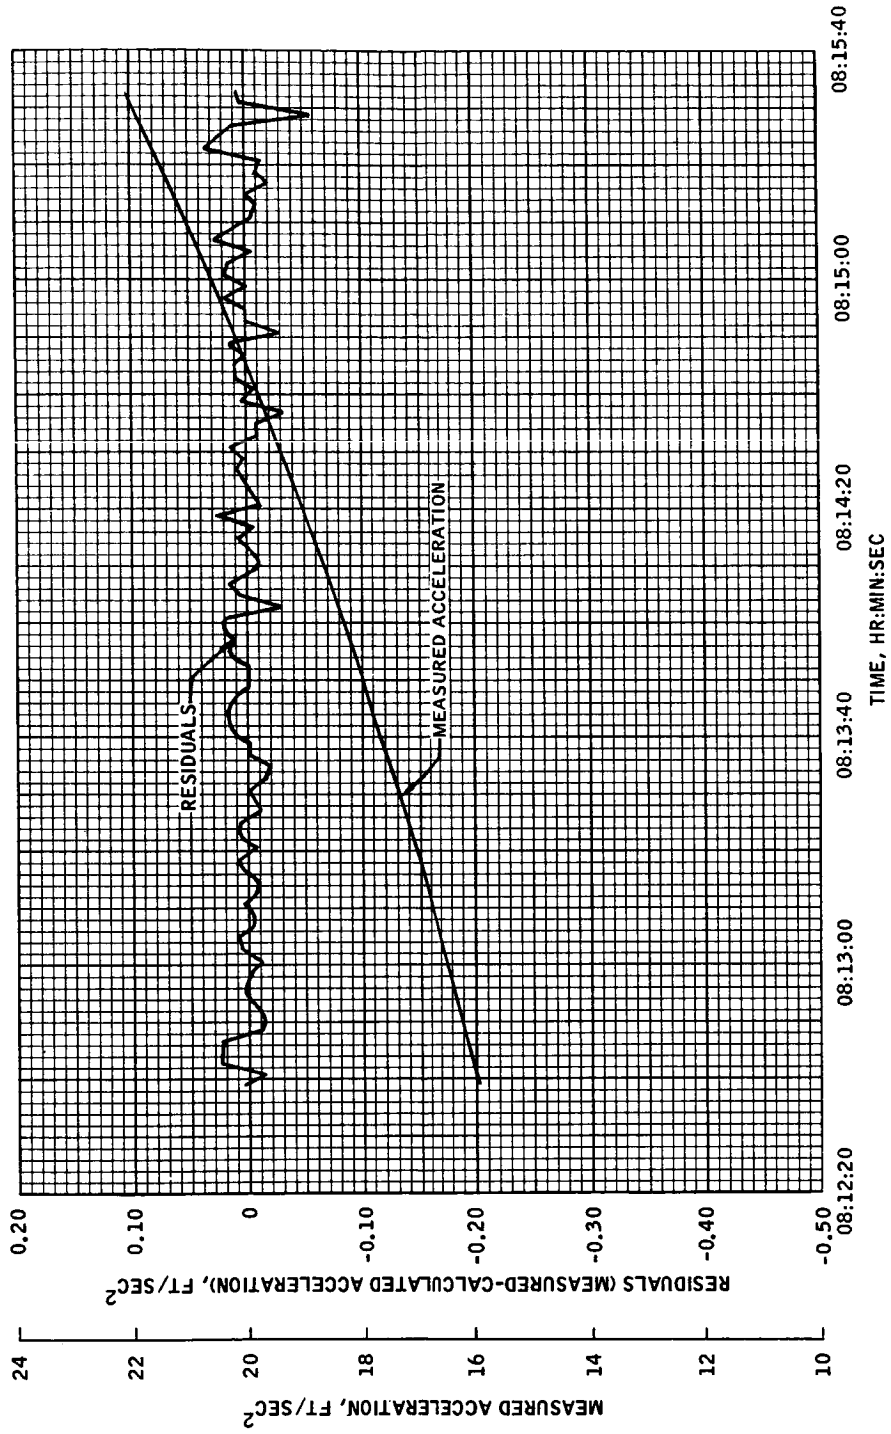
FIGURE 5.17-2.- SERVICE PROPELLSION SUBSYSTEM SECOND BURN ACCELERATION MATCH.

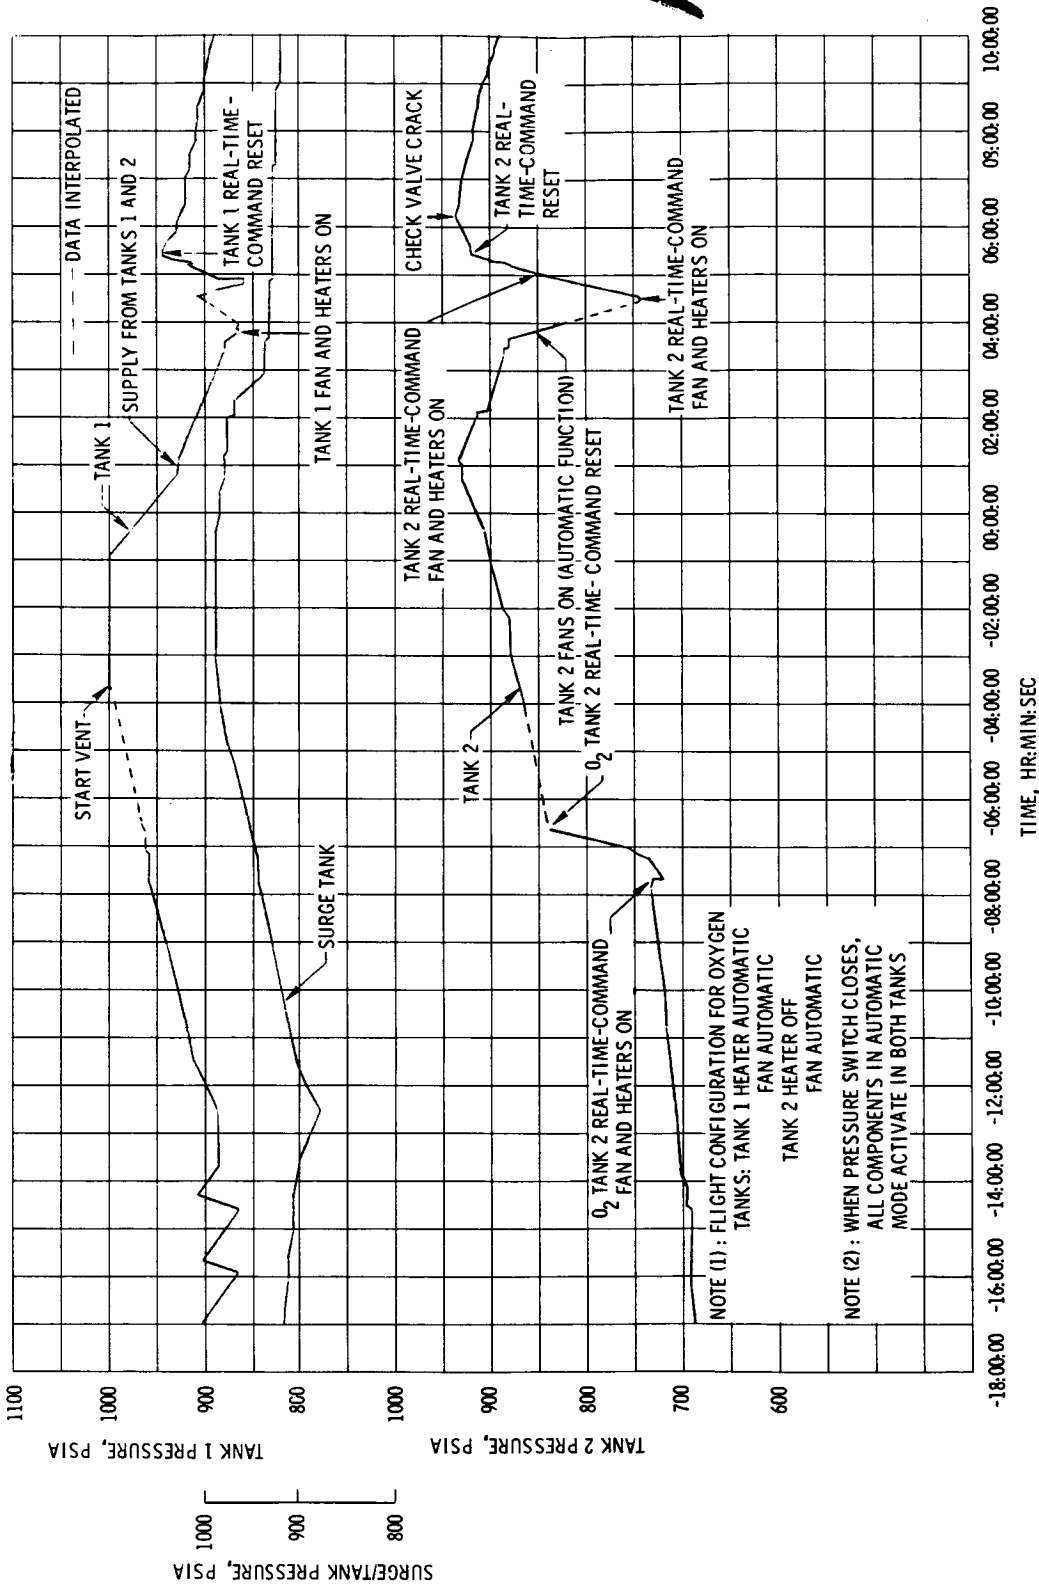
FIGURE 5.18-1. - OXYGEN TANK PRESSURE AND EVENTS.
