APOLLO 4 MISSION REPORT

MANNED SPACECRAFT CENTER

January 1968

MSC-PA-R-68-1

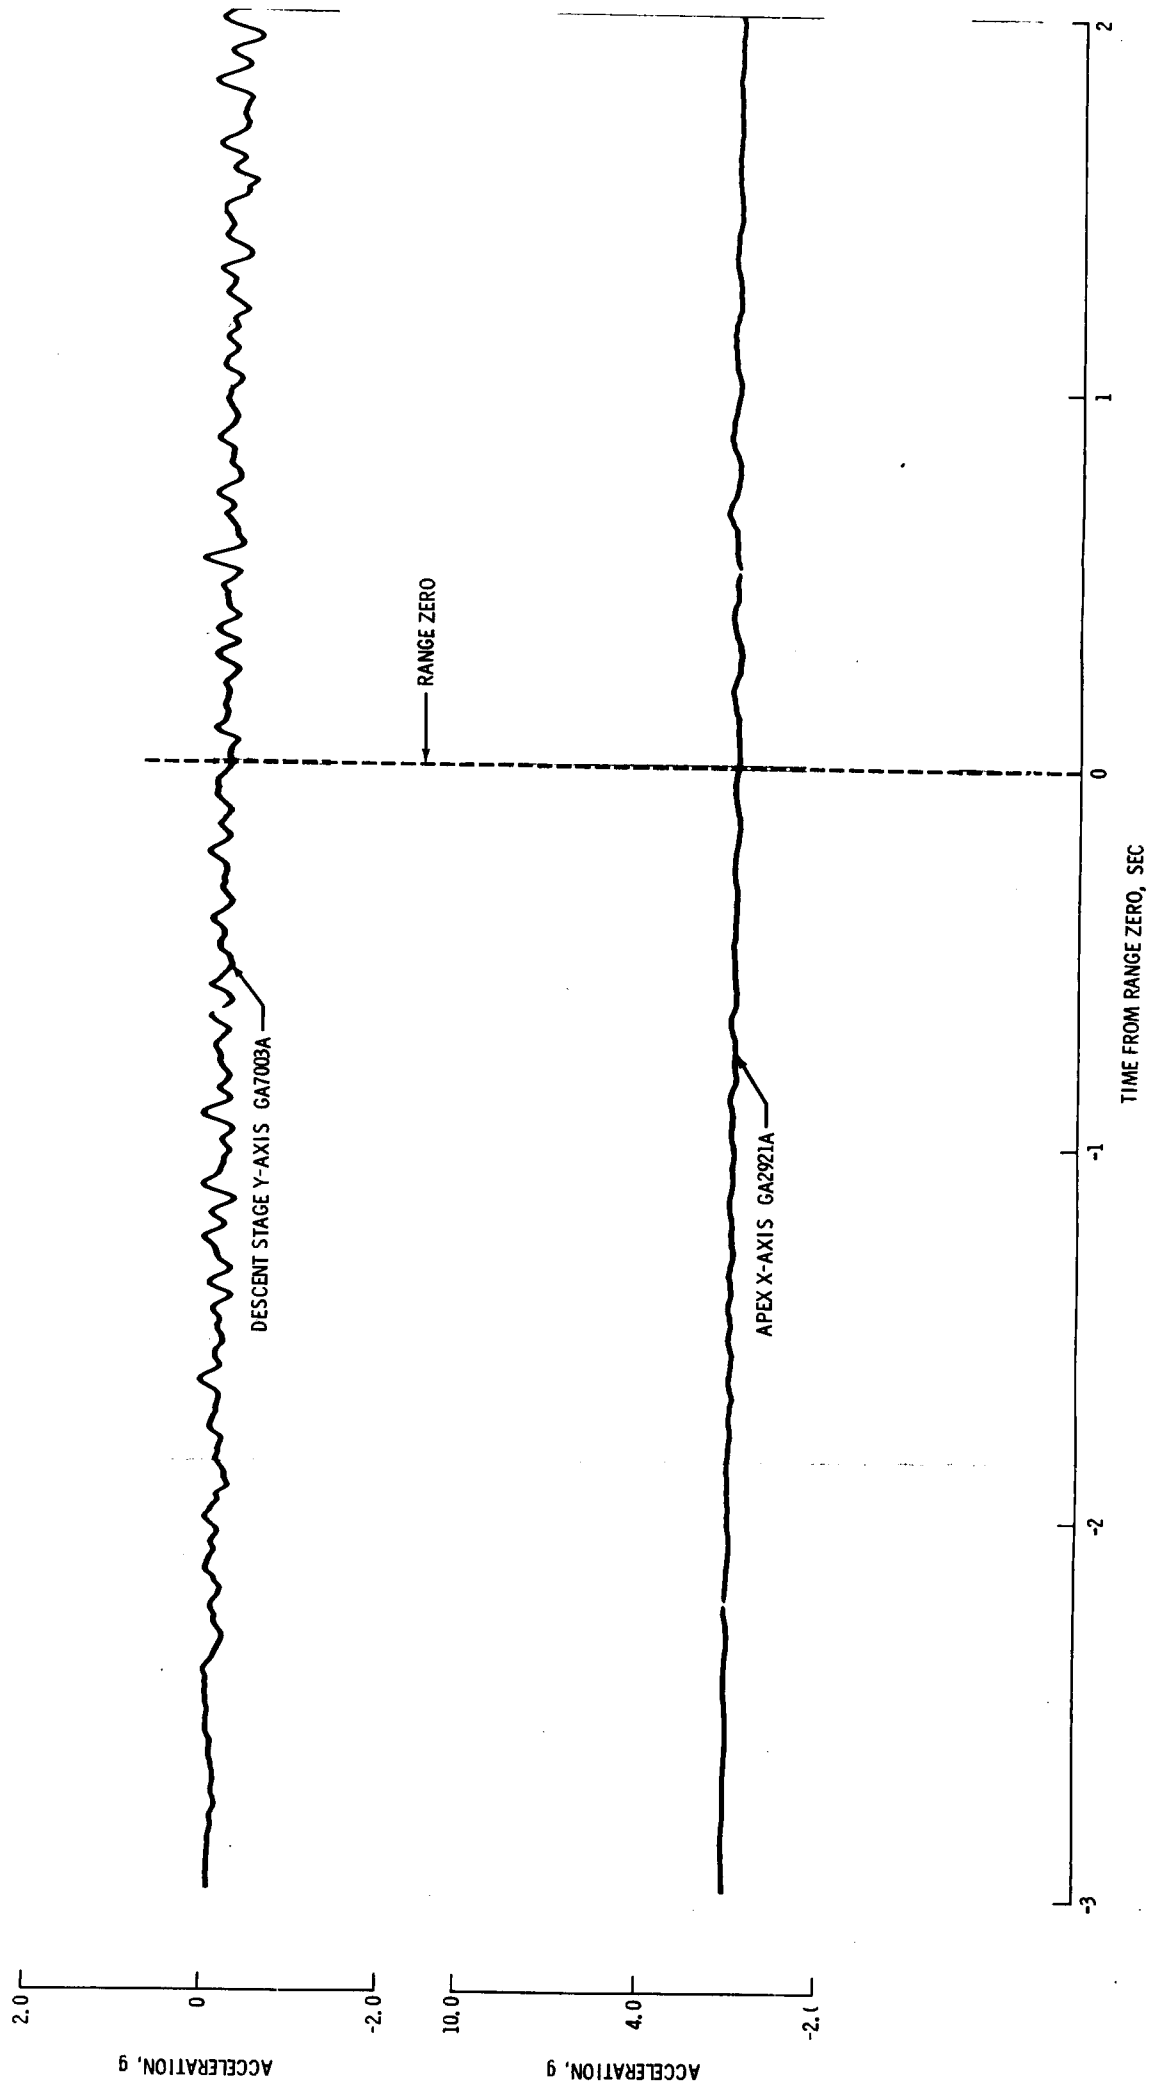
FIGURE 6.1-3. - LUNAR MODULE ACCELERATIONS AT LIFT-OFF.

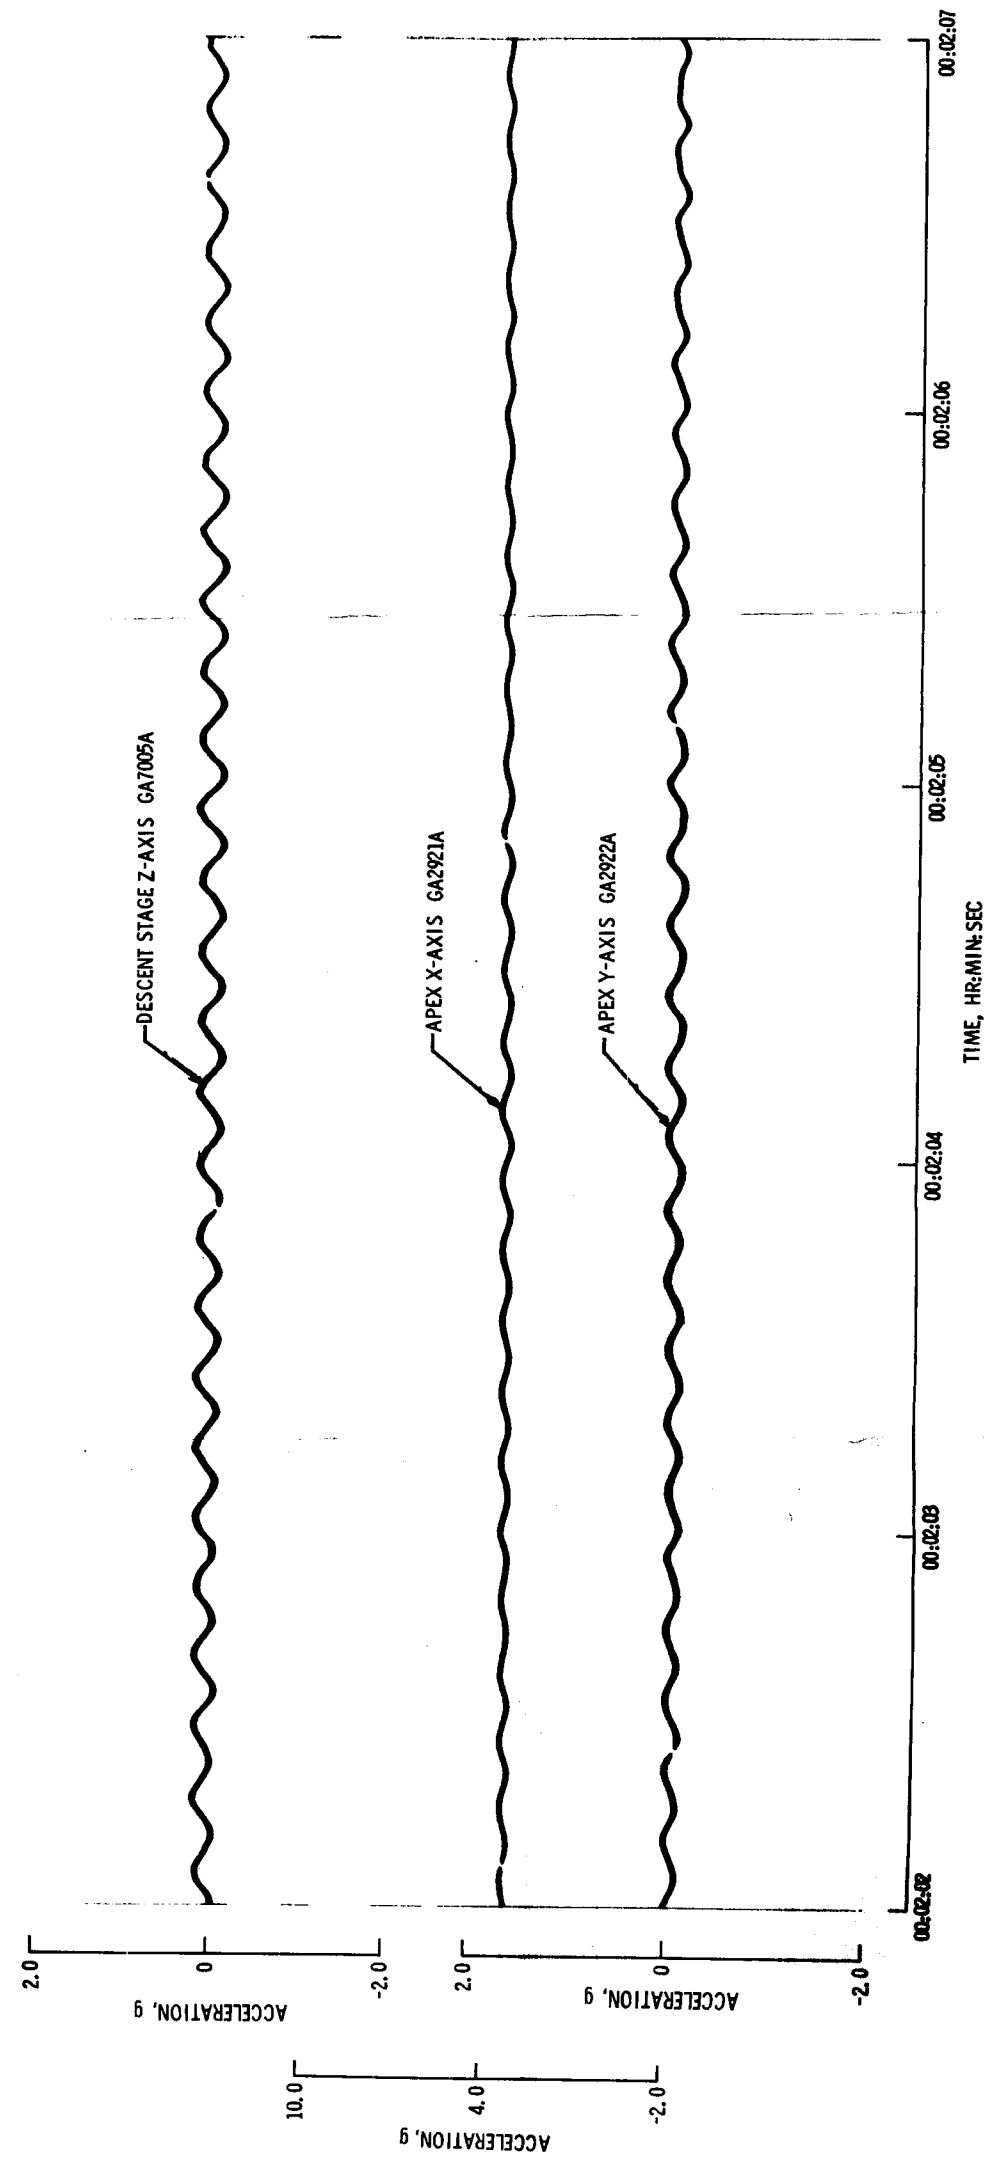
FIGURE 6.1-4. - LUNAR MODULE ACCELERATIONS DURING HIGH OSCILLATION PERIOD.

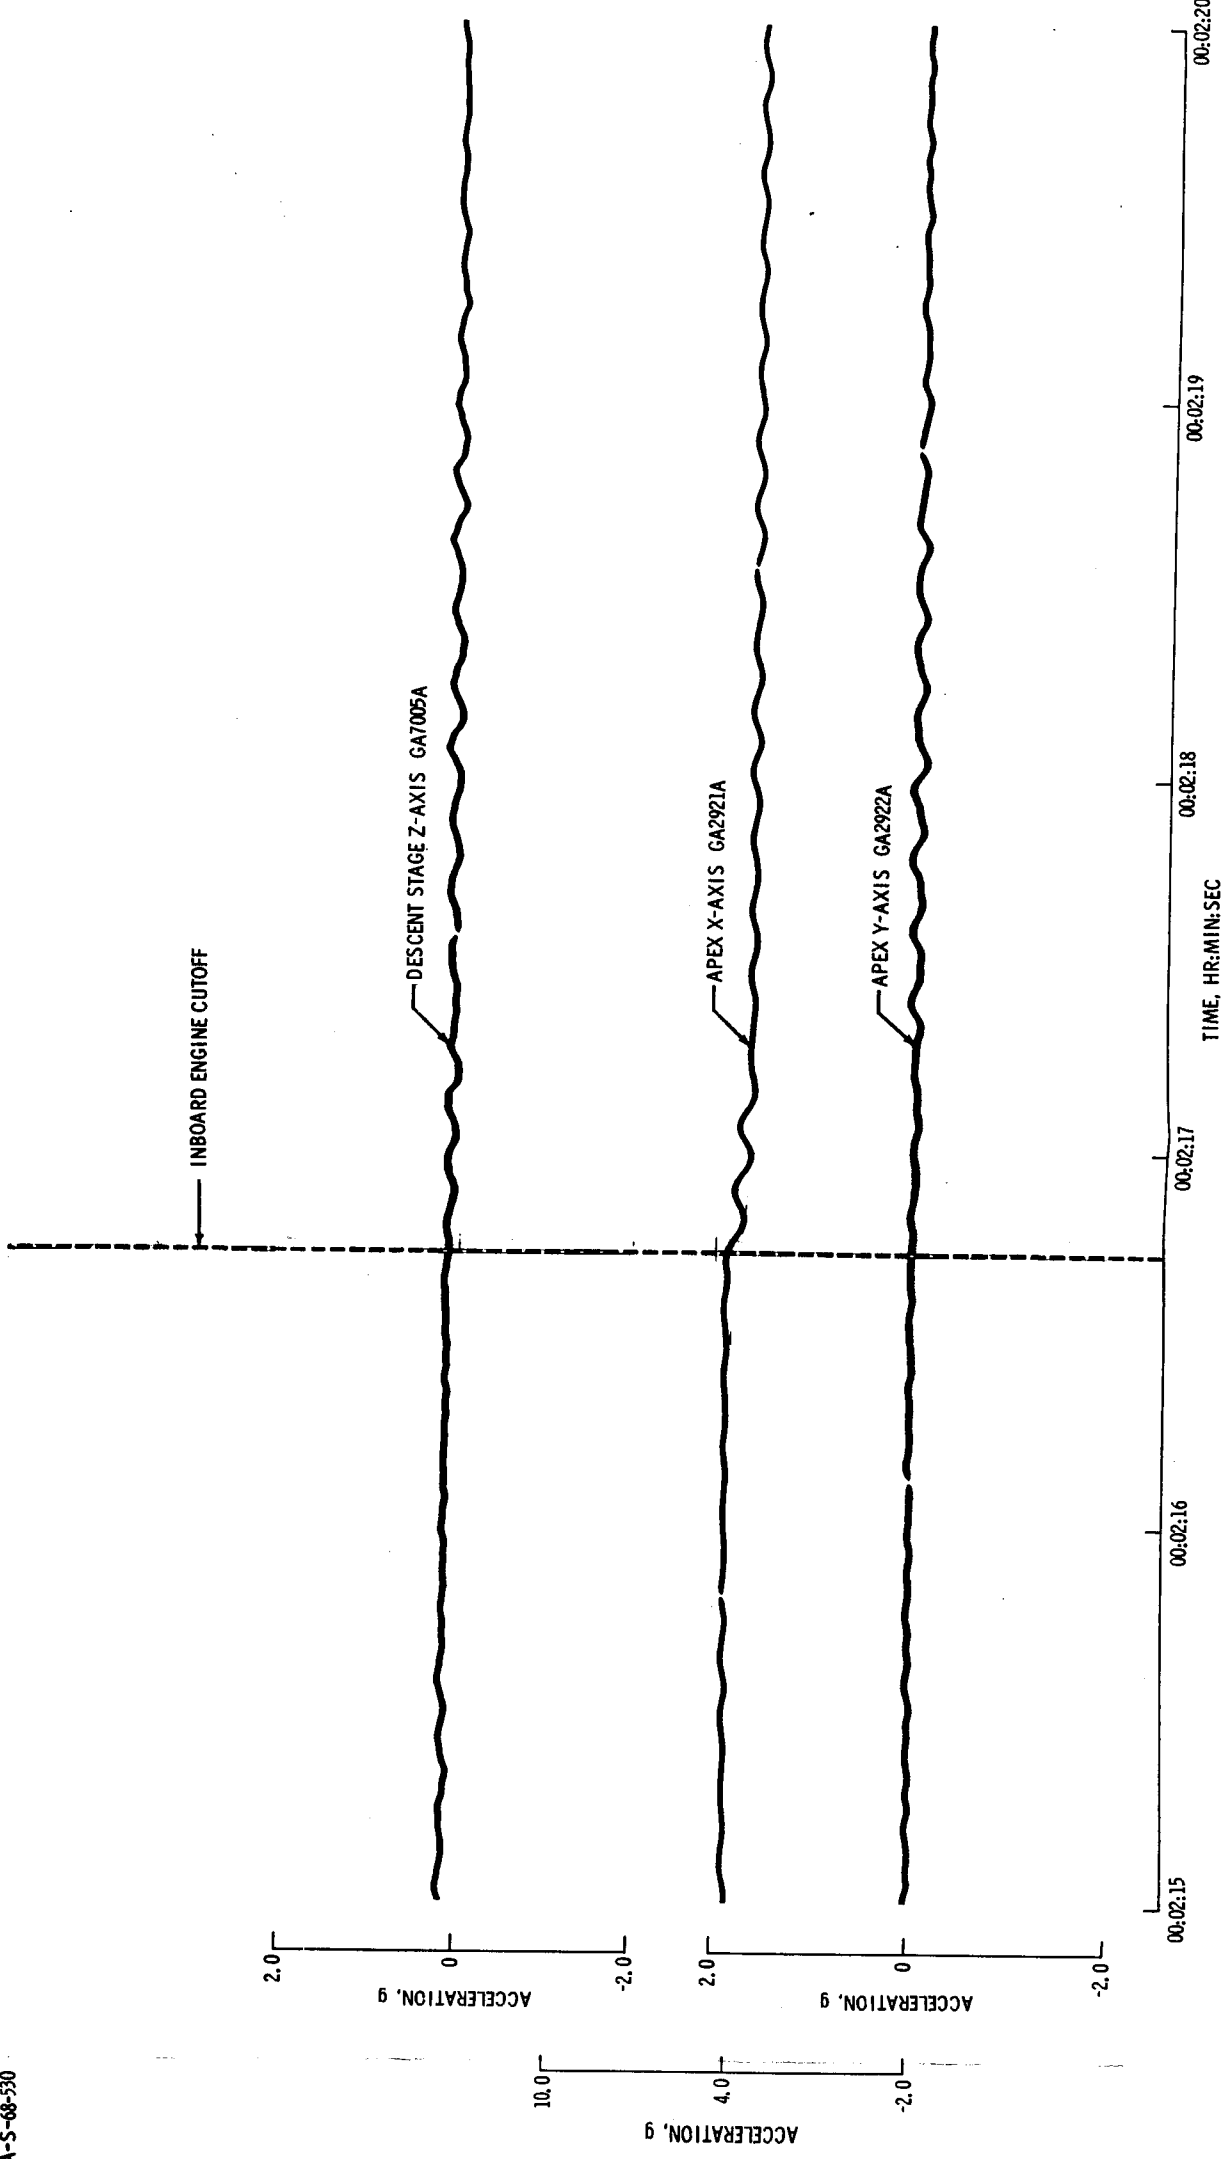
FIGURE 6.1-5. - LUNAR MODULE ACCELERATIONS DURING FIRST STAGE CENTER ENGINE CUTOFF.

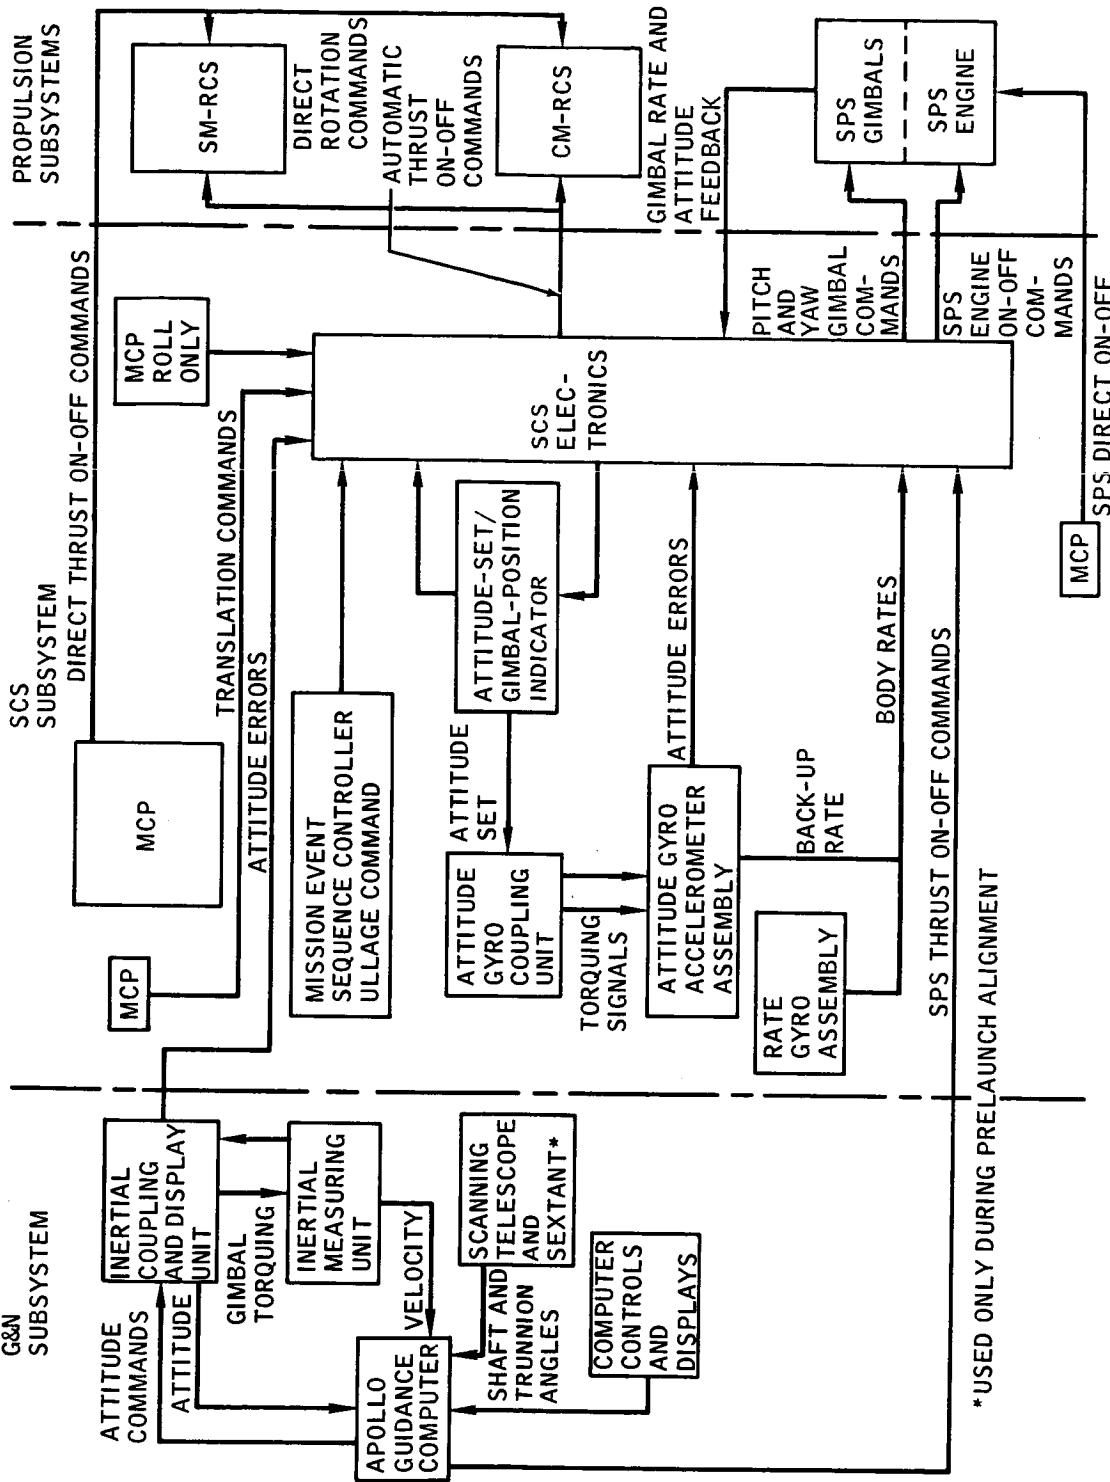
FIGURE 13.1-10. - STABILIZATION AND CONTROL SUBSYSTEM FUNCTIONAL SCHEMATIC.

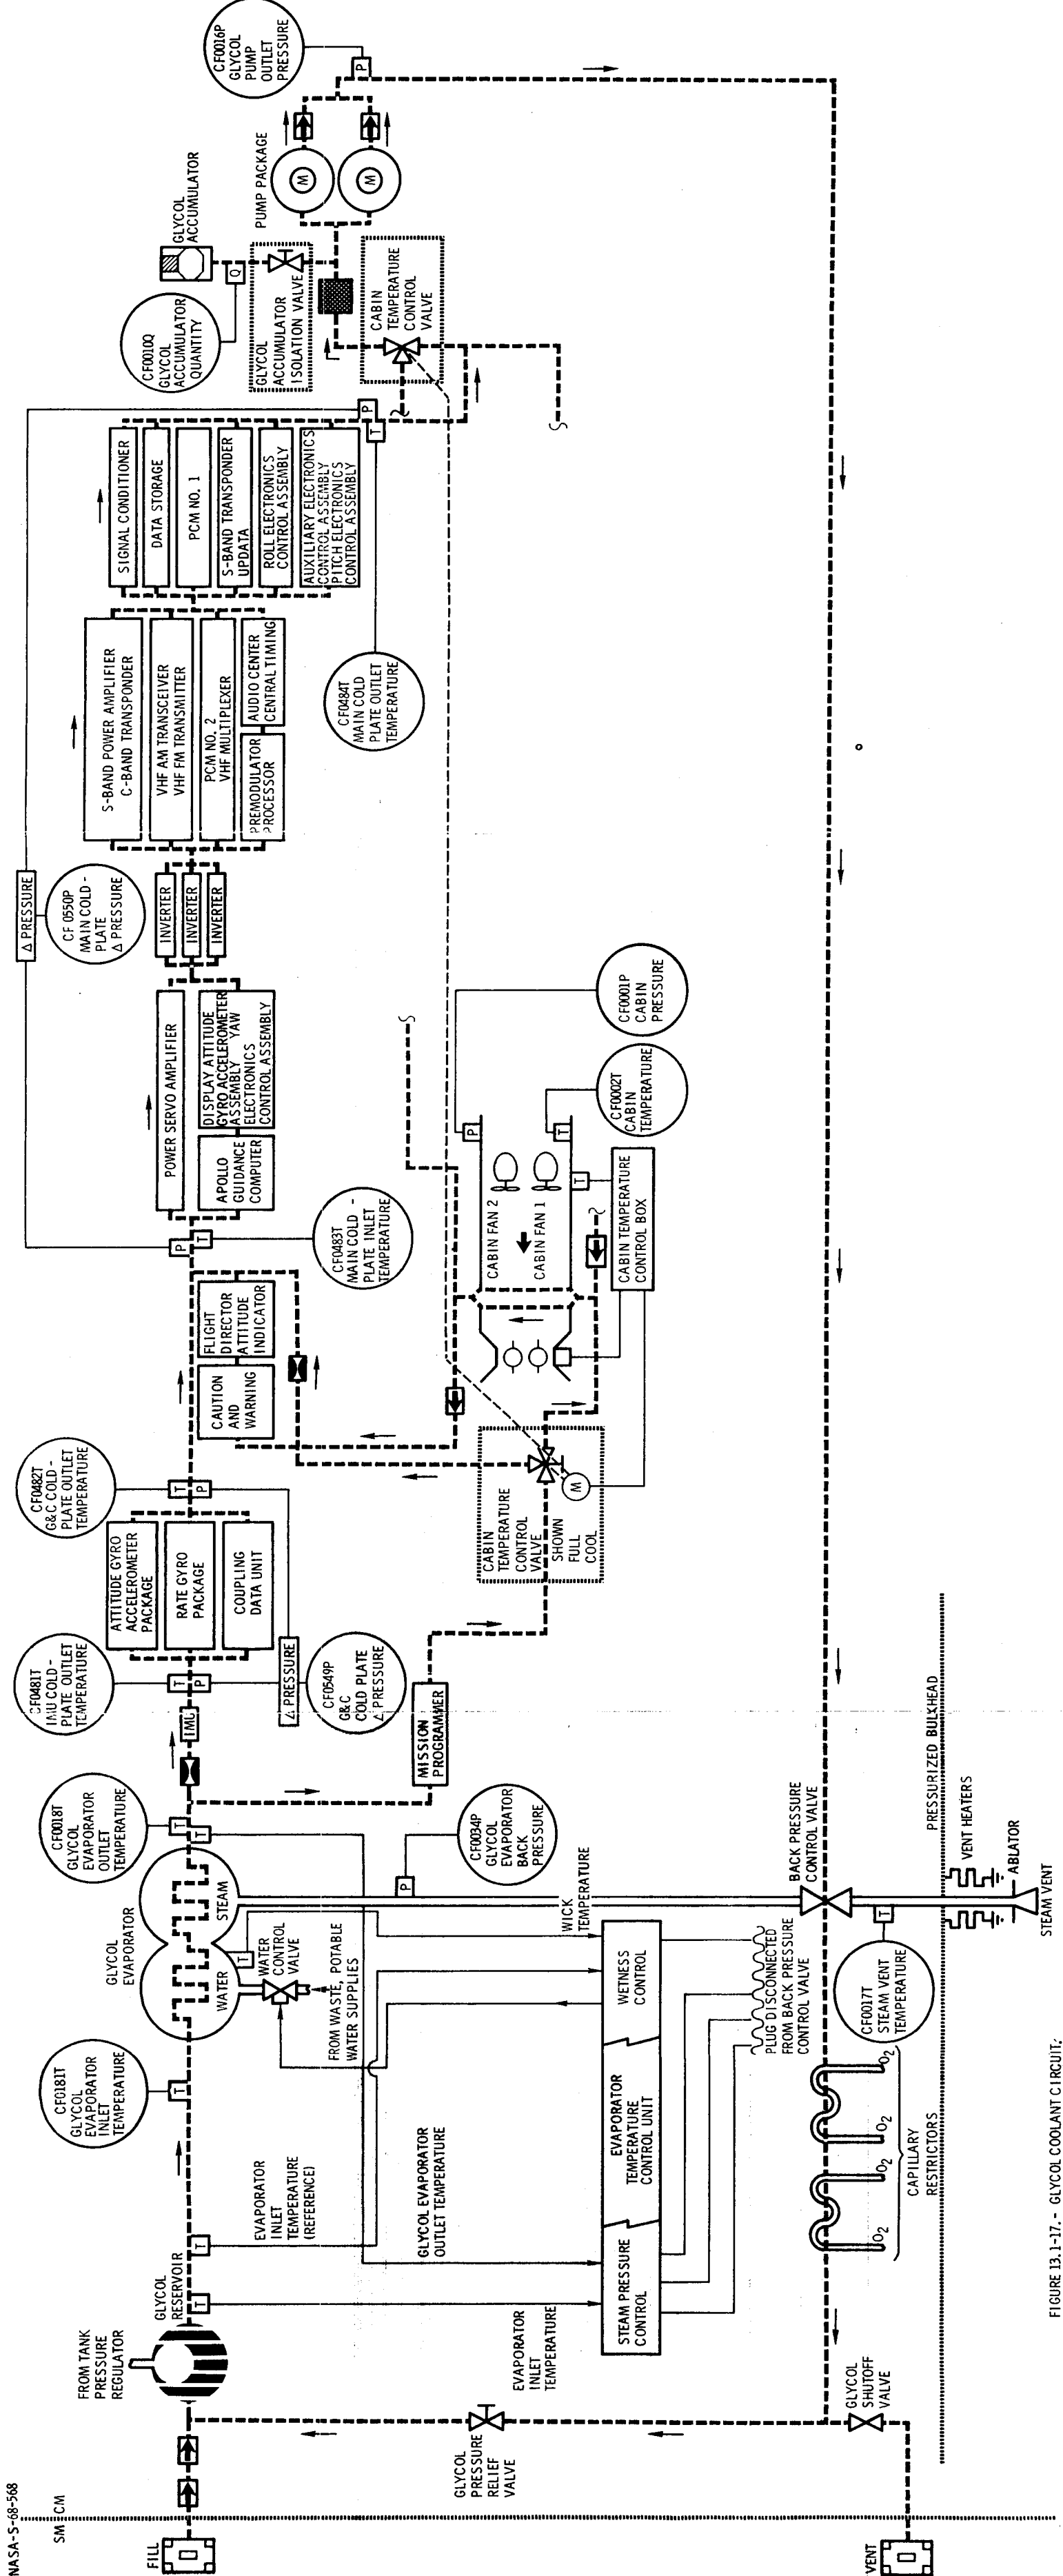
FIGURE 13.1-17. - GLYCOL COOLANT CIRCUIT.

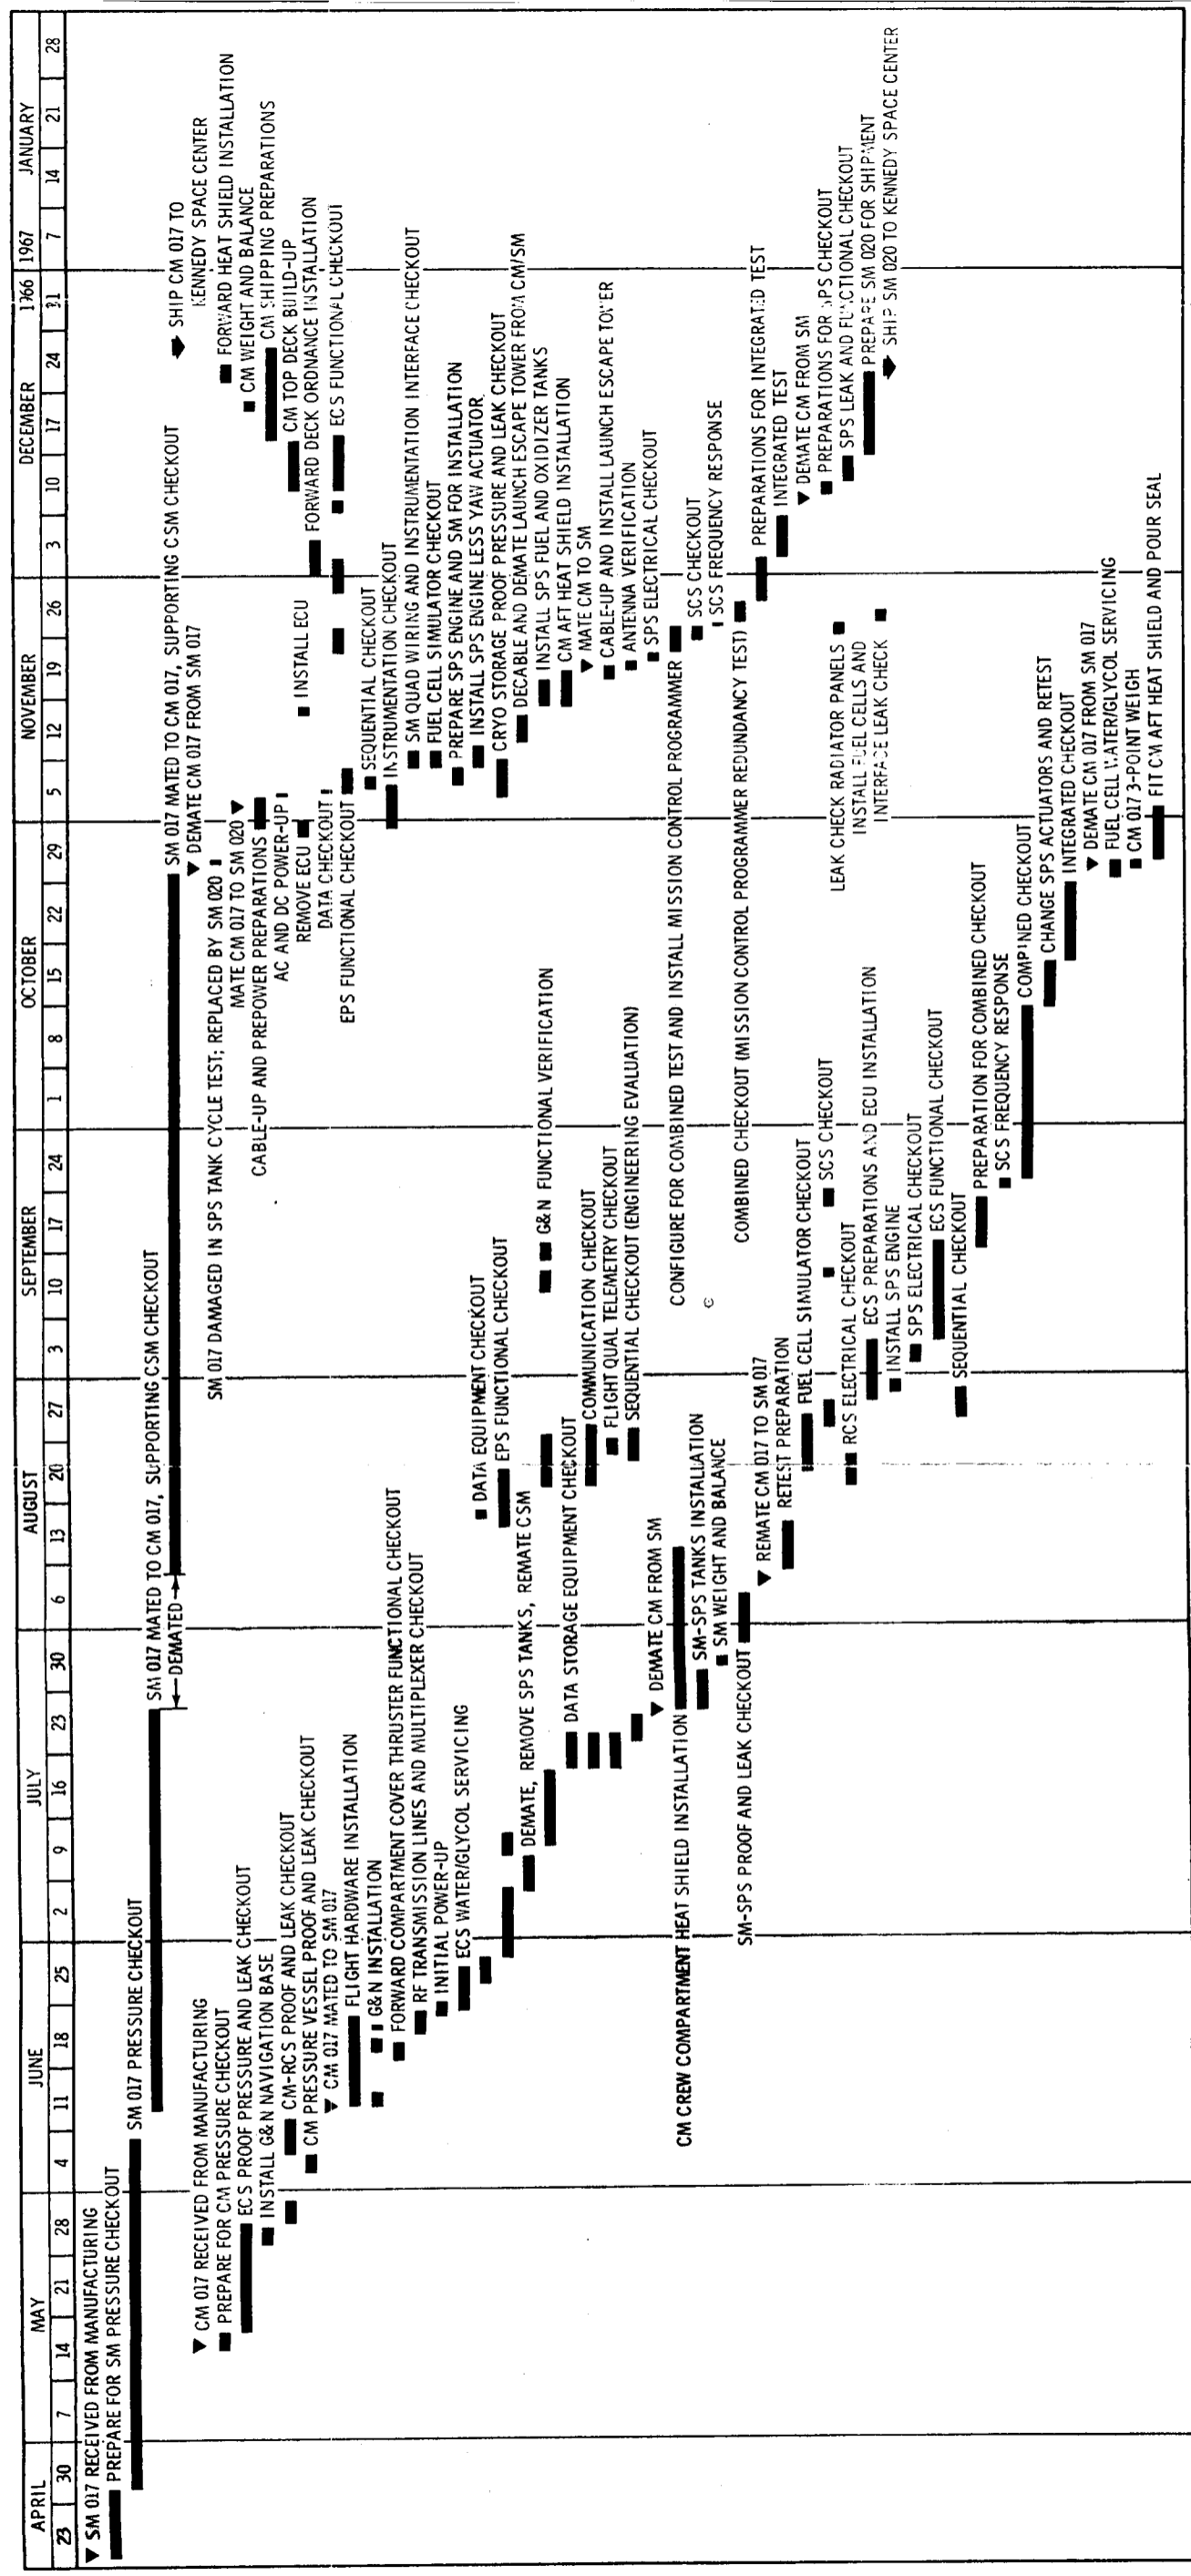
FIGURE 14.1-1. - FACTORY CHECKOUT FLOW FOR COMMAND AND SERVICE MODULE AT DOWNEY.

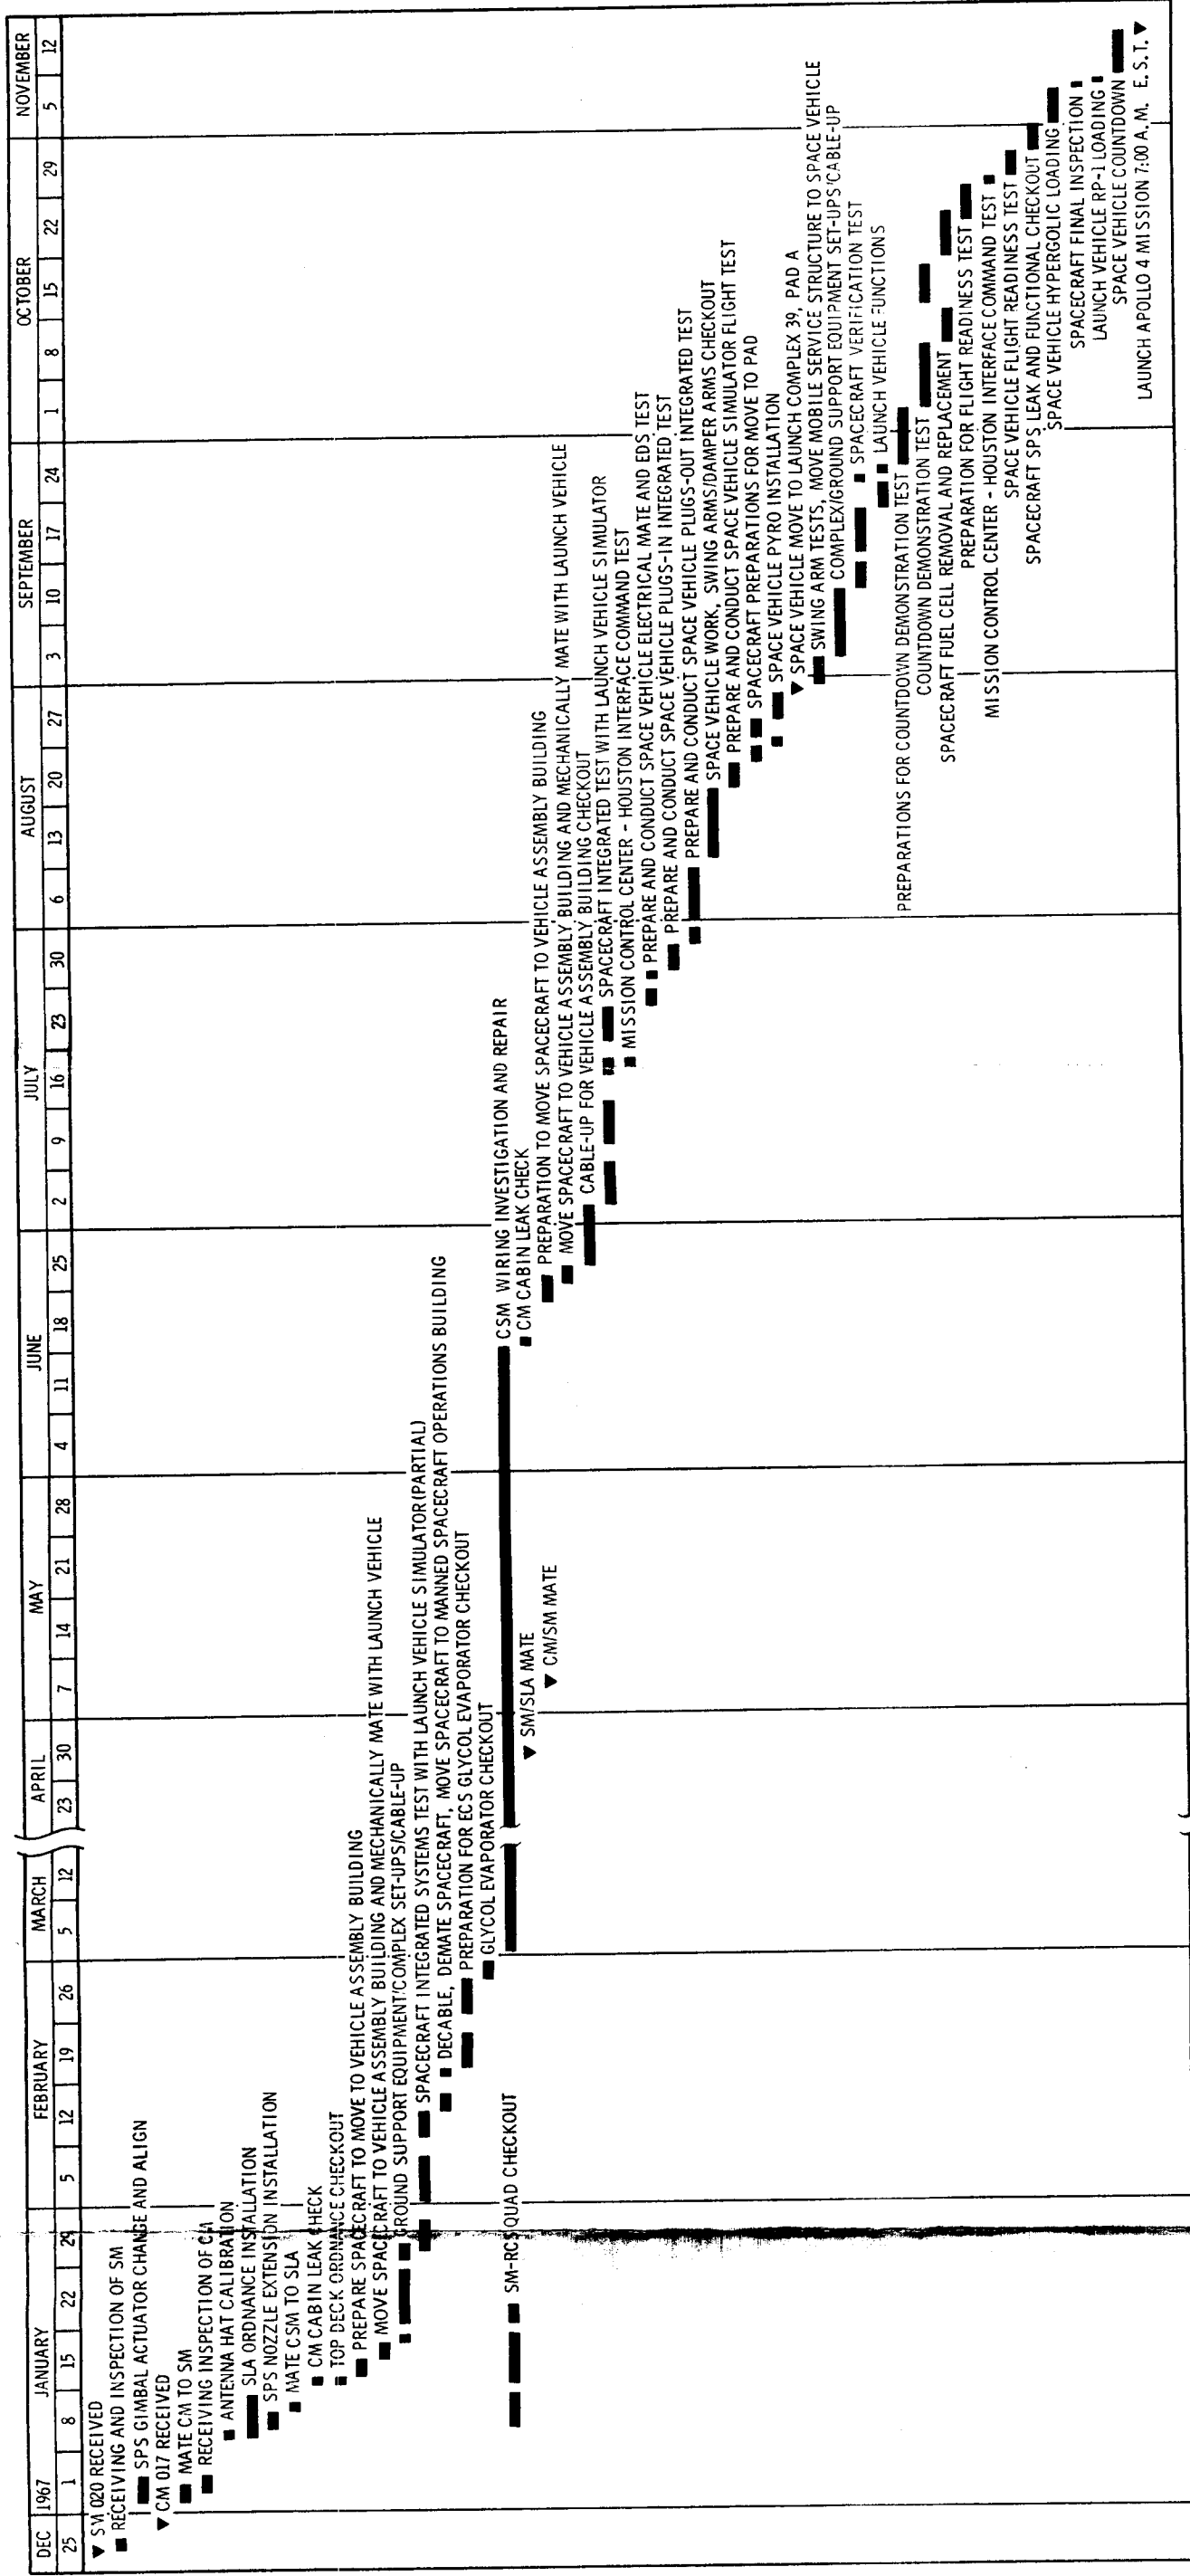
FIGURE 14.1-2. - PRELAUNCH CHECKOUT FLOW FOR COMMAND AND SERVICE MODULE AT KENNEDY SPACE CENTER.
