## GEMINI PROGRAM MISSION REPORT

# GEMINI XII

JANUARY 1967

MSC-G-R-67-1

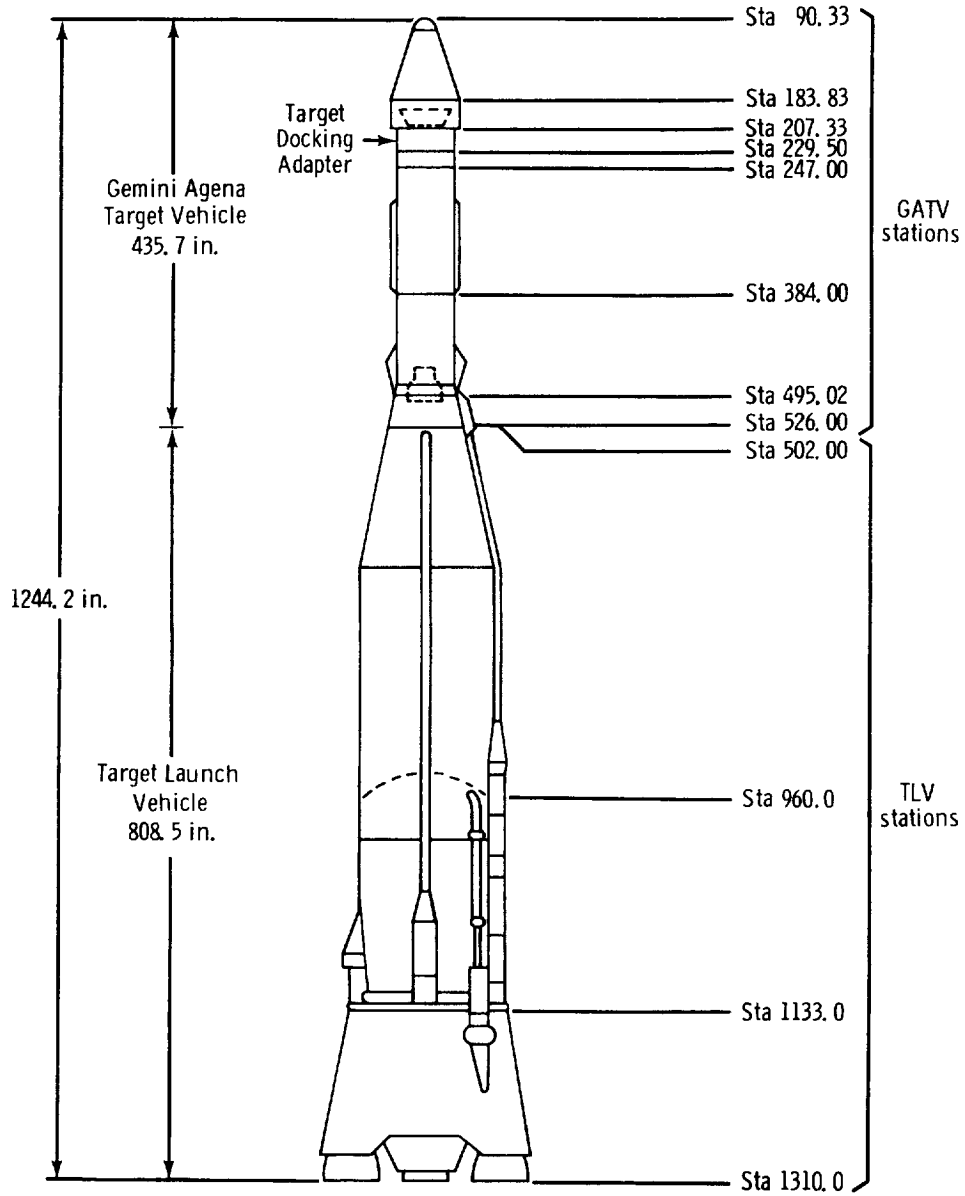
Figure 3.0-2, - TLV/GATV relationship.

(a) Launch configuration.

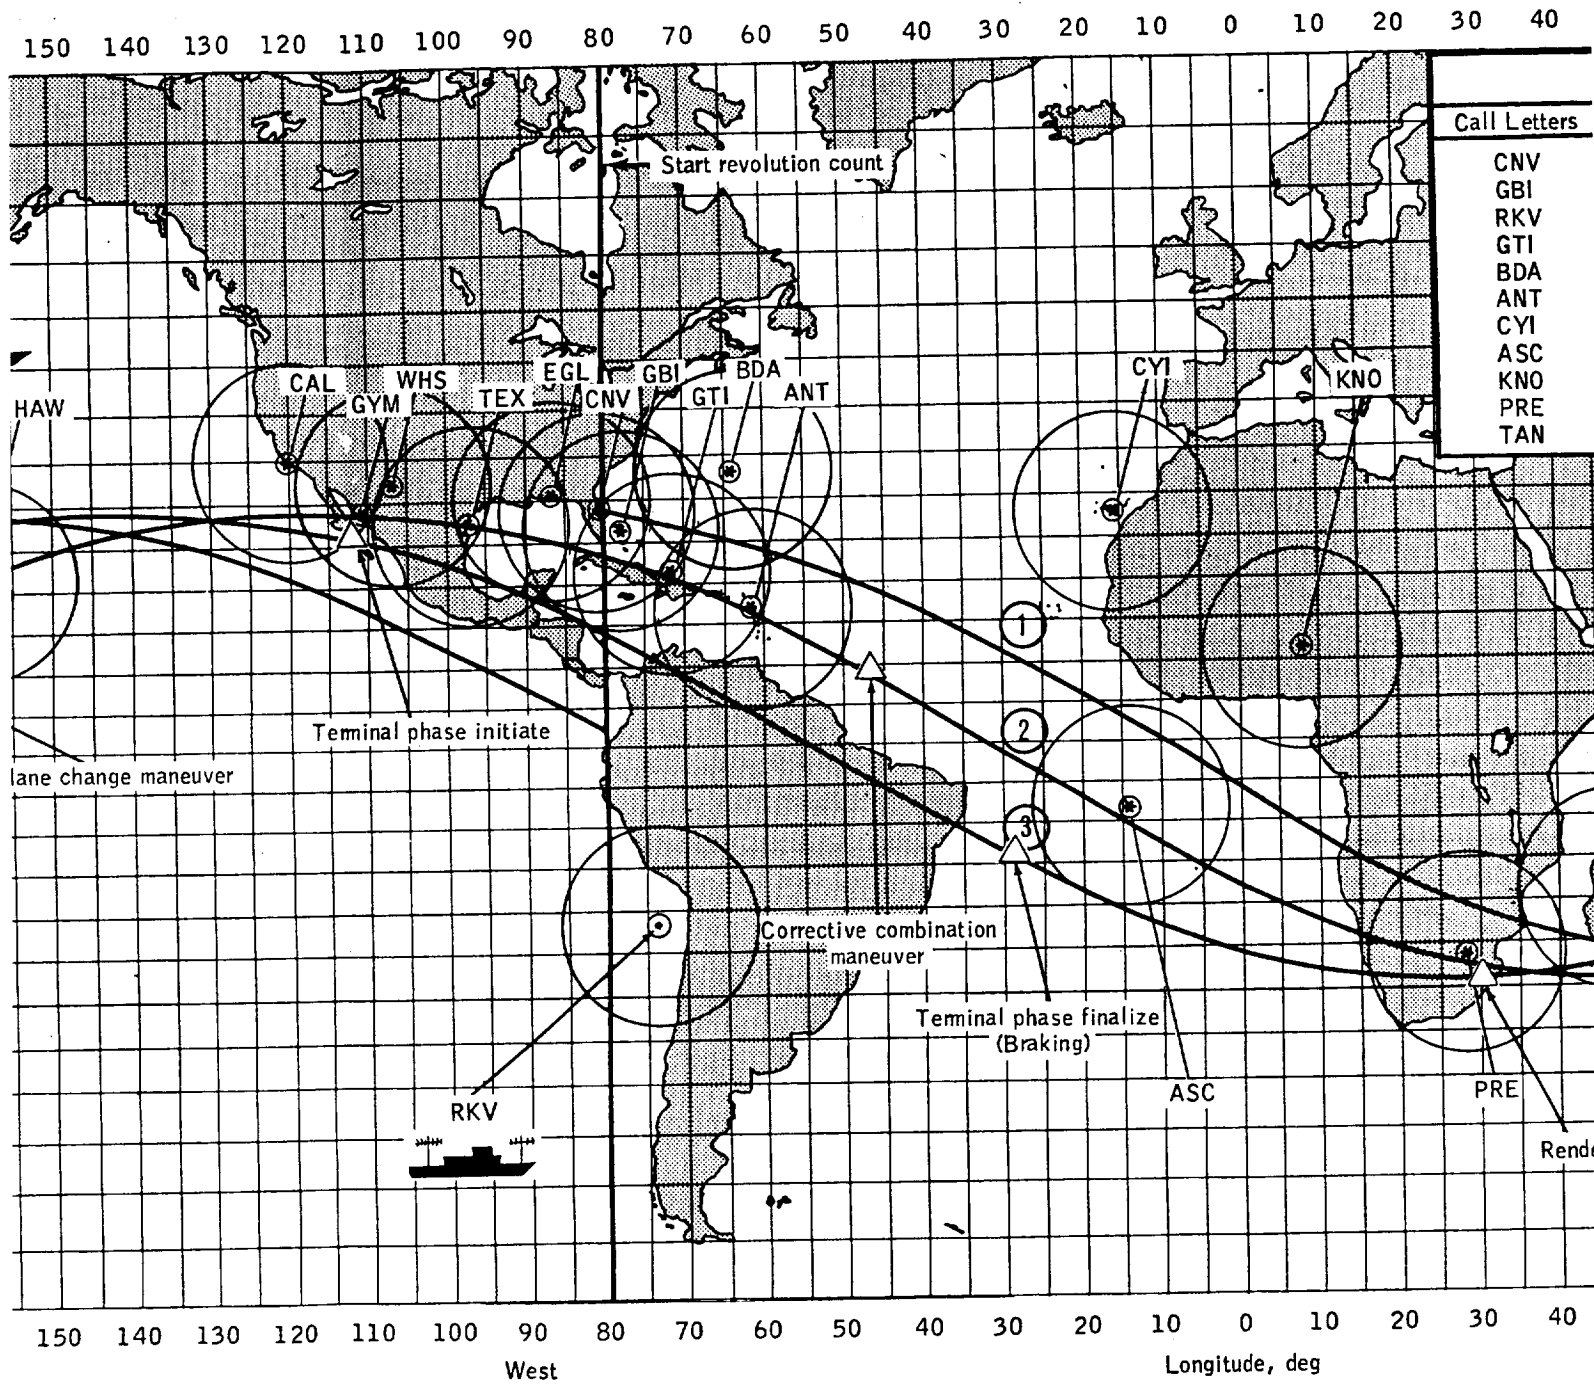
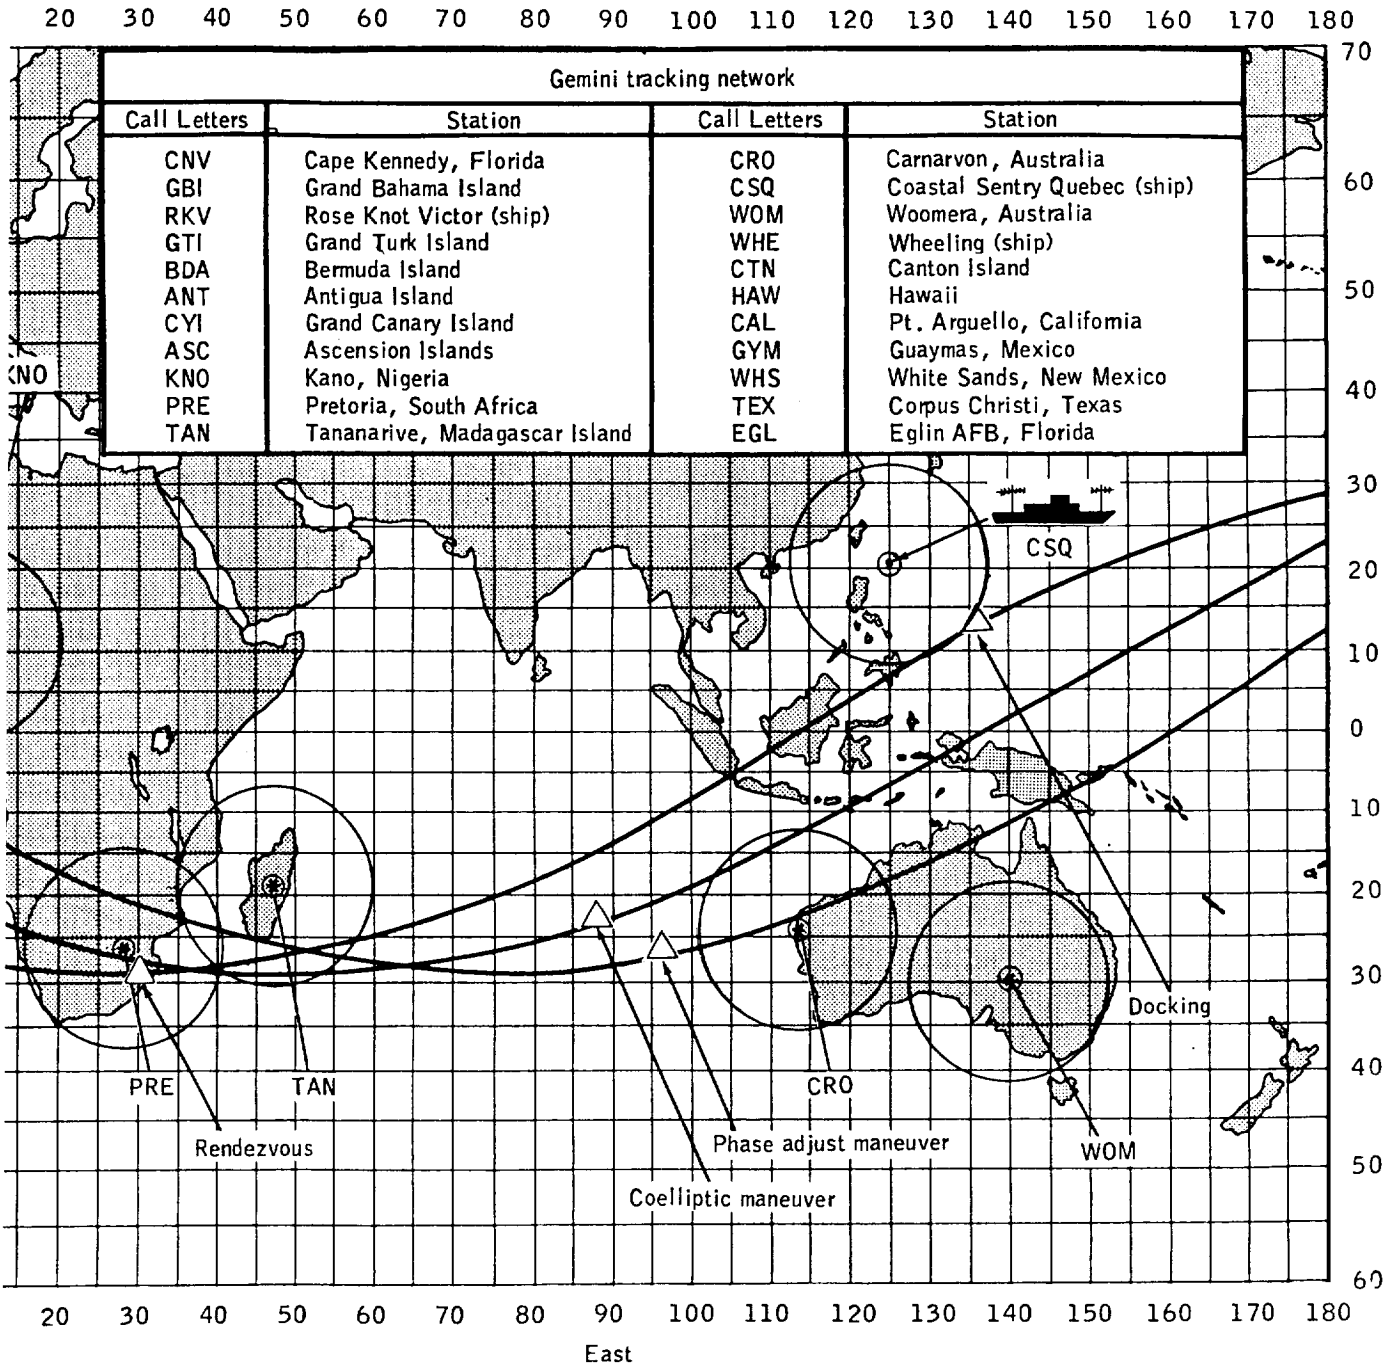
Figure 4.3-1.- Ground track for the Gemini XII orbital mission.

(a) Revolutions 1 through 3.

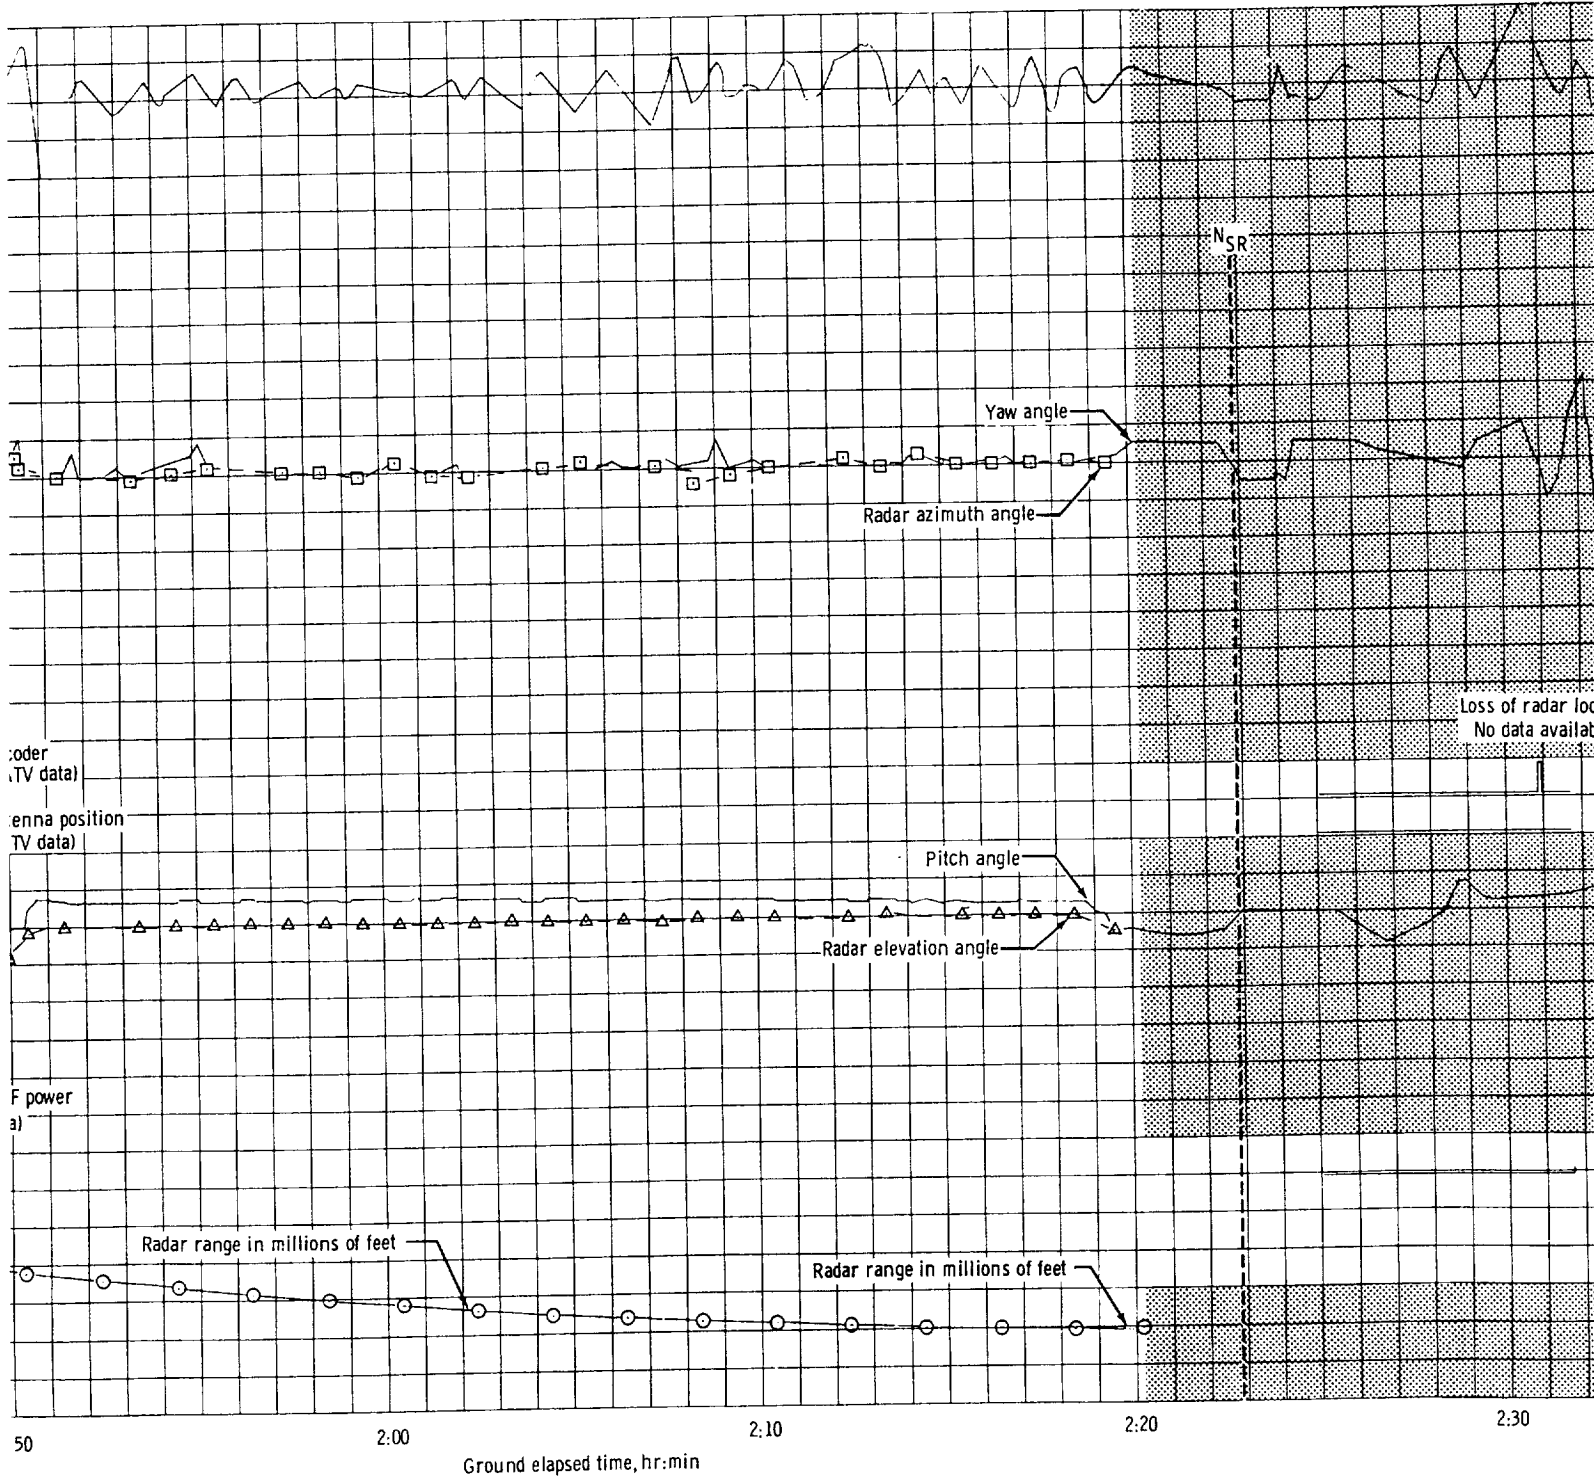
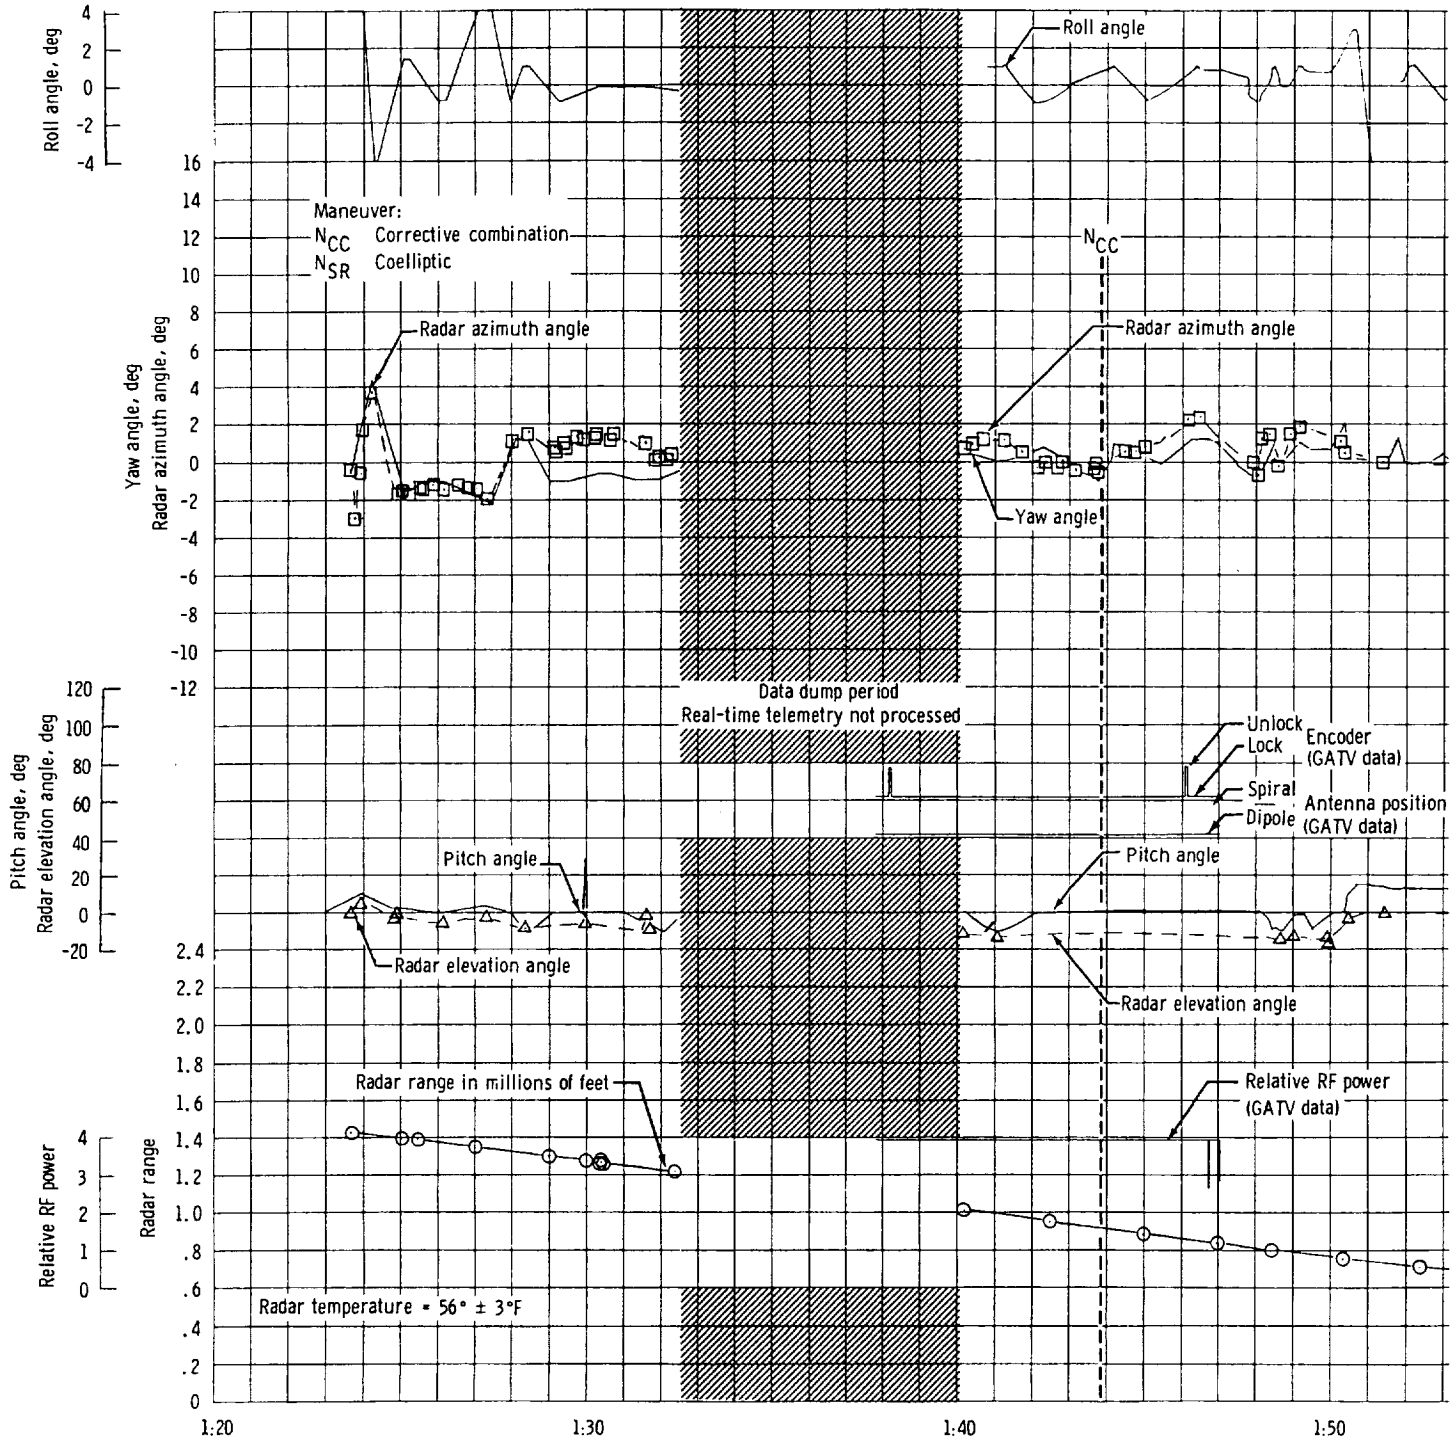
Figure 5.1.5-5. - Computer data for the closed-loop rendezvous.

(a) 1 hr 20 min to 2 hr 50 min g. e. t.

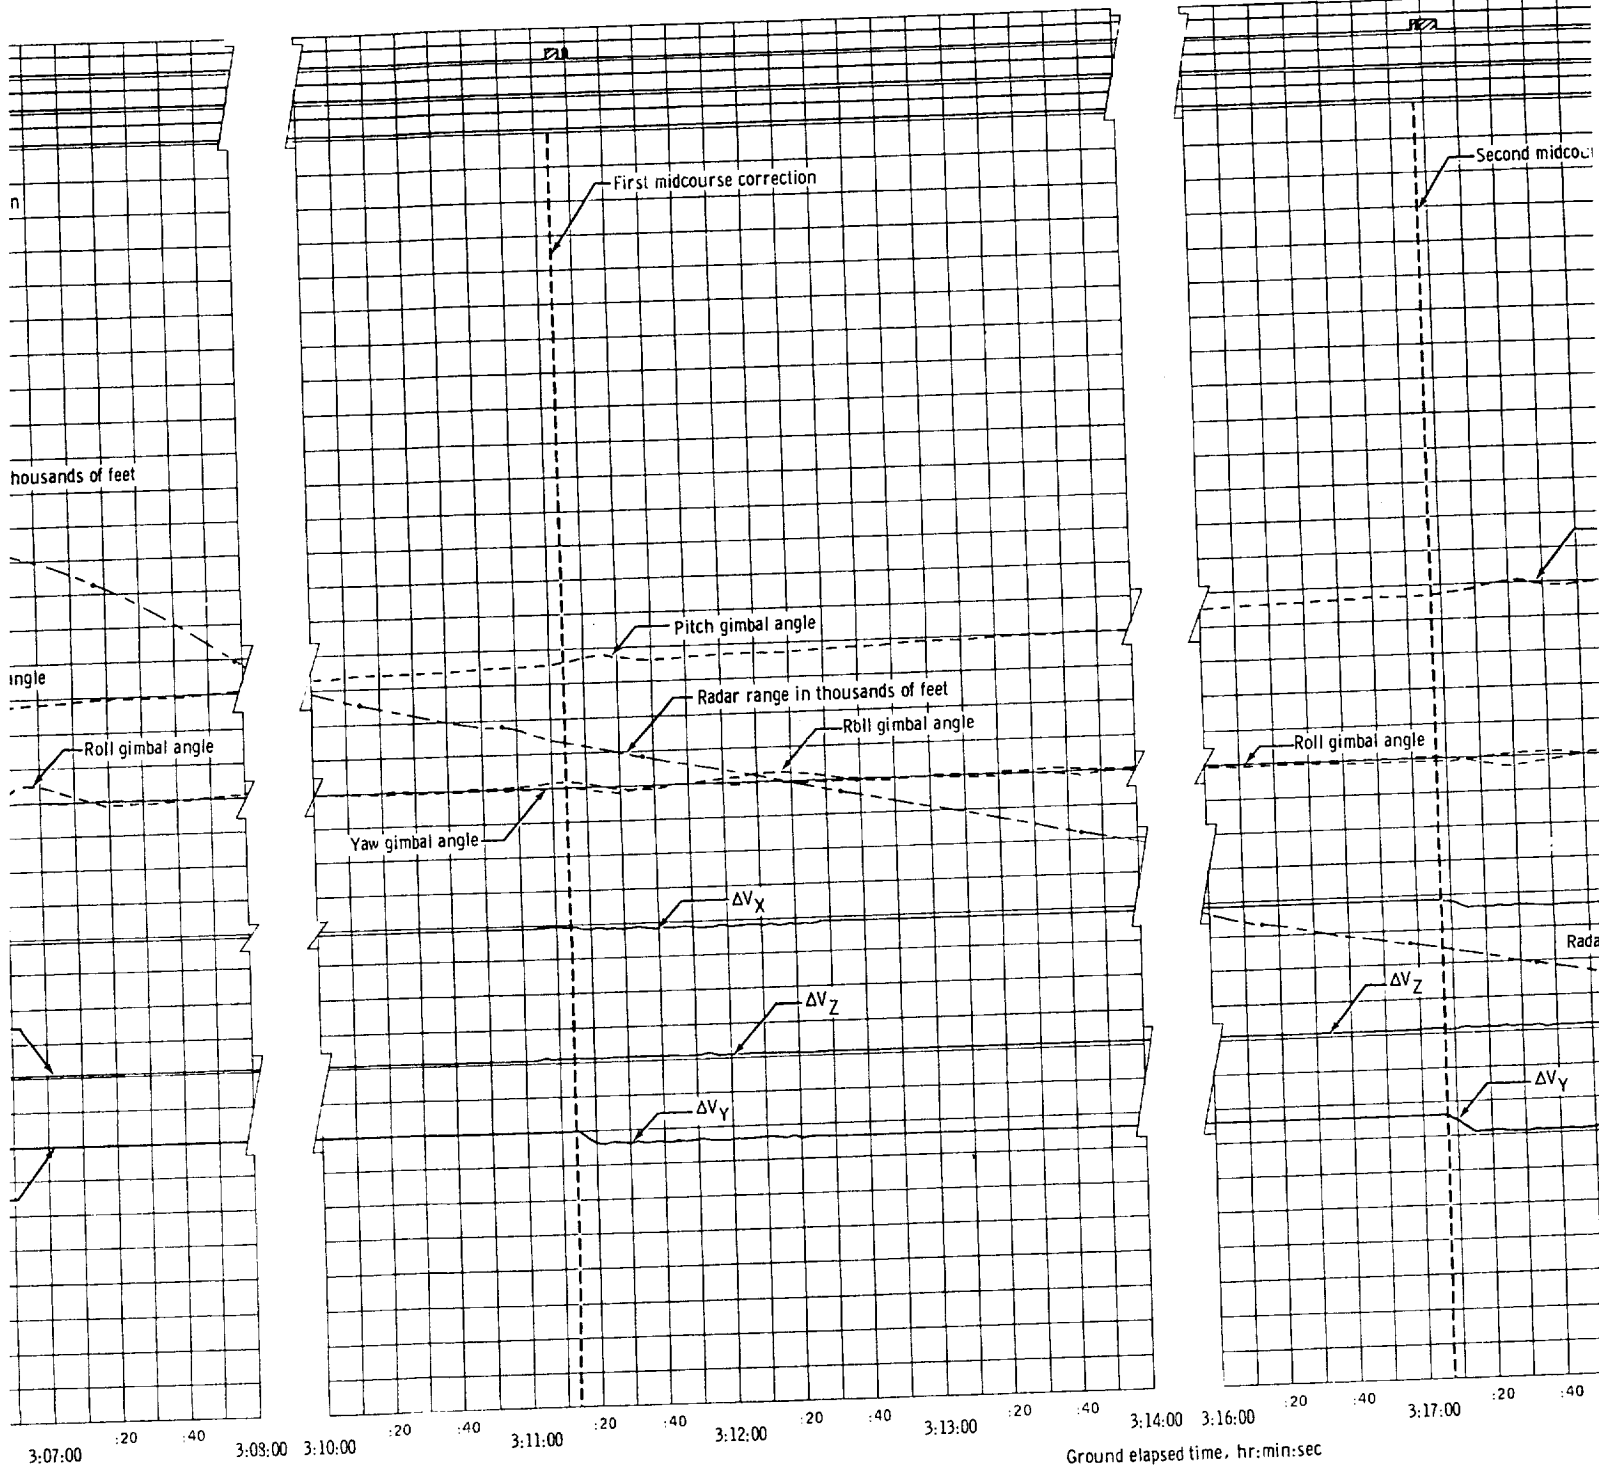
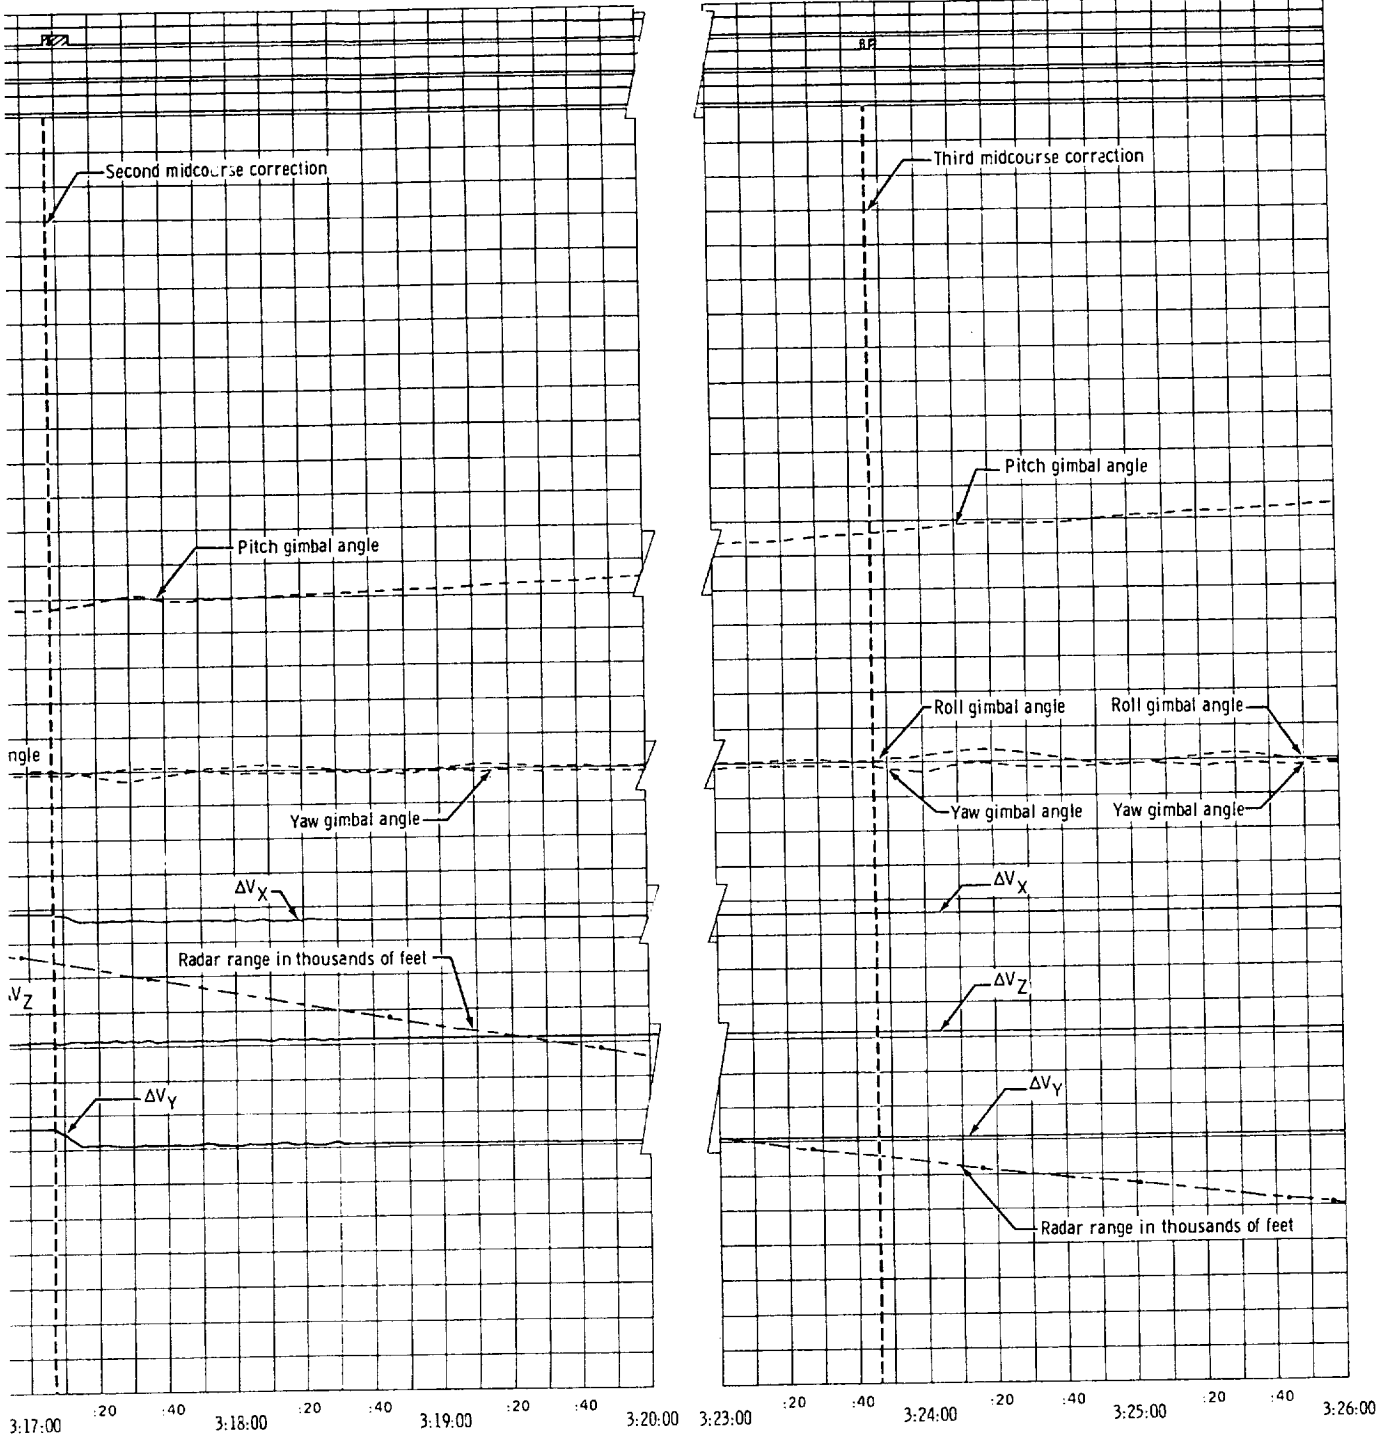
Figure 5.1.5-6. - Spacecraft applied  $\Delta V$ 's, gimbal angles, and radar range, from TPI to first docking.

(a) 3:05:00 to 3:26:00 g. e. t.

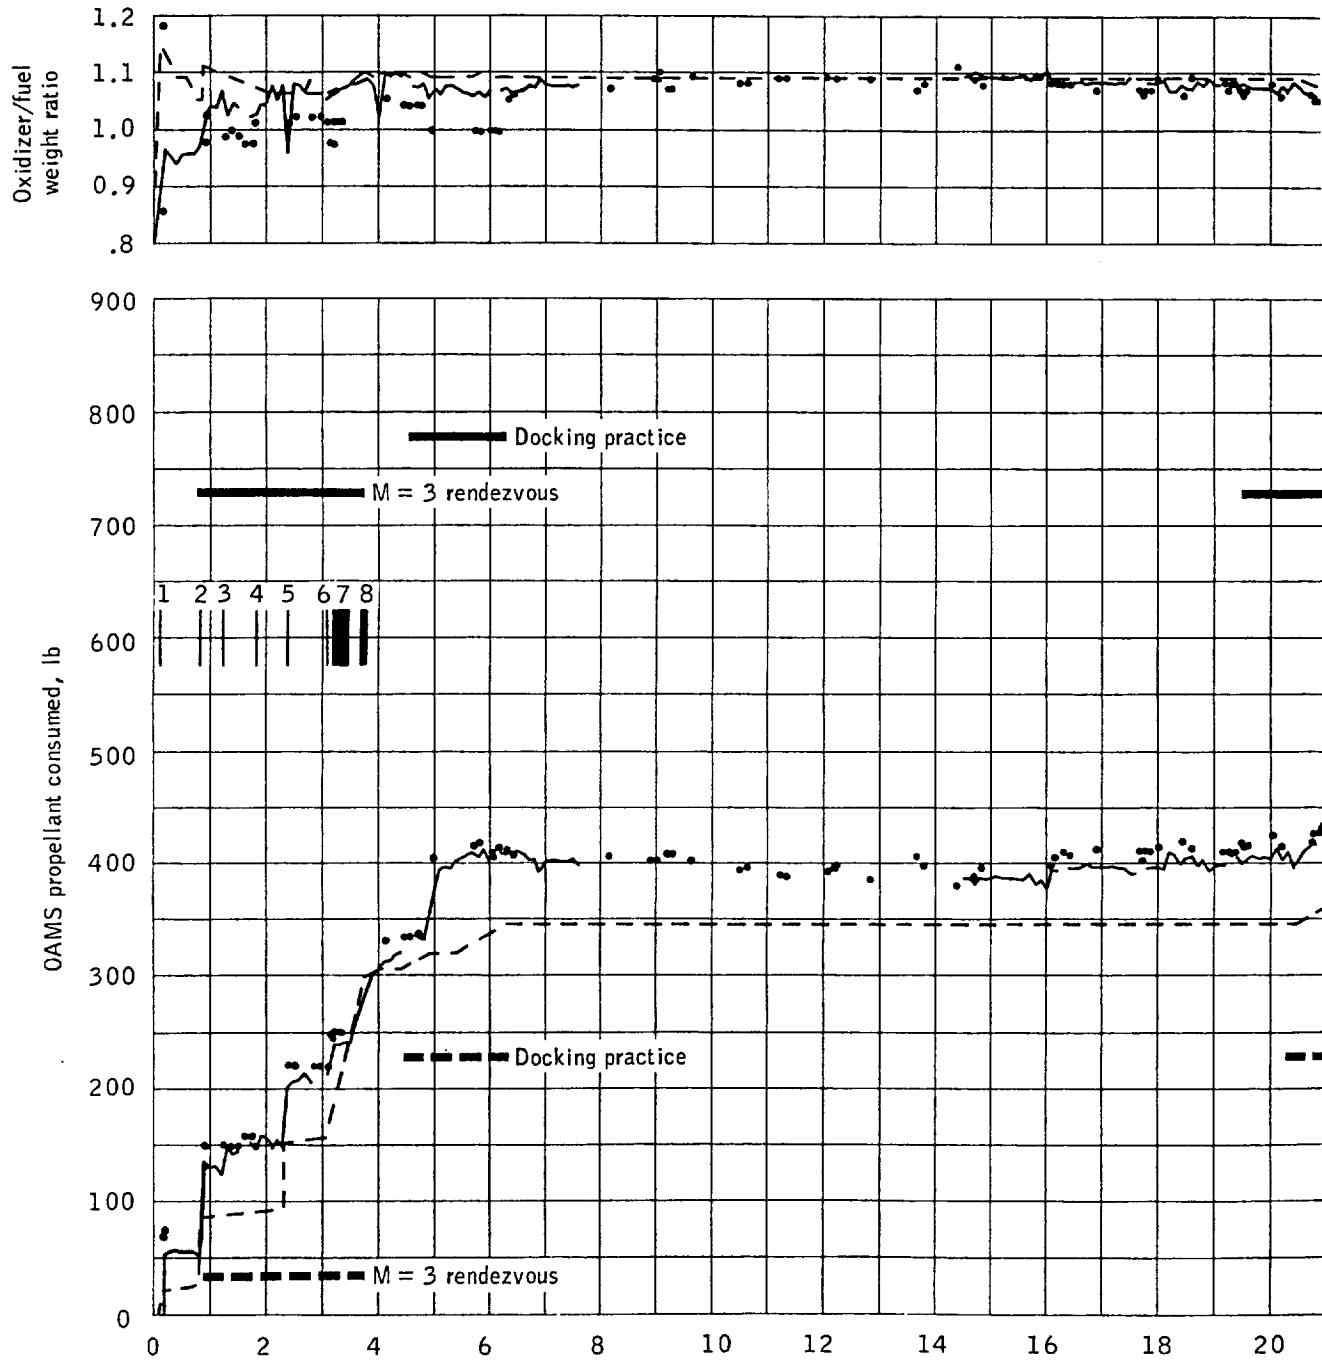
Figure 5.1.8-2. - OAMS propellant consumption.

(a) 0 to 46 hours g.e.t.

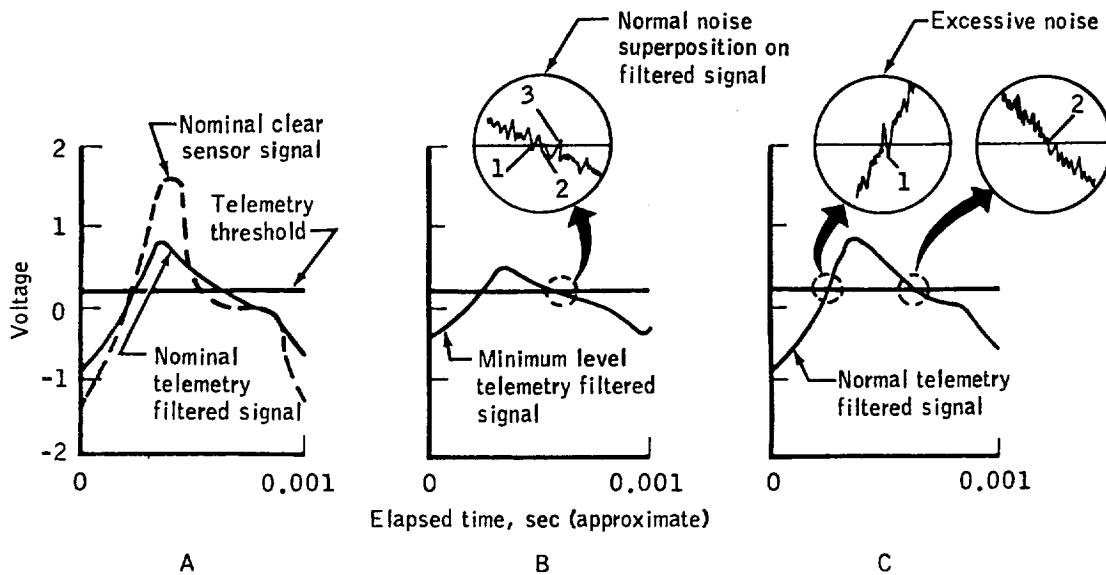
Figure 5.4-4. - Engine turbine speed to telemetry counter signals.

- A - Nominal conditions showing sensor output and signal to telemetry counter.
- B - Minimum signal to counter due to increased sensor-to-gear air gap. Circle shows how noise can trigger telemetry.
- C - Same as B, but based on nominal signal to counter. This requires a higher noise level to cause a false count.

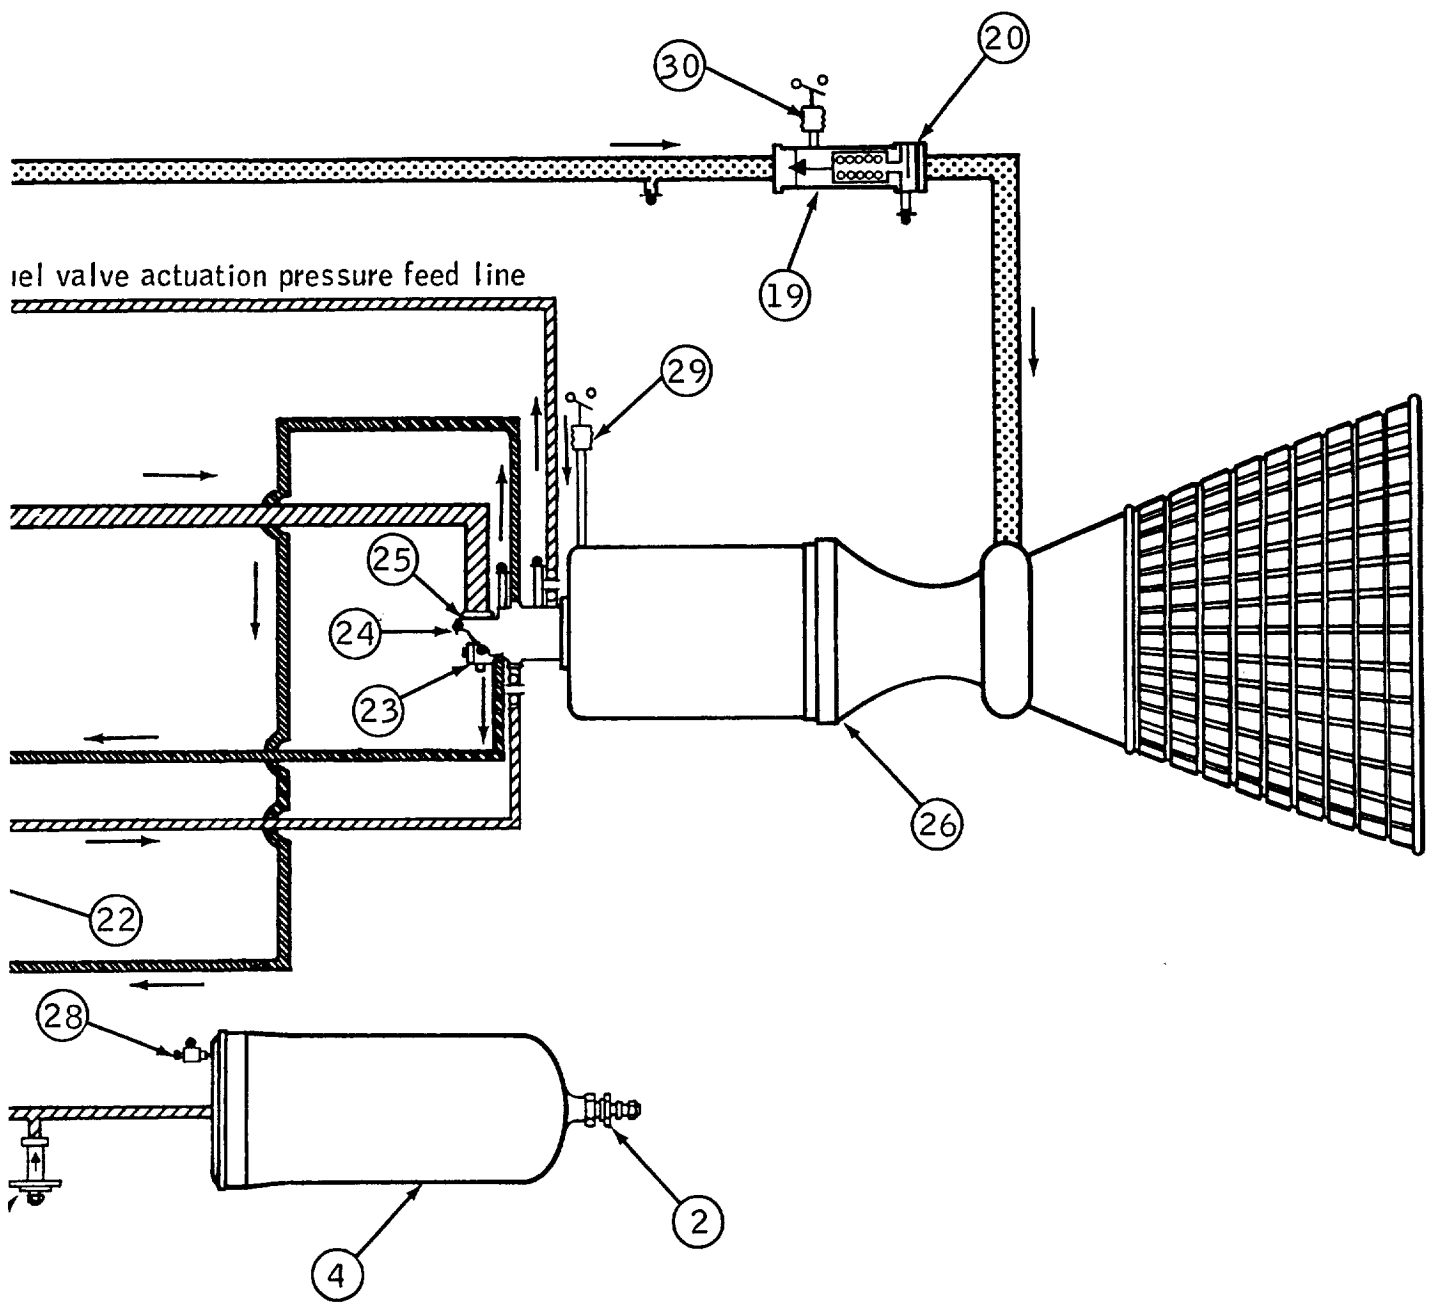
- 1 Nitrogen fill valve - oxidizer
- 2 Nitrogen fill valve - fuel
- 3 Oxidizer start tank
- 4 Fuel start tank
- 5 Oxidizer fill and drain valve
- 6 Fuel fill and drain valve
- 7 Oxidizer venturi
- 8 Fuel venturi
- 9 Gas generator oxidizer solenoid valve
- 10 Gas generator fuel solenoid valve
- 11 Gas generator
- 12 Fuel pump
- 13 Oxidizer pump
- 14 Fuel filters
- 15 Oxidizer filter
- 16 Gear case
- 17 Turbine manifold
- 18 Turbine exhaust duct
- 19 Oxidizer valve
- 20 Oxidizer frangible disc (rupture-180 psi)
- 21 Check valve and bleed port (oxidizer)
- 22 Check valve and bleed port (fuel)
- 23 Pilot-operated solenoid valve
- 24 Fuel valve
- 25 Fuel frangible disc (rupture-525 psi)
- 26 Thrust chamber
- 27 Oxidizer bleed valve
- 28 Fuel bleed valve
- 29 Oxidizer manifold pressure switch
- 30 Oxidizer feed pressure switch

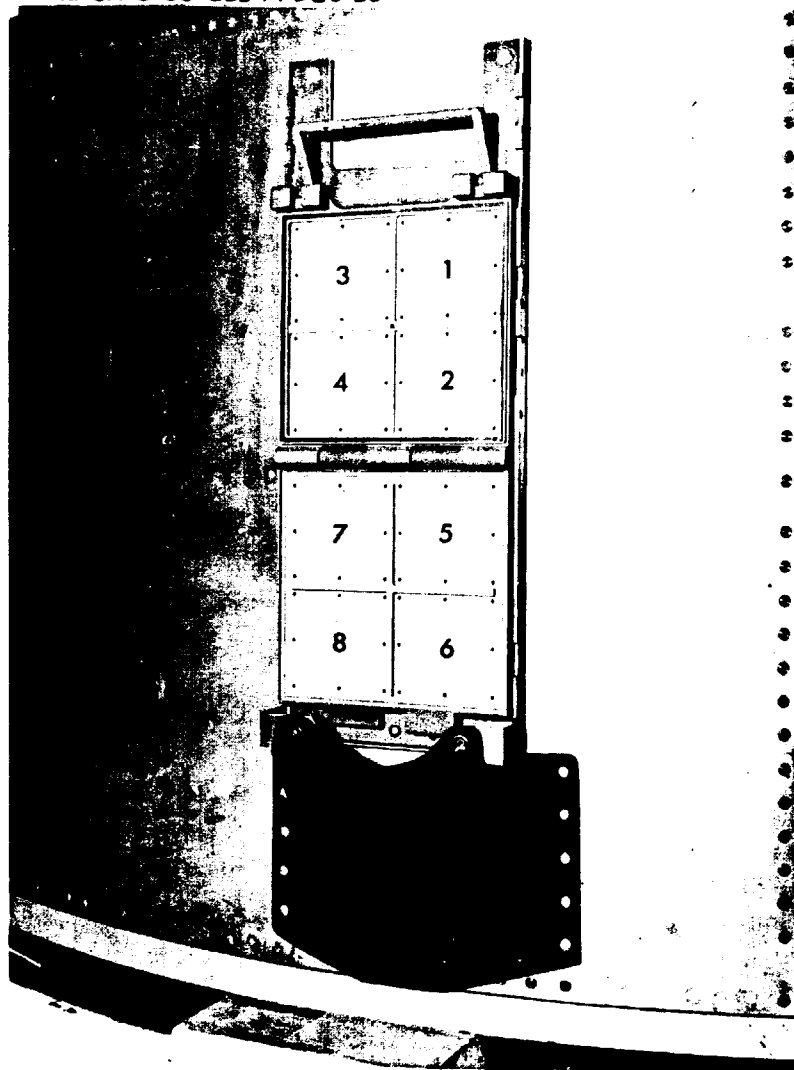
1. Shielded screening
2. Chromium-coated glass
3. Biological exposure with filters
4. Glass
5. Polished glass
6. Gold foil two  $\mu$  thick; two layers plus thick plastic film below
7. Stereoscan samples, copper and stainless steel
8. Stainless steel

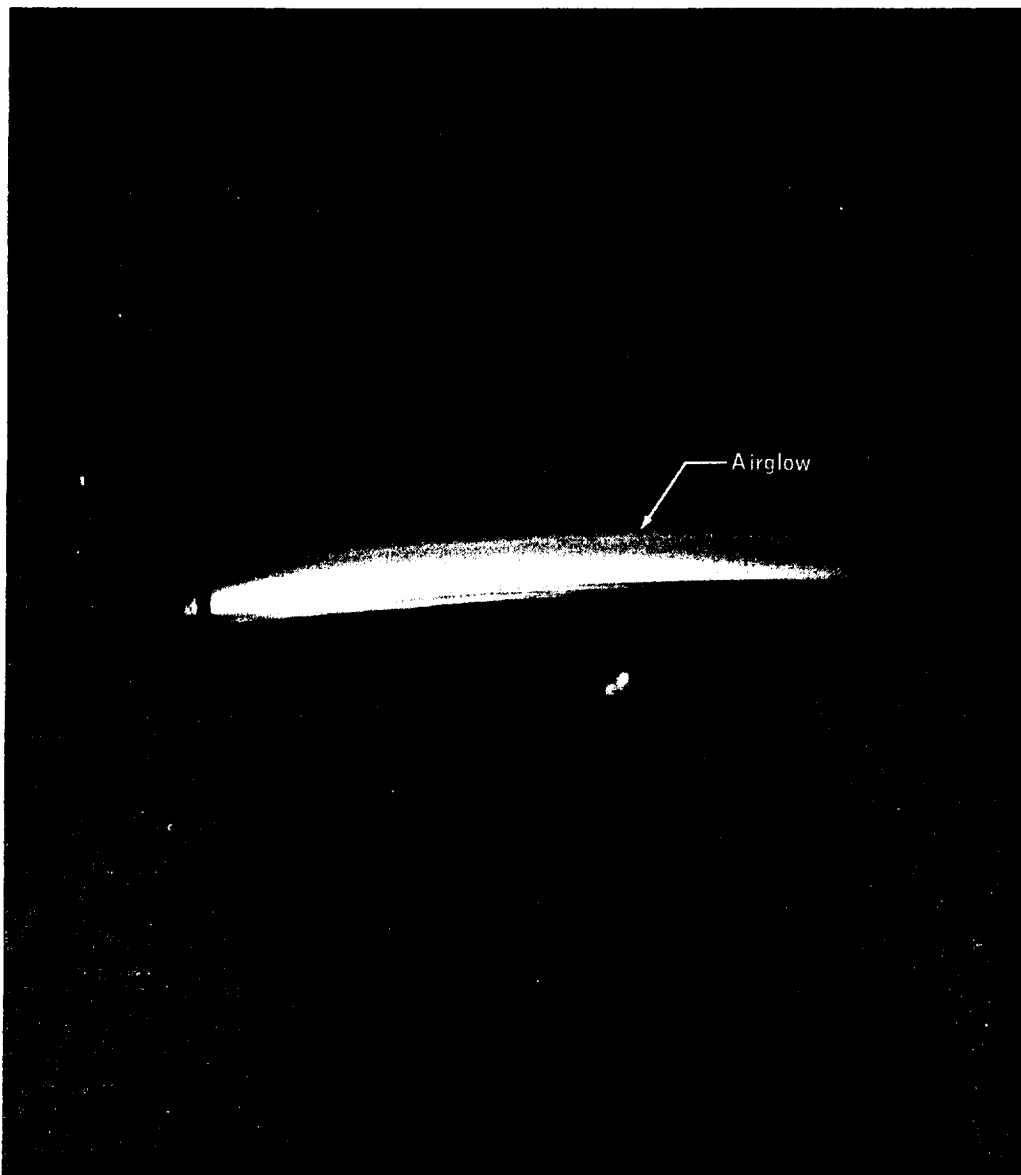
Figure 8.9-4. - A 20-second exposure using a red filter—taken four minutes after sunset. The emission layers observed are probably due to the OH radical.
