FBM/IC 032

APOLLO II IRIG BALL BEARING
WHEEL DESIGN VERIFICATION
TEST PROGRAM

CHARLES STARK DRAPER LABORATORY
CAMBRIDGE, MASSACHUSETTS, 02139

September 1970

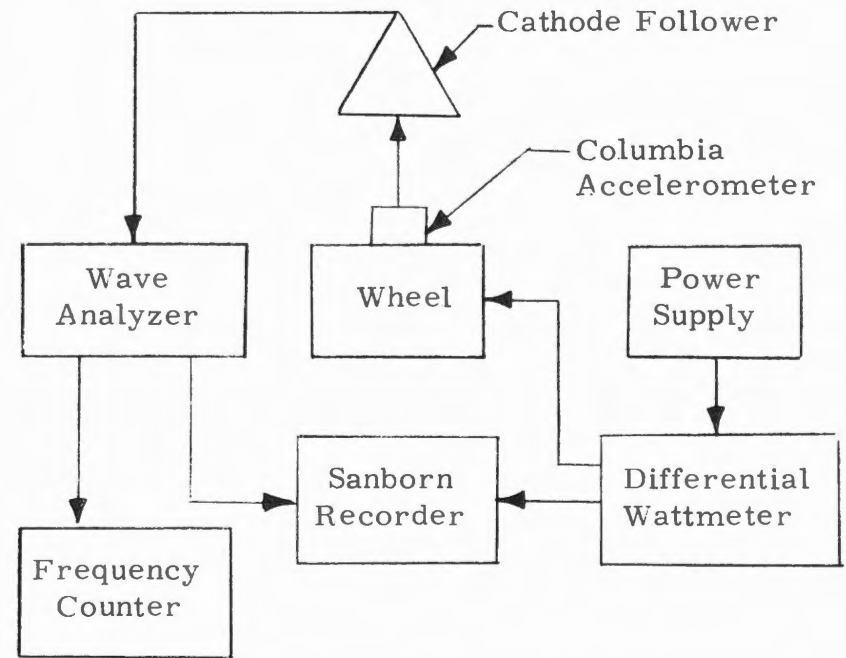
(B) Comparison of Differential Wattmeter output and beat frequency from wave analyzer.
