MPR-SAT-FE-72-1

JUNE 19, 1972

## SATURN V LAUNCH VEHICLE FLIGHT EVALUATION REPORT-AS-511 APOLLO 16 MISSION

Saturn Flight Evaluation Working Group  
George C. Marshall Space Flight Center

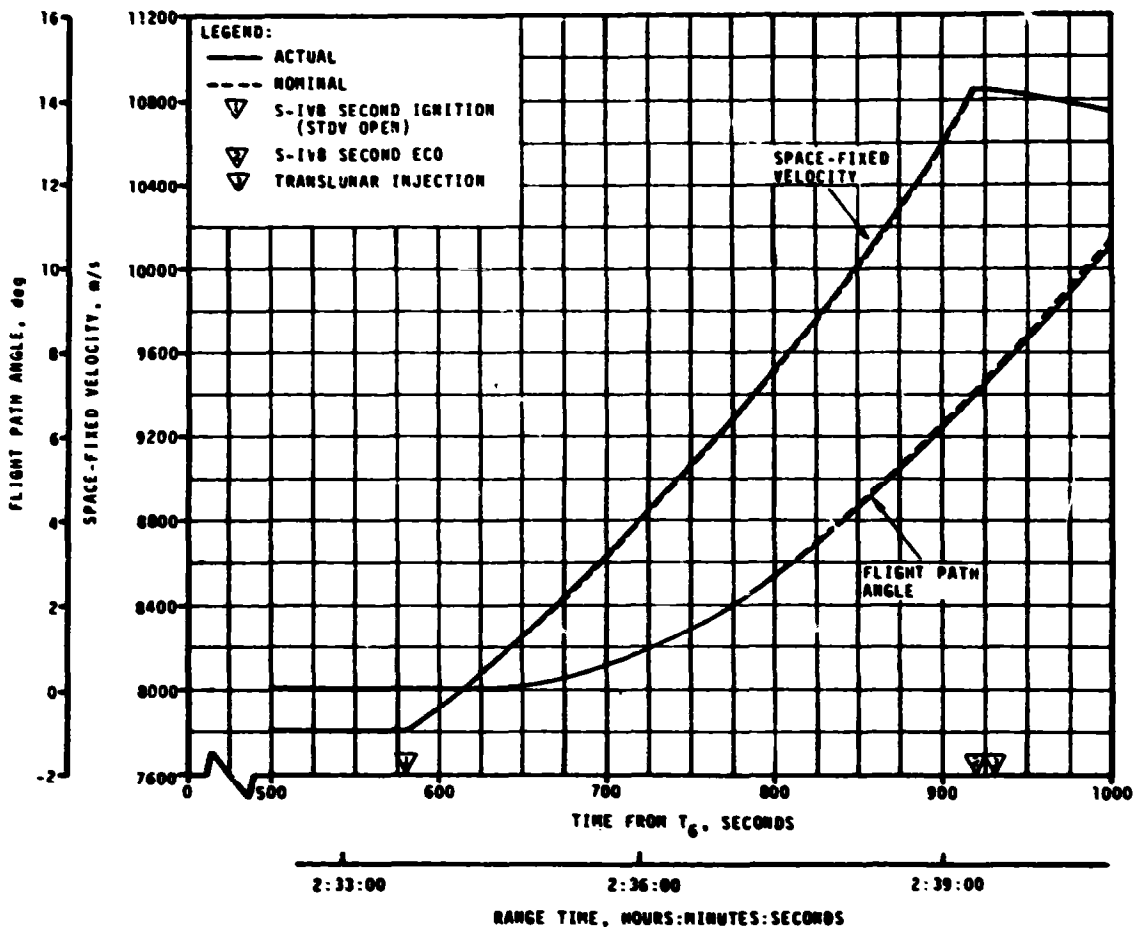
Figure 4-6. Injection Phase Space-Fixed Velocity and Flight Path Angle Comparisons

Comparisons between the actual and nominal space-fixed velocity and flight path angle are shown in Figure 4-6. The actual and nominal injection phase acceleration comparisons are presented in Figure 4-7. The actual and nominal targeting parameters at S-IVB second guidance cutoff are presented in Table 4-2.

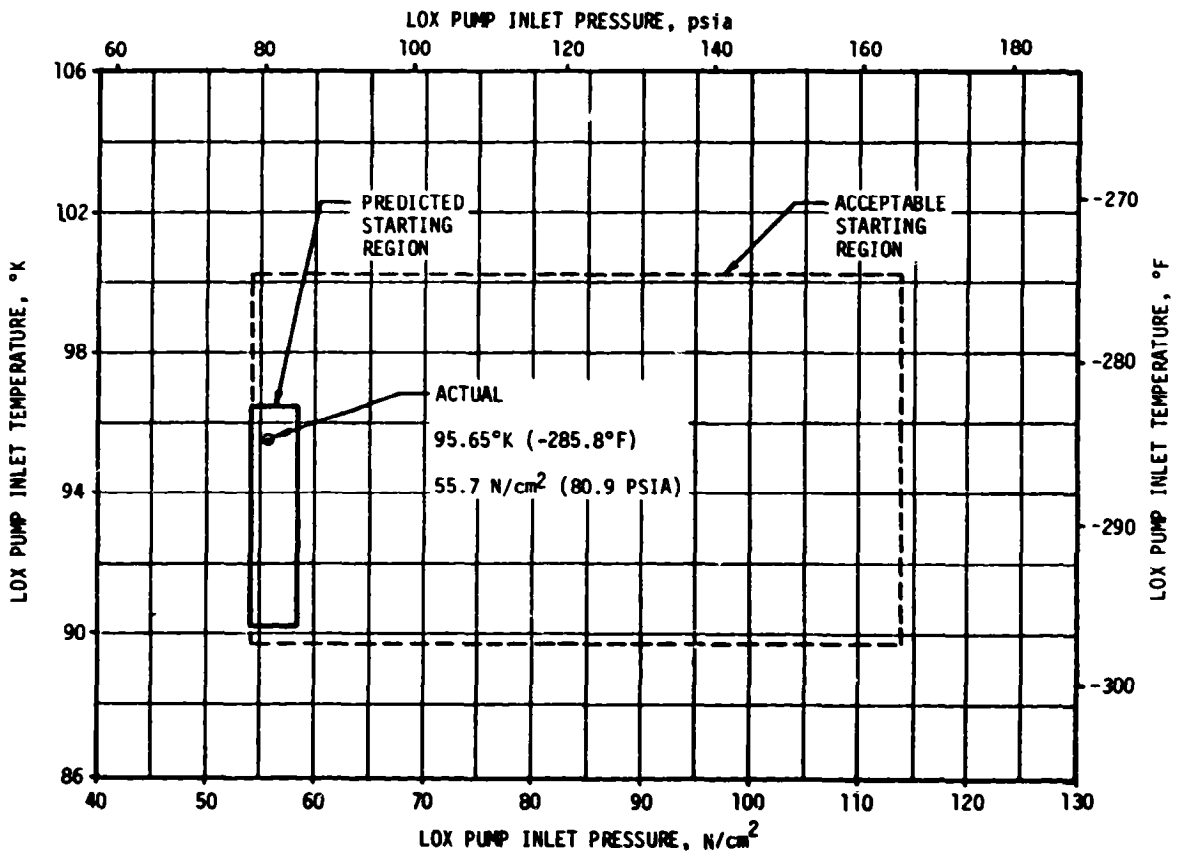
Figure 5-1. S-IC LOX Start Box Requirements

Although within specifications, the start times as measured from engine control valve open signal to 100-psig chamber pressure, was faster than predicted for all engines. Table 5-1 shows actual and predicted times to 100 psig chamber pressure corrected to nominal prestart conditions. The programmed time for engine control valve open signal is calculated for each F-1 engine to minimize start sequence dispersions and is historically

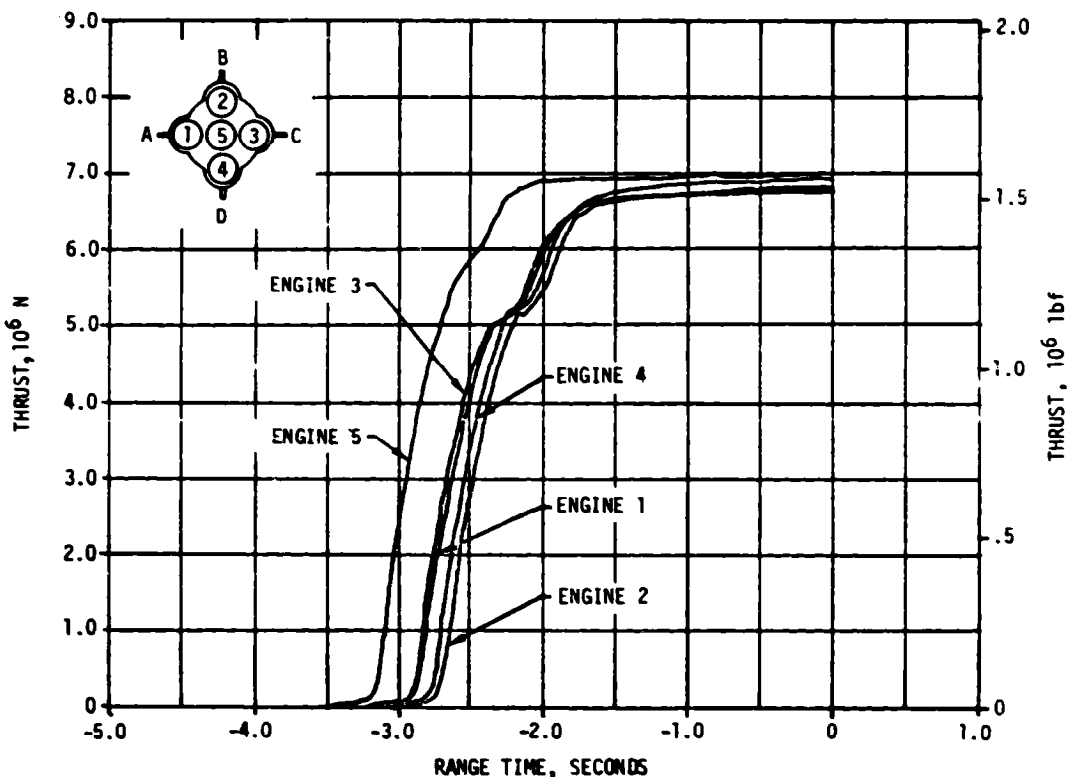
Figure 5-2. S-IC Engines Thrust Buildup

Thrust buildup rates were as expected, as shown in Figure 5-2. The shift in thrust buildup near the 1100 Klbf level on the outboard engines is attributed to ingestion of helium from the LOX prevalves during startup and is a normal occurrence. The thrust shift is absent on the inboard engine (engine 5) because the POGO suppression helium injection system is not used on this engine.

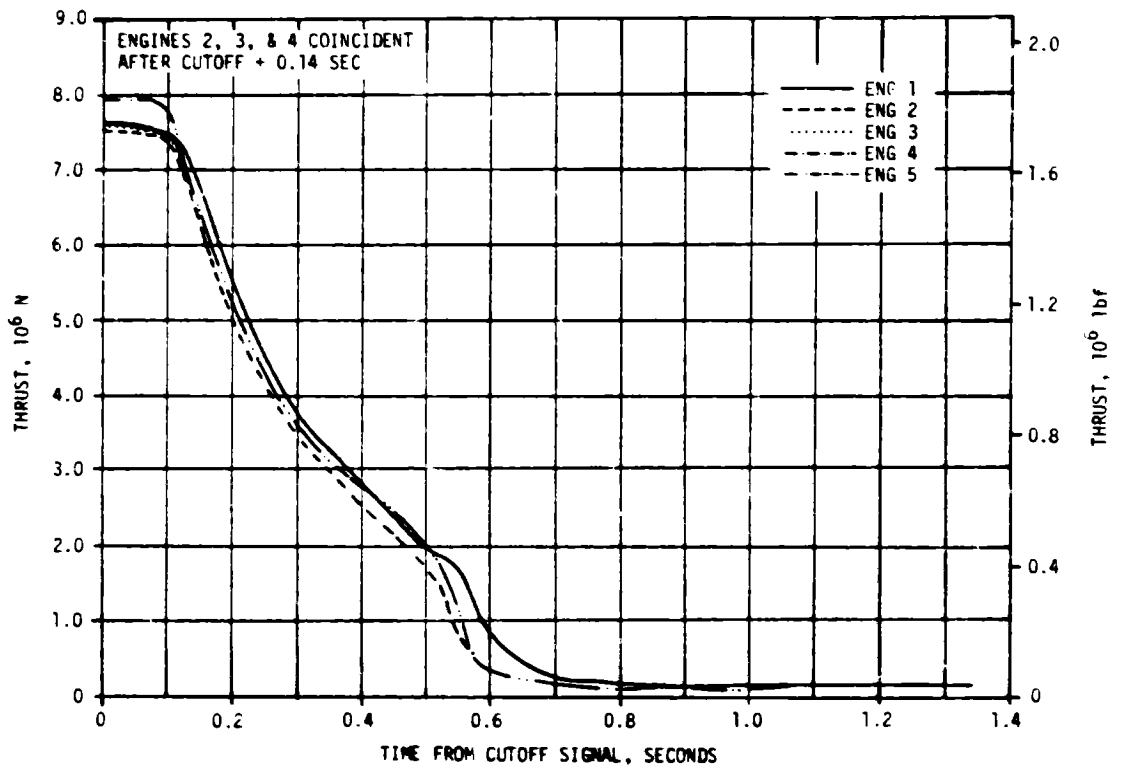
Figure 5-4. F-1 Engine Thrust Decay

The F-1 engine thrust decay transient was normal. Thrust decay of the F-1 engines is shown in Figure 5-4. The cutoff impulse, measured from cutoff signal to zero thrust, was 775,690 lbf-s for the center engine (10.9 percent greater than predicted) and 2,700,932 lbf-s for all outboard engines (2.6 percent less than predicted). The total stage cutoff impulse

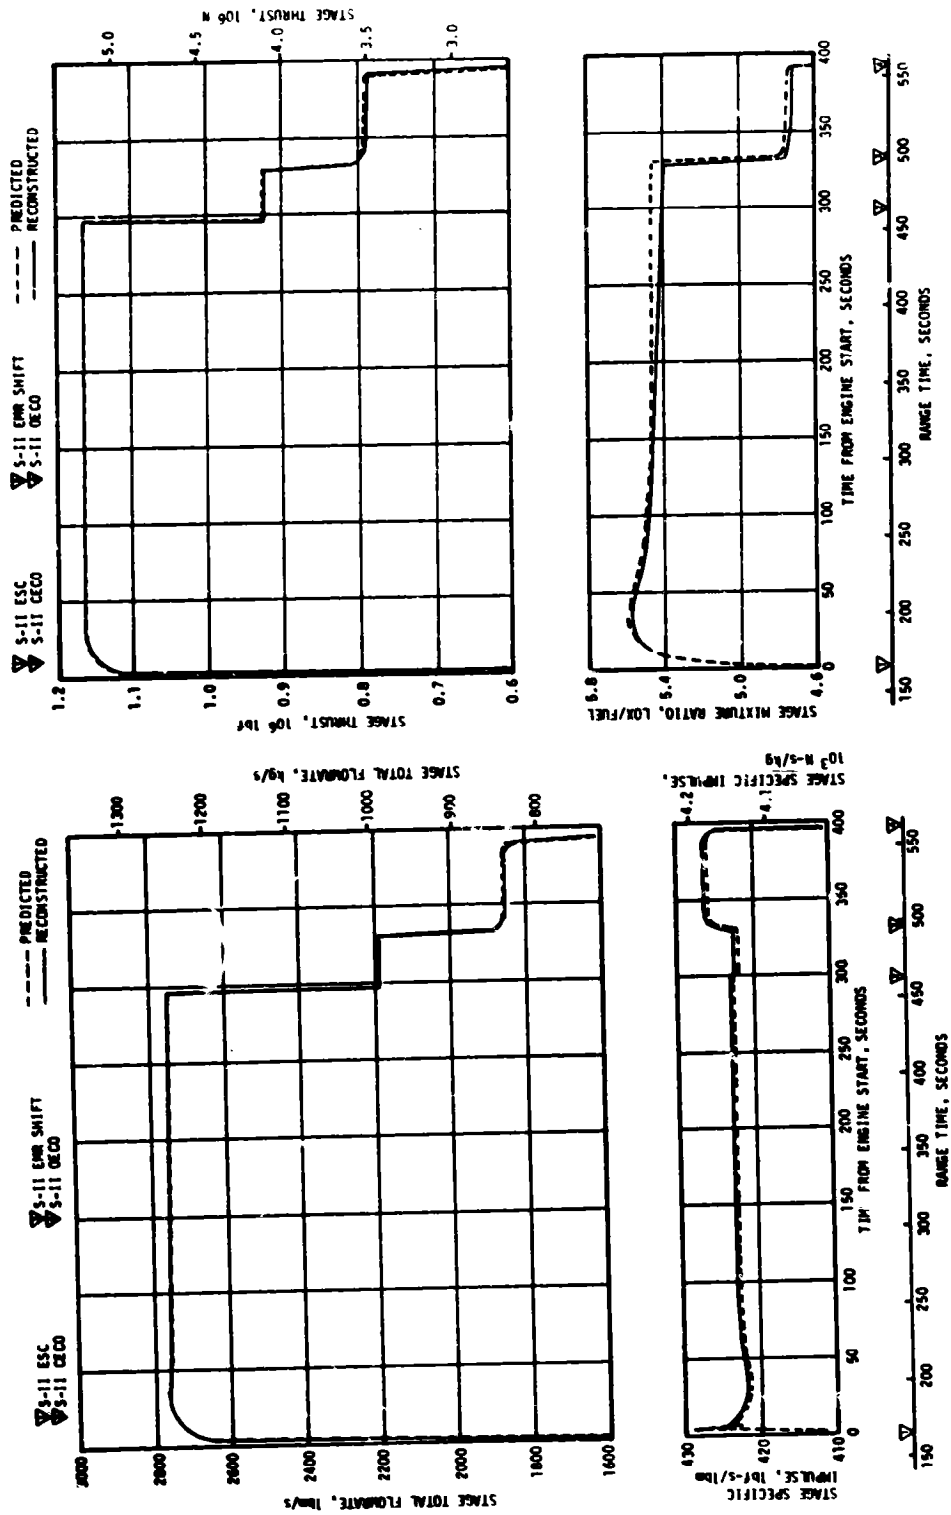
Figure 6-6. S-II Propulsion Performance

S-II OEEO was initiated by the stage LOX depletion cutoff system as planned. The LOX depletion cutoff system again included a 1.5 second delay timer. As in previous flights (AS-504 and subsequent), this resulted in engine thrust decay (observed as a drop in thrust chamber pressure) prior to receipt of the cutoff signal. The pre-cutoff decay was less than that observed on AS-510 due to lower engine thrust and EMR levels at OEEO.

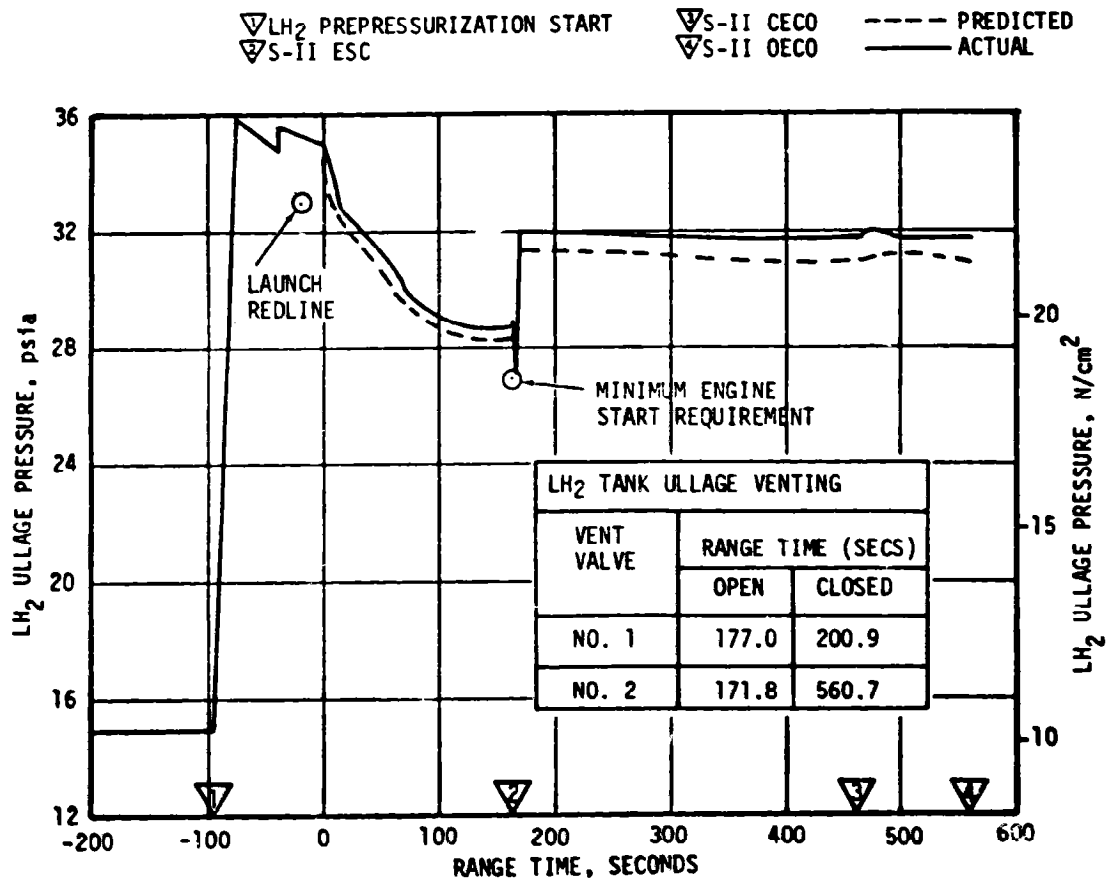
Figure 6-8. S-II Fuel Tank Ullage Pressure is an acceptable condition and no corrective action is necessary.

The LH<sub>2</sub> ullage pressure during S-II boost was controlled by an orifice in the LH<sub>2</sub> tank pressurization line, with maximum tank pressure controlled by the LH<sub>2</sub> vent valves. Except for the normal low pressure spike during start transient, the ullage pressure throughout the S-II boost period was controlled by the LH<sub>2</sub> vent valves within the 30.5 to 33 psia allowable band. LH<sub>2</sub> tank vent valve 1 opened at 177.0 seconds and remained open until 200.9 seconds. LH<sub>2</sub> tank vent valve 2 opened at 171.8 seconds and remained open until 560.7 seconds. The LH<sub>2</sub> ullage pressure was approximately one psi higher than the predicted pressure because the vent valves controlled the pressure in mid-cracking pressure range rather than the minimum crack level. This

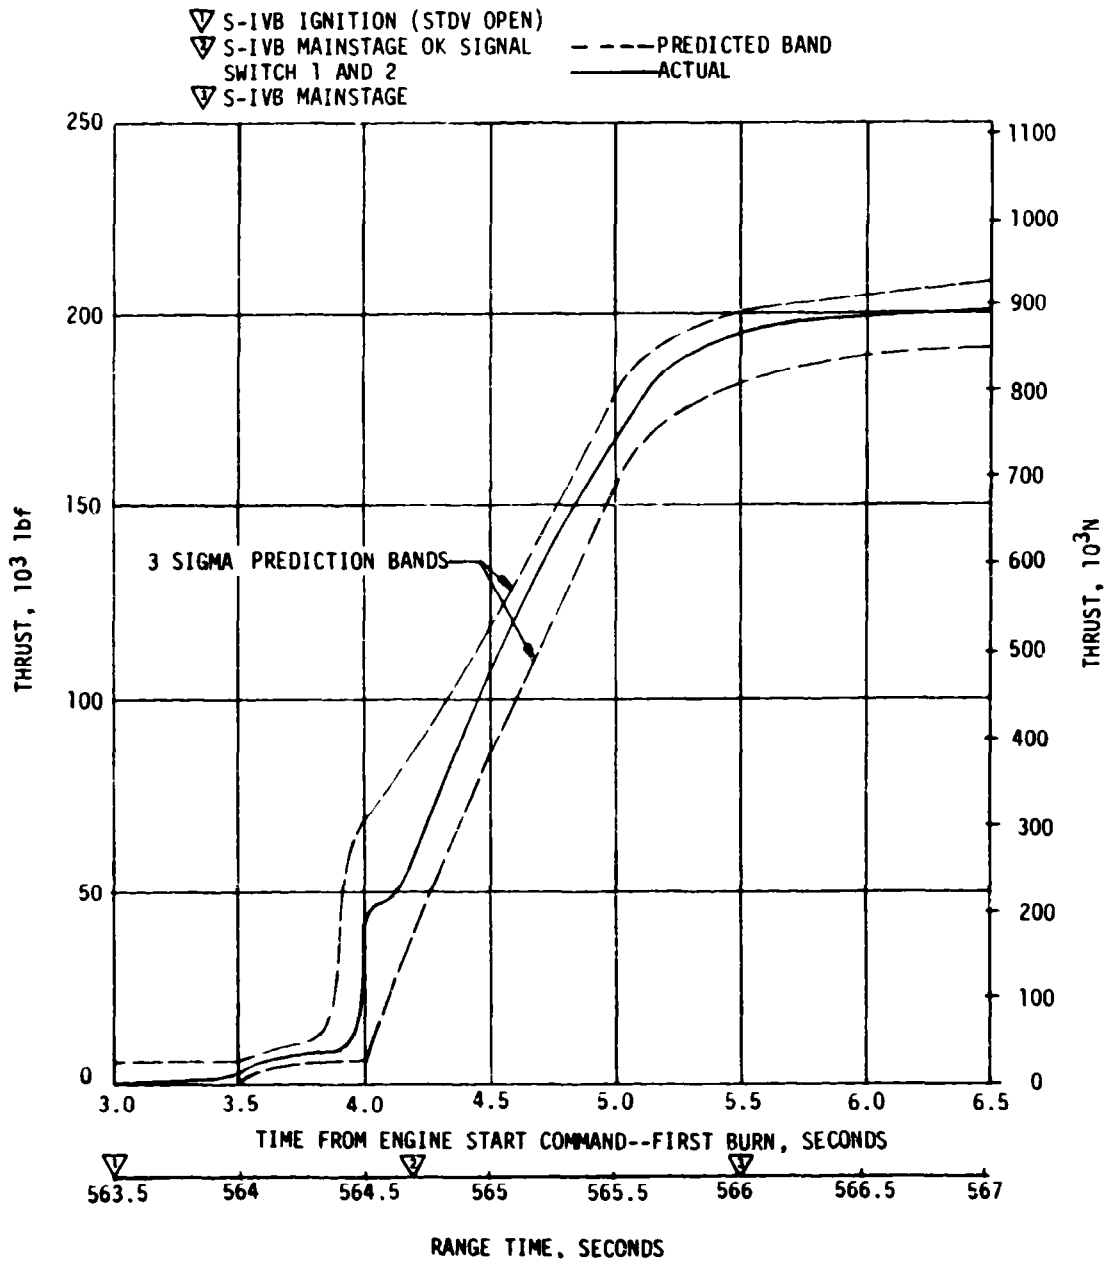
Figure 7-2. S-IVB Thrust Buildup Transient for First Burn

The first burn start transient was satisfactory, and the thrust buildup was within the limits set by the engine manufacturer. Thrust data during the start transient is presented in Figure 7-2. This buildup was similar

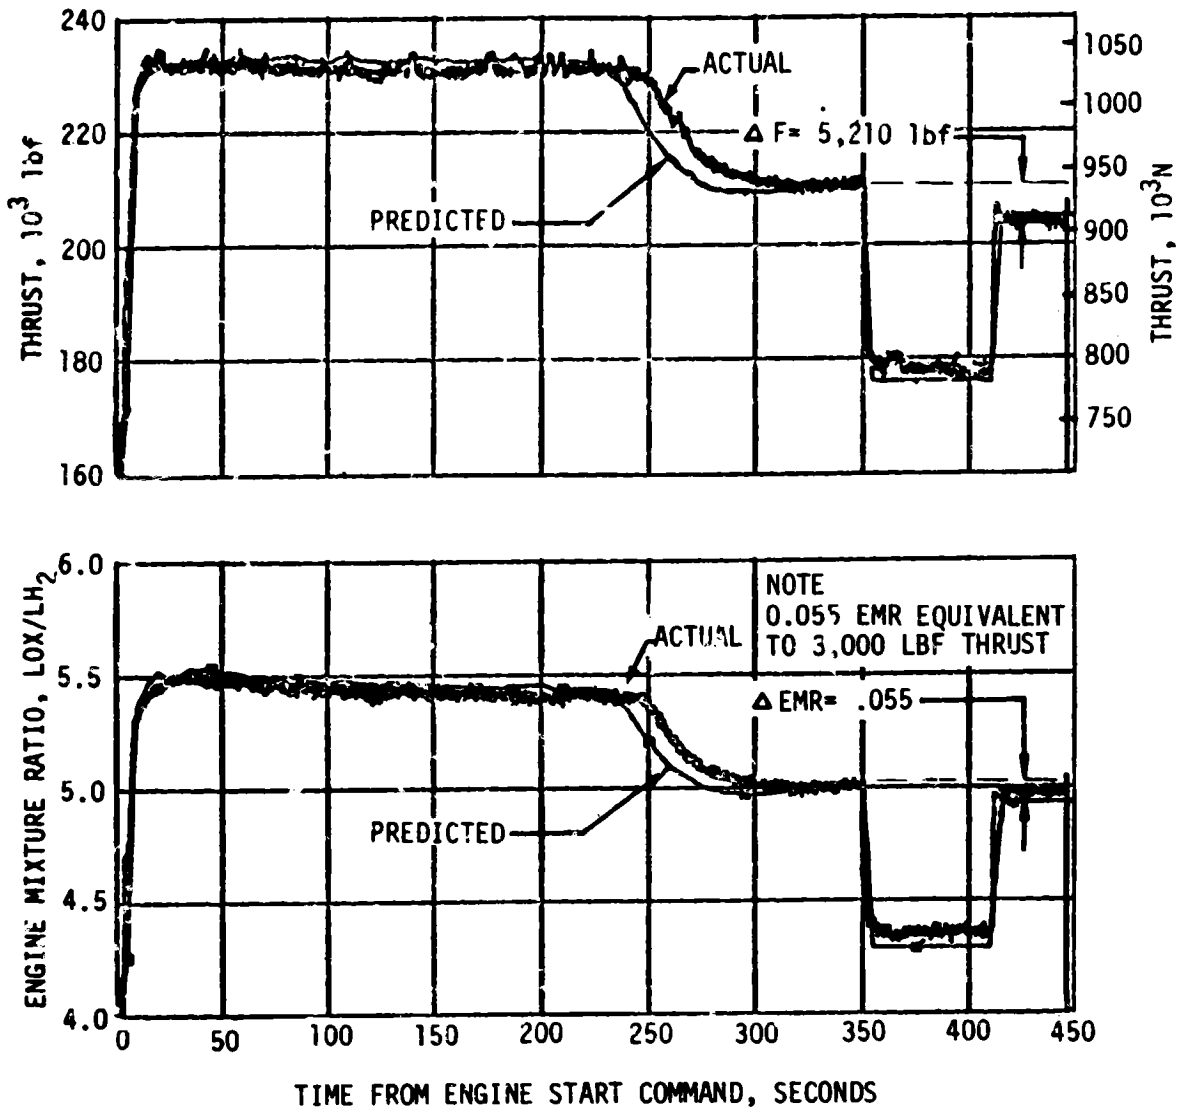
Figure 7-10. S-IVB Engine Steady State Performance During Stage Acceptance Test

- The AS-511 stage acceptance test data (Figure 7-10) after ESC + 420 seconds was used for the "old" 5.0 EMR flight prediction. However, further analysis indicated that a performance shift occurred at this time and that the performance level prior to the 4.5 EMR operation was more typical. Also, past flight data more nearly corresponds to the acceptance test 5.0 EMR level prior to operation at the 4.5 EMR level, therefore the earlier in-run data was used for the "new" 5.0 EMR flight prediction for AS-511.

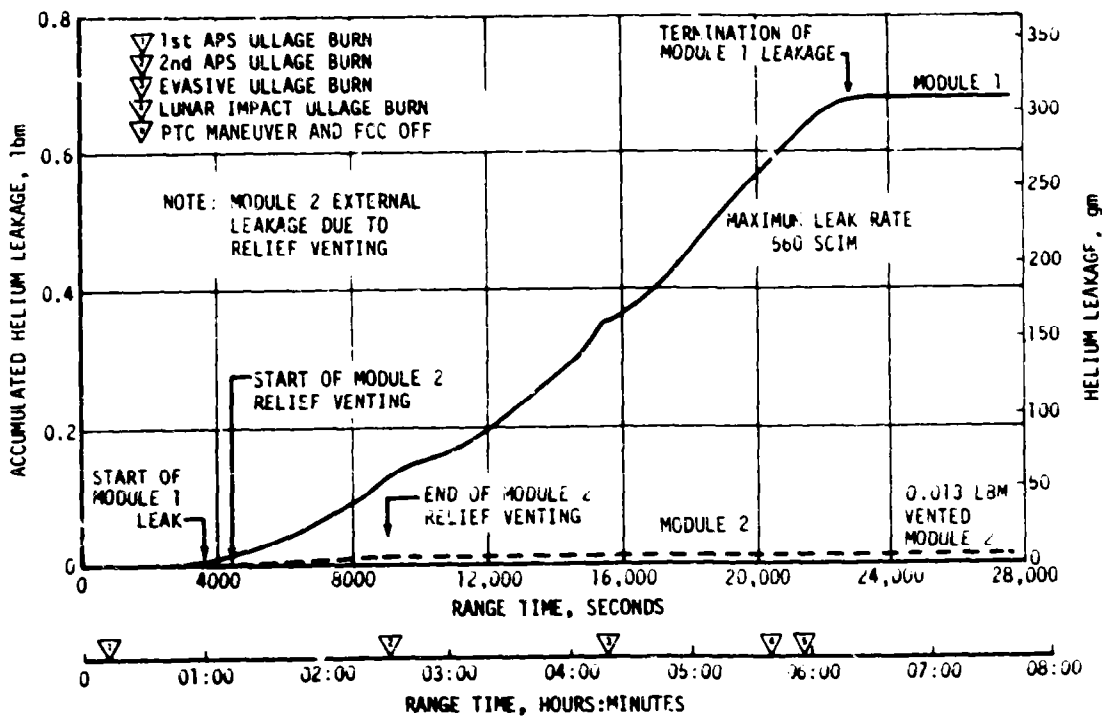
\*LEAKRATE WENT TO APPROXIMATELY ZERO  
 \*\*LEAKRATE CONTINUED TO LOSS OF SIGNAL

Figure 7-20. S-IVB APS Accumulated Helium Leakage for Modules 1 and 2

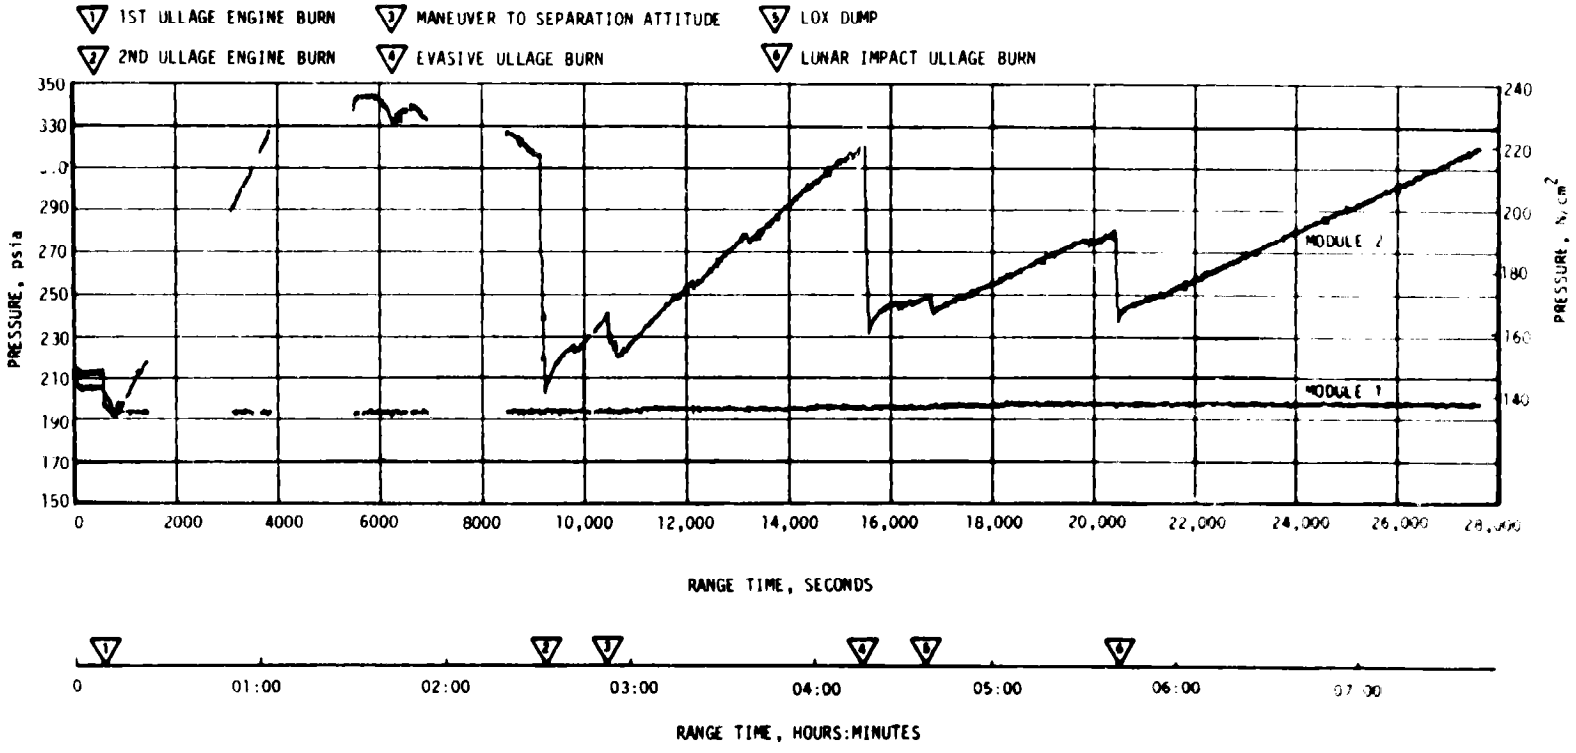
The internal Helium leakage from the high pressure side of the low pressure side of the APS Module 2 propellant pressurization system resulted in

Figure 7-21. APS Regulator Outlet Pressure

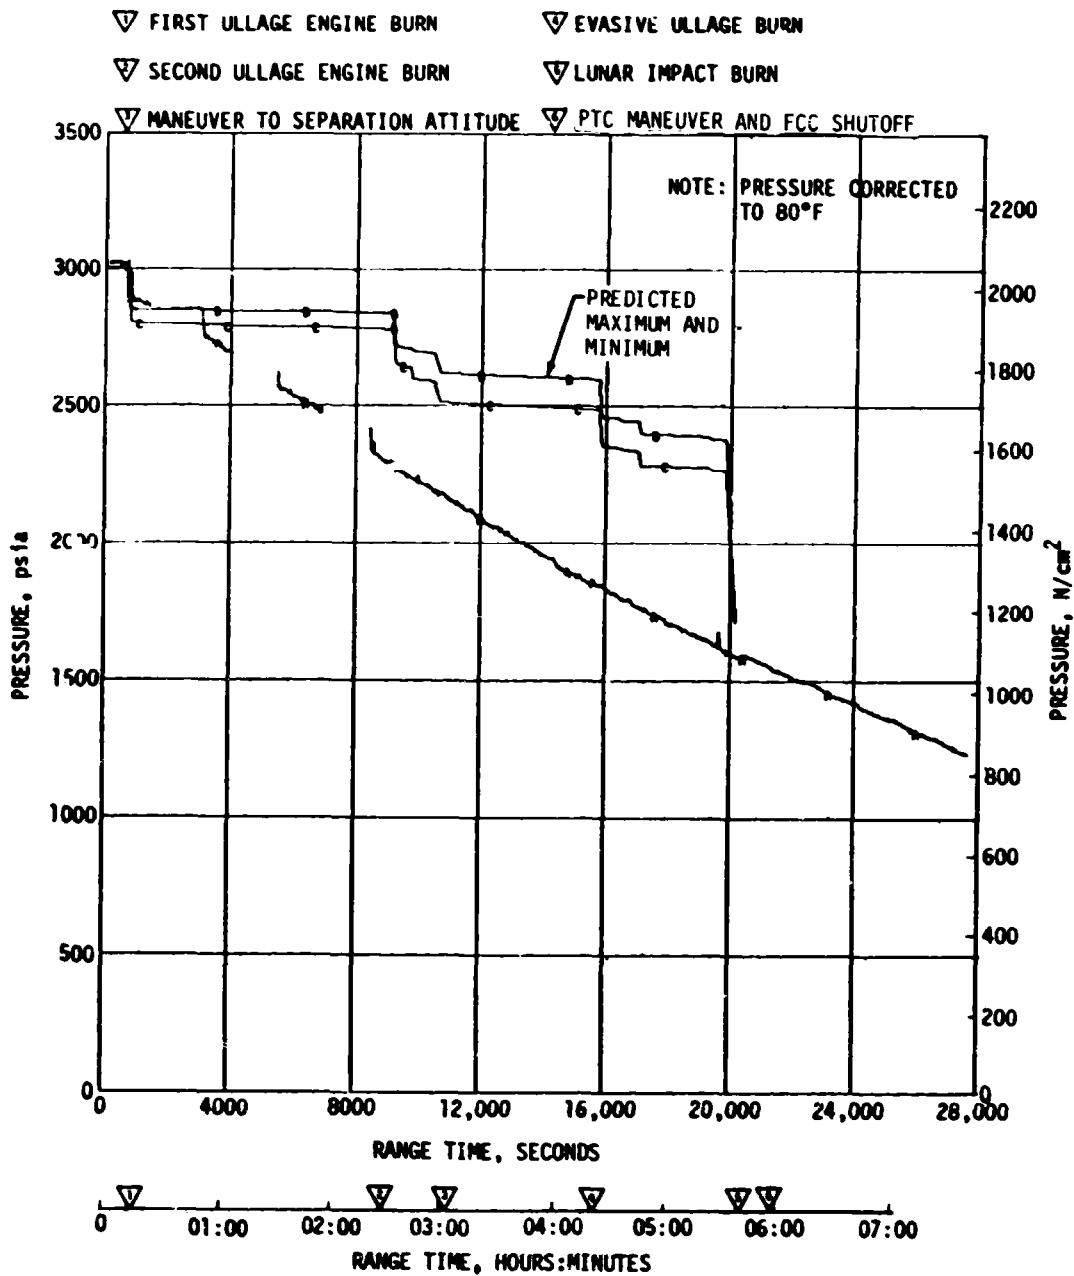
During the launch countdown while pressurizing the APS Module 2 helium sphere at approximately T-8.5 hours the pressure stabilized at 208 psia for approximately six seconds and gradually increased to 212 psia (Figure 7-26). During the same period the Module 1 pressure stabilized

Figure 7-23. APS Module 2 Supply Pressure

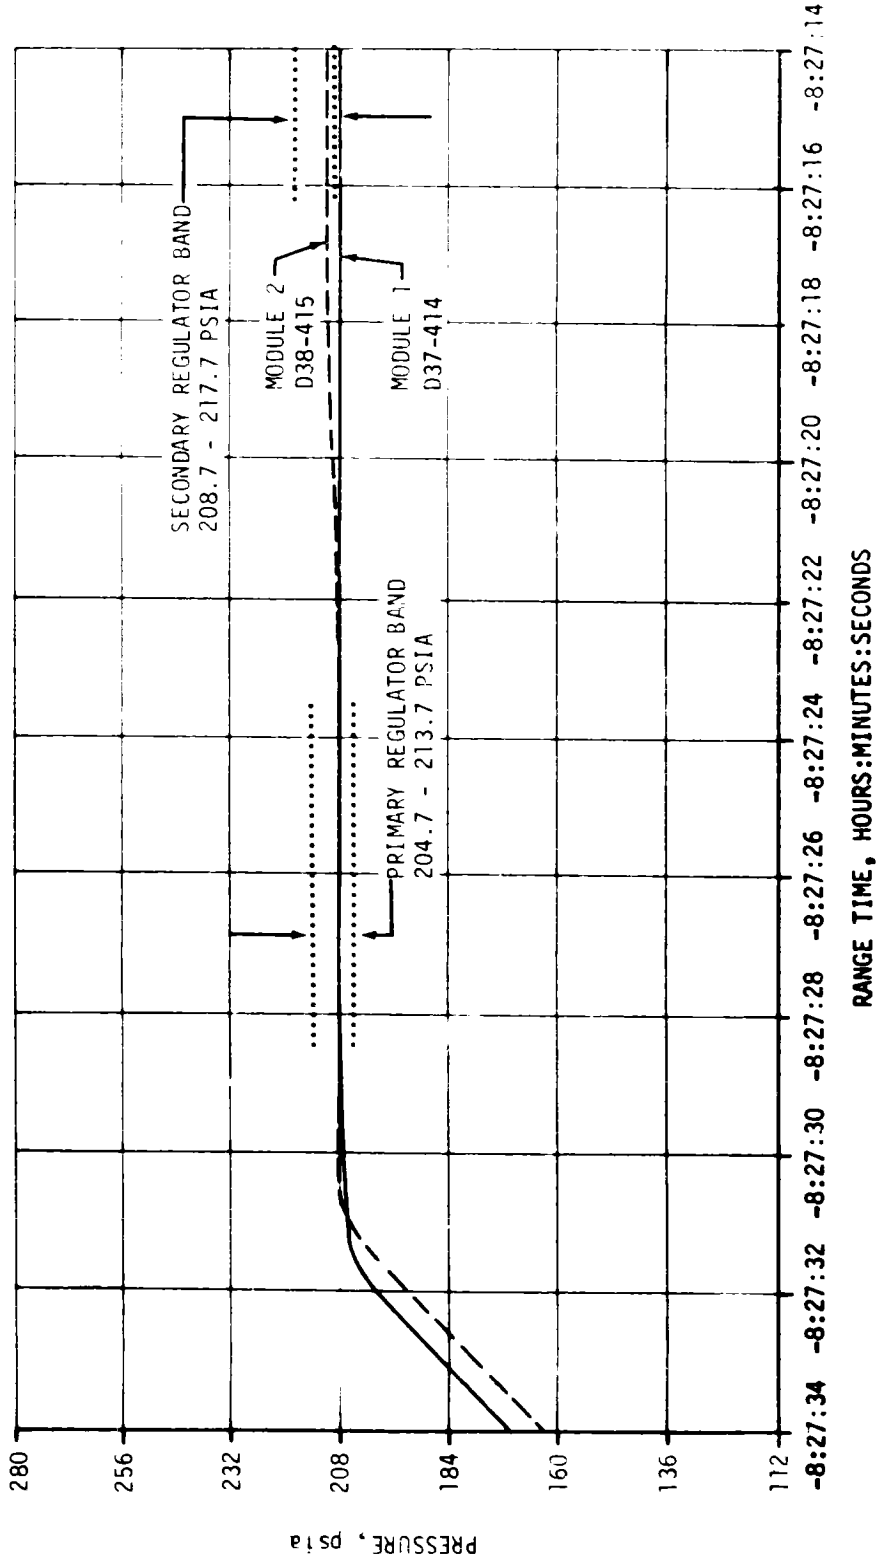
Figure 7-26. APS Helium Regulator Outlet Pressure During Pressurization

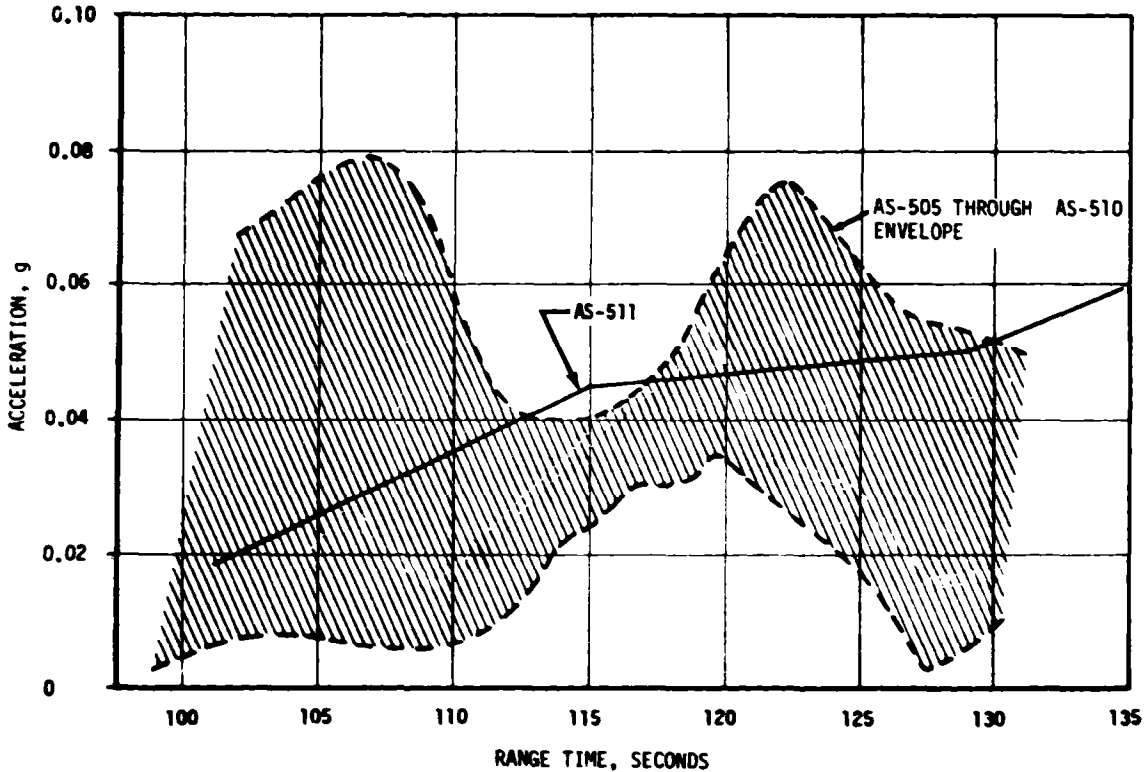
During S-IC stage boost, the significant vehicle response was the expected four to five hertz first longitudinal mode response. The low amplitude oscillations began at approximately 100 seconds and continued until S-IC CECCO. The peak amplitude measured in the IU was +0.06 g, the same as seen on AS-510 and AS-509, but occurred later in flight than previously seen. The AS-511 IU response during the oscillatory period is compared with previous flight data in Figure 8-4. Spectral analysis of engine chamber pressure measurements shows no detectable buildup of structural/propulsion coupled oscillations. POGO did not occur during S-IC boost.

Figure 8-4. IU Accelerometer Five Hertz Response During S-IC Burn (Longitudinal)

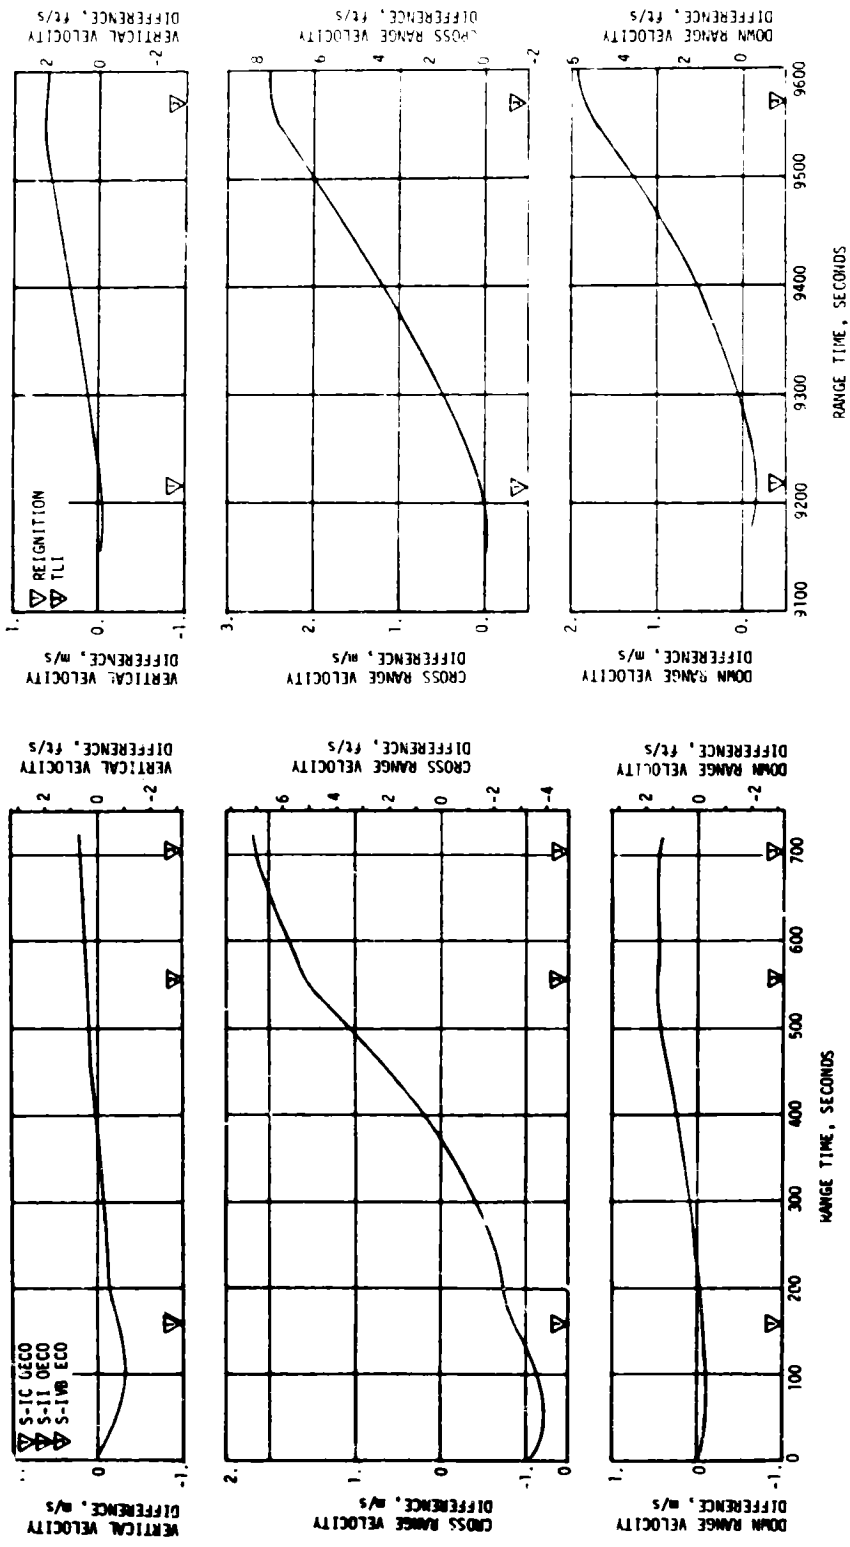
Figure 9-1. Trajectory and ST-124M Platform Velocity Comparisons, Boost-to-EPO (Trajectory Minus LVDC)

Platform velocity differences for the out-of-orbit burn mode are shown in Figure 9-2. At (T6-7.7 seconds), the platform velocity measurements were set to zero in the LVDC. The corresponding trajectory data were adjusted by the values at T6 for comparison with the LVDC outputs. The differences reflect a combination of hardware errors necessary to compute a trajectory initialized to a parking orbit state vector solution that would pass through a post Translunar Injection (TLI) state
