## Development of Channel Processes and the Need to Forecast Deformations of the Stryi Riverbed

### ABSTRACT

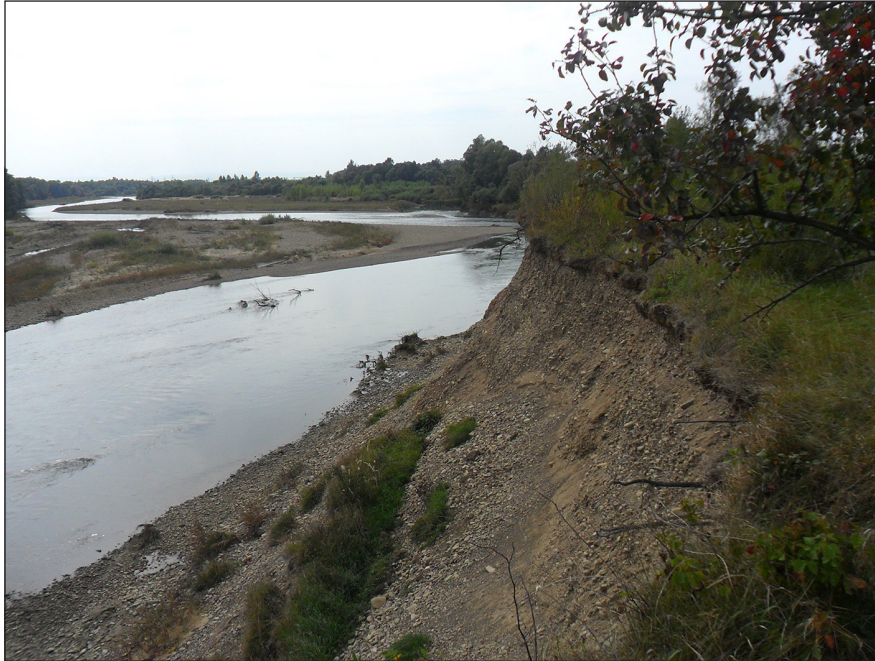
**Fig. 2.** Significant vertical deformations of the Stryi riverbed caused by the gravel-pebble mixture extraction and floods of the past periods

The maximum intensity of erosion is observed in such rivers as Rozhanka (near the village of Rozhanka, 45 mm/year), Slavska (near the town of Slavske, 35 mm/year) and Stryi (town of V. Snyovydne, 31.25 mm/year). Intensive lowering of the bottom of the Stryi riverbed due to regressive erosion was confirmed by the results of field research conducted in 1997–2010. And the same studies in 2010–2015 showed intense erosion and incision of channels in the river systems of Yablunka, Oryava and Opir (Mykhnovych and Pylypovych, 2017). The main reasons for the intensification of erosion processes in the basin of the Stryi River and its tributaries are the extraction of gravel from the riverbed near the town of Stryi and the increase in water runoff during floods, which is reflected in the longitudinal profiles of the analyzed rivers. This conclusion is also confirmed by the nature of the spread and development of vertical deformations in other river systems of the Ukrainian Carpathians (Fig. 2) (Kovalchuk et al., 2013).

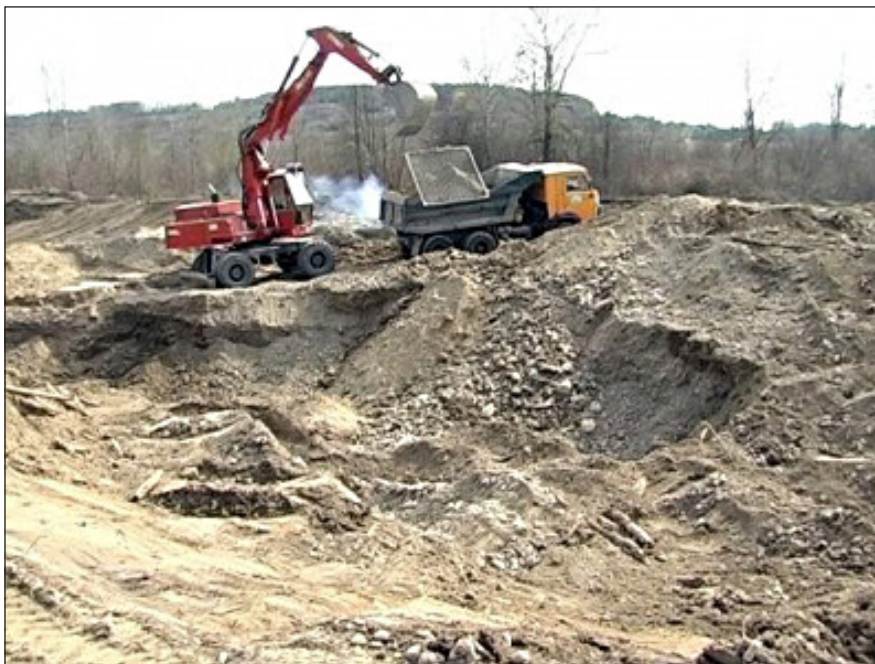
**Fig. 3.** Unauthorized quarrying in the Stryi riverbed (Snitynskyi et al., 2019)

Extraction of gravel and pebble material and straightening of riverbeds are characteristic of almost all river systems of the upper part of the Dniester basin. The presence of sand-gravel mixtures on the channel territory encourages their extraction, which is often unauthorized, which causes deformation processes of the riverbed and its banks (Fig. 3). Soils that are light in mechanical composition are eroded, especially during floods. This causes the development of erosion processes in the riverbeds and adjacent areas (Snitynskyi et al., 2019).
