# MDPCT1 quench data and performance analysis

**Abstract**—MDPCT1 is a four-layer cos-theta Nb<sub>3</sub>Sn dipole demonstrator developed and tested at FNAL in the framework of the U.S. Magnet Development Program. The magnet reached record fields for accelerator magnets of 14.1 T at 4.5 K in the first test and 14.5 T at 1.9 K in the second test and then showed large degradation. While its inner coils performed exceptionally well with only two quenches up to 14.5 T and no evidence of degradation, the outer coils degraded over the course of testing. By adopting new measurement and analysis techniques at FNAL we are discussing in detail what happened. Both success and failure in our diagnostics are discussed. The evolution of techniques over the course of two tests (and three thermal cycles) shows the path to address challenges brought by the first four-layer magnet tested at FNAL. This paper presents the analysis of quench data along with diagnostic features and complementary measurements taken in support of the magnet performance analysis.

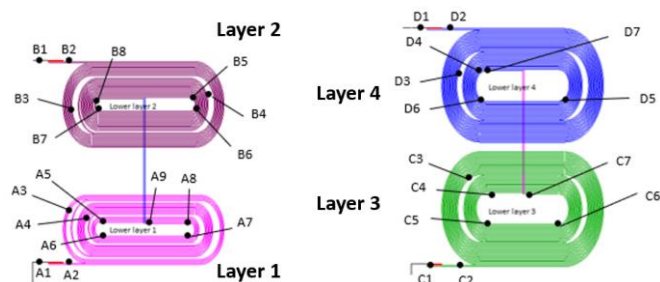
Fig. 1. Voltage Tap (VT) schematics in the “15 T” magnet. Inner coils 2 and 3 form layers 1 (A) and 2 (B), and outer coils 4 and 5 form layers 3 (C) and 4 (D). Readout is based on pairs of VTs (e.g., 5c6\_c7 is a segment in coil 5 made of VTs c6 and c7). The lead end (LE) is on the left of the figures.

The primary source of information for the quench analysis was voltage taps (VT) and their sequential segments. The VT schematics used in MDPCT1 is shown in Fig. 1. While most of the VT on the outer layers 3 and 4 became non-responsive early in the initial testing (first test), all but one were recovered for MDPCT1b. In addition, two types of quench antennas provided flux-change information: one inside the warm bore with seven axially placed elements [6] and another based on flexible Printed Circuit Board technology, flex-QA [7], with 2 x 6 sensors attached to the outer surface of the warm bore tube (opposite azimuthal locations), Fig 2. Two temperature sensors were also installed on the poles of the innermost layers, close to the magnet lead end. All those data were taken up to 1 s before quench detection at ~ 8 kHz acquisition rate.

Most of the VT readout traces of the outer coils, 4 and 5, were cut in the initial MDPCT1 testing and we only know that quenches happened in layers 3 and 4 (the same as C and D, Fig. 1), in both coils, in roughly the same proportion. Better location information proved to be unreliable. After repairs, MDPCT1b had fully functional VT taps and we had excellent coverage for quenches. While both coils were training similarly in the first test [5], [10], in MDPCT1b it was coil 5 limiting the performance (Fig. 3). We identified three quench signatures characterizing most of the quenches, Fig. 5.

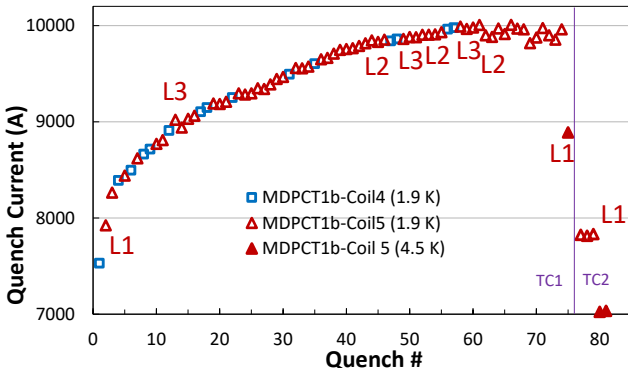
Fig. 3. MDPCT1b training, including different temperatures and thermal cycles. “L\*” indicate first occurrences for different quench locations (see later).

Both outer coils underperformed, with their performance affected by the initial imperfect end support and possibly design [10]. The training curve of MDPCT1b is shown in Fig. 3. The limiting outer coil reached ~74% of its SSL, both at 1.9 K and 4.5 K, and earlier both outer coils started training at 56-58% SSL. After reaching its record field in MDPCT1b, magnet quenching became erratic with signs of degradation. Temperature dependence studies clearly showed degradation with respect to the first magnet test [5] with nearly 10% lower current (field) at 4.5 K. This was followed by additional sudden 20% degradation after a thermal cycle [5] with reproducible and

nearly identical currents as fractions of SSL at 1.9 K and 4.5 K. Virtually all features observed pertained to one of the outer coils – coil 5 (Fig. 3).

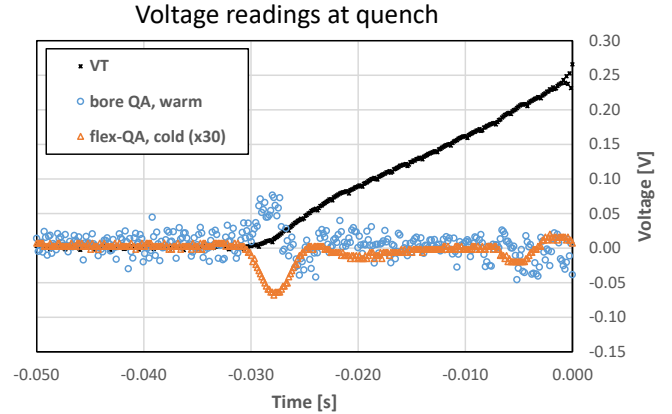
Fig. 4. The second (last) quench in the inner coil: Earliest segment/section of VTs and QAs responding to quench development, quench detection is at 0 s.

Fig. 4 shows the inner layer quench signatures in the first sensing elements. Both QA gave prompt response to quenches. As seen, the flex-QA also demonstrated excellent signal-to-noise ratio [7]. Having multiple sensors, we were able to determine the quench location and propagation velocity. The location, at the innermost turn, three cm from VT A7 towards the straight section, was consistent between VTs and QA. Quench propagation, based on VT, was 23 m/s.

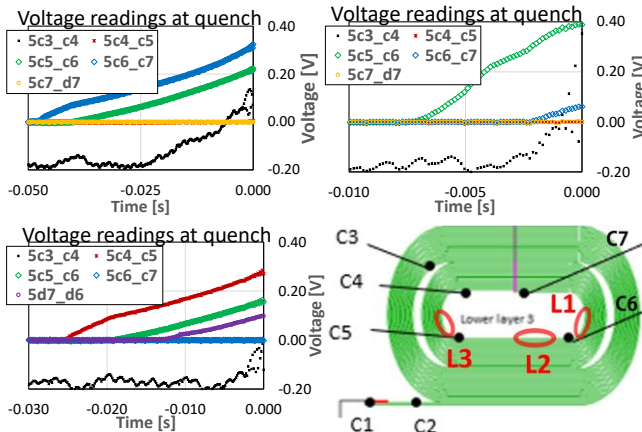
Fig. 5. Voltage segment patterns in MDPCT1b – those three signatures describe most of the quenches. Approximate locations were extracted based on arrival time differences and lack of adjacent activity. From left to right and to bottom: locations/patterns shown are numbered L1, L2 and L3. The figure on lower right shows the quench locations in the coil.

For all but few quenches we identified quench location to within ~20 cm along the conductor length (some quenches developed in two layers). Coil 5 started quenching in the location L1 at the non-lead end and was followed by different quench-

es, with location L3 at the lead-end becoming persistent soon after, Fig. 5 and Fig. 3. Only after 45 quenches the straight section location L2 became active and dominating with increasingly intermittent quenches at L3. Quenches with “erratic” behavior were at location L2. Higher temperature and ramp rate quenches observed after training quenches and all quenches in TC2 happened in the non-lead end location L1. L1 and L2 locations are around the area where the straight and the end sections meet, on one side of the magnet. Most quenches occurred on the same coil side, Fig. 5. About 65% of all MDPCT1b magnet training quenches were in those three locations, and the last quench of different origin and signature in coil 5 was quench 55. During training in TC1, excluding different temperature and ramp rate quenches, there were 28 L3 type quenches, 20 L2 quenches and 3 L1 quenches.

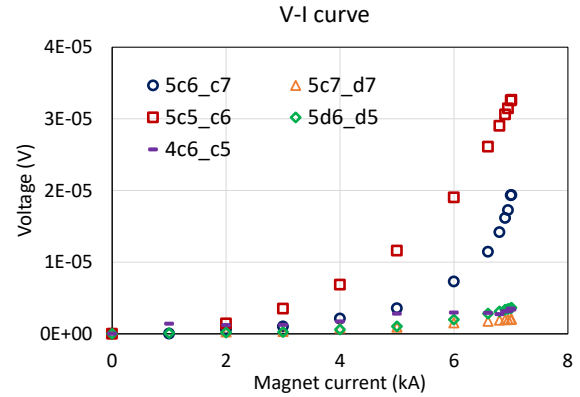
Fig. 6. V-I characteristics of VT segments with developing resistance. At highest currents 5c6\_c7 gives 35  $\mu\text{V}/\text{A}$  differential increase. The uncertainty on measurement points (RMS over 25 s interval) for the most affected short segments is 30-60 nV.

At the end of MDPCT1b testing, we performed dedicated low-noise V-I measurements extracting information about resistive behavior of the weakest VT segment near quench current and behavior of most VT segments at various currents. Results are presented in Fig. 6. We show signals with abnormal behavior and the two most significant ones belong to the segments where spontaneous quenches occur. They develop resistance practically immediately after current start ramping which suggests degradation is likely associated with many strands. As seen on the figure, coil 4 was also showing similar though much less extreme behavior in the same segment(s) with an order of magnitude smaller voltage rate increase vs. current. Some short segments around the affected ones which we were able to measure showed similar trends. The long segments covering outer parts of the layers were too noisy to produce any discernable signal below micro-volt level. No resistance developed in the short inner coil segments.

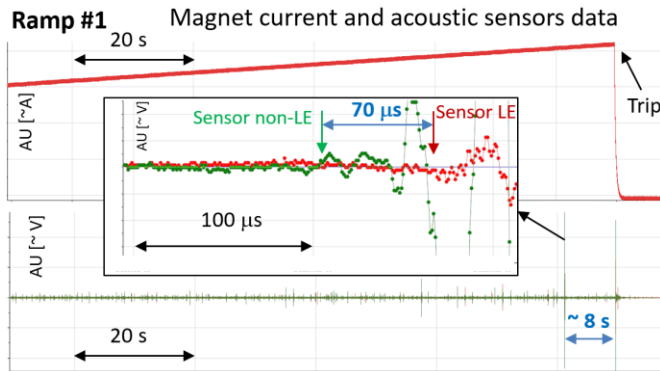
Fig. 7. Current profile for Ramp 1 in TC2 of MDPCT1b (top), acoustic measurements (bottom) at the same timescale and measurements around the beginning of the large spike  $\sim 8$  s before the trip (inset). Y-axes employ arbitrary units (AU), but the large event nearly saturated our DAQ (5 V).

The first ramp of TC2 of MDPCT1b ended with a trip associated to a drop in liquid helium levels at the magnet top due to parallel cryogenic activities. However, a very large mechanical event was detected 8 s before the trip, Fig. 7. This was a unique event.

The time difference  $\Delta t$  between the start of signals from the two acoustic sensors can be determined from Fig. 7 with some uncertainty. The distance  $L$  between sensors is known (105 cm) and the velocity ( $v$ ) of sound large uncertainty is predominantly coming from assumptions about the type of wave propagating (2.5-5 km/s for the solids in the magnet). Then, one can estimate the location of the mechanical event, assuming a point source, as  $f_L = [1 - \Delta t (v/L)]/2$ ,  $f_L$  being the fractional length along the magnet axis where the origin of mechanical disturbance is.

We find the location of the event within about 15 cm along the magnet and it is consistent with the area of the limiting quench locations. However, later examinations of the coil and the magnet did not produce any visual evidence of the large mechanical event observed – no breaking, scratches or other abnormal signs were discovered at any part of the magnet. Thus, we do not have an explanation of what might have caused this disturbance. X-ray/CT-scan photography is the next assessment tool we are planning to use investigating the limiting coil.

What this large event showed is that longitudinal precision of acoustic event detection can be very good even with many unknowns about parameters of the mechanical wave. It also demonstrated that determination of start of signal can be complicated without additional processing, Fig. 7. It is much more difficult to do the assessment we did with an order of magnitude lower signals, i.e. typical events seen.
