Nondestructive testing of high strength conductors for high field pulsed magnets

Jun Lu, Todd Adkins, Iain Dixon (senior IEEE member), Doan Nguyen and Ke Han

In this paper, we present results of our non-destructive testing (NDT) inspection of Glidcop AL60 wires using eddy current testing (ECT), ultrasonic testing (UT) and x-ray radiography (2D and 3D). Chevron cracks were found in some AL60 conductors by all three NDT techniques. Surface inclusions were found by ECT. We have developed a long length ECT wire inspection capability.

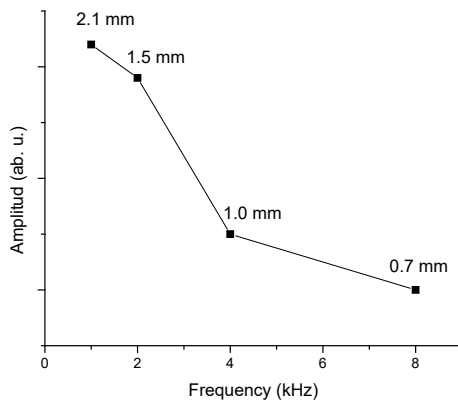
Fig. 1 ECT flaw signal amplitude versus frequency for a hole of 2 mm diameter and 1.2 mm below the surface of an AL60 wire. The eddy current penetration depths in mm are labelled for each frequency. The solid line is a guide to the eye.

An experiment was designed to confirm the skin effect in AL60 wire. A hole of 2 mm diameter and 1.2 mm below the front surface was drilled from the backside of a 5.2 mm thick AL60 wire. The 0.44" diameter 500 Hz – 40 kHz spot probe was used. Fig. 2 shows the ECT signal of the hole as a function of operating frequency. Evidently, the signal decreases with increasing frequency which corresponds to decreasing eddy current penetration depth. It is significantly smaller when the penetration frequency is smaller than the depth of the hole of 1.2 mm.

Most commercial ECT probes operates above or at 100 Hz. At this frequency, penetration depth for copper is about 6.6 mm. This seems to be the penetration limit of ECT for our application. On the other hand, frequency dependence of eddy current penetration can be used to estimate the depth of a flaw. As indicated in Fig. 1, it can be estimated that the flaw is deeper than 1 mm. Our experiments also showed that lateral spatial resolution of ECT is in the order of millimeters, and it is difficult to estimate the size and shape of a flaw. In spite of these limitations, it seems to be possible to develop a criterion based on the amplitude of the flaw signal and use it to accept or reject wires.

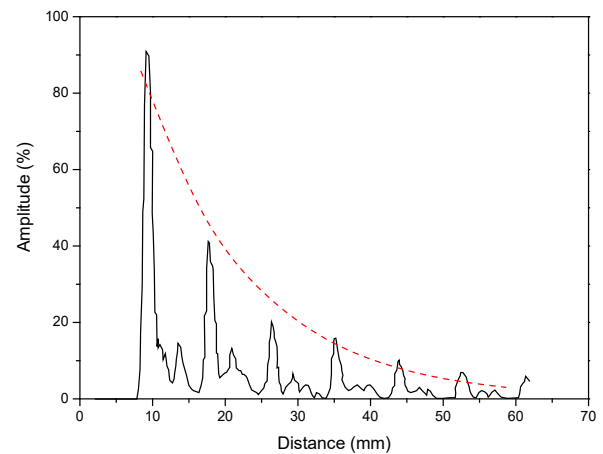
Fig. 2. UT echo amplitude versus distance (A-scan) of an 8.4 mm thick AL60 wire. The peaks are multiple back well reflections. The distance between peaks is 8.4 mm. The dashed line is an exponential function with a characteristic length of 15 mm.

UT generates ultrasonic waves and uses the reflection of ultrasonic waves to detect a flaw. High frequency ultrasound provide better spatial resolution at a cost of reduced penetration depth due to the sound wave attenuation in the material. The ultrasonic wave attenuation in AL60 was measured by an echo amplitude vs. time (A-scan) of an 8.4 mm thick wire which showed multiple back wall reflections. As shown in Fig. 2, the back wall reflection amplitudes decay with distance. This decay is consistent with an exponential decay function with a characteristic length of about 15 mm (the dashed line). It shows that UT can easily penetrate 20 mm of AL60 material with the ultrasonic power used in that experiment. This is adequate for inspection of our AL60 wires and precursor rods.

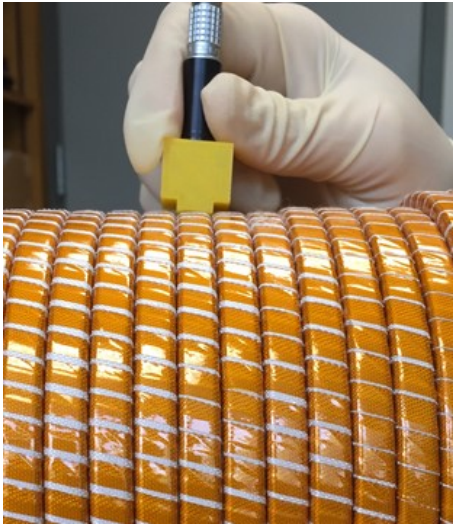
Fig. 3. ECT inspection of surface cracks during an AL60 coil winding. An Olympus 0.125" diameter 50 – 199 kHz surface probe was used.

Fig. 3 depicts the ECT inspection during a coil winding. High frequency probe up to 199 kHz was used for high surface sensitivity. The corresponding penetration depth is 0.15 mm. The outer surface of entire wire was successfully inspected as the wire was wound into a coil. No cracks were found.

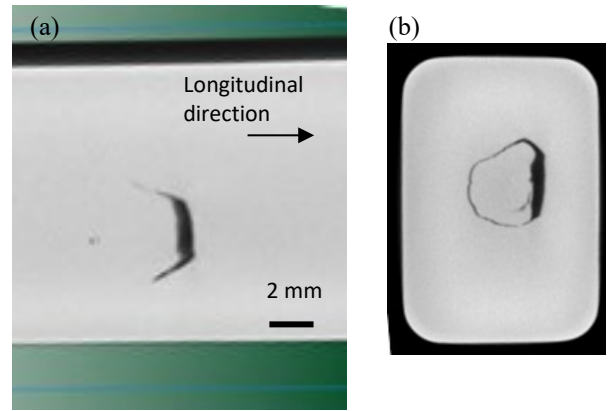
Fig. 4. X-ray computed tomography (CT) results of a large chevron crack in an $8.4 \times 12.3 \text{ mm}^2$ AL60 wire. (a) longitudinal slice of the CT data. (b) transverse cross-section slice of the CT data.

In order to systematically study the chevron cracks, a wire of 40 cm long $8.4 \times 12.3 \text{ mm}^2$ cross-section were sent to Delphi Precision Imaging Inc. for x-ray inspections. This wire has a possible chevron crack as indicated by a very shallow dent on the surface. Indeed, x-ray 2D and CT scans revealed a large chevron cracks as shown in Fig. 4. Two additional chevron cracks with no surface indications were also found, as labeled A and B in Fig. 5. This sample with known chevron cracks identified by x-ray were subsequently used as a reference sample for ECT and UT studies.

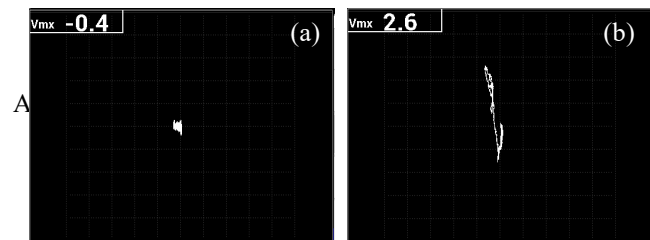
Fig. 6. ECT signal of (a) flaw A and (b) flaw B at 500 Hz.

ECT was performed on both flaw A and B at 500 Hz. The results are shown in Fig. 6. There was no significant ECT signal from the small flaw A (Fig. 6(a)). This is likely due to its smaller size. Because the minimum depth of this flaw is greater than the penetration depth of 2.95 mm at 500 Hz. In contrast, the minimum depth of the much larger flaw B is less than 2.95 mm. Therefore a significant ECT signal was observed as shown in Fig. 6(b). These results are qualitatively in agreement with x-ray images.

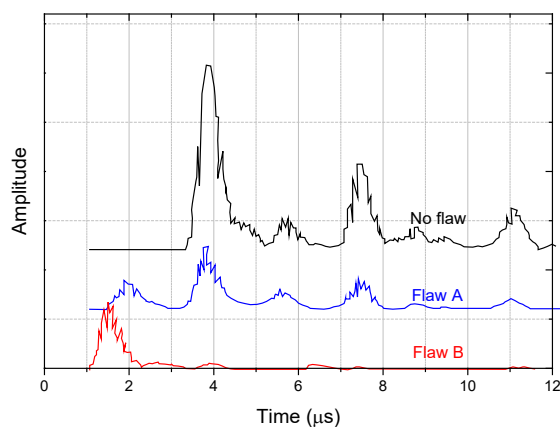
Fig. 7. UT A-scan of the two flaws shown in Fig. 5.

UT A-scan was also performed on flaws A and B of the same sample. A-scan traces from regions with flaw A and B are shown in Fig. 7 together with a trace on a no-flaw region as a reference. The trace of no-flaw region shows only reflections from back wall. In comparison, the trace of flaw A region has significantly reduced back wall reflections, and a broad peak appears at about half the time of the first back wall reflection, indicating a reflection from flaw A, which is near the center of the wire in depth. In the trace of flaw B, the back wall reflection is very small. A peak on the left of the flaw A reflection indicates that the top of the flaw is further close to the surface.

Data in Fig. 7 demonstrates that an internal flaw can be detected by the reduction of back wall reflection as well as the appearance of a feature before the first wall reflection. The fact that flaw A could be clearly detected by UT but not by ECT demonstrates that UT has significantly greater depth penetration compared with ECT. The results of this UT experiment on flaw A and B are consistent with the x-ray results in Fig. 5.

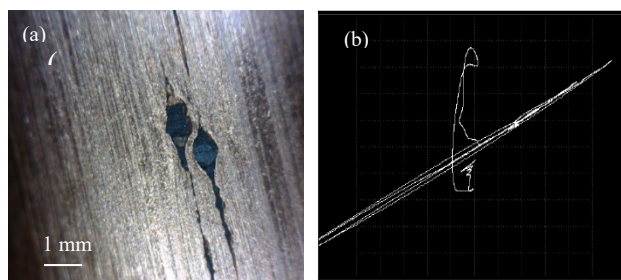
Fig. 8. Inspection of surface inclusions on an AL60 wire (a) a picture of two inclusions and (b) the corresponding ECT signal.

Another type of flaws often found by ECT is the surface inclusions (Fig. 8(a)). Most of these inclusions have similar surface appearance as the wire, are difficult to distinguish by visual inspection. Our tensile fatigue tests showed that inclusions of > 0.5 mm in depth can cause significant reduction in wire's fatigue life. So it is necessary to inspect the wire for surface inclusions by NDT. ECT has been proven to be very effective. Fig. 8(b) shows an ECT trace of an inclusion. Both chemical analysis and magnetic imaging have determined that the inclusion is ferromagnetic. This explains the ability of finding very small inclusions by ECT.

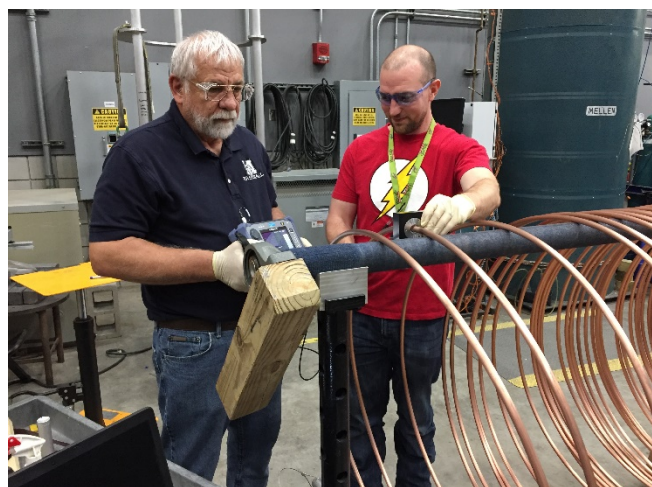
Fig. 9. ECT inspection of 13.7 mm diameter Glidcop AL60 precursor (about 100 m long). The encircling probe with frequency range of 100 -500 MHz was used.

By the time of writing this paper, we have inspected a few hundreds of meters of AL60 wires and identified a number of surface inclusions. Fig. 9 shows ECT surface inspection of an about 100 m long 13.7 mm diameter AL60 precursor rod. An encircling probe of 20.8 mm inner diameter 100 – 500 kHz was used. A plastic adaptor was made to fit the 13.7 mm diameter rod being inspected.
