DOE/NASA CONTRACTOR
REPORT

DOE/NASA CR-161340

PROTOTYPE SOLAR HEATING AND COMBINED HEATING AND COOLING SYSTEMS (Quarterly Report No. 9)

General Electric Company Space Division Post Office Box 8661 Philadelphia, Pennsylvania 19101

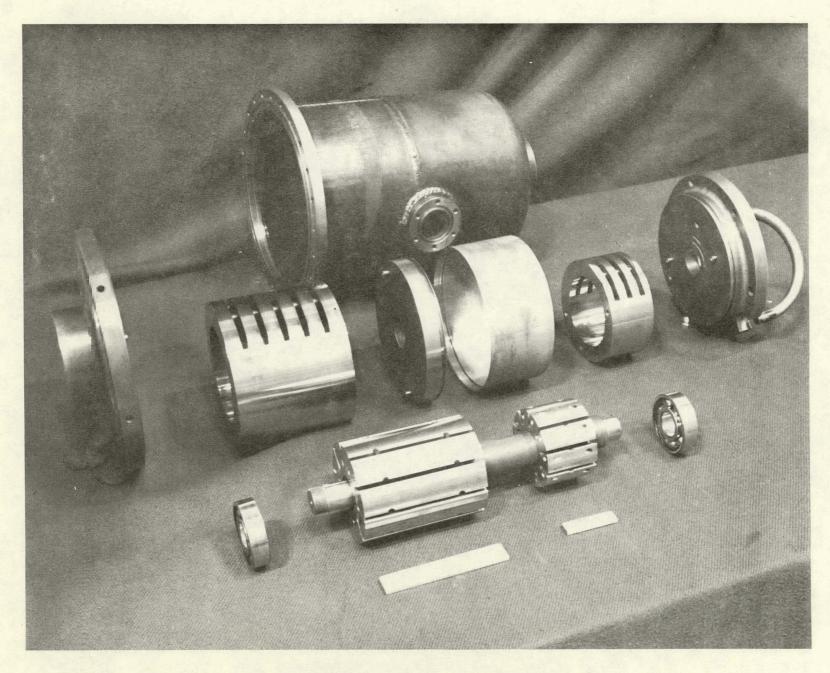
FIGURE 4-3. REH-30 TWO-STAGE EXPANDER

Inspection of the expander after disassembly indicated slight vane damage due to foreign debris, and slight interference rubbing of the first stage rotor. Evidence of insufficient first stage lubrication was indicated. Expander and test facility modificaions are being made for the resumption of testing. Figure 4-3 shows the major components of the REH-30 two-stage expander.

FC-88/Krytox 143AD oil as the working fluid. Test results were generally good with the exception of expander efficiency. During a seven hour testing period, expander speed covered the range of 0 to 2200 rpm. Maximum vapor temperature and pressure into the expander was 285°F and 210 psia respectively, at design vapor flowrate of 1094 lb/hr. While the inlet temperature was 5°F below design point, pressure was 10 psi above design point. Output power was below design point since internal expander clearances and expander lubrication techniques were not optimized. Vane pressure balancing, noise level, and low speed torque characteristics were satisfactory.

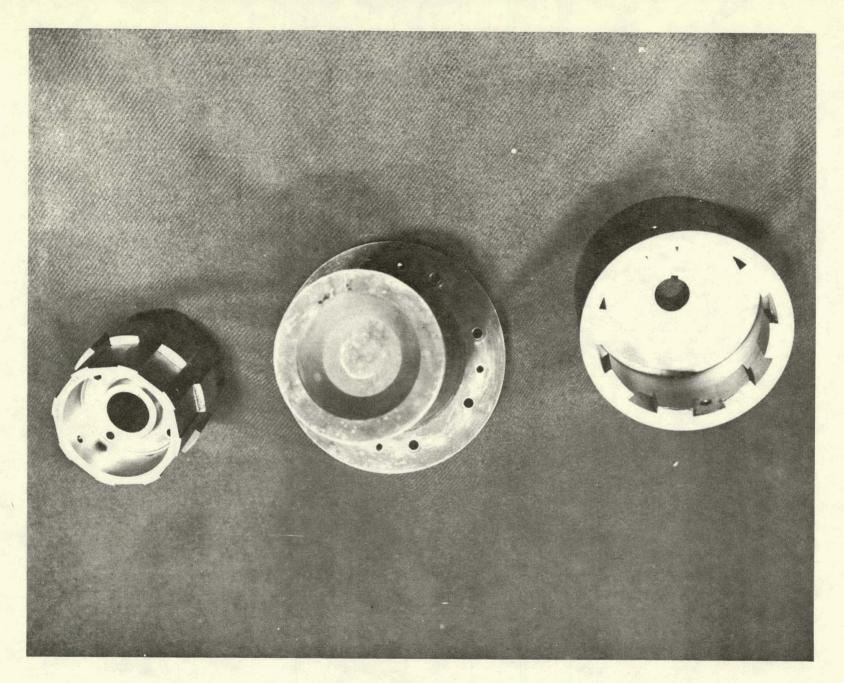
FIGURE 4-4. REH-30 MAGNETIC DRIVE

The over-running clutches, magnetic drives and Inconel 718 drive partitions for the REH-30 and REH-100 have been received. Testing of the REH-30 magnetic drive at room temperature and at 190°F has been completed. Static testing and dynamic testing up to 2200 rpm has been completed for the REH-30 magnetic drive. Test results show a magnetic drive efficiency of 99% and a 22% safety factor on torque capacity at design point conditions. Testing of the REH-100 magnetic drive is planned for next quarter. Figure 4-4 shows the key components of the REH-30 magnetic drive, and Figure 4-5 shows the magnetic drive on test.

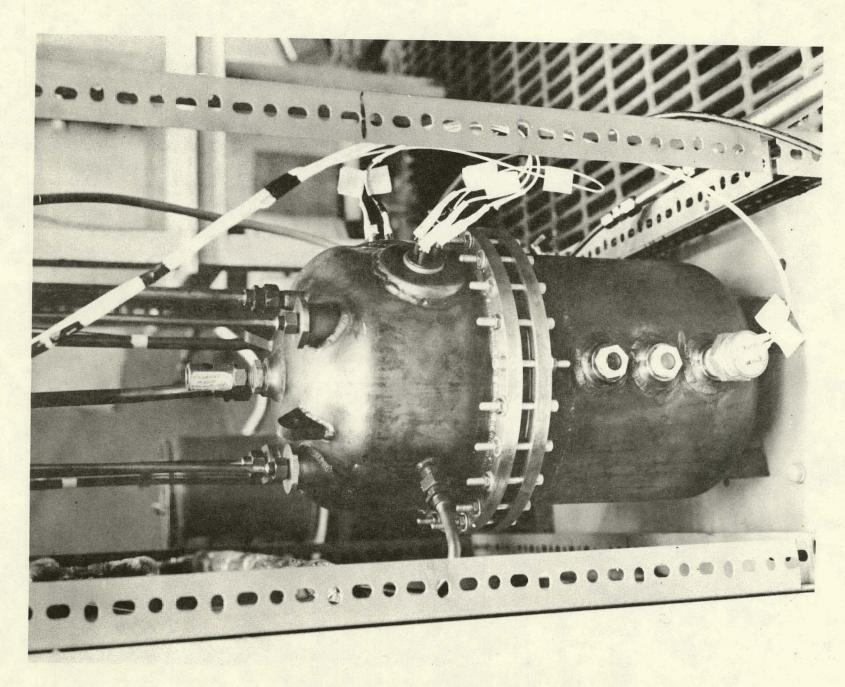
FIGURE 4-6. REH-30 FEED PUMP ON TEST

for power consumption, performance of the pump has been satisfactory. As of FW-39, 800 hours of time have been accumulated with the last build-up accounting for over 600 hours of continuous running. During this brief endurance, there has been no loss of volumetric efficiency. At the present time, the power input is 400 watts as compared to a goal of 254 watts at design flowrate and pressure rise. Pump components (thurst bearing) are being modified to reduce the input power level. These components will be tested early next quarter. Figure 4-6 shows the REH-30 pump on test.

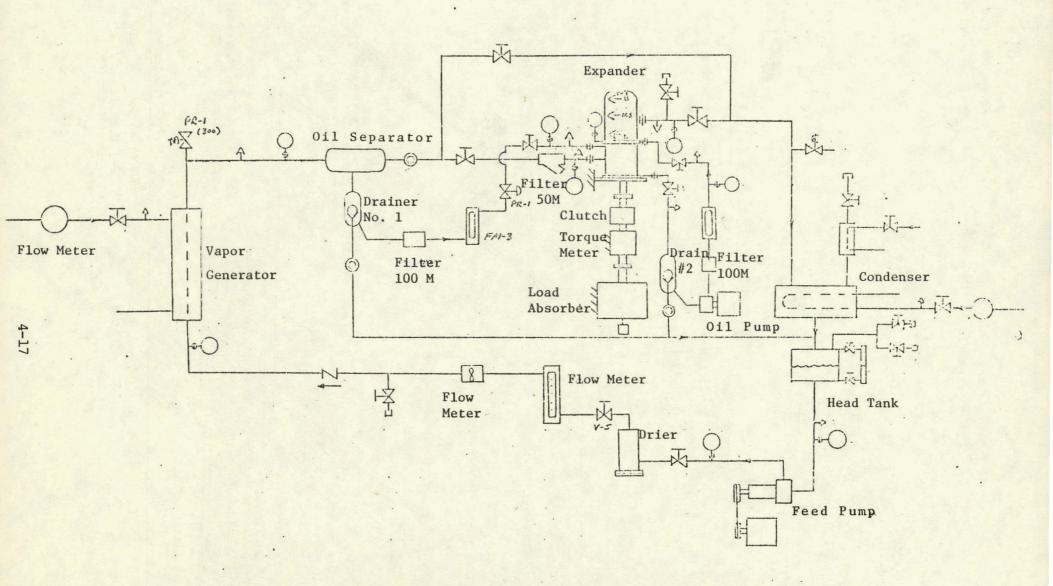
FIGURE 4-8. SCHEMATIC FOR TEST FACILITY FC-88, TWO STAGE EXPANDER

The 3-ton "B" test loop facility is now fully operational. The facility is capable of testing the new two-stage expander using FC-88 as the working fluid and Krytox oil as the lubricant. Higher temperature water is available at the vapor generator, $320^{\circ}F$ as compared to $295^{\circ}F$ previously. Higher range temperature and pressure sensors were installed to be compatable with the new operating conditions. Figure 4-7 is a schematic representation of the expander test facility.

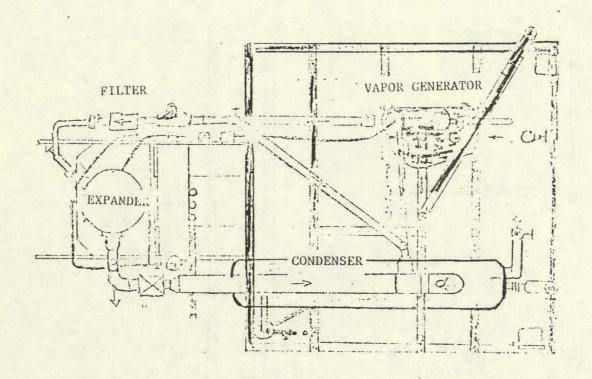
FIGURE 4-10. 10 TON EXPANDER FACILITY

The design effort is well underway for upgrading to 10-ton expander test facility. Figures 4-8 thru 4-12 depict the components, interconnecting piping, valves, flow meters, torque meter and support stand for the 10-ton expander. The shaded areas presently exist and the unshaded area represent new piping, components, sensors etc. It is planned to complete the test facility modifications during the 4th Quarter 1978.
