THE PLATELET MECHANISM OF EROSION OF DUCTILE METALS

Submitted to Wear

A.V. Levy

May 1984

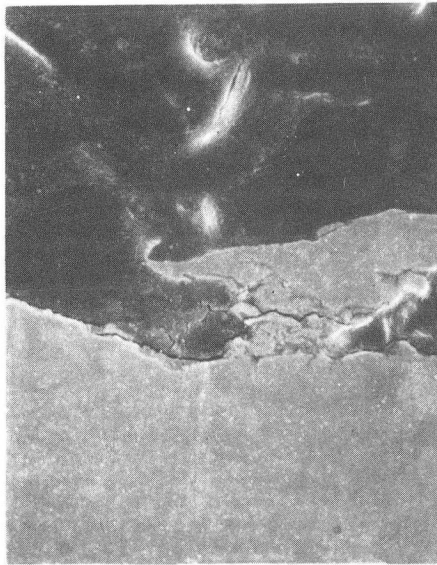
310 STAINLESS STEEL  
30° IMPINGEMENT ANGLE  
710°C  
CROSS SECTIONAL VIEW

Fig. 10. Cross section of 310SS eroded surface showing platelets.

Two examples of the shapes of platelets formed on the surface of eroding ductile metals are shown in Figures 10 and 11. Figure 10 shows at low magnification the cross section of the eroding surface of 310SS tested at an elevated temperature. Platelets can be seen along the surface. The lower, higher magnification photo of the platelet between the two polishing marks in the upper photo shows a distressed, mushroom shaped platelet whose stem is cracked. This platelet is very near to being removed, probably by only one or two more particle impacts.

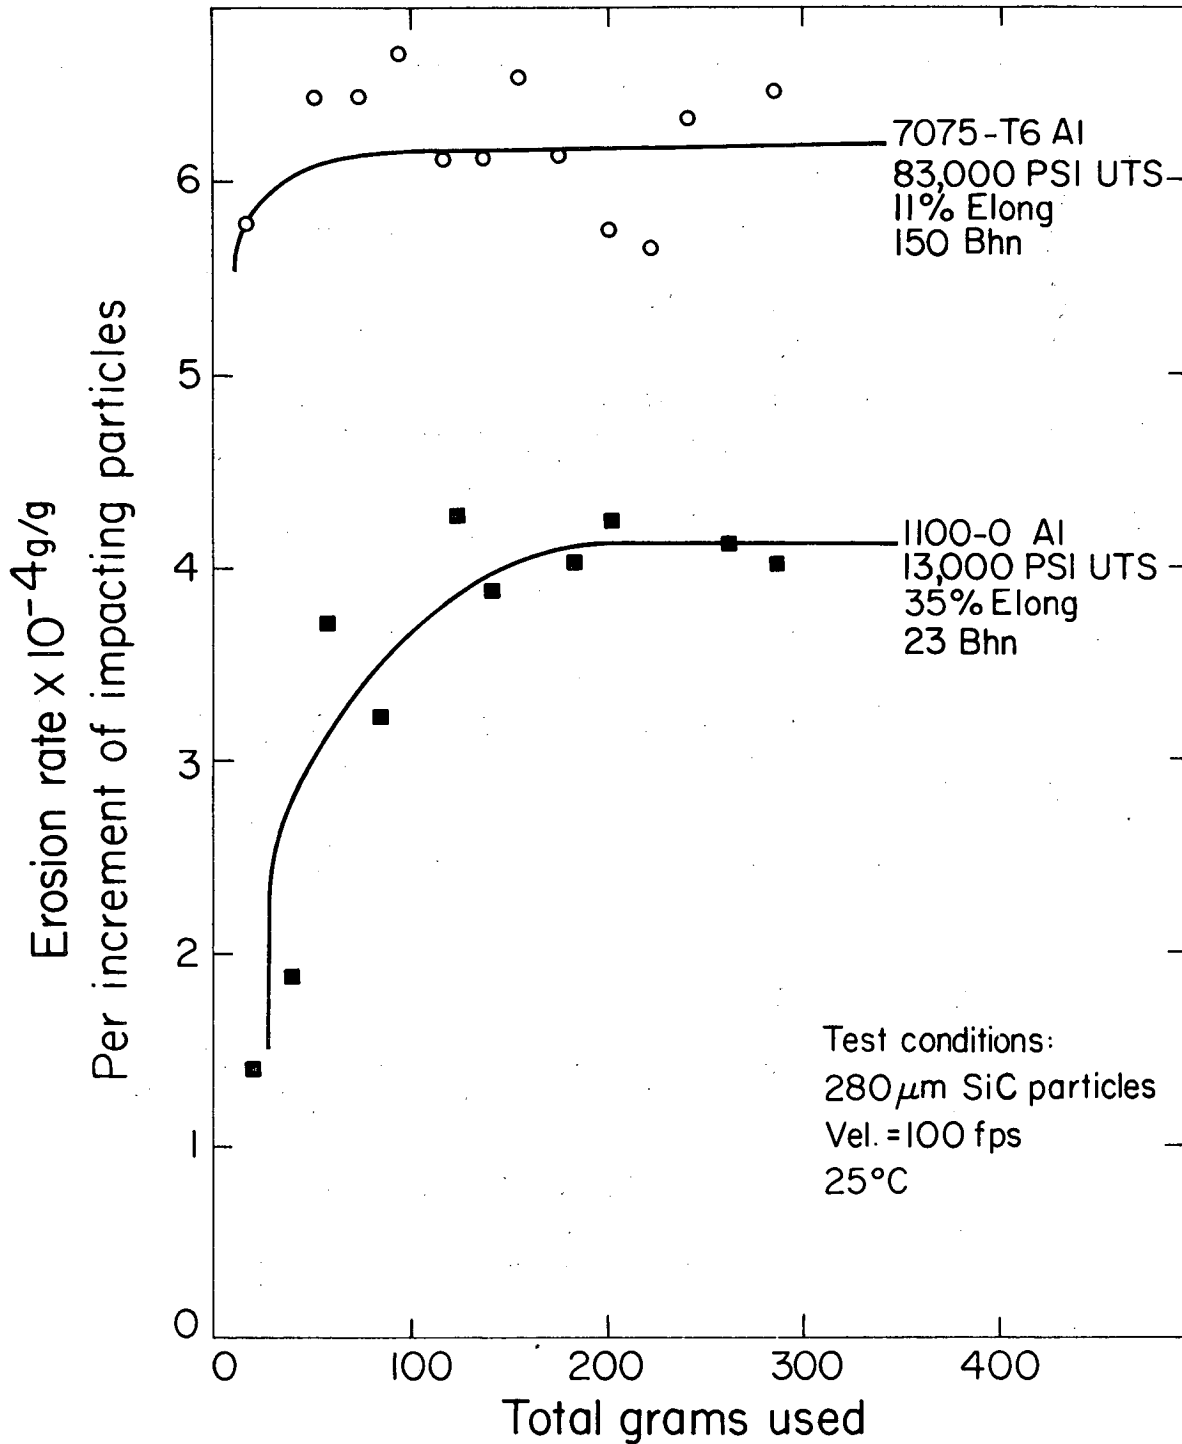
Fig. 17. Erosion rate of 7075-T6 and 1100-0 aluminum.

In work by this author several steel and aluminum alloys have been tested at various strength, hardness and ductility levels.<sup>4, 6</sup> In Figure 1 it can be seen that a fine pearlite microstructure with a hardness of  $R_B$  99 erodes some 40% faster at steady state erosion conditions than does the same steel in the softer,  $R_B$  79, more ductile, spheroidized condition.<sup>4</sup> Figure 17 shows the incremental erosion rate curves for 1100-0 aluminum and 7075-T6 aluminum. Both alloys formed the same type and size of platelets when eroded with SiC particles, but the erosion rates are markedly different. The 7075-T6 with a tensile strength of 76,000 PSI eroded 50% faster than the much weaker 1100-0 Al that has a tensile strength of 13,000 PSI. However

1100-0 is much more ductile than the 7075 Al, 35% compared to 11% elongation. In the case of these aluminum alloys, higher ductility results in greater erosion resistance. In tests on 304SS to determine the effects of properties on erosion behavior, it was determined that less ductile, as rolled sheet had a higher erosion rate than annealed sheet.<sup>6</sup>

In Reference 7 Gulden reported that 2024-T6 aluminum eroded considerably more than the weaker but more ductile 2024-T6 aluminum. This compares with the results shown in Figure 17 comparing 7075-T6 with 1100-0 aluminum. In tests on 1095 steel she measured erosion rates that were 2-1/2 times higher for the Rc 66 full hard condition compared to the Rc 20 annealed condition.<sup>7</sup> However, in erosion tests of binary Fe-Cr alloys that were hardened by solid solution strengthening rather than the strained lattice hardening that occurs in the 1095 steel, she observed that erosion resistance did vary directly with hardness.

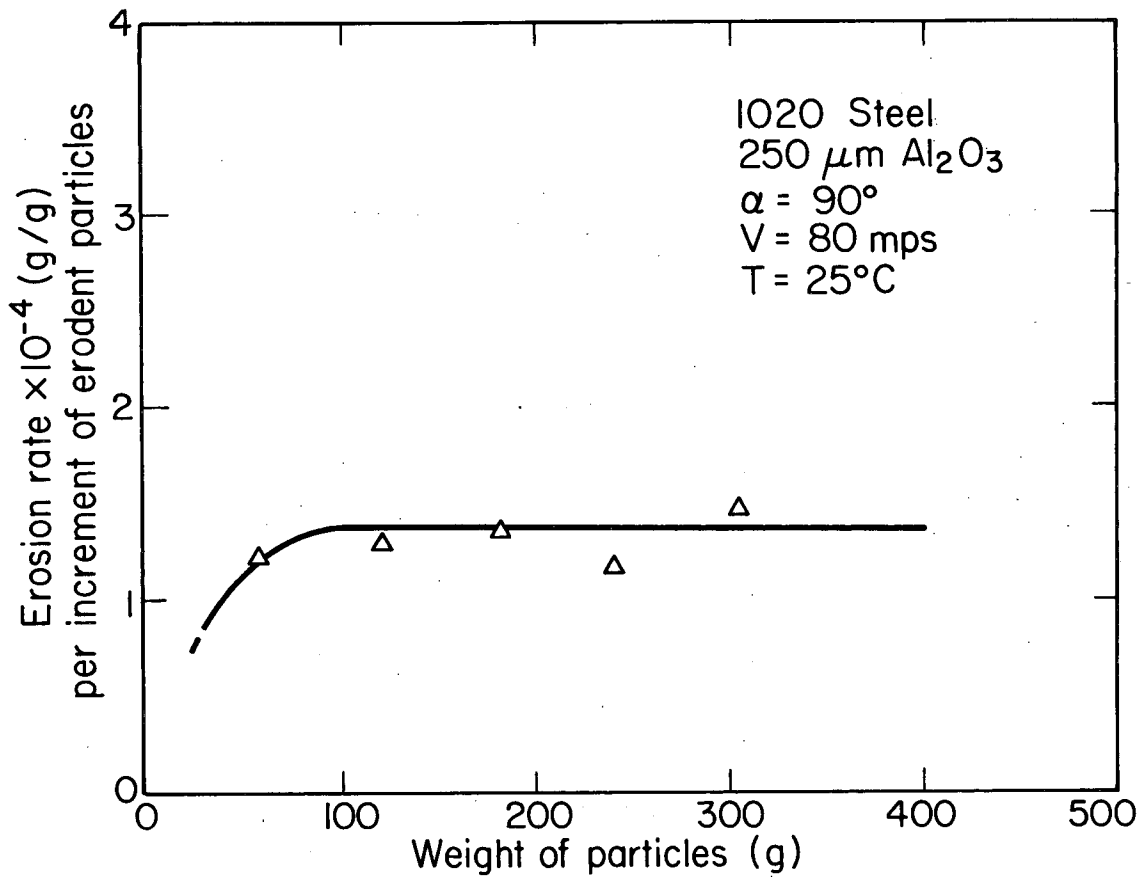
Fig. 19. Erosion rate of 1020 steel using  $\text{Al}_2\text{O}_3$  particles.

Another example of the effect of strain hardening of the sub-surface "anvil" is shown in Figure 19 and 20. In this experiment, the impacting particle was varied and the erosion of annealed 1020 steel determined.<sup>18</sup> A weak mineral particle that fragmented on impact, apatite, and a strong particle that did not,  $\text{Al}_2\text{O}_3$ , were used with all other testing conditions being the same. Figure 19 shows the incremental erosion curve using  $\text{Al}_2\text{O}_3$  particles. The number of particles to reach steady state was of the order of 50g. Figure 20 shows the curve for the weak, apatite particle. Almost 200g of particles were required to reach steady state erosion even though the level of that steady state erosion was only 25% as great as that which occurred when the  $\text{Al}_2\text{O}_3$  particles were used.

It was postulated that the reason that the 1020 steel eroded with  $\text{Al}_2\text{O}_3$  particles reached steady state erosion in less than half the erodant weight it took when using the apatite particles is that the weak apatite fragmented into small particles when they impacted the surface. The effective size of the apatite particles after they broke up was too small with too little available kinetic energy to strain harden the sub-surface layer as effectively as the intact, larger  $\text{Al}_2\text{O}_3$  particles did. It thus took longer to form an "anvil" in the 1020 steel and it was not as an effective one as that formed by the  $\text{Al}_2\text{O}_3$
