Load tests on dismantled 50-year-old prestressed concrete bridge deck beams

P. Savino, A. Quattrone, D. Sabia, B. Chiaia & F. Tondolo

ABSTRACT: This paper presents the results of three large scale experimental tests within the survey conducted on 50-year-old prestressed concrete (PC) girders for the BRIDGE|50 research project (www.bridge50.org). The girders were retrieved from a viaduct before dismantling operations once located in the urban area of Turin, Italy. Together with other structural members they represent one of the most prominent project of this type worldwide. The PC elements have 19.2 m span length and I-shaped cross section with 14 cm cast-in situ slab with variable damage due to deterioration caused by both service and lifting operations during dismantling phase. For each specimen, static tests have carried out applying monotonic or cyclic loading up to the ultimate load, measuring deflections, loads and strains in several positions for two I beams and one box beam. The results of the tests in terms of load-deflection responses and strains are reported for each beam investigated and compared considering previous tests from the same project already reported in lite

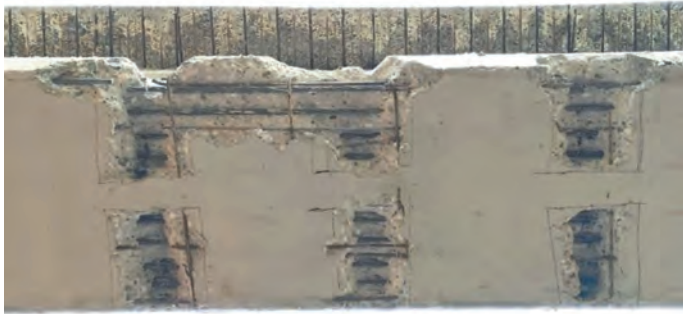
Figure 3. Strands cutting in B5-P46/47 girder (bottom view).

According to the diagnostic campaign performed before the load tests session, the beams investigated in this paper were considered in good conditions. Beam B5-P46/47 was intentionally damaged by cutting 8 strands at the midspan to induce a different failure mode from that observed in previous tests (Savino et al. 2023b), as depicted in Figure 3. The damage was created by cutting a total of eight strands in the bottom flange at a distance of 60.0 cm from the girder midspan on either side.
