**NIST Technical Note 2054**

**Compartment Fire Experiments on  
Long-Span Composite-Beams with  
Simple Shear Connections  
Part 1: Experimental Design and Beam  
Behavior at Ambient Temperature**

This report, Part 1, presents details of the test setup, specimens, design basis of fire loading, instrumentation, and the behavior of the composite beam with double-angle connections at ambient temperature. The ambient temperature test indicated that the composite beam specimen failed by a shear stud near the west end, followed by concrete breakout failure and yielding of the steel beam. The measured moment capacity was approximately 80% of the calculated flexural strength. The double-angle connection at the west end failed by weld fracture, which caused collapse of the composite beam. The ambient behavior of the composite beam specimen presented herein will serve as a baseline to compare with the composite beam assemblies tested under combined mechanical loads and fire exposure, which are presented in a subsequent report; Part 2 (Choe et al. 2019). The datasets obtained from these tests provide technical information to advance performance-based design of composite floor assemblies in

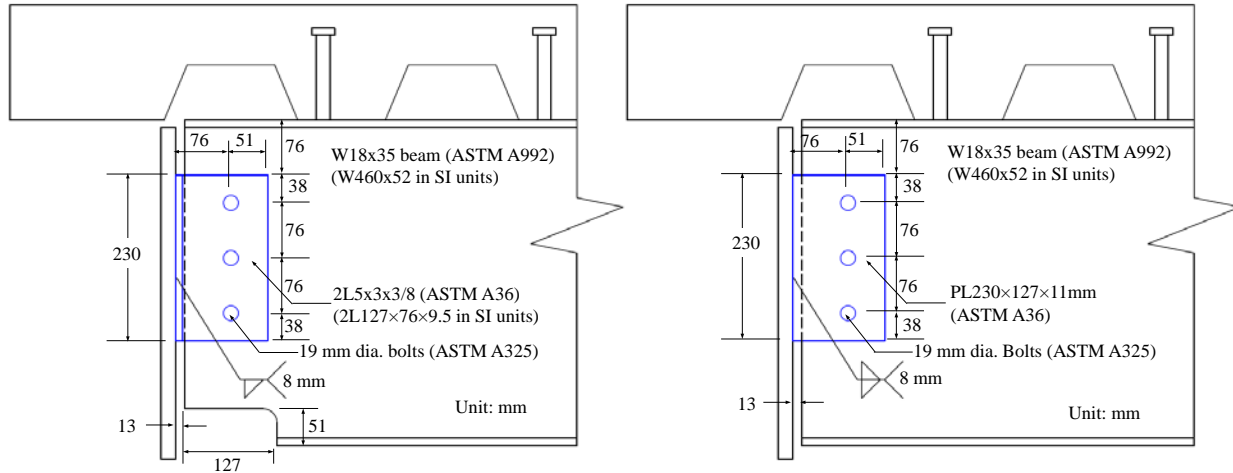
**Figure 2-2** Shear connections at the end of specimens (a) double angle and (b) single plate.

Figure 2-2 illustrates the beam end connections, either double angles or a shear tab. For double-angle connection, two L5×3×3/8 angles made of ASTM A36 steel were used. The angle legs were bolted to the beam web using three 19 mm diameter bolts, made of ASTM F3025 steel (Gr. A325), spaced at 76 mm. The top bolt was located at 114 mm from the top of the steel beam. The AISC standard bolt holes in the web were located 76 mm from the column face. The bottom flange of the steel beam was coped as recommended in the AISC manual. The angle legs on the column side were shop-welded, using an 8 mm fillet weld (E70XX electrodes), to a sacrificial plate attached to the columns. The design strength of double-angle connections was governed by weld shear, which was 267 kN (including the AISC strength reduction factor of 0.75). For the shear tab connection, a 11 mm thick plate (made of ASTM A36 steel) was bolted to the web of the steel beam and welded to the column side via a sacrificial plate. The bolt size and spacing were the same as those used in the double-angle connection. However, the steel beam was not coped. The calculated shear capacity was 242 kN (including the AISC strength reduction factor of 0.75).

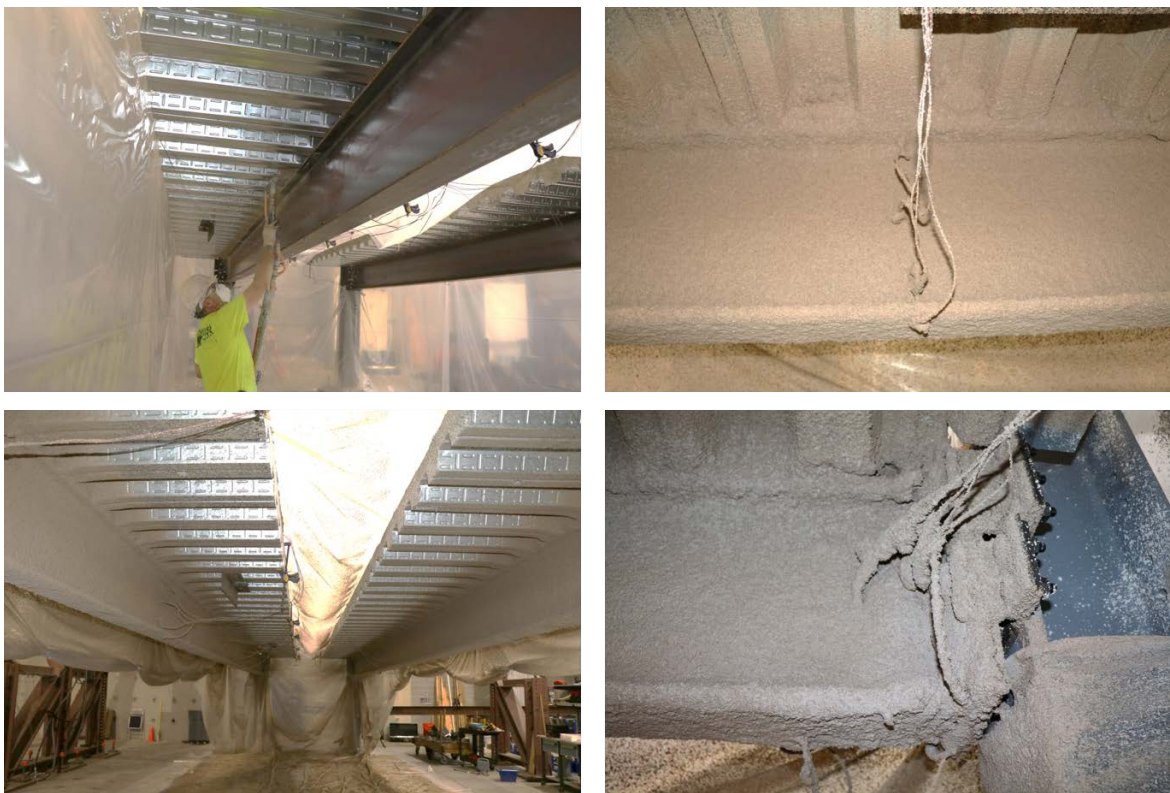
**Figure 2-3 Application of the Sprayed Fire Resistive Materials on the prototype floor beam assemblies.**

Figure 2-3 shows photographs of the beam assemblies during the SFRM installation. Exposed steelwork including the W18×35 steel beams and the beam-to-column connections were coated with Southwest Type 5MD material. For the 2-hour restrained beam rating of floor beams, the design thickness of SFRM was 16 mm as specified in UL Directory N791 (UL 2011). The connection regions were over-sprayed to achieve the SFRM thickness of 27 mm. This is the same design thickness required for the 3-hour fire rating of W12×106 columns. The gap between the steel beam and steel deck units were also filled with the SFRM. No additional fireproofing material was installed at the underside of steel decking since the floor assembly was constructed with the 8.25 cm thick lightweight concrete cast on 7.62 cm deep galvanized, fluted deck units.

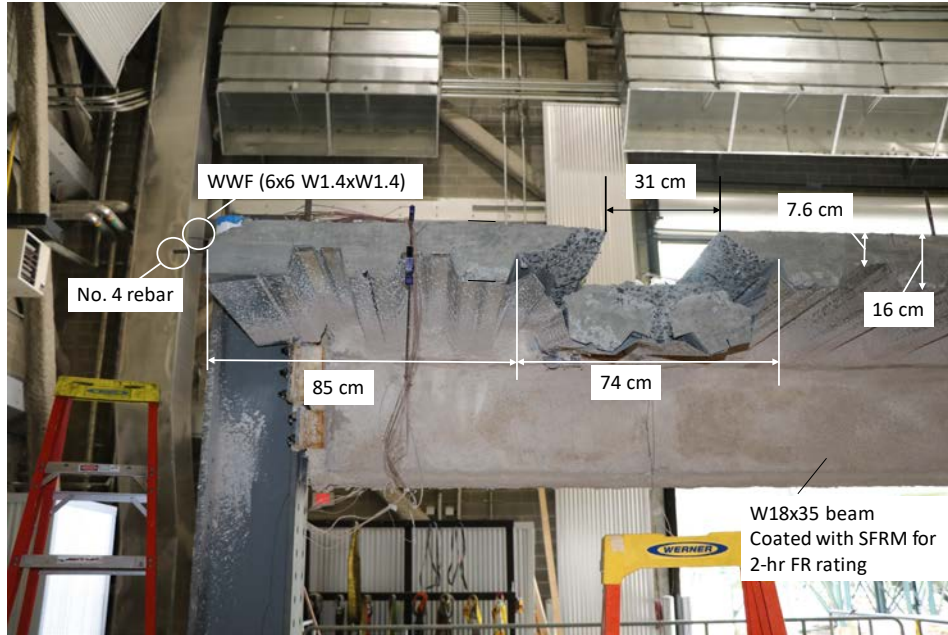
Figure 2-5 Front view of damaged concrete slab of CB-SP-SC.

The concrete slab of CB-SP-SC was locally damaged while being cured inside the laboratory. Figure 2-5 and Figure 2-6 show photographs of the extent of damage. The slab about 85 cm from the west end exhibited through-depth fracture of concrete and complete severing of welded wire fabric. In addition, there were hairline cracks around the damaged zone, along the longitudinal centerline of the support beam and near the slab edge. This incident also caused failure of one thermocouple array (out of 24 arrays) and a fiber optic cable deployed for additional measurement of temperature in the concrete slab.

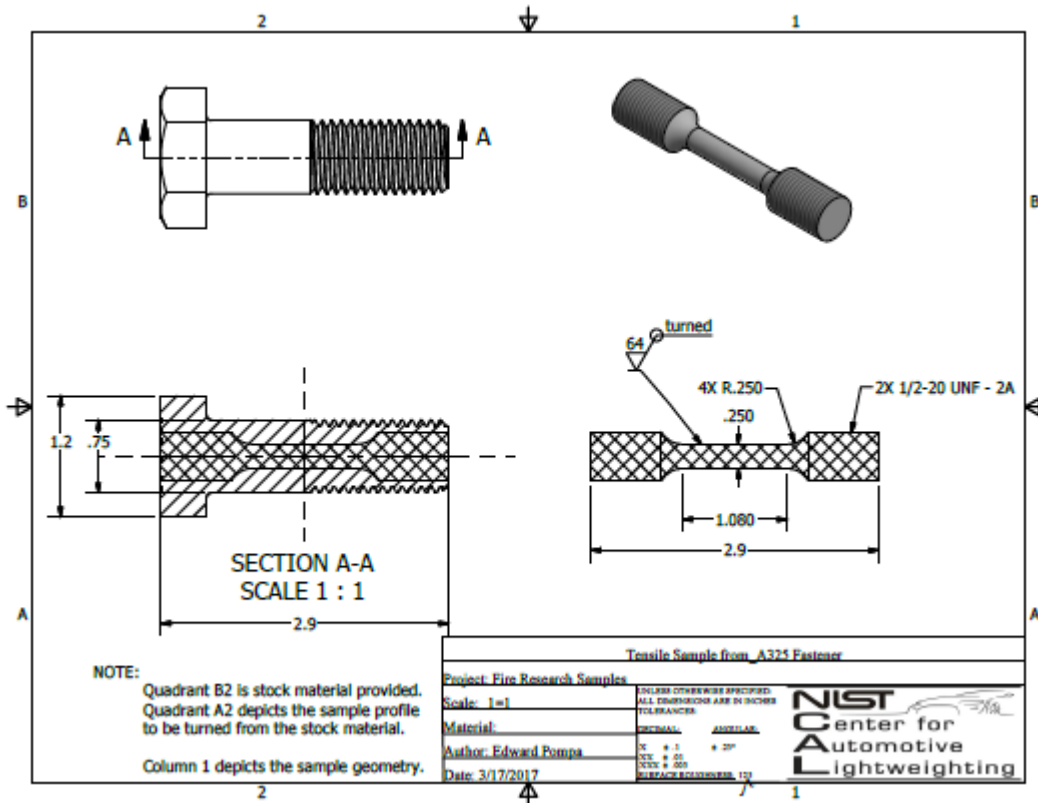
Figure 2-9 Tensile specimen machined from A325 bolt. Units = cm.

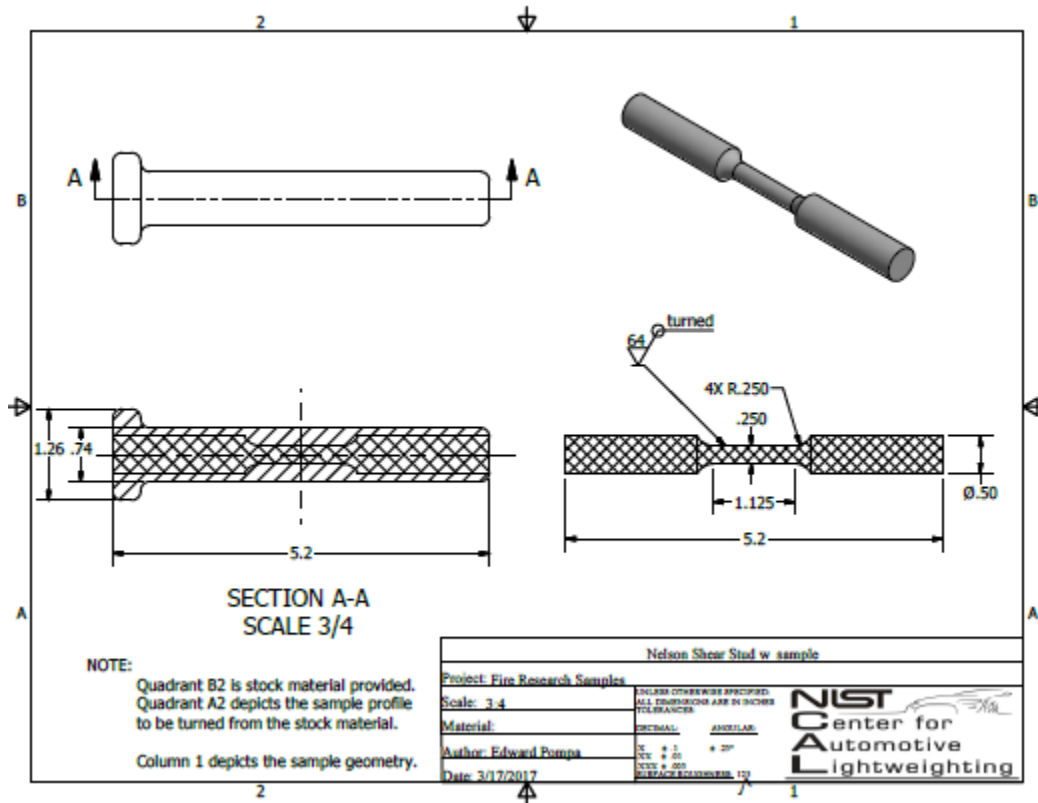
Figure 2-10 Tensile specimen machined from shear stud. Units = cm.

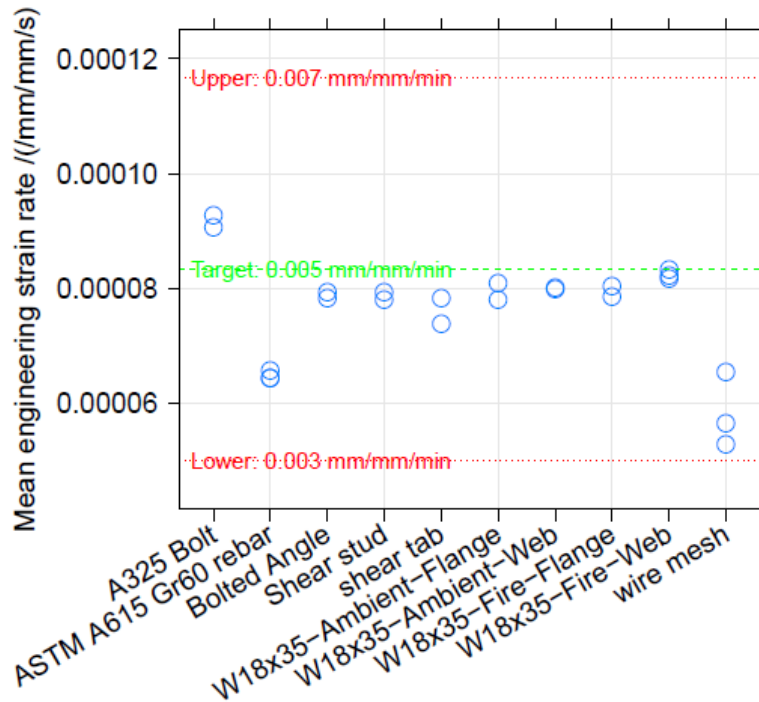
**Figure 2-12 Average engineering strain rate during each test. Dashed colored lines denote the acceptable strain rate range in ISO 6892.**

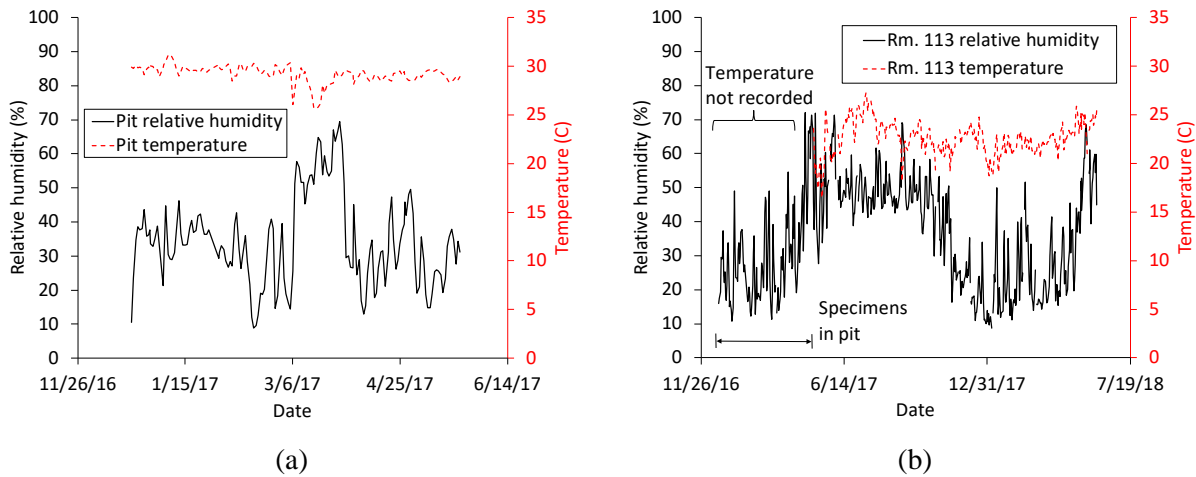
The measured relative humidity and air temperature in the curing pit are plotted in Figure 2-14(a). Due to problems with the humidity control in the curing pit, the target relative humidity of the air was not achieved on average ( $34.5 \pm 13.1$  %), however, the target air temperature was maintained within the desired margin ( $29.2 \pm 0.9$  °C). The ambient test specimen was cured in the testing hall where the relative humidity and temperature were not measured, however, daily measurements made in the adjacent test hall (NFRL Room 113) with similar conditions to those in NFRL Room 125 are shown in Figure 2-14(b).

**Figure 2-14 Air temperature and relative humidity: (a) in curing pit; (b) approximate conditions in test hall.**

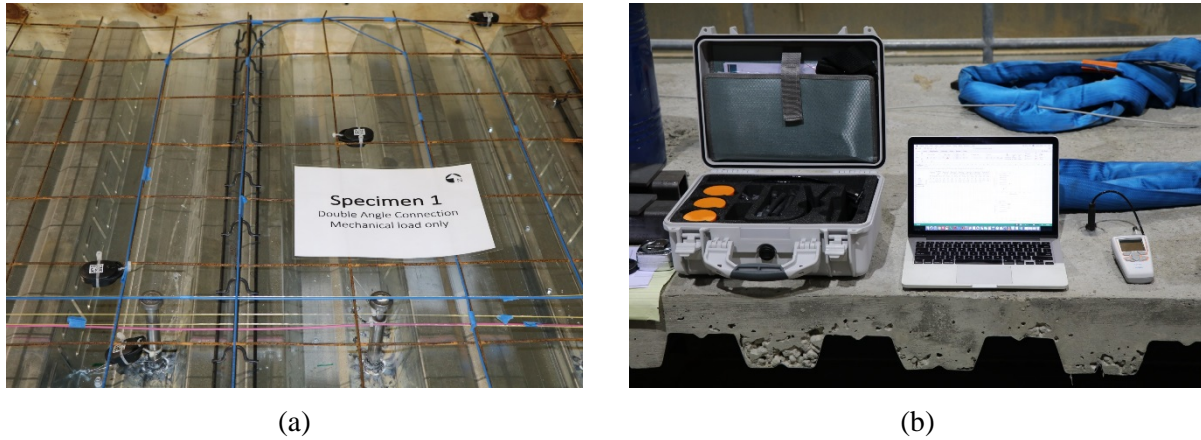
Two different sensor types were used to measure the relative humidity and temperature inside the slabs during curing. The first sensor type was a wireless sensor purported to be able to be placed in the formwork prior to casting (up to 150 mm from the surface) and transmit the data to a mobile phone via Bluetooth (Figure 2-15a). The manufacturer-specified accuracy of the temperature and relative humidity are  $\pm 0.4$  °C and  $\pm 3$  %, respectively. We were unable to successfully transmit data from the majority of the 15 sensors installed in the concrete and the data that were gathered varied significantly from theoretical predictions as well as from independent measurements with a second technology; therefore, the results are not discussed further in this report. The second sensor was a wired probe placed into perforated sleeves embedded in the concrete during casting (Figure 2-15b). The manufacturer specified accuracy of the temperature and relative humidity in the applied temperature range are  $\pm 0.2$  °C and less than  $\pm 2.5$  %, respectively. The temperatures measured in the specimens are shown in Figure 2-16 and the relative humidity measurements in Figure 2-17. No data were recorded immediately prior to Test 2 and Test 3. The relative humidity measurement immediately prior to Test 5 is believed to be erroneous because the seal on the probe tube had been removed and the concrete allowed to dry locally. The moisture content of the

Figure 2-15 Monitoring of relative humidity in the slab during curing: (a) embedded wireless sensors (black ovals); (b) downhole relative humidity probe.

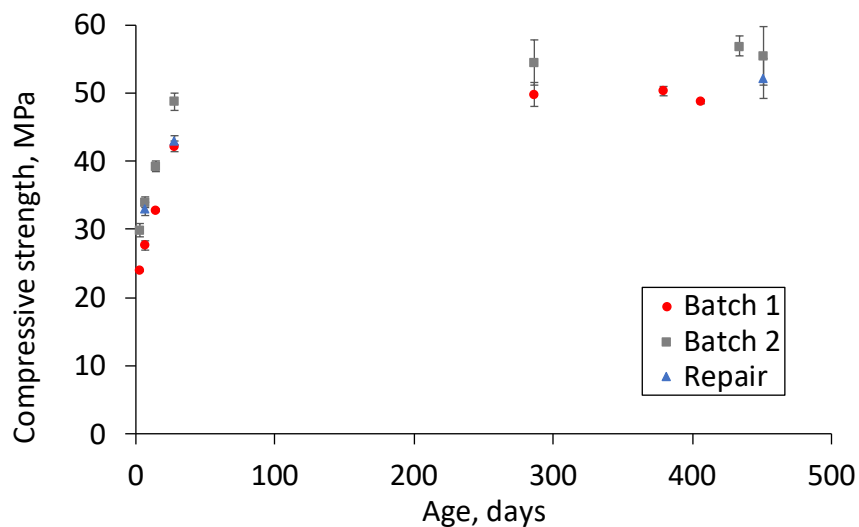
**Figure 2-18 Compressive strength development (error bars are standard deviation)**

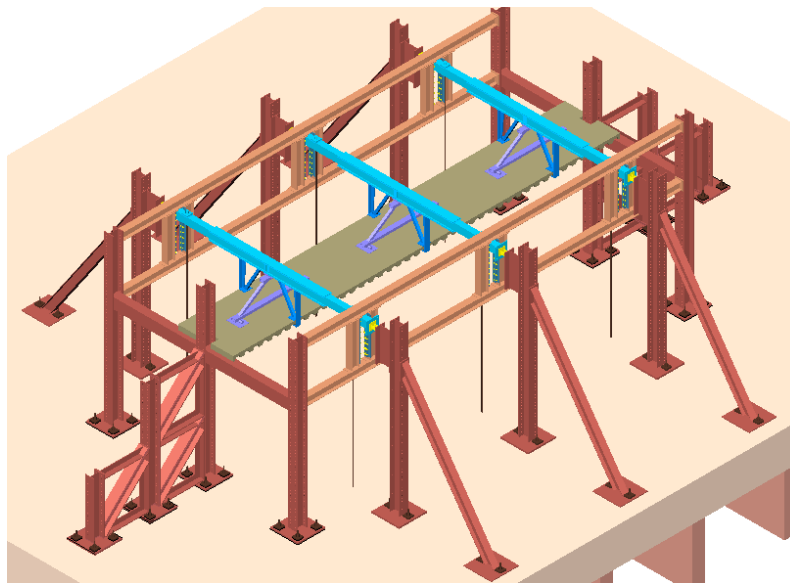
The W12x106 columns were laterally braced using a set of brace modules made of the same wide-flange sections (Figure 3-1). The base plates of columns and brace modules were anchored to the strong floor using high strength steel bars with a total clamping force of 5400 kN. The lateral stiffness of the column attached to brace modules was 190 kN/mm for a lateral force pushing the column away from the test compartment and 170 kN/mm for a lateral force pulling the column toward the test compartment, as described in Section 3.1.2.

**Figure 3-1 (a) A 3D schematic and (b) photograph of the structural test setup (fire compartment walls are not shown).**

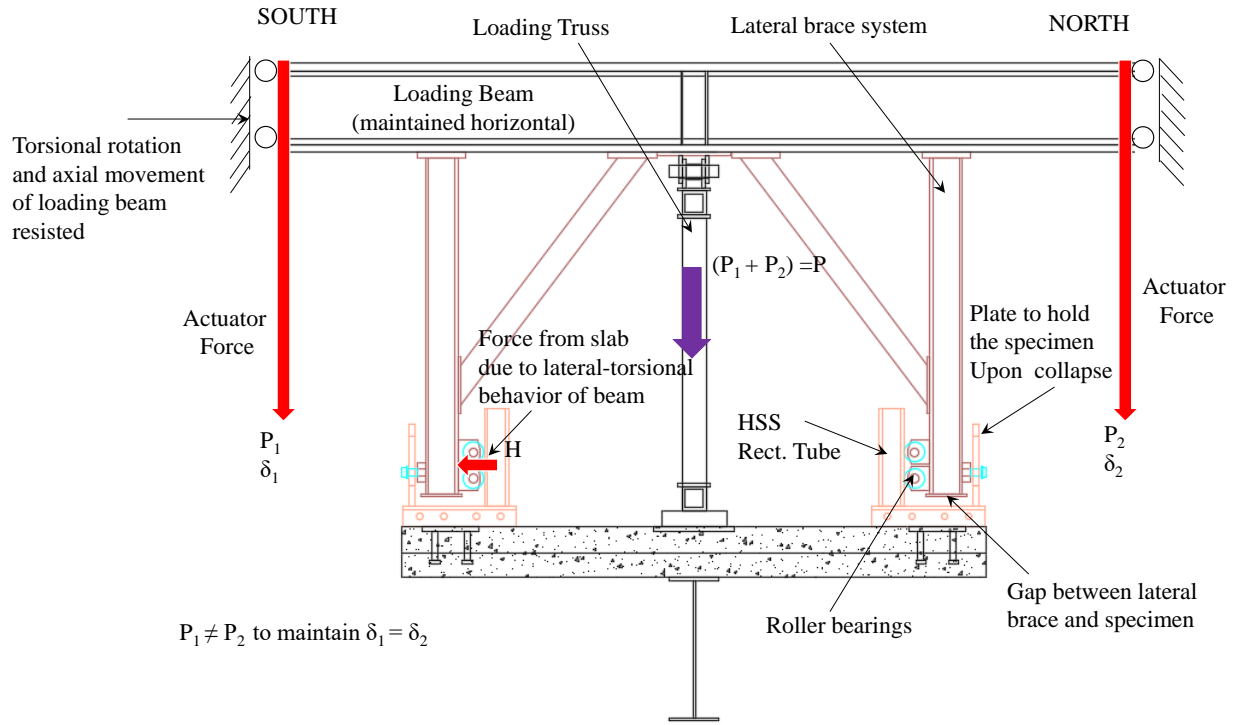
**Figure 3-6 Cross-section view of the specimen with loading system.**

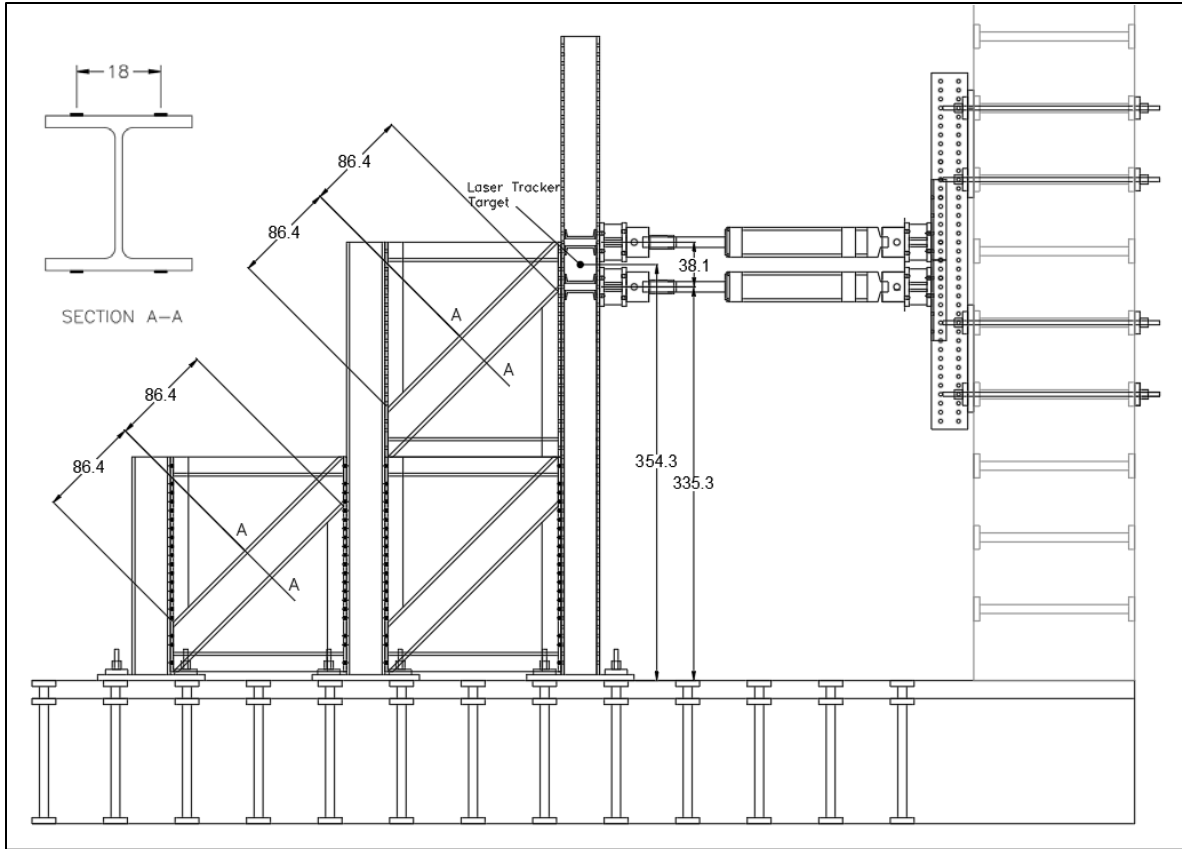
**Figure 3-7 Setup for lateral stiffness test of braced columns (units in cm).**

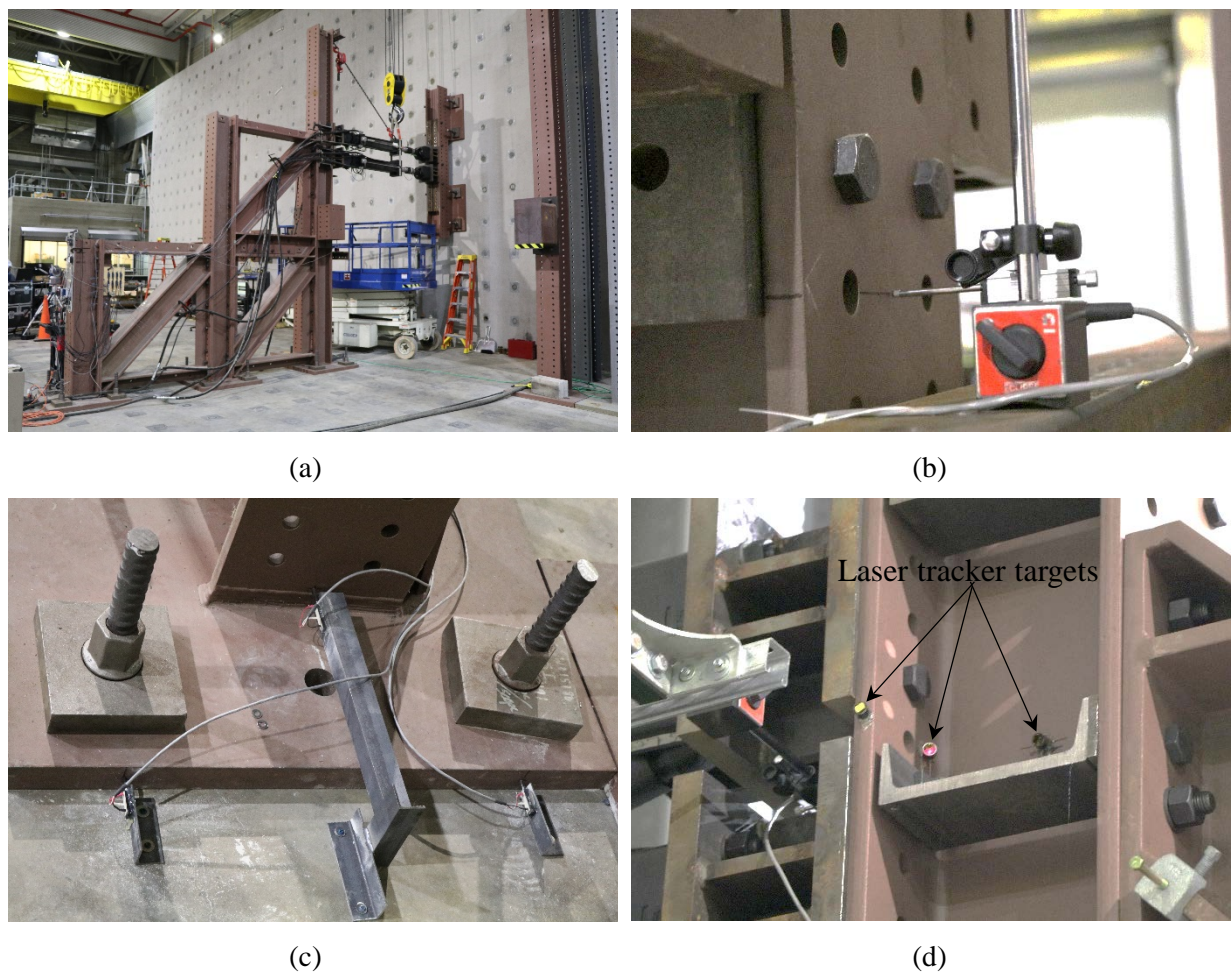
**Figure 3-8** Photographs of (a) the lateral stiffness test setup, (b) displacement sensor, (c) slip sensor, and (d) targets for laser tracker system.

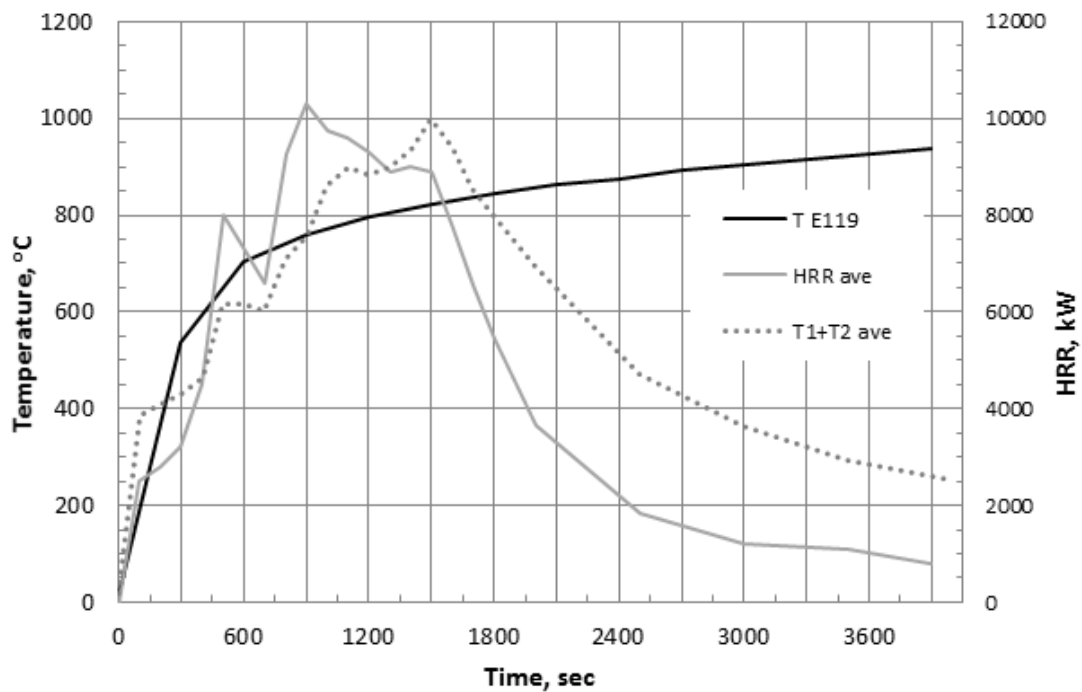
Figure 3-9 Average HRR and nominal temperature of NIST full-scale office fire experiments (Hamins et al. 2008) with time-temperature curve from ASTM E119.

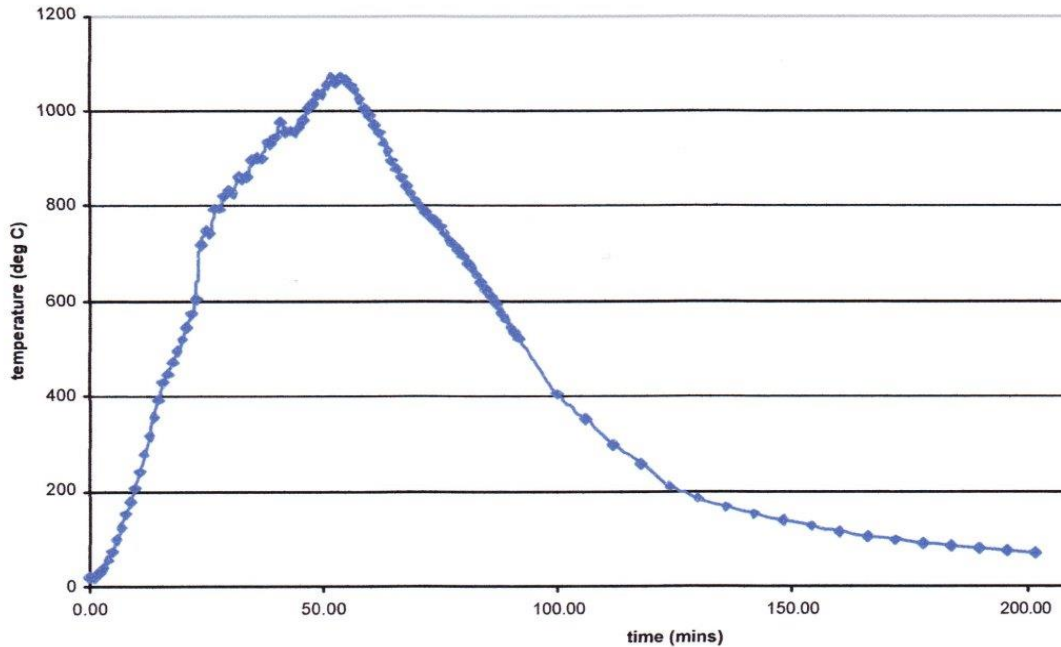
**Figure 3-10 Average compartment time-temperature response in Cardington Test 7 (BRE 2004).**

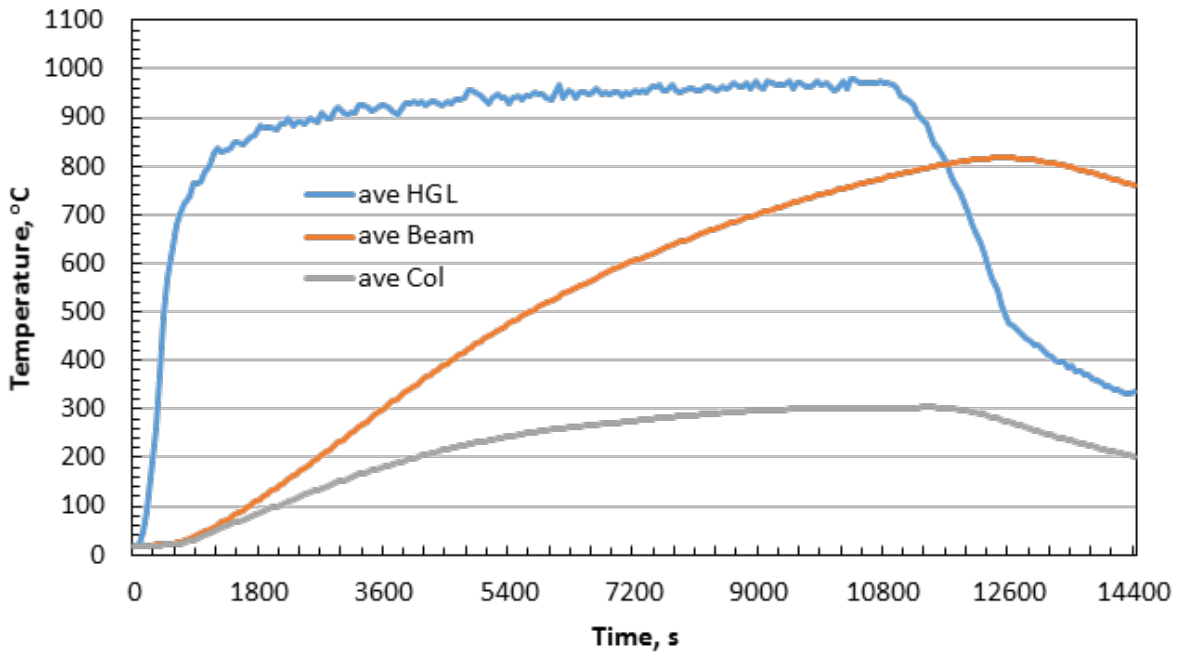
Figure 3-15 Average temperatures of hot gas layer (blue), spatial average along lower flange of steel beam (orange), and average temperature of columns near beam connection (gray) for case 5Be.

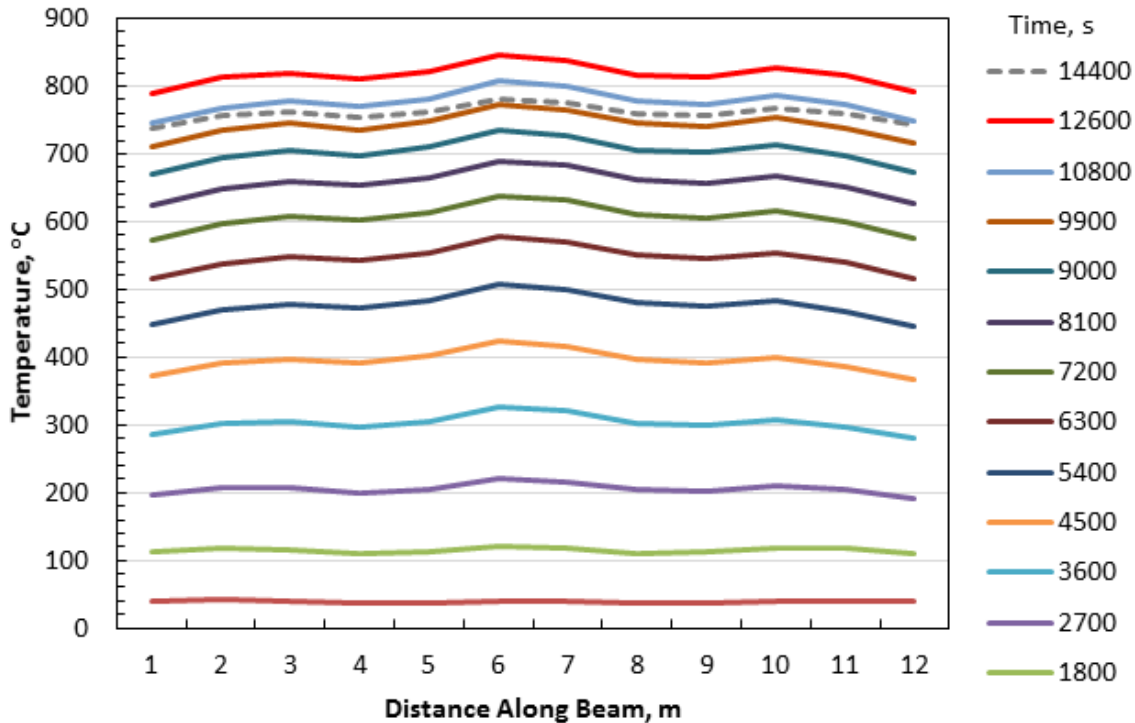
Figure 3-16 Temperatures along lower flange of steel beam (case 5Be).

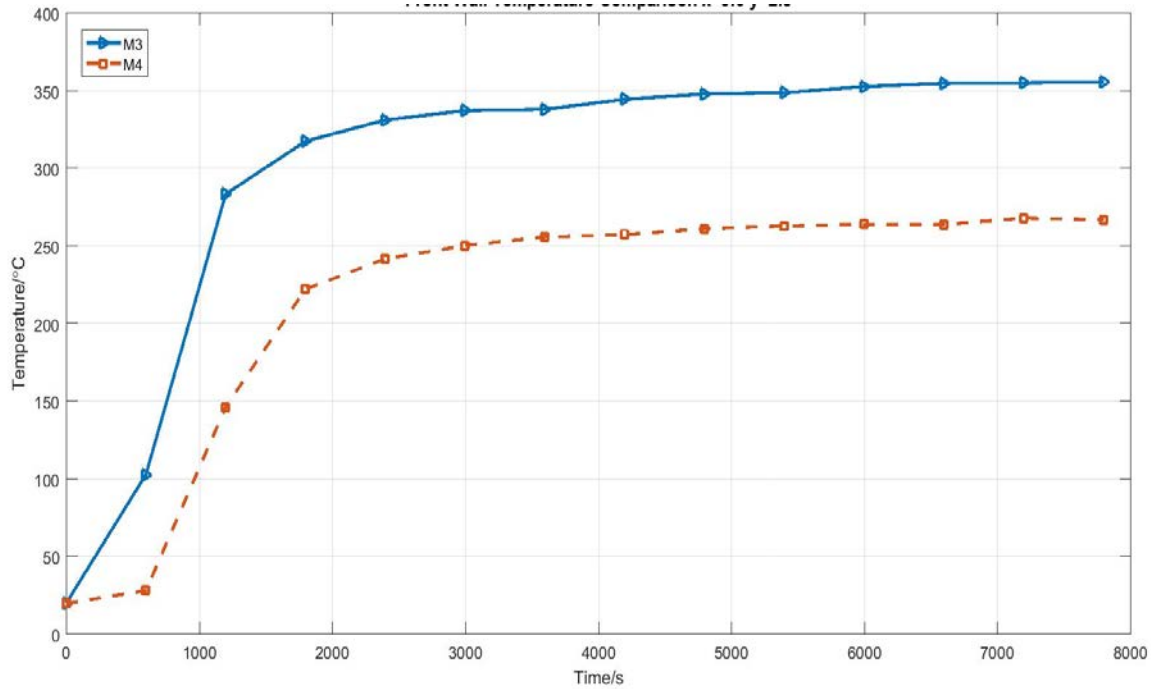
**Figure 3-17 Laboratory-side wall temperature of at  $x=9.0$ ,  $y=2.5$  comparing 25 mm of ceramic fiber blanket (blue curve) to 50 mm of ceramic fiber blanket (red-dotted curve).**

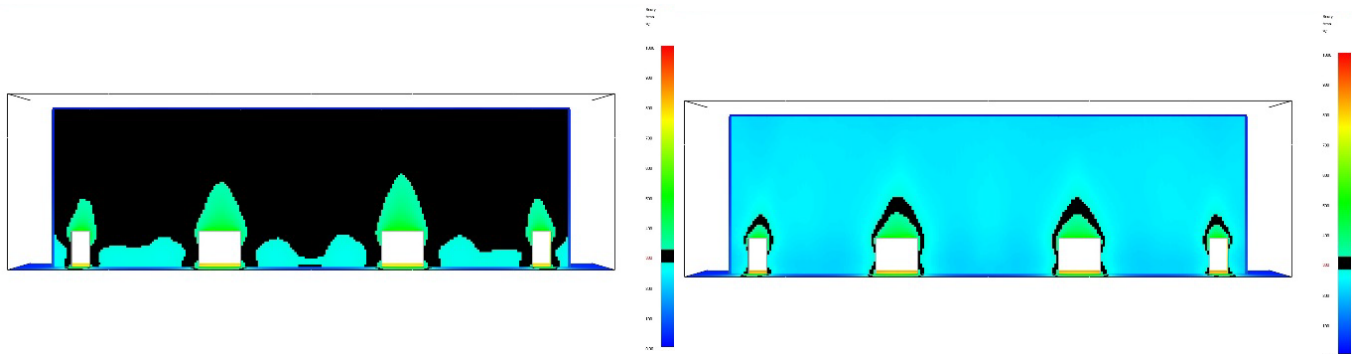
**Figure 3-18 Temperature of front wall (outside) with temperatures of 300 °C and higher shown in black; 25 mm insulation on left compared to 50 mm on right.**

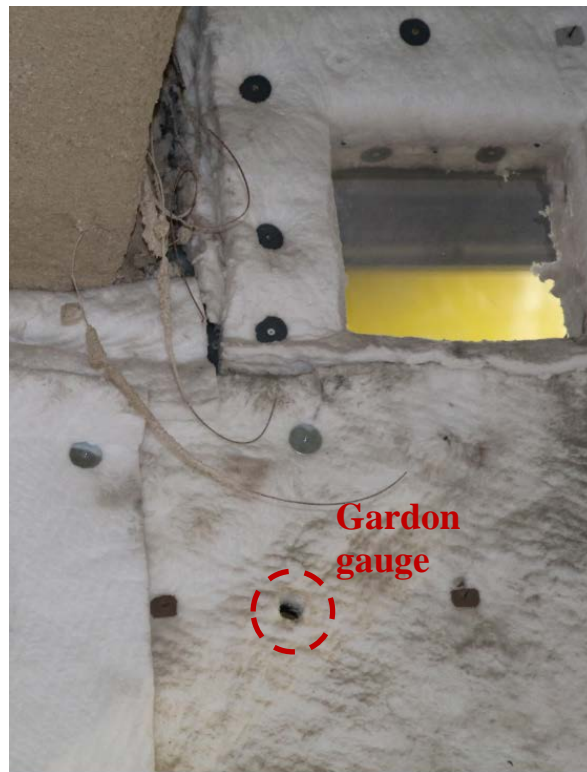
Figure 4-7 Gardon gauge mounted on the east wall.

A Gardon gauge (Medtherm model 64-20-18) was placed on the east wall 410 mm below the bottom flange of the specimen (Figure 4-7). The diameter of this gauge was 25.4 mm. It was placed in a steel pipe (inside diameter = 25.4 mm) and water-cooled during the fire tests.

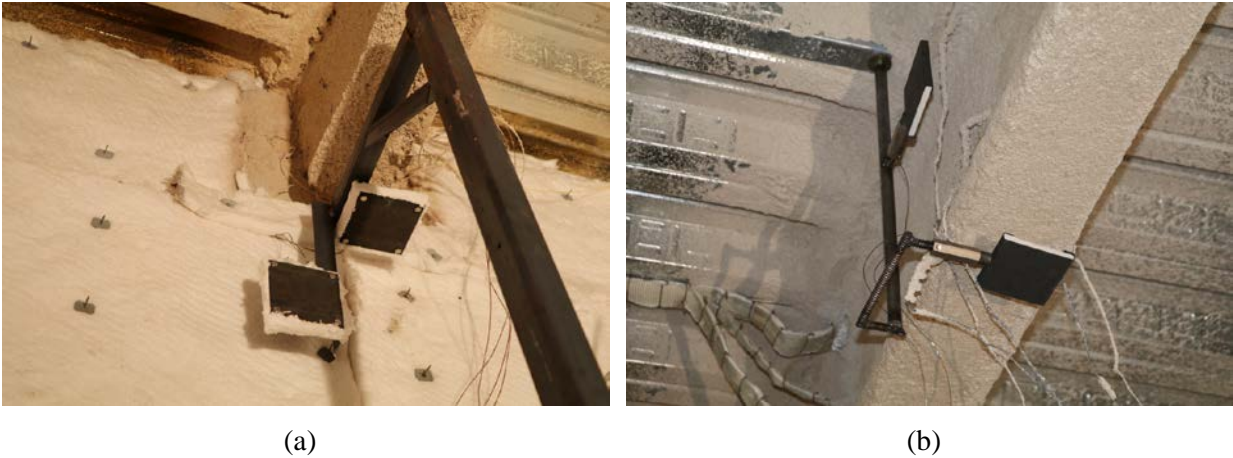
**Figure 4-8 Location of plate thermometers: (a) east connection; (b) mid-span of the beam.**

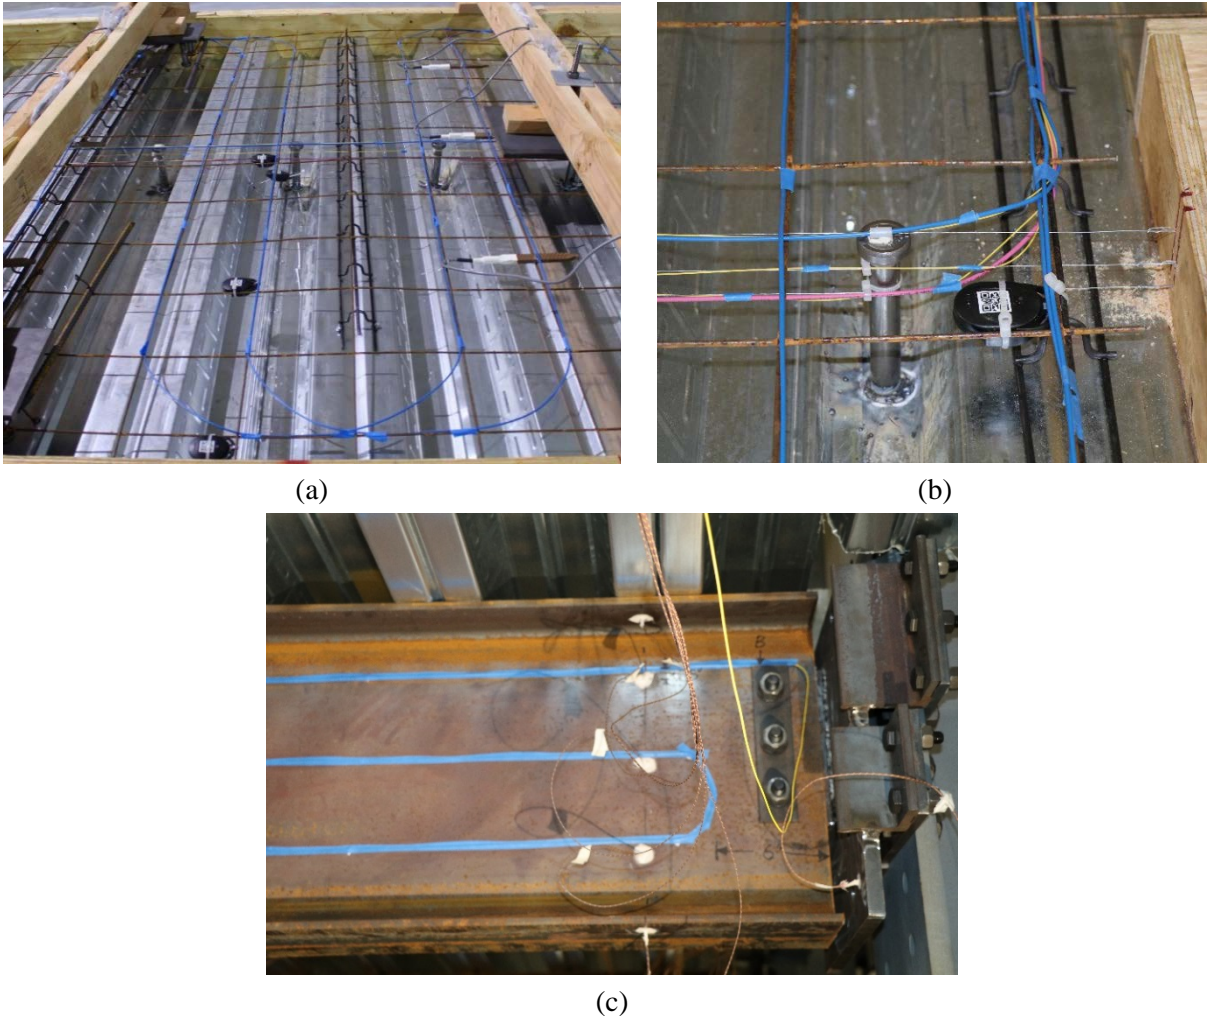
**Figure 4-12 Photographs of installed distributed fiber optic sensors: (a) transverse (T-DFOS) temperature sensors (blue), (b) longitudinal (L-DFOS) temperature (blue and pink) and strain (yellow, thin), and (c) temperature sensor on web of steel beam (blue tape over thick yellow optical fiber).**

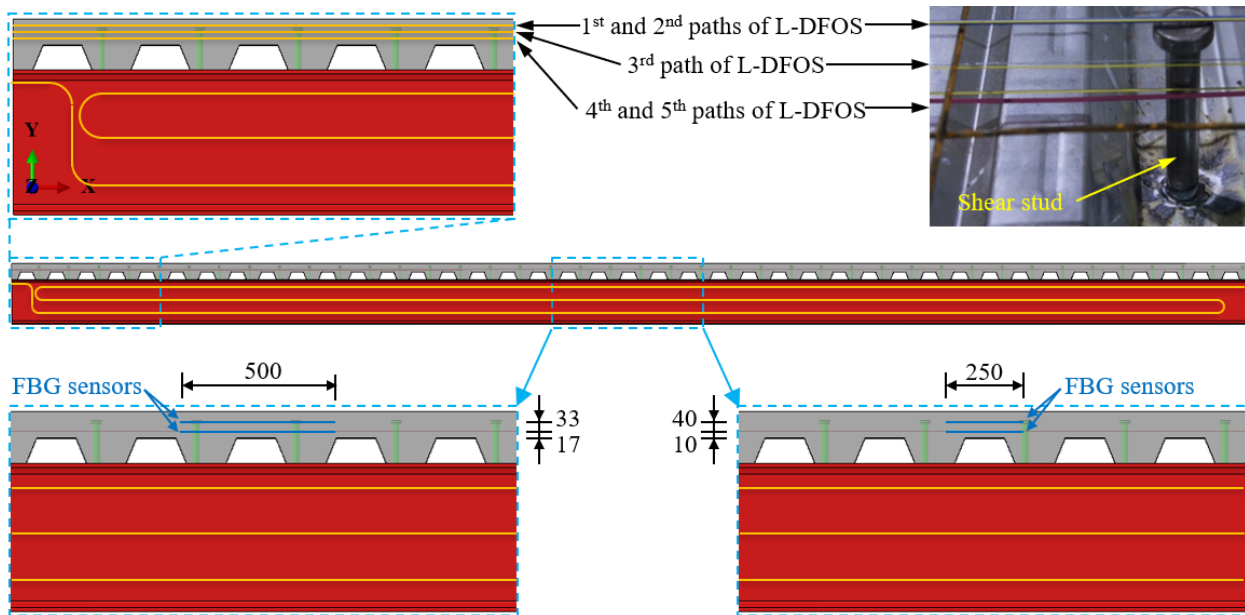
**Figure 4-13** Side view of the locations of distributed fiber optic sensors (DFOS) and Fiber Bragg Grating (FBG) sensors in the concrete slab. The length and locations of the FBG sensors in CB-DA-AMB (left) are different from those in CB-DA and CB-DA-SC (right) (units in mm).

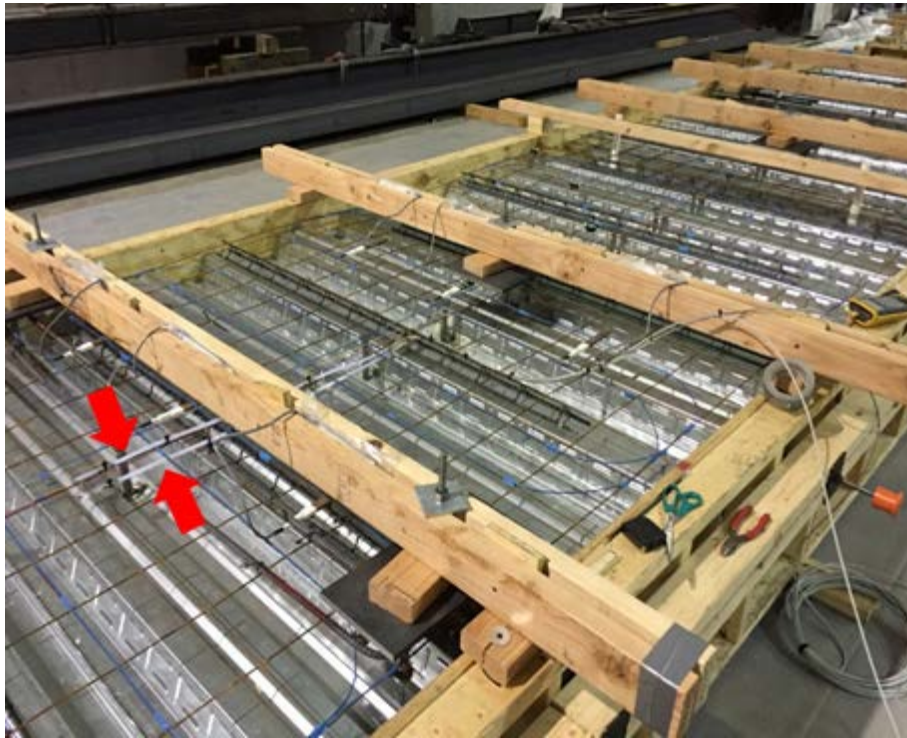
**Figure 4-17 Fiber Bragg Grating sensors in CB-DA-AMB indicated by red arrows.**

Fiber Bragg Grating (FBG) strain sensors were embedded in the concrete deck in specimens CB-DA-AMB, CB-DA, and CB-DA-SC. These sensors measure an average change in strain over their gauge length and require temperature compensation from other sensors (thermocouples) in the slab. The FBG sensors have a measurement standard uncertainty of  $\pm 3.1 \mu\epsilon$ ; a result of the uncertainty in the fiber optic system reading the reflected wavelengths from the FBG's and from the uncertainty in the thermocouples used for the thermal compensation. Two different forms of FBG sensors were employed: for the ambient temperature slab (CB-DA-AMB), the FBGs had a gauge length of 50 cm and the FBG was encased in a polyethylene tube. The FBGs in specimens CB-DA and CB-DA-SC, which were subjected to fire testing, had a gauge length of 25 cm and were encased in a polytetrafluoroethylene tube for protection at temperatures up to 300 °C. Both fibers were coated in polyimide to improve durability. Steel cylinders mechanically attached to the

optical fiber marked the ends of the measurement region (gauge length) and transferred strain from the concrete to the sensor. Two sensors were installed in parallel in the concrete near the midspan of the beam to measure both axial strain and bending in the deck. The FBG sensors were installed near ceramic-encased resistive strain gauges (CB-DA-AMB only) and distributed fiber optic sensors to facilitate comparison of the strain measurements. The locations of the sensors are shown in Figure 4-11 and Figure 4-13. Figure 4-17 shows the installed sensors in specimen CB-DA-AMB, with the red arrows indicating the two FBG sensors before the concrete pour. Figure 4-18 and Figure 4-19 show close-ups of specimens CB-DA and CB-DA-SC, with one of the thermocouples used for temperature compensation of the FBG visible in Figure 4-19. A Smartec MuST Dynamic Reading Unit and Micron Optics Enlight software were used to read and record measurements. Measurements were taken at a rate of one measurement per minute for the initial curing, and ten measurements per second for the load testing.

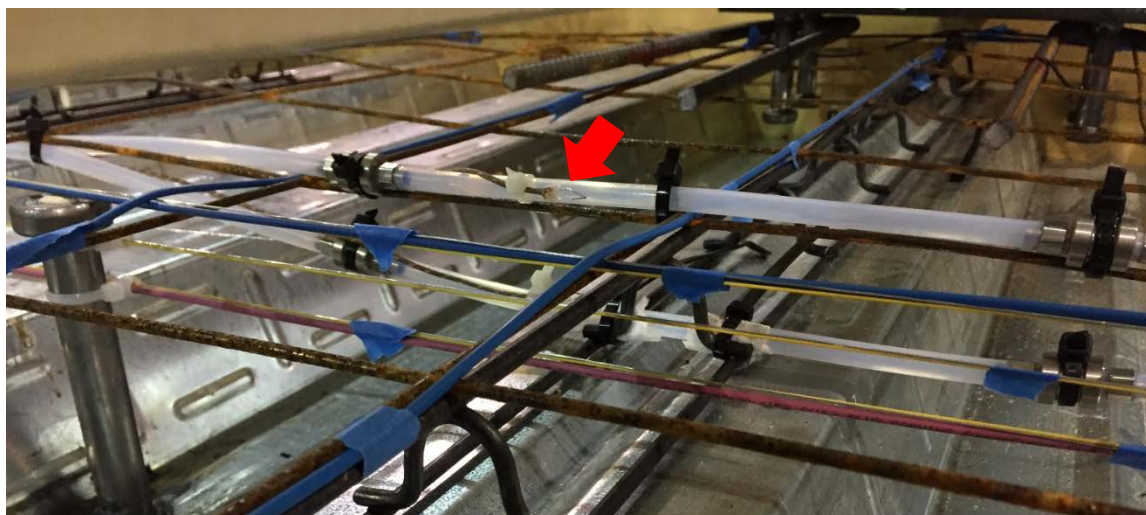
**Figure 4-19 Fiber Bragg Grating sensors in CB-DA-SC with thermocouple indicated by red arrow.**

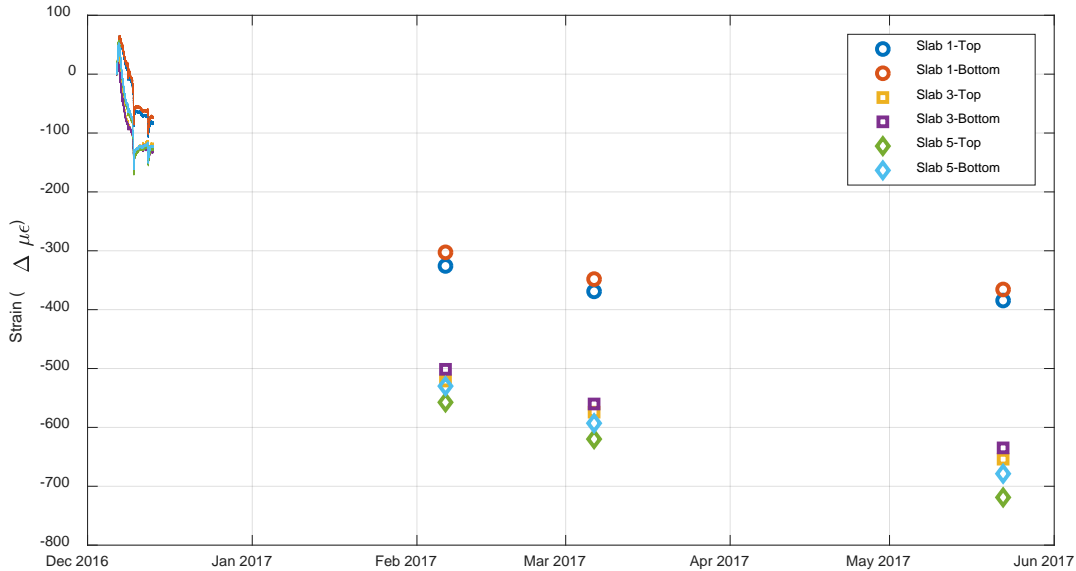
**Figure 4-22 Fiber Bragg Grating strain development over first six months after casting (CB-DA-AMB = Slab 1; CB-DA = Slab 3; CB-DA-SC = Slab 5).**

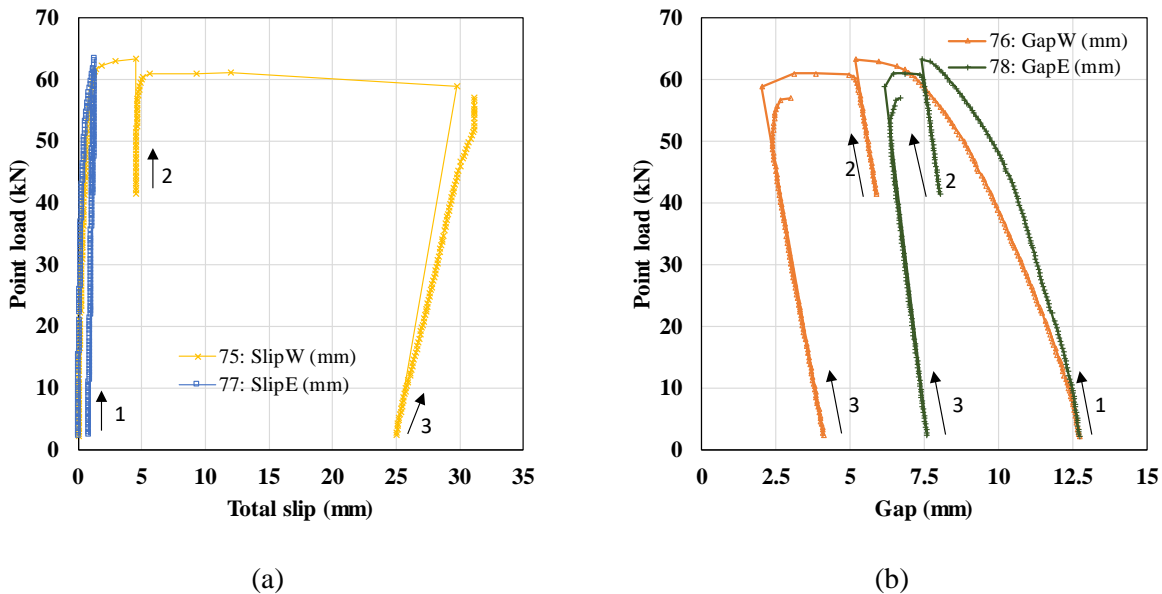
**Figure 5-4 (a) Slip between concrete slab and steel beam and (b) gap distance between sacrificial plate and beam web.**
