**NIST Technical Note 2054**

**Compartment Fire Experiments on  
Long-Span Composite-Beams with  
Simple Shear Connections  
Part 1: Experimental Design and Beam  
Behavior at Ambient Temperature**

This report, Part 1, presents details of the test setup, specimens, design basis of fire loading, instrumentation, and the behavior of the composite beam with double-angle connections at ambient temperature. The ambient temperature test indicated that the composite beam specimen failed by a shear stud near the west end, followed by concrete breakout failure and yielding of the steel beam. The measured moment capacity was approximately 80% of the calculated flexural strength. The double-angle connection at the west end failed by weld fracture, which caused collapse of the composite beam. The ambient behavior of the composite beam specimen presented herein will serve as a baseline to compare with the composite beam assemblies tested under combined mechanical loads and fire exposure, which are presented in a subsequent report; Part 2 (Choe et al. 2019). The datasets obtained from these tests provide technical information to advance performance-based design of composite floor assemblies in

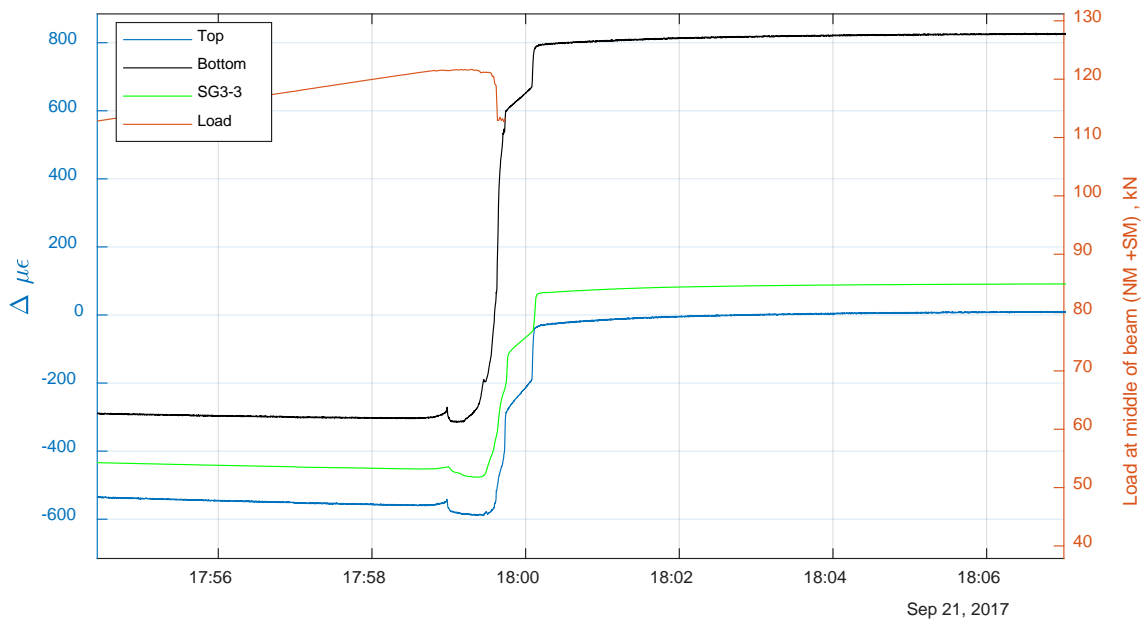
**Figure 5-10 First cracking measured by Fiber Bragg Grating sensor.**

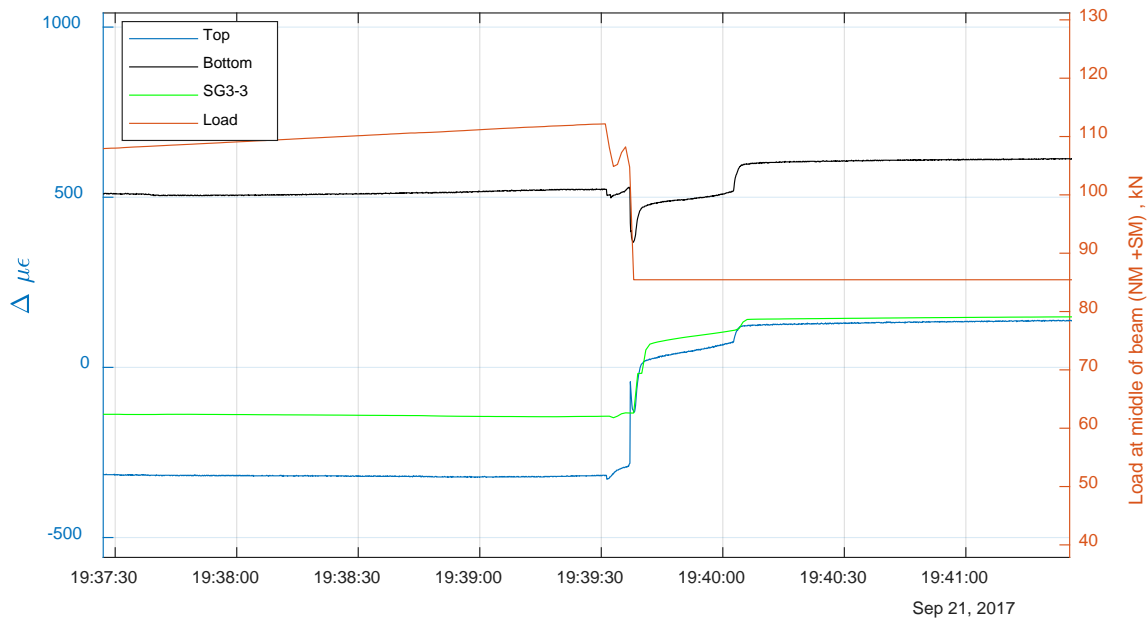
**Figure 5-11 Final cracking measured by Fiber Bragg Grating sensor.**

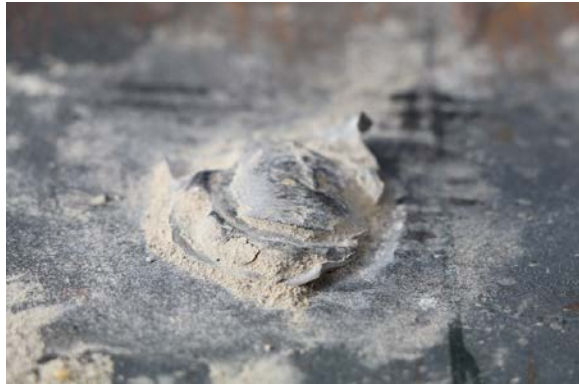
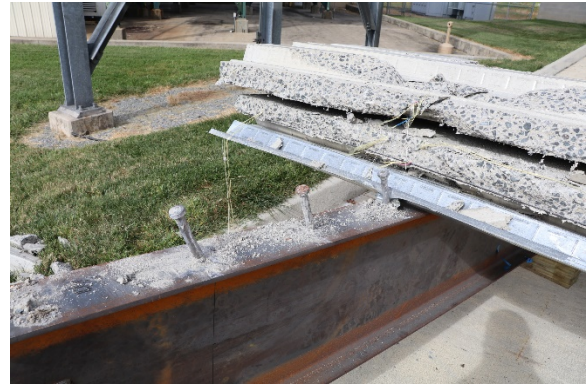
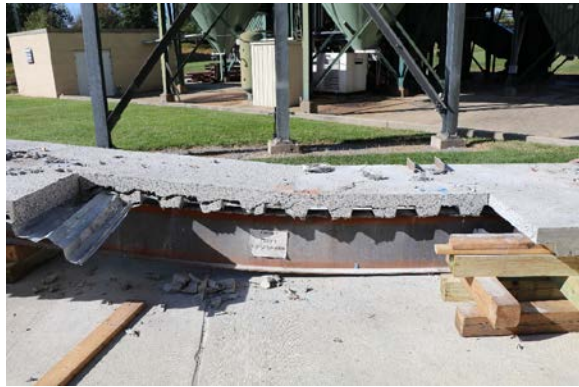
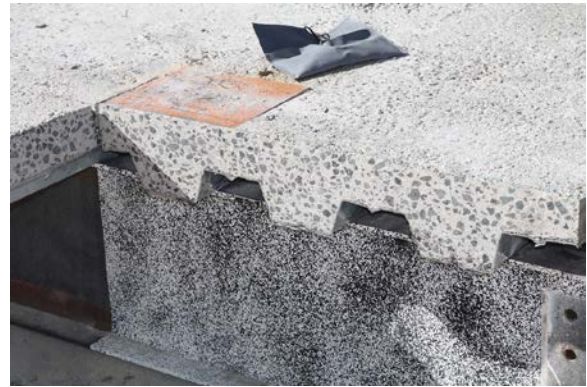
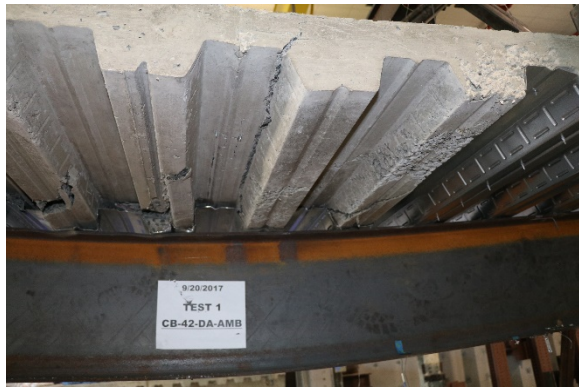
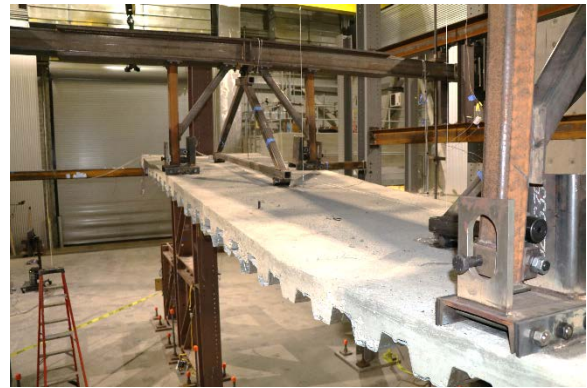
**Figure 5-12 (a) fracture of first shear stud at west end, (b) west side of specimen after concrete removal, (c) cut-section of concrete slab at midspan, (d) cut-section of concrete slab at east end, (e) exposed concrete at 1 m left of beam centerline, (f) deflected specimen after the test.**

Figure 5-12 and Figure 5-13 show photographs of the specimen taken after the test representing different failure modes of the specimen during the test. During Cycle 1, when the test specimen was subjected to a monotonically increasing bending moment about its strong axis, the specimen exhibited failure at the interface between the shear studs and the concrete at the west end. The load-displacement curve started plateauing at an average point load of about 63 kN when the shank of the first shear stud fractured as shown in Figure 5-12a. During Cycle 2, when the specimen was unloaded to about 40 kN and reloaded again, as the first shear stud had already fractured at the west end, the remaining shear studs in the west half of the specimen had to transfer the total shear between the concrete and steel in that region. Hence, the composite interaction failure quickly propagated from west end toward the midspan. As in Figure 5-12b that shows the west end of the specimen after concrete removal, shear studs deformed towards the west, in the direction of compressive forces from the concrete slab subjected to flexural loading. Figure 5-12c and Figure 5-12d show the cut sections of the concrete slab at midspan and at the east end, respectively. As shown, concrete breakout around the shear stud occurred in the west half of the specimen while no concrete breakout was observed in the east half of the specimen. As the west half of the beam lost the continuity between the beam and slab, plastic hinging formed in the critical section at the west support of the middle loading truss (about 1 m from the beam centerline). This region was subjected to the maximum bending moment and the bearing stress from the point load. The beam

failed by yielding and a flexural crack was developed through the depth of the concrete slab (Figure 5-12e). Figure 5-12f shows the deflected shape of the specimen. Crushing of concrete in the top of the slab was not observed. Figure 5-13a and Figure 5-13b show the connections at the west and east ends, respectively. During Cycle 3, the legs of the west angles welded to the column sacrificial plate were completely detached at the peak load of 57 kN, which was the same as the limit state of angle connections (i.e., weld shear) designed using the AISC design table. Figure 5-13b shows deformed angle legs on the column face and weld fracture at the top of the angle legs at the east angle connection.

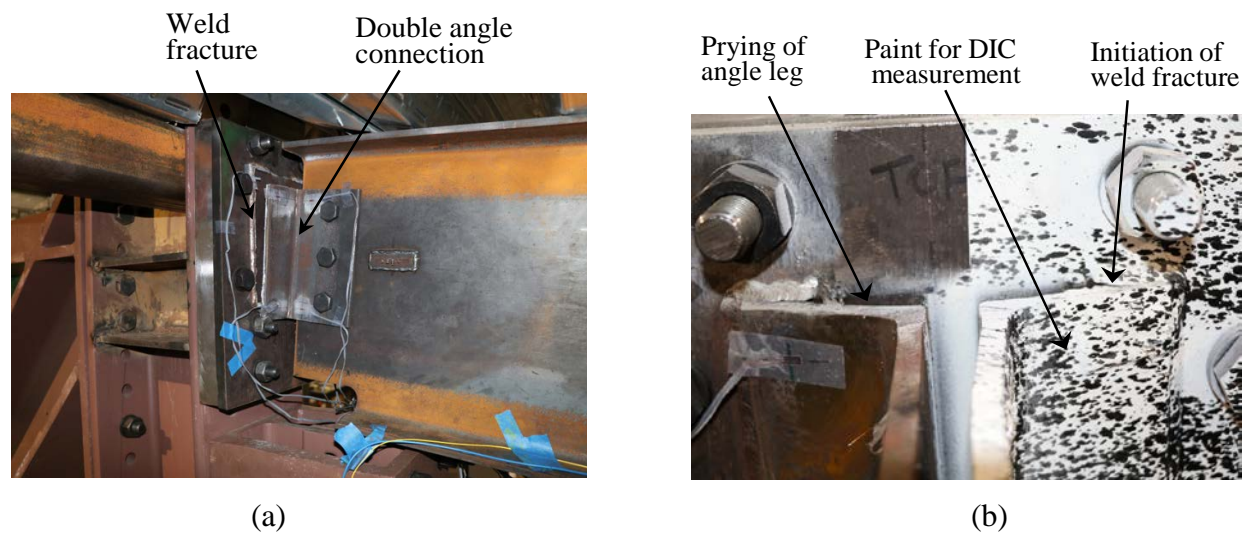
**Figure 5-13(a) west connection after the test and (b) east connection after the test. Paint pattern on right side of image (b) was used for Digital Image Correlation measurements (not reported here).**
