**NISTIR 8160**

**Influence of Fire on the Lateral Load  
Capacity of Steel-Sheathed  
Cold-Formed Steel Shear Walls**

**Report of Test**

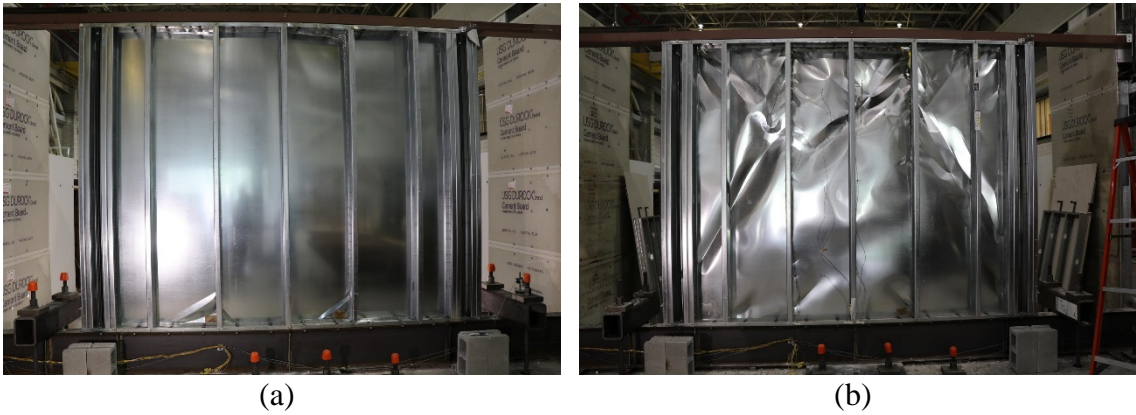
Figure 30: Photograph of back of metal sheathed side of wall after mechanical loading to 2.8 % drift; nonstructural gypsum removed: (a) unburned wall; (b) wall after burning.

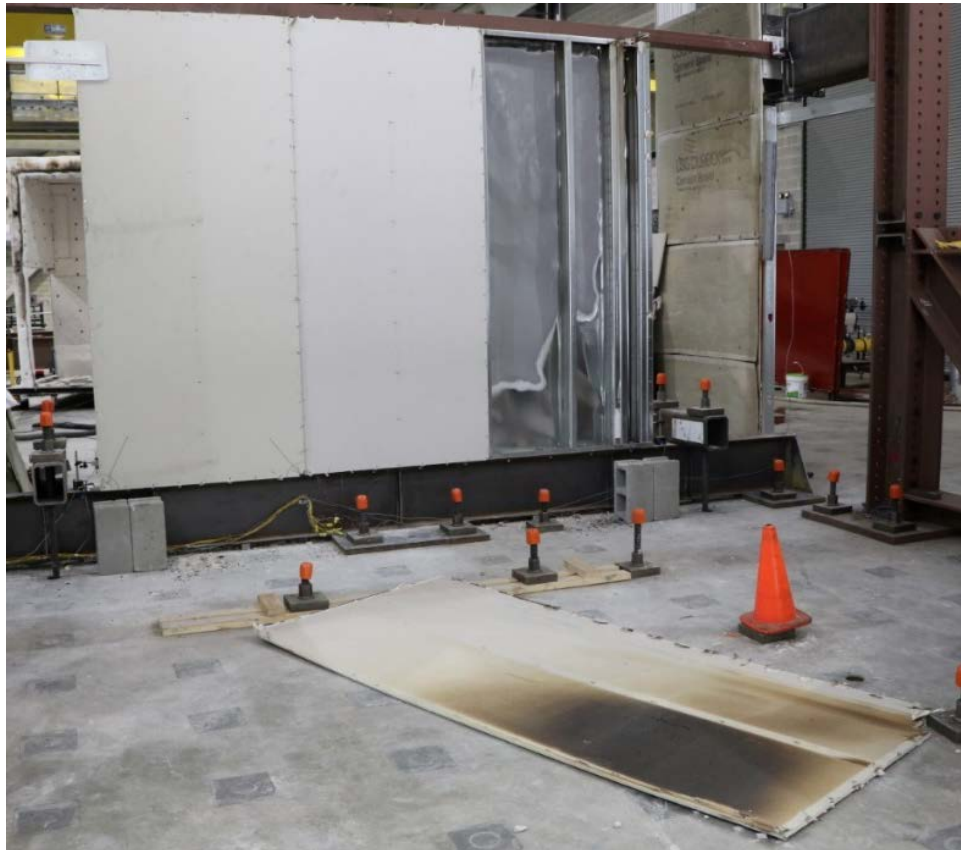
Figure 31: Photograph of back of metal sheathed side of wall after fire loading for 26m 40 s and mechanical loading to 2.8 % drift.

Doubling the burn time to 26 m 40 s caused additional reduction (11 % to 18 % in compression and tension, respectively) of the post-fire load capacity. This is believed to be

due to the damage to the nonstructural gypsum board on the unexposed side of the wall in the longer burn (Figure 31) which was not present in the shorter burn tests. However, additional testing is recommended to confirm this hypothesis.

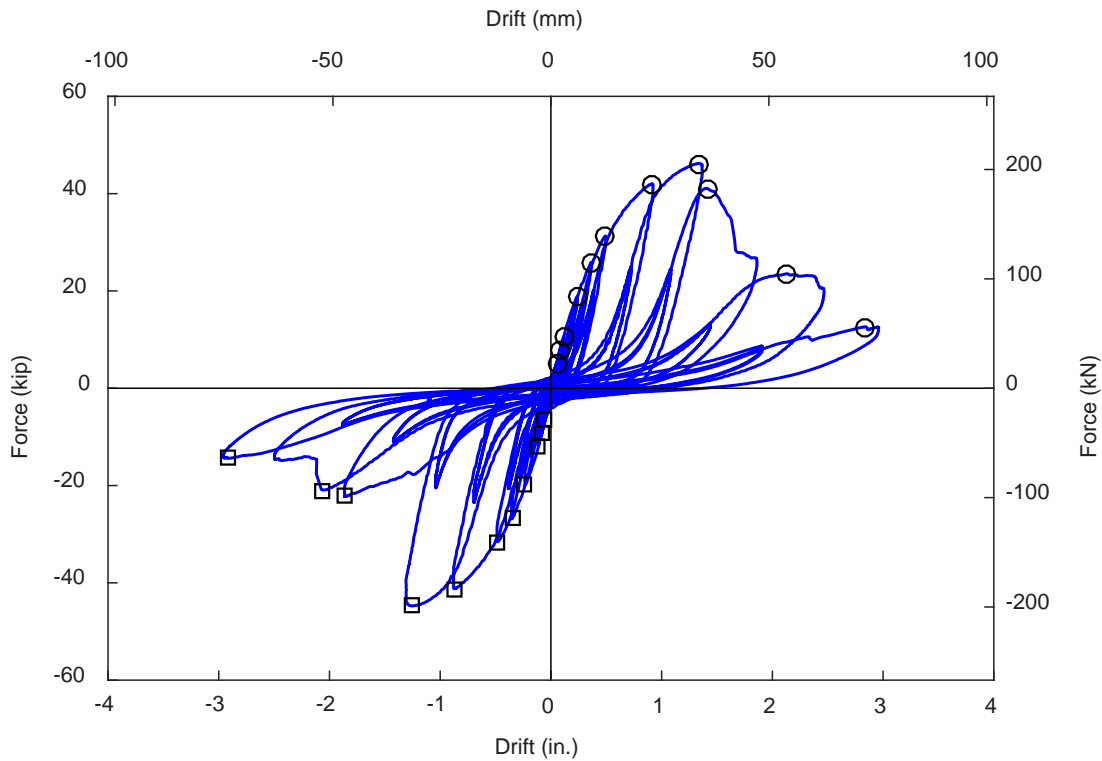
Figure 52: CFS02 - Lateral load (Actuator Force) versus drift (Disp\_Longitudinal\_SP) during mechanical loading.

- Stiffening of bottom framing beam (W16x26) resolved rolling problem observed in CFS01a. The top loading channel still flexed about  $\pm 1.5$  in. (38 mm) which allows for vertical movement of top of wall that may not be representative of the six-story building. Damage to the specimen was only visible during post-peak cycling; localized to panel seams. Upon removal of nonstructural drywall following the test, local buckling of sheet steel at bottom of wall was observed; primarily on north most panel. Numerous screws sheared ( $>25\%$ ) on nonstructural gypsum, however, no board fracture occurred.
- Uplift sensors were removed after 14 minutes to avoid damage to the sensors.
- Circles (squares) in the force versus drift figures indicate the peak compression (tension) load achieved at a given drift level.

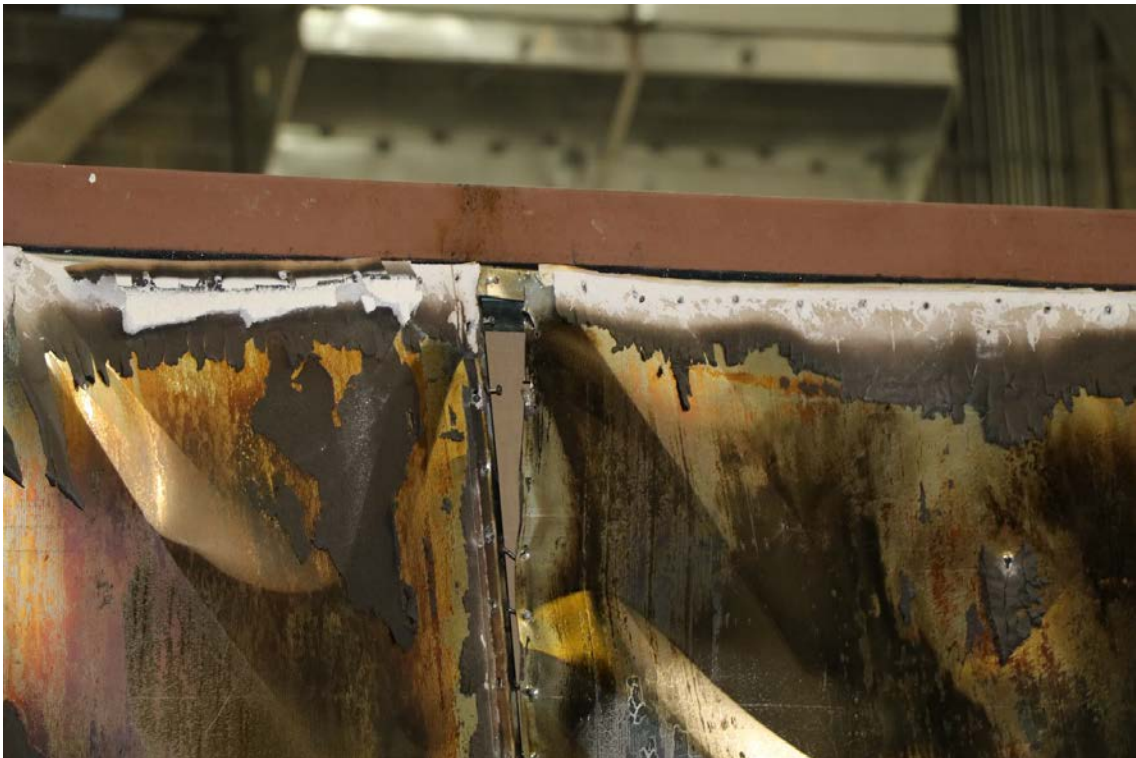
Figure 69: CFS03 – Photograph of metal sheathed side of the burned wall after mechanical loading to 2.8 % drift (CFS03c) highlighting tearing of sheet metal.

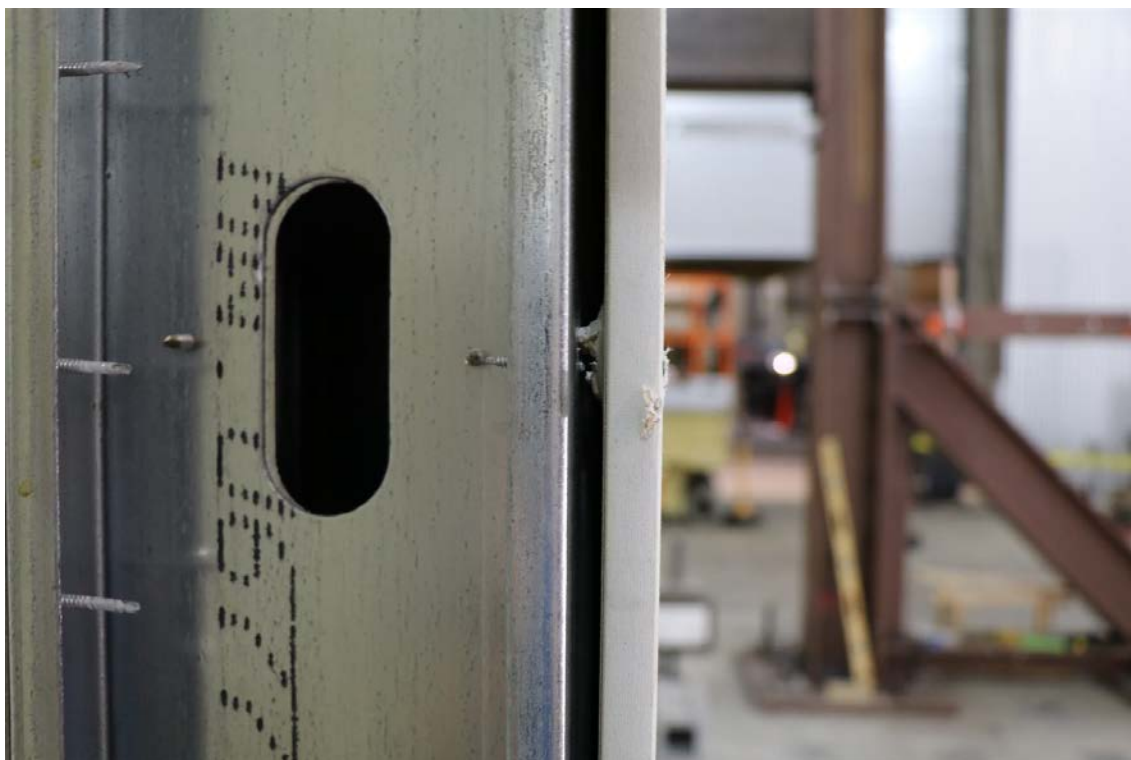
Figure 71: CFS03 – Photograph of gypsum sheathed side of wall after mechanical loading to 2.8 % drift (CFS03c) highlighting screw shearing.

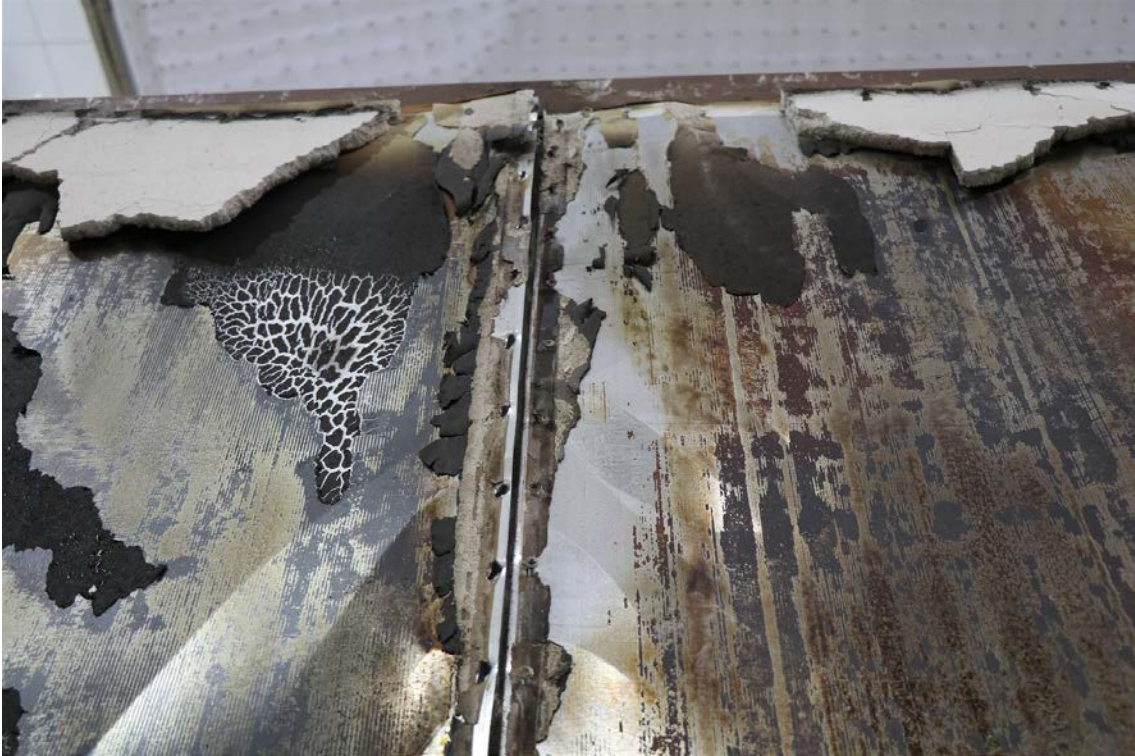
Figure 93: CFS05 – Photograph of metal sheathed side of the burned wall after mechanical loading to 2.8 % drift (CFS05b) highlighting sheeting damage.

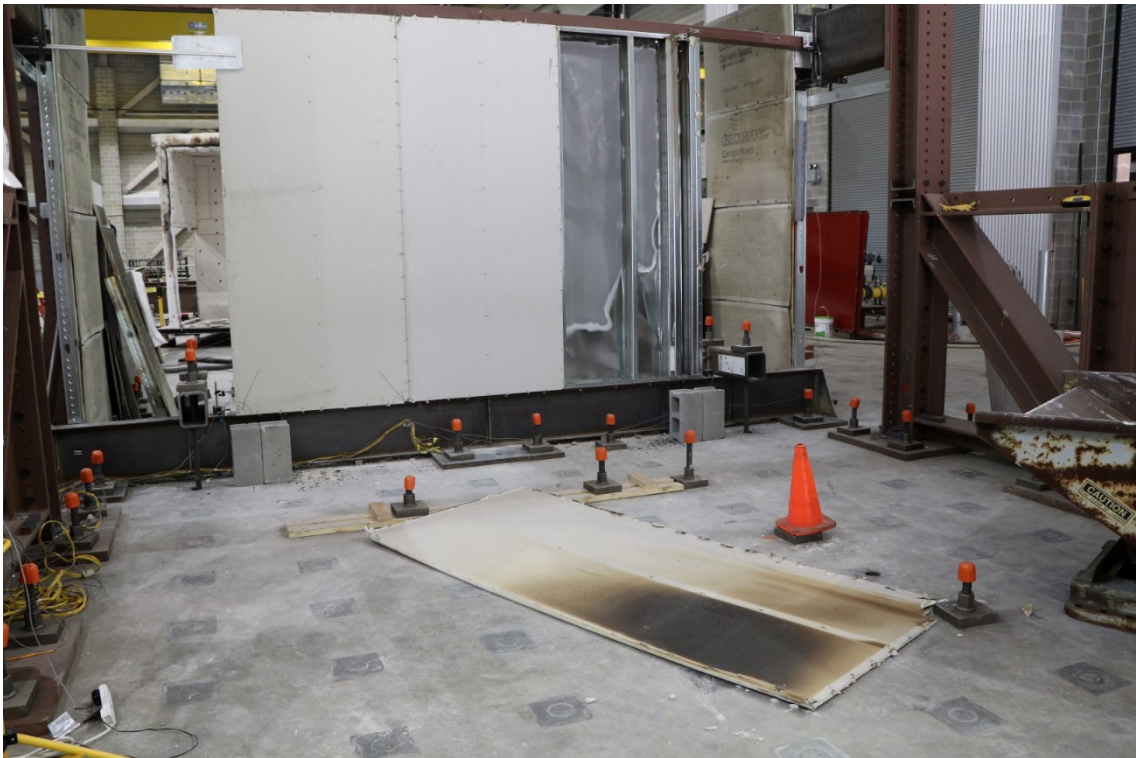
Figure 105: CFS06 – Photograph of back of metal sheathed side of wall after mechanical loading to 2.8 % drift (CFS06c) highlighting charring of gypsum board.
