89 We present in this manuscript a back analysis of the San Leo 2014 landslide with the objectives of better  
90 understanding the secondary instability phenomena developing at the edges of the plateau and recognition of the  
91 mechanisms acting on the slope in the medium- to long-term (i.e., decades to centuries). The Finite Element  
92 Method (FEM) code Phase2 (now called RS2, Rocscience Inc., 2014a) was used to simulate the event. This  
93 FEM code has been widely used to simulate similar slope failures. Styles et al. (2011) used Phase2 to back  
94 analyse the Joss Bay Chalk cliff failure where the progressive development of a wave-cut notch at the base of a  
95 coastal cliff was modelled using simulated model excavation stages. Sturzenegger and Stead (2012) used Phase2  
96 to model the Palliser Rockslide, Canada, as a stepped failure surface, while Kasmer et al. (2013) assessed the

## 126 **Case study: the San Leo lateral spread**

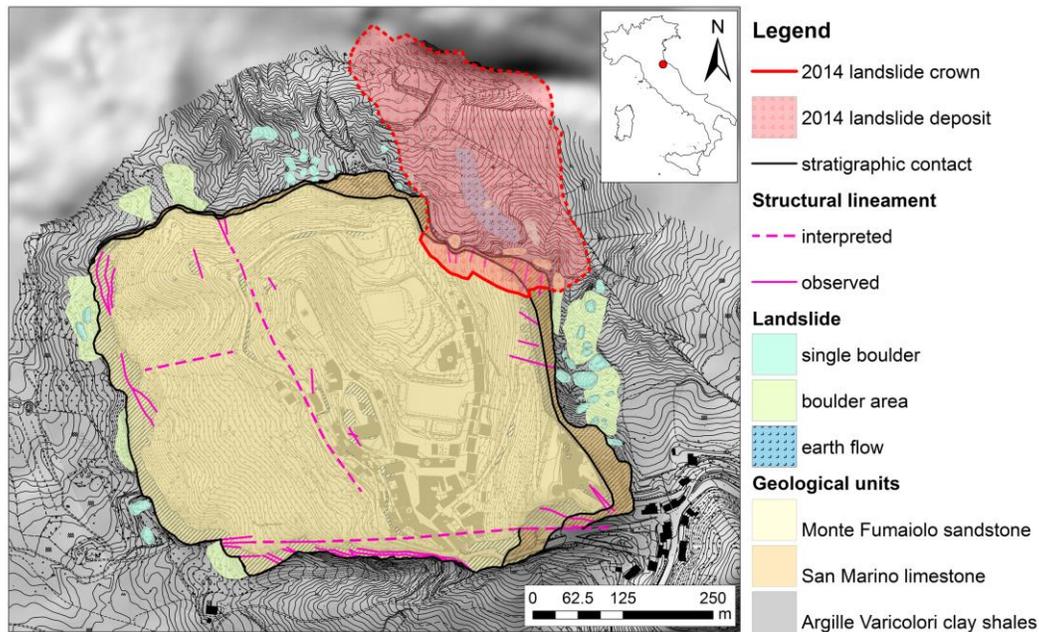
176 **Fig. 1** Pre-event geological and structural map of the San Leo rock slab, the red line shows the area involved in the 2014  
177 landslide (modified after Badioli, 2012).

153 In the San Leo slab (Fig. 1), a 500 m long and 600 m wide plateau, two units belonging to the Epiligurian  
154 domain can be recognised: the San Marino limestones and the Monte Fumaiolo sandstones, lying unconformably  
155 on the Argille Varicolori scaly clays. The whole slab has a general north-westward dip and is bordered by  
156 approximately 100 m high, sub-vertical and overhanging cliffs. The rock mass is highly fractured. In particular,  
157 the northern, eastern and southern sides of the slab show a higher degree of fracturing, while the western side is  
158 more massive (Spreafico et al., 2015d).

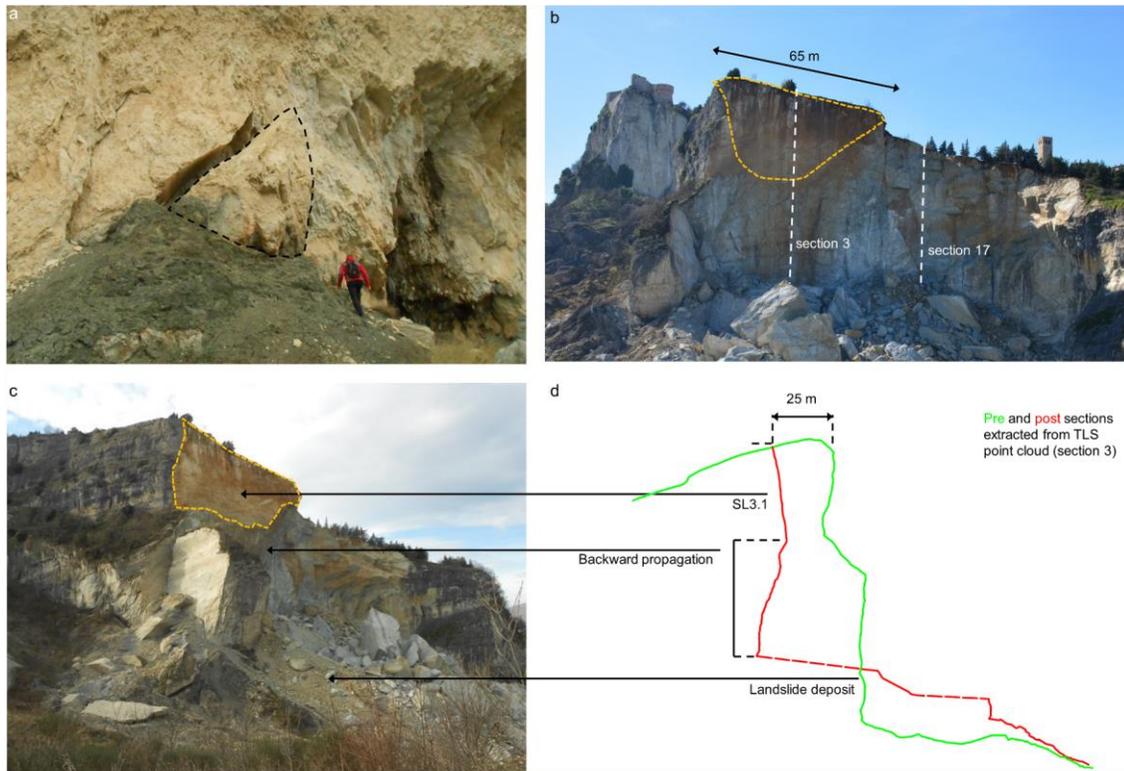
**Fig. 2.** Views and sections of the San Leo plateau a) rock wedge detachment observed in the area of the 2006 landslide; b and c) views of the landslide area: the dashed yellow line borders the discontinuity referred to as SL3.1; d) section 3 from TLS, shown in green is the pre-failure surface and in red the post-failure surface. For section 17 see Fig. 4. Section numbers are reported in Spreafico et al. (2015c).

200 On the 11<sup>th</sup> May 2006 about 50'000 m<sup>3</sup> of rocks detached from the northern side of the slab, causing the  
201 reactivation of an ancient earth flow at the base of the cliff. Laboratory and in-situ tests were performed on the  
202 clayey terrains. In particular an upper layer (1-3 m thick) with reduced mechanical properties, with respect to the  
203 deeper layers, was recognized. Moreover, during field surveys conducted in 2014 in the same areas, several rock  
204 detachments were observed, especially at the base of the cliffs (Spreafico et al., 2015d). In these areas no  
205 erosional features have yet developed. The phenomena mostly comprised wedge failures involving at least two  
206 pre-existing joint-sets (Fig. 2a). They are always associated with the presence of the softened clay shale layer,  
207 along which the wedges can slide (Fig. 2a). The pre-existing joint sets act as lateral release surfaces for the

211 On 27<sup>th</sup> February 2014 a failure occurred in the north-eastern cliff involving a volume of about 330'000 m<sup>3</sup> of  
212 rock. After the event, a major pre-existing discontinuity plane, about 65 m long and 40 m wide, was recognized  
213 in the upper part of the landslide scarp (discontinuity SL3.1 in Fig. 2b and c). From observations of the  
214 weathering of the surface, it is suggested that this discontinuity was probably already open before the failure.  
215 Several field surveys conducted after the landslide allowed discontinuities with similar orientation to be  
216 identified in the area bordering the north-eastern cliff and showed a mean spacing of about 20-22 m (Enser srl,  
217 2014). In the lower area of the landslide scarp, the failure seemed to propagate along smaller minor joints and  
218 through the fracture of intact rock bridges, showing a backward-propagation (Fig. 2d, red line). Terrestrial Laser

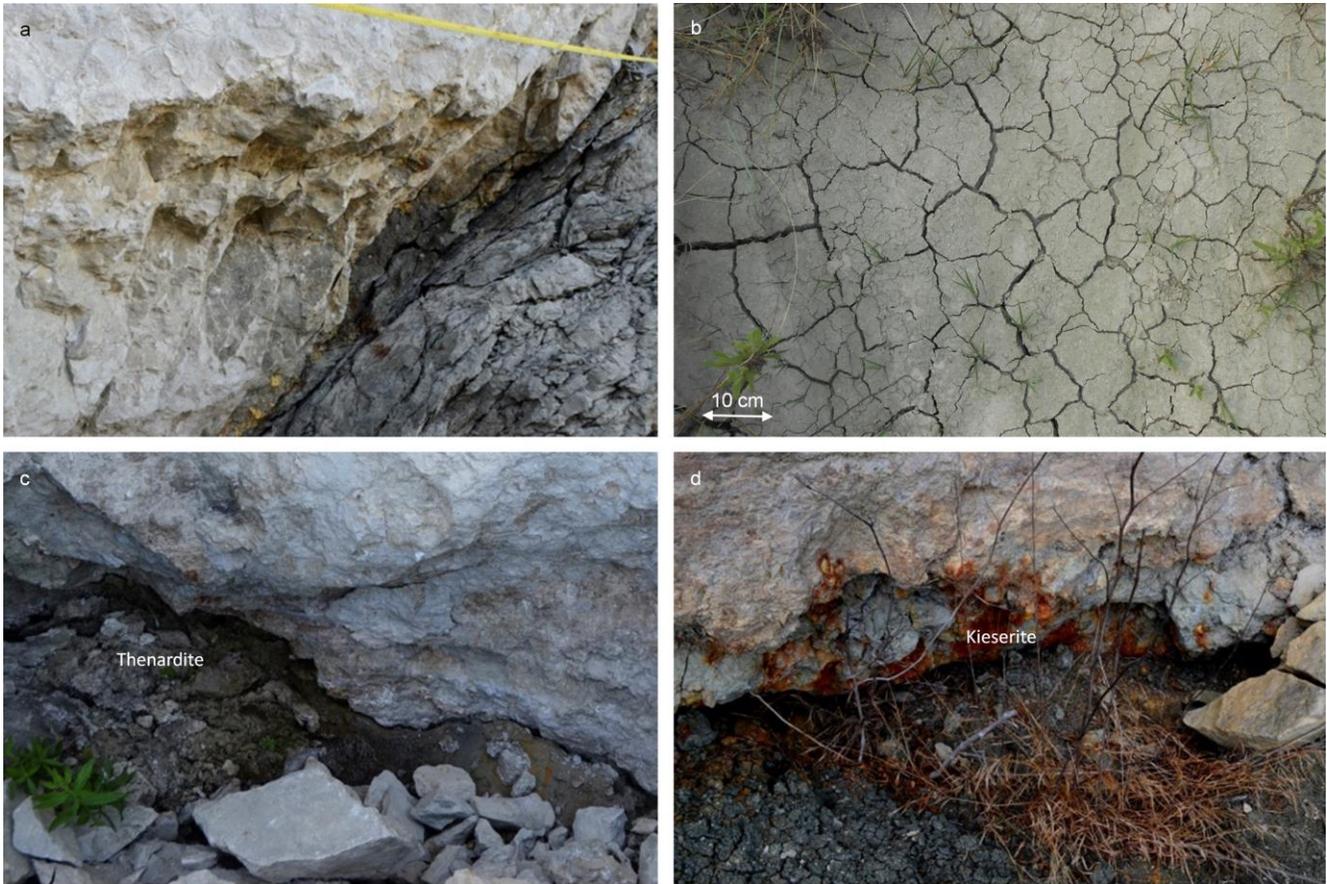
255 **Fig. 3.** Photographs of the clay shales outcropping in the San Leo area: a), c) and d) at the contact with the rock slab at the  
 256 base of the northern cliff; b) example of shrinkage-induced cracks in the proximity of the 2006 landslide deposit.

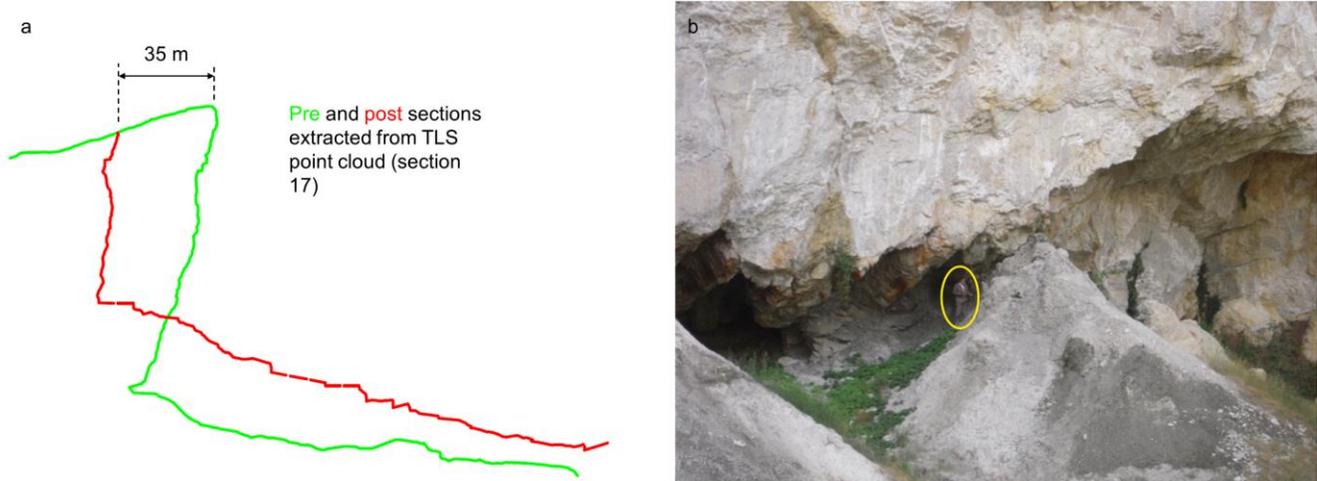
370  
371 **Fig. 4. San Leo 2014 event:** a) section 17 from TLS, shown in green is the pre-failure surface and in red the post-failure  
372 surface are shown. For the trace section see Fig. 2b; b) pre-failure photographs showing the undermining at the base of the  
373 cliff and in the yellow circle a person for scale (Photograph courtesy STB Romagna).

362 and analysed: the first has been selected as the most overhanging slope (section 17, Fig. 4a), while the second is  
363 representative of the pre-failure geometry (section 3, Fig. 2d). Section 17 was used to back-analyse the rock  
364 parameters, assuming that, prior to the failure, the factor of safety should have been larger than 1. A Shear  
365 Strength Reduction (SSR), approach was used with gradual reduction of the strength parameters of the materials,  
366 until failure was reached. A Strength Reduction Factor (SRF) lower than 1 means that the slope is not stable. The  
367 application of this method has been discussed by several authors including Hammah et al., (2005), Diederichs et  
368 al., (2007) and Hammah et al., (2007). The resulting parameters (Table 1) were subsequently used to perform the  
369 simulations on the most representative section (section 3).

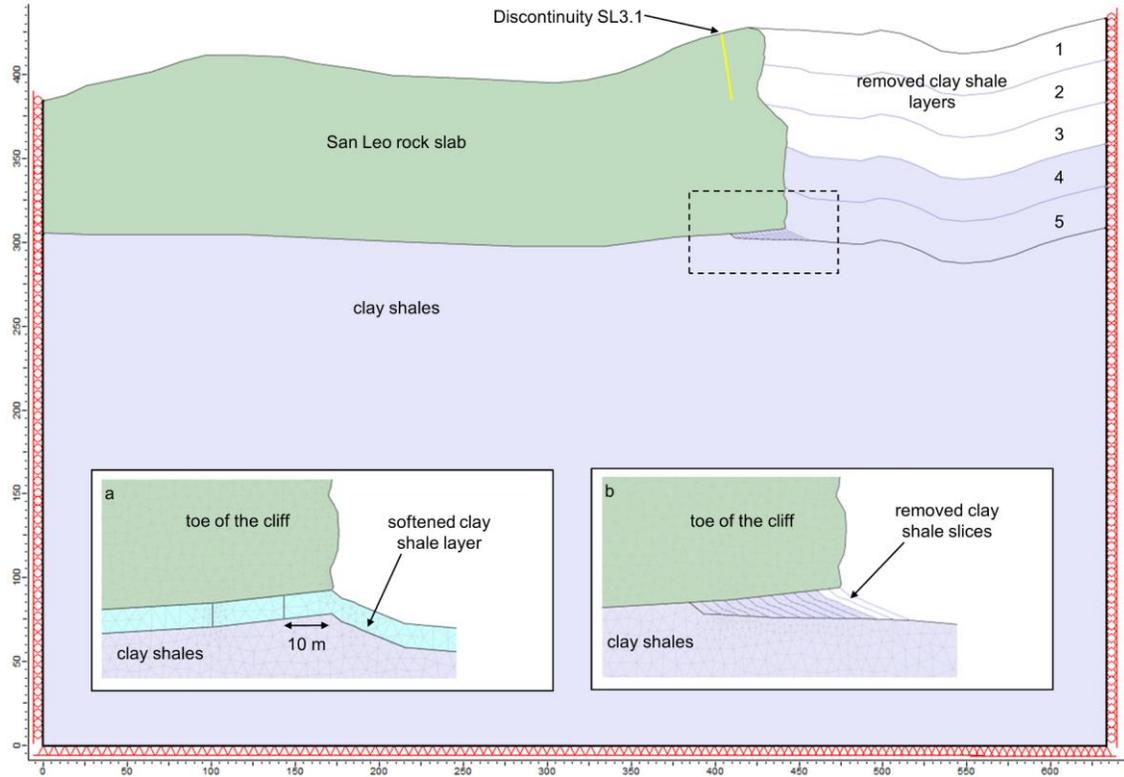
375 The FEM simulations shown in Fig. 5, were performed on the San Leo section 3. For all simulations, the initial  
376 steps consisted of the gradual removal of 5 clay shale layers from the top of the model. As suggested by  
377 Bozzano et al. (2008), this approach allows simulation of the recent evolution of a slope and the related stress  
378 history, i.e. the differential erosion (Fig. 5, step 1 to 5), acting mostly on the softer clay shale unit with respect to  
379 the structural surfaces of the rocky slab. An additional simulation was conducted, including the progressive  
380 removal of vertical layers from the border of the slab in order to simulate the effects of previous rock  
381 falls/topples, similar to the one that occurred in 2014; no significant differences were detected with respect to the  
382 first approach for the purpose of the presented analyses.

The modelling scheme consists of several steps in order to simulate the erosional processes driven by groundwater seepage (Fig. 5b). In particular, elongated clay shale slices of 2.5 m were progressively removed starting from the toe of the cliff. The role of the pre-existing discontinuity SL3.1 was analysed through comparative simulations in which it was either omitted or included. An SSR approach was then used, to calculate the SRF for each model step. A SSR Search Area option was adopted which allows focusing of the failure surface search within a particular region of the model, i.e. the area located at the border of the slab; the results allowed the degree of erosion to be correlated with the stability of the slope.

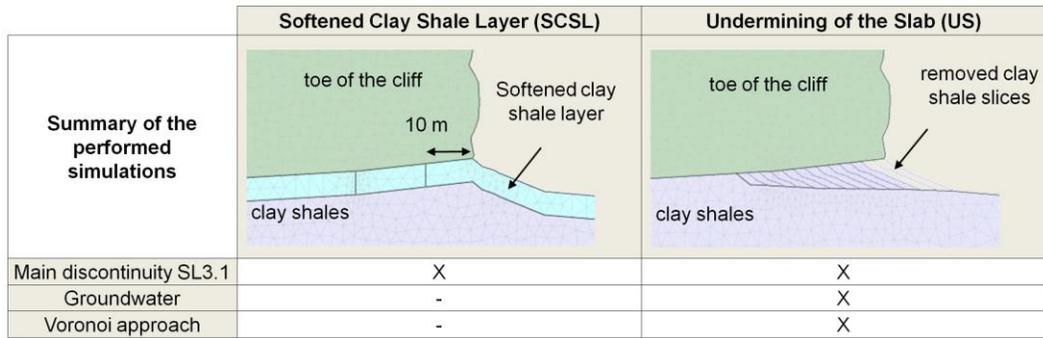
Fig. 6. Schematic illustration showing the types of simulations performed.

All simulation results were compared with the information collected during geomorphological surveys and TLS data. In particular the TLS post-failure surface was used to validate the numerical results. A summary of the simulations is illustrated in Fig. 6, where the influence of the insertion of the main discontinuity SL3.1 was studied for the two main potential causes of slope failure: 1) the presence of a Softened Clay Shale Layer (SCSL) and 2) the Undermining of the Slab (US). The influence of variations in the groundwater level and the effect of the water pressure acting on the main discontinuity were taken into account in the US model only. In all previous simulations the jointed rock mass was treated as an equivalent continuous medium, i.e. the discontinuities were inserted implicitly (except for discontinuity SL3.1). The Voronoi approach implemented in the US model incorporated a simplified Discrete Fracture Network, DFN, in order to explicitly simulate the discontinuities, both the pre-existing joints (simulated through the simplified DFN) and the intact rock fractures, represented by the sides of the Voronoi polygons.

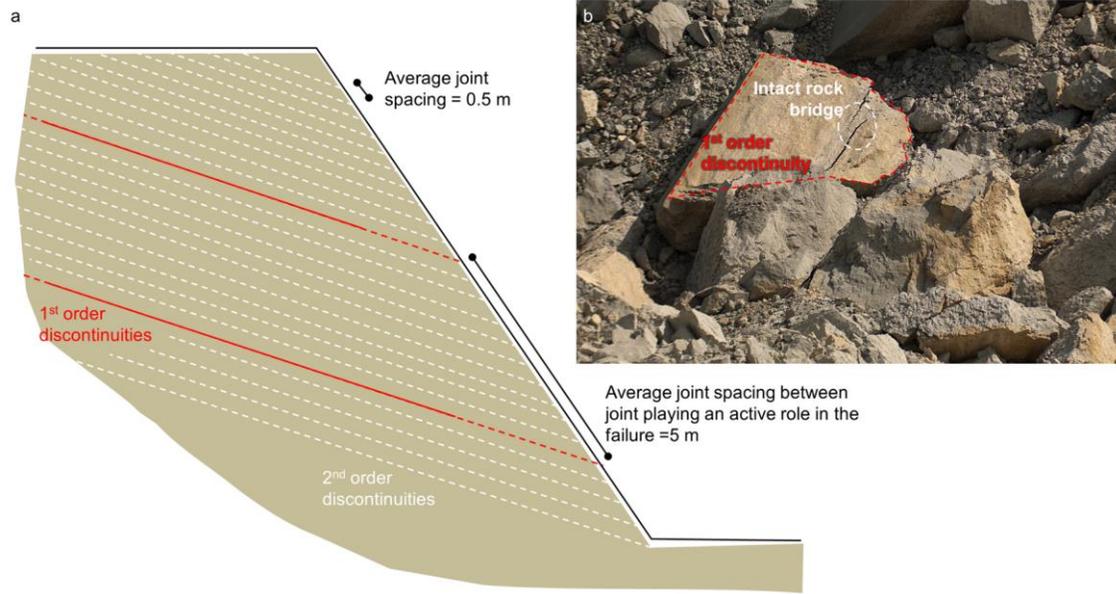
**Fig. 7.** Discontinuity characterization: a) sketch of a conceptual slope illustrating the difference between the average joint spacing measured in the field and the effective joint spacing of the discontinuities actively involved in the actual failure mechanism; b) example of 1<sup>st</sup> order discontinuity and of second order discontinuities, interrupted by intact rock bridges, in the deposit of the 2014 San Leo landslide.

477 To consider only those fractures actively involved in the failure, the spacing was assumed on the basis of the  
478 average post-failure block dimensions, assuming that the edges of these blocks can be considered as 1<sup>st</sup> order  
479 discontinuities.

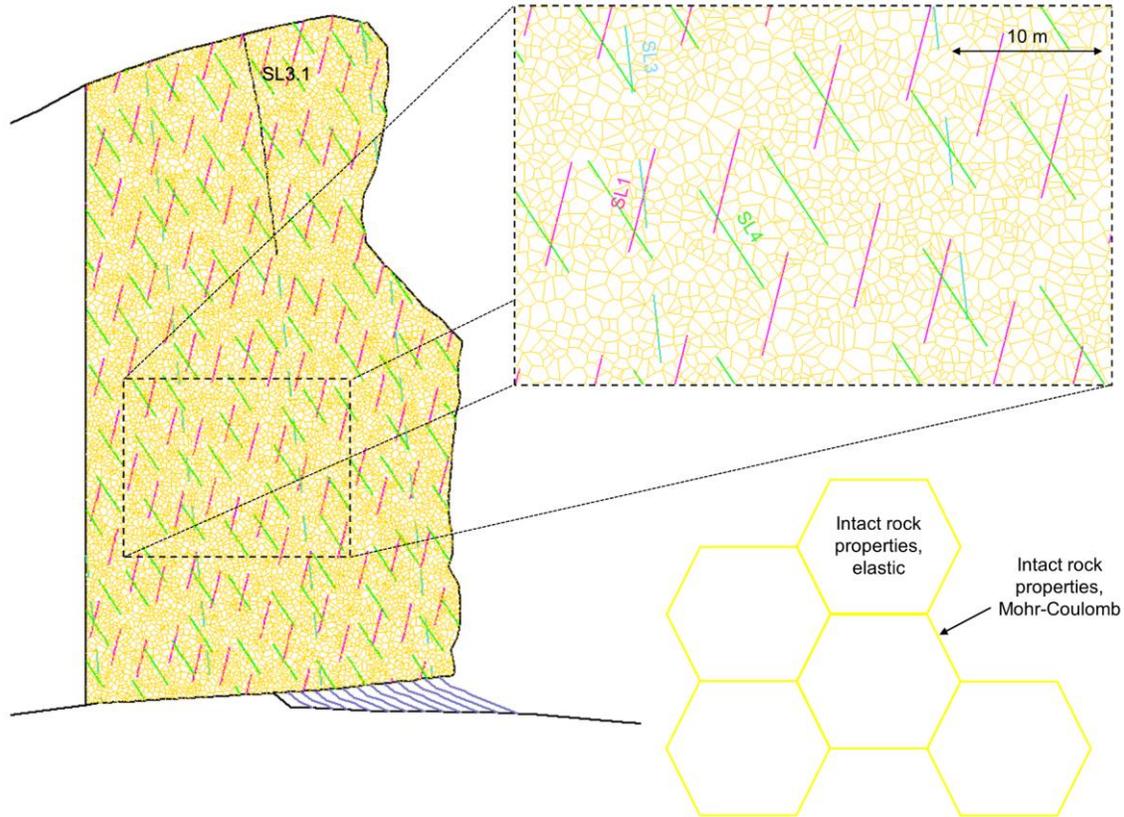
498  
499 **Fig. 8.** Geometry of the Voronoi network (in yellow) and of the simple DFN. Shown in magenta, blue and green are  
500 discontinuities belonging respectively to the discontinuity sets SL1, SL3 and SL4 (persistence equal to 50%).

Three joint networks, each representing one of the joint sets, were introduced into the Phase2 model, using parallel deterministic networks. This simplified Discrete Fracture Network (DFN) was implemented with the aim of evaluating the interaction between the pre-existing discontinuities and their propagation through the intact rock matrix. Using the parallel deterministic network it is possible to choose an infinite joint length, or to specify persistence, defined as the ratio of the joint length to total length along the joint plane. Three scenarios were simulated, varying the persistence of the pre-existing discontinuities between 25, 50 and 75%. Different simulations were performed for each of these scenarios, to account for the probabilistic nature of the DFN generation. The Voronoi contacts were characterized with the same properties of the rock mass, to allow the simulation of the rock mass fracturing. The use of the Voronoi logic allows a more realistic simulation of slope failure and shows fracture initiation and propagation during slope failure (Vivas Becerra, 2014).

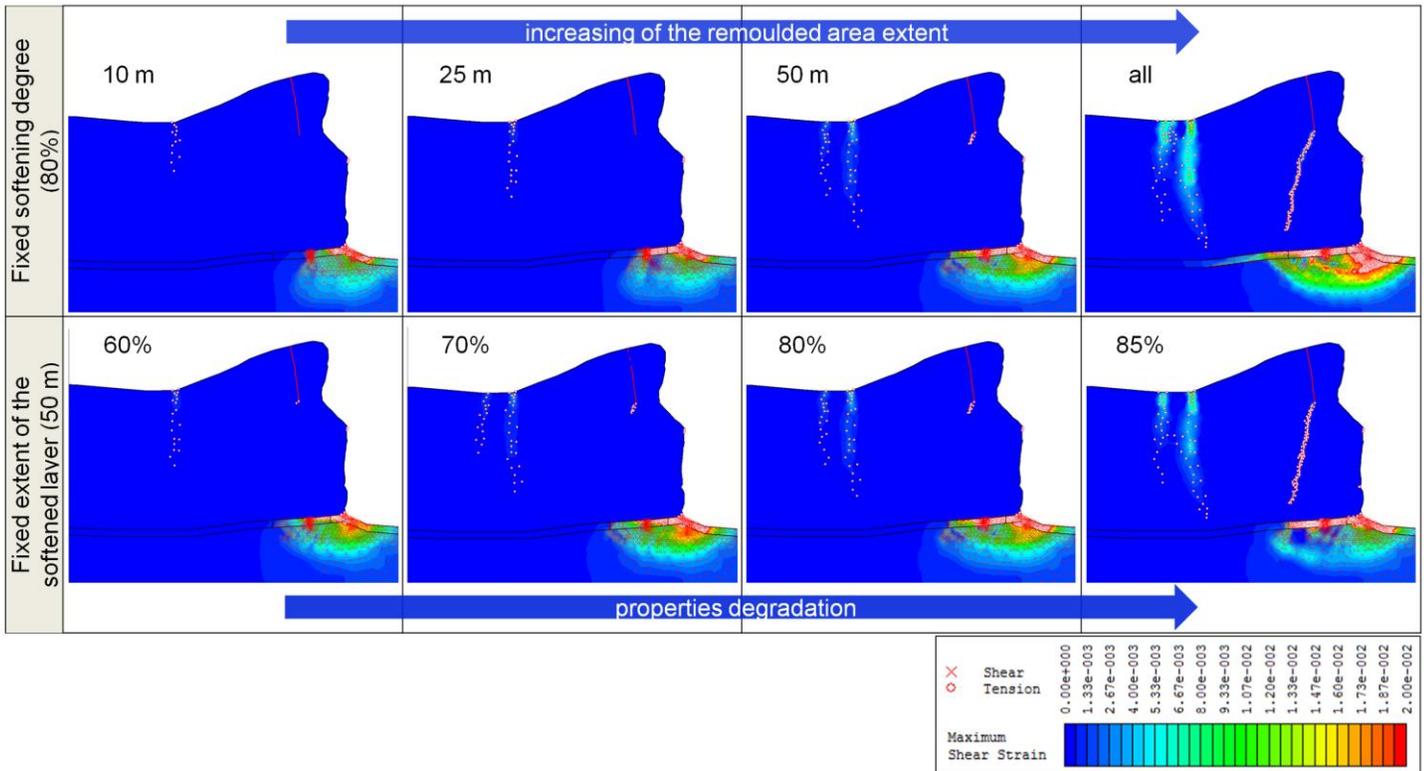
541 **Fig. 9.** Results of the SCSL simulations. Upper row: Degree of softening fixed and increasing length of extent of the  
 542 softened layer (from left to right); lower row: fixed length of extent of softened layer and lowering of the mechanical  
 543 properties of the layer (from left to right)

512 Various degrees of softening and different lengths of in-slope extent of the softened clay shales layer were  
513 investigated. Analyzing the maximum shear strain values and the yielded elements (i.e. mesh elements which  
514 failed in shear or tension) it is possible to recognize which combination of parameters was critical for the onset  
515 of slope instability. In Fig. 9, the most relevant simulation results are shown. In the upper row of fig, 9 the  
516 alteration degree was fixed at 80 % of the initial values, while the lateral extent of the softened layer was  
517 increased in length. The slope reached a critical state when the softened layer was extended under the entire  
518 length of the slab. Simulations carried out using a reduced extent of the softened layer (5, 10 and 50 m,  
519 respectively) do not simulate slope failure. The lowering of the clay shale properties appeared to trigger tensile

520 failure in the upper area of the slope and the propagation of the discontinuity SL3.1 when the layer was extended  
521 a length of 50 m under the slab. In the simulations represented in the lower row (Fig. 9) the extent of the layer  
522 was fixed at 50 m, and clay shale properties gradually changed. The elements located near the failure surface  
523 seem to yield when the initial clay shale properties were reduced by 85 %. The shape of the failure detachment

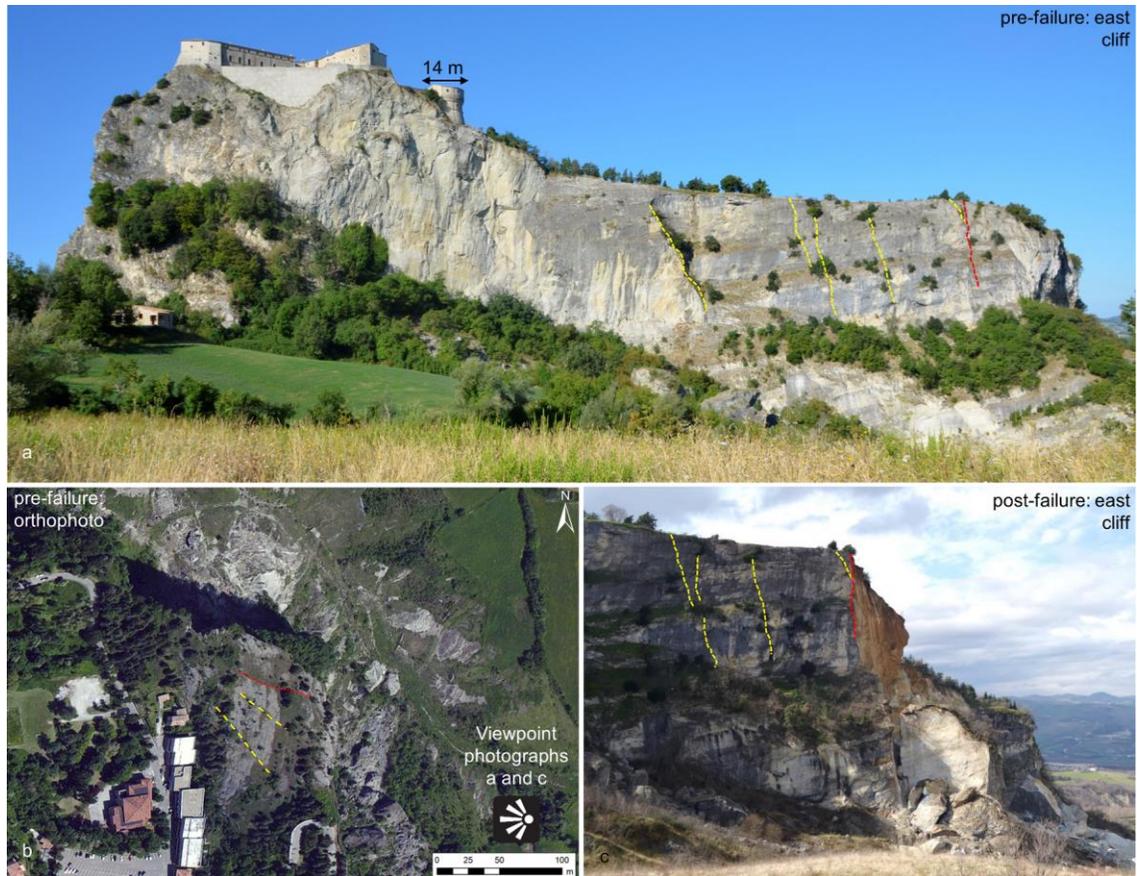
544  
 545  
 546 **Fig. 10.** Views of the east cliff, before (a, b) and after (c) the 2014 failure. SL3.1 is shown as a red dotted line;  
 547 discontinuities having an orientation similar to SL3.1 are highlighted as yellow dotted lines. b) Orthophoto of the NE cliff  
 548 (Bing), the yellow dotted lines indicate discontinuities (detected also in the field) while the evidence interpreted as the  
 549 discontinuity SL3.1 is indicated with a red dotted line.  
 550

524 surface was correctly reproduced by the model, showing the backward propagation in the lower sector of the  
 525 scarp. Areas with higher tensile strain displaying a vertical shape were detected at the top of the slab, about 100  
 526 m to the rear of the cliff. Similar features were recognized in the field, both pre and post-failure, as shown in Fig.  
 527 10.

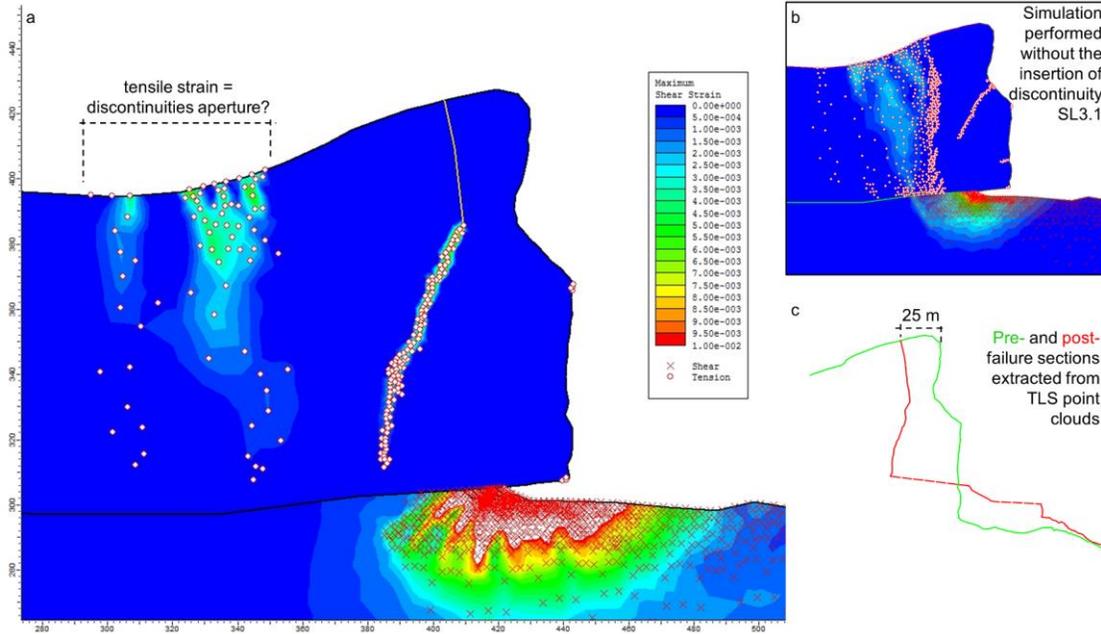
*Fig. 11. Results of the US simulations: a) Maximum shear strain measured at stage 14; b) US model results with no pre-existing discontinuities; c) Pre- and post-landslide sections extracted from TLS point clouds*

505 Both the SCSL and US simulations performed without the insertion of the discontinuity SL3.1 at the top of the  
506 slope, showed a failure pattern that did not agree with field observations on the San Leo 2014 failure. In this  
507 case, a larger volume of rock mass was involved in the failure and the backward propagation of the failure  
508 surface was not reproduced. The insertion of the discontinuity resulted in the simulation of a failure surface that  
509 agreed very closely to that measured with the TLS post 2014 San Leo failure; a comparison is shown in Fig. 11.

552 In the US simulations the strain propagation also initiates from the lower part of the discontinuity SL3.1 and  
 553 propagates down- and backwards (Fig. 11a). The SRF for each stage of the simulation are plotted against the  
 554 meters of clay shale removed, e.g. the degree of undermining. The critical SRF = 1 is reached at between 22.5  
 555 and 25 m of excavation (Fig. 12). Tensile strain is recorded in the inner part of the slab, probably also including  
 556 the effects of increase in joint aperture. As anticipated, displacements and yield in the clay shales are mostly  
 557 recorded in the first stages of the simulation, i.e. reproducing the recent evolution of the slope and the related  
 558 stress history (stage 1 to stage 5). However, additional shear yielding and movements can be correlated to the  
 559 overburden load of the slab. In stage 6 the weight of the plateau is supported by a continuous clay layer, while in

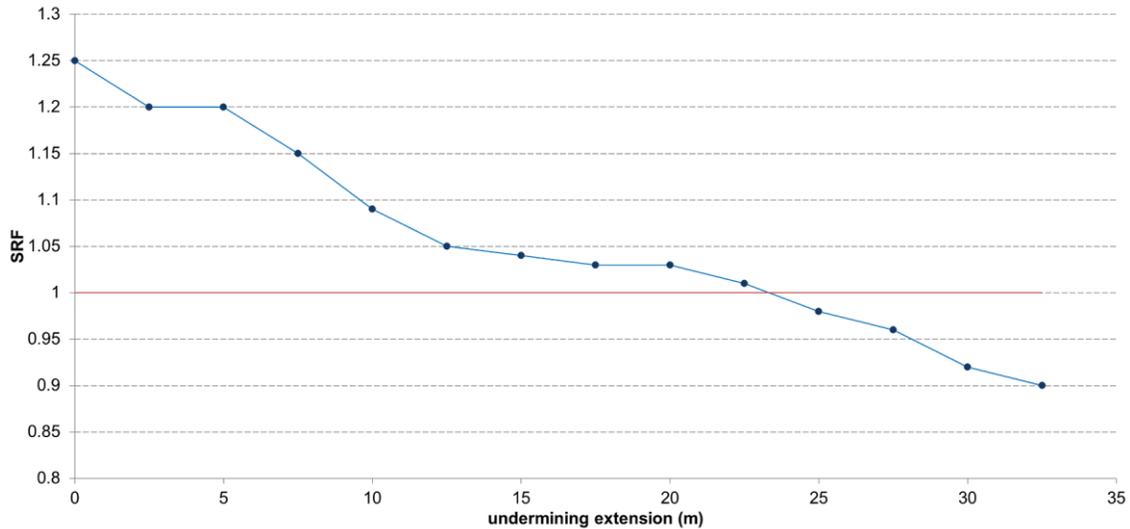
*Fig. 12 SRF for each stage of the simulation, plotted against the length in meters of removed clay shales*

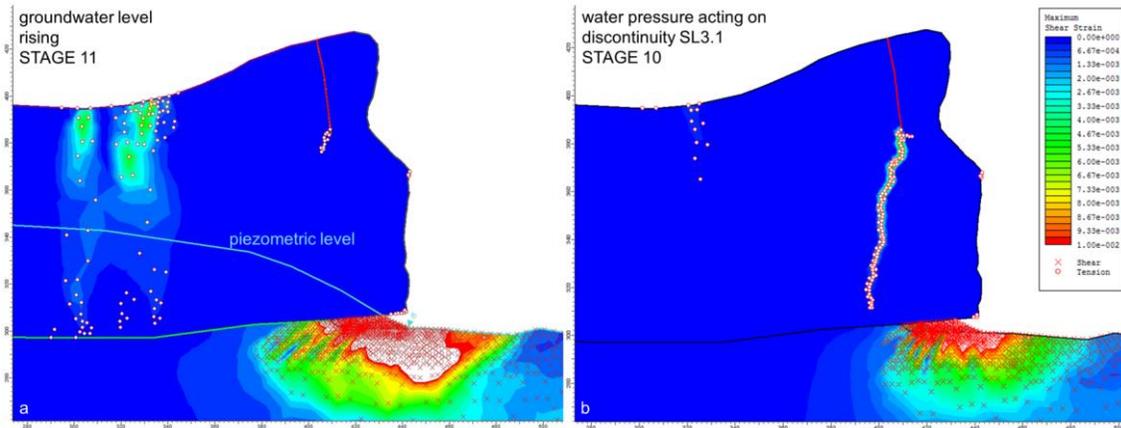
584  
585 **Fig.13.** Results of the evaluation of the groundwater effects in the US simulation: a) effects of the rise in groundwater level  
586 (about 4 m) at the 11<sup>th</sup> stage of the simulation; b) effects of the water pressure acting on discontinuity SL3.1  
587 of the simulation

The insertion of the elevated piezometric line in the US simulation (Fig. 13a) led to a general deterioration in the stability conditions of the slope. In particular, in the model without the insertion of the piezometric line, the failure developed at stage 15 (about 22.5 m of undermining) while, taking into account the piezometric line, the failure developed at stage 12 (about 15 m of undermining). Thus, the groundwater level increase was simulated at the 11<sup>th</sup> stage. As shown in Fig. 13a, the results of the simulation highlight that this process alone was not sufficient to trigger the instability. The water pressure acting on the main detachment discontinuity (Fig. 13b) can be considered a probable triggering factor. In fact, as illustrated in Fig. 13b, the inclusion of water pressure led to the failure at stage 10 (about 10 m of undermining). It should be noted that modelling the rise in groundwater level alone does not allow the role of water flow in terms of weathering and erosion to be assessed. In fact, an increase in groundwater level might imply an effective increase of water seepage velocity and thus an

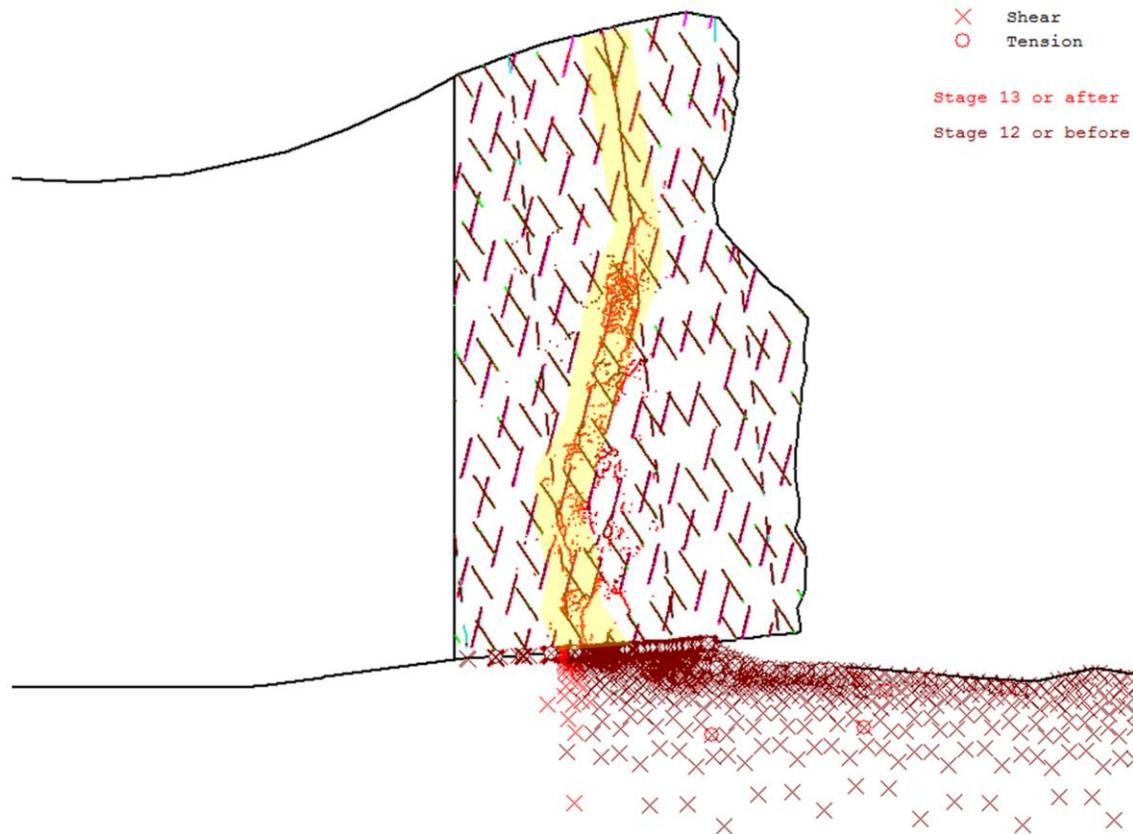
604 **Fig.14.** Results of the Voronoi simulation, shown in red are the joints yielded at the failure stage and in dark red the joints  
 605 yielded at previous stages of the simulation. Non-yielded joints are represented with their original colour (green, magenta  
 606 and blue). Failures in the clay shale substratum are only partially shown, for visualization purposes.

597 simulated. Finally, results of the simulation performed using a joint persistence of 50% are shown in Fig. 14. The  
598 failure surface follows the main joint in the upper area of the cliff. In the lower portion both the joints belonging  
599 to the simple DFN, e.g. the pre-existing joint sets and the Voronoi joint network are involved in the slope failure.  
600 The results are representative of the actual failure surface. The different simulations performed for the last  
601 scenario (joint persistence = 50%) suggested that, in addition to the joint persistence, the positions of the pre-  
602 existing joints also plays a role in the definition of the critical degree of undermining for slope failure.

607 The Voronoi approach allowed highlighting of the fracture propagation through the intact rock mass and  
 608 interaction with the pre-existing joints and also more realistic simulation of the detachment mechanisms. Some  
 609 fracture of intact rock bridges can also be seen in areas not directly involved in the slope failure phenomena,  
 610 probably related to boundary induced effects developing between the area with and without the Voronoi-  
 611 network, or to the tensile stress developed in the inner part of the slab, visible also in the previous simulations.
